National Register of Historic Places  
Registration Form

historic name Downer Methodist Episcopal Church

state New Jersey code NJ county Gloucester code 015 zip code 08094

name/title Sheila K. Koehler, Senior Preservation Specialist (minor revisions by NJHPO, February 2010)  
organization Westfield Architects & Preservation Consultants date July, 2009  
street & number 425 White Horse Pike telephone 856-547-0465  
city or town Haddon Heights state NJ zip code 08035

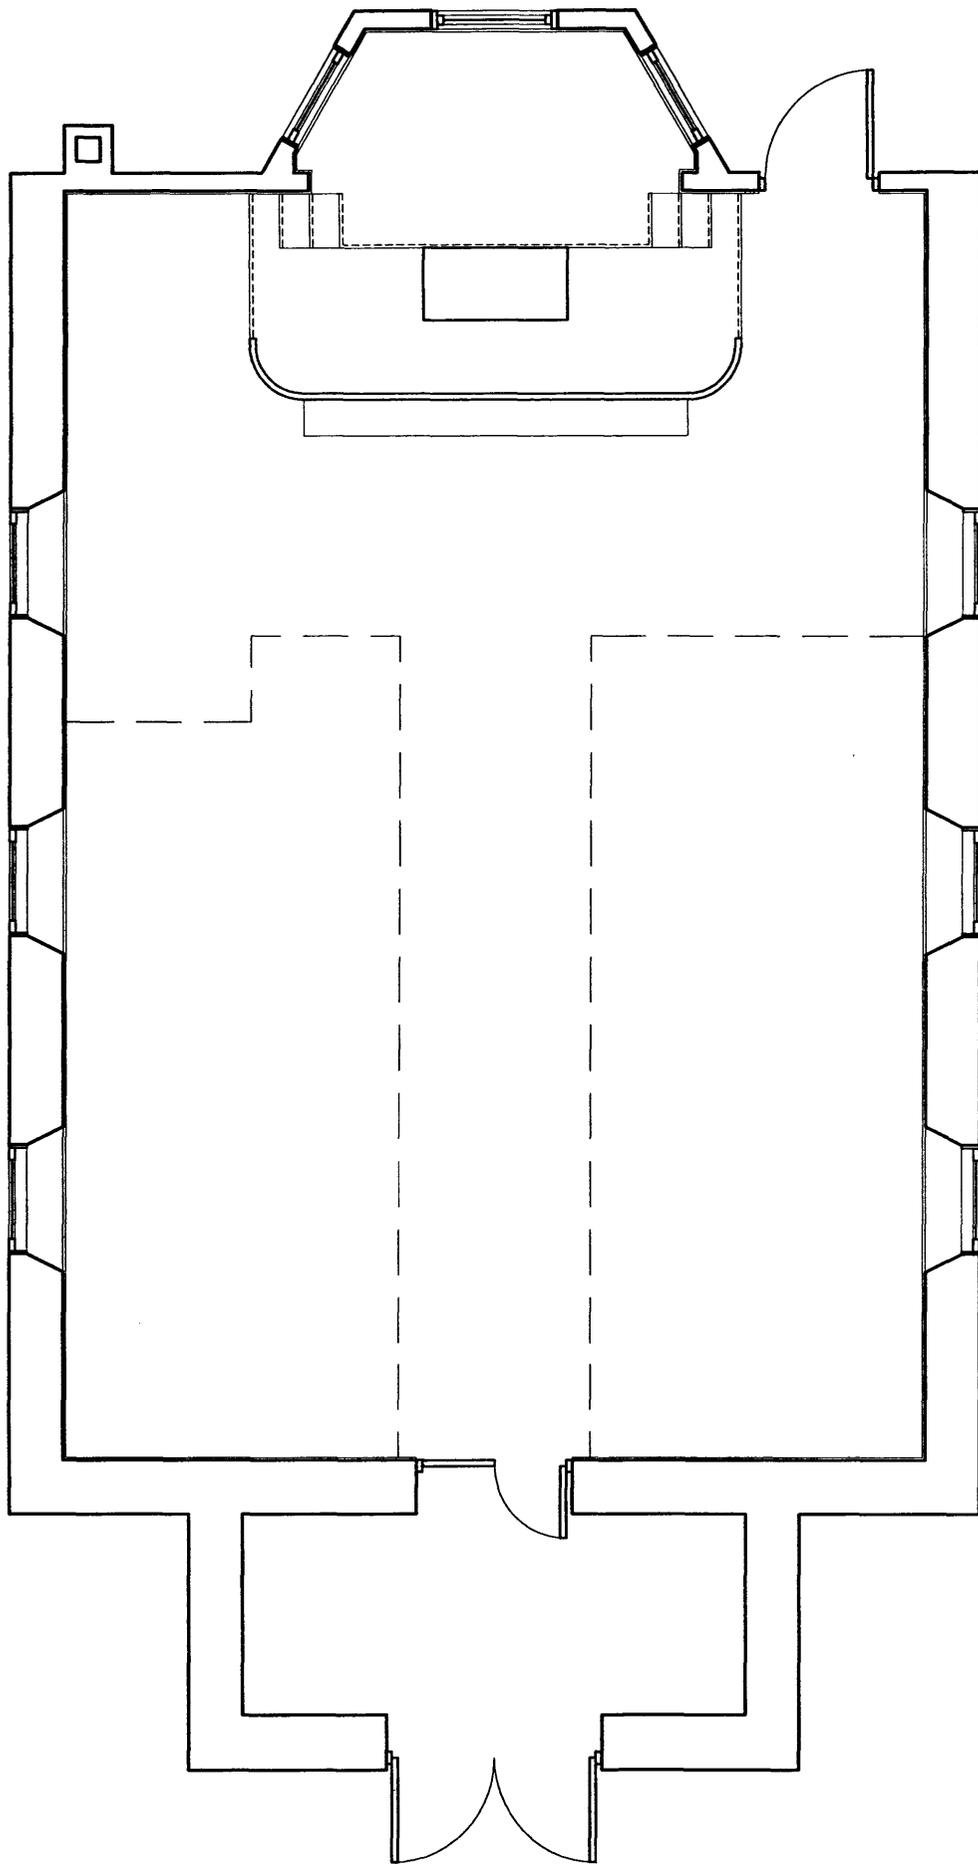
First Floor Plan  
Scale:  $\frac{3}{16}$ " = 1'-0"

The interior of the church consists of a vestibule and nave. The nave, or sanctuary, has a carpeted floor, pine vertical-beaded-board wainscoting, sandfloat plaster walls above, and an open truss ceiling. A two-level chancel is located at the east end of the room. (photograph 10) The lower level, where the communion table is located, is one step up from the floor and is separated from the main level by a communion rail with turned balusters and newel posts and a molded railing. The communion rail curves toward the east wall at either end, following the curve of the step. (photograph 18) Two additional sets of two steps provide access to the upper level, where the pulpit is located, from either side. The east elevation bay is behind the pulpit and is connected to the main space by a round opening that reveals the three-part, sloped ceiling of the bay, which is separated visually from the bay walls by a small wood molding. A center aisle separates two rows of pews. (photograph 12) Narrow outer aisles separate the pews from the north and south walls. An open space near the southeast corner houses a organ, while a space in front of the north row of pews houses the piano. The front pew in the north row is shorter than the other pews to make room for the piano. The pew endcaps have slanted scroll tops with rosettes. (photograph 20) The rounded hand rests have carved rosettes as well. The body of the endcap has a raised pointed-arch panel, while the front edge is carved in a trefoil profile, a second trefoil pattern is cut out of the bottom edge, and the back edge of the endcap is chamfered below the curved back.

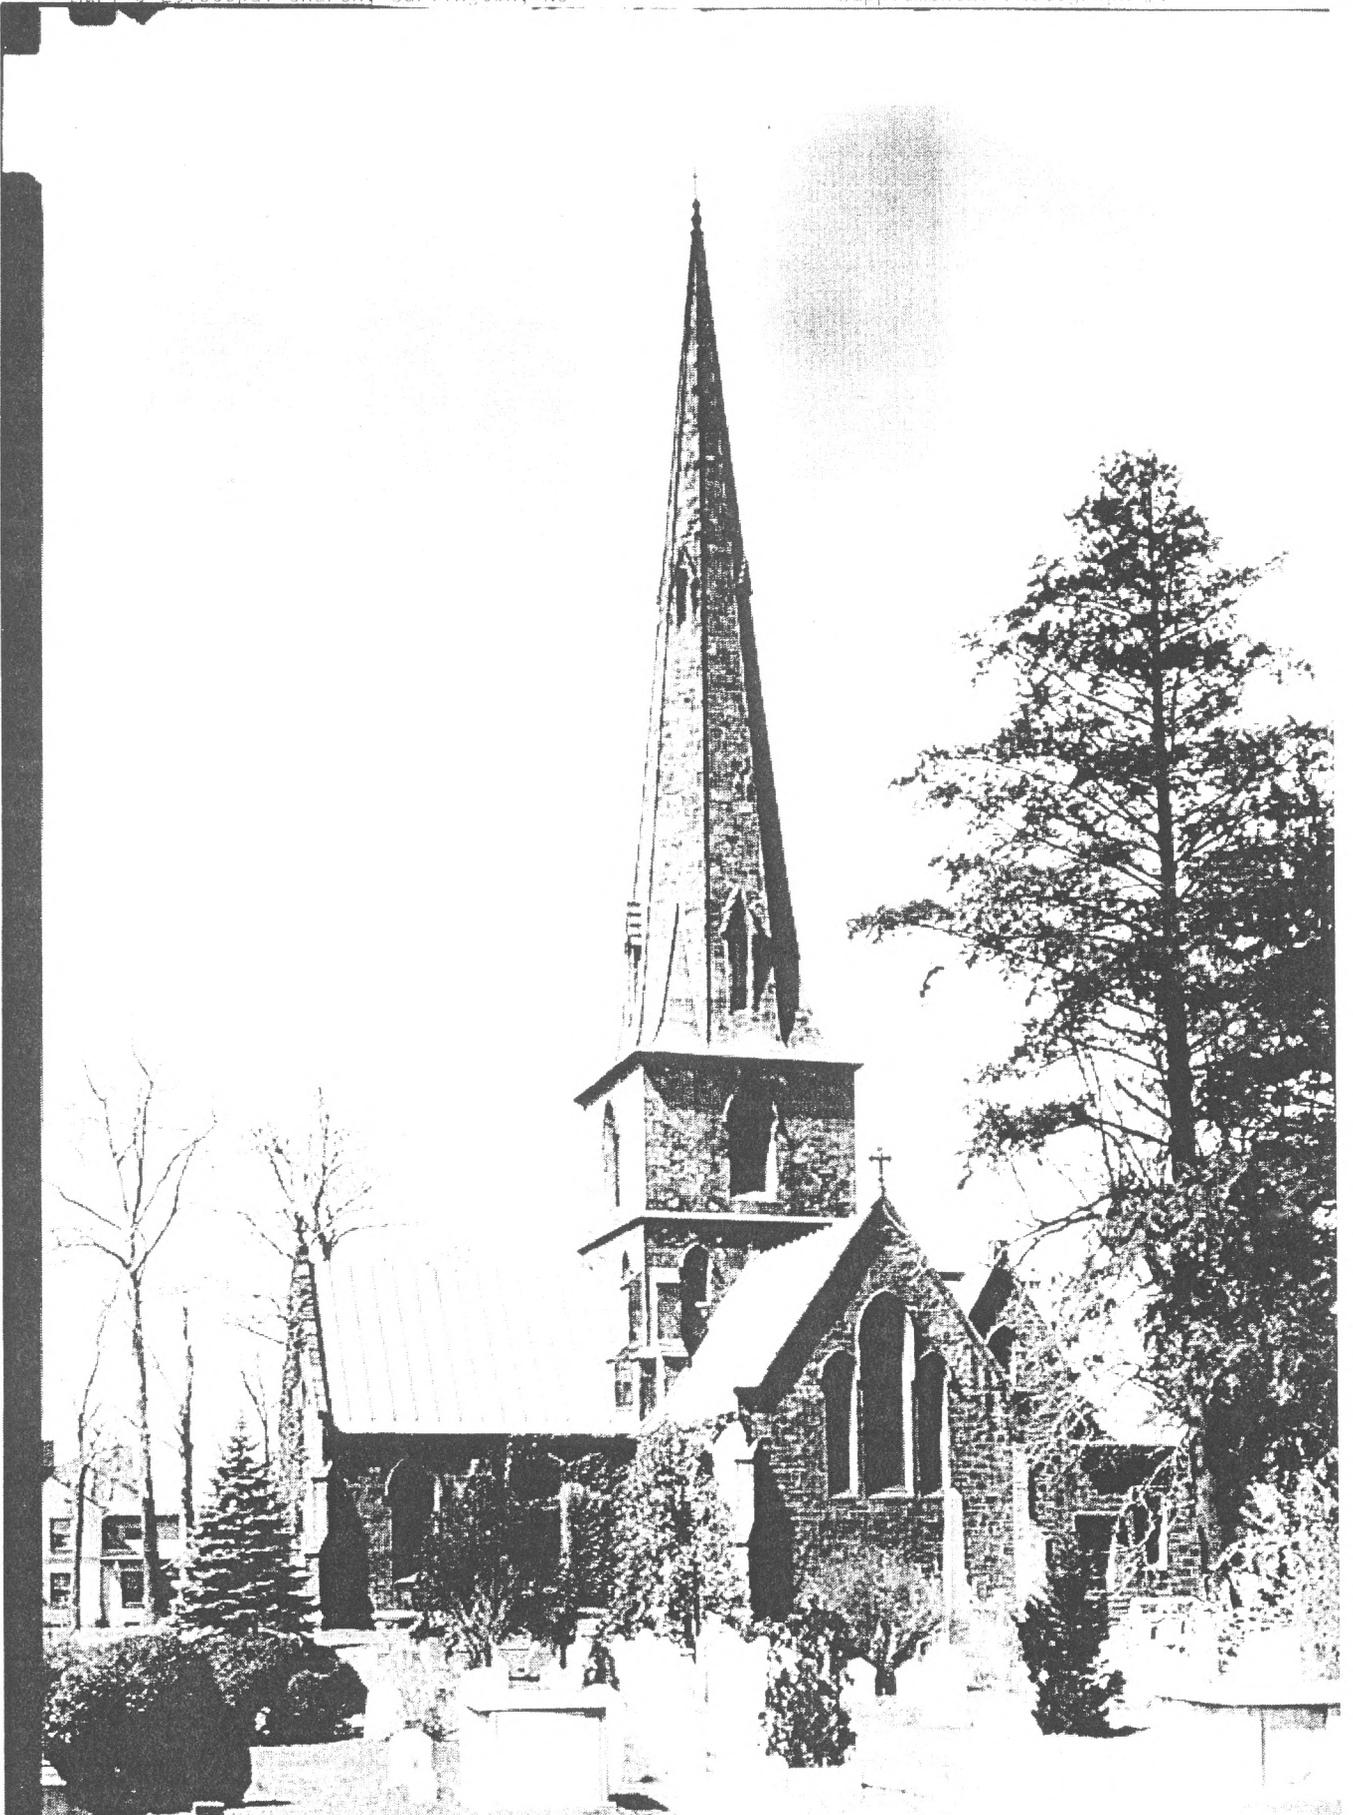
Supplemental Photograph #1

St. Mary's Episcopal Church, Burlington, NJ

One of the most noted Gothic Revival churches in New Jersey is the new St. Mary's Church in Burlington, designed by architect Richard Upjohn and constructed between 1846 and 1854. (supplemental photographs 1 and 2) This church is constructed of ashlar-laid sandstone and has many architectural characteristics of the medieval English parish church model: pointed-arch windows with hood molds, tracery, and stained glass; stone buttresses; steep, gabled roofs with stone parapets; a tower; and, on the interior, an open truss ceiling, plain plaster walls, and painting on the chancel ceiling. Although it is also based on the parish church prototype, St. Mary's has a full transept crossing the nave and chancel, and a stone tower and spire located at the crossing. While this building has a few elements in common with Downer, such as the use of stone, steeply-pitched roofs, an open truss ceiling plan, and plain plaster walls, the greater level of detail and the more complex design sets it much closer to the strict interpretation of the Gothic Revival style.

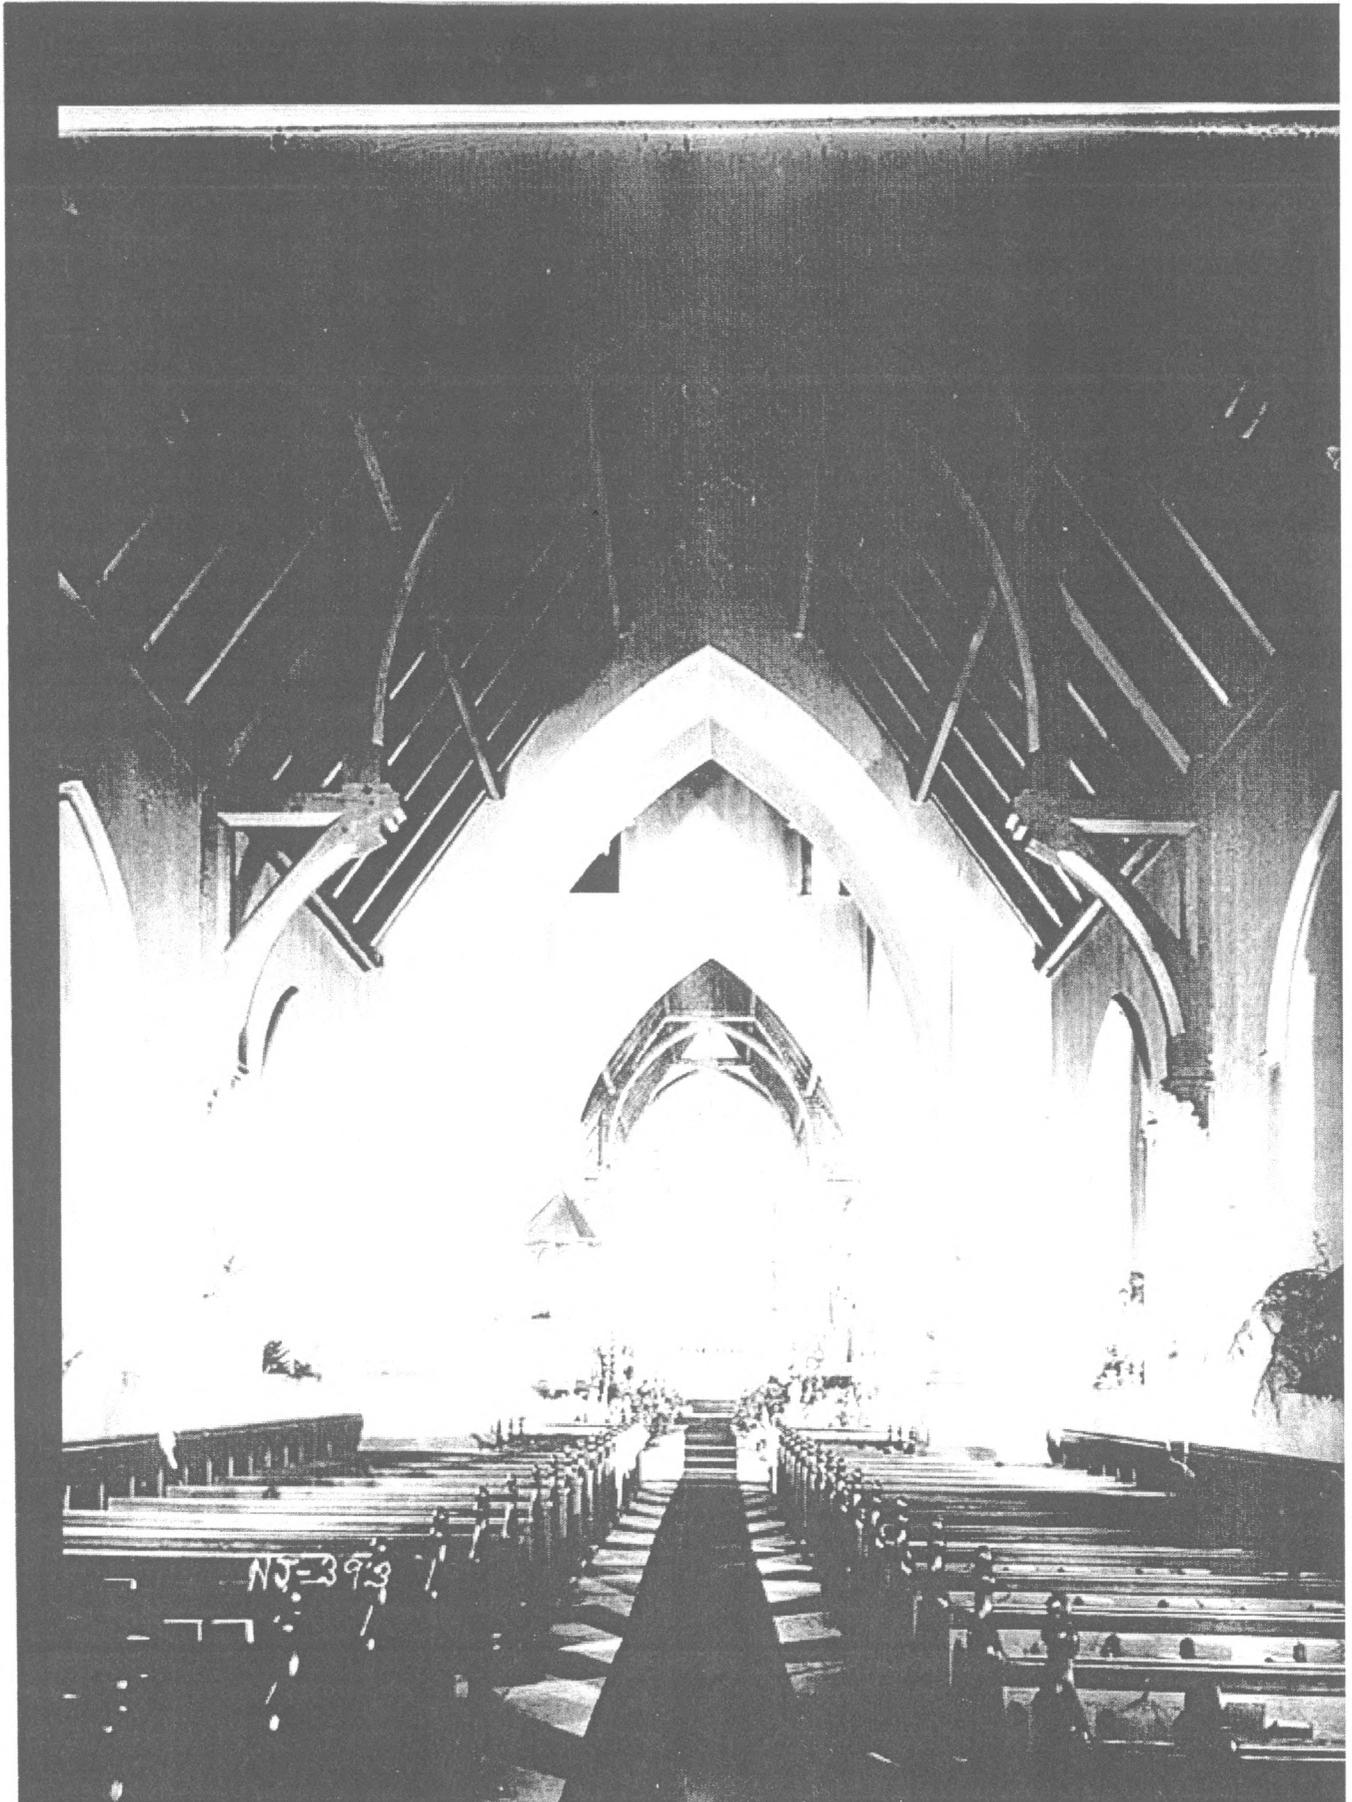
Supplemental Photograph #2

St. Mary's Episcopal Church, Burlington, NJ
