1 Of 16 Presentation drawing with watercolor wash, "Design Plan for Garden Treatment," prepared by the Salem landscape architecture firm of

2 of 16 General view of property from Leffelle Street, looking south.

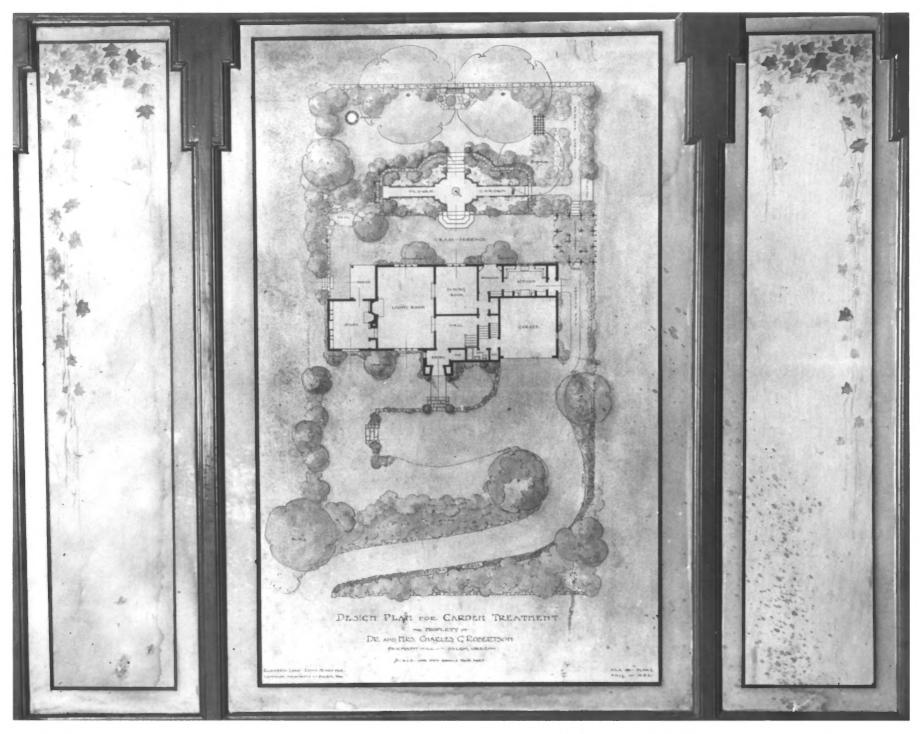
Lord and Schryver and dated "Fall of 1931." The drawing was mounted and framed for use as a fireplace screen by the original occupants.

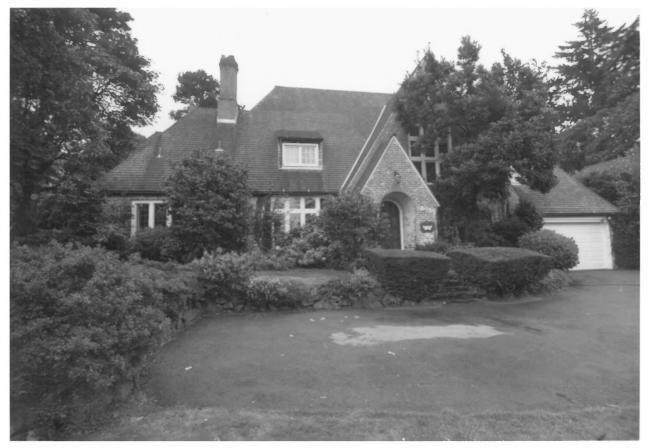
3 of 16 North(front) elevation from driveway.

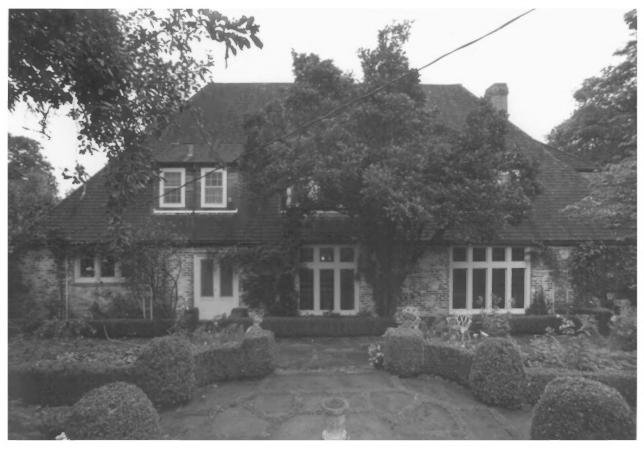
4 of 16 South(garden) elevation from flower garden.

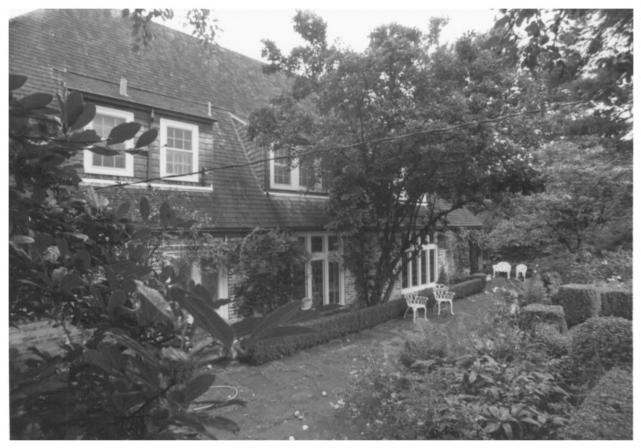
5 of 16 South elevation, looking easterly along lower terrace.

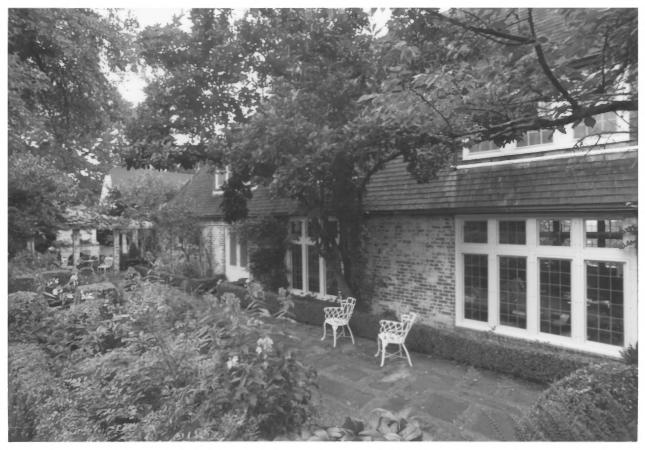
## 6 of 16

South elevation, looking westerly along lower terrace toward arbor termination.

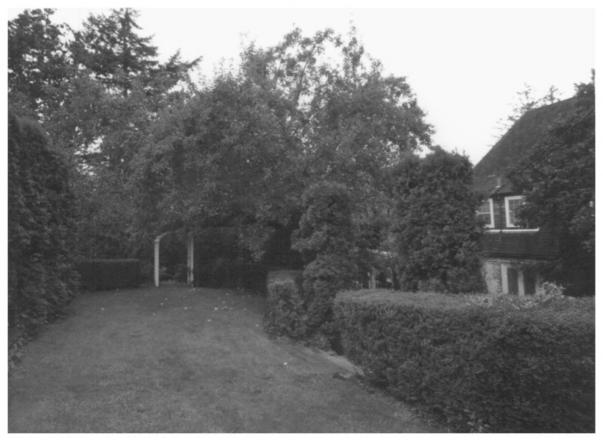
7 of 16 South elevation, looking westerly along upper garden terrace toward trellis marking entrance to small

"reserve garden."

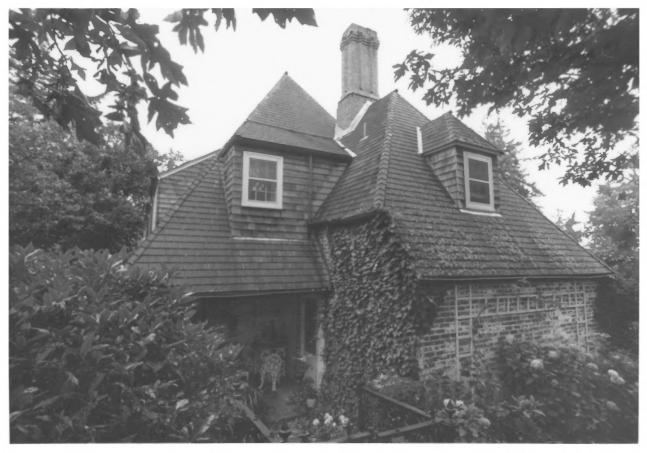
8 of 16 East end elevation showing small porch in southeast corner giving access to the study.

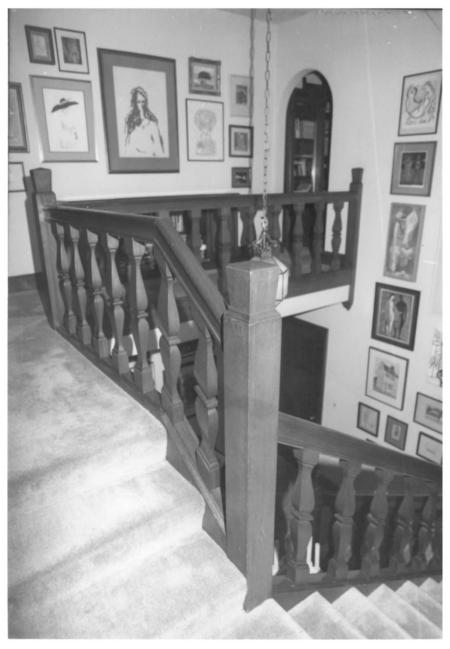
9 of 16 Entry stairhall, looking southwesterly, showing raking section of stair railing.

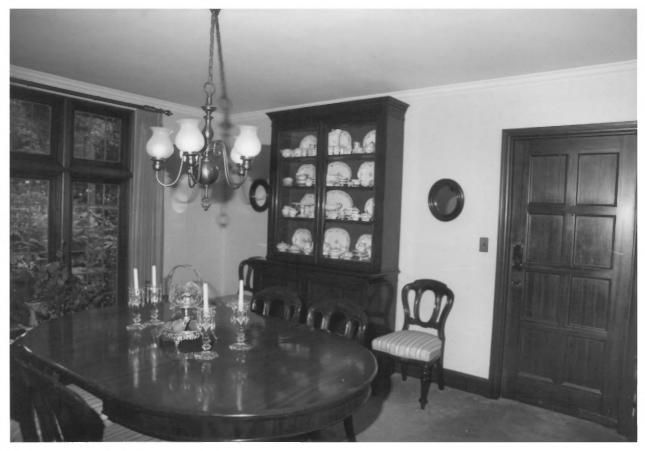
10 of 16 Dining room, looking southwesterly. North-south axis of garden layout is centered on the dining room window.

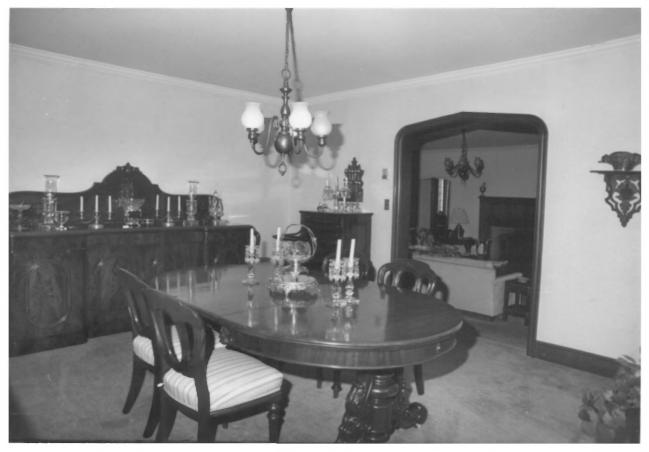
11 of 16 Dining room, looking easterly into living room. Note ogee-arched doorway.

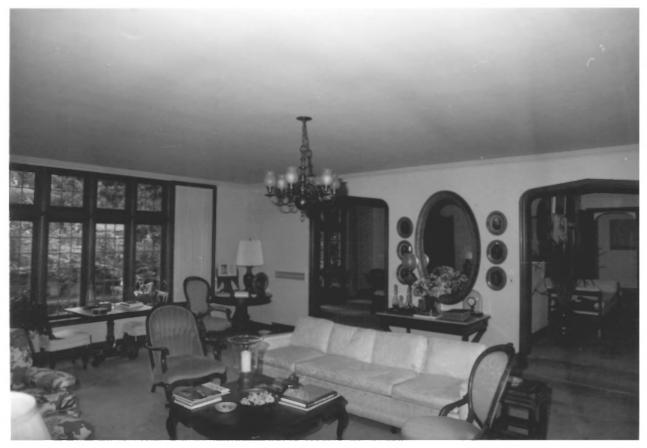
12 of 16 Living room, looking westerly into stairhall and dining room. Heavilymullioned windows with leaded panes are typical.

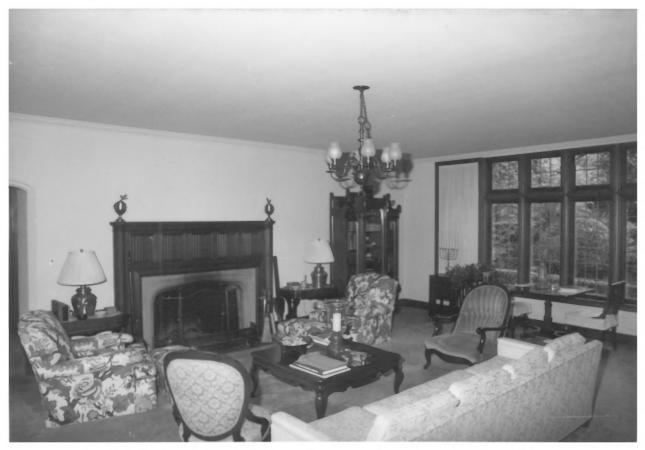
13 Of 16 Living room, looking southeasterly. Chimneypiece is distinguished by Tudor-arched fireplace opening and by linen fold paneling.

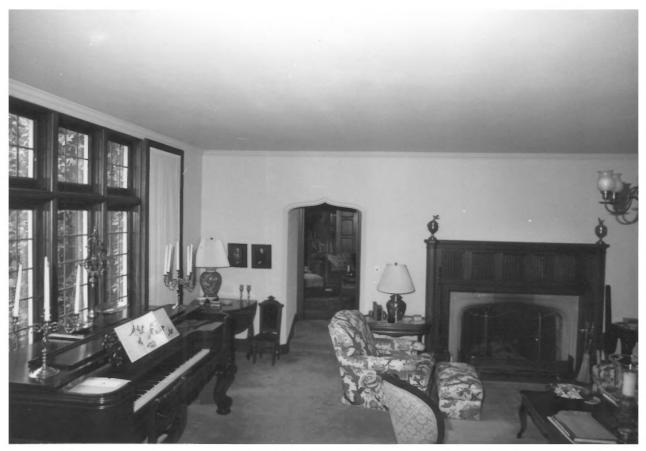
14 Of 16 Living room, looking east into study. Note ogee-arched doorway.

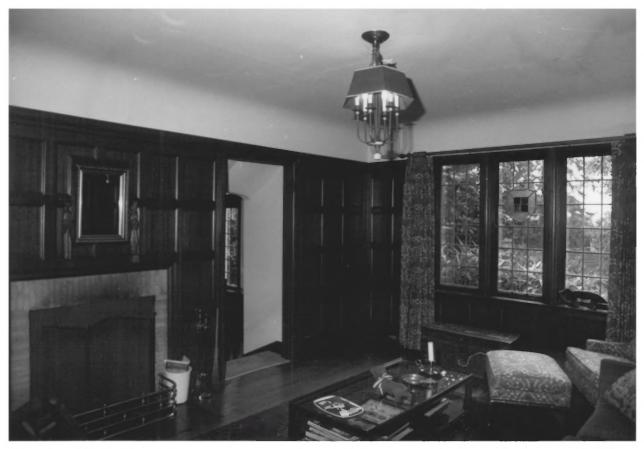
15 of 16 Study, looking northwesterly, traditionally finished with dark paneling, mullioned windows with

leaded panes, heraldic motif in colored glass.

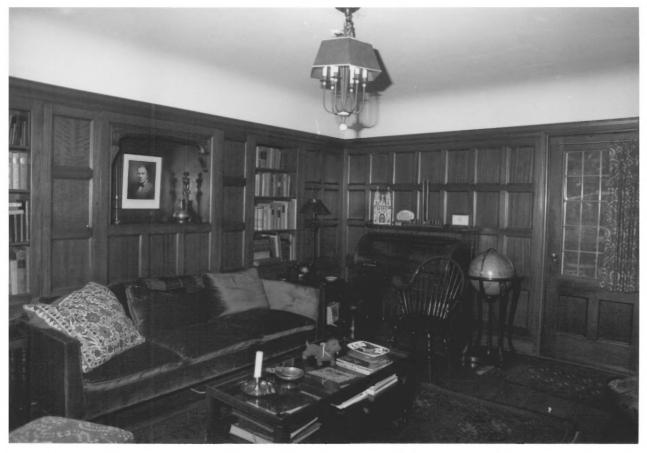
16 of 16 Study, looking southeasterly. Note coved cornice. Doorway gives access to small porch at secluded corner of garden.
