1. The Michel Prudhomme Home
2. Opelousas, La. *St. Landry Parish*
3. C. Kenneth Deshotel
4. January 1976
5. P. O. Drawer 1668, Opelousas, La.
6. View of front (west side)
7. No. 1 *17*

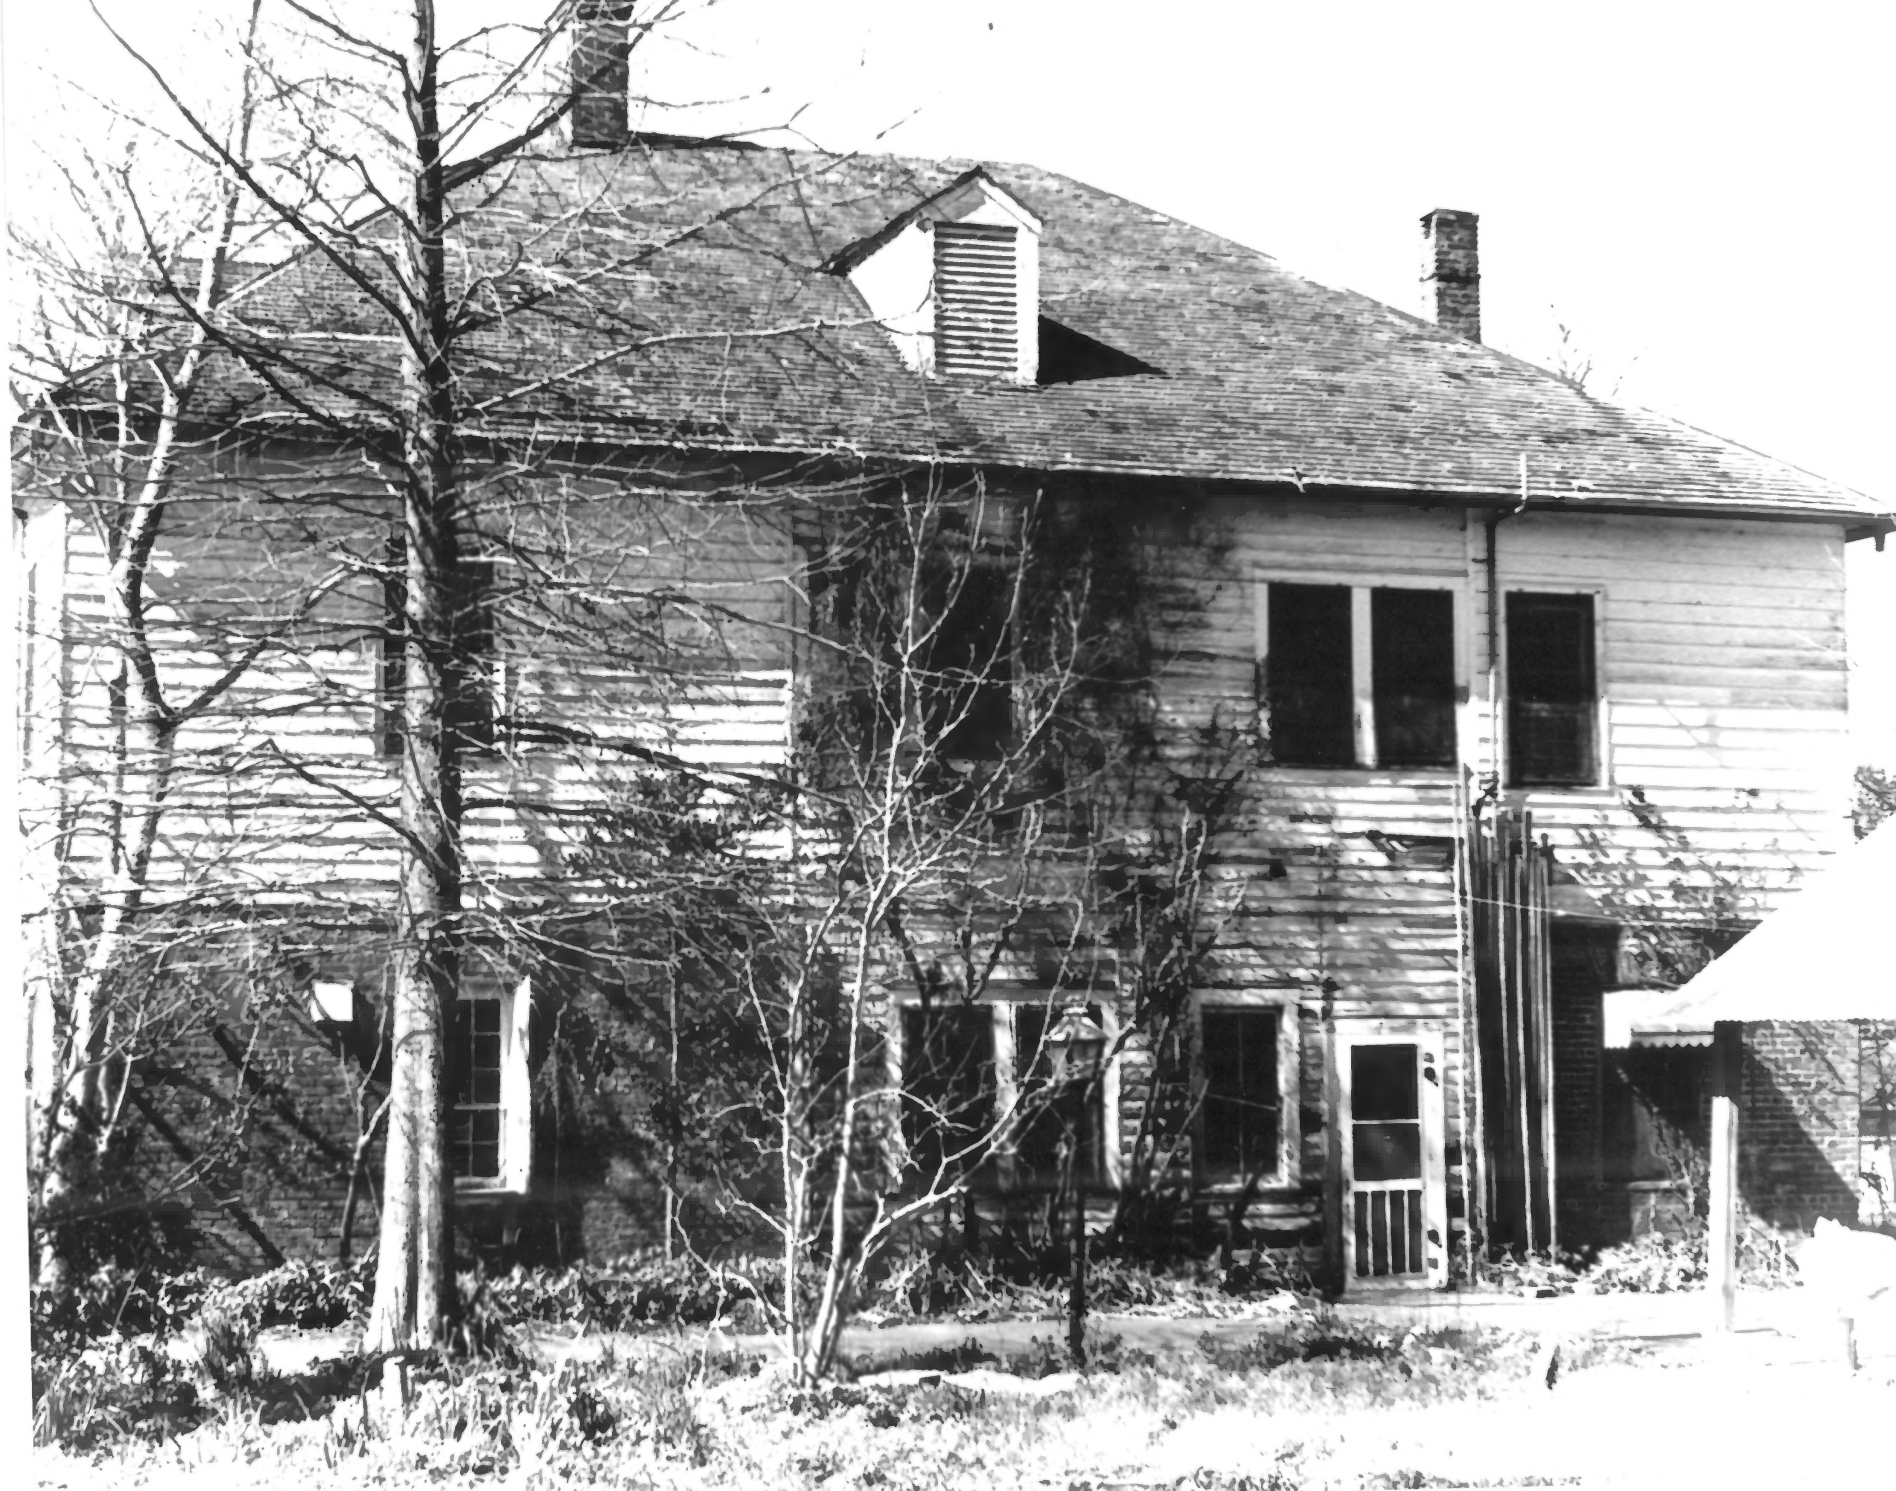
- #
1. The Michel Prudhomme Home
 2. Opelousas, La. *St. Landry Parish*
 3. C. Kenneth Deshotel
 4. January 1976
 5. P. O. Drawer 1668, Opelousas, La.
 6. View of rear (east side)
 7. No. 2 of 17

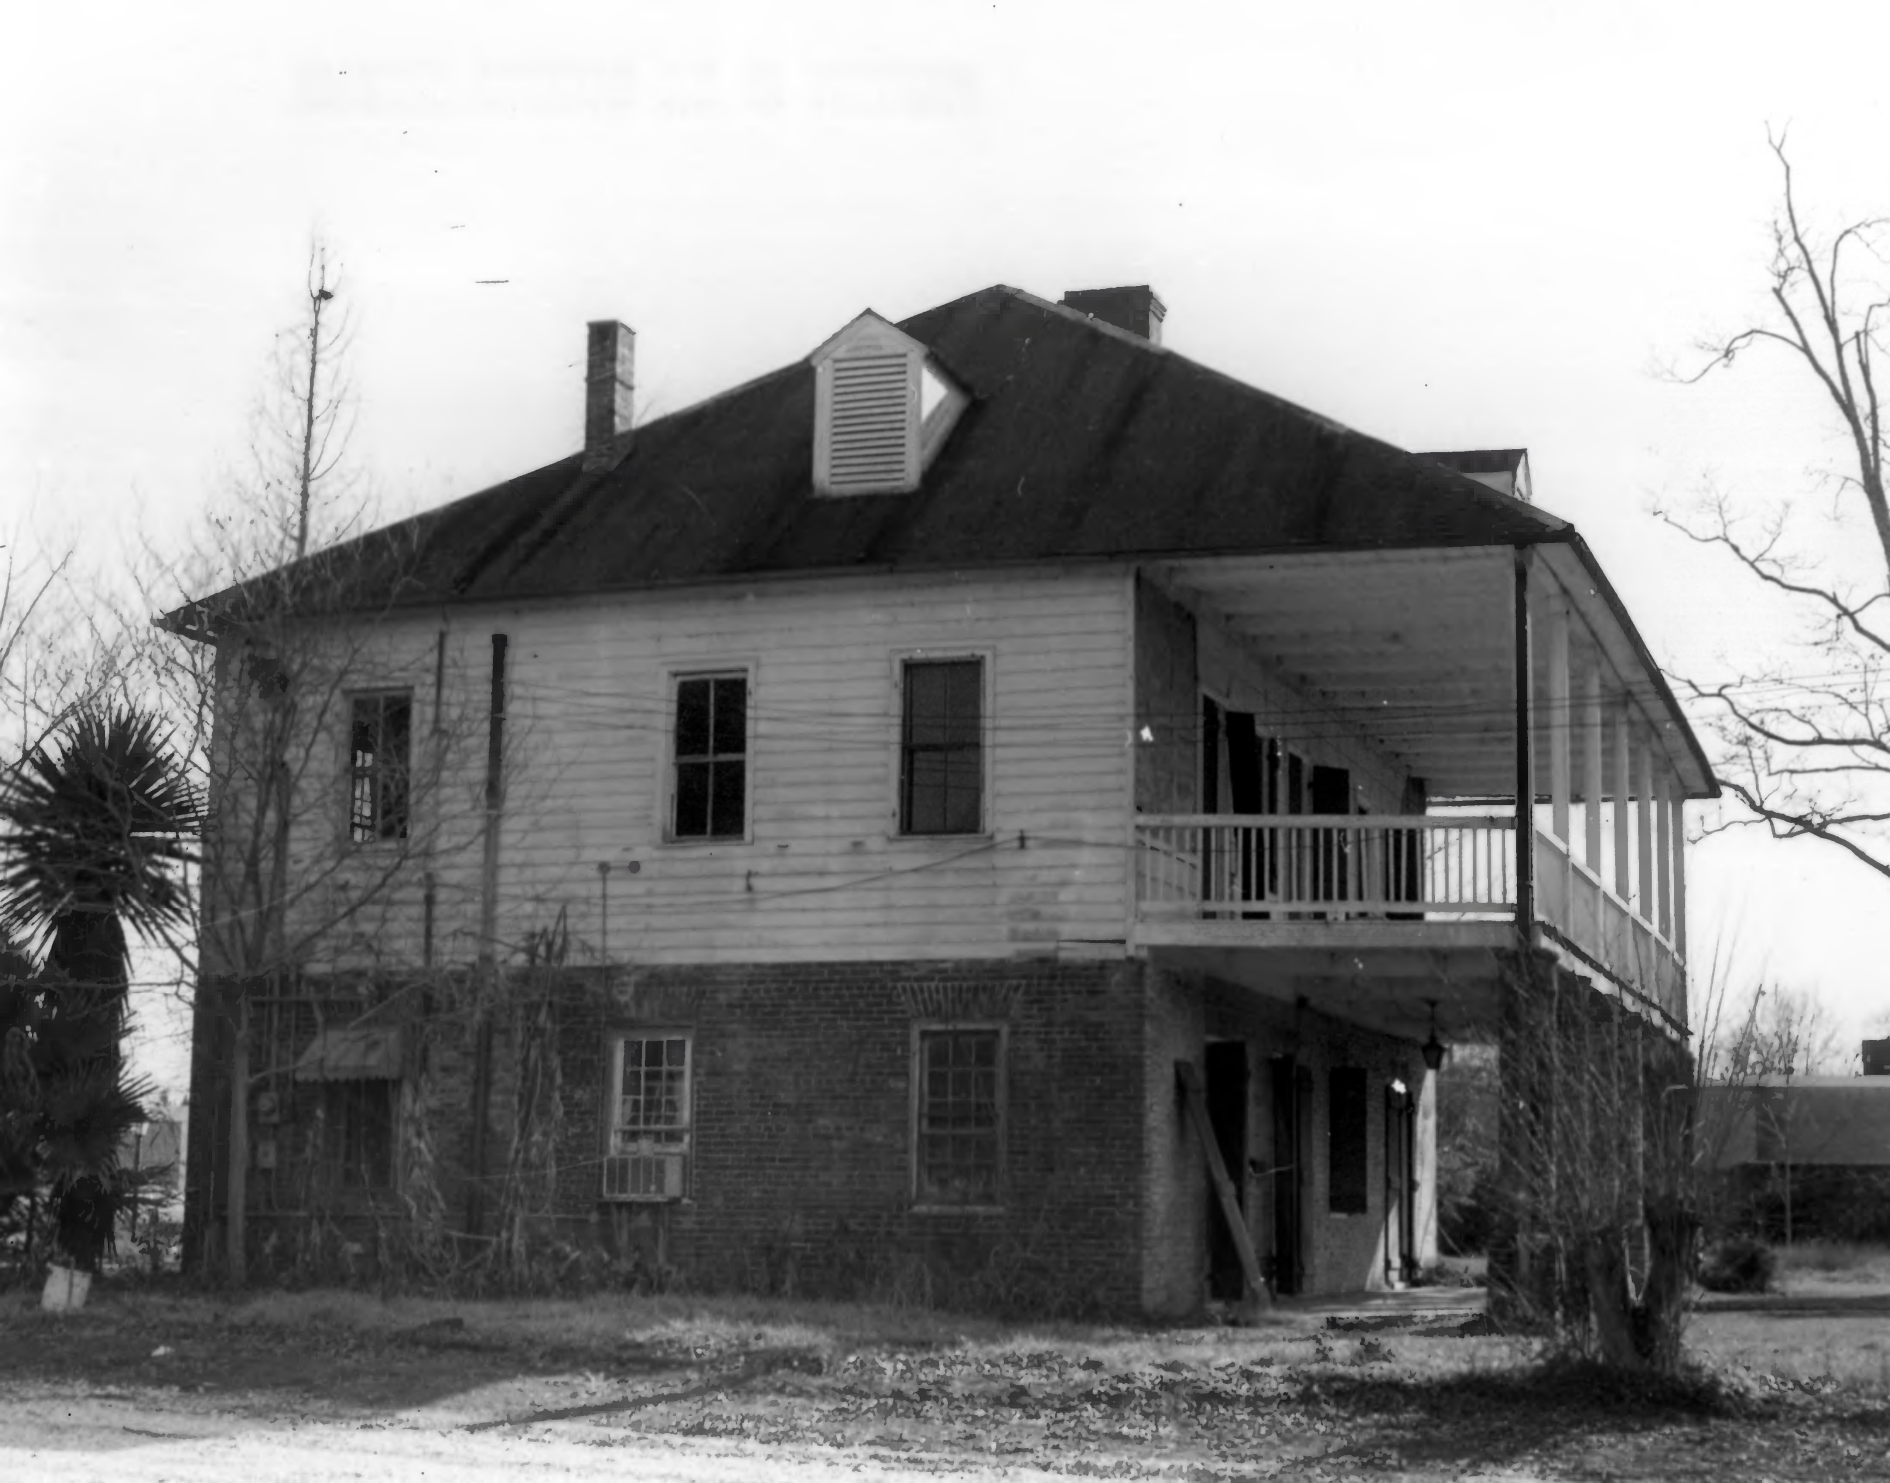
1. The Michel Prudhomme Home
2. Opelousas, La. *St. Landry Parish*
3. C. Kenneth Deshotel
4. January 1976
5. P. O. Drawer 1668, Opelousas, La.
6. View of north side
7. No. 3 *417*

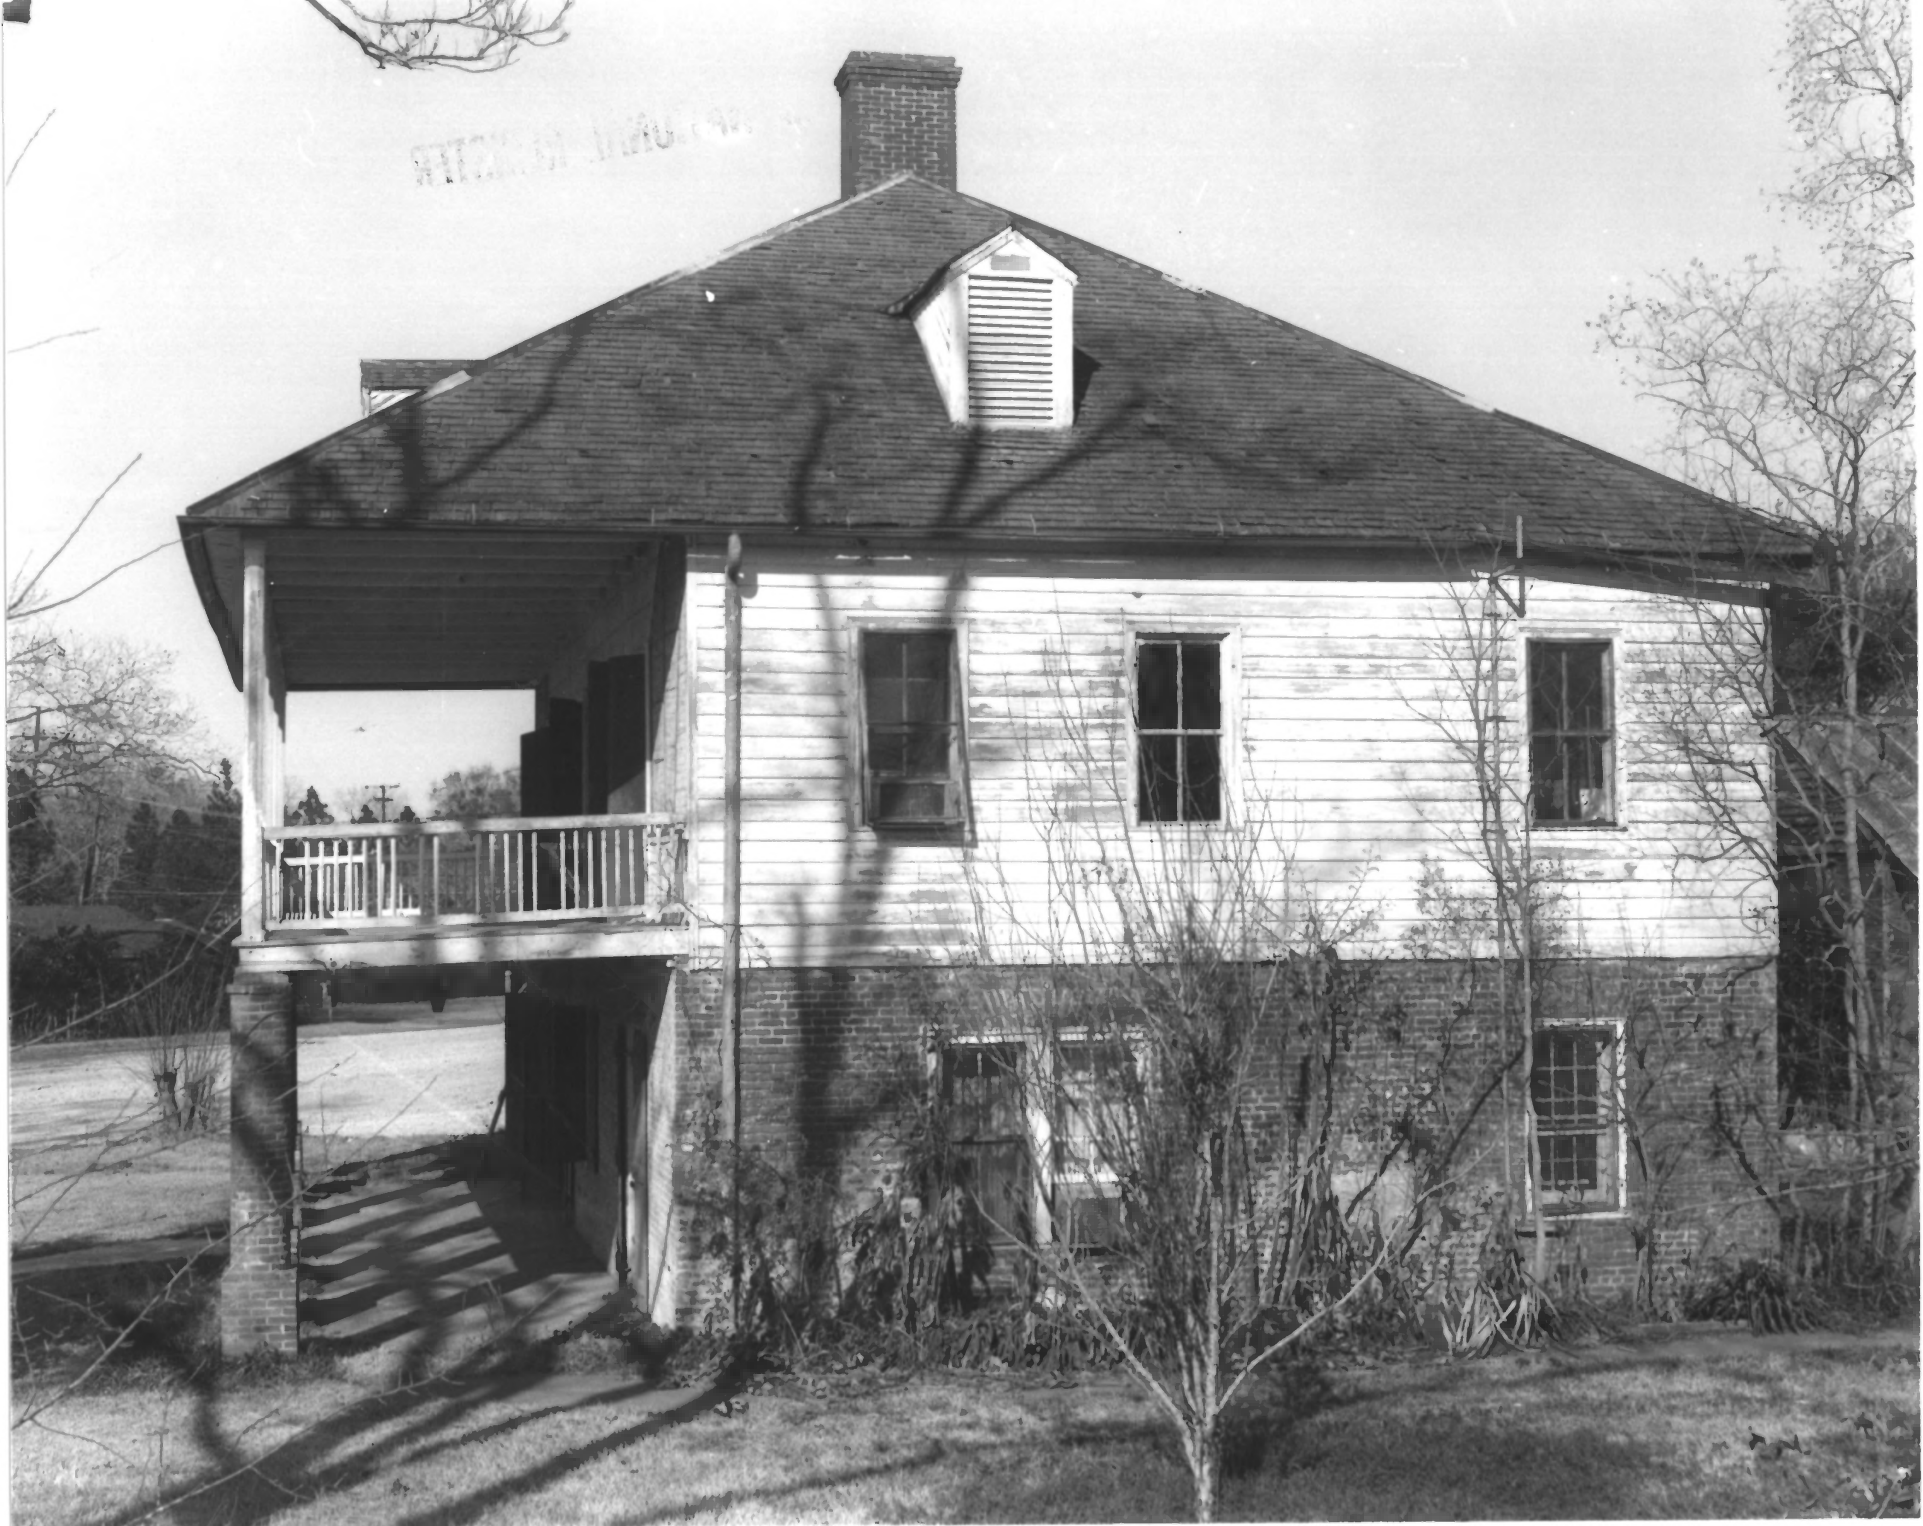
1. The Michel Prudhomme Home
2. Opelousas, La. *St. Landry Parish*
3. C. Kenneth Deshotel
4. January 1976
5. P. O. Drawer 1668, Opelousas, La.
6. View of south side
7. No. 4 *of 17*

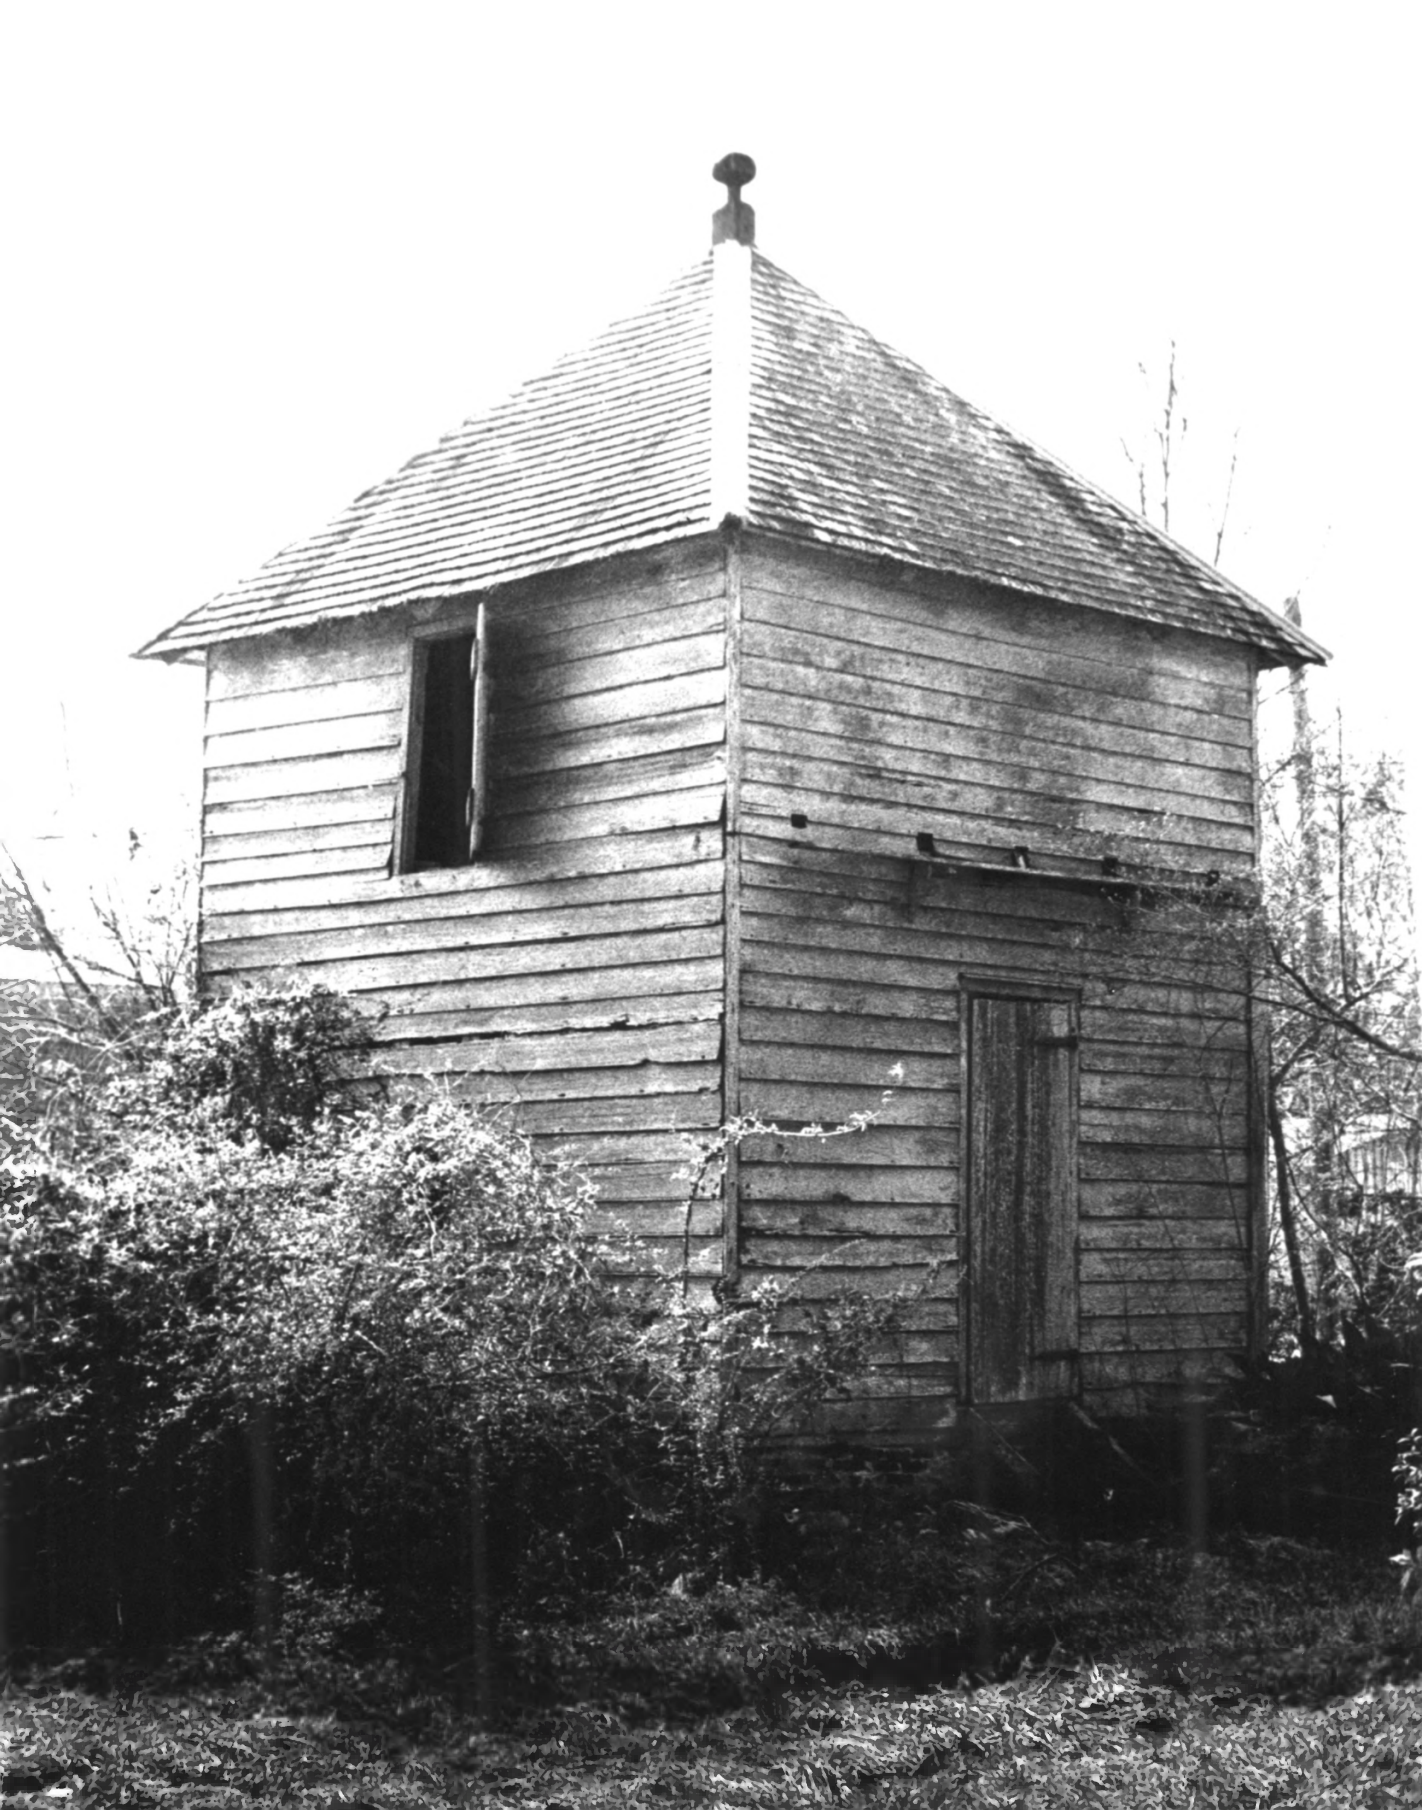
1. The Michel Prudhomme Home
2. Opelousas, La.
3. Rod Mikinski *St. Landry Parish*
4. February 1976
5. Opelousas Daily World
6. Pigeonnier - North and east sides
North side with door - east side
with window
7. No. 5 *of 17*

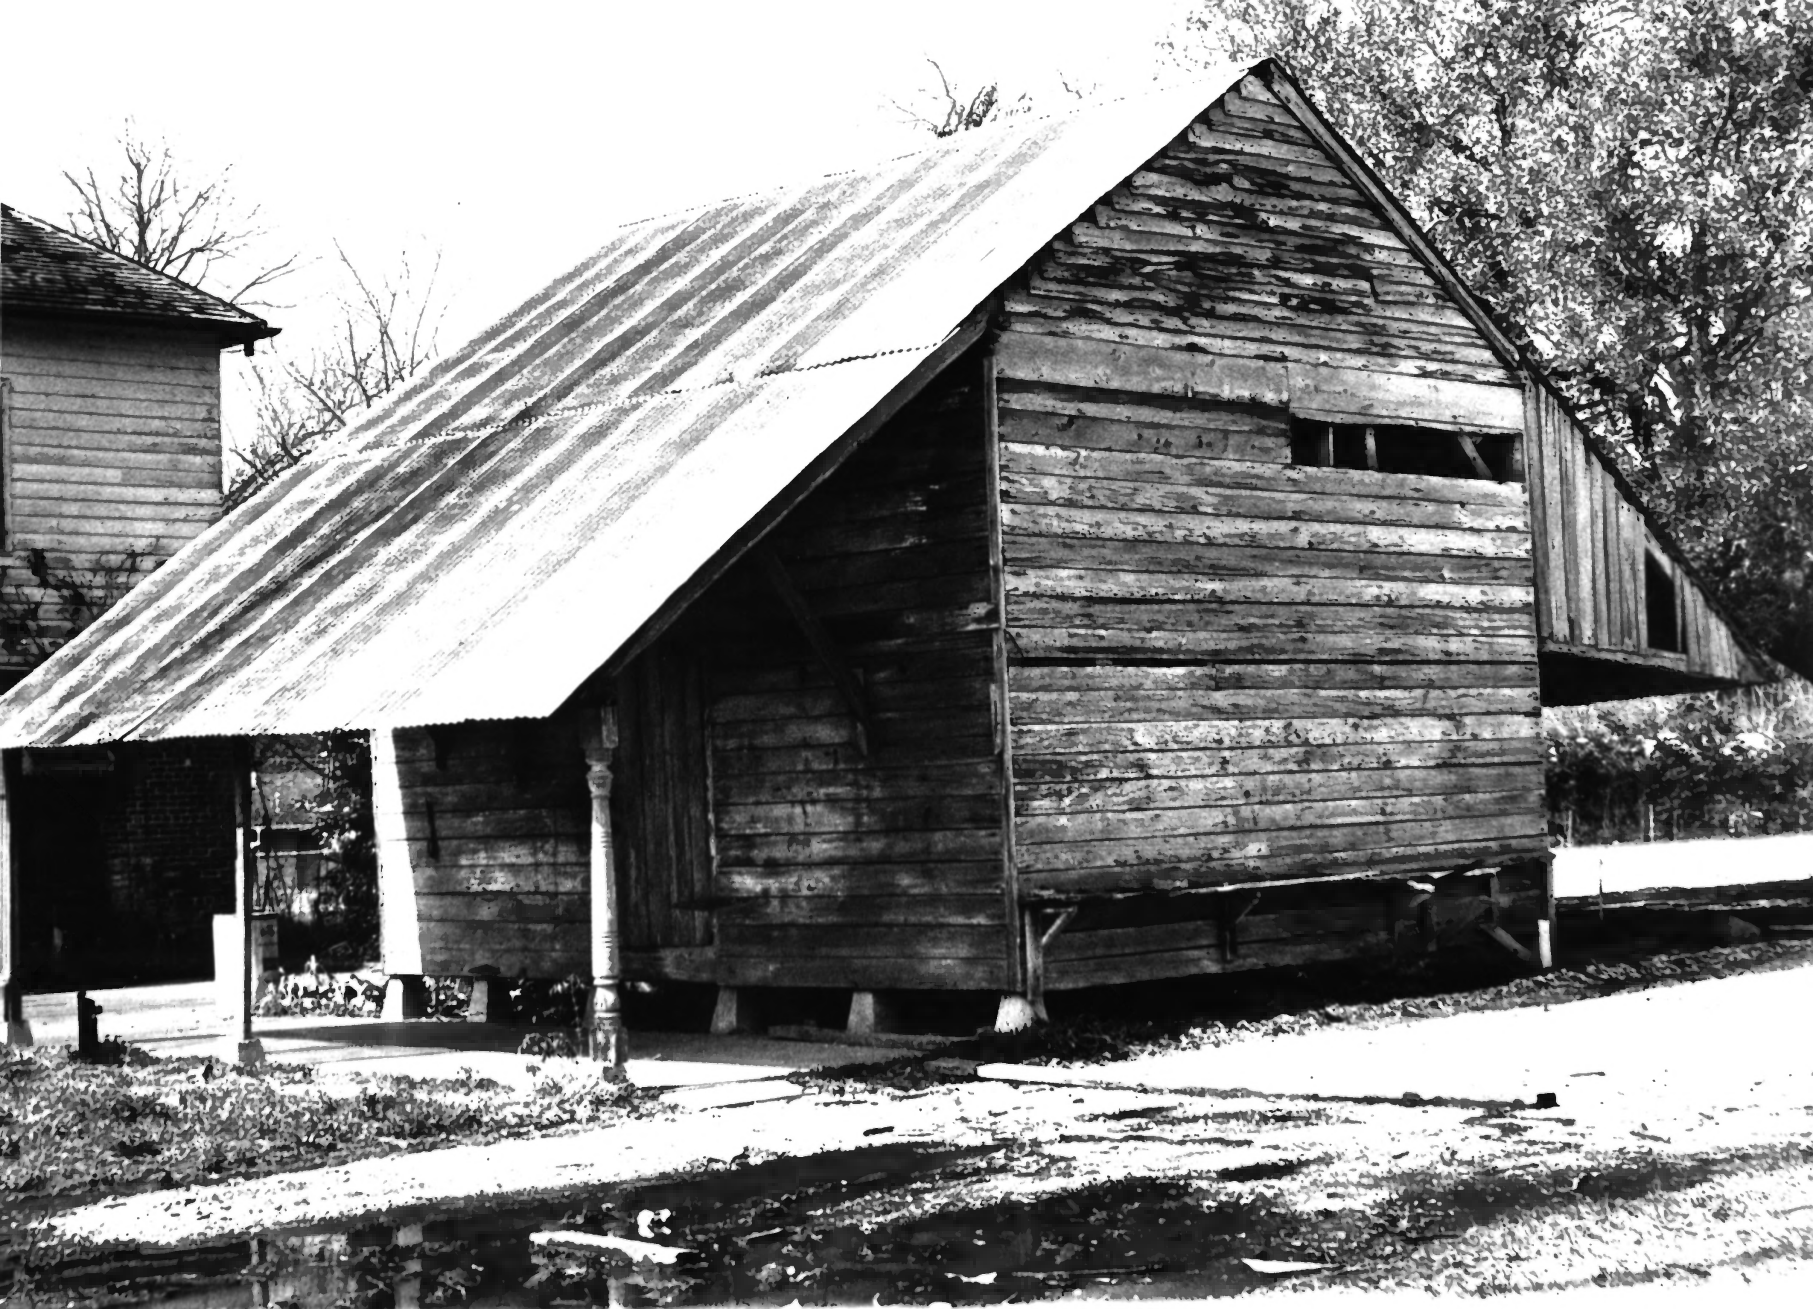
1. The Michel Prudhomme Home
2. Opelousas, La.
3. Rod Mikinski *St. Landry Parish*
4. February 1976
5. Opelousas Daily World
6. Corncrib - east and south sides
South side with door
7. No. 6 of 17

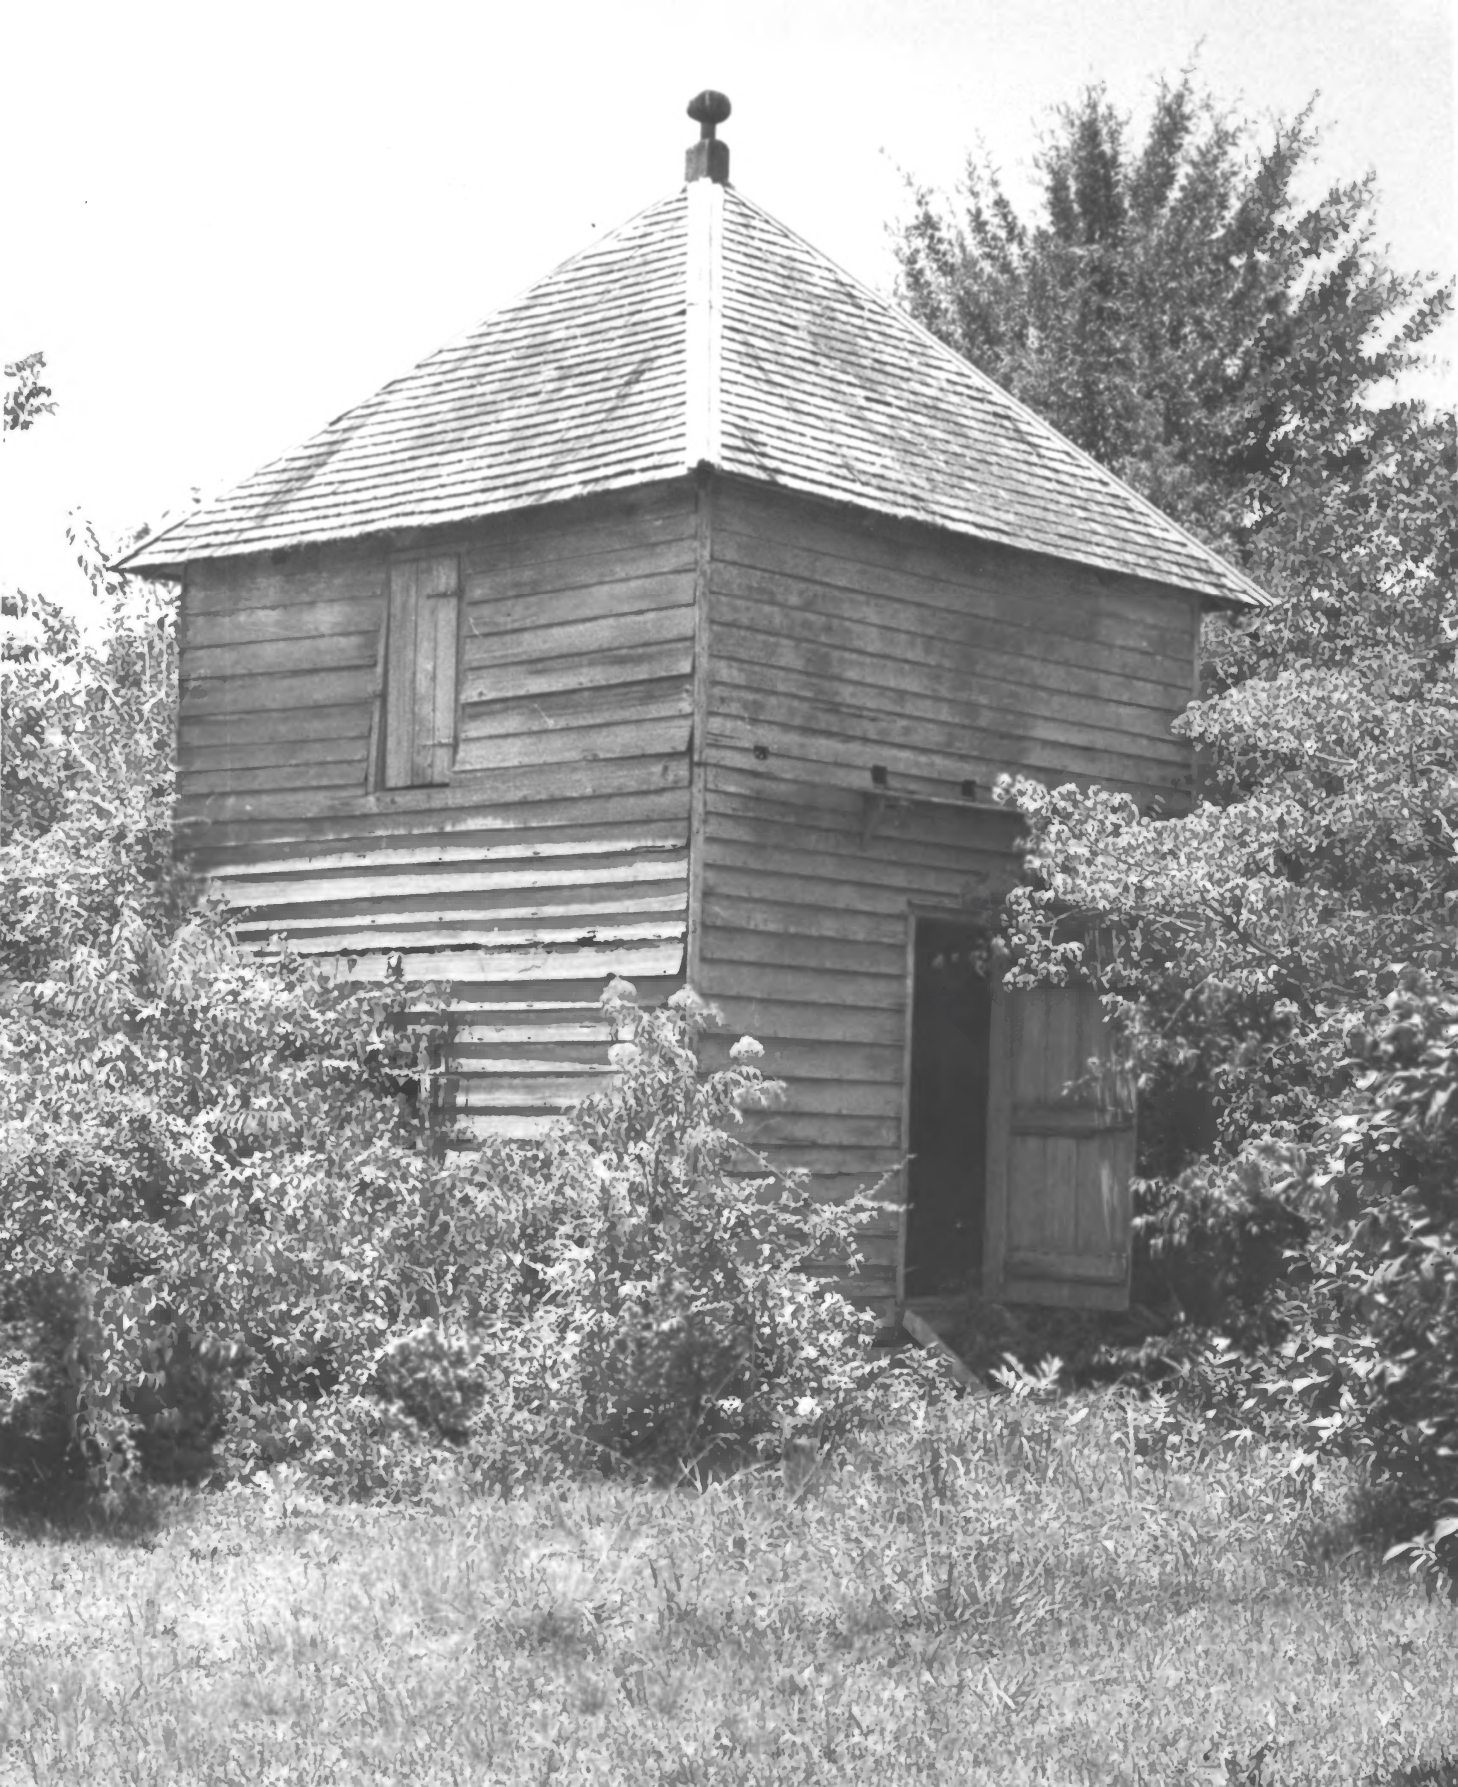
1. The Michel Prudhomme Home
2. Opelousas, La.
3. Daily World Photographer
4. July 1976
5. Kenneth Deshotel, Opelousas, La.
6. Pigeonnier, looking southwest, about 60 feet from the right front corner of house. Originally was an identical pigeonnier to left front of house, but no longer remains. Interior has same type of beaded beams as
7. No. 78 MAY 24 1977 Doc in house.

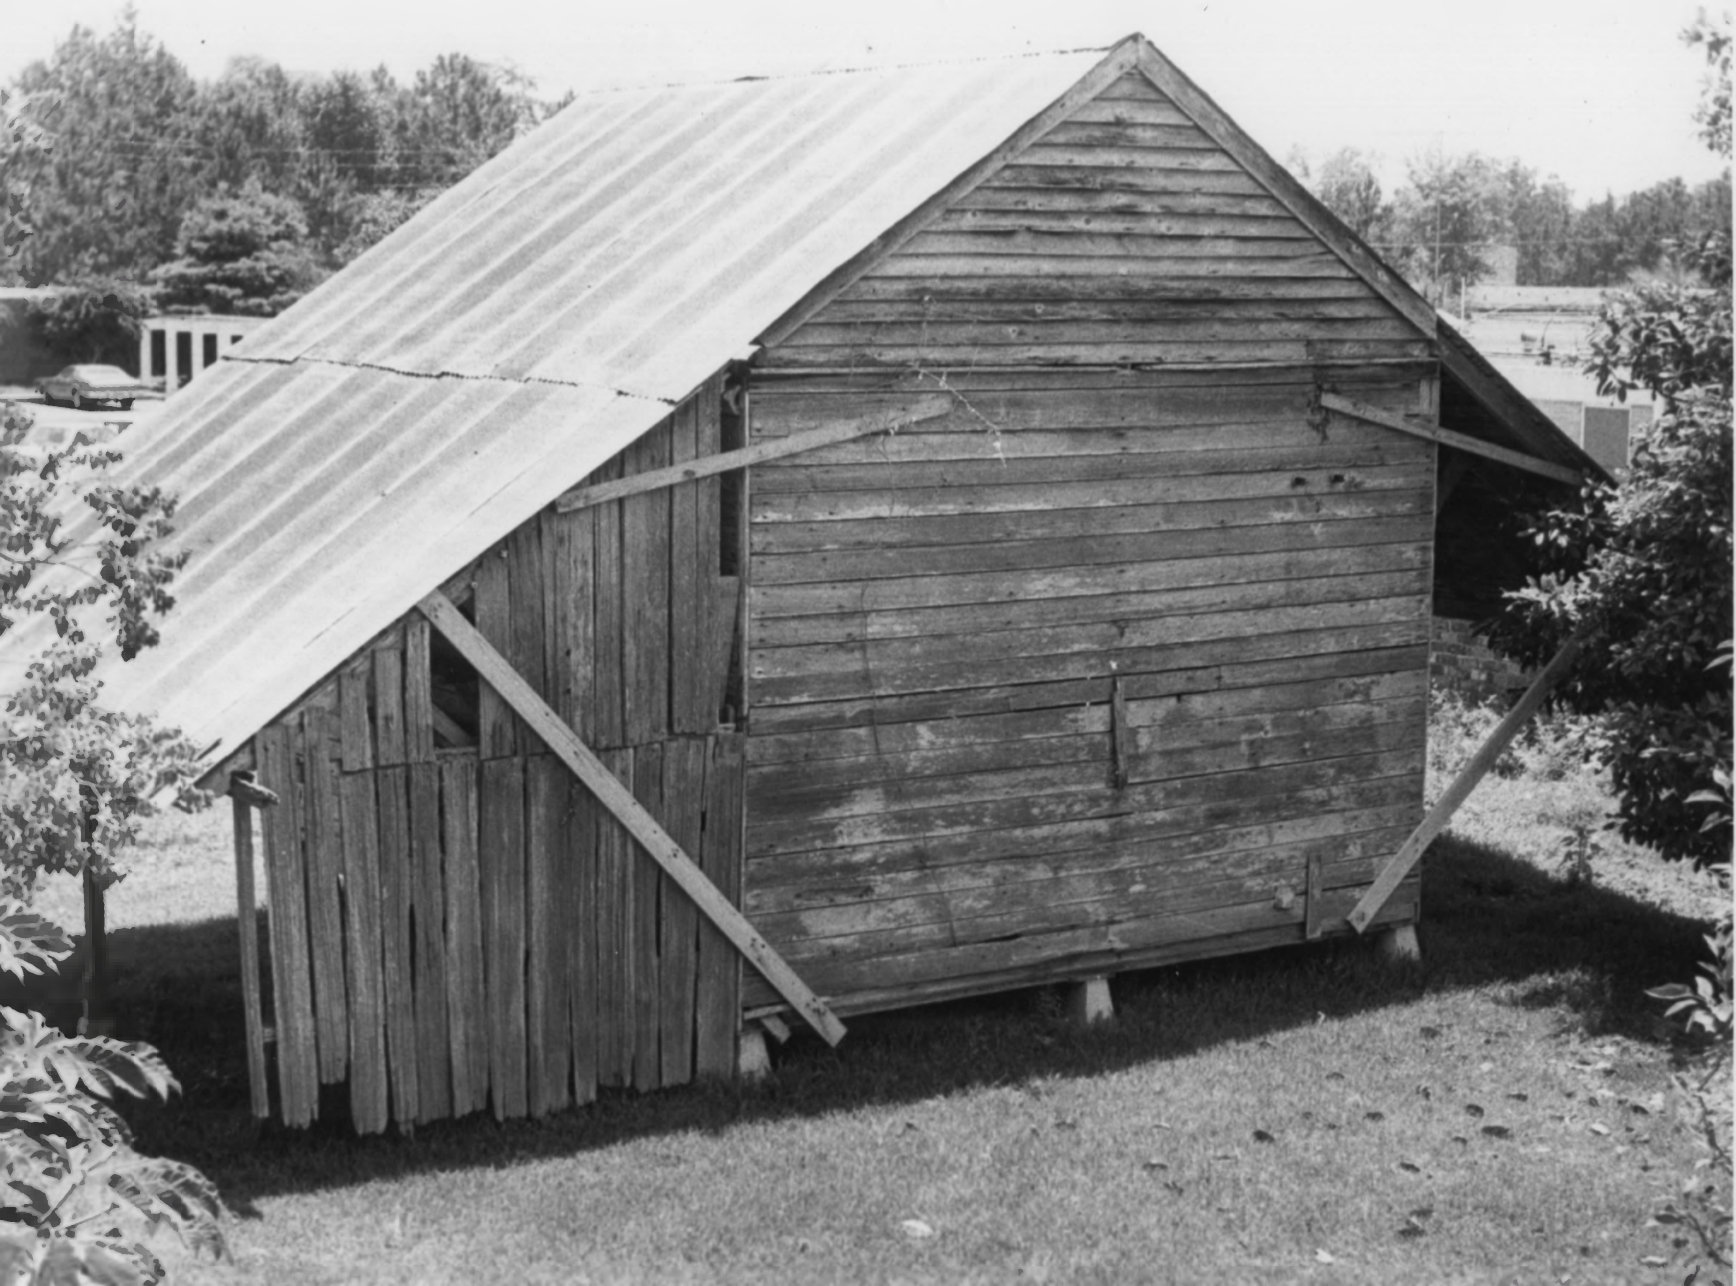
1. The Michel Prudhomme Home
2. Opelousas, La.
3. Daily World Photographer
4. July 1976
5. Kenneth Deshotel, Opelousas, La. *St Landry Parish*
6. Corncrib to the southeast of house, about 30 feet away. Originally was on other side of house but had to be moved because wasn't within present property boundaries. Has same pegged construction as found in framing of house roof.
7. No. 8 *4/17*

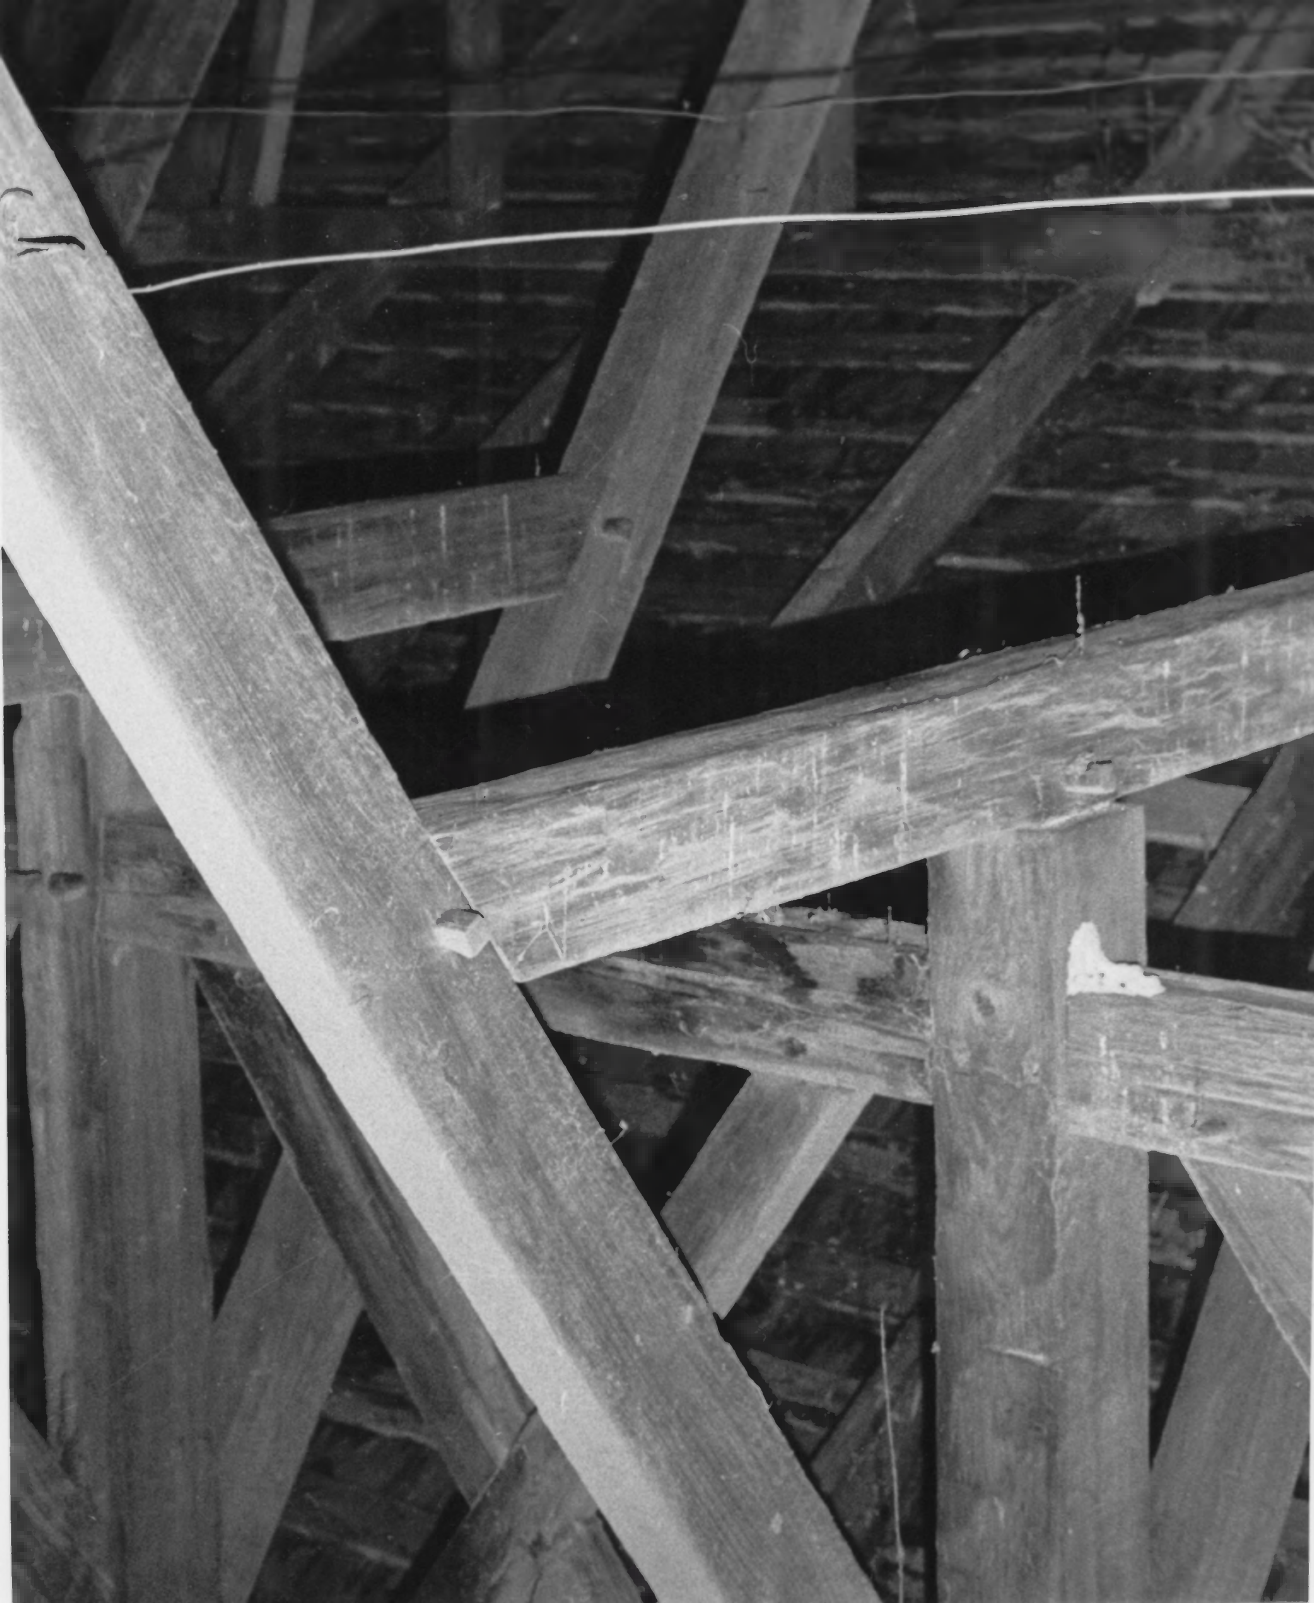
1. The Michel Prudhomme Home
2. Opelousas, La. *St Landry Parish*
3. Daily World Photographer
4. July 1976
5. Kenneth Deshotel, Opelousas, La.
6. Roof framing timbers, showing hewn cypress
and pegged construction
7. No. 9 *2/17*

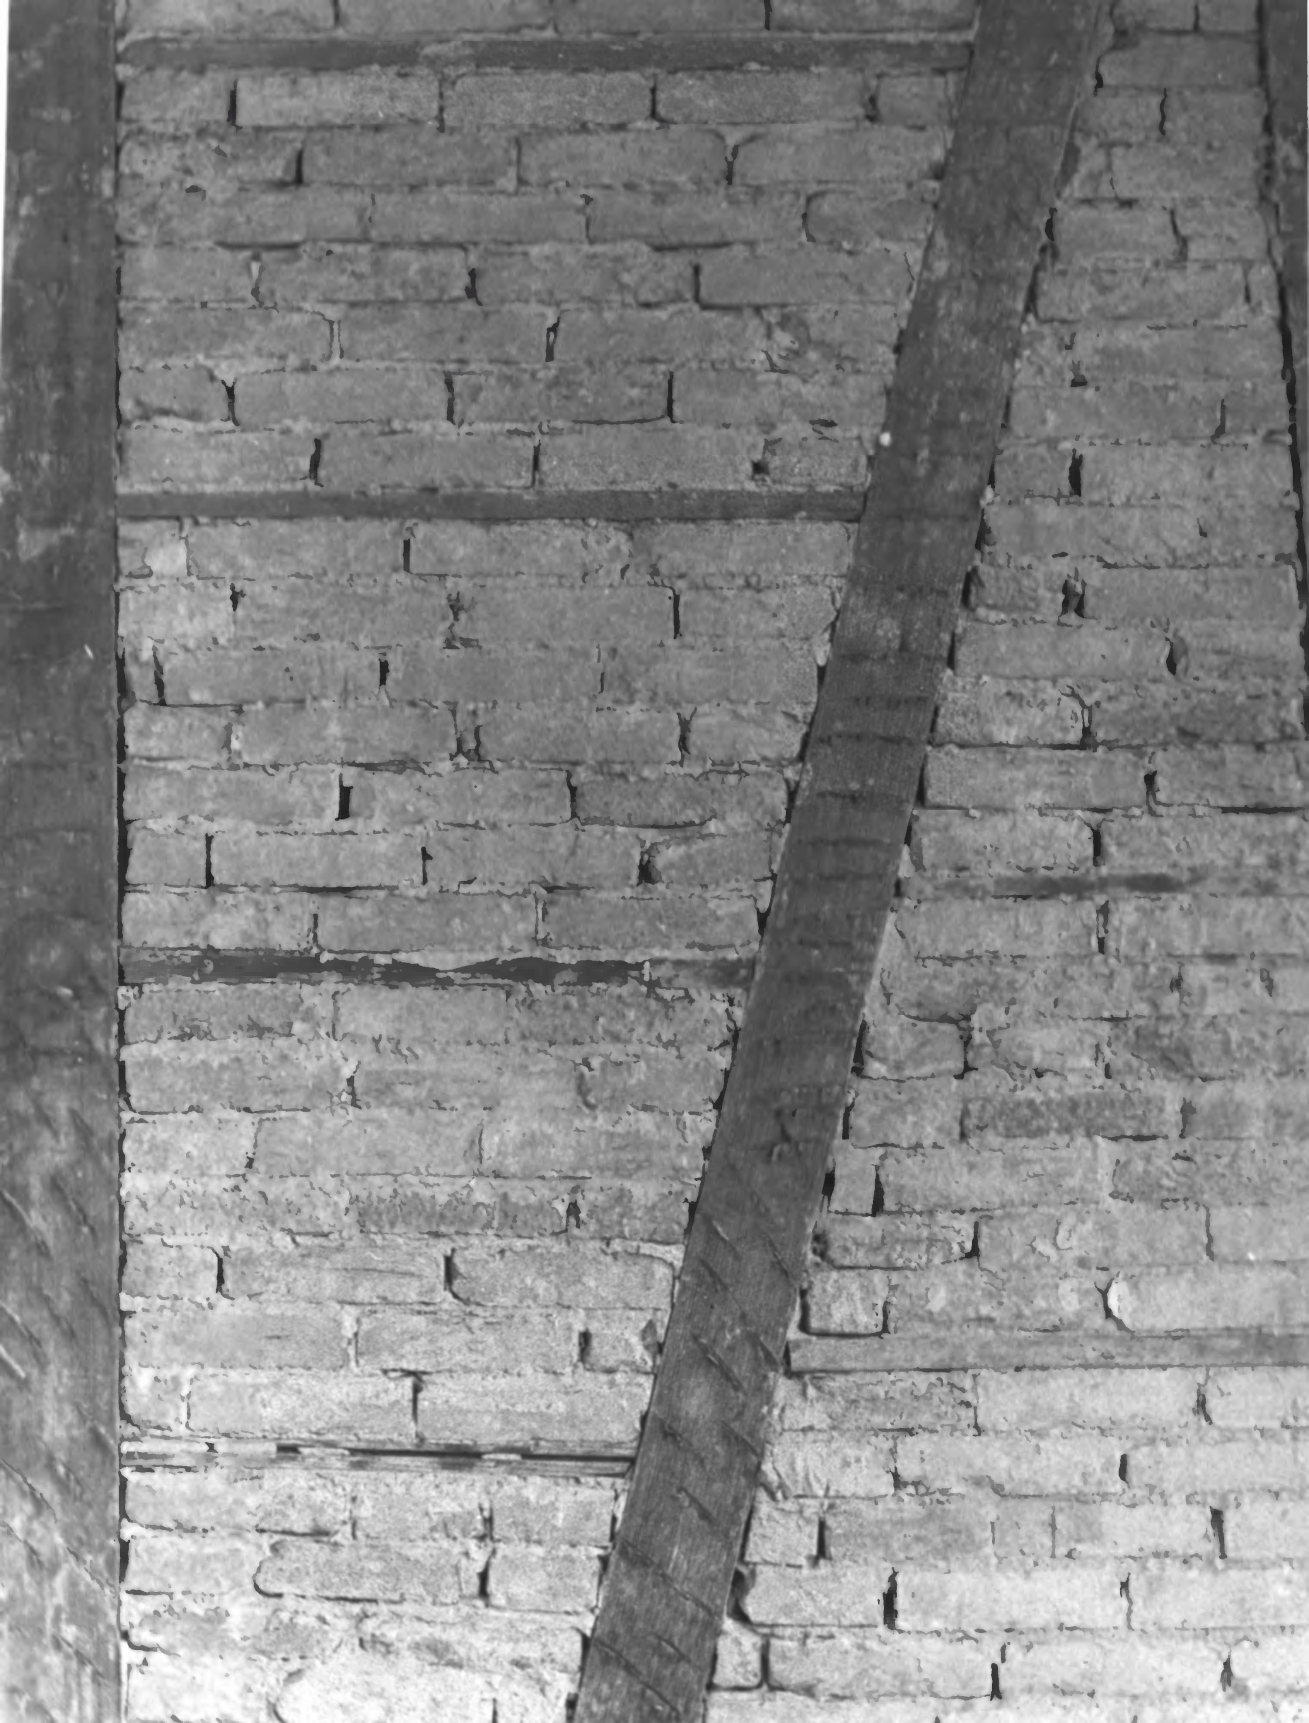
1. The Michel Prudhomme Home
2. Opelousas, La. *St. Landry Parish*
3. Daily World Photographer
4. July 1976
5. Kenneth Deshotel, Opelousas, La.
6. Briquette-entre-poteaux, now uncovered, on south end of front gallery, second floor
7. No. 10 *at 17*
