1. The Michel Prudhomme Home
2. Opelousas, La. *St. Landry Parish*
3. C. Kenneth Deshotel
4. January 1976
5. P. O. Drawer 1668, Opelousas, La.
6. View of front (west side)
7. No. 1 *17*

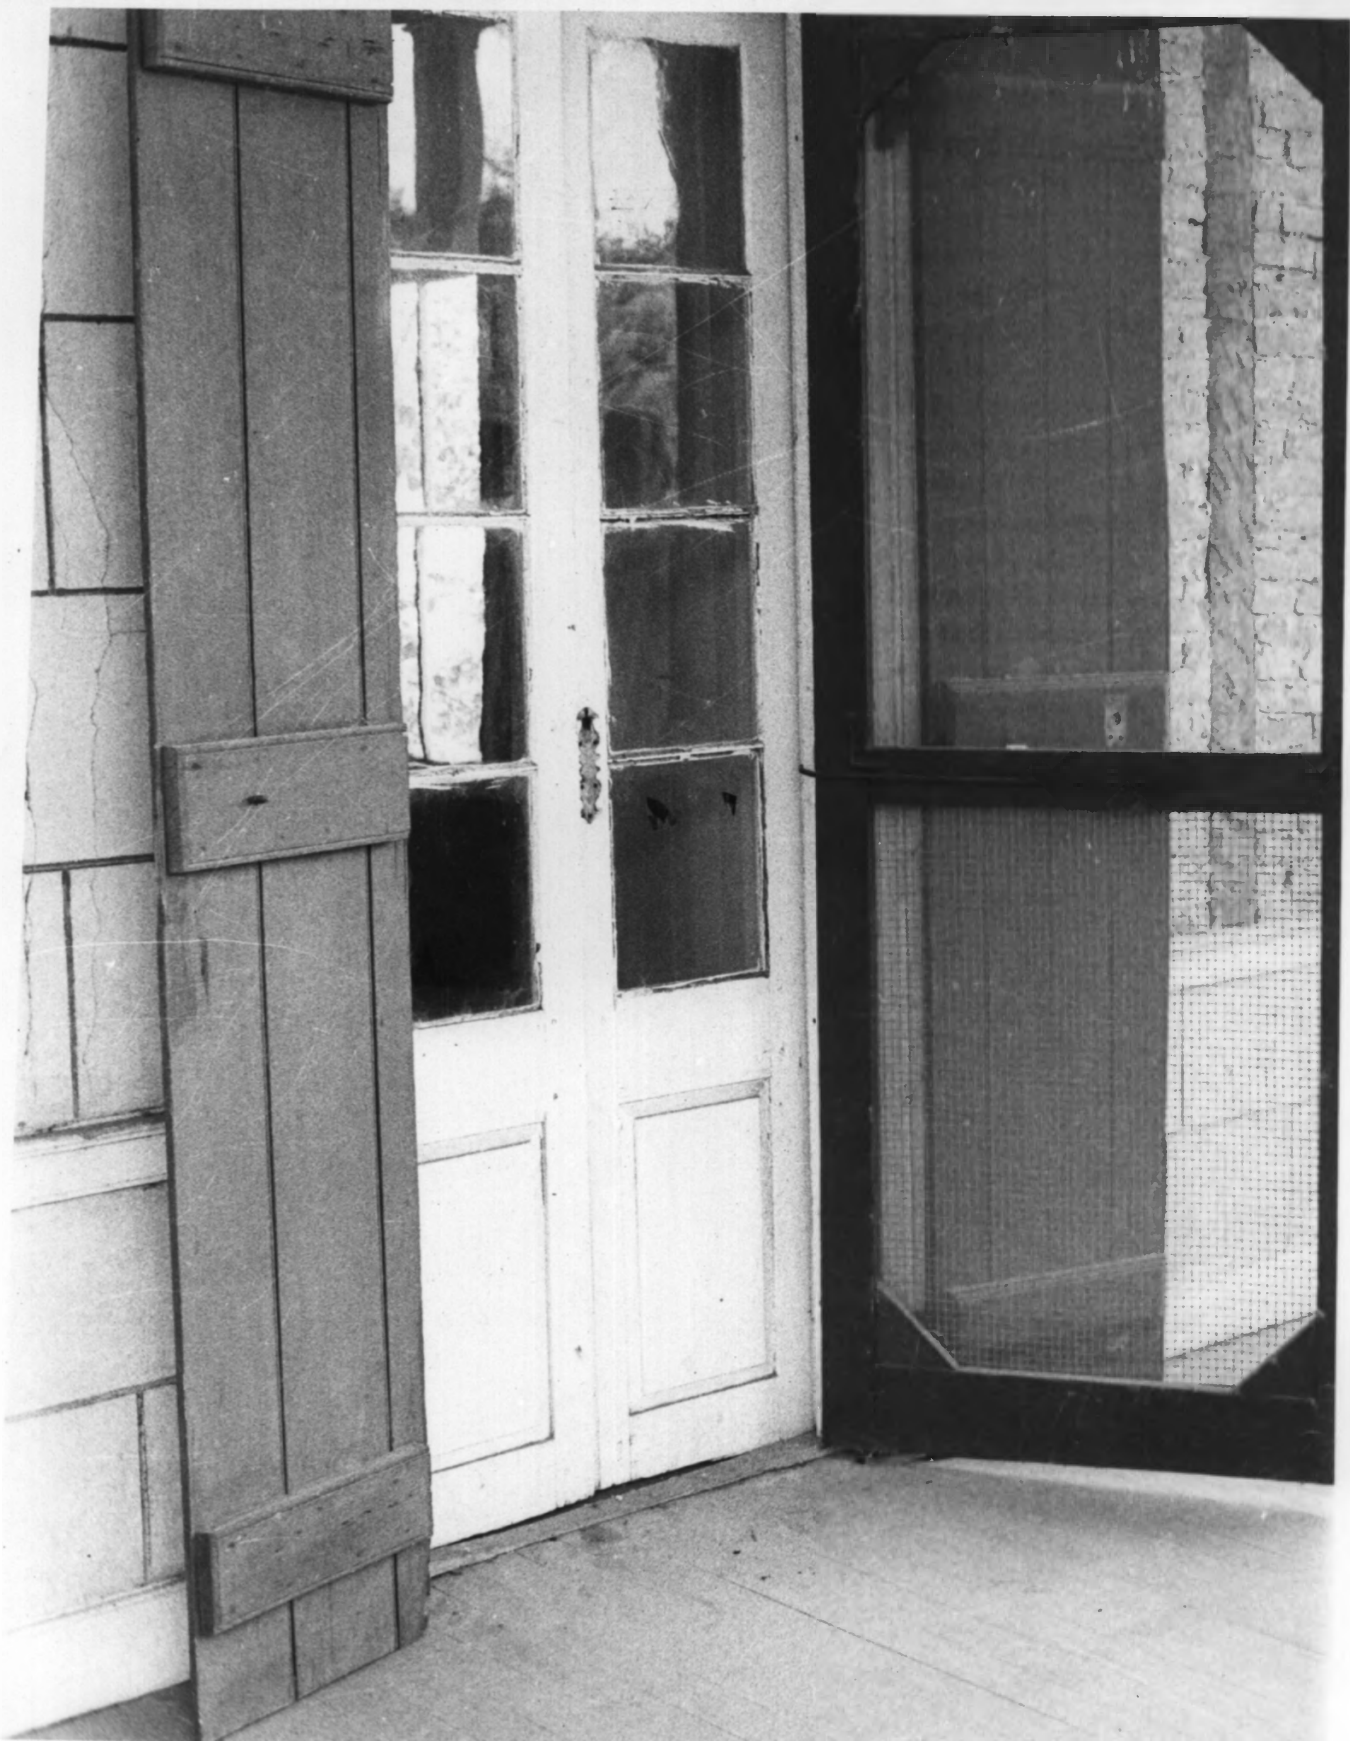
1. Michel Prudhomme Home
2. Opelousas, La. *St. Landry Parish*
3. Daily World Photographer
4. July 1976 **APR 5 1977**
5. Kenneth Deshotel, Opelousas, La.
6. Exterior door of the southwest corner room, upstairs, opening onto the gallery. Shows the scored stucco facade, the briquette-entre-poteaux construction, some of which is now exposed, and the batten
7. No. *11* **MAY 24 1977 Doc** shutters.

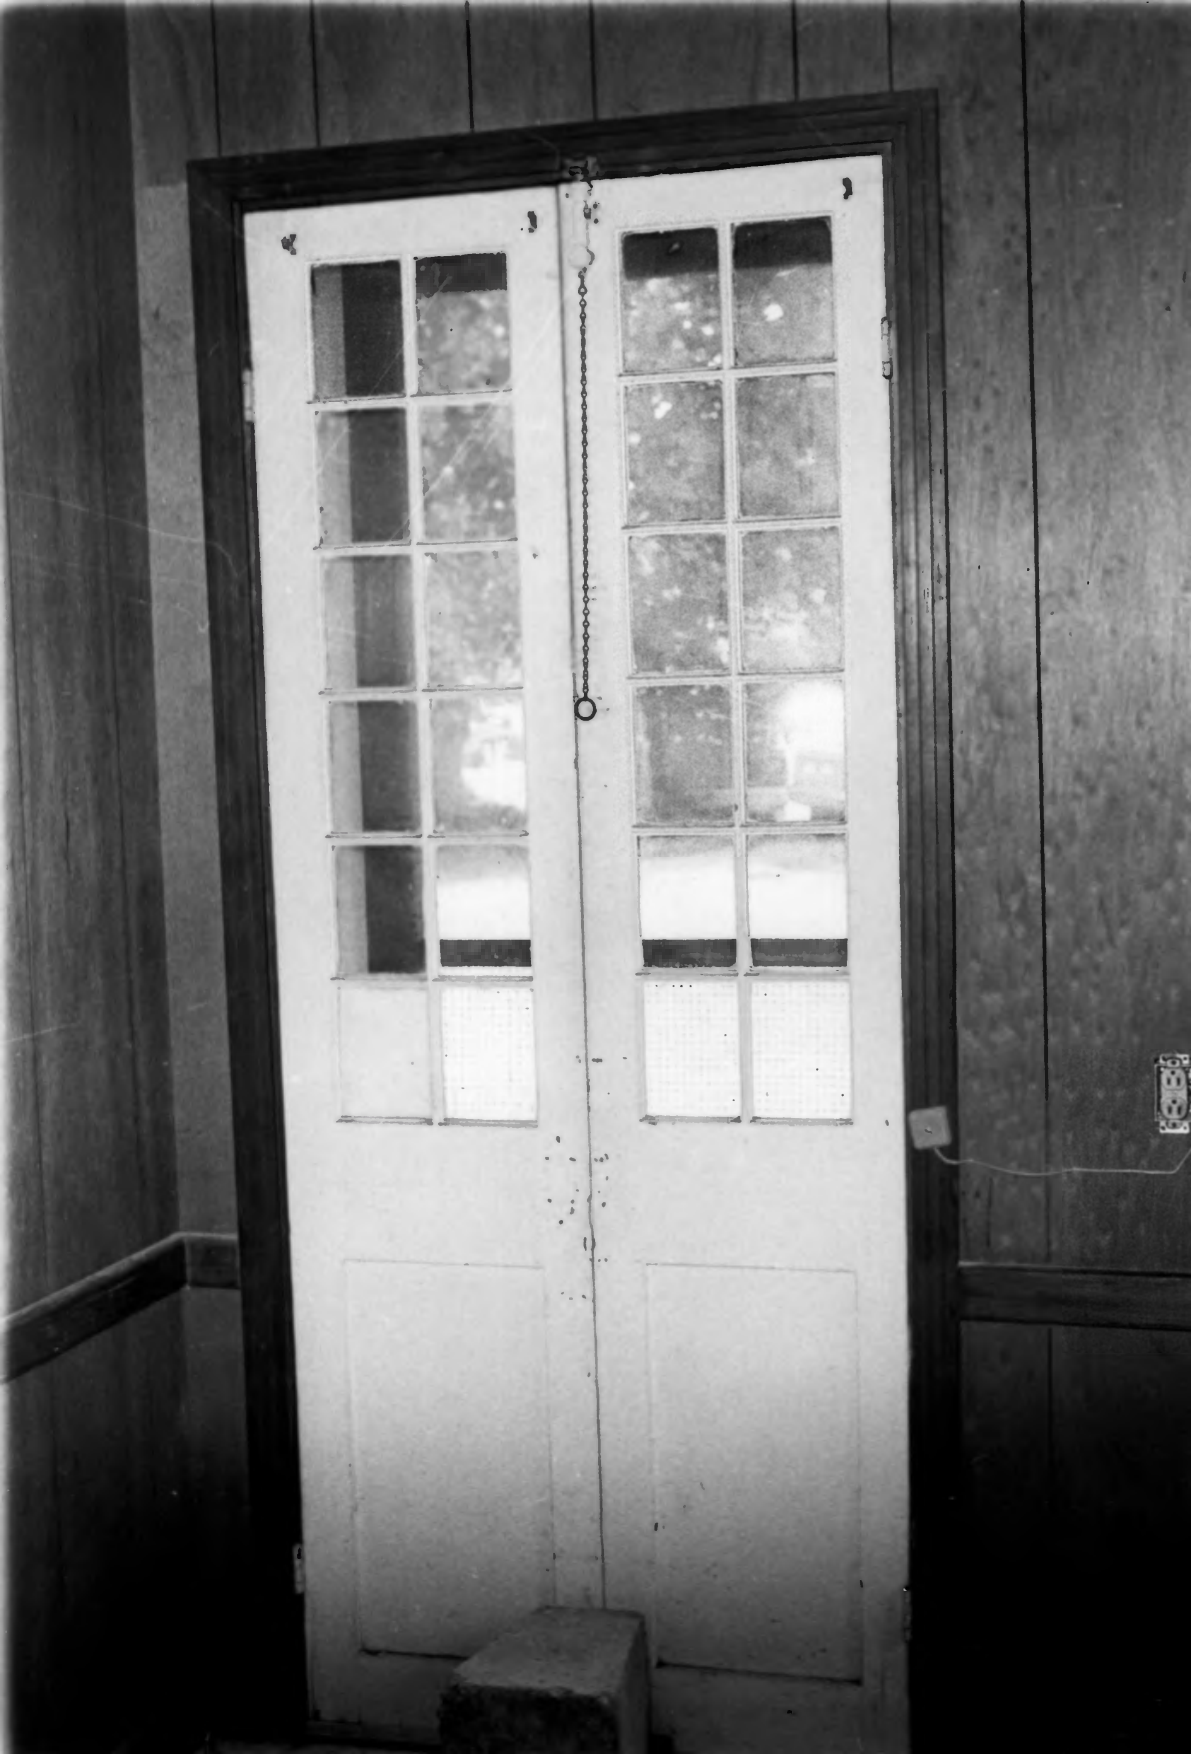
1. Michel Prudhomme Home
2. Opelousas, La.
3. Daily World Photographer **APR 5 1977**
4. July 1976 *St Landry Parish*
5. Kenneth Deshotel, Opelousas, La.
6. Interior of front door on first floor at northwest corner of house. May be an original door. Panelling shown is used in only two rooms - this one which recently served as a bedroom and the adjoining room which is a bathroom. **MAY 24 1977**
7. No. 12 *217*

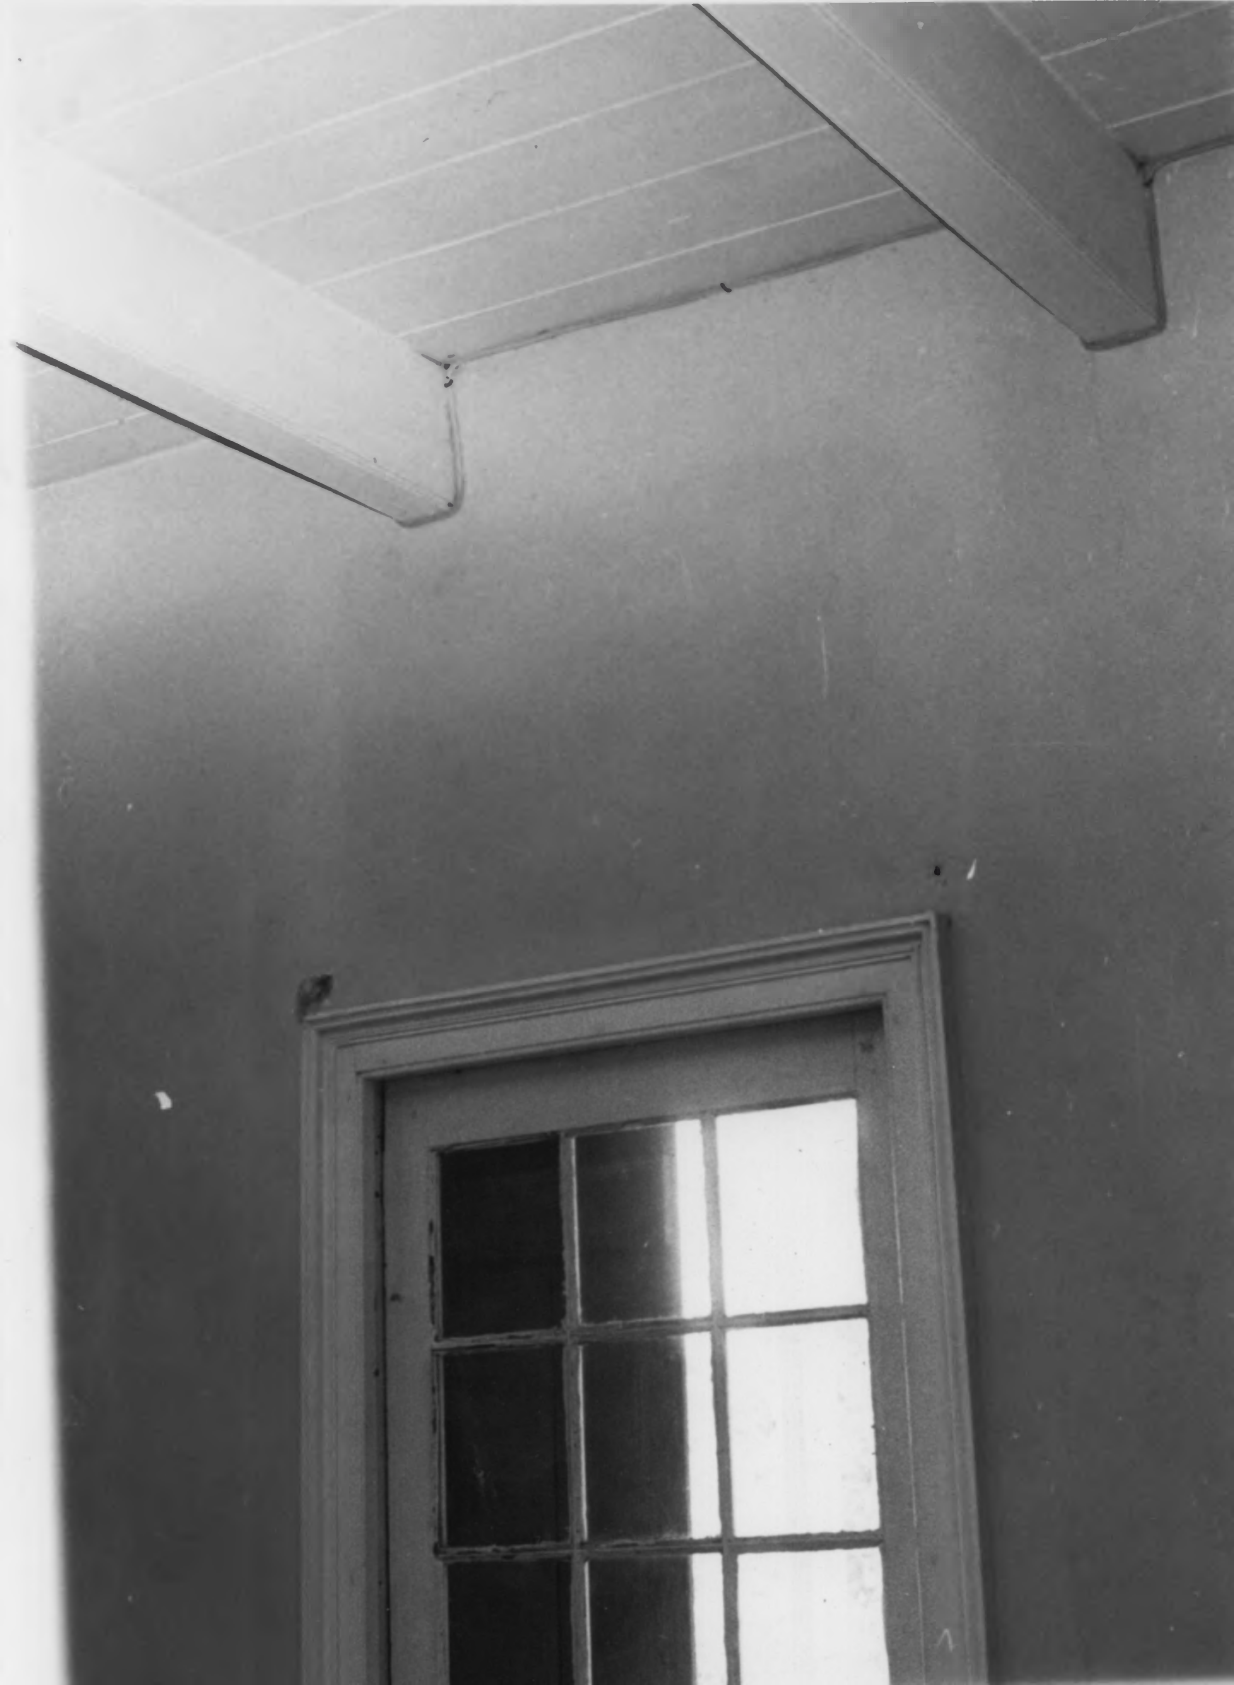
1. Michel Prudhomme Home
2. Opelousas, La.
3. Daily World Photographer **APR 5 1977**
4. July 1976 *St. Landry Parish*
5. Kenneth Dëshotel, Opelousas, La.
6. Cypress beaded beams and ceiling boards in second floor center room at front of house (west). Originally was living room. Original moulding in house is like that on this window. Plaster walls.
7. No. 13 ^{of} **MAY 24 1977** Doc-

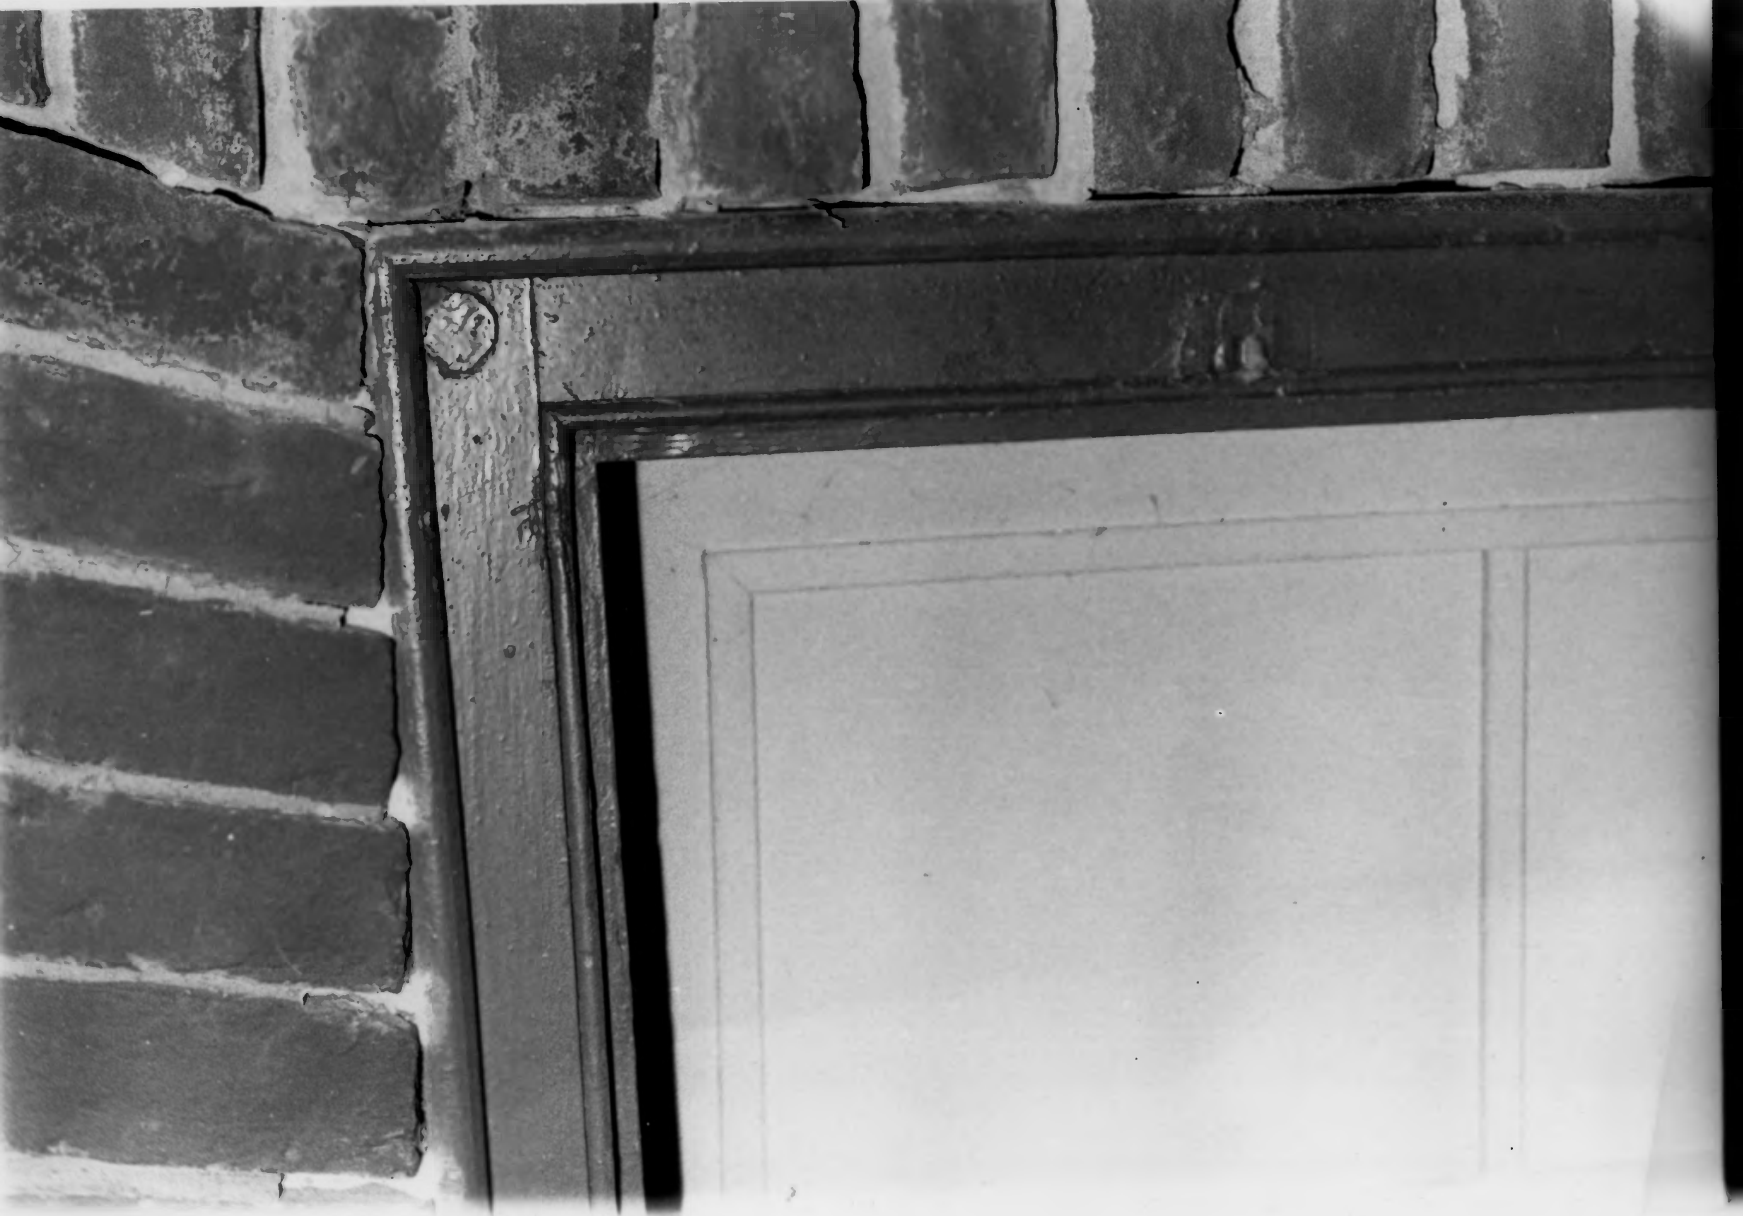
1. Michel Prudhomme Home
2. Opelousas, La. *St. Landry Parish*
3. Daily World Photographer **APR 5 1977**
4. July 1976
5. Kenneth Deshotel, Opelousas, La.
6. Door from back gallery (now enclosed) into room at northeast corner of house on first floor. Shows the pegging which was used in all door and window enframements.
7. No. 14 *17* **MAY 24 1977 Doc**

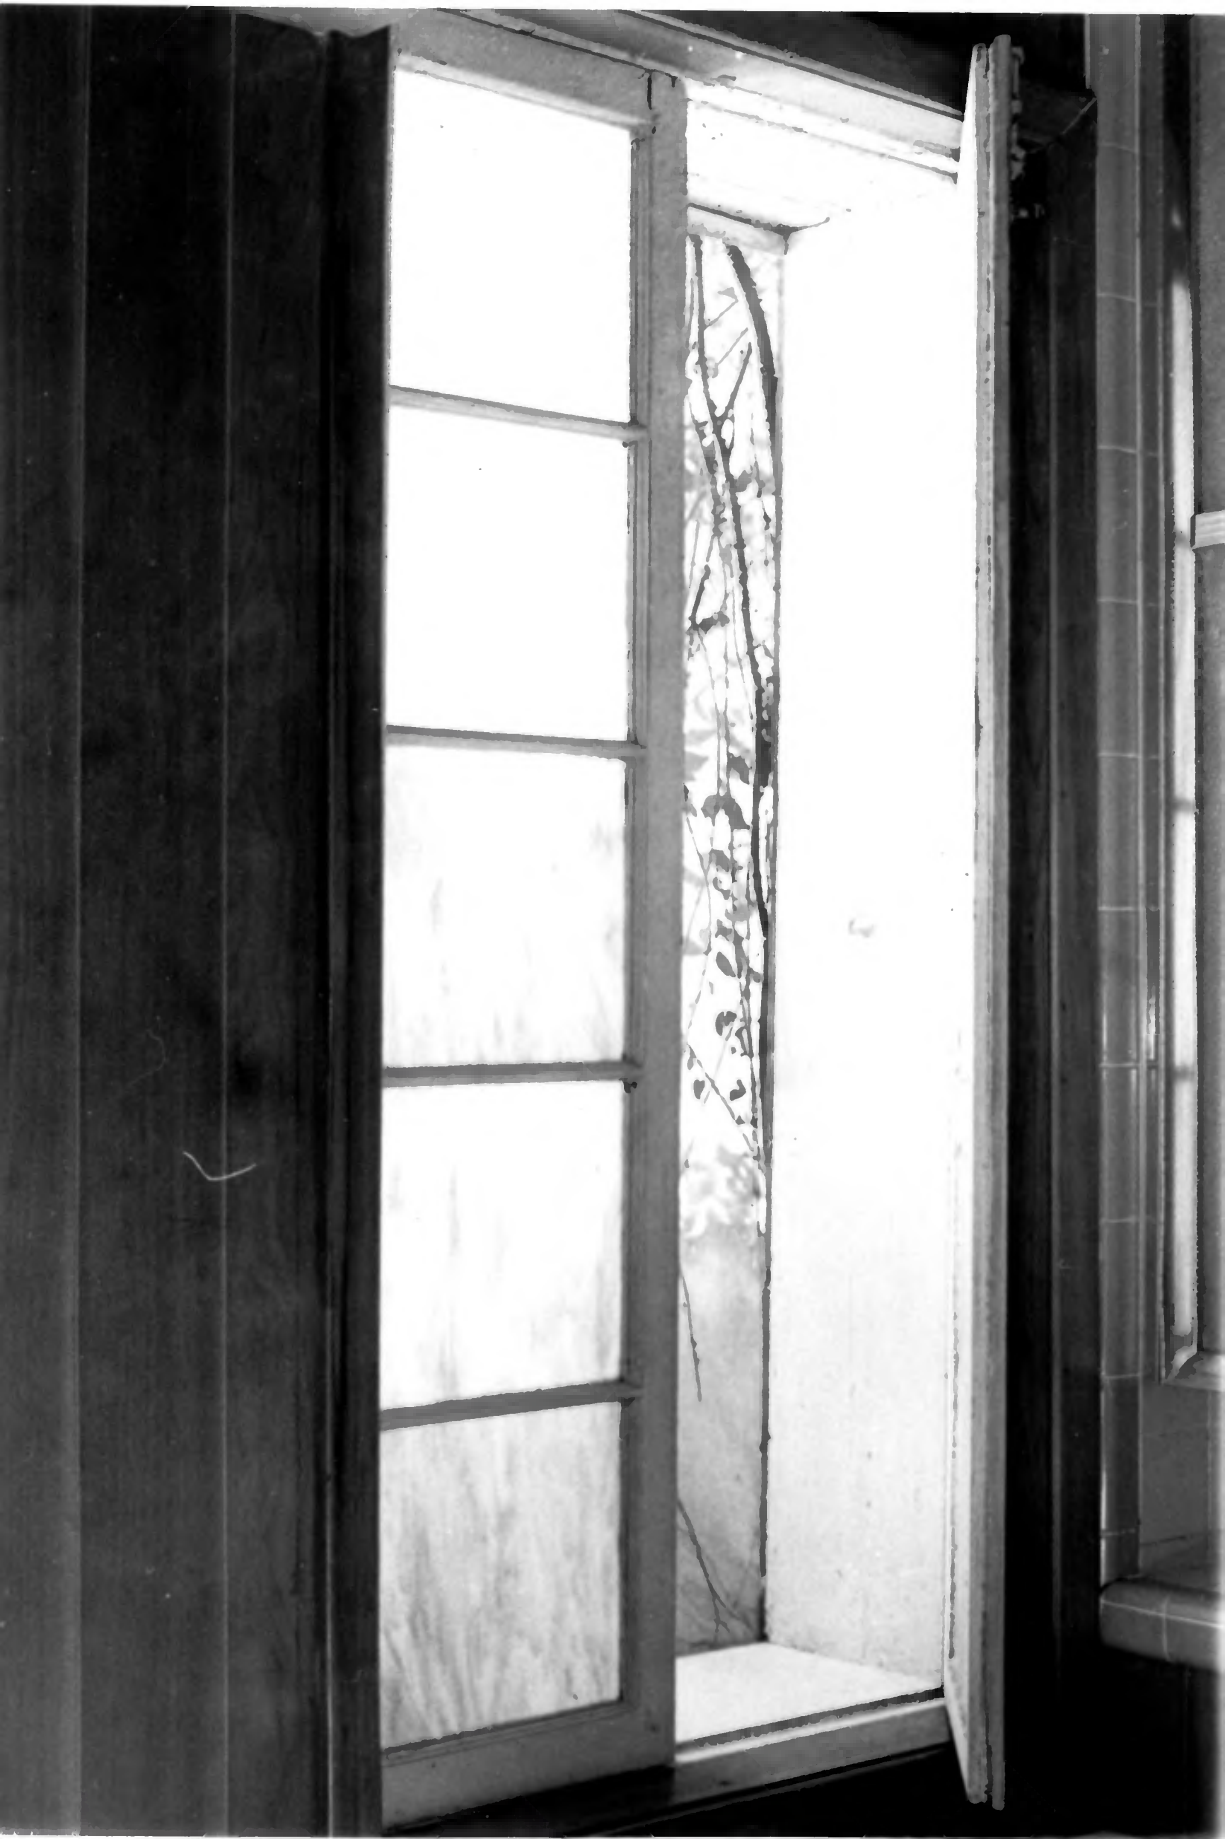
1. Michel Prudhomme Home
2. Opelousas, La.
3. Daily World Photographer
4. July 1976 *St. Landry Parish*
5. Kenneth Deshotel, Opelousas, La.
6. Casement window in northeast corner of house on first floor, now a bathroom. Thought to be one of original windows (except for the glass) like those which had been used across back side of first floor.
7. No. 15 *17* **MAY 24 1977** Doc-

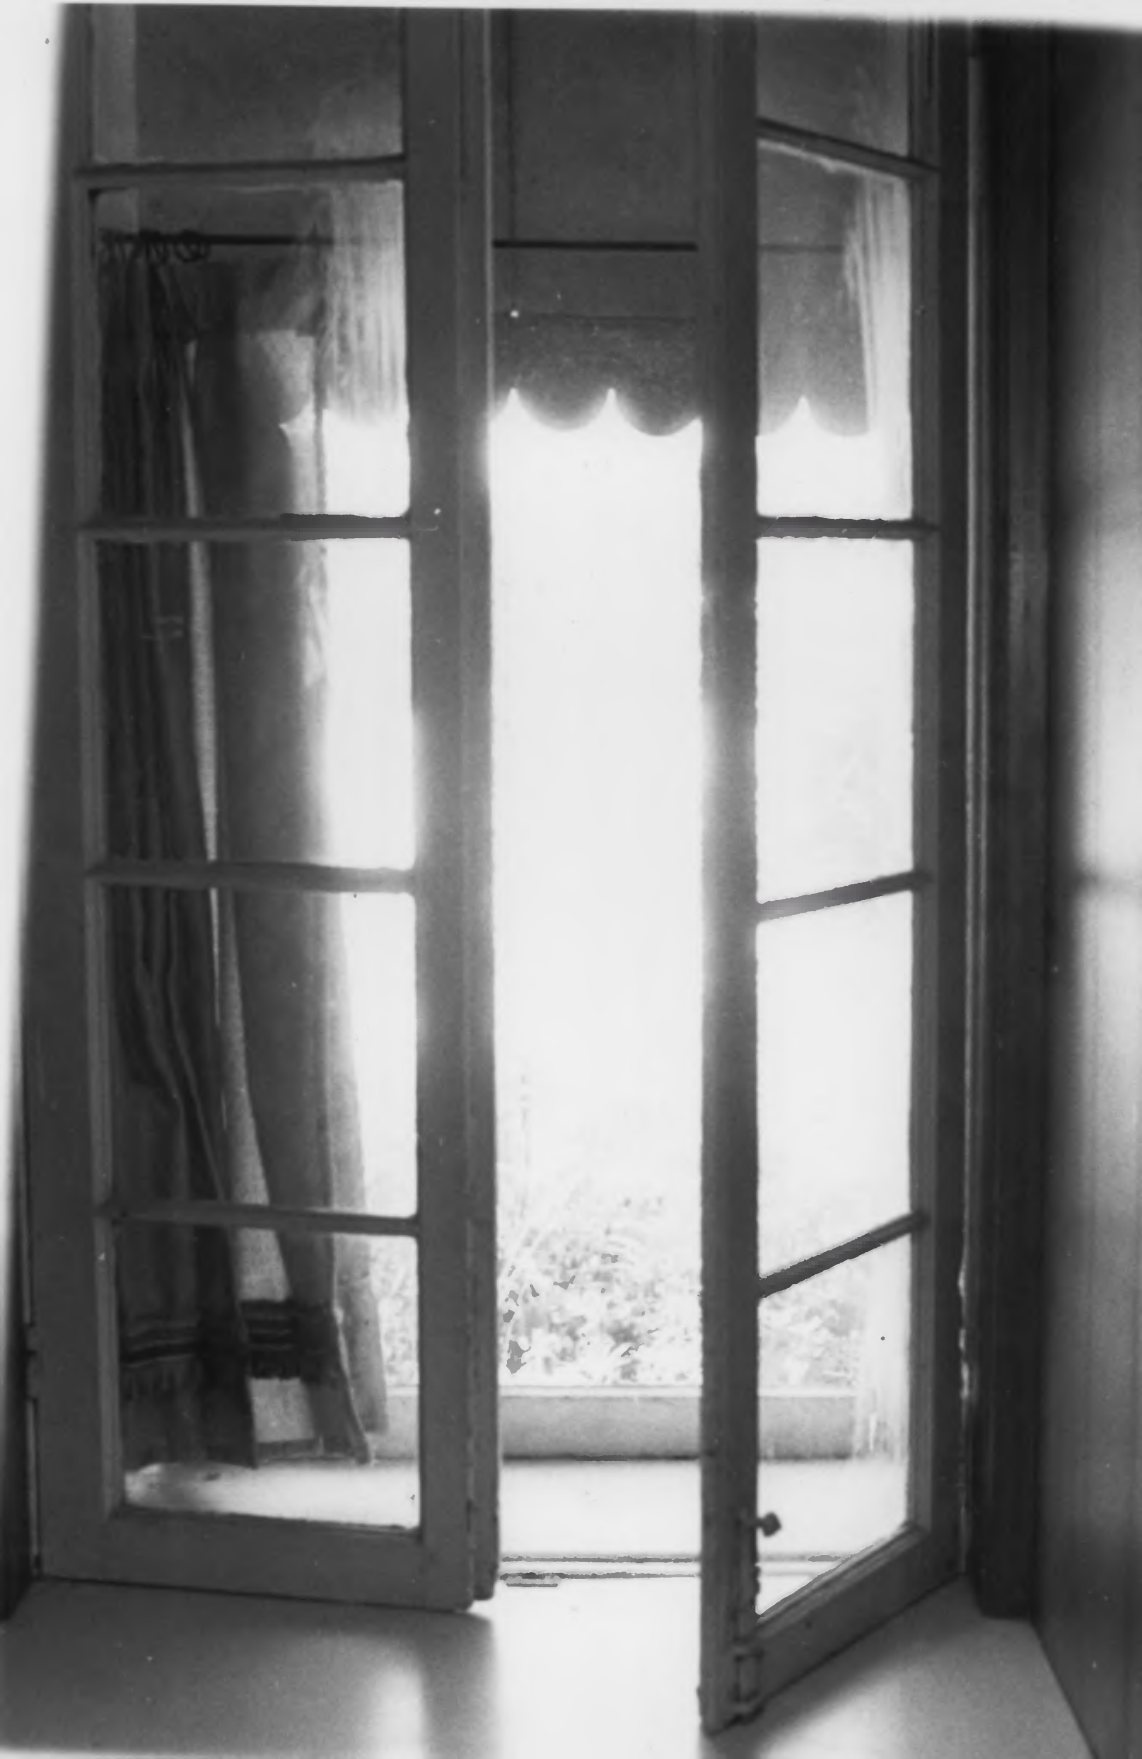
1. Michel Prudhomme Home
2. Opelousas, La.
3. Daily World Photographer
4. July 1976 *St. Landry Parish*
5. Kenneth Deshotel, Opelousas, La.
6. Casement window of first floor, northeast corner room, now a bathroom.
7. No. 16 *217*

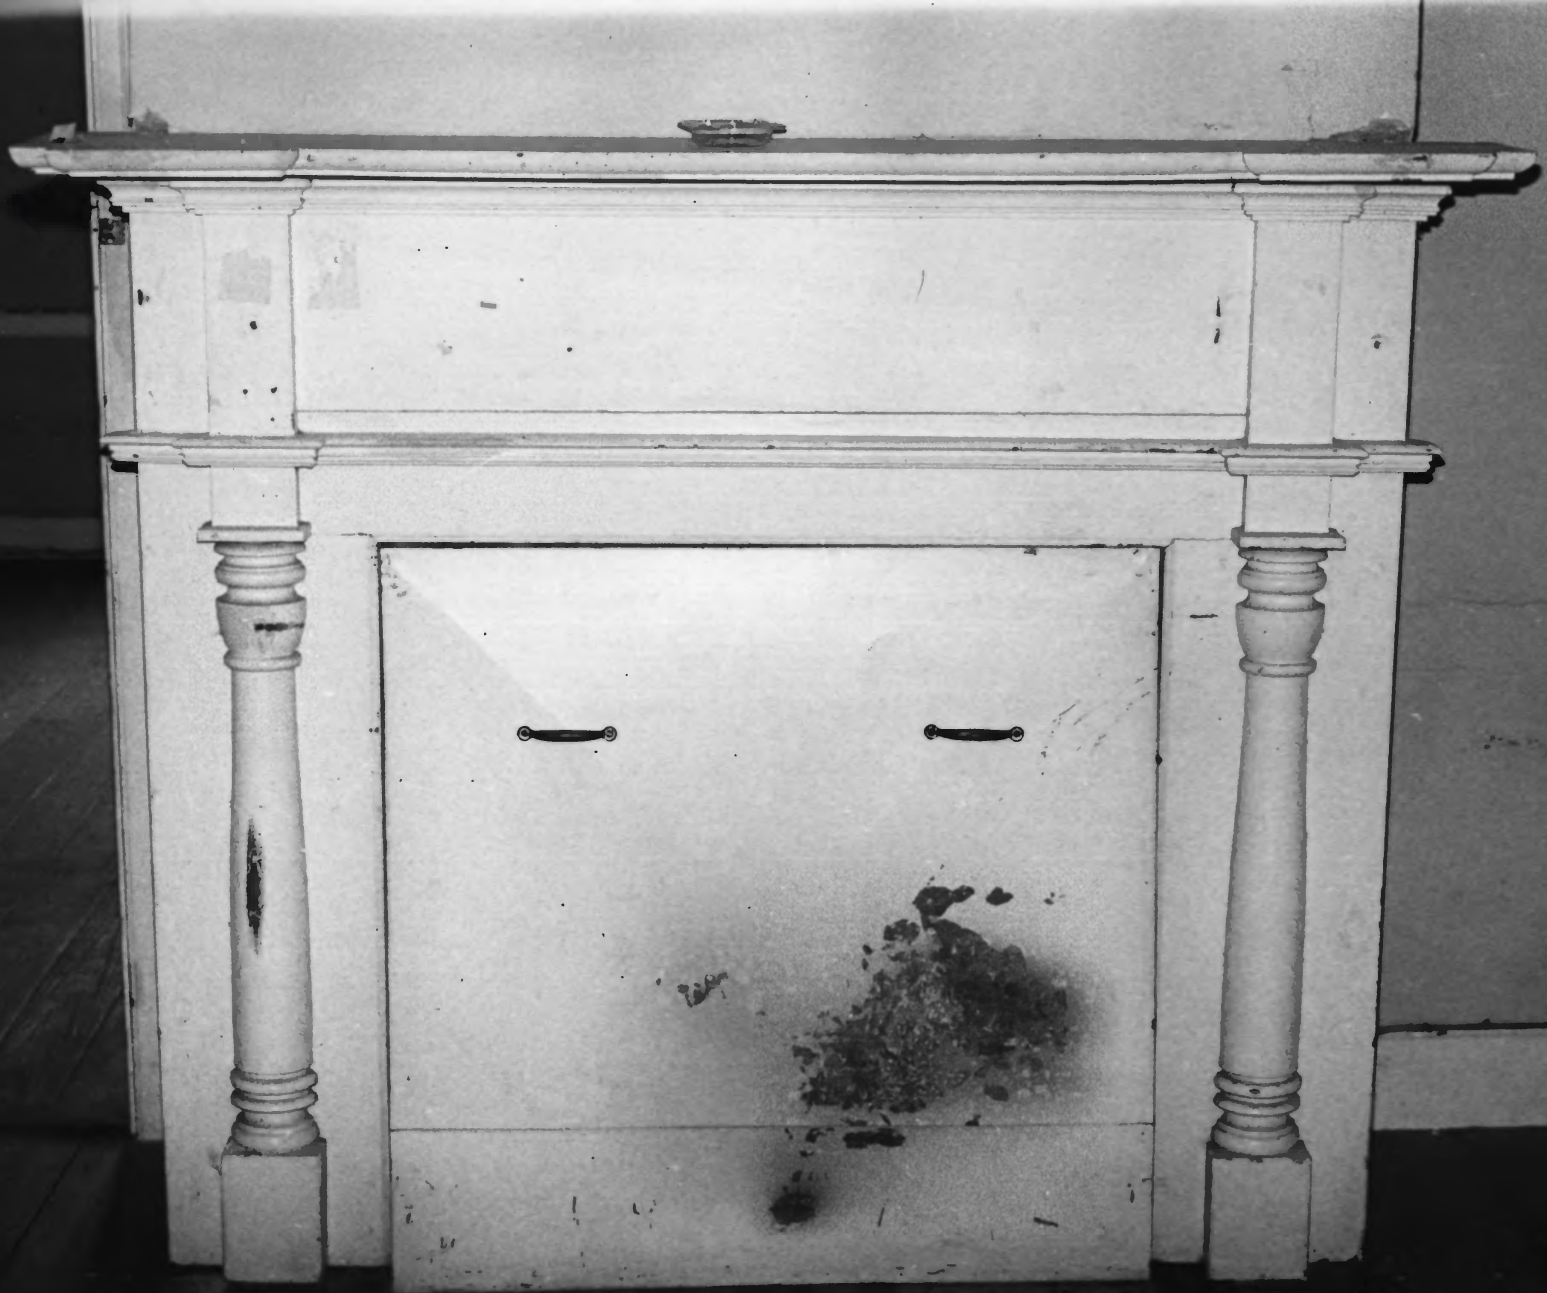
1. Michel Prudhomme Home
2. Opelousas, La.
3. Daily World Photographer
4. July 1976 *St. Landry Parish*
5. Kenneth Deshotel, Opelousas, La.
6. Original (?) mantel of upstairs center room which had been living room. This is a double fireplace and the mantel in the room behind is identical.
7. No. 17 of 17
