KENTUCKY HISTORIC RESOURCES INVENTORY

Site No. Fa-42

1. Historic Name(s) <u>Frederick Shryock house</u>		22. ADD/County <u>Bluegrass / Fayette</u>	
Original Owner <u>Frederick Shryock</u>		23. U.S.G.S. Quadrant (15'/75') <u>Clintonville</u> G.I.S. Mod.

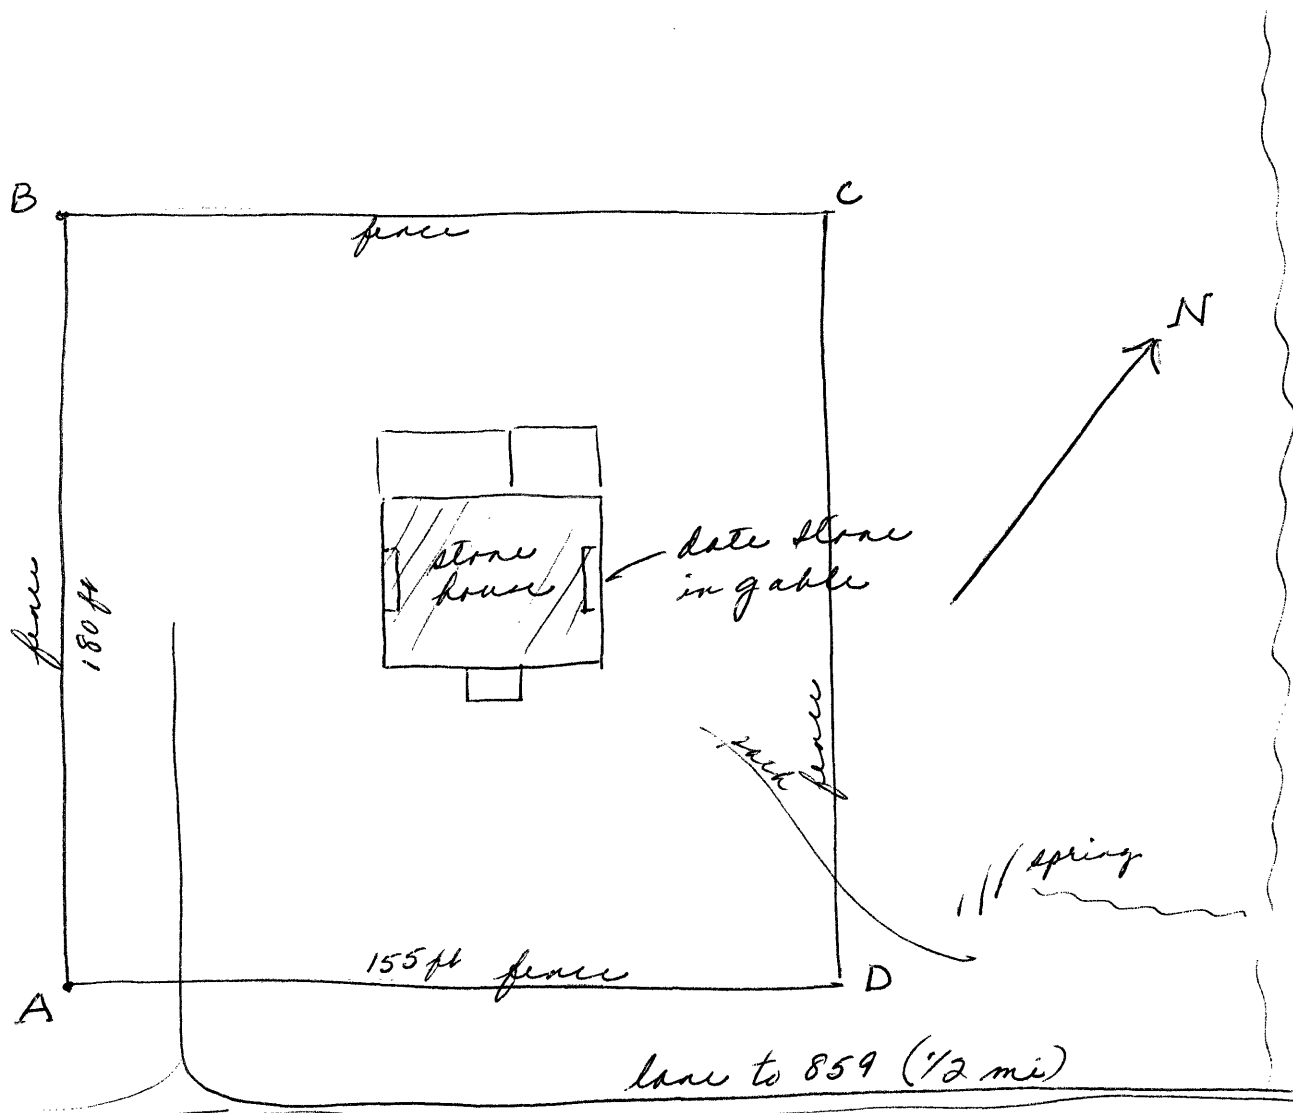
SKETCH MAP OF SITE SHOWING BOUNDARIES AND KEY BUILDINGS AND FEATURES WITH NORTH ARROW.

Beginning at A near the lane entrance to the yard, thence with fence around yard NW 180 ft to B, NE 155 ft to C, SE 180 ft to D at the lane, thence SW with lane 155 ft to the beginning containing only the stone house and about 2/3 acre.
