NATIONAL REGISTER OF HISTORIC PLACES
REGISTRATION FORM

historic name: Aage and Kristine Larsen Homestead

Aage and Kristine Larsen Homestead

Aage and Kristine Larsen Homestead
Sheridan County, Montana

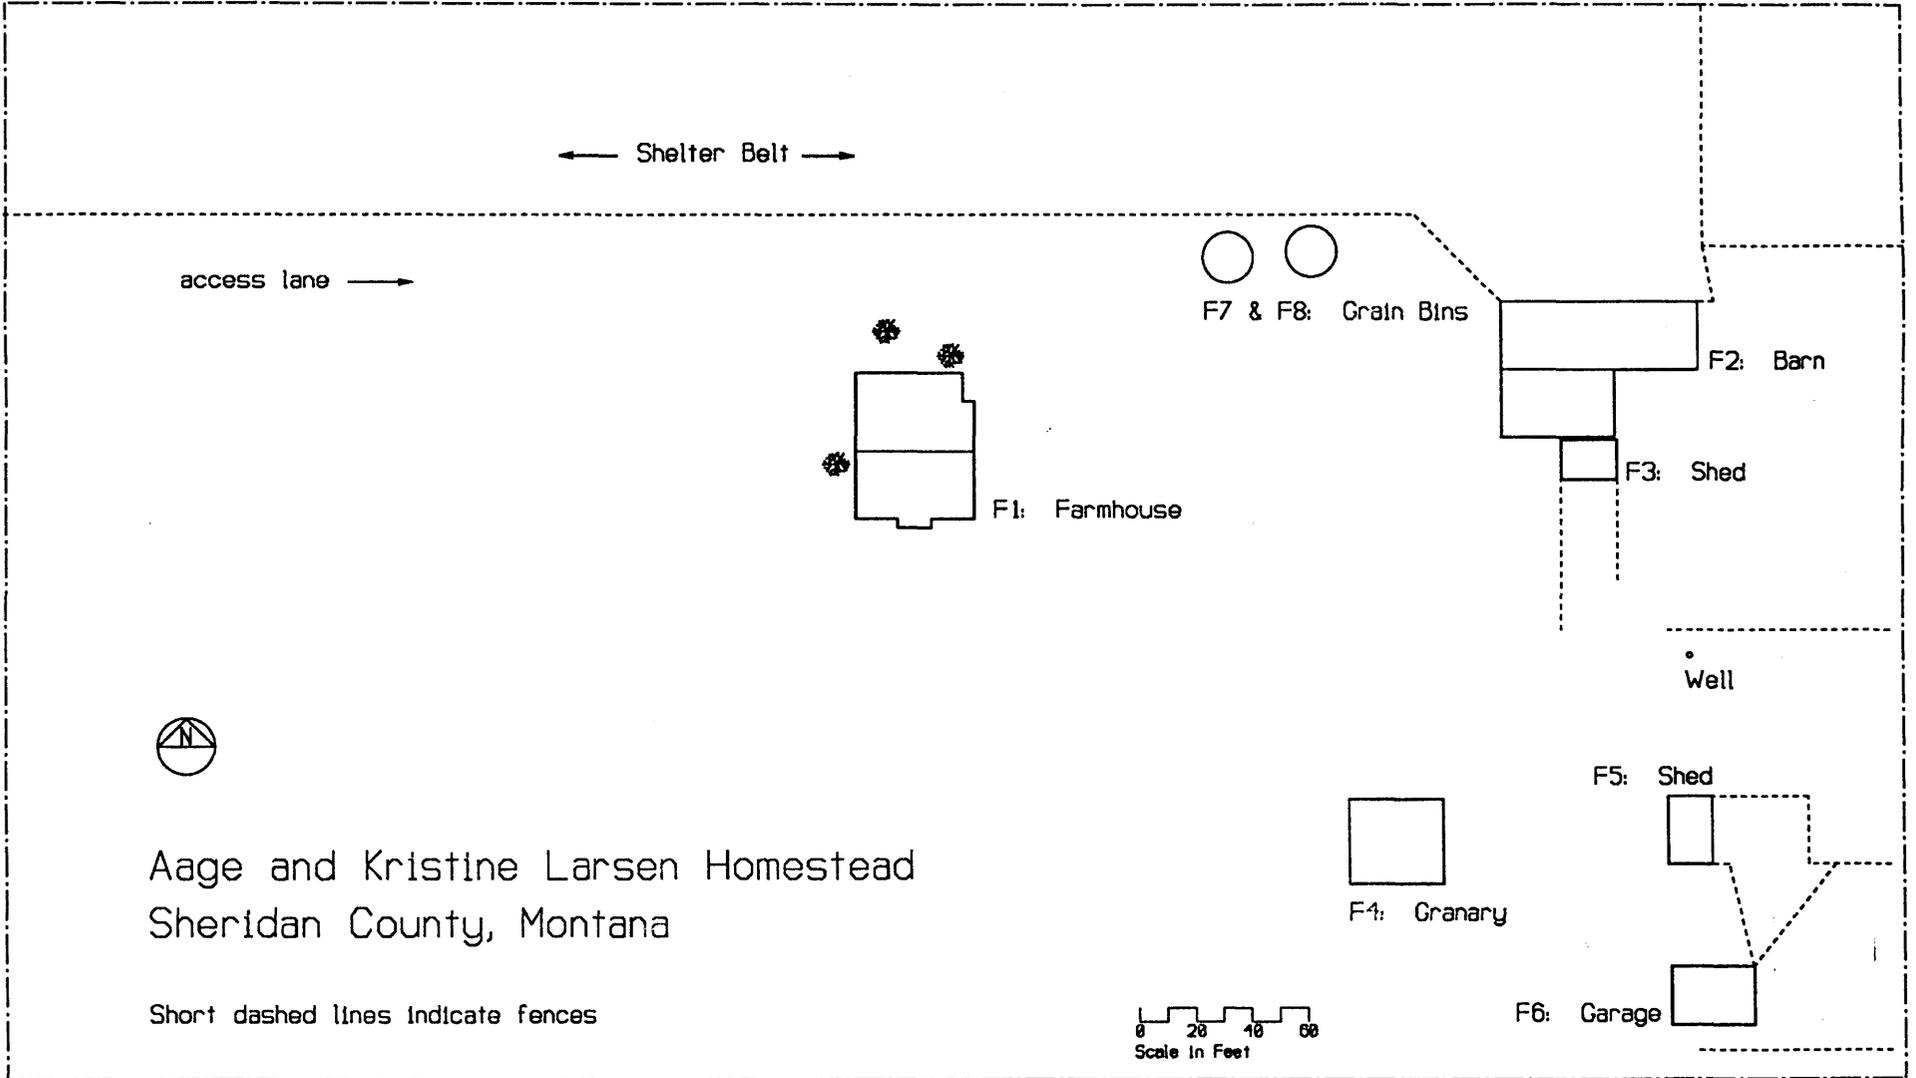
The boundary for the historic district encompasses about 4 acres of land, measuring 380 feet north-south by 675 feet east-west (see accompanying sketch map). The boundary is defined on the north by the northern edge of a shelter belt of trees, and to the west by the east edge of the right-of-way for County Highway 516. Beginning at a point 105 feet north and 75 feet east of the northwest corner of the barn (feature 2), the boundary extends west along the north edge of the tree belt--and parallel with an east-west fence along the south edge of the tree belt--to a point on the east edge of the right-of-way for County Highway 516. The boundary then continues south along the east edge of the highway's right-of-way 380 feet to a point; then 675 feet east to a point; then north 380 feet to the point of beginning. The district is located in the NW¼ of Section 7, T33N, R58E, M.P.M.

Short dashed lines indicate fences
