**National Register of Historic Places
Registration Form**

historic name Teweles and Brandeis Grain Elevator
other names/site number Midland Mill

street & number 92 East Maple Street
city or town Sturgeon Bay
state Wisconsin **code** WI **county** Door **code** 029 **not for publication vicinity zip code** 54235

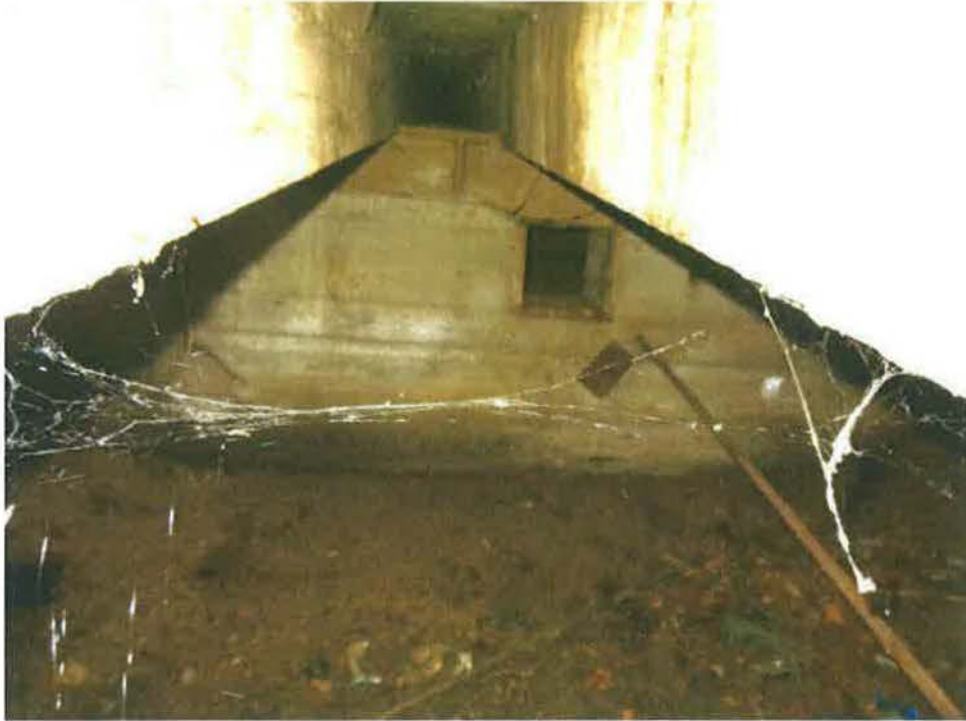
Photo 1: Foundation wall at shallow basement

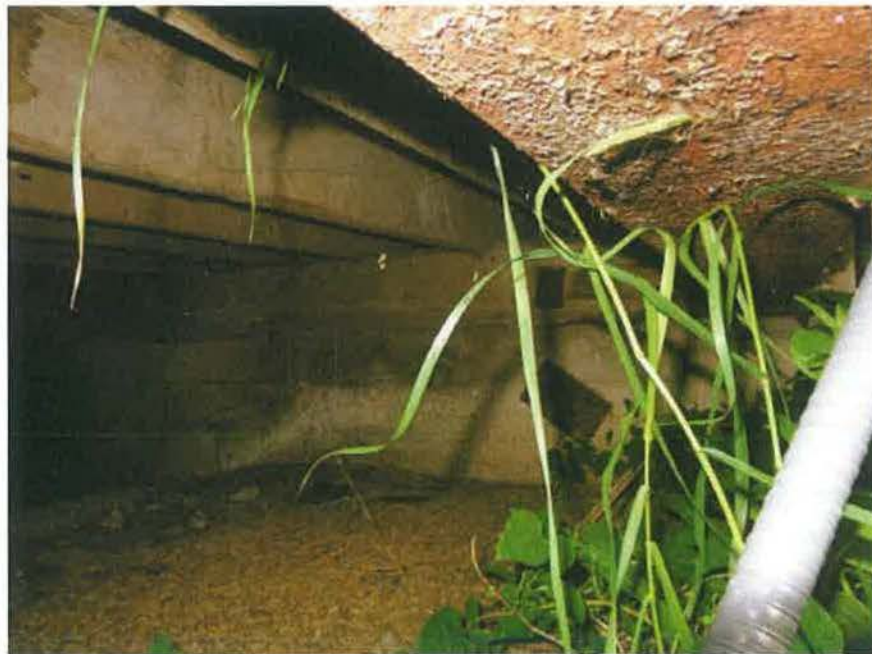
Photo 2: Foundation grade-beam with wood joists above

Recommendation 5: Investigate further the foundation grade beam conditions by removing selected main floor beams and visually inspecting a representative sample of the grade beams. Repair or replace broken or cracked grade-beams.

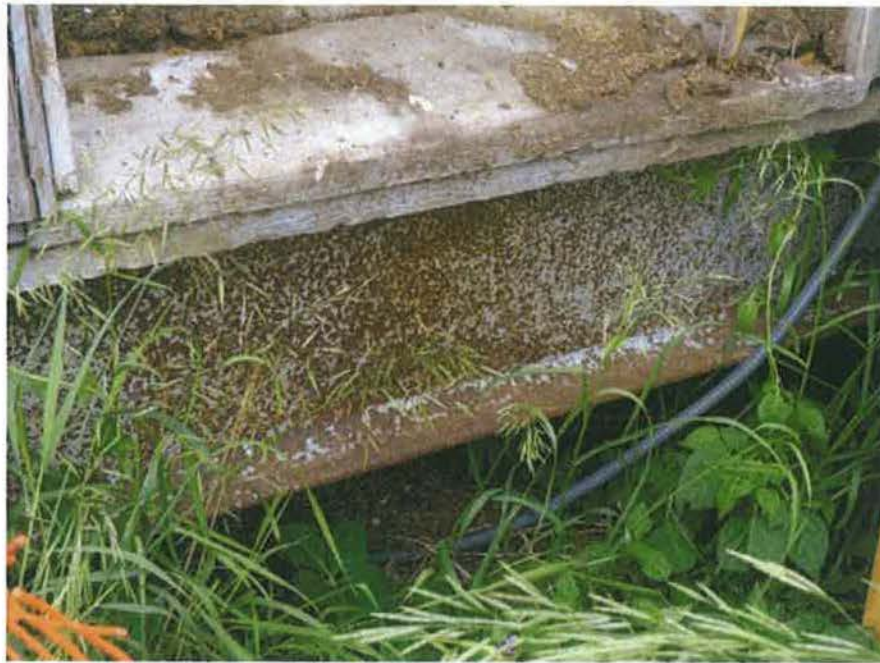
Photo 3: Steel beam under north wall

Recommendation 6: Remove the broken grade-beam on grid C and the steel beam under the north wall; replace these with new concrete grade-beams.

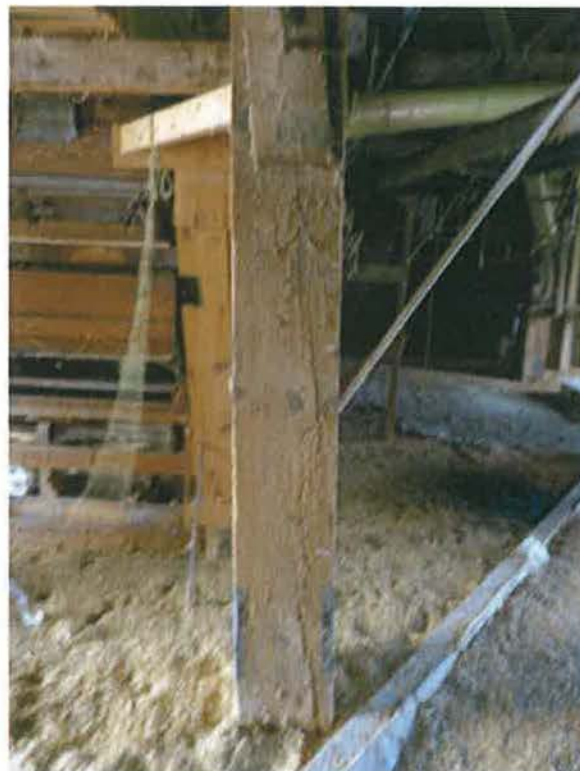
Photo 4: Interior solid posts

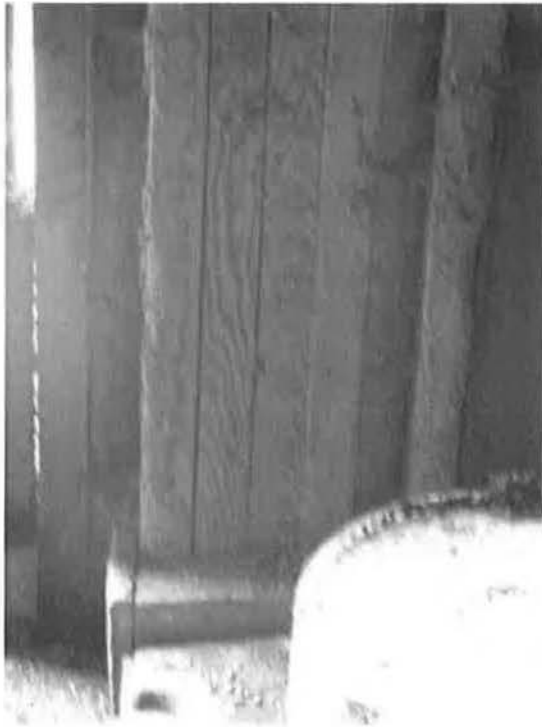
Photo 5: Typical built-up perimeter post

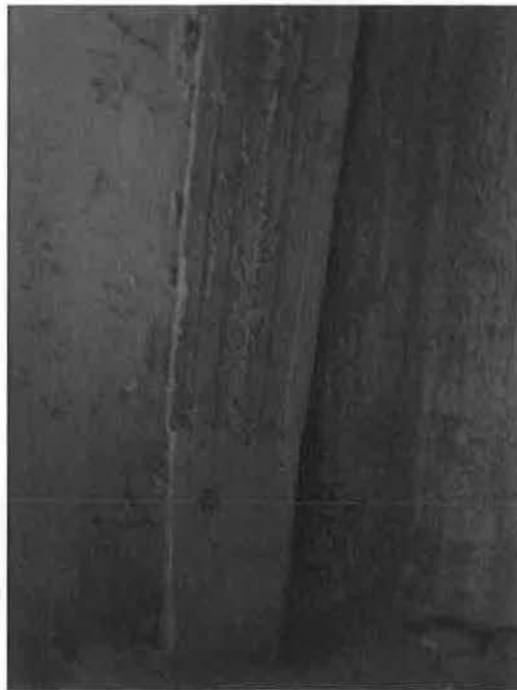
Photo 6: Built-up post showing first-level deflection

- b. The first floor framing is 3 ½" out of plumb in the east/west direction and 7" out of plumb in the north/south direction. The small deflections and low stresses due to the out-of-plumb condition and wind forces, calculated by the 3-D computer model, indicate that the granary elevator is stable in its current configuration.

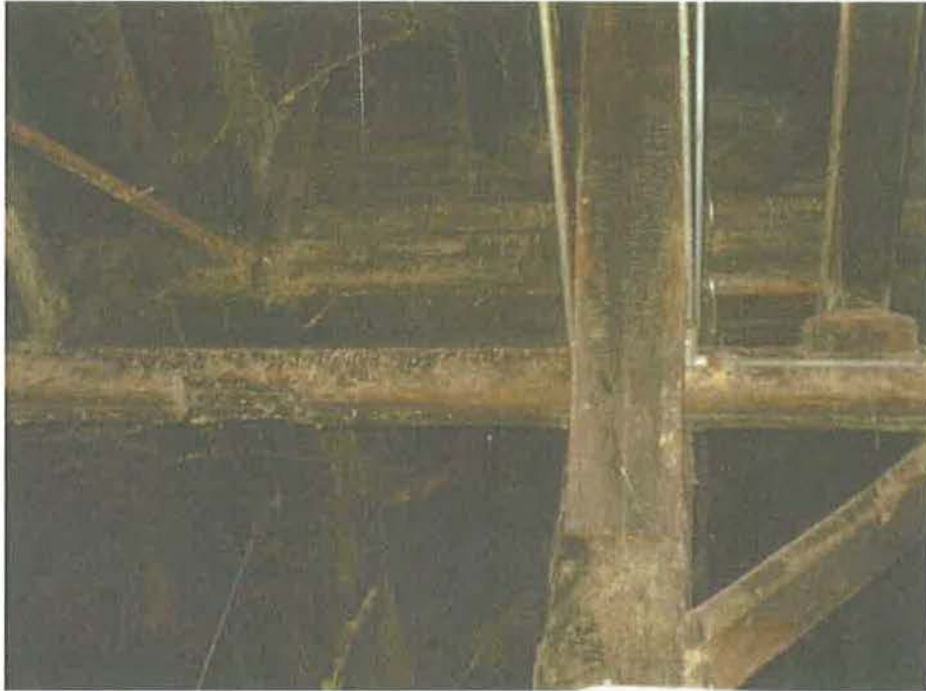
Photo 7: First-floor framing – post, beam and diagonal kicker

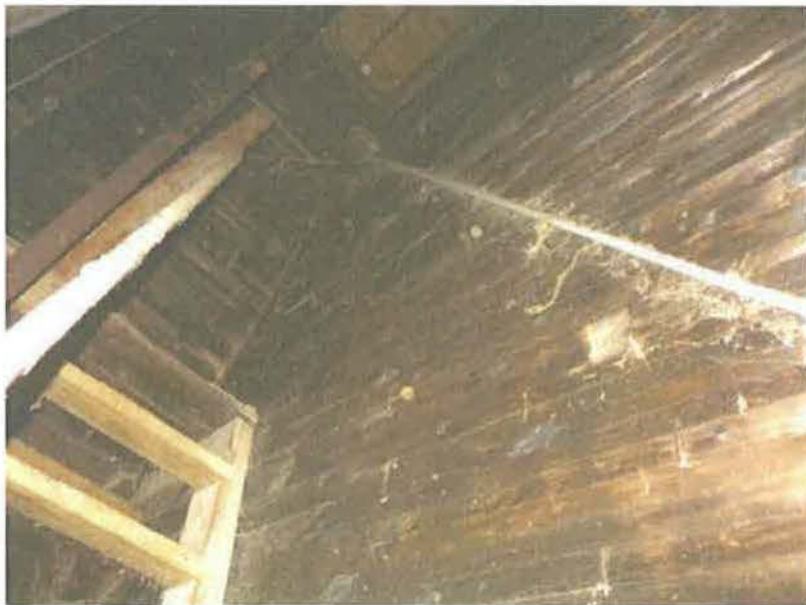
Photo 8: Grain bin showing cribbed-construction

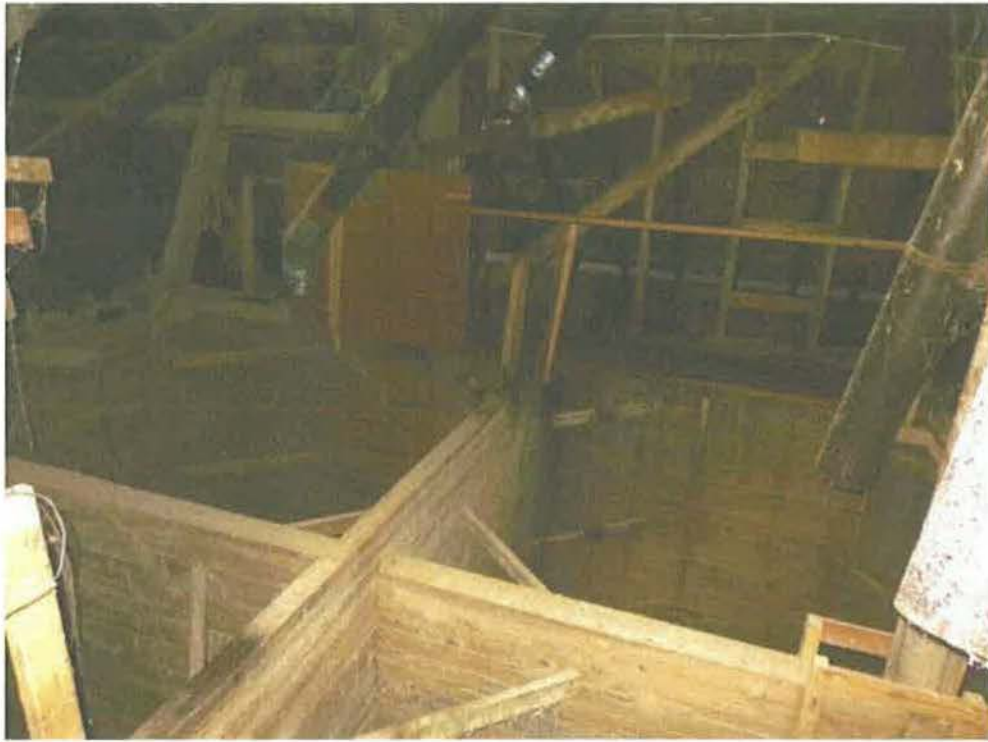
Photo 9: Top of grain bins with roof framing beyond.

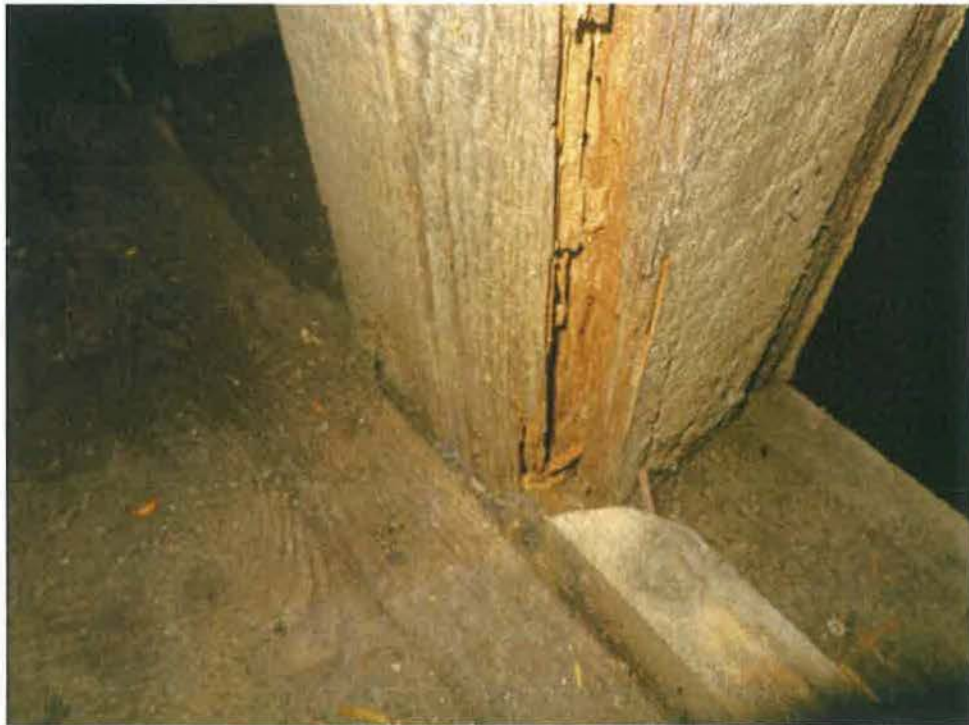
Photo 10: Dry rot at bottom of roof post.

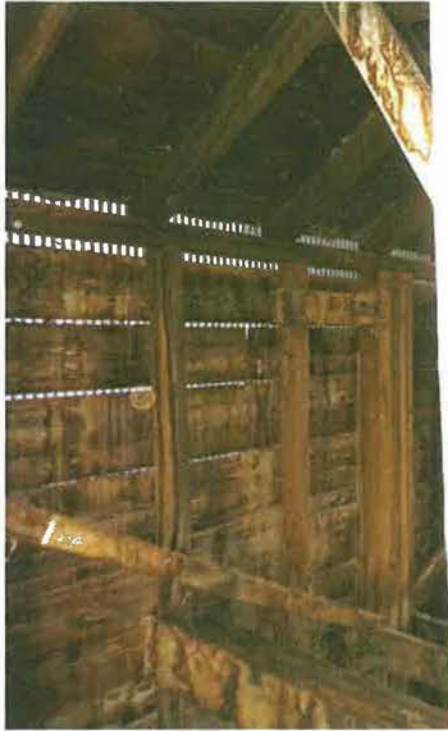
Photo 11: Head-house wall and roof framing

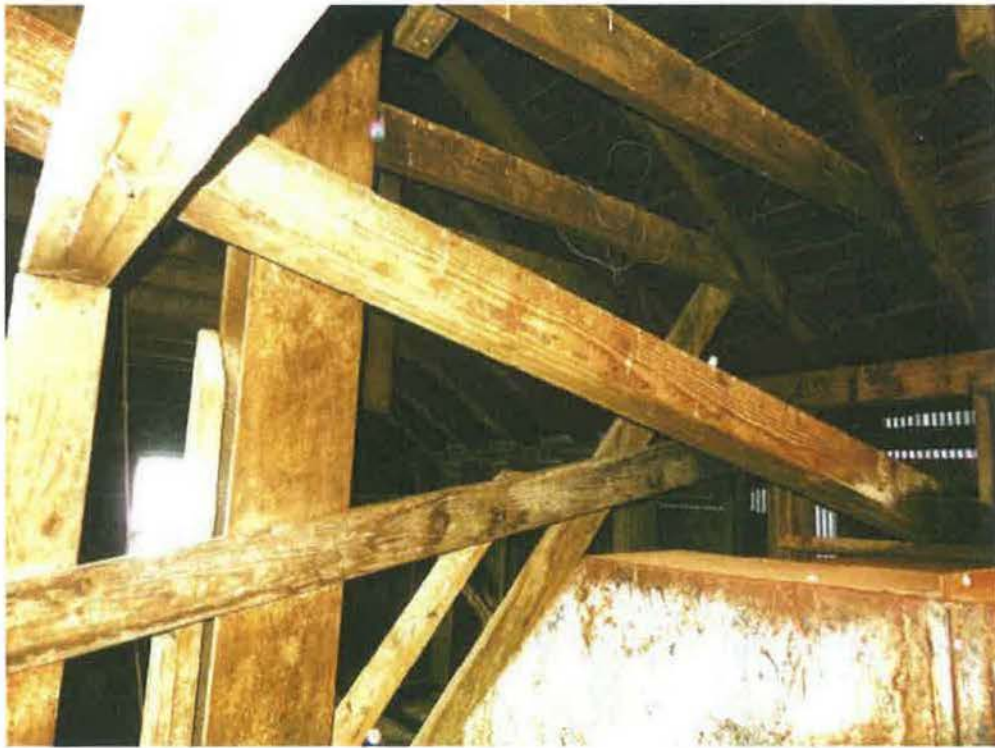
Photo 12: Roof framing
