**National Register of Historic Places
Continuation Sheet**

Azusa Civic Center
Property Name

historic name Azusa Civic Center

Azusa Civic Center
Los Angeles County, California

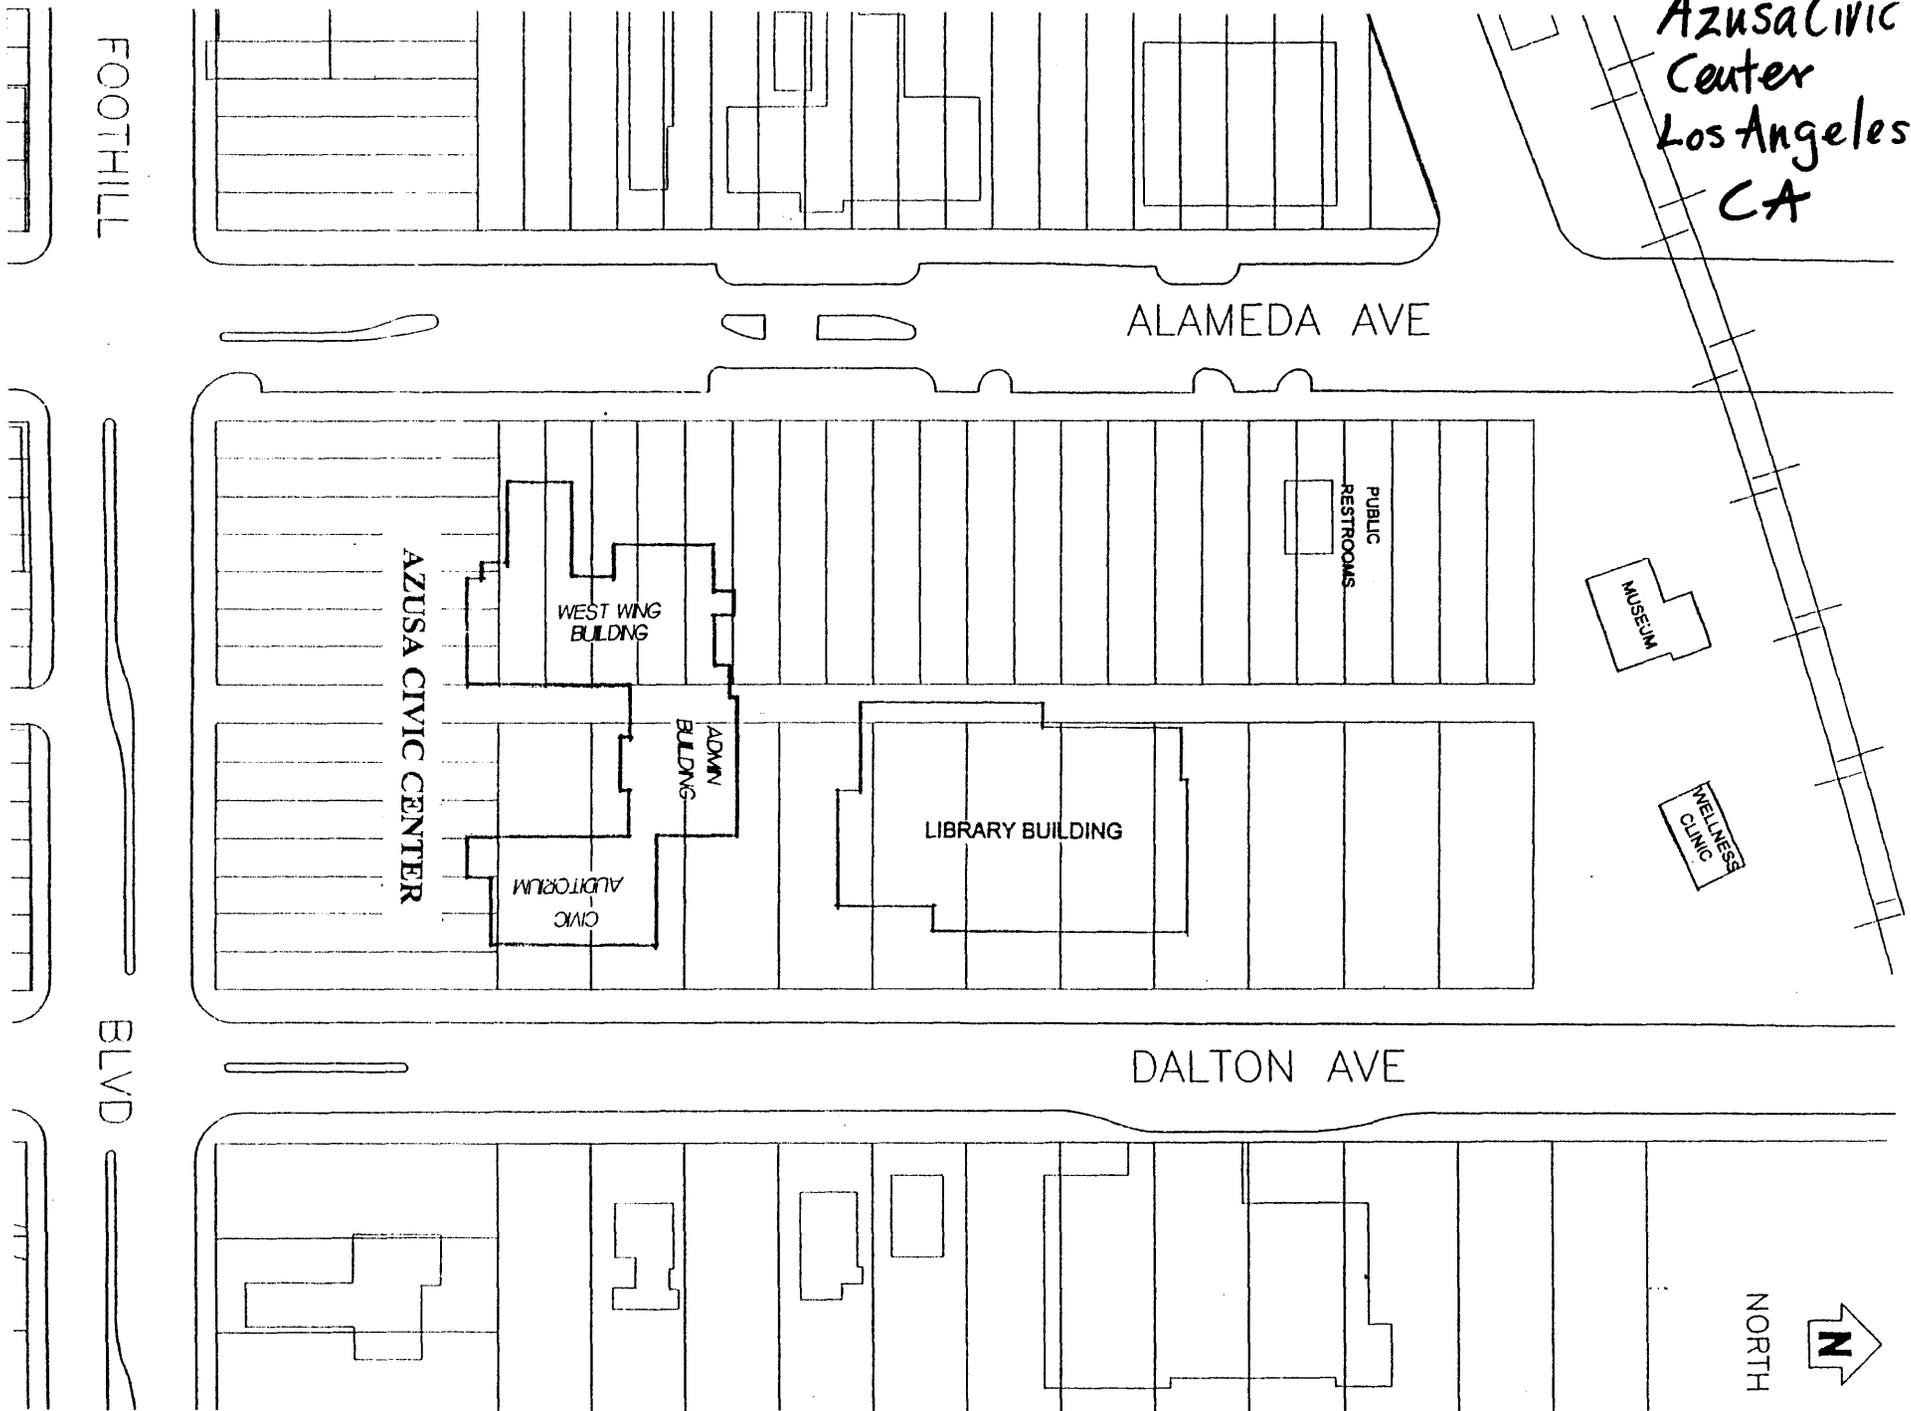
BOUNDARY OF THE PROPERTY

AZUSA CIVIC CENTER
213 E. FOOTHILL BLVD.
AZUSA, LOS ANGELES COUNTY, CA
