KENTUCKY HISTORIC RESOURCES INVENTORY

Site No. Do 360

1. Historic Name(s) <u>Stone house on ^{old} Stage Road</u>		22. ADD/County <u>Bluegrass, Boyle</u>	
Origin Owner <u>not known</u>		23. U.S.G.S. Quadrant (15'/75') <u>Boyanville vic</u>

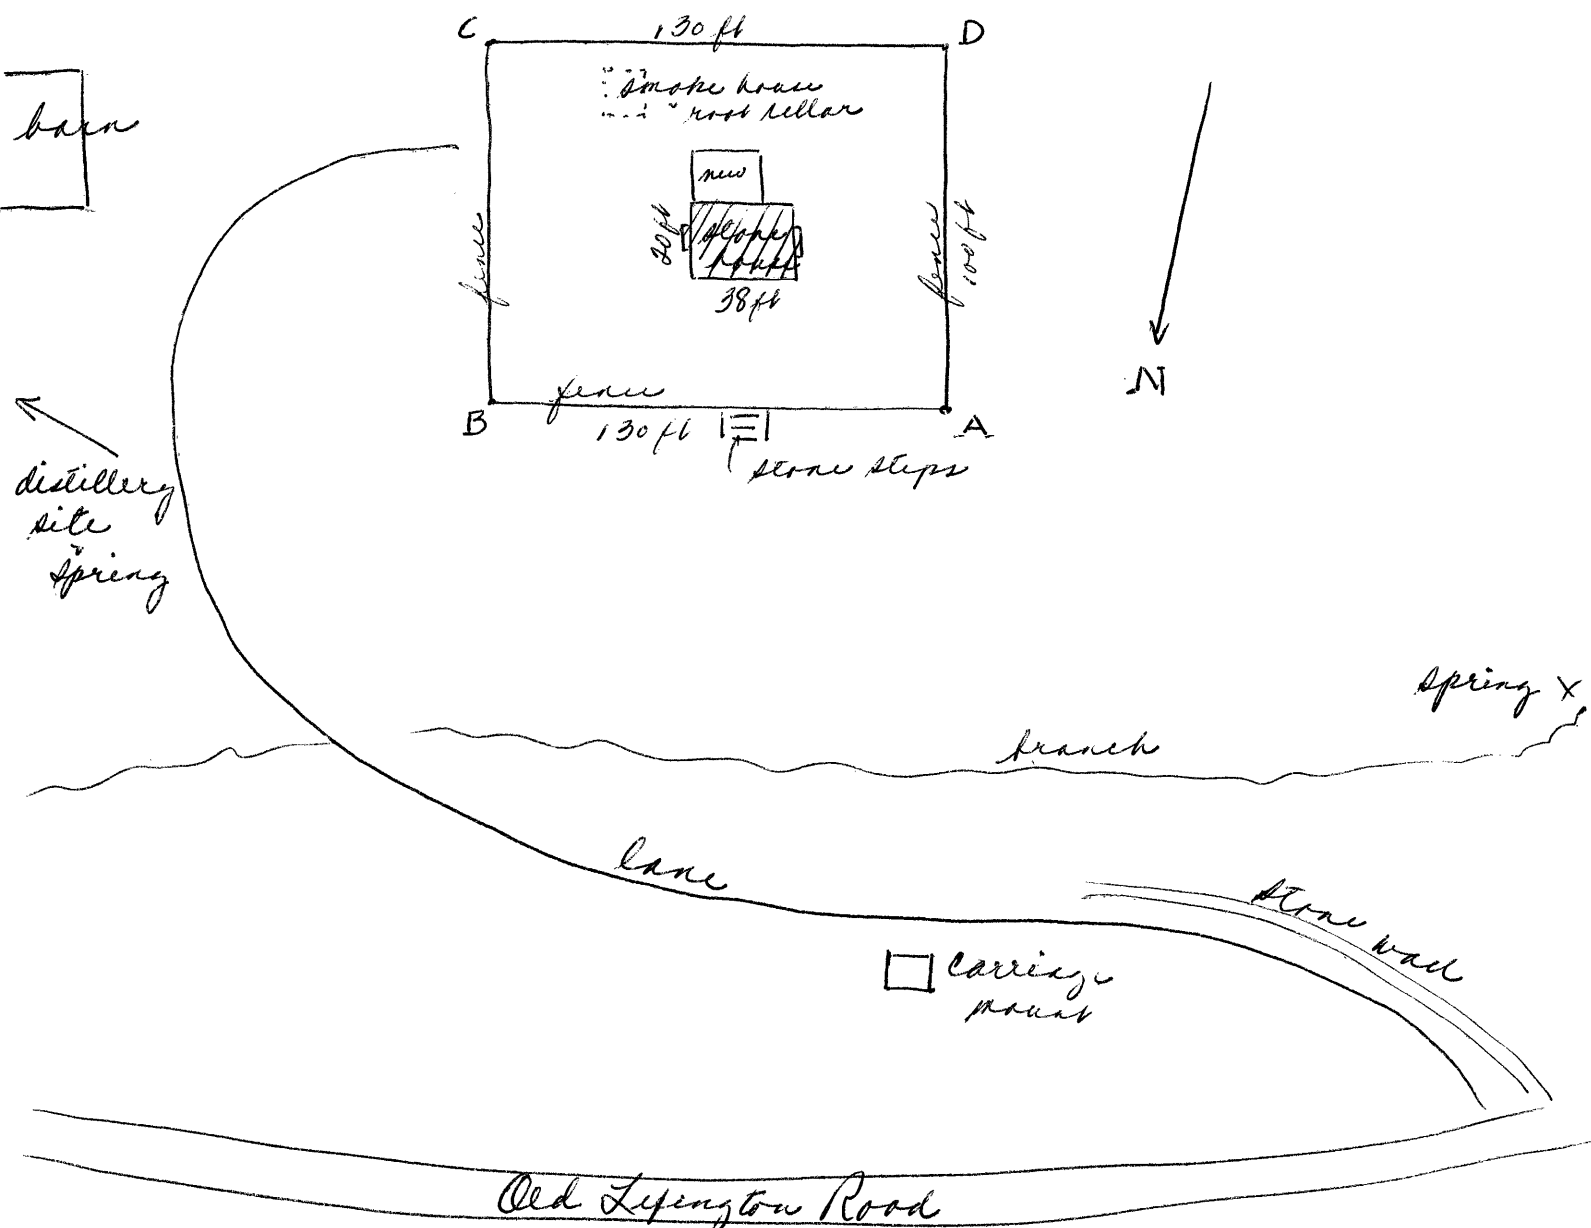
SKETCH MAP OF SITE SHOWING BOUNDARIES AND KEY BUILDINGS AND FEATURES WITH NORTH ARROW.

Beginning at a post in the NW corner of the yard, thence with fence around yard E 130 ft to B, S 100 ft to C, W 130 ft to D, and N 100 ft to the beginning containing the stone house - about 1/3 acre. (Property has 33 acres, giving description to site, but no other buildings or structures.)
