United States Department of the Interior
National Park Service
National Register of Historic Places
Registration Form

historic name Stephens Homestead
other names/site number

street & number 800 Willow Grove Road, Stephens State Park
city or town Mount Olive Township
state New Jersey code NJ county Morris code 027 zip code 07828

Stephens Homestead is a frame, Second-Empire style farmhouse in Mount Olive, New Jersey built for Amzi Stephens c. 1870. The house is five bays wide by six bays deep in an irregular plan consisting of a main section and a rear wing. The main section of the house is two stories in height plus an attic story under a concave mansard roof, above a basement. The rear wing is two stories in height over a basement and has a shallow gable roof and simplified exterior details from the main section. The house has original clapboard siding with wood trim and an exposed stone foundation. It is oriented in the east/west direction with the main entrance facing west. The property is located in the Township of Mount Olive in Morris County, New Jersey. It is located within Stephens State Park, which features stands of oak, pine and hemlock trees interspersed with open gr

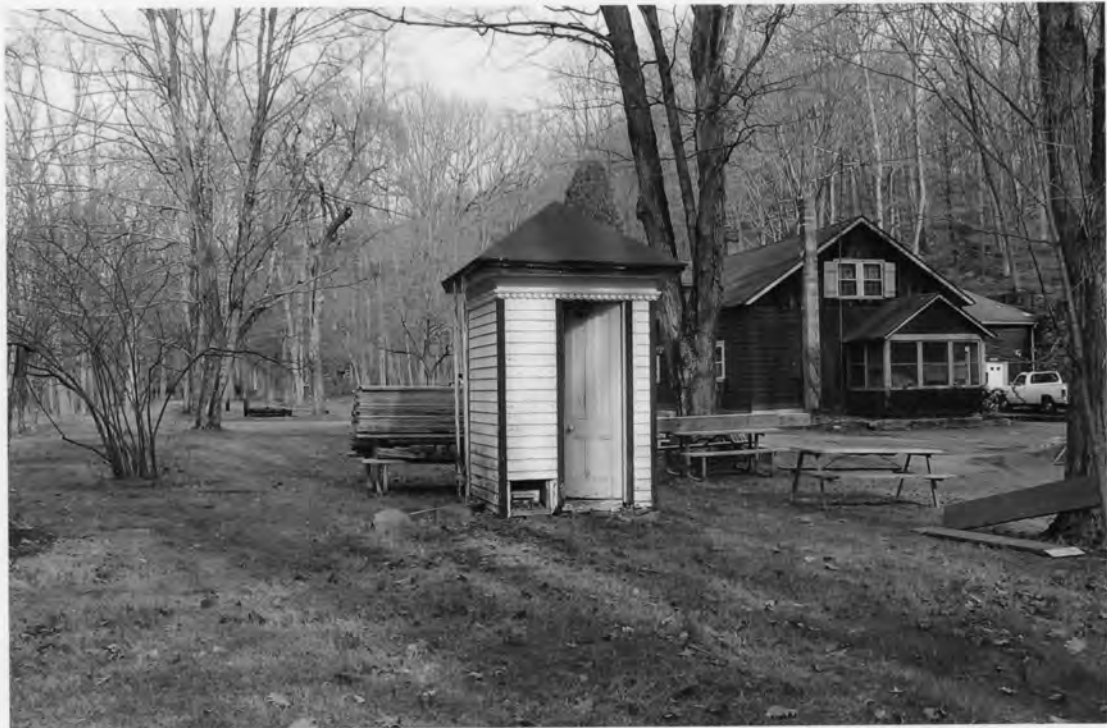
A late-nineteenth-century, hipped-roof outhouse is located east of the house (Photograph 22). The outhouse has horizontal wood siding with wood trim and a cornice with simple decorative molding. It has a hipped roof with flat-seam metal and has a brick foundation. The entrance faces south and is an unglazed four-panel wood door. There is a one-over-one wood-hung sash window on the east elevation.

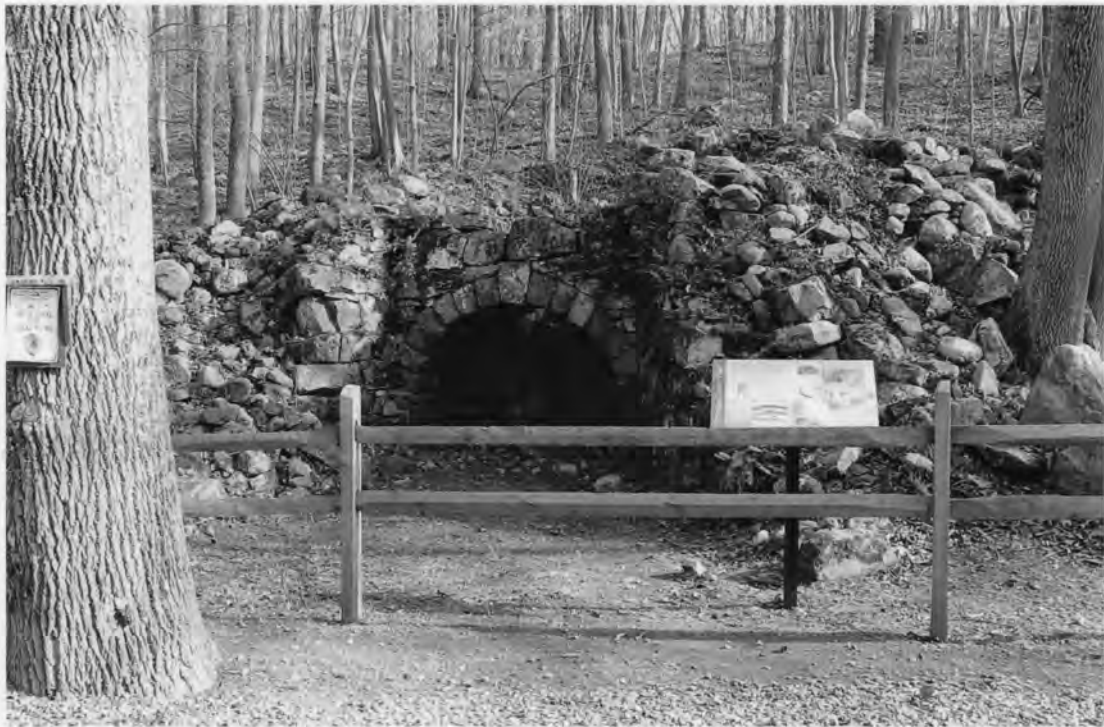
A late-nineteenth-century lime kiln is located northeast of the house near the parking lot north of Stephens State Park Road (Photograph 25). The kiln was built into the side of a hill and has a concave front wall. The front wall has a single-bay stone arched opening where the lime was raked out. This arch is unusual and is not like those typically found on lime kilns of this type in this region¹. The arch needs to be stabilized and the upper stone portion has fallen in part, but all of its elements appear to remain within the structure; the kiln retains good integrity.

The Stephens Homestead is also significant under Criterion C for the historic lime kiln, which is a good and rare surviving example of a method of construction for lime kilns in the mid-to-late-nineteenth century. The geological characteristics of Mount Olive, with its limestone rich soil, account for the lime kiln on the property. The use of lime as soil neutralizer dates back to ancient times. Quicklime, or calcium oxide, is produced by burning limestone (calcium carbonate) at an extremely high temperature, around 900° C. When the quicklime is hydrated, it creates calcium hydroxide, or slaked lime, which can then be applied to soil to neutralize the acidity and increase fertility. Lime has been used in soil in northern New Jersey since before the Revolutionary War. It is mentioned in historic records as early as the 1760s, but was not widely used until the nineteenth century. "Farmers who owned deposits had a great advantage over others... Eventually the evident results of the new practice impelled farmers who had no limestone on their farms to invest time and money in obtaining either the calcined lime or the raw limestone."¹⁹ A large quantity of lime kilns were built in Warren and Sussex Counties in New Jersey and in eastern Pennsylvania due to the limestone-rich earth. The Musconetcong Valley, which is where Amzi Stephen's farm was located, had large outcroppings of limestone.²⁰ He would have produced lime for use on his own farm as well as to sell to other neighboring farmers for a profit.

loaded from an opening at the top, and was filled with alternating layers of limestone and fuel, either wood or coal. Sod usually covered that opening at the top in order to seal it. At the base of the front wall was an arched opening where a fire was lit. The kiln burned continuously for days until all of the fuel had burned up. Once cooled, the remaining burned lime, now quicklime, was then removed through a door or opening on the side of the kiln. Vertical draw kilns were built and used differently. This type of kiln resembled a three-story building with a vertical iron boiler inside. The top floor was used for filling the furnace with limestone. Wood was fed through doors on the middle floor and burned as fuel. As the limestone burned, it dropped down into the bottom section where it landed in containers and was hauled away. More limestone and wood could be added for continuous production of quicklime. About five to seven barrels of quicklime could be drawn every two hours.²¹ Amzi Stephens' lime kiln is a set kiln. It was built into the side of a hill as many early kilns were and has a concave front wall for added strength. It has a single-bay, round-arch opening from which the burned lime was removed. It is not the typical arch often found on set kilns, adding to its significance. The arch currently needs to be stabilized and the top portion of the kiln is no longer intact, but what remains of the kiln retains overall good integrity. There are not many lime kilns remaining in Morris County; kilns are more common in nearby Warren and Sussex Counties, so the fact that this one remains in Morris County adds to its significance. The kiln survives today as an important example of a structure used for agricultural pursuits in Morris County.

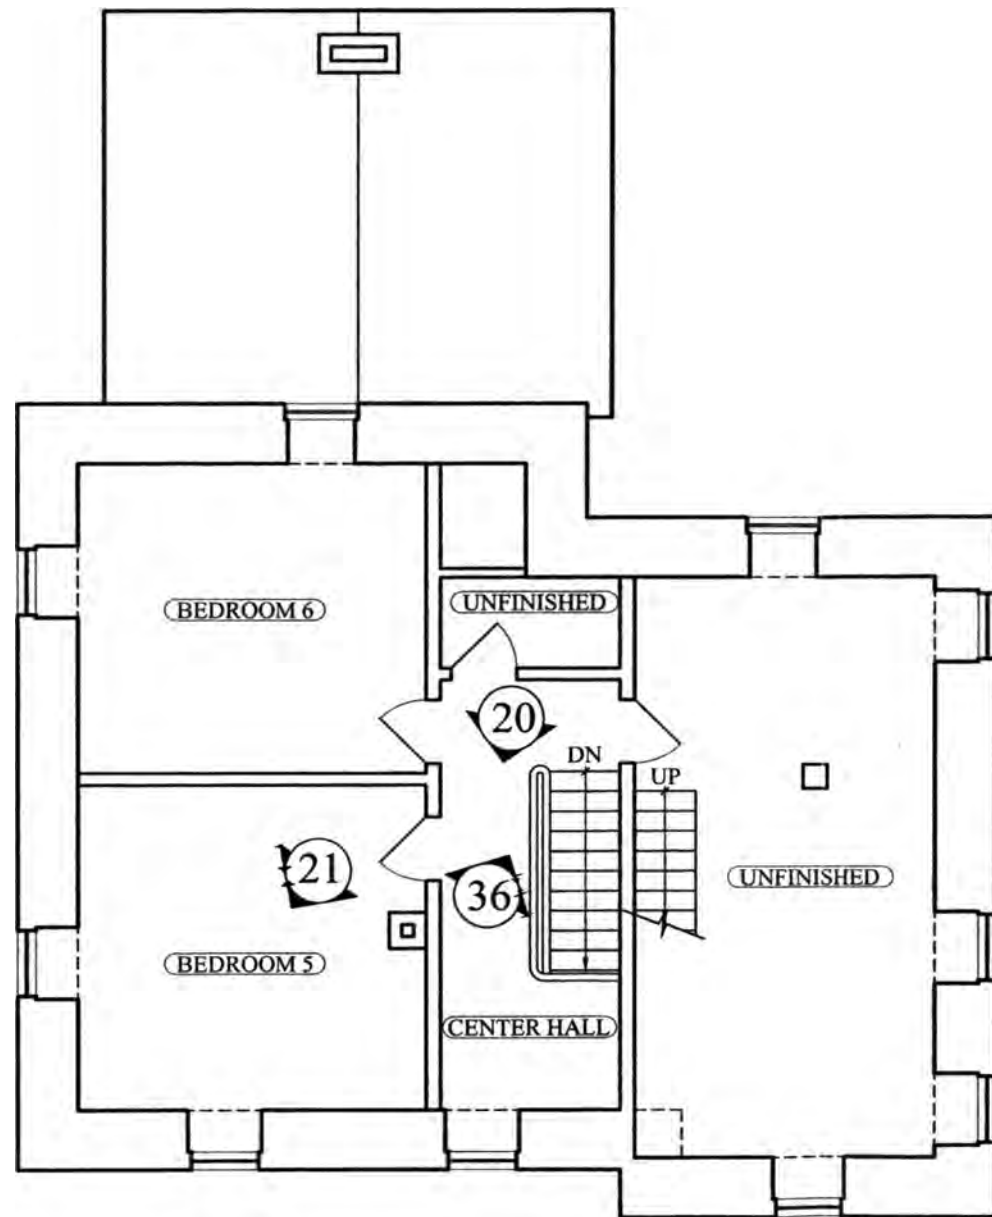
THIRD FLOOR PLAN - PHOTO KEY
 NOT TO SCALE

The third floor is encompassed within the steep mansard roof, so the walls are thicker and slightly angled; only the main section of the house has this third story. The main staircase continues up from the second floor and comes to the center hall, similar to the front hall on the second floor. Off this hall are two bedrooms and two unfinished spaces. The first unfinished space is the entire south side of the main section and contains a simple wood stair to the roof, and the second is a small space to the east of the stair.
