National Register of Historic Places Registration Form

Historic name: Gird Point Lookout
Other names/site number: 24RA0137
Name of related multiple property listing:
L-4 Fire Lookouts in the USFS Northern Region (Region 1), 1932-1967
(Enter "N/A" if property is not part of a multiple property listing)

Street & number: Gird Point, Sapphire Mountains, Bitterroot National Forest
City or town: Hamilton State: Montana County: Ravalli
Not For Publication: Vicinity:

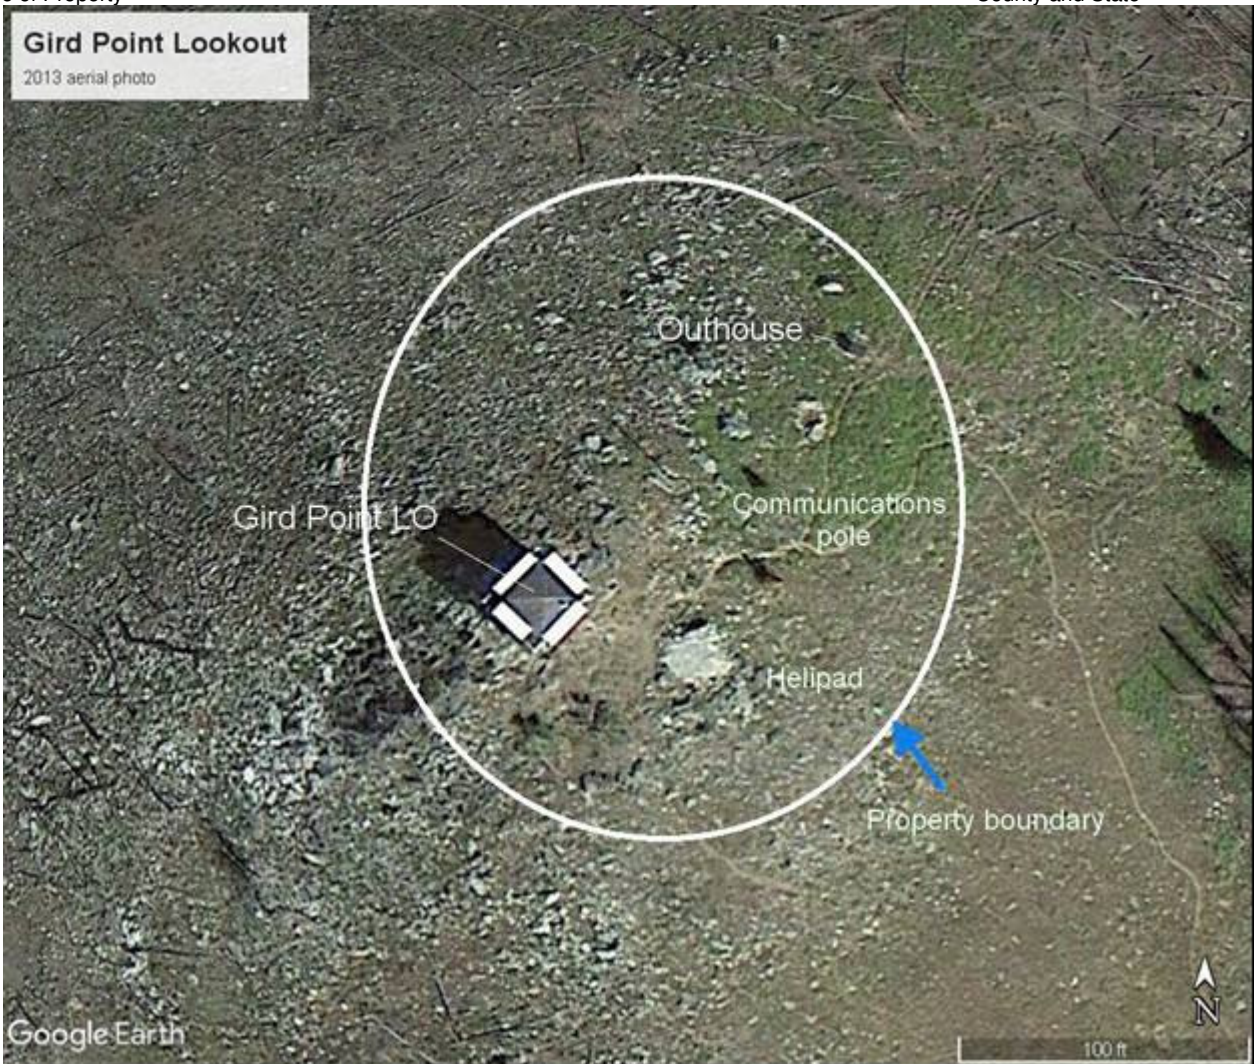
Gird Point Lookout site plan, 2013 aerial photo.

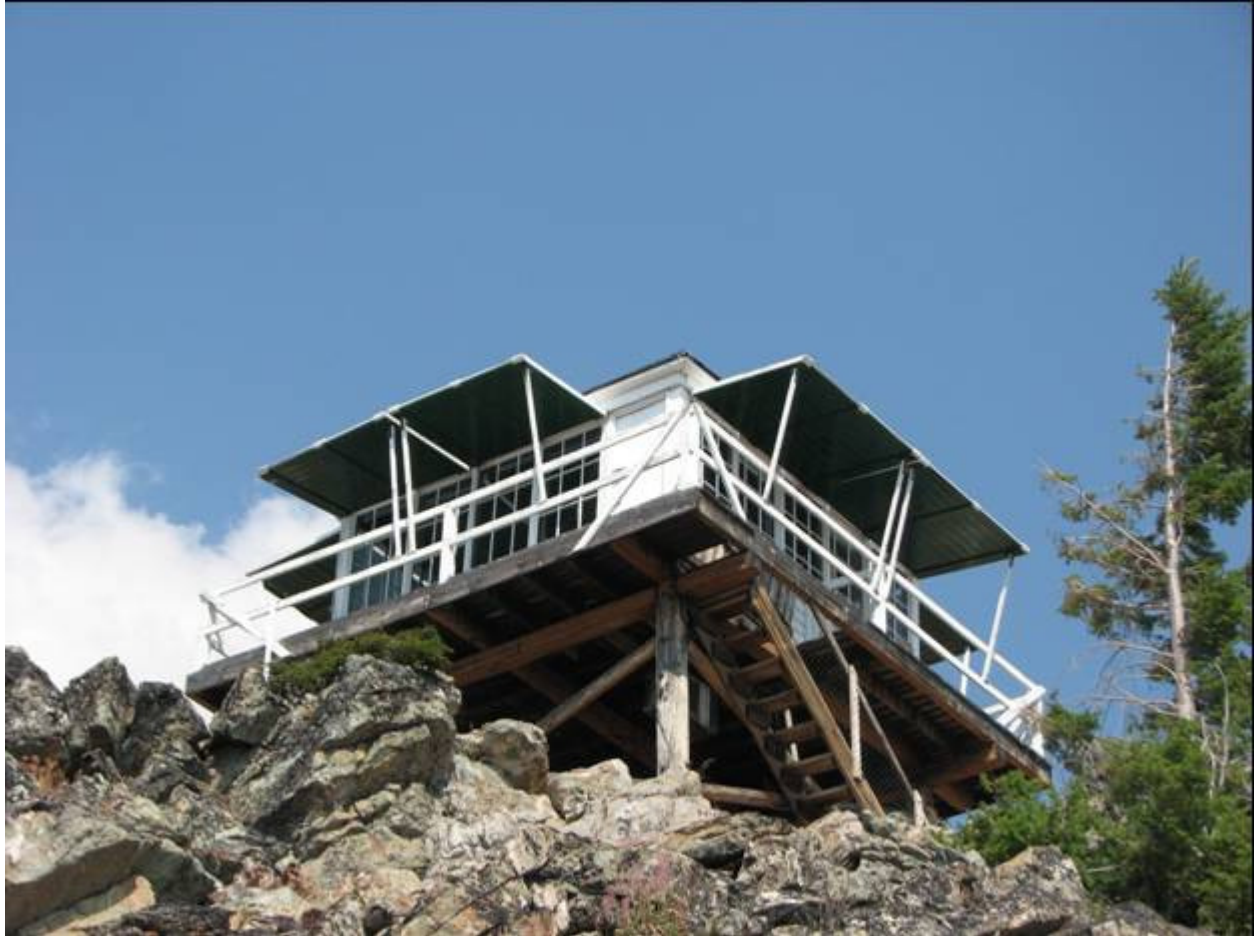
MT_RavalliCounty_GirdPointLookout_0001. Looking north to the southwest (front) and southeast sides of Gird Point Lookout.

Gird Point Lookout (contributing building) Gird Point Lookout, constructed in 1939, is a 14-foot by 14-foot wood frame lookout cab with a pyramidal roof built atop a 10-foot high, log tower. The tower and cab are aligned so that they sit at a 45 degree angle to the cardinal directions. Simple drop wood siding covers the lower portion of the exterior walls, and the roof is covered with sawn cedar shingles with metal ridge caps. A metal stove pipe extends above the southeast slope of the roof at its north end. The entry into the lookout house is located at the east end of the southwest-facing wall. A modern wood board-and-batten door has replaced the original multi-light door. Four nine-light windows are located in the wall west of the entry. The remaining three walls each contain five, nine-light, wood windows, two of which slide sideways allowing ventilation. Several of the window panes are missing—the holes covered with

cardboard. Each of the lookout cab's four walls has two top-hinged shutters; when open, the shutter struts are affixed to the bottom rail of the catwalk railing. The building retains its lightning protection.

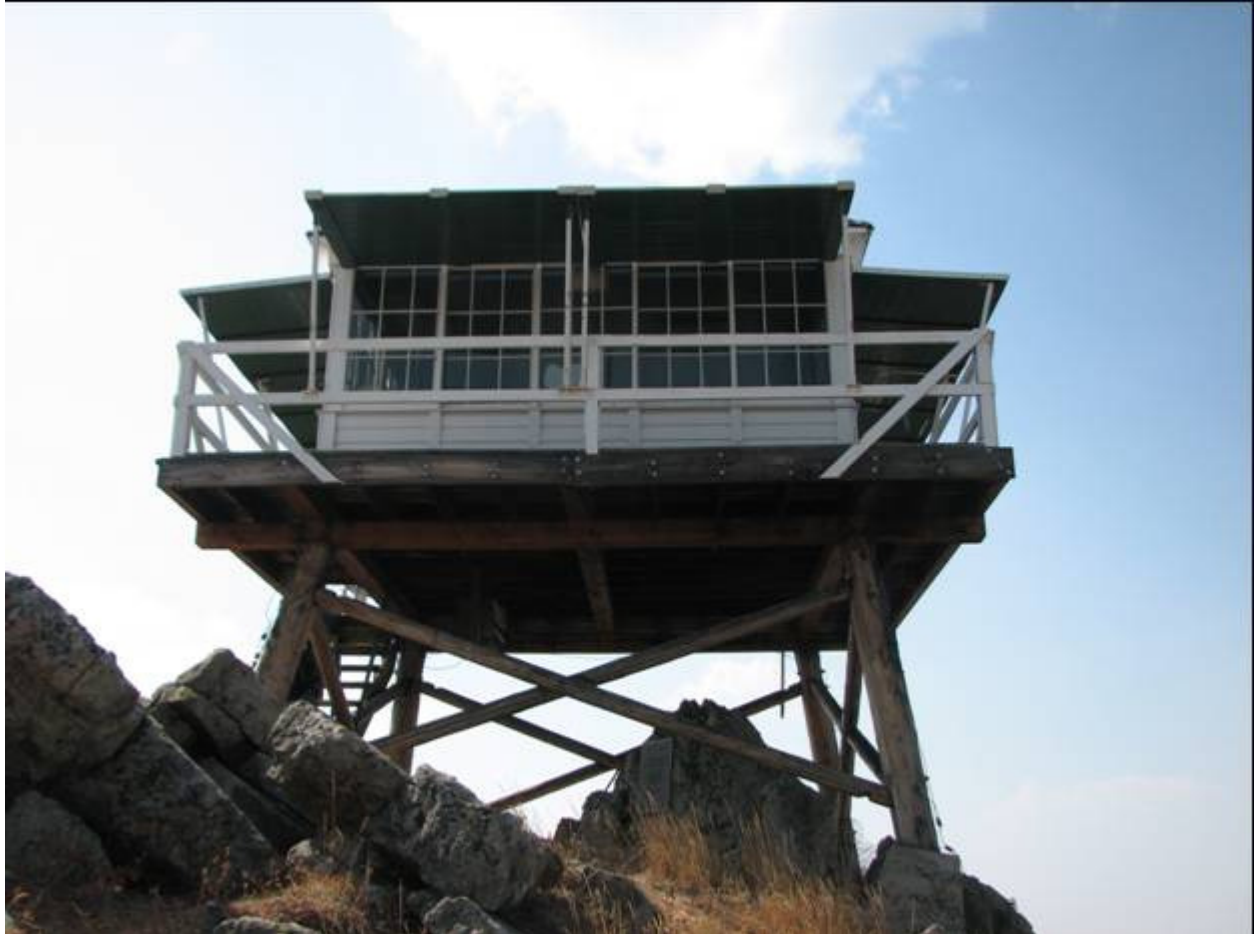
MT_RavalliCounty_GirdPointLookout_0002. Looking southwest to the northeast wall of the lookout.

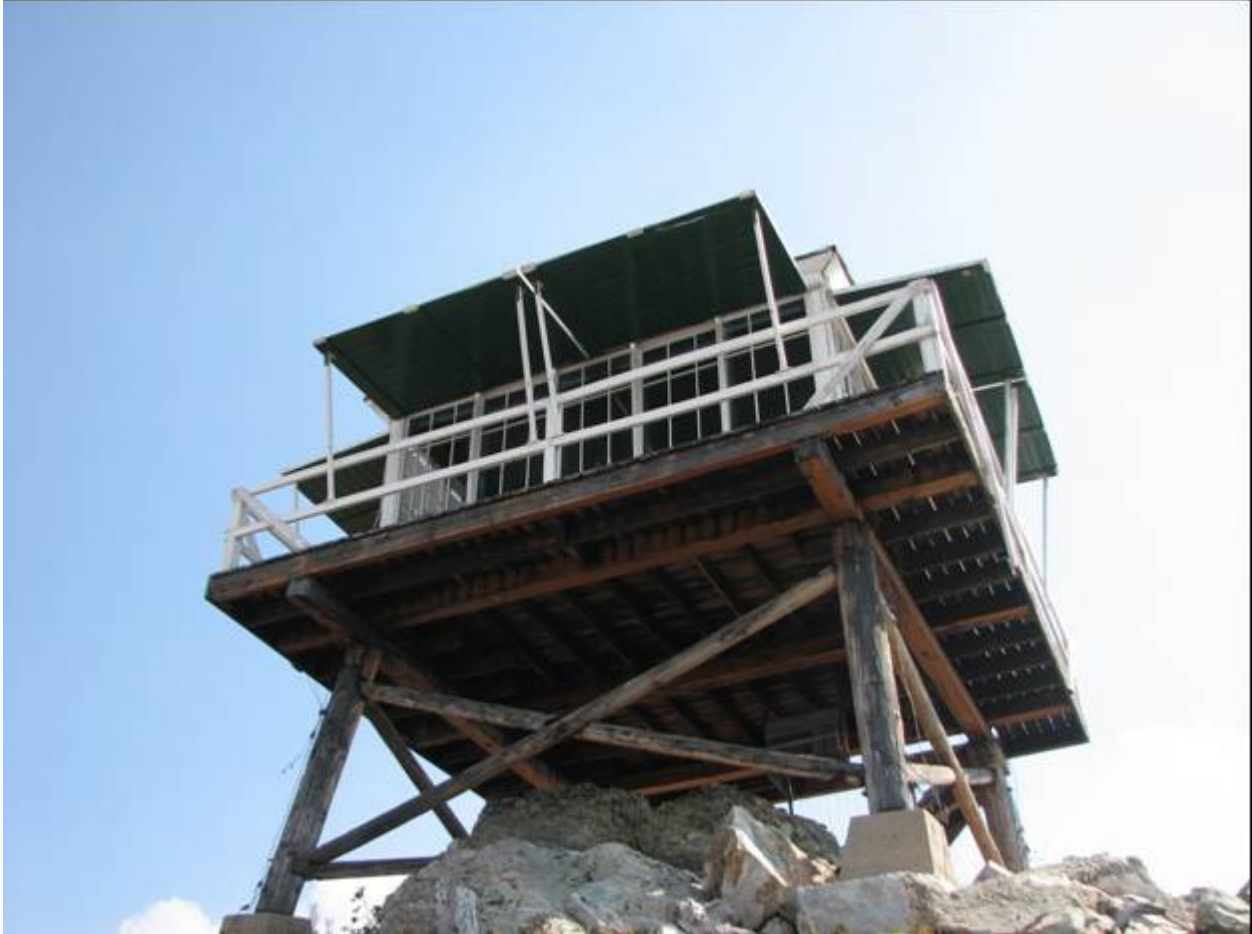
MT_RavalliCounty_GirdPointLookout_0003. Looking southeast at the northwest wall of the lookout.

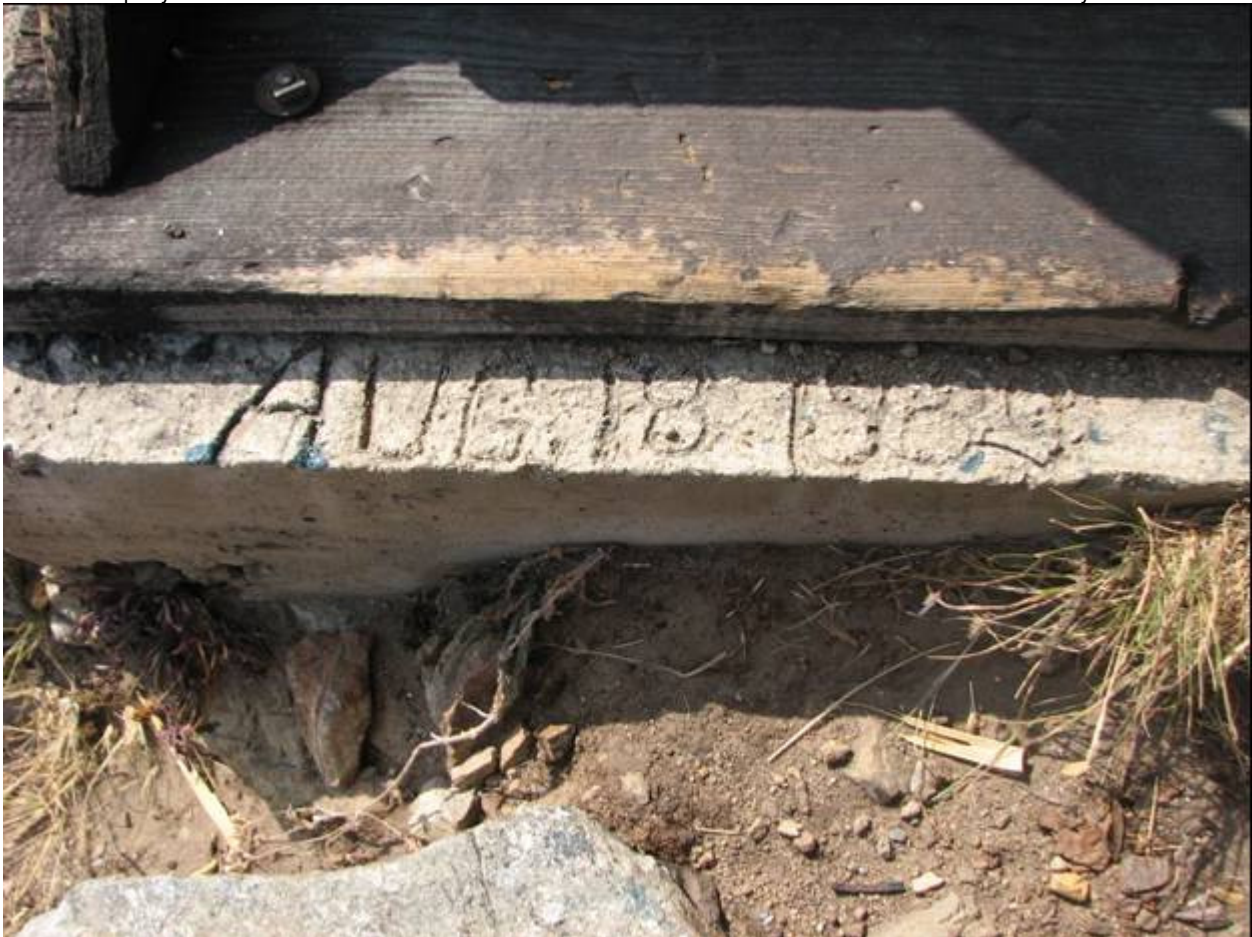
MT_RavalliCounty_GirdPointLookout_0004. Detail of the concrete footing for the stair etched with "Aug. 18 1939."

The four log legs of the cross-braced log tower are supported by cast-in-place battered concrete footings. A single-flight stairway is located on the southeast side of the lookout tower. The base of the stairway rests on a concrete footing etched with: "Aug. 18 1939." The stair stringers and treads are made with dimensional lumber. A safety railing on the outside edge of the stairway has been fashioned by attaching hog wire to a dimensional lumber hand rail which in turn is attached to two vertical wood posts. A small wooden storage box is suspended from the base of the cab adjacent to the inside edge of the stair. Originally, the box could be accessed by someone standing on the stair, however, access is now blocked by wire mesh attached to the inside edge of the stair. At the top of the stairway, a trapdoor leads to the catwalk that surrounds the cab. A spring-loaded safety gate is located the north edge of the trap-door opening.

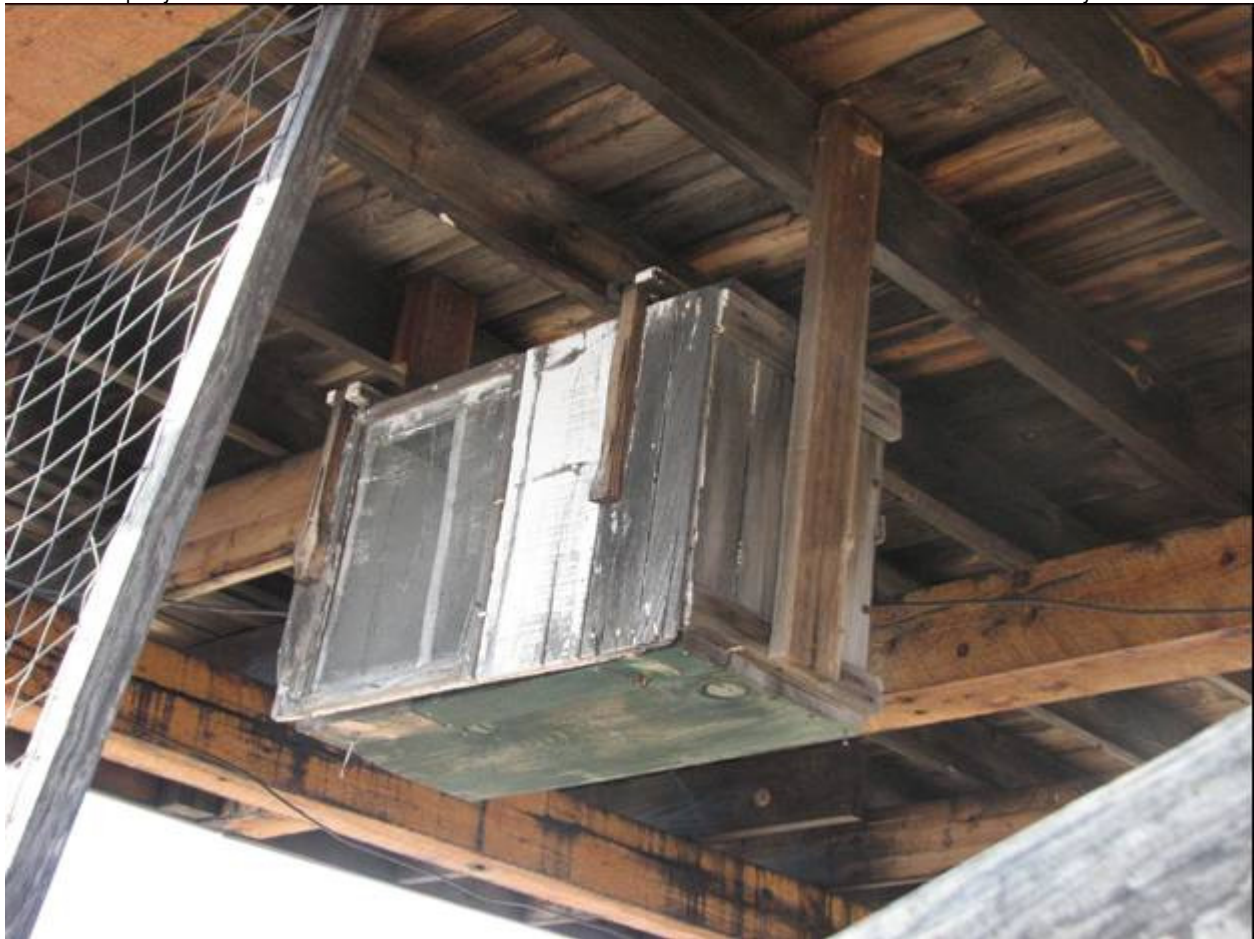
MT_RavalliCounty_GirdPointLookout_0005. Wood storage box suspended from the base of the lookout.

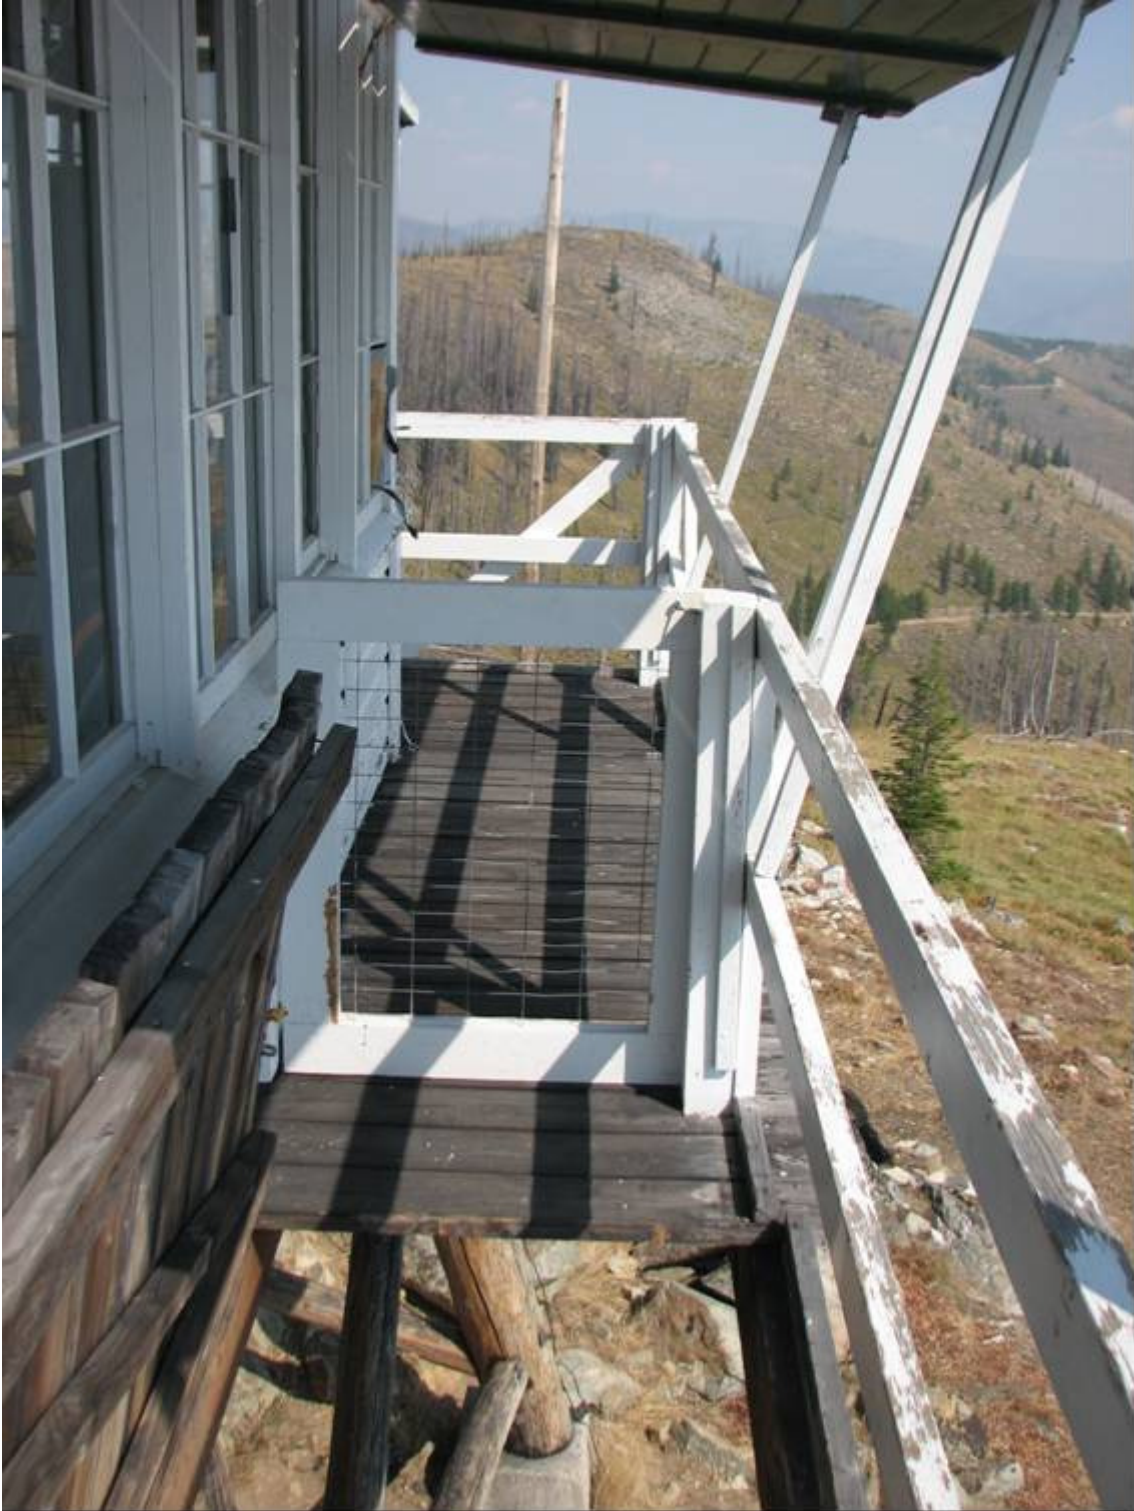
MT_RavalliCounty_GirdPointLookout_0006. Looking northeast to the spring-loaded safety gate at the edge of the trap door in the northeast side of the catwalk.

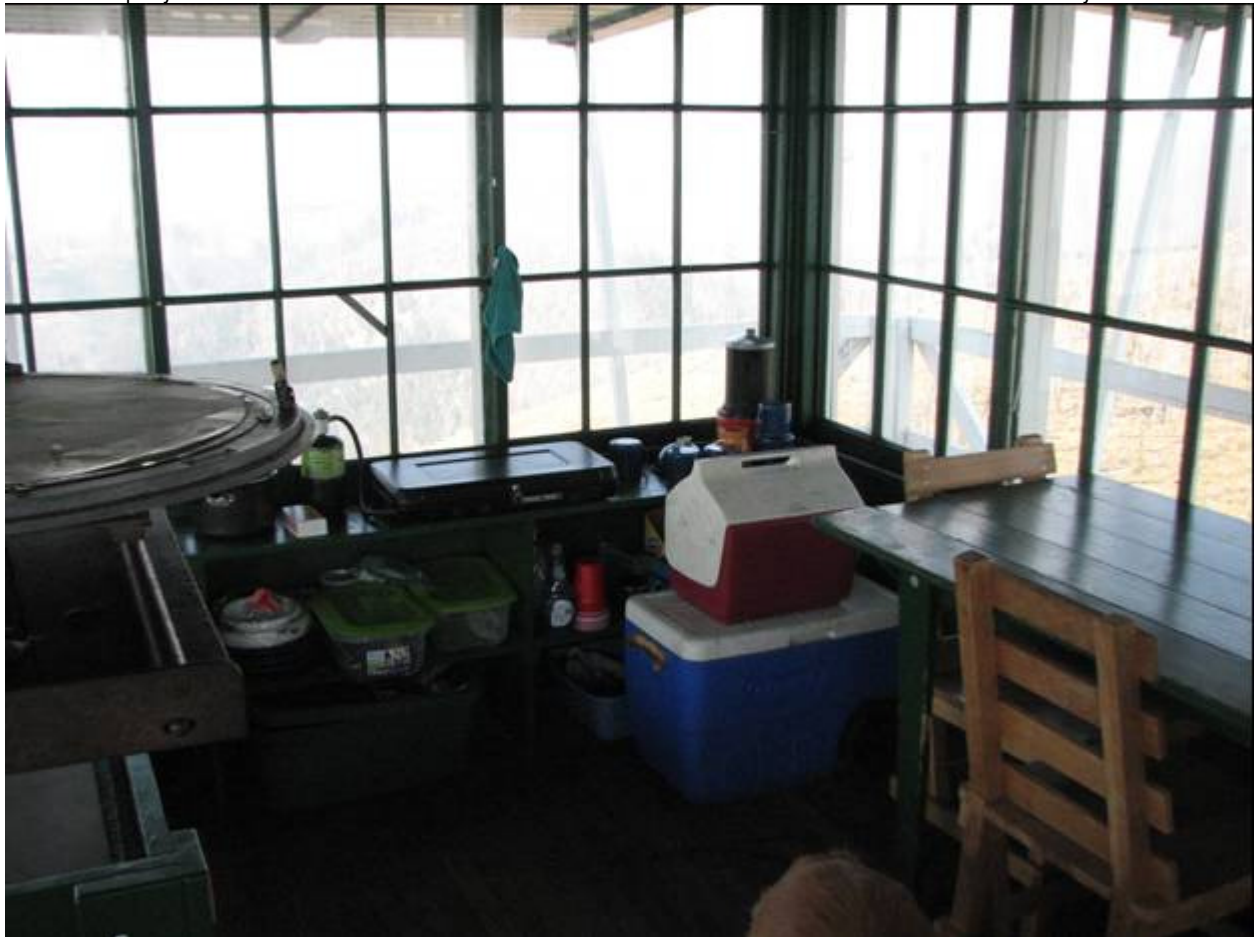
MT_RavalliCounty_GirdPointLookout_0007. Interior, showing table and shelves.

In the one-room interior, the original maple floor is intact and in fair condition. The interior is fitted with a plywood platform bed frame, a metal stand with an Osborne fire-finder, a small wood heating stove, a small table, and a storage bench.

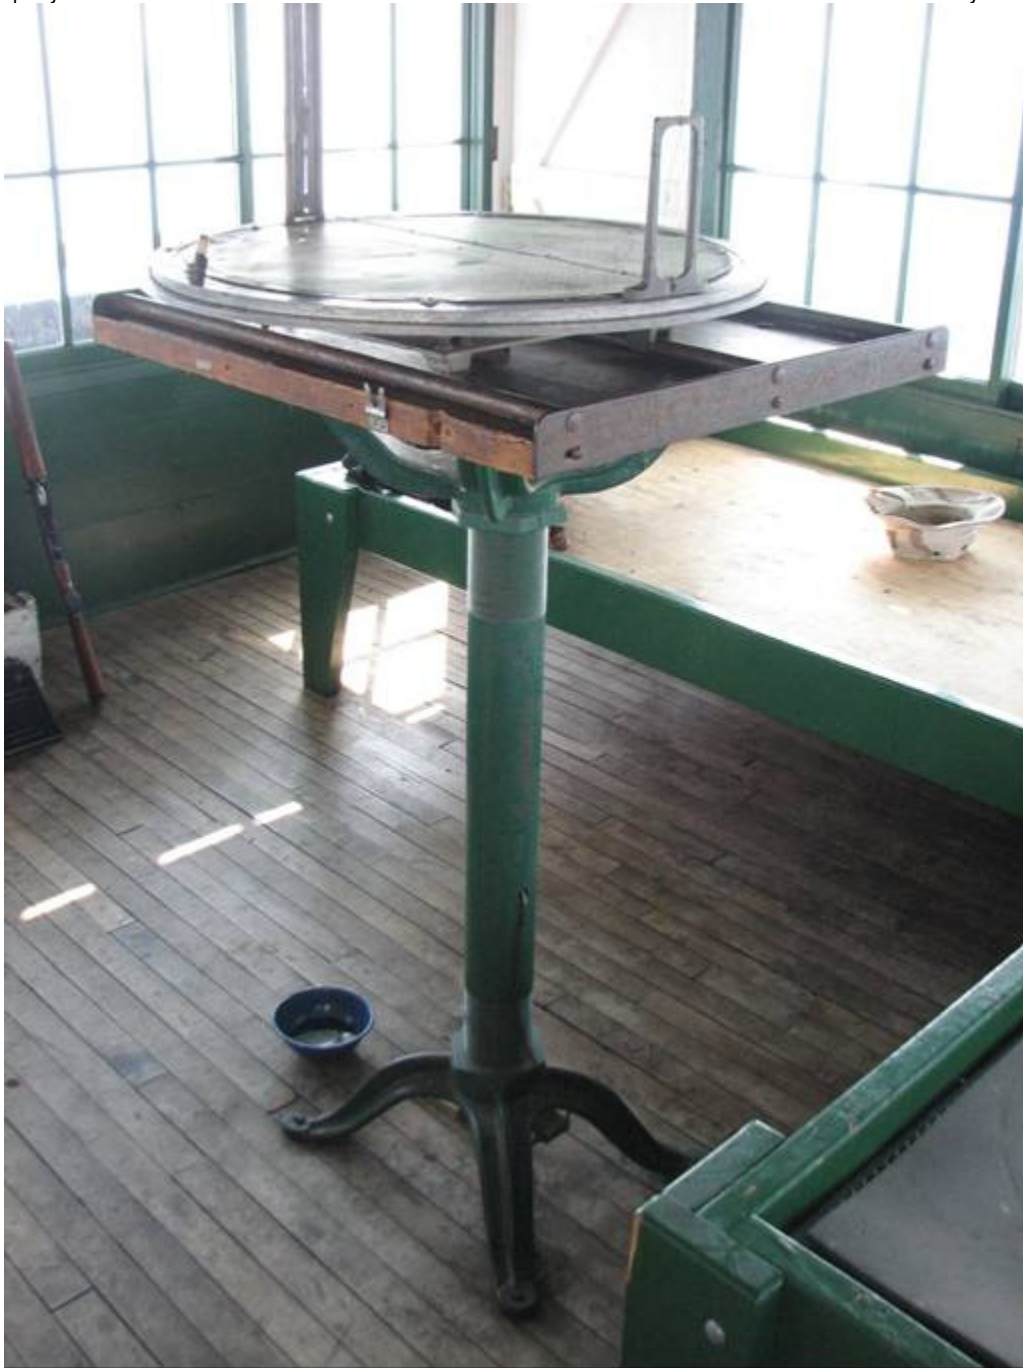
MT_RavalliCounty_GirdPointLookout_0008. Interior showing platform bed frames and fire-finder stand.

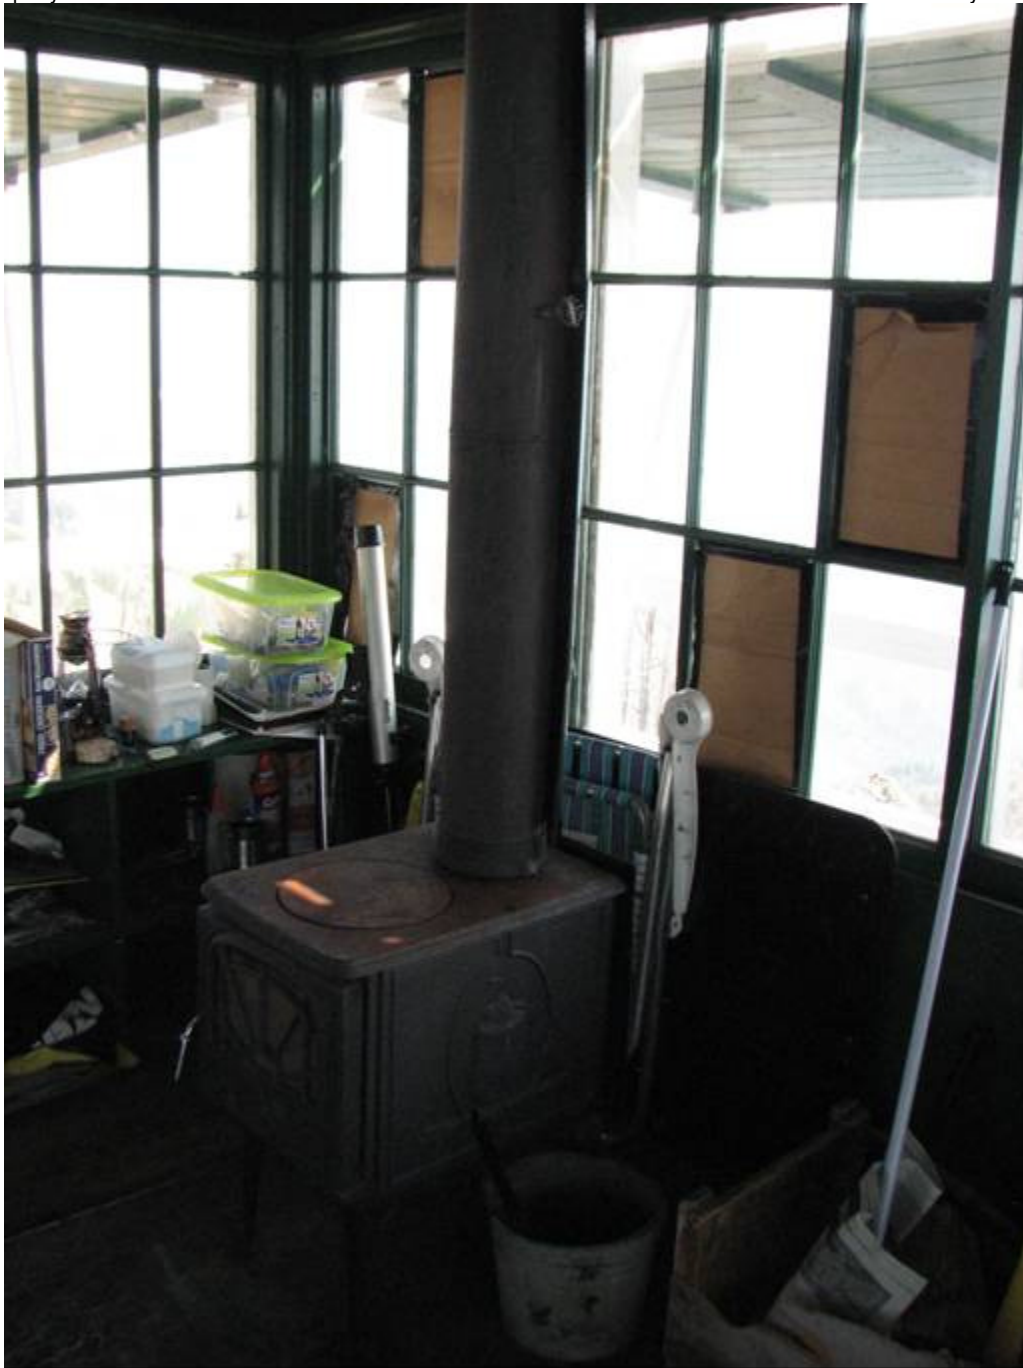
MT_RavalliCounty_GirdPointLookout_0009. Interior: wood stove.

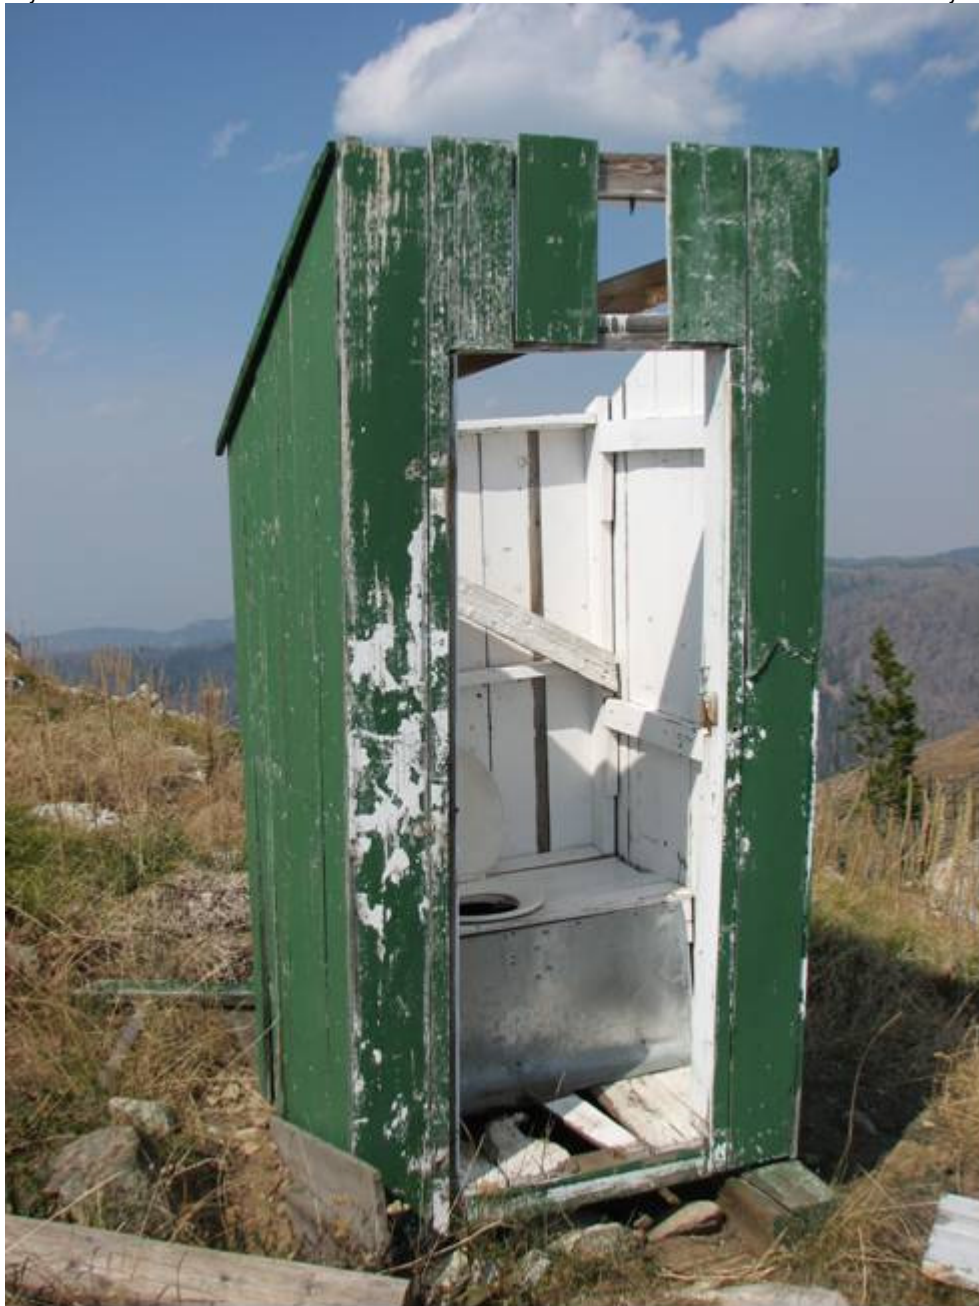
MT_RavalliCounty_GirdPointLookout_0010. Looking west to the south and east sides of the outhouse.

Outhouse (contributing building) The outhouse is located roughly 120 feet northeast of the lookout. It is a one-story frame building with a steep shed-style roof. The exterior walls are enclosed with vertical boards. At the time of the survey the outhouse was in poor condition. The roof is missing and the original, Z-braced, vertical board door lay on the ground. The Forest Service intends to replace the outhouse in the near future.

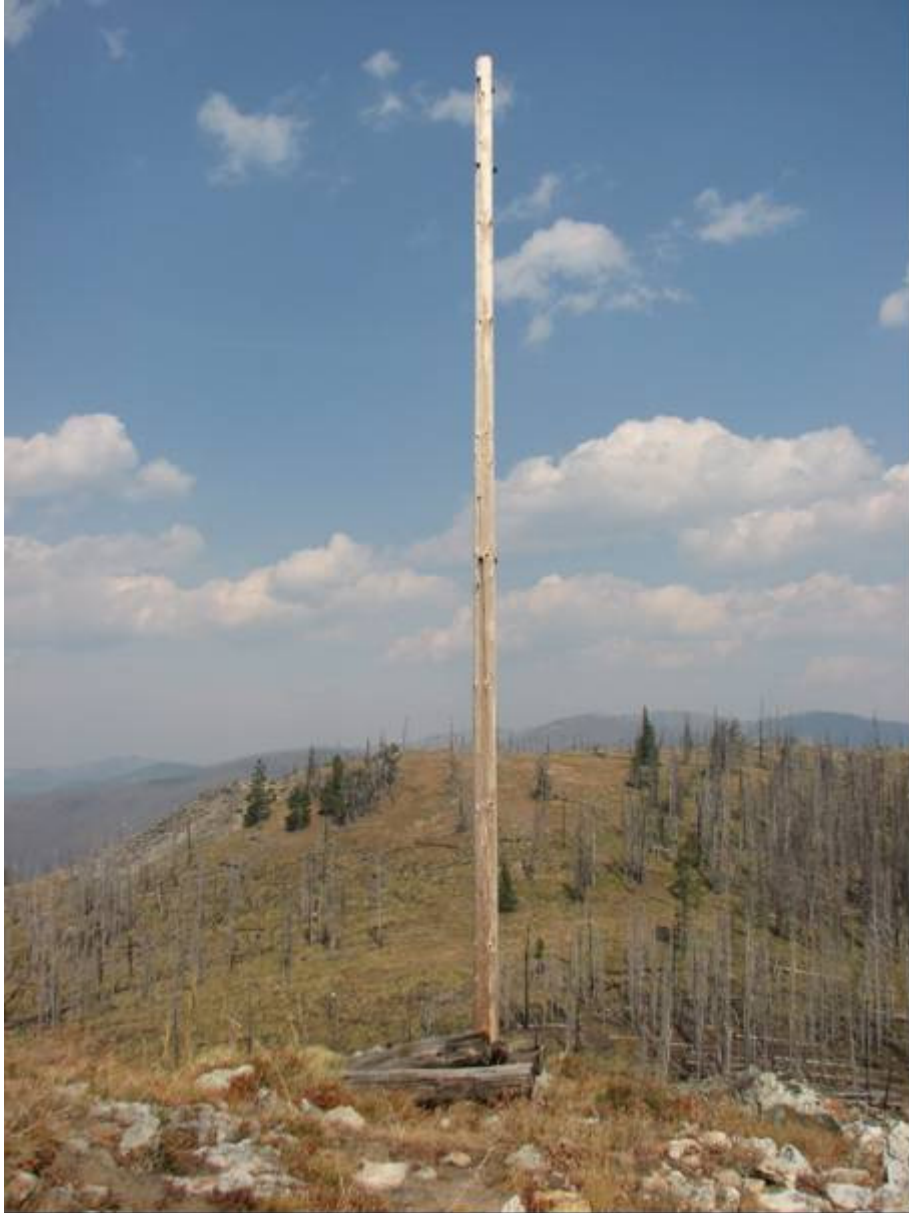
MT_RavalliCounty_GirdPointLookout_0011. Looking northeast to the communications pole.

Communications pole (noncontributing structure) A recently-erected peeled log pole, presumably to support communications antennae, is located about 40 feet northeast of the lookout.

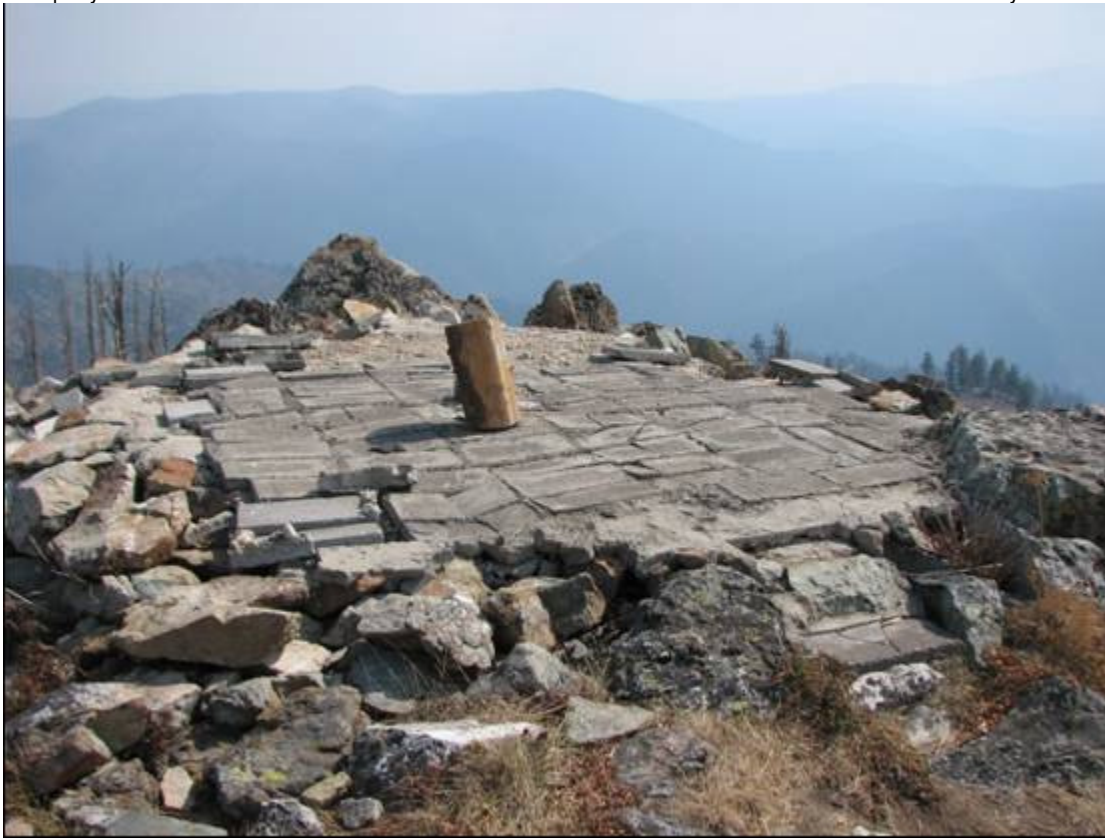
MT_RavalliCounty_GirdPointLookout_0012. Looking southeast over the helipad.

Helipad (noncontributing structure) A small helipad is located about 25 feet east of the lookout. It consists of a 10-foot by 12-foot leveled area within a natural talus outcrop that has been paved with concrete blocks.
