National Register of Historic Places Inventory—Nomination Form

Type an entire	23 Complete applicable	300110113			
1. Nan	ne				
historic Ban	k of Jersey				
and or common	n Same				
2. Loc	ation				
street & numbe	er Main St reet				N/A not for publication
city, town J	ersey	N/A	vicinity of		
state Georg	ia co	ode 013	county	Walton	code 297

BANK OF JERSEY Jersey, Walton County, Georgia

PROPERTY SKETCH MAP

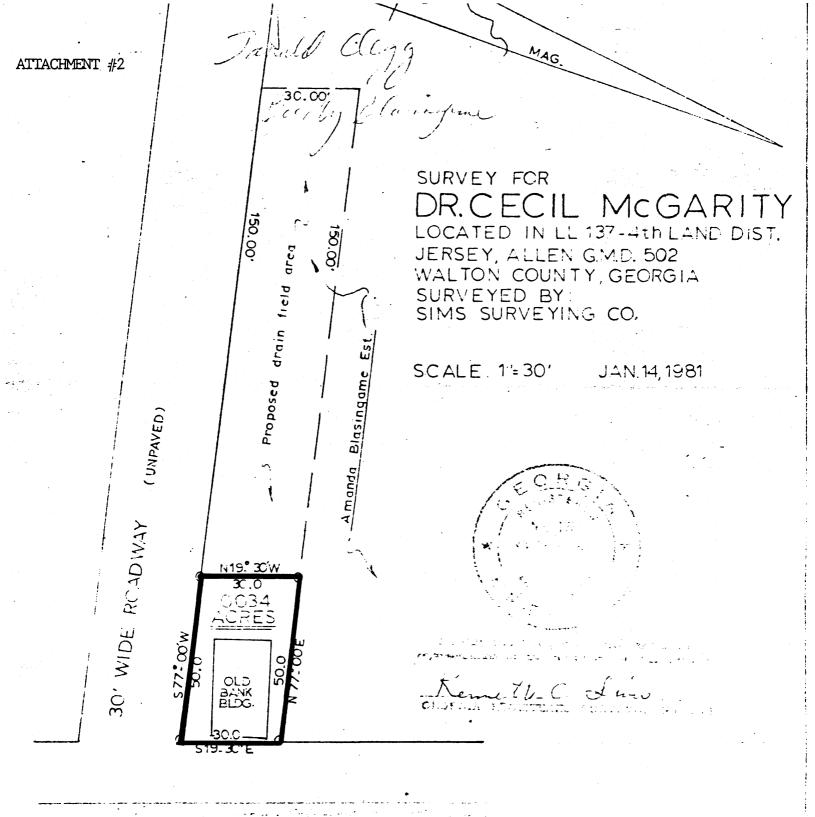
Source: Surveyor's Map

Scale: 1": 30'
Date: 1981
North:

Property Boundary:
