National Register of Historic Places Registration Form

Historic name Vivero de Peces de Maricao
Other names/site number Fish Hatchery, Criadero de Peces, Criadero Insular de Peces
Name of related multiple property listing New Deal Era Constructions in the Forest Reserves of Puerto Rico 1933-1942 (AMENDMENT)
(Enter "N/A" if property is not part of a multiple property listing)

Street & Number SR-401, Km 1.7, Maricao Afuera Ward
City or town Maricao State Puerto Rico County Maricao
Not for publication Vicinity

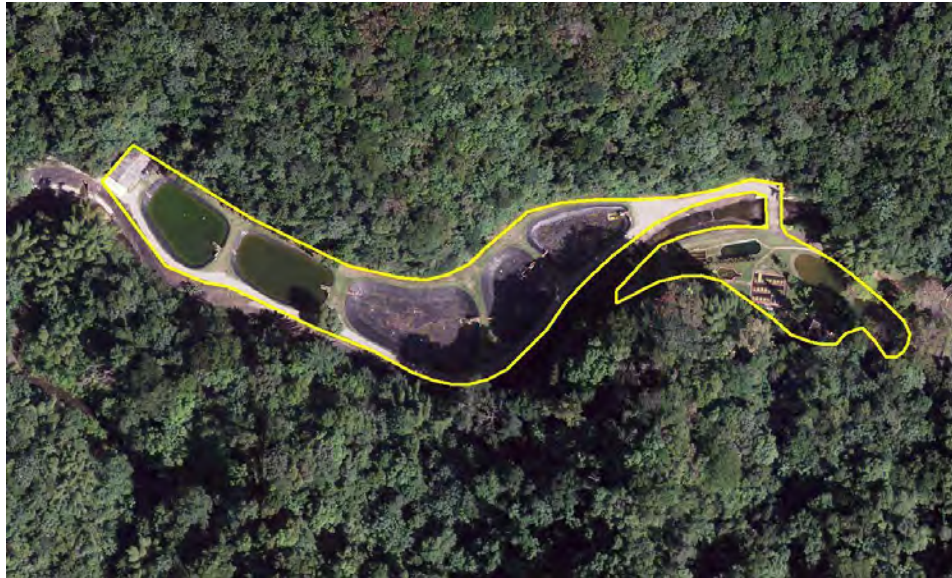
Figure 3. Vivero de Peces Maricao district boundaries that include northern and southern segments.

The hatchery's other five large oval shaped grow-out ponds and the equipment building are located on a strip of land on the north of the Maricao River. Access to this area is by way of a concrete second bridge. Two service roads serve to encompass the grow-out ponds and join where equipment storage building is located. Between these grow-out ponds, there are service roads that are used for maintenance of these structures. The equipment building is a large one story, rectangular concrete construction used for equipment and supplies.

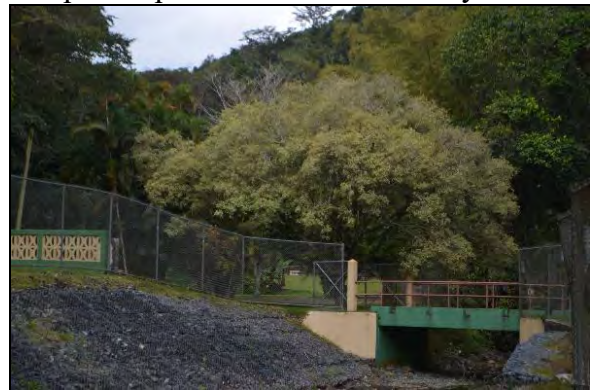
Pictures 1 and 2. View of the Visitors Parking, as seen from the Hatchery and photo of the old bridge taken from the Maricao river basin.

This small concrete vehicular beam one spans bridge crosses the Maricao River and serves as the main access to the fish hatchery. The Civilian Conservation Corps completed its construction by 1938.

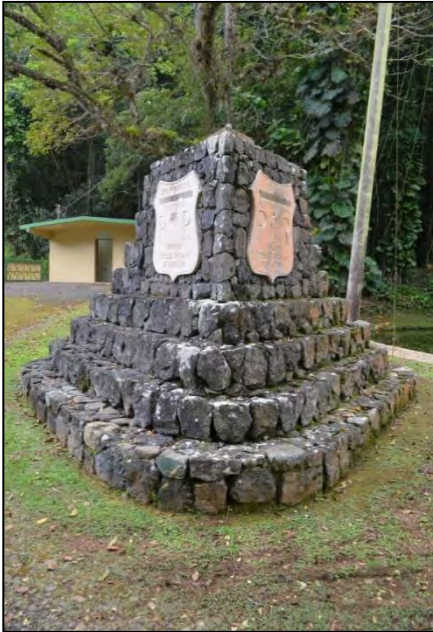
Pictures 3, 4 and 5. View of the pedestal at the entrance to the facility, close up of its plaque and photo that shows the pedestal location in relation to the hatchery's service roadway.

A historic object located close to the entrance bridge. This 1938 stepped pedestal with stone facing has two stone shield plaques identifying the entrance to the facility. These signs are mounted two sides of the pedestal, facing northeast towards the bridge entrance and west toward the service roadway.

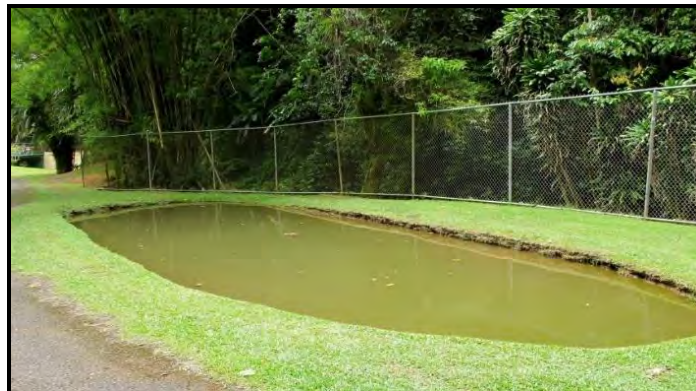
Picture 6. View of spawning pool CR1. This is the smallest pools in the hatchery.

An oval shaped, shallow, dirt floor, spawning pool built by the Civilian Conservation Corps in 1937-1938. This pool is located north of the fish hatchery's service road. Bluegills are bred in this spawning pool.

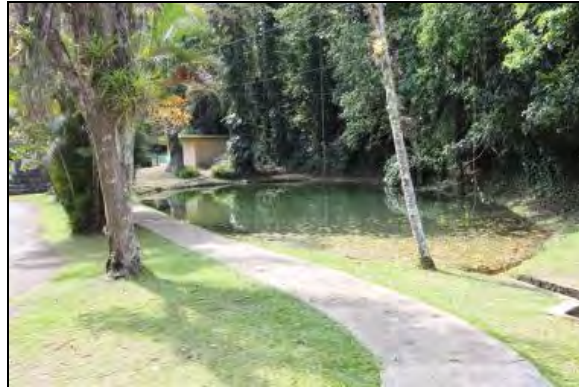
An oval shaped, shallow, dirt floor, spawning pool built by the Civilian Conservation Corps in 1937-1938. This pool, located south of the service road, is the largest of the three spawning pools built for the fish hatchery. Tilapias are bred in this pond.

Picture 7. Spawning Pool CR2 with restroom building in background (to the right).

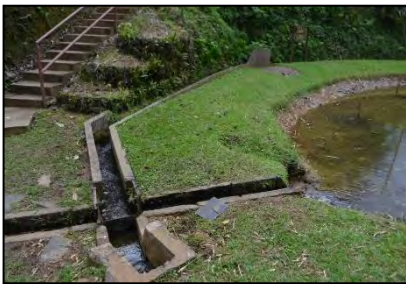
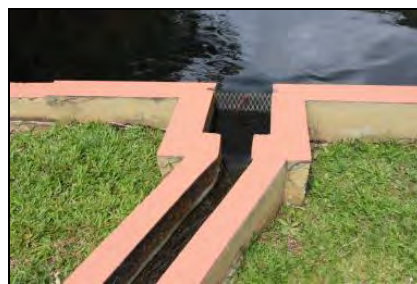
This system of channels that connects the ponds and tanks in the southern segment of the district is part of the original system designed for the fish hatchery in 1937-1938. Later in 1998/2000 it was affected by the intervention. However, it seems that the concrete water ways and sluice system connecting the spawning pools and holding tanks (CR1, CR3, T1-24, T29, T25, T26-28, G1, G2 and G3) conforms to original design and retains integrity.

Pictures 8, 9, and 10. Showing the waterways and their sluiceways in ponds.

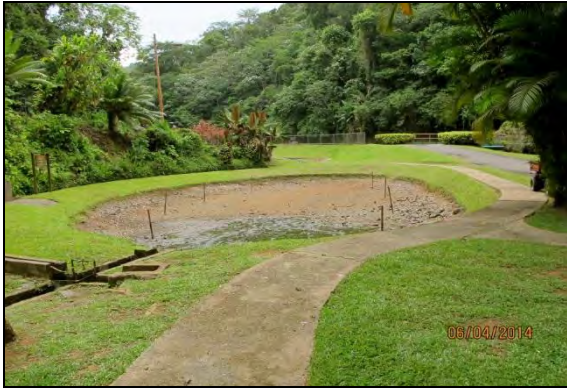
This structure, known as *Charca de Reproducción 3*, was one of two original spawning ponds built in 1937-1938 by the Civilian Conservation Corps. This spawning pond has dirt floor, which is better suited than concrete surface, for egg laying by the fish. Bass are bred in this pond.

Pictures 11 and 12. View of the pool (CR3) is undergoing its weekly maintenance. First photo looking approximately west. Second photo looking approximately east.

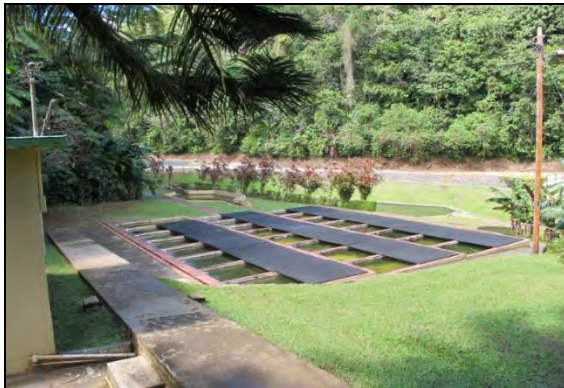
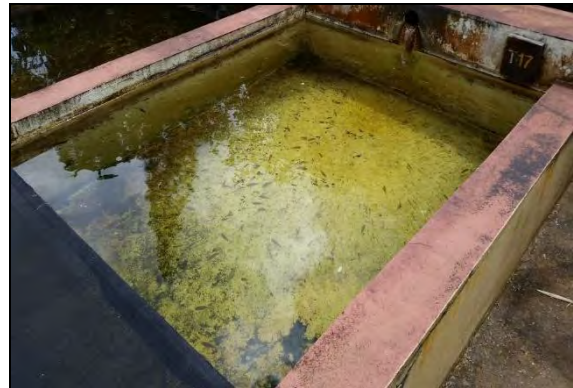
Tank 1 through Tank 24, also known as fish battery, built by 1937-1938 by the Civilian Conservation Corps. It is made up of 24 pools in which water is fed through gravity.

Pictures 13 and 14. General view of the old fish battery (T1-T24) and a close up of one of the pools.

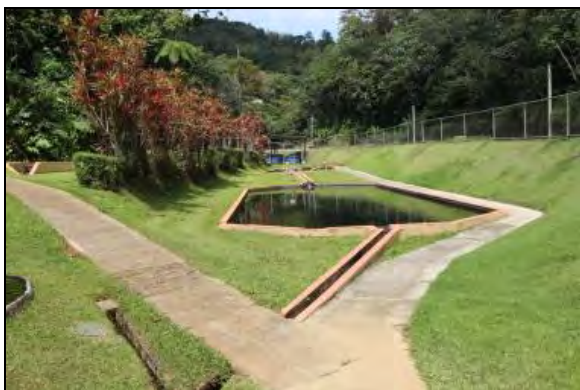
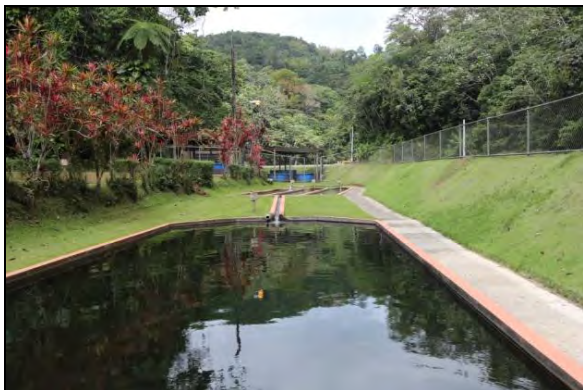
Picture 15 and 16. First photo shows part of water channel holding tank (T29) in the foreground. Second photo is taken from sidewalk to the left of the holding tank looking west, while in the background T26-T28 and Gazebo 2.

This chamfered rectangle shaped holding tank was constructed in 1937-1938 by the CCC.

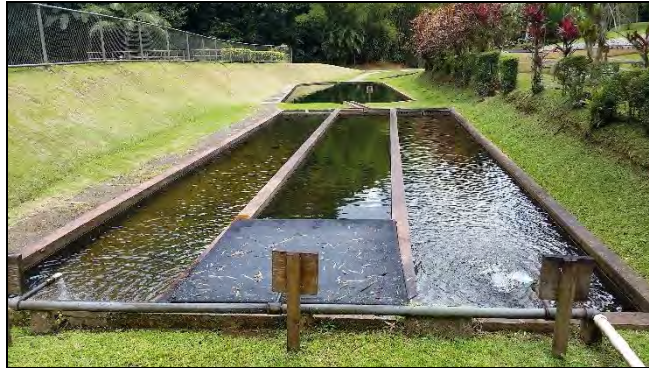
Picture 17. View of the retention tank’s (T26-T28) three pools. Photo taken from the Gazebo area looking east.

This retention tank is rectangular shaped and is divided into three long pools. This tank currently is used for the “tilapia” production. Built in 1937-38 by the CCC.

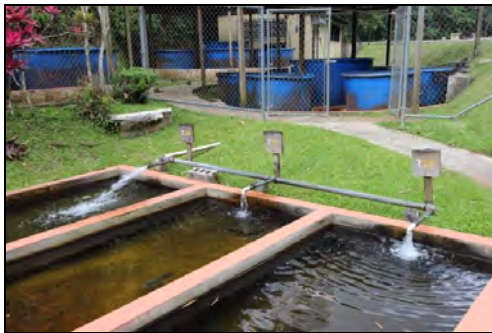
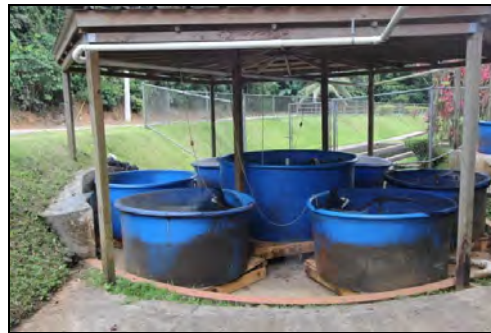
The Gazebo was previously used as a 1938 circular tank, with diameter of 6.096 meters, which used to have a rotating mechanism that provide exercise for the small fishes. Today the circular tank has been modified to house seven large blue colored plastic drums. They are presently experimentation tanks used by the nursery.

Pictures 18 and 19. First photo is taken from retention tanks (T26-T28) looking southwest.
The second photo shows Gazebo 2 (G2) looking east.

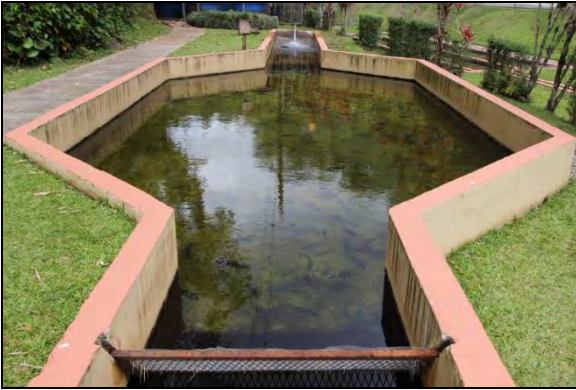
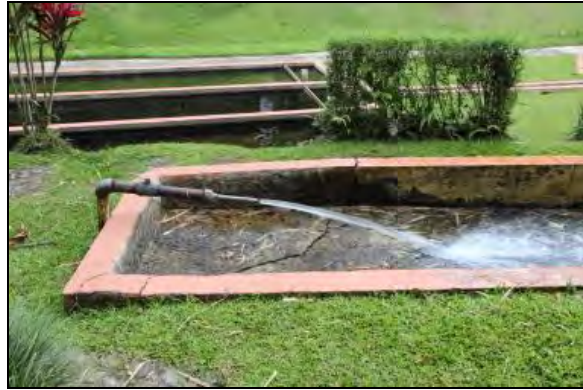
This “guitar” shaped concrete holding tank, measuring 18.288 meters long by 6.096 meters wide, is used today as a retention tank for large fishes. This structure was built by the CCC in 1937-1938. The structure suffered minor damage when a tree fell on its western end (see Picture 21).

Pictures 20 and 21. First photo of the holding tank (T25) looking east, while second photo shows the damaged area.

20. View of Holding Tank T25, looking approximately east.
21. Close up of the damaged area in holding tank T25. Looking approximately north.
22. General view of the Administration building as seen from the sidewalk to the north of spawning pool #3. Looking approximately south.

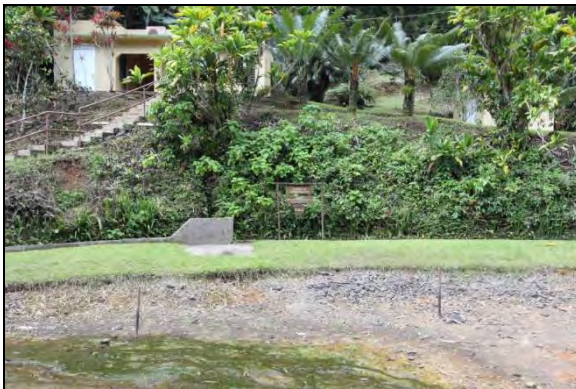
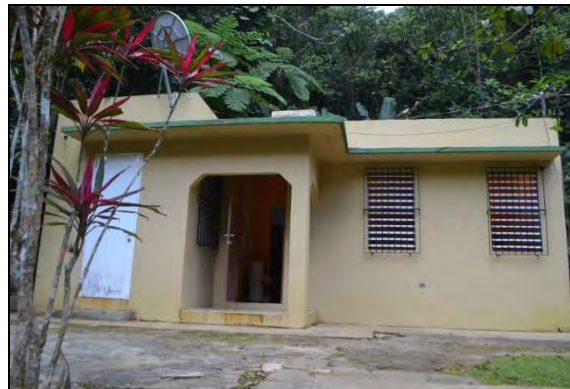
The Hatchery Office, known also as Administrator building, serves as the fish hatchery's administrators and staff residential facility. The original building, one story concrete flat roof, dates from the 1937-1938. Although changes have been made to the building, like closing windows on its main facade, the property retains the original volume and floor plan.

Pictures 22 and 23. The first photo is of the Hatchery Office in the elevated area south of a spawning pond (CR3) and the second view shows the building main facade taken from the stairway looking southwest.

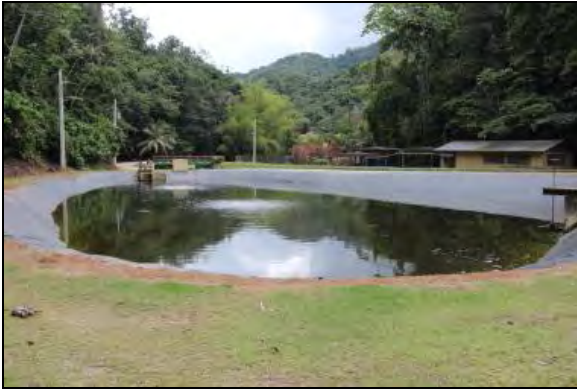
A grow-out pond, measuring approximately 1,406 square meters (15,134 square feet), is located to the east of CC3 and west of three-span concrete bridge. This grow-out pond is located in the northern sector of the fish hatchery. The structure was originally built in 1940-1941 by the Civilian Conservation Corps as part of the expansion of the fish hatchery. It was modified by the Government of Puerto Rico in 1998/2000 intervention.

Pictures 24 and 25. First photo of grow-out pond #2 (CC2) looking southeast with Nursery, Gazebo area and concrete bridge in the back ground. In the second photo shows the pond in foreground, looking northeast.

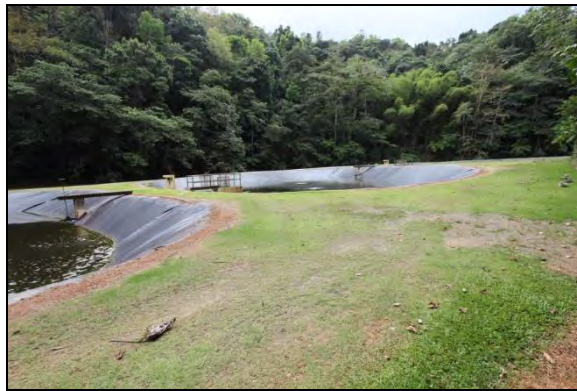
A grow-out pond, measuring approximately 1,509 square meters (16,238 square feet), located in the northern sector of the fish hatchery. This structure was originally built in 1940-1941 by the Civilian Conservation Corps as part of the expansion of the fish hatchery. The structure was modified by the Government of Puerto Rico in 1998/2000 intervention.

Picture 26. View of the grow-out pond #3 (CC3) looking southwest.

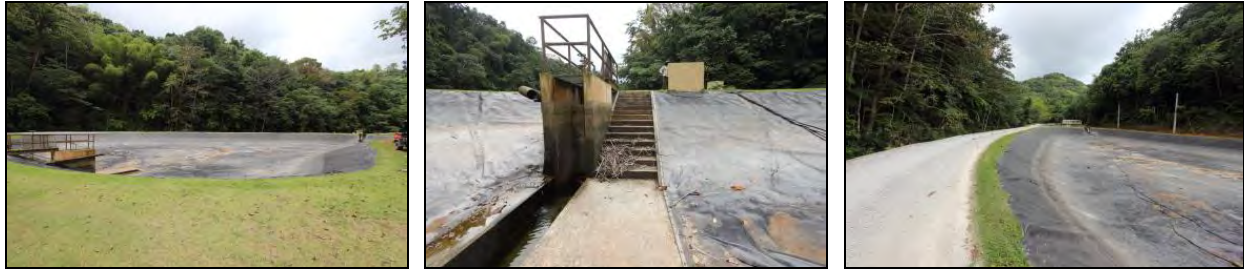
Picture 27, 28 and 29. Views of the grow-out pond #4 (CC4) emptied for routine maintenance. The photos were taken from the interior service road, close up of its fish kettle and from the exterior service road (close to the river bed).

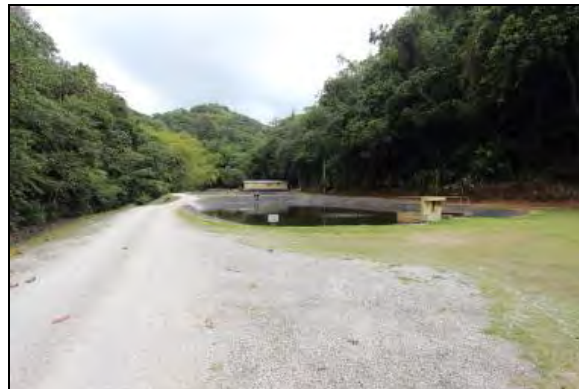
A grow-out pond, measuring approximately 1,449 square meters (15,594 square feet), located between CC4 (east) and CC6 (west) in the northern sector of the fish hatchery. This structure was originally built in 1940-1941 by the Civilian Conservation Corps as part of the expansion of the fish hatchery. The structure was modified by the Government of Puerto Rico in 1998/2000 intervention. However, although its shape might have been altered, it continues to serve in its historic function.

Picture 30. View of the grow-out pond #5 looking northwest. In the background are grow-out pond #6 and the Equipment building.

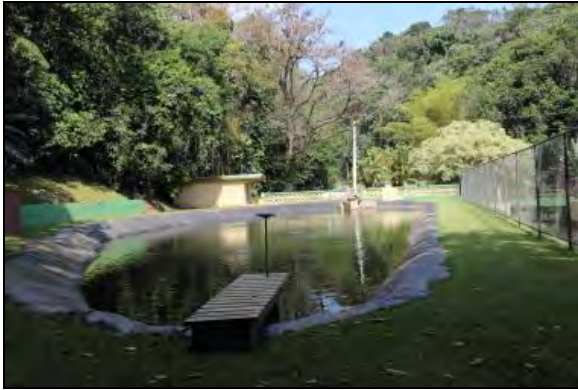
A large, about eight feet deep, grow-out pond, that measures 925 square meters (9,959 square feet), located at the east end of the southern area of the fish hatchery. This grow-out pond was built by the Department of Natural and Environmental Resources at an unknown date prior to 1996. The structure surface is covered in an impermeable membrane and is controlled from its fish kettle. Currently bluegills are bred in this grow-out pond.

Pictures 31 and 32. Grow-out pond CC1. First picture looking west, while second picture looking east.
Restroom building in the background to the left of the CC1 (Picture 31).

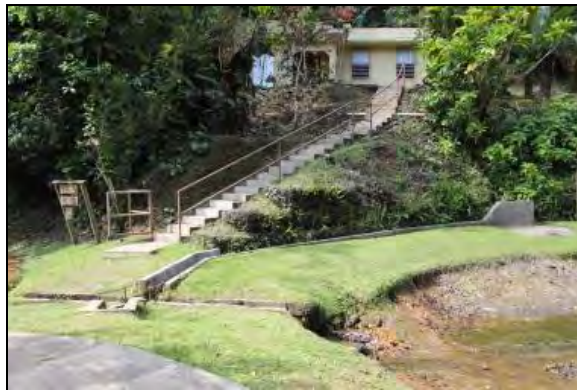
A concrete staircase built to provide access to the administration area from the spawning pool (hatching office) area. This stairway, made up of 30 steps, was probably built as part of a recent construction.

Pictures 33. Concrete stairway and spawning pool CR3 with Administration building in the foreground a top of the hill.

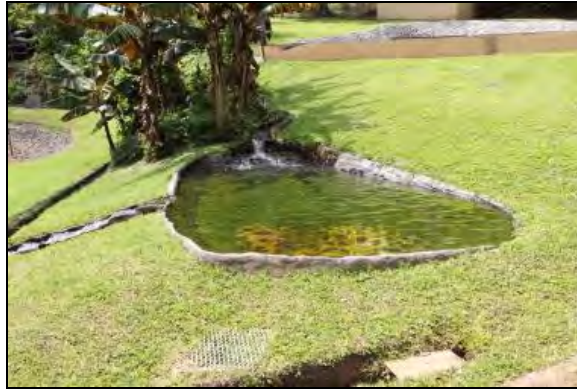
The small ornamental pond located close to the sidewalk junction, leading to the runway tanks, is an oval shaped structure that serves exclusively as a decorative function. There is no known date of its construction.

Picture 34. Ornamental pond just above the sidewalk. The holding tank T1-T24 can be seen in the background.

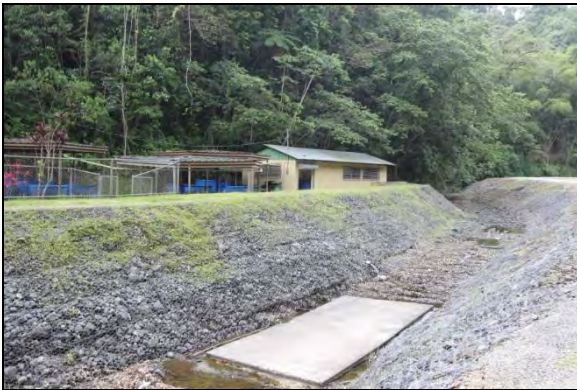
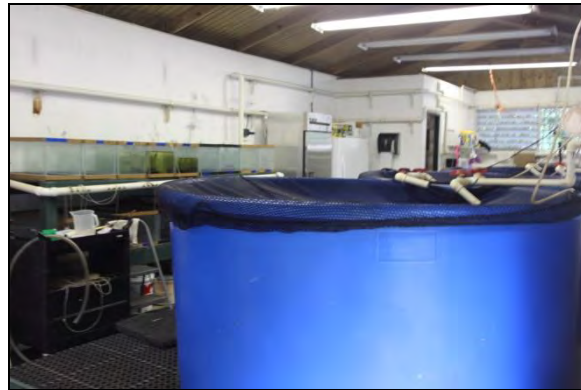
Pictures 35 and 36. Exterior and interior view of the Nursery Building.

This nursery is a concrete, front gabled rectangular plan one story building. This building is where the fish eggs, on spawning mats from the spawning ponds, are kept until the larvae hatch. It has a system of fishbowls that run the length of the building. The nursery is also used as a research laboratory. The hatchery's original wooden edifice was replaced at an unknown date by the current concrete building.

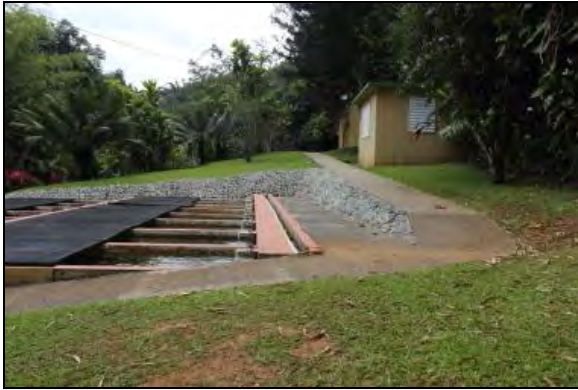
The small one story building, close to the old raceway tanks and the administration building, is used in part for the scientific research conducted in the fish hatchery. The building was built at an unknown date. In the 1960s a one story wooden building was located in this area.

Pictures 37 and 38. View of the Temperature and Photoperiod Lab located on an incline close to the Hatchery Office. The first view, looking east shows the T1-T24 pond to the left, the lab and the Hatchery Office to the right. The second photo shows the laboratory looking northwest.

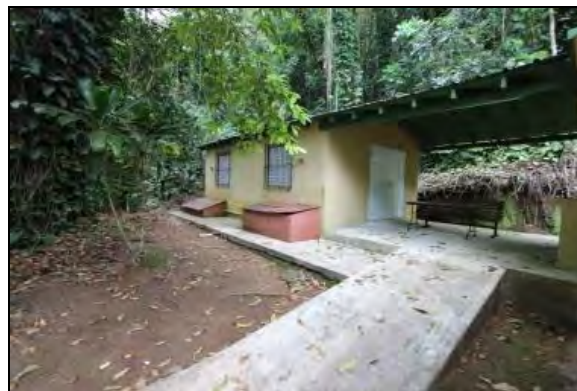
The Quarantine Lab is a one story, rectangular plan concrete building built at an unknown date. The facilities are joined to the administration building by a wooden roof. The building is used for diseased fish, to prevent the spread of contagion among the fish population. There are fish tanks (from 6-8) that run with their own water filtration system.

Picture 39. View of the Quarantine Lab looking southeast.

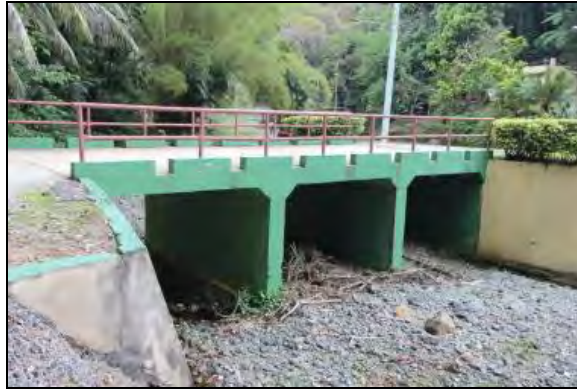
The three span concrete bridge was built as part of the 1998/2000 improvements to the hatchery. This structure was designed, with the capacity to withstand one hundred year flooding, by Engineer Casiano Ancalloe, for the Department of Natural and Environmental Resources. The original 1941 bridge was destroyed in the 1998 flooding.

Picture 40. Three span concrete bridge over the Maricao River.

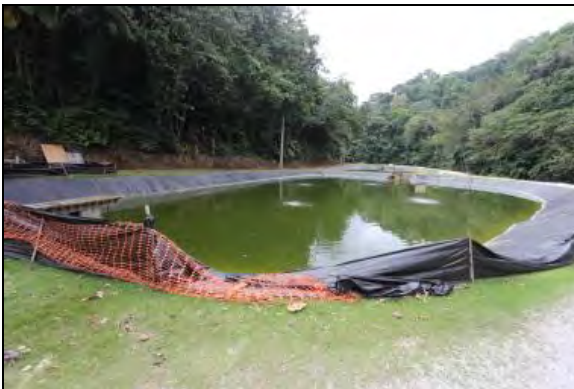
A grow-out pond, measuring approximately 1,382 square meters (14,877 square feet), located between CC5 (east) and the Equipment Building (west) in the northern sector of the fish hatchery. This structure was built at an unknown date.

Picture 41 and 42. View of the grow-out pond #6 looking southeast (#41) and looking northwest (#42). In the first picture has a close up view of the impermeable membrane used to cover the bottom and sides of the pond. In the background of second picture is the Equipment Storage Building.

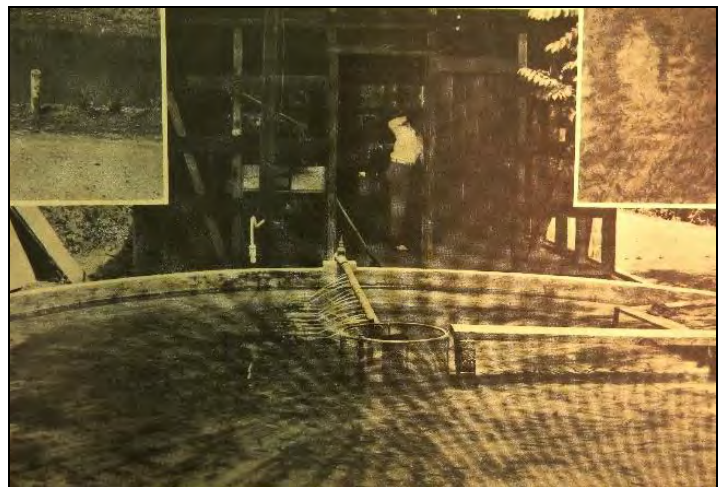
Figures 7 and 8. View of fish battery and in second photo the nursery building and round ponds. Album de Oro (1938).

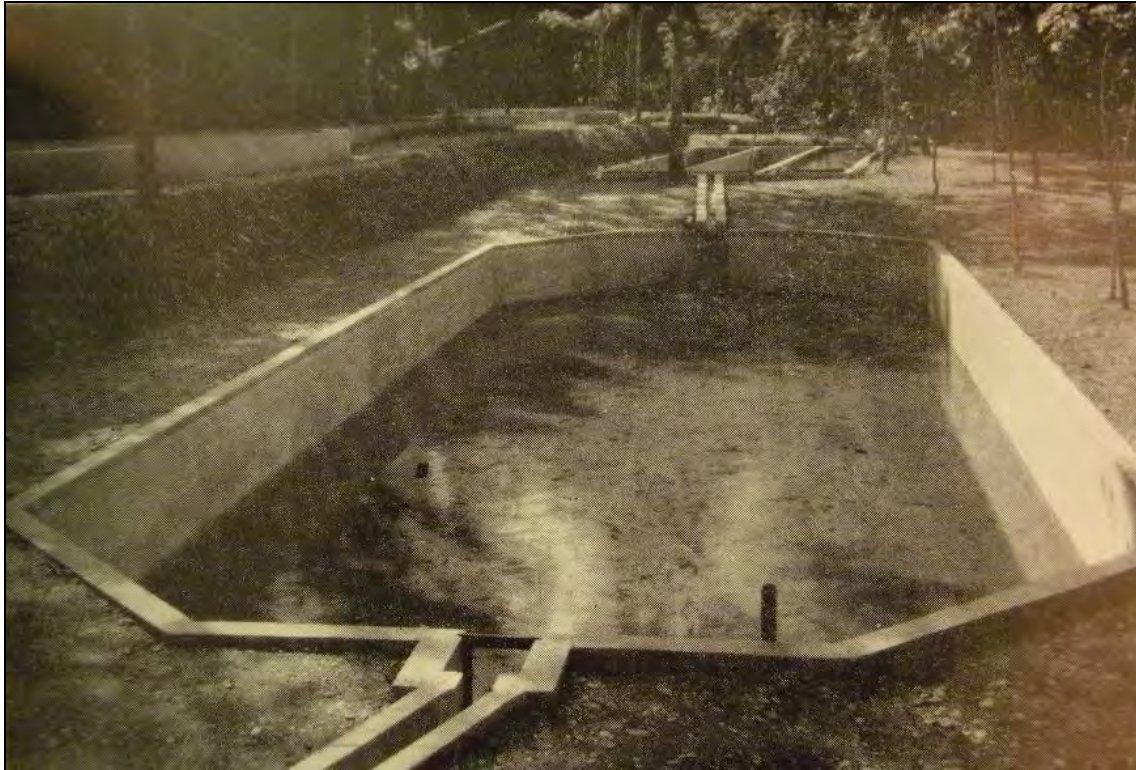
Figure 9. View of the holding tank built in 1938. Informe anual del Comisionado de Agricultura y Comercio, Ejercicio 1937-38.

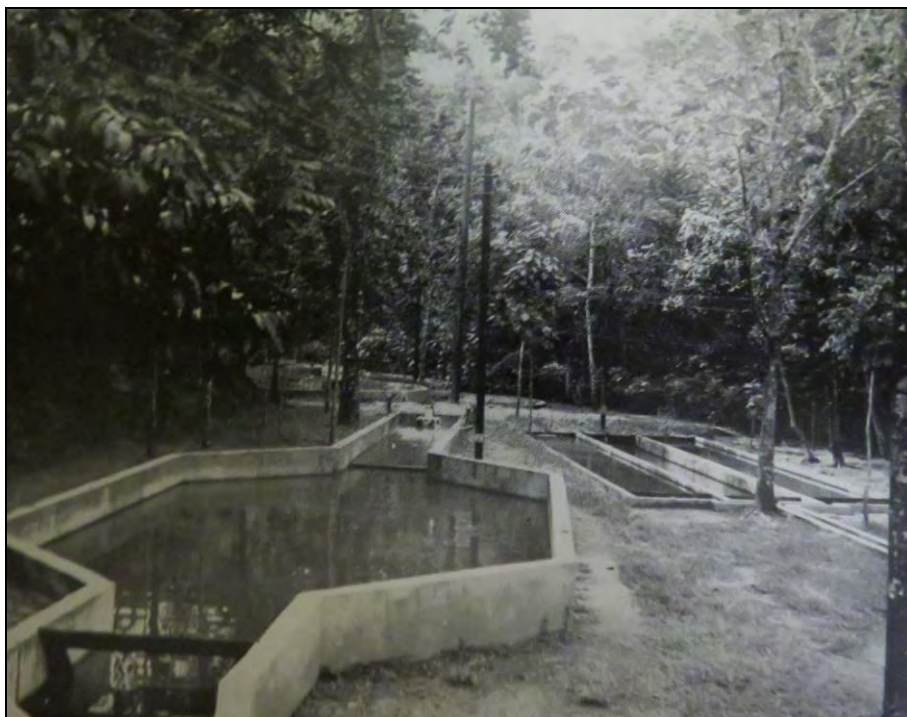
Figure 10. View of the holding tank and in the background the retention tank and circular tank. Revista de Agricultura y Comercio de Puerto Rico. Marzo 1939

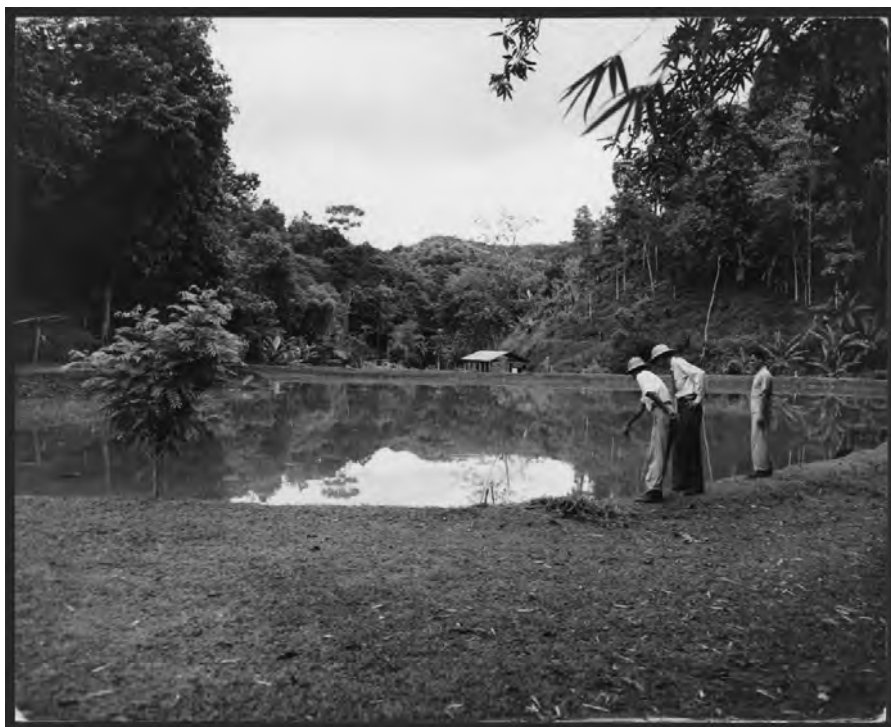
Figure 12. View of Vivero de Peces Maricao, 1953 by Antonio Antiles, Colección de Fotos del Periódico El Mundo. <http://bibliotecadigital.uprrp.edu>
