National Register of Historic Places Inventory—Nomination Form

| Type all entries | -complete applic | cable sect | ions | | | | |
|--|---|---|--|---|---|--|---|
| historic | The Williams | Place | | | | | |

ARCHAEOLOGICAL ADDENDUM WILLIAMS PLACE SPARTANBURG COUNTY

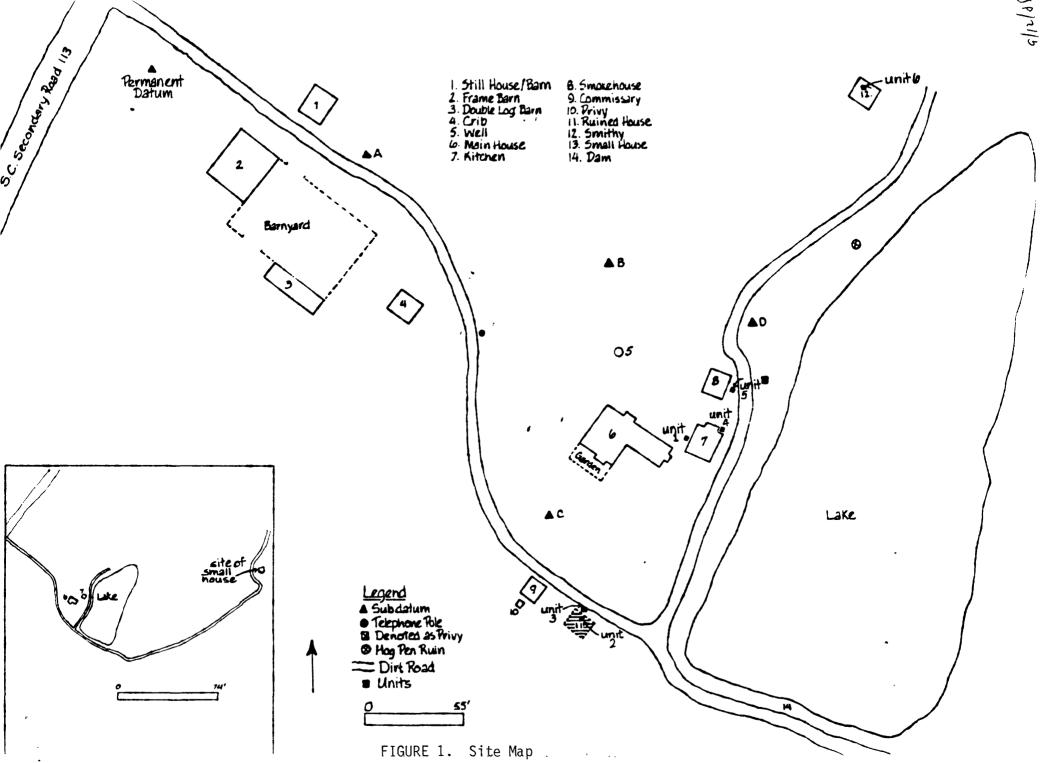
This introductory stage of archaeological fieldwork included the excavation of six 2.5 X 2.5 ft.test units placed in association with various structures at the site (See Figure 1): Units 1 and 4 (detached kitchen), Units 2 and 3 (ruined house), Unit 5 (smokehouse) and Unit 6 (smithy). These units were selected due to their ability to reflect various activities at the Williams Place. Moreover, a site map was constructed detailing the spatial distribution of standing structures.
