NATIONAL REGISTER OF HISTORIC PLACES
PROPERTY PHOTOGRAPH FORM

Niagara Camp

CITY, TOWN Tuolumne X VICINITY OF COUNTY Tuolumne STATE California

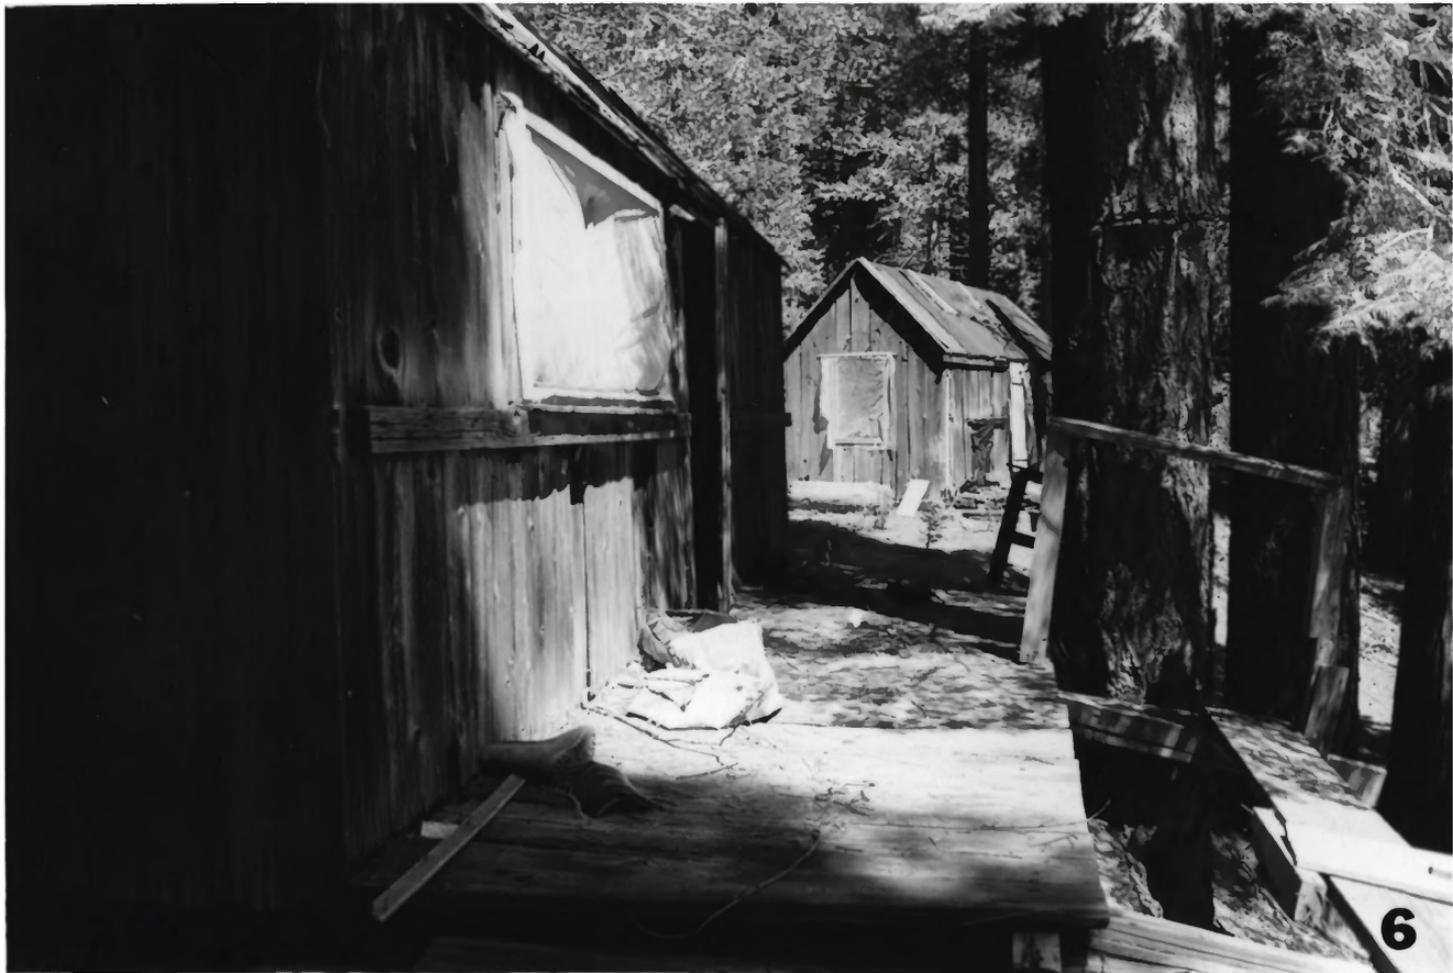
108
Looking northeast above and parallel to the railroad grade (to the right off of photograph) there are two cabins that are the remains of the family camp.

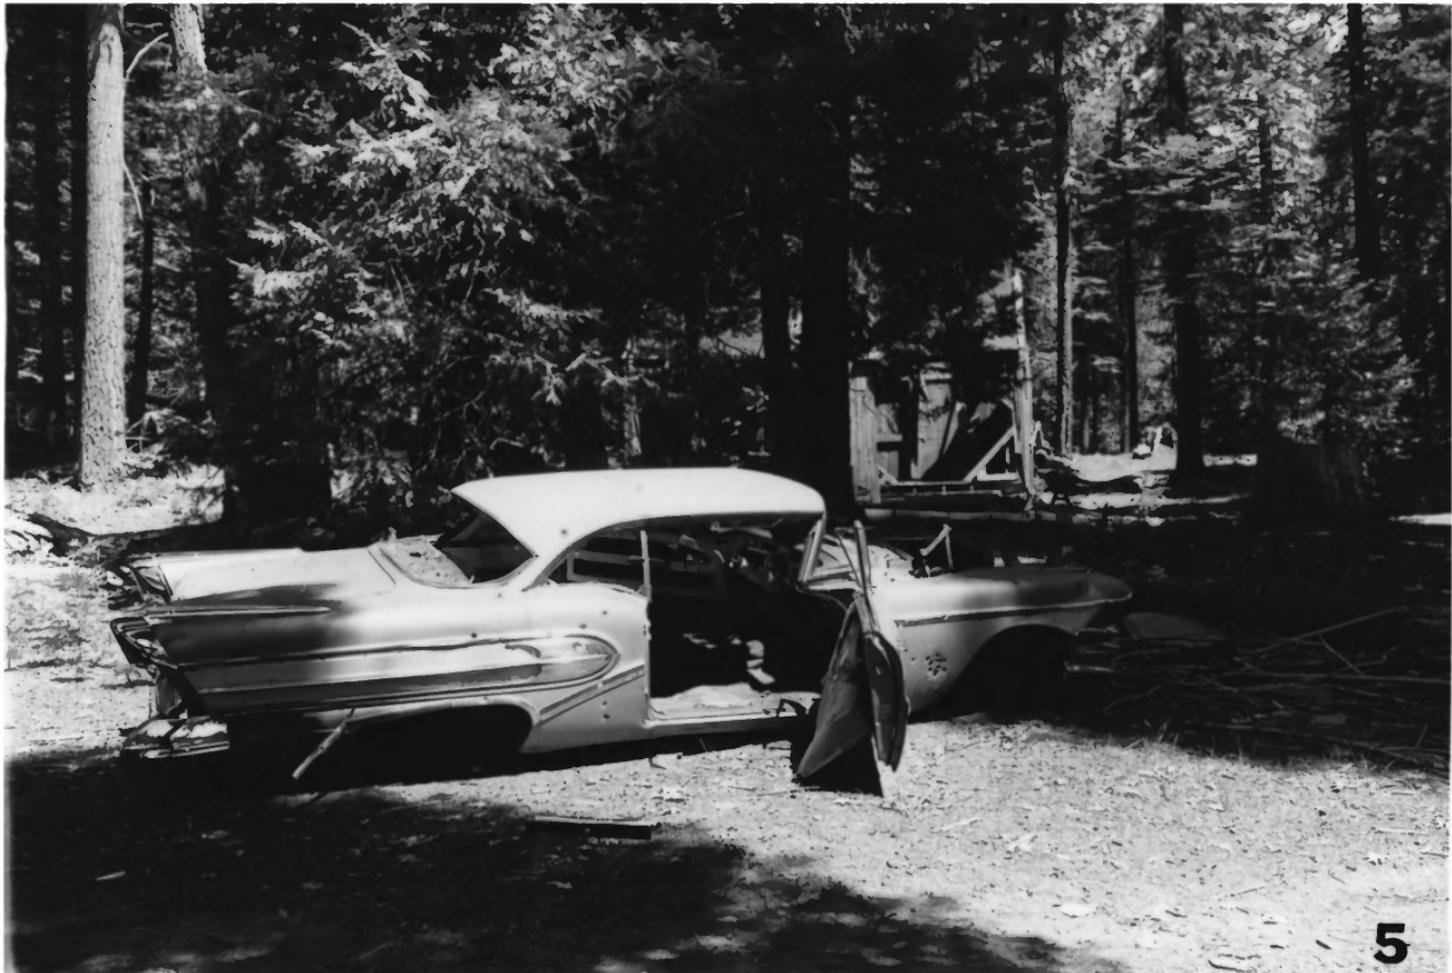
PHOTO NO 5

Looking to the southwest, directly in front of the boiler shown in the foreground of photo #4, there is a junked car. Behind the car (A) is a building partially standing.

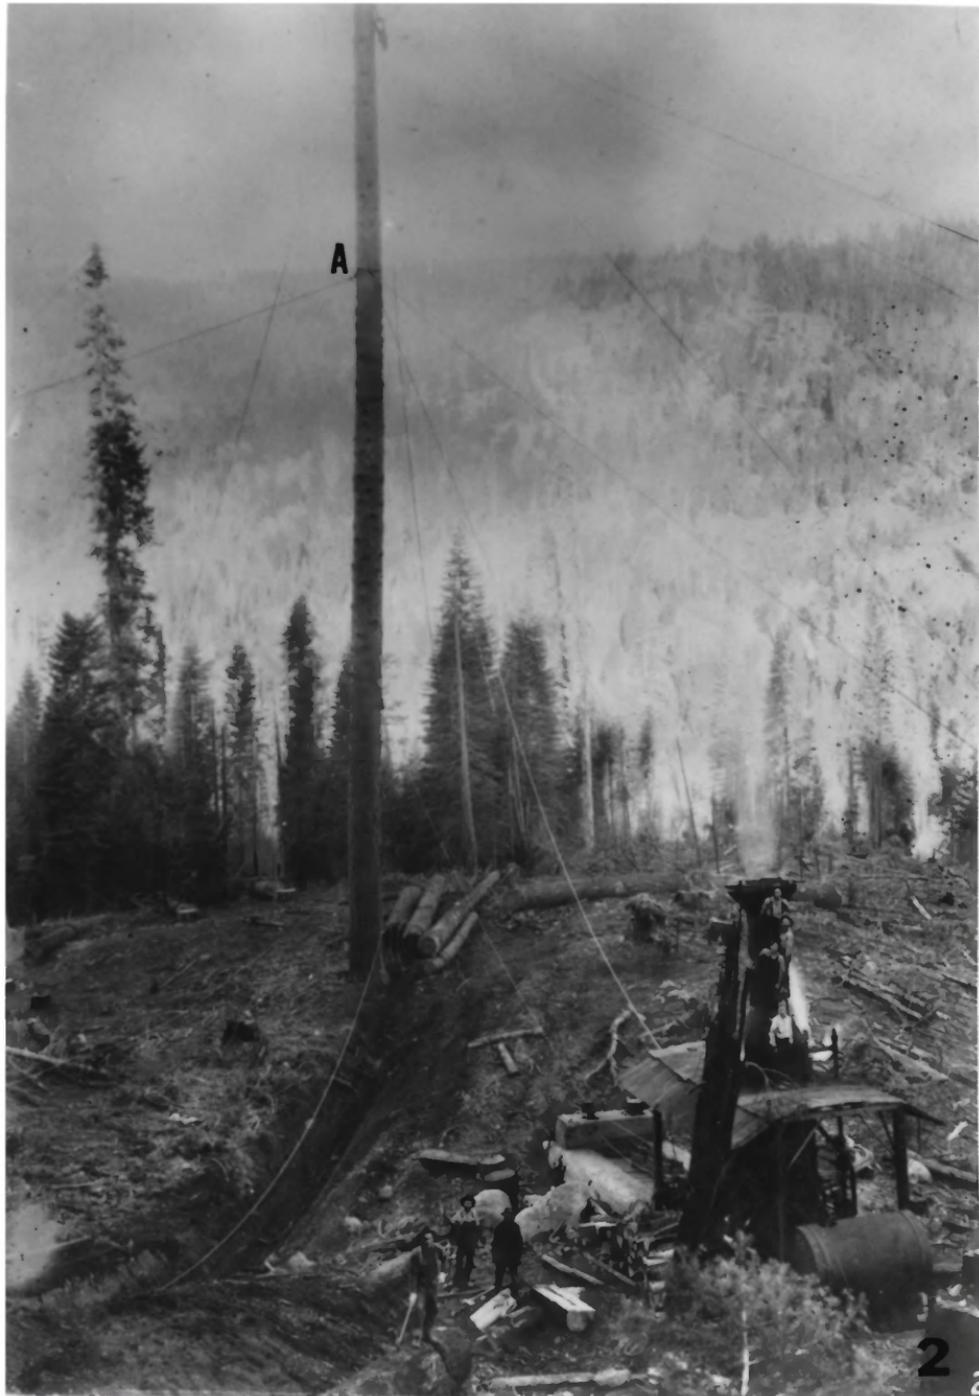
PHOTO NO 2

This copy of an original photograph which was taken around 1925 illustrates the use of the spar pole (A). The cable hooked onto a limbed tree (A) was used to drag the timber via steam donkey power to and onto the railcar.

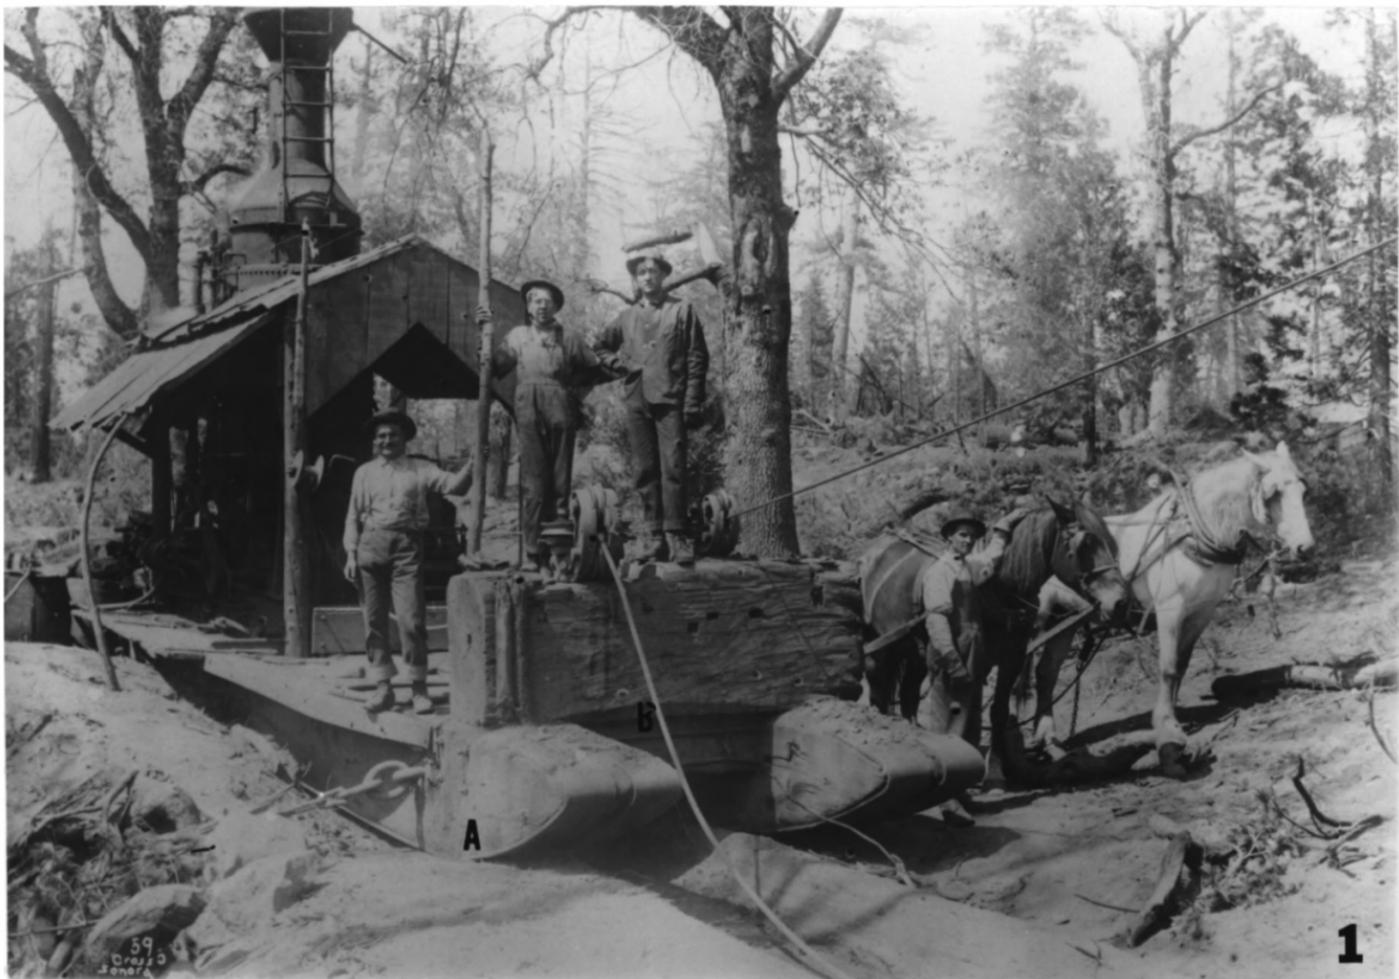
PHOTO NO 1

This copy of an original photo which was taken around 1925 at Camp Clavey, illustrates the appearance of the steam donkeys. Notice the skids (A) which aided the donkey in moving from one place to another. The donkey pulled itself with a pulley, a cable (B) that was hooked onto a tree and its own steam.

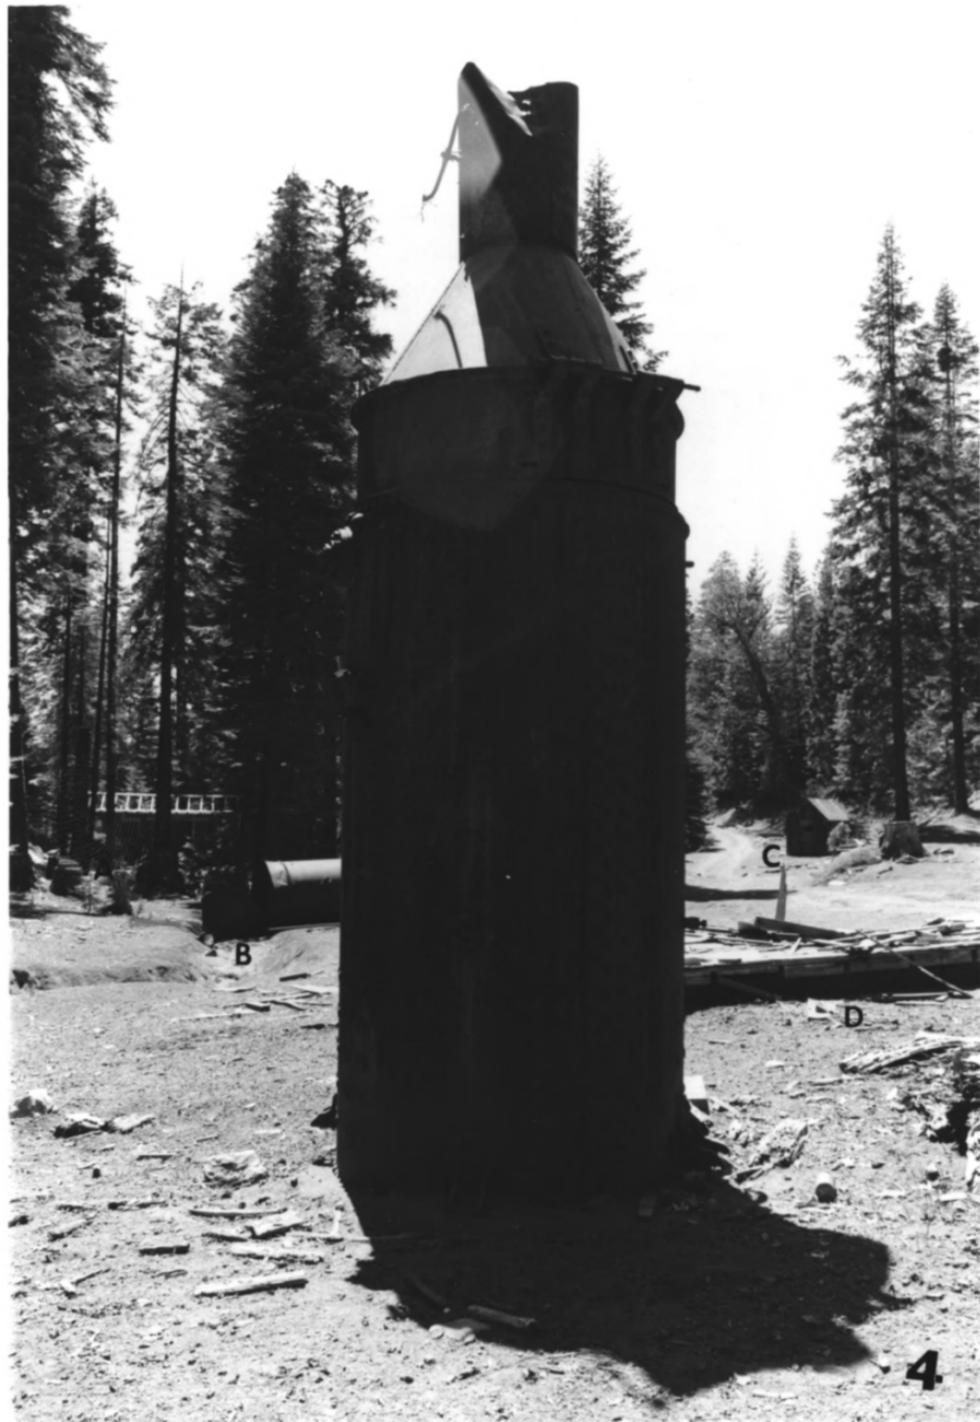
PHOTO NO

Standing at one of the shower water boilers (in foreground) looking in a northeast direction in the center of the main camp can be seen: A. The railcar used for a bunkhouse and later for food storage. B. Another shower water boiler on its side. C. A small shed in fair shape. D. A pile of rotting lumber where, most possibly, the shower house stood.

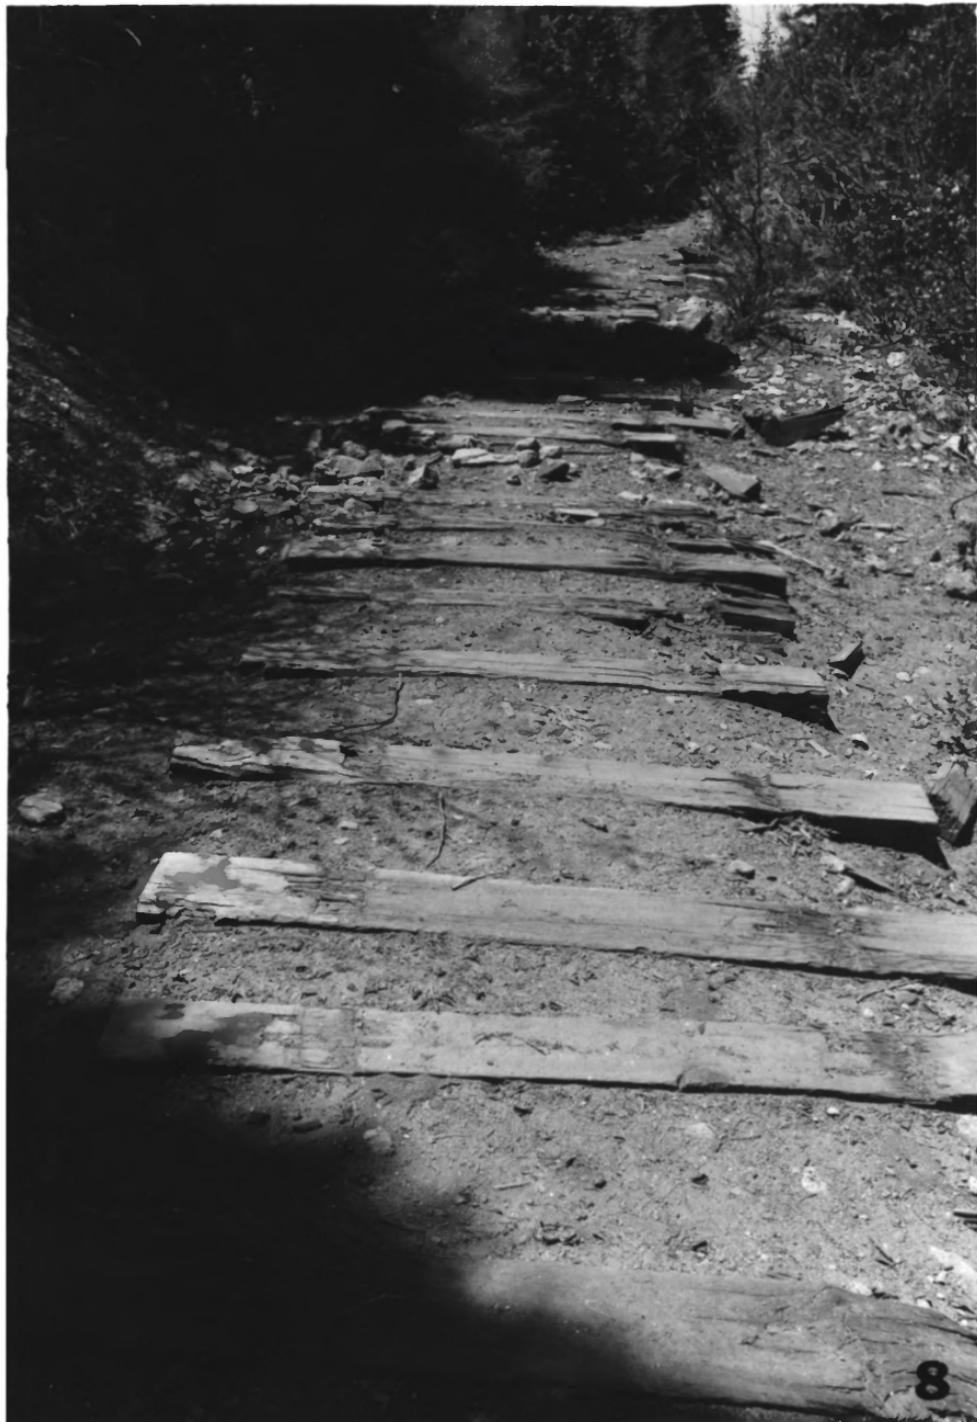
Looking southwest from the end of the trestle towards the steam donkeys, the railroad bed still has its cedar ties but the rails have been salvaged.

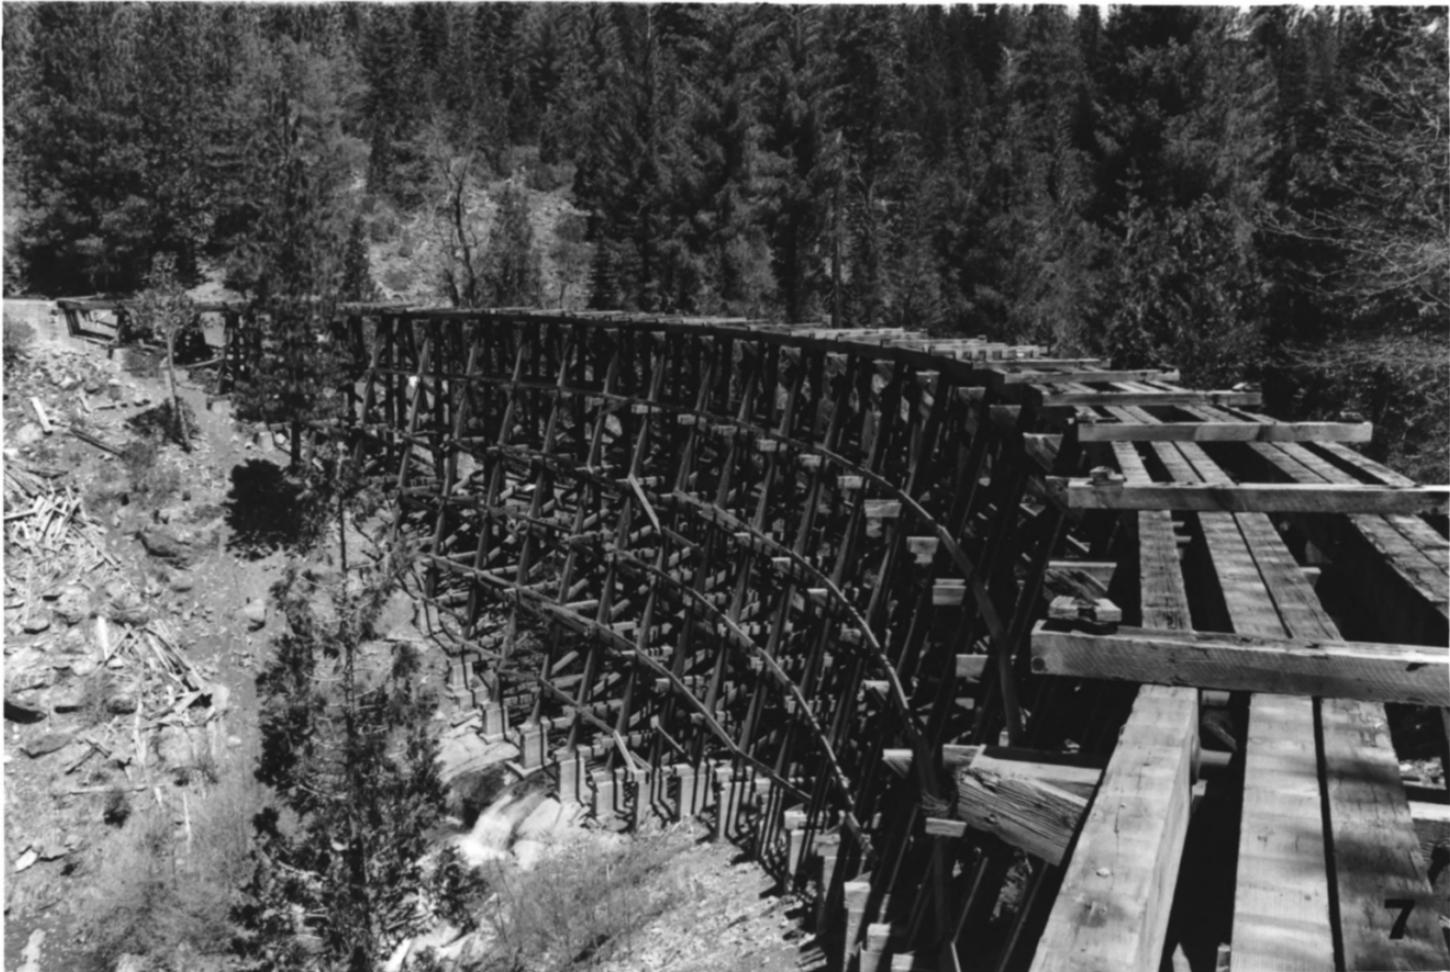
PHOTO NO 7

This photo is taken at the northeast end of the trestle looking southwest toward the family and main camps. The trestle, built of red fir is 318 feet long and towers above Niagara Creek (A) 54 feet.

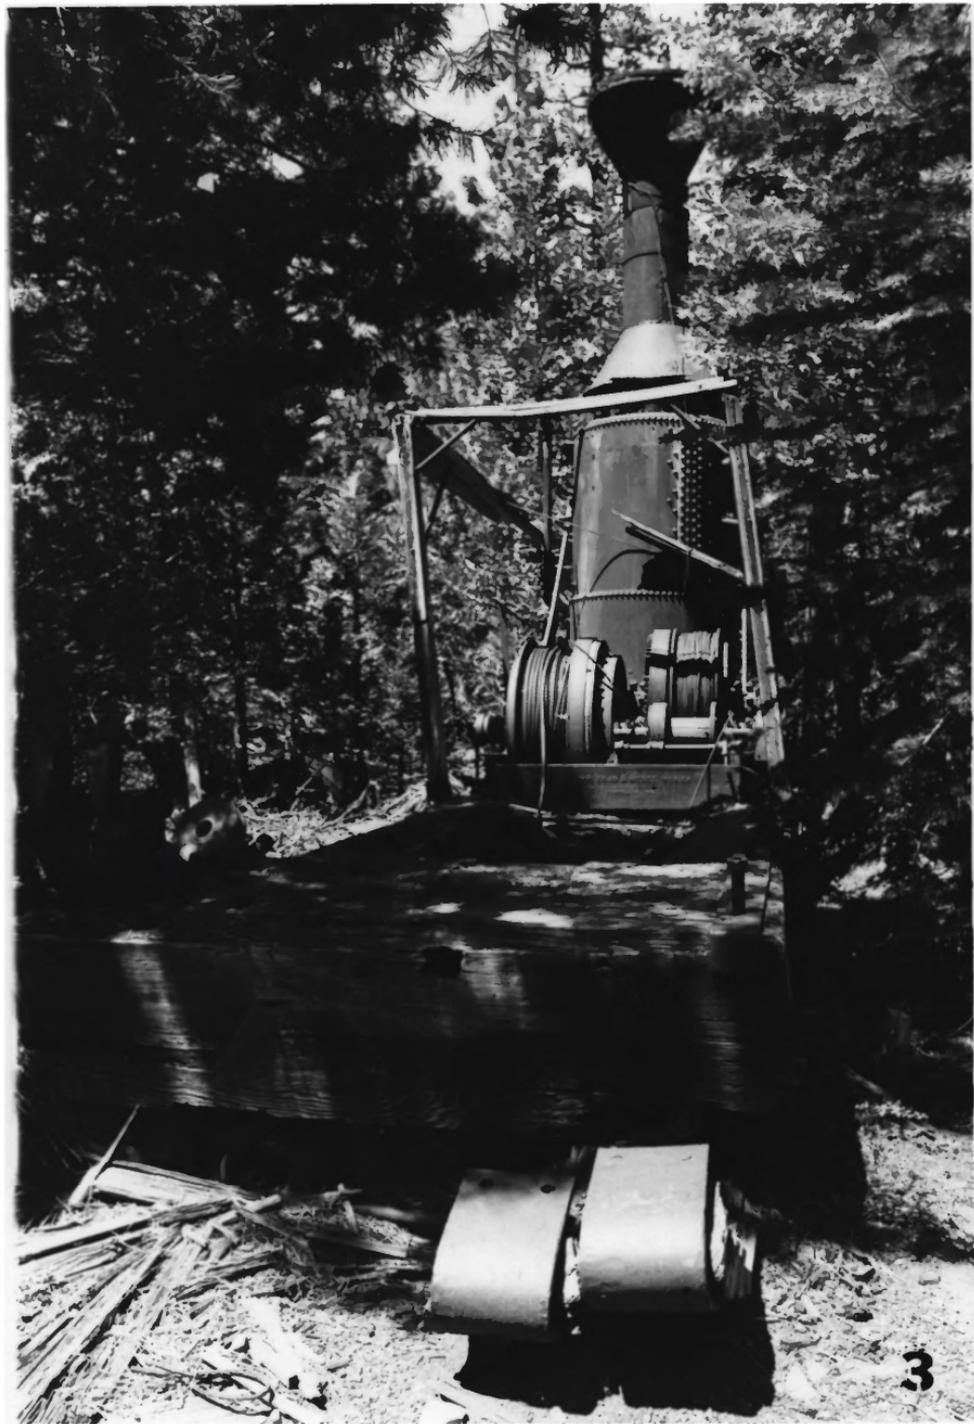
PHOTO NO 3

Looking to the northeast, this Willamette brand, is one of the four steam donkeys. Note the skids and cable.
