KENTUCKY HISTORIC RESOURCES
Individual Inventory Form

Resource # 107
Shelby County

1. Name of Resource: Shelby D. Ware House		16. Date: 1st quarter 19th century or Original Building earlier (?) [] Addition 20th century []	
2. Original Owner: Unknown		17. Style: Settlement Vernacular [2V]

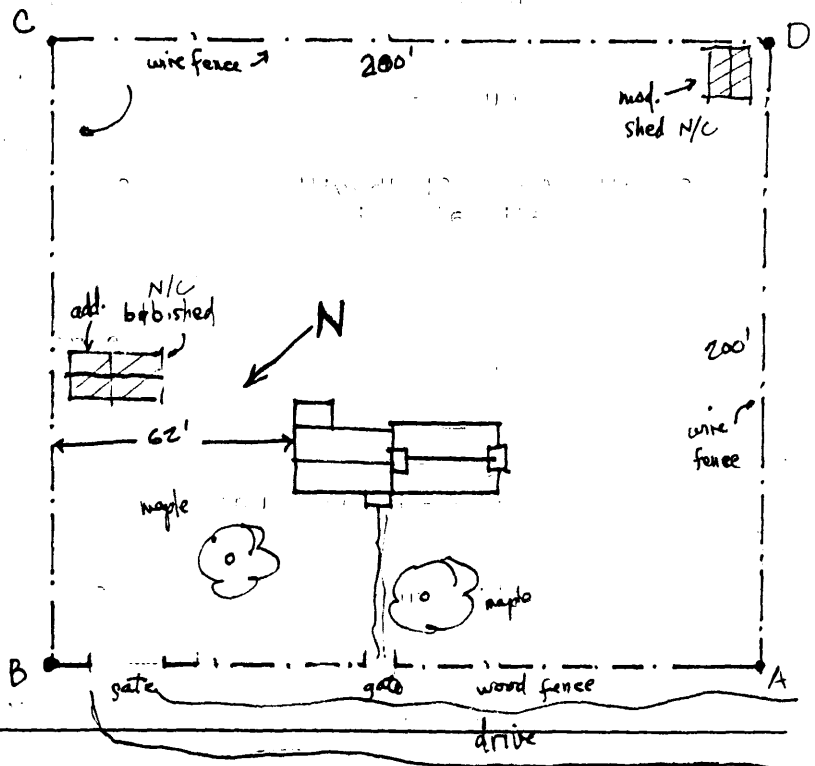
44. Site Plan (and boundary description and justification for N.R. sites):

Beginning at Point A where two fences intersect in the northwestern corner of the yard 100 feet northwest of the northwestern corner of the dwelling, 200 feet northeastward along fence to its intersection with another fence (B); 200 feet southeastward along fence to its intersection with another fence (C); 200 feet southwestward along fence to its intersection with another fence (D); 200 feet northwestward to point of origin.

The boundaries were chosen to encompass the house and domestic-related space which is enclosed by fences separating the yard from surrounding fields.

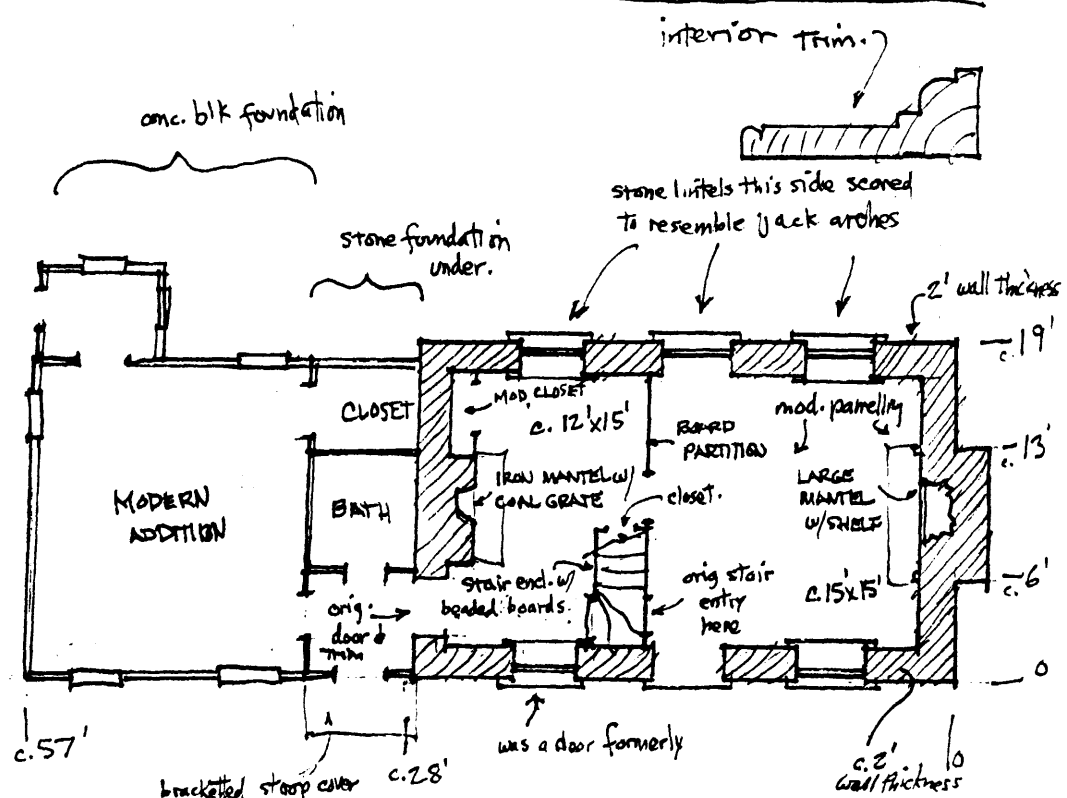
45. Description and House Plan:

A 1-story, 3-bay coursed rubble hall-parlor (two-room) house. Large chimney (partially exterior) at southwest end, smaller interior chimney at northeast end. Southeast front was principal facade. Has jack arch over door, stone lintels over windows scored to resemble splayed jack arches, watertable ledge, basement vents, beaded window frames with molded backbands, cornice and rakeboards replaced throughout. 9/6 sash. Northwest front, like southeast has center door flanked by windows, but no jack arches, and northeastern window (to parlor) was a door originally. Modern frame wing contains one room separated from northeast gable by a hyphen containing a bath, closet and foyer. Foundation appears to be old coursed rubble under hyphen and may contain older elements. Door from hyphen to main house has early detailing. A pair of small garret casement openings with modern windows flank southwest chimney. Exposed wooden anchors set in the wall support the cornice.

Larger southwestern room (hall) heated by fireplace (now closed) with enormous mantel with shelf. Hearth removed. Room sheathed with modern panelling obscuring some early details. Molded chairrail and beaded base. Board partition separates smaller northeastern room (parlor). Stair, which now opens from parlor and rises in beaded board enclosure, originally opened into larger room. The mantel was replaced with an iron coal grate, surround and mantel in the late 19th century.
