**National Register of Historic Places
Registration Form**

historic name Enid Downtown Historic District

3. state Oklahoma code OK county Garfield code 047 zip code 73701

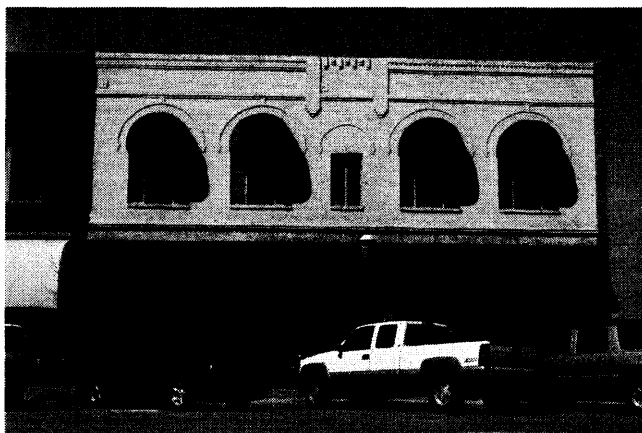
Photo 105. 122-124 E. Broadway Avenue, Two-Story Commercial Style – Late Victorian

The district includes eighty-two buildings in a mostly regular area, of which fifty-three or 65% are contributing to the historic character of the district. They were constructed during the district's period of significance for architecture and commerce, from 1900-1957, and the architecture of downtown district is both commercial and governmental. The predominant architectural style in the district is Commercial and there are 42 or nearly 51% of these buildings. In this nomination, "Commercial Style" is divided into periods and buildings are designated "Commercial-Late Victorian", c. 1900 to c. 1915, or just "Commercial Style", c. 1915 and after. Typical single and two-story Commercial buildings are seen below.

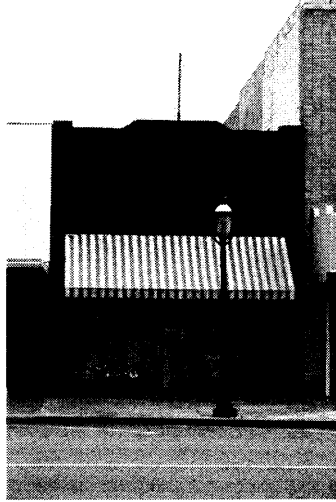
Photo 94. 113 S. Grand Avenue, One-Story Commercial Style

The district is characterized by patterns that evolved nationally for commercial buildings in the late nineteenth and early twentieth centuries. Building sites are narrow deep lots, with buildings that have connected façades, sometimes stores or businesses occupying more than one lot. Storefronts, whether on a one- or more-story building, are generally divided into an upper façade with a cornice, frieze and transom area, and a street façade usually contains display windows over bulkheads which are on either side of a primary and sometimes secondary entrance. Many times doors are recessed, sometimes entries are tiled, and mostly cloth or metal awnings protect the storefront and shelter pedestrians. Street discrete centered or side doors provide access to upper levels.

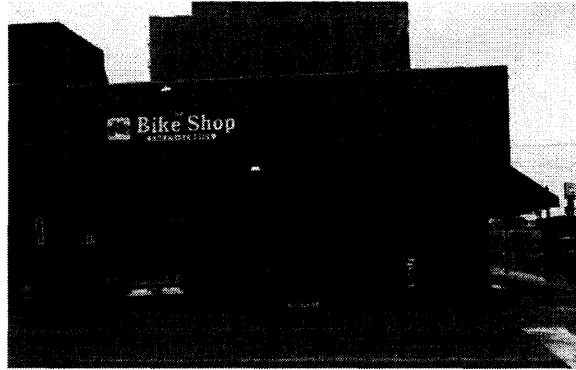
Photo 43. 202-204 W. Randolph Avenue, 1950s Commercial Building

This building shares the same characteristics of other earlier district buildings described above. Its architecture complements existing buildings and contributes to the district.

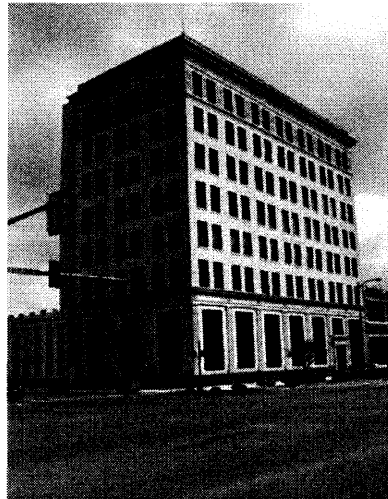
Photo 67. First National Bank, Classical Revival
201 N. Grand Avenue

There are buildings in the district which exhibit the Classical Revival architectural style, such as the First National Bank and U. S. Post Office and Court House.

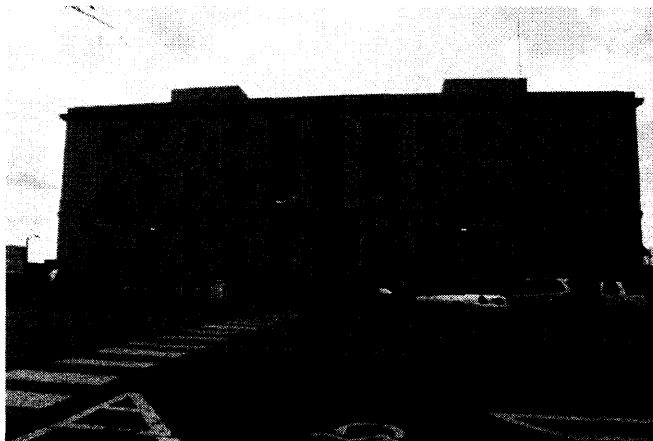
Photo 115. 115 W. Broadway Avenue.⁵

⁵ This stylized Classical building is sometimes referred to as PWA Deco- a Modern interpretation of Classicism.

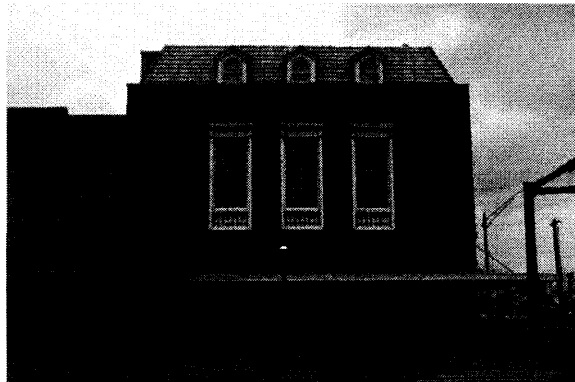
Photo 65. 102-104 W. Randolph Avenue, Colonial Revival.

The Montgomery Ward Building at 102-104 W. Randolph Avenue is an unusual Colonial Revival style building whose dominance at a corner with N. Grand Avenue creates an important frame to the east end of W. Randolph Avenue.

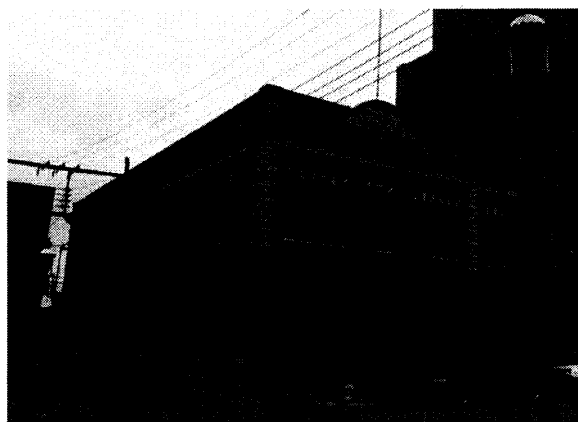
Photo 46. 216-218 N. Independence, Italianate Renaissance Revival

The Pioneer Telephone and Telegraph Company Building is one of two Italian Renaissance Revival buildings in the historic district.

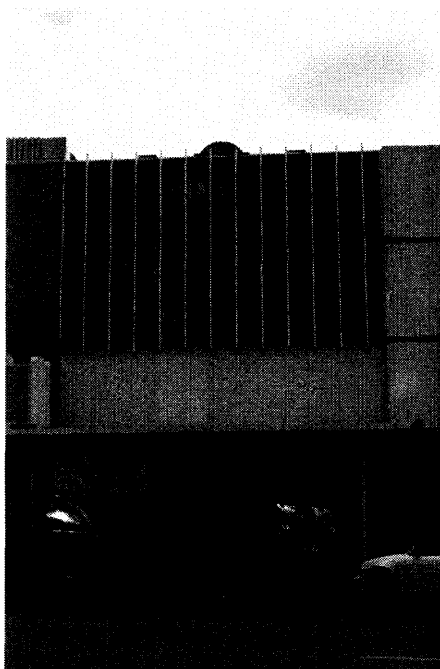
Photo 96. 119 S. Grand Avenue

As such, a false façade adversely impacts the building's integrity. The removal of the false façade can alter the determination of the building as non-contributing to contributing if sufficient original material remains to allow the historic character of the building to be apparent. An example is below at 119 S. Grand Avenue. Removal of added façade could possibly make this building contributing since details from the original façade are present, at least in part, because they show at the top of the parapet wall. In another example, the potential of 111 N. Grand Avenue to contribute if the façade were removed is more difficult to predict.

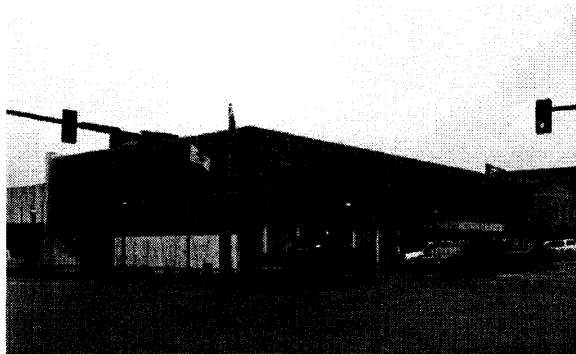
Photo 8. 101 S. Independence Avenue, International Style

Some district buildings are not yet of sufficient age. An example is Security National Bank.
