National Register of Historic Places Registration Form

Historic name: (Appleton) Union Meeting House
Other names/site number: _____
Name of related multiple property listing: N/A
(Enter "N/A" if property is not part of a multiple property listing)

Street & number: 2875 Sennebec Road
City or town: Appleton State: Maine County: Knox
Not For Publication: n/a Vicinity: n/a

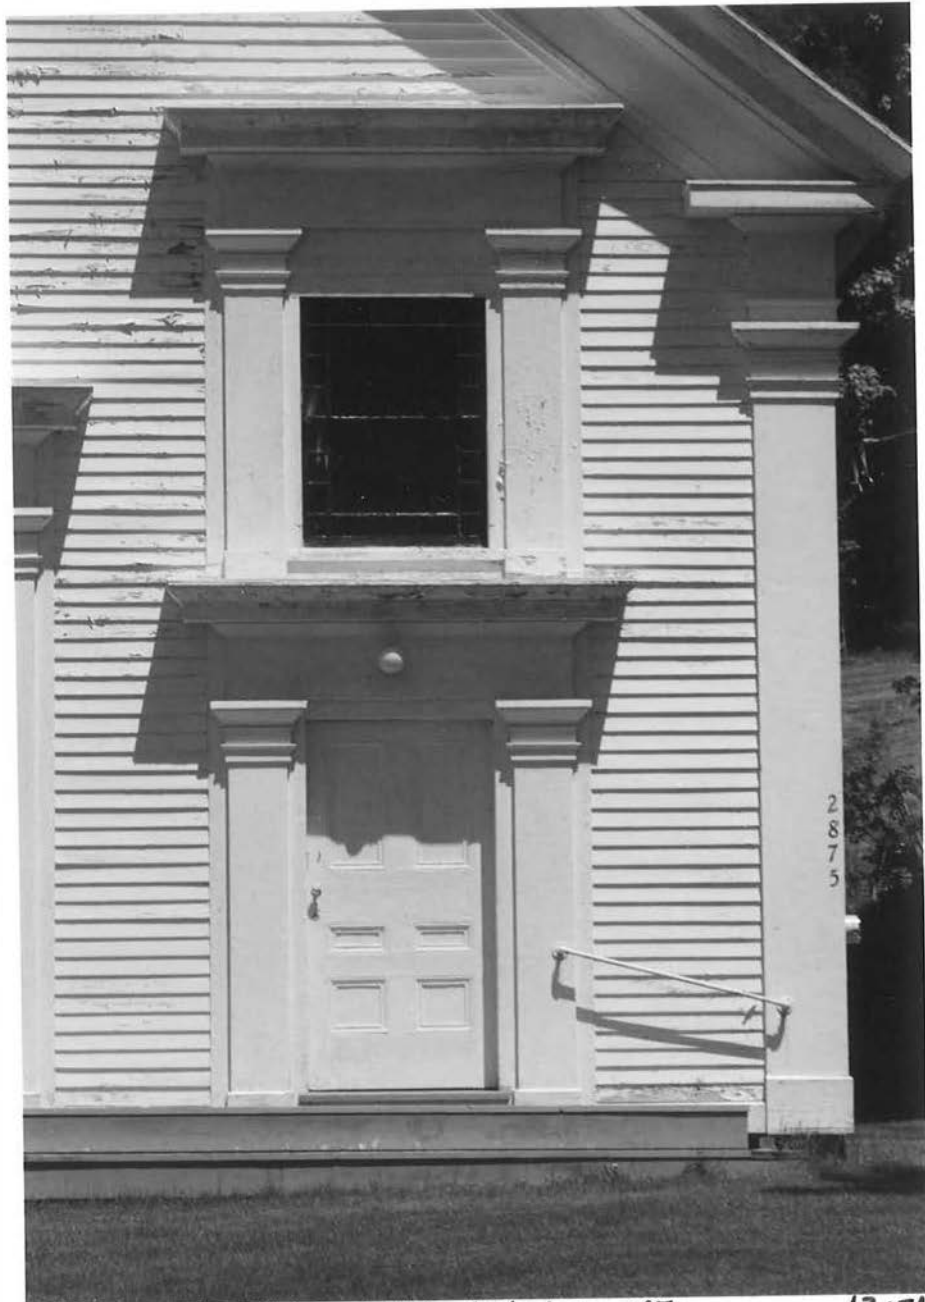
(30F15)

The exterior of the Meeting House is clapboarded, with a wood water-table providing the bottom course, and it has 17 1/2 inch wide, 2 inch thick wood corner pilasters and molding. At the west end facing Sennebec Road (Photograph 2.) there are two front doors, in the old New England Protestant tradition; one at either side of the front, with a large central art glass double window which rises up through the ceiling of the front vestibule and ends above the floor of the balcony. The entry doors and the doors from vestibule to the auditorium are apparently made for the building, and are of a unique 6-panel Georgian-influenced design that places two rails close together near the latch mechanisms. (Photograph 3.)
