National Register of Historic Places Registration Form

Historic name: Ohio Finance Building
Other names/site number: Peters Power Building, Crumrine Building, 43 W. Long St.
Name of related multiple property listing:
N/A
(Enter "N/A" if property is not part of a multiple property listing)

Street & number: 39-47 W. Long Street
City or town: Columbus State: Ohio County: Franklin
Not For Publication: N/A Vicinity: N/A

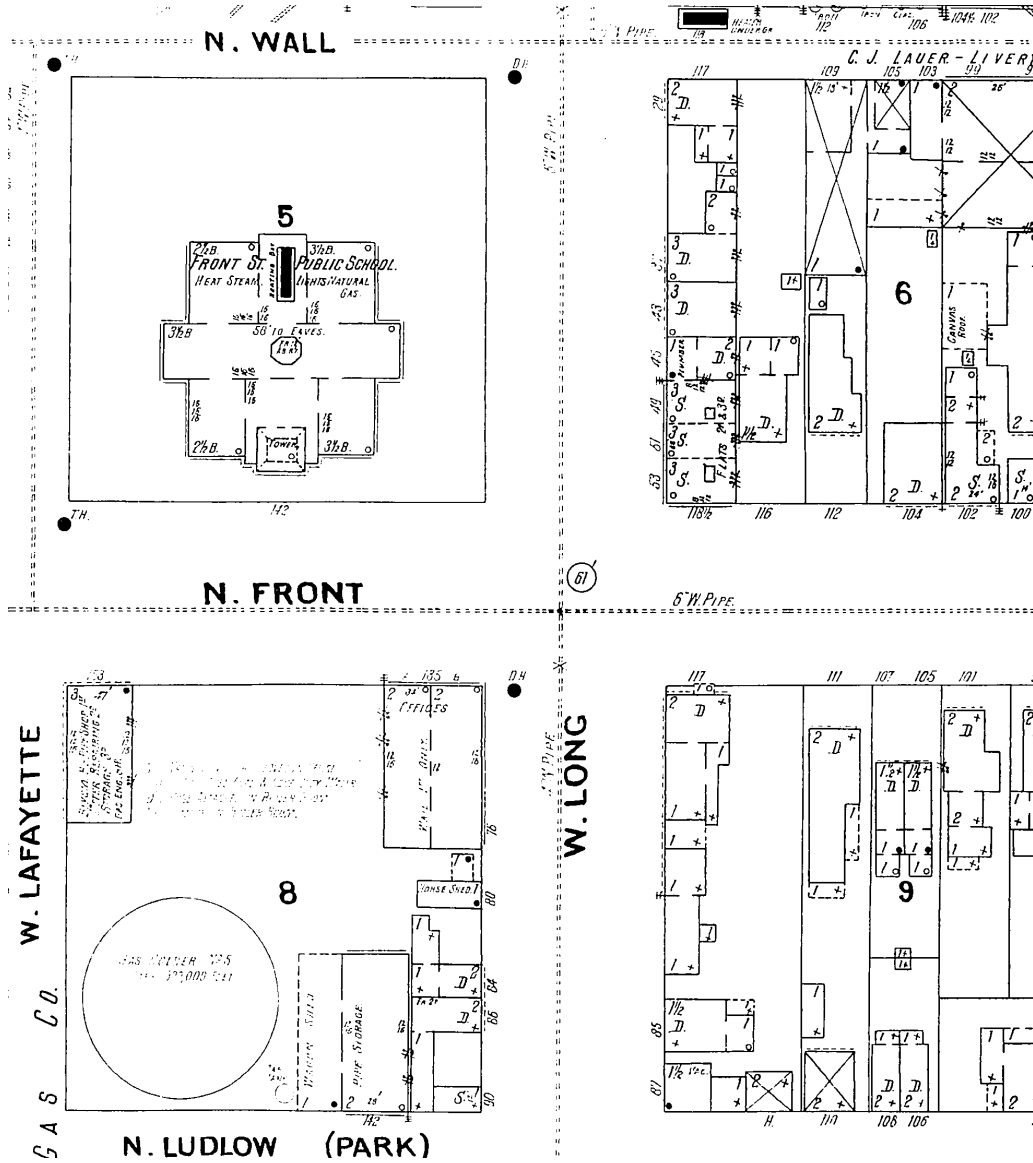
Figure 2: Detail of 1901 Sanborn Fire Insurance Map, Columbus, Ohio, Volume 1 Sheet 20.
Columbus Metropolitan Library

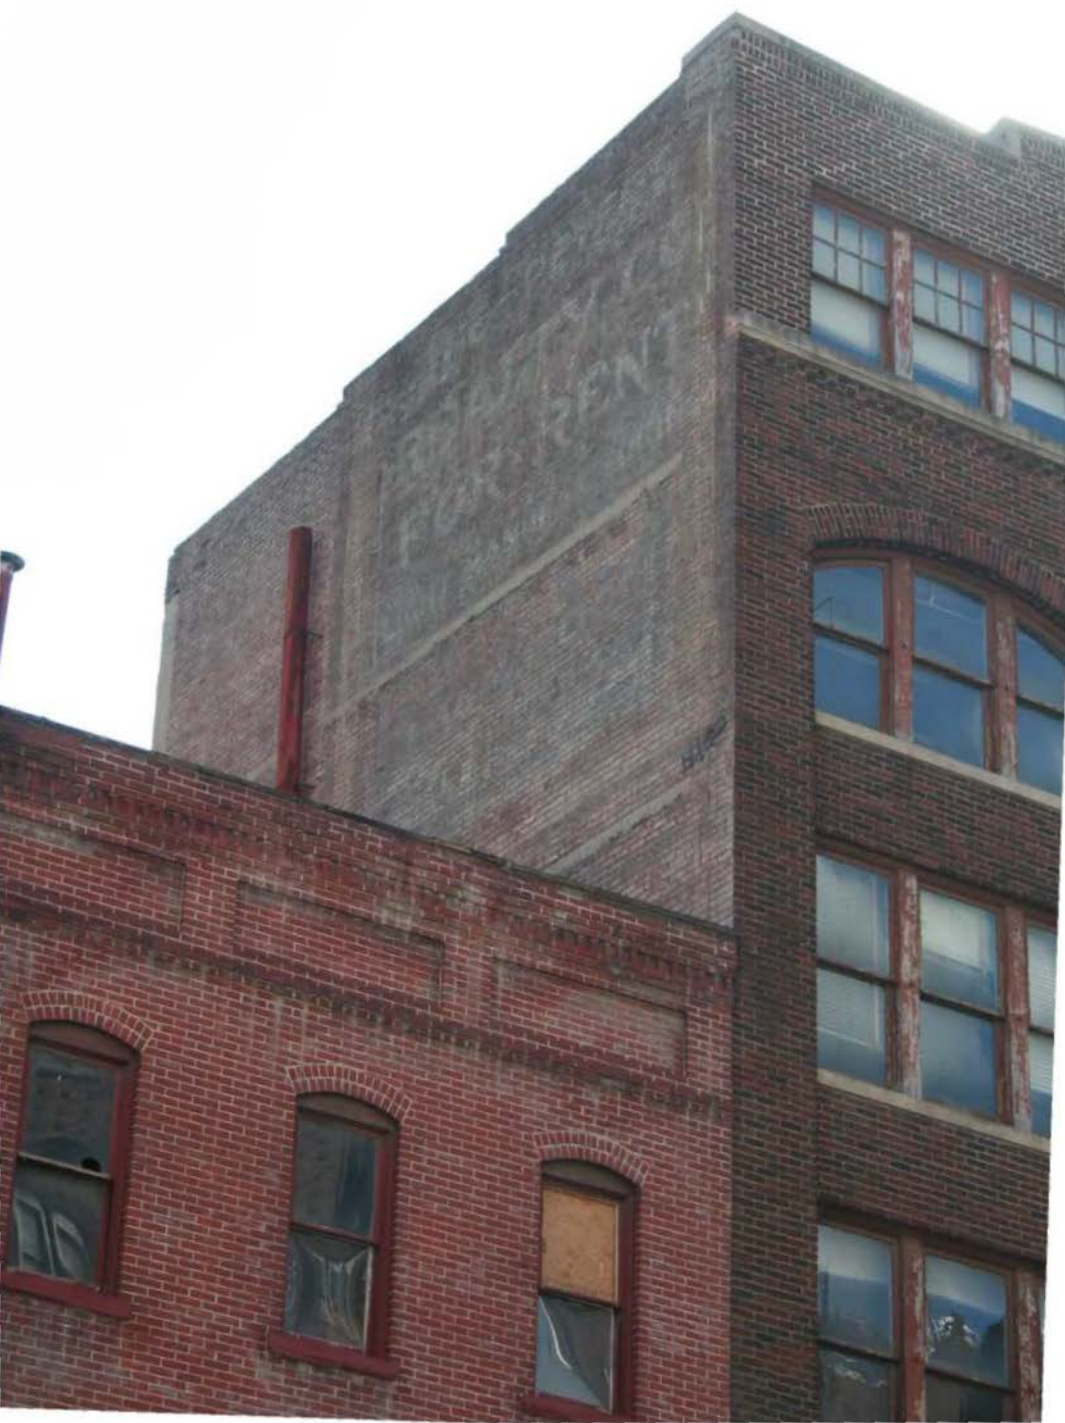
Photo #3 (OH_ FranklinCounty_OhioFinance_0003)

East elevation, upper level, camera facing southwest

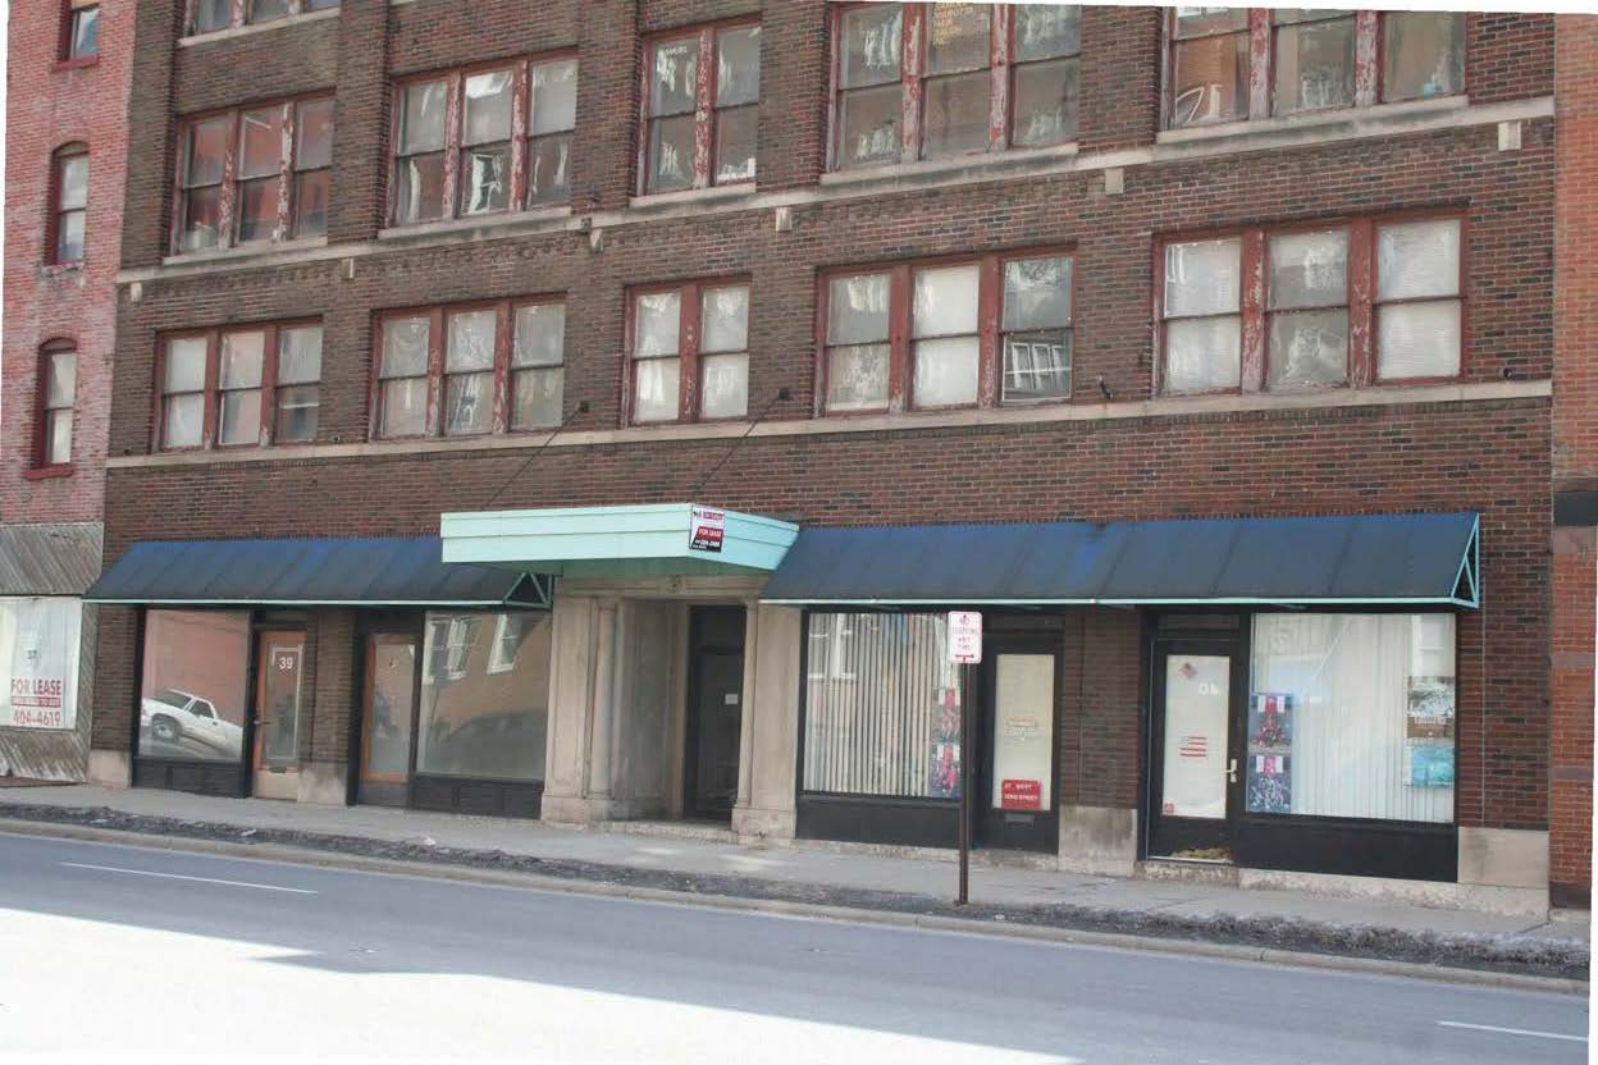
Photo #4 (OH_ FranklinCounty_OhioFinance_0004)

Southwest oblique, camera facing northeast

The west elevation rises four stories above the adjacent 3-story building (Photo 4). Modern lighting fixtures on the fourth level illuminate a modern billboard that stretches from the bottom of the fifth floor to the top of the seventh. A stepped parapet parallels the roof slope from the front of the building to the rear. The east elevation rises three stories above the adjacent 4-story building (Photo 3). Concrete floor slabs are visible on the exterior at the sixth and seventh level. A historic painted advertisement reading 'The Peters / Realty Co. / For Rent / Light Manufacturing' dates to c.1915. The outline of the painted signage rises from the bottom of the sixth level to the top of the seventh. A stepped parapet matches the one described on the west elevation above.

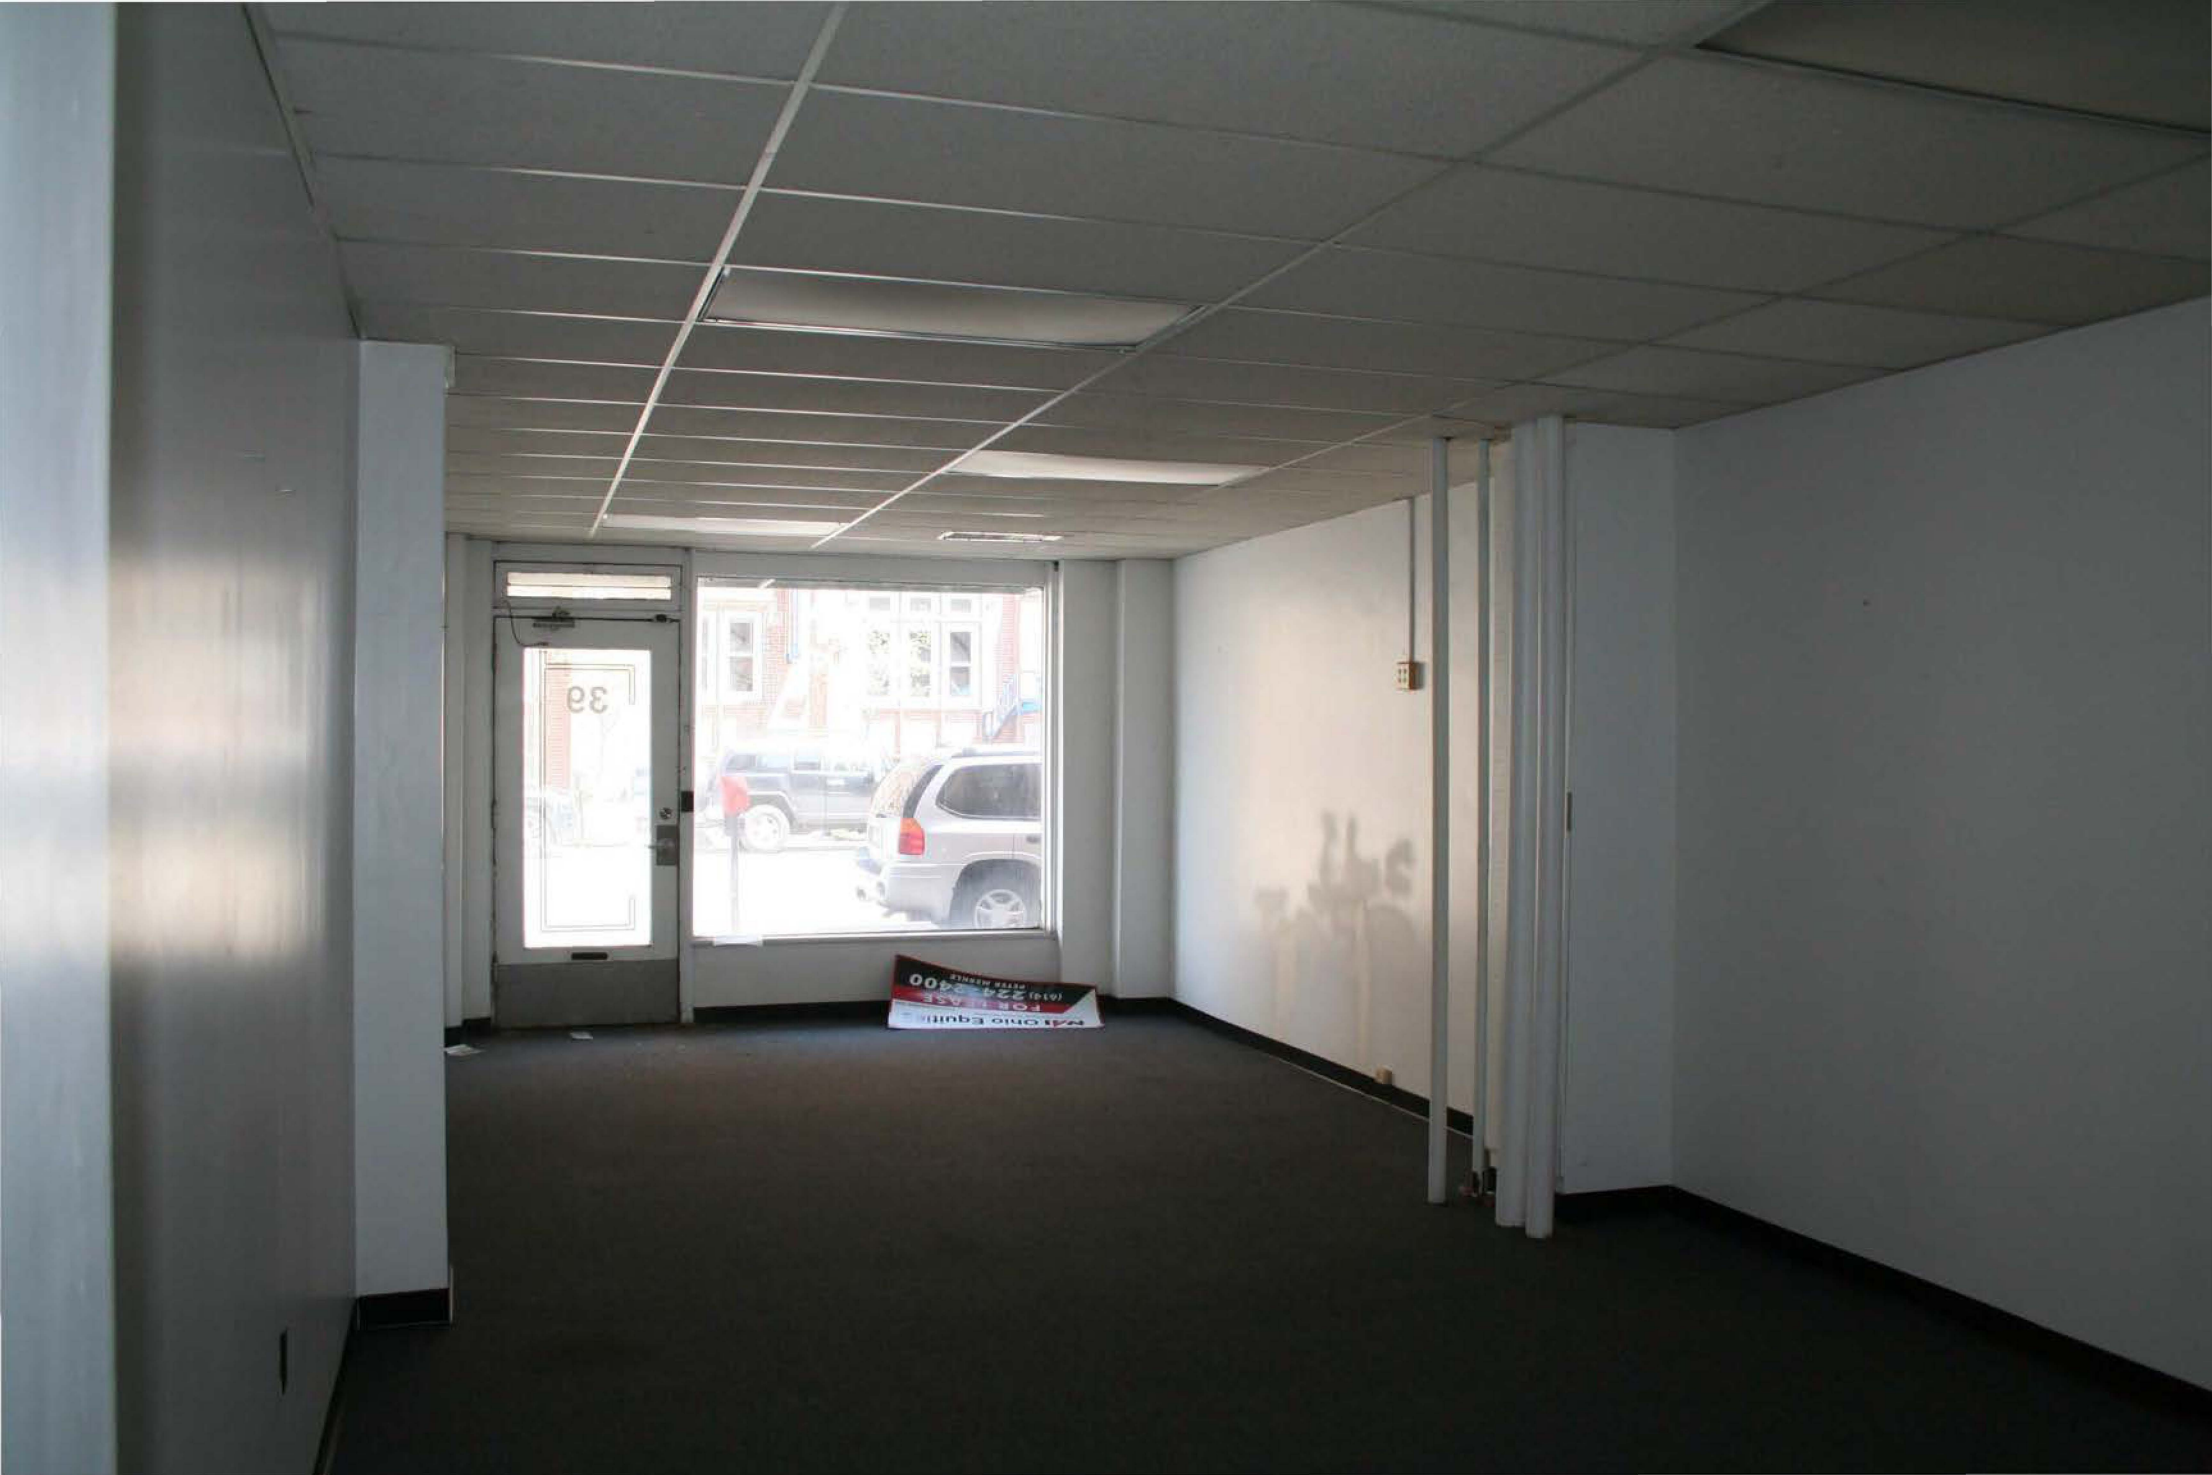
Photo #5 (OH_ FranklinCounty_OhioFinance_0005)

North façade, storefront detail, camera facing southeast

The primary north façade of the Ohio Finance Building consists of textured red brick with simple stone details. Defined by five bays, the base of the building is two stories in height, with four bays of original storefronts flanking a recessed central entry (Photo 2). Decorative stone surrounds the entry with two Doric columns carved in relief at the corners of the entry opening. Each storefront consists of a wood bulkhead, one large undivided plate glass window, and a one full-light door with narrow transom. Three of the four storefronts retain decorative prism glass transom that span the window and entry (Photo 5). The storefronts are divided by a brick pilaster that terminates at a stone base. Two non-historic awnings span each half of storefronts on either side of the entry. A non-historic suspended awning covers the main building entry. The second level begins the typical fenestration pattern of the façade. A typical unit consists of three 1/1 double-hung wood windows, with the exception of the central bay above the entry which consists of two 1/1 double-hung wood windows. A continuous sill stretches across the entire façade under the second level windows. The building base terminates at the top of the second story, defined by a smooth and simple band of stone, corbelled brick dentils, and square stone blocks at each column line between bays.

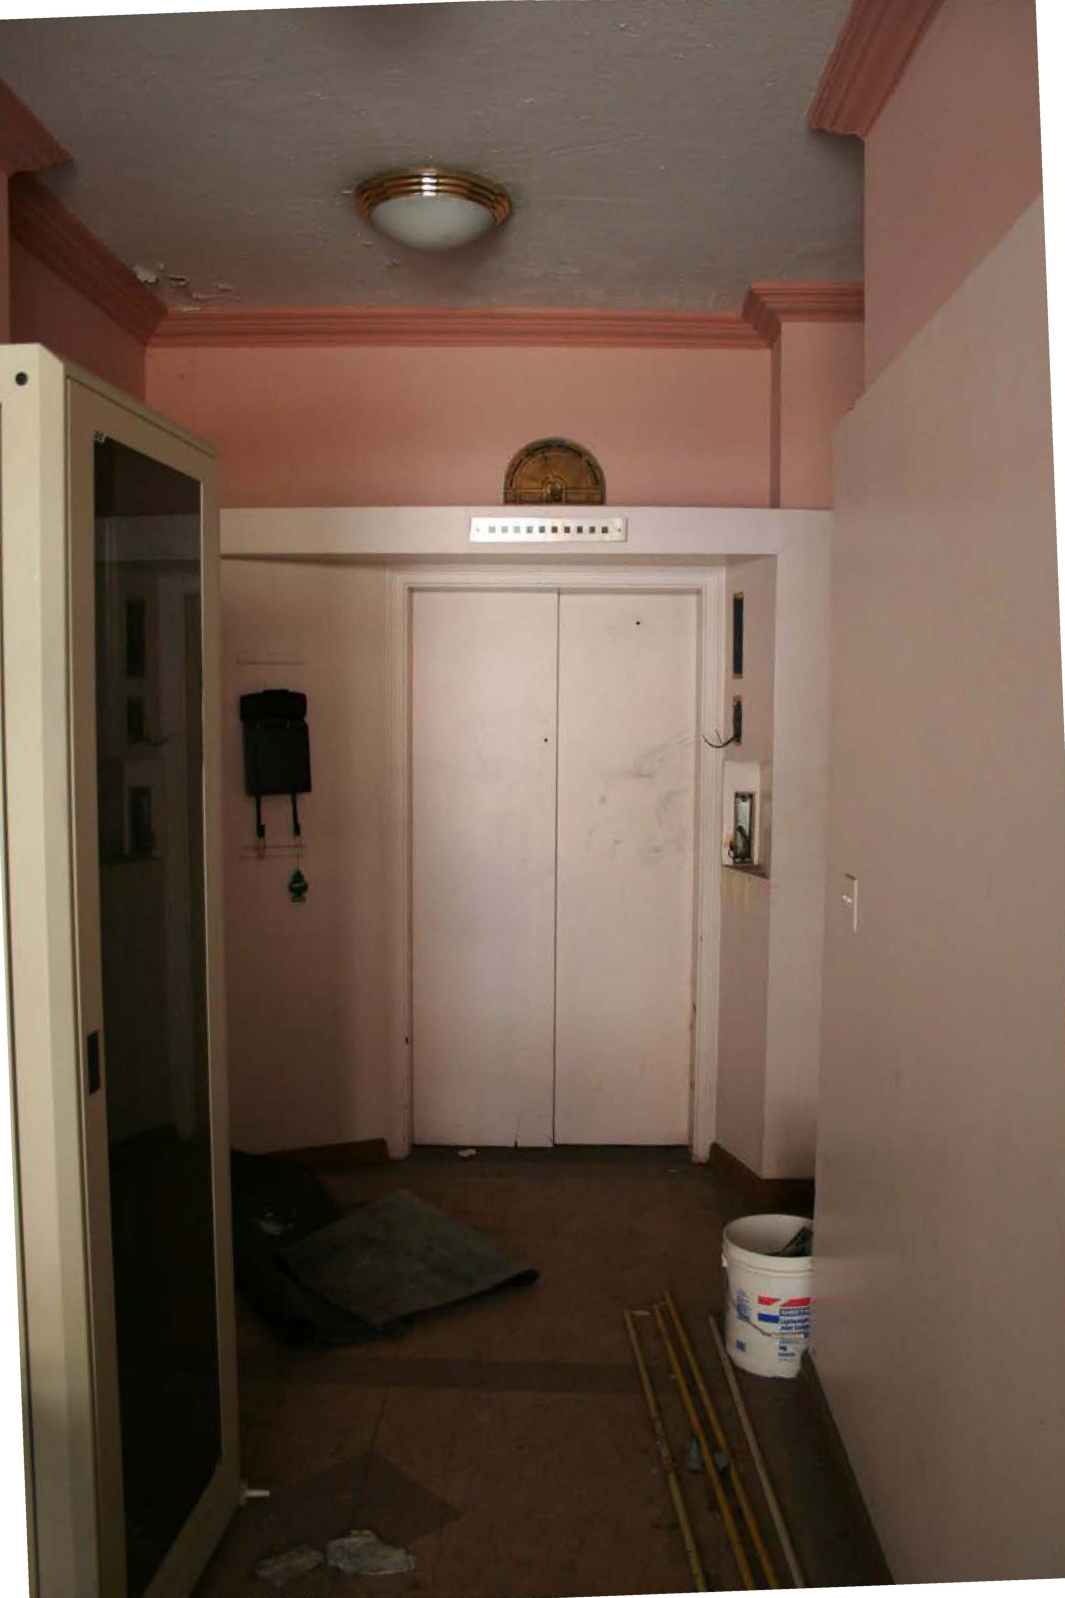
Photo #6 (OH_ FranklinCounty_OhioFinance_0006)

First floor, typical storefront interior, camera facing north

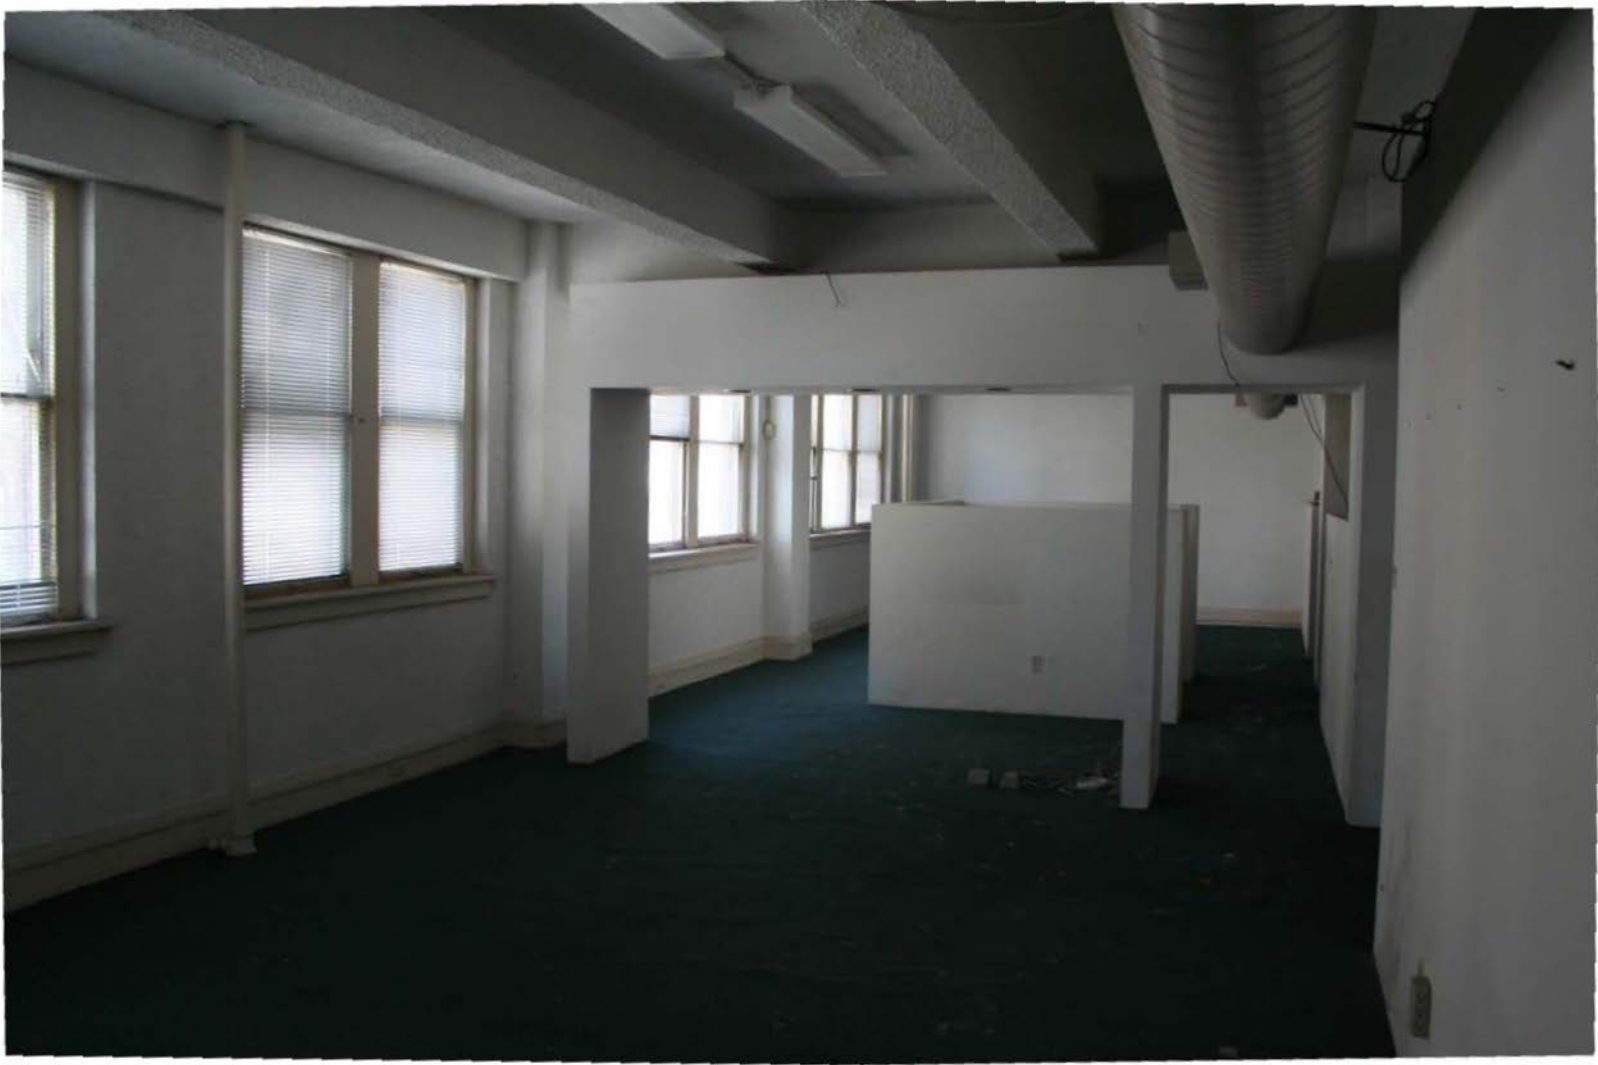
Photo #7 (OH_ FranklinCounty_OhioFinance_0007)

First floor, entry detail, camera facing south

Upon entering through the recessed central entry, a short hall with terrazzo flooring and crown molding ends at the historic elevator, installed at an unknown date (Photo 7). The adjacent stairwell to the west of the elevator includes historic painted concrete stairs with metal railings, establishing a central circulation core at the rear of the building (Photo 9). Two store fronts flank the central hall, each defined by one original plate-glass window with an adjacent door. The narrow commercial spaces extend to the rear of the 1925 addition, defined by non-historic partitions and dropped ceilings (Photo 6). A small hall connects both units at the rear of the building. The two storefronts on the west side of the building's central entry are currently occupied, but retain a similar configuration as described above.

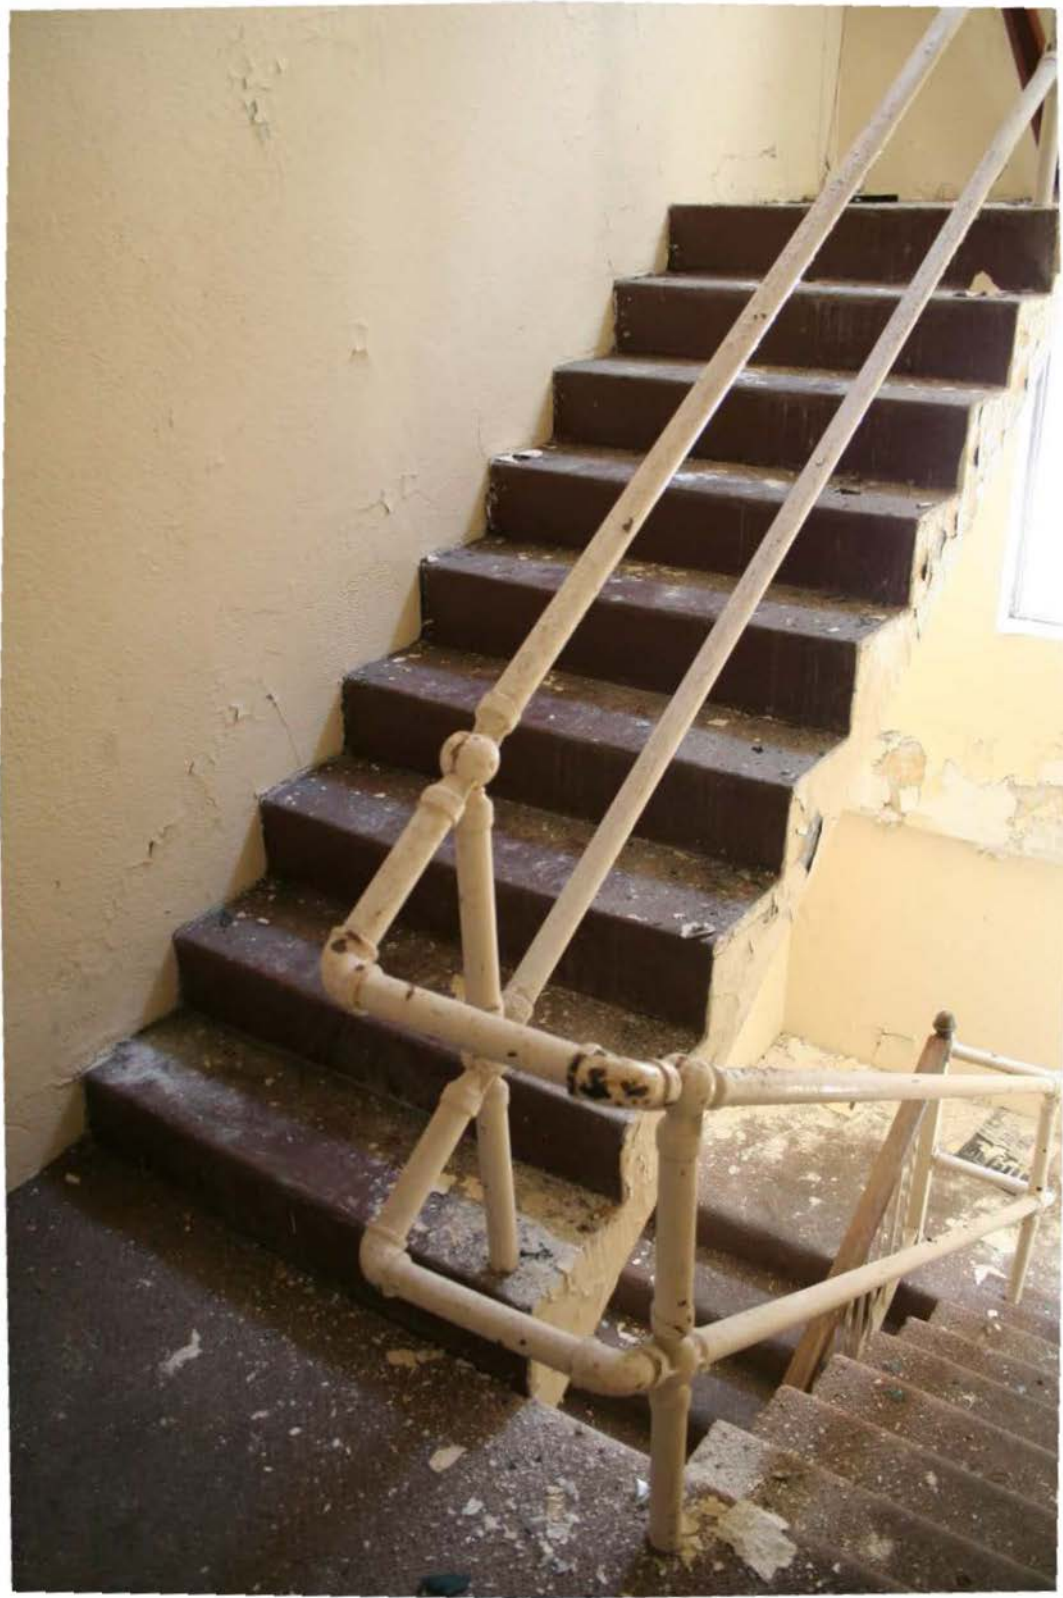
Photo #8 (OH_ FranklinCounty_OhioFinance_0008)

Second floor, office interior, camera facing east

The floors above the storefronts each reflect a distinct period of use, ranging from historic office use to contemporary mixed-use. The second floor has been built out for modern office use with non-historic partitions, carpeting, lighting, boxed columns, and a modern HVAC system (Photo 8). A light well at the rear of the building contains original 1/1 wood double-hung windows, although the opening has previously been roofed over at an unknown date. The third floor consists of two units; one of which was used as a salon in the 1990s and has been tailored with contemporary wood flooring, drywall partitions, and modern light fixtures (Photo 10). Exposed concrete ceilings and beams, reflecting the building's original industrial use, remain throughout in addition to original windows. The second unit on this floor has been configured as a two bedroom residential unit, with non-historic partitions and plumbing. The fourth through seventh

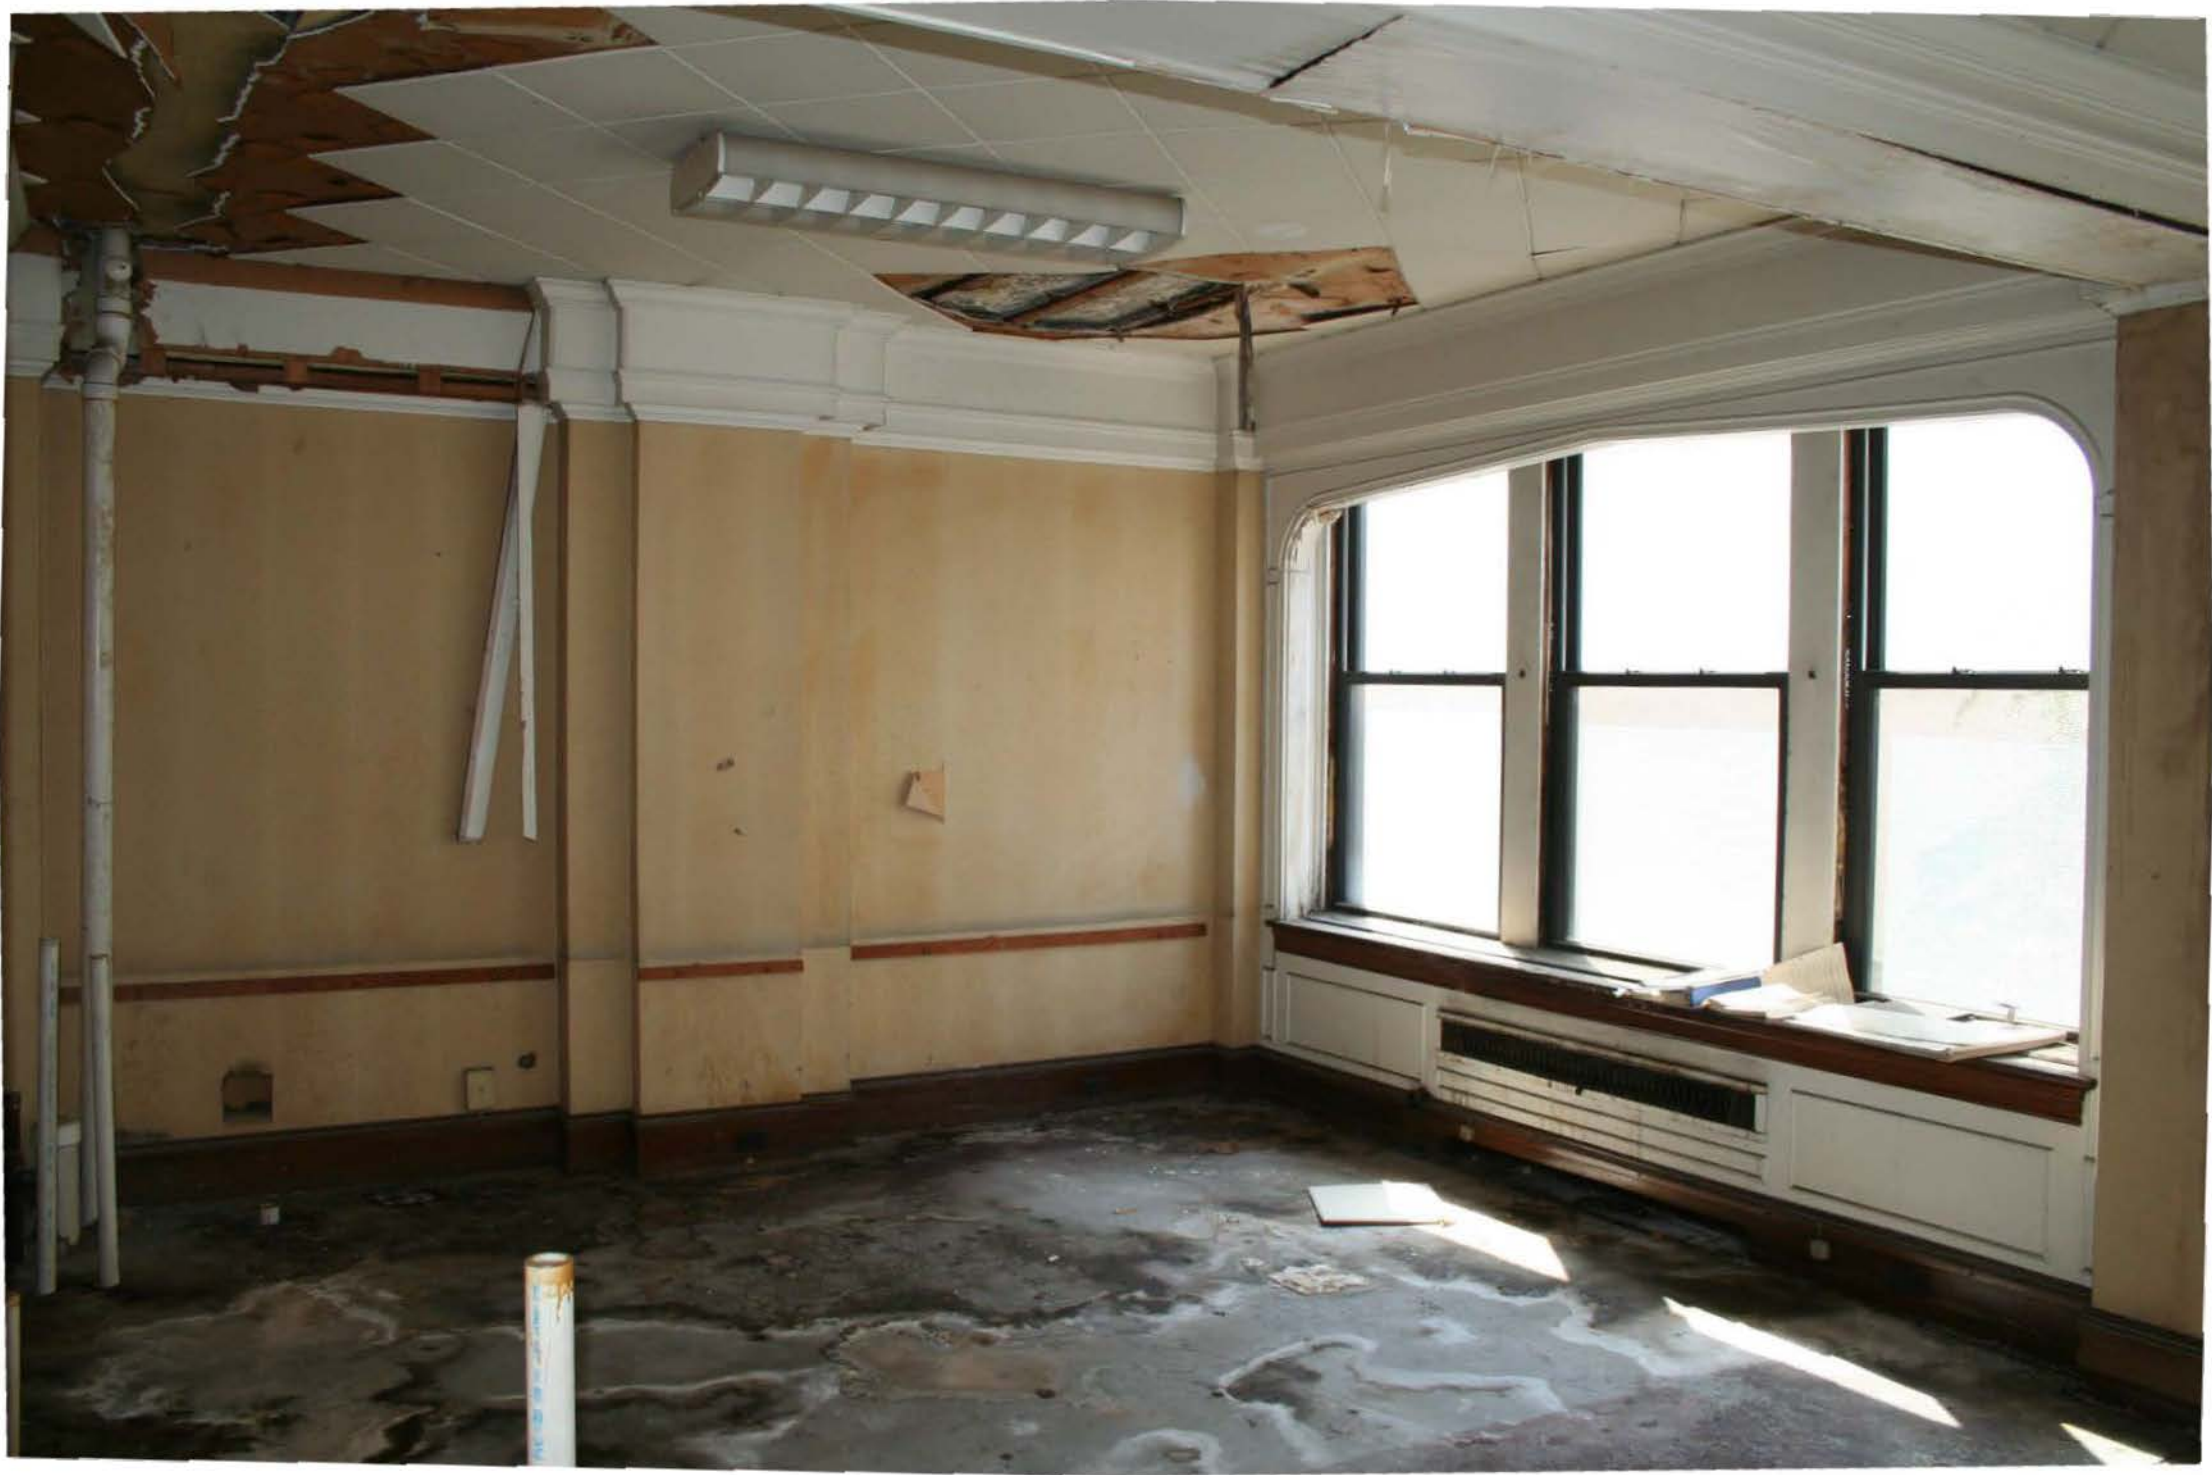
Photo #10 (OH_ FranklinCounty_OhioFinance_0010)

Third floor, residential interior, camera direction east

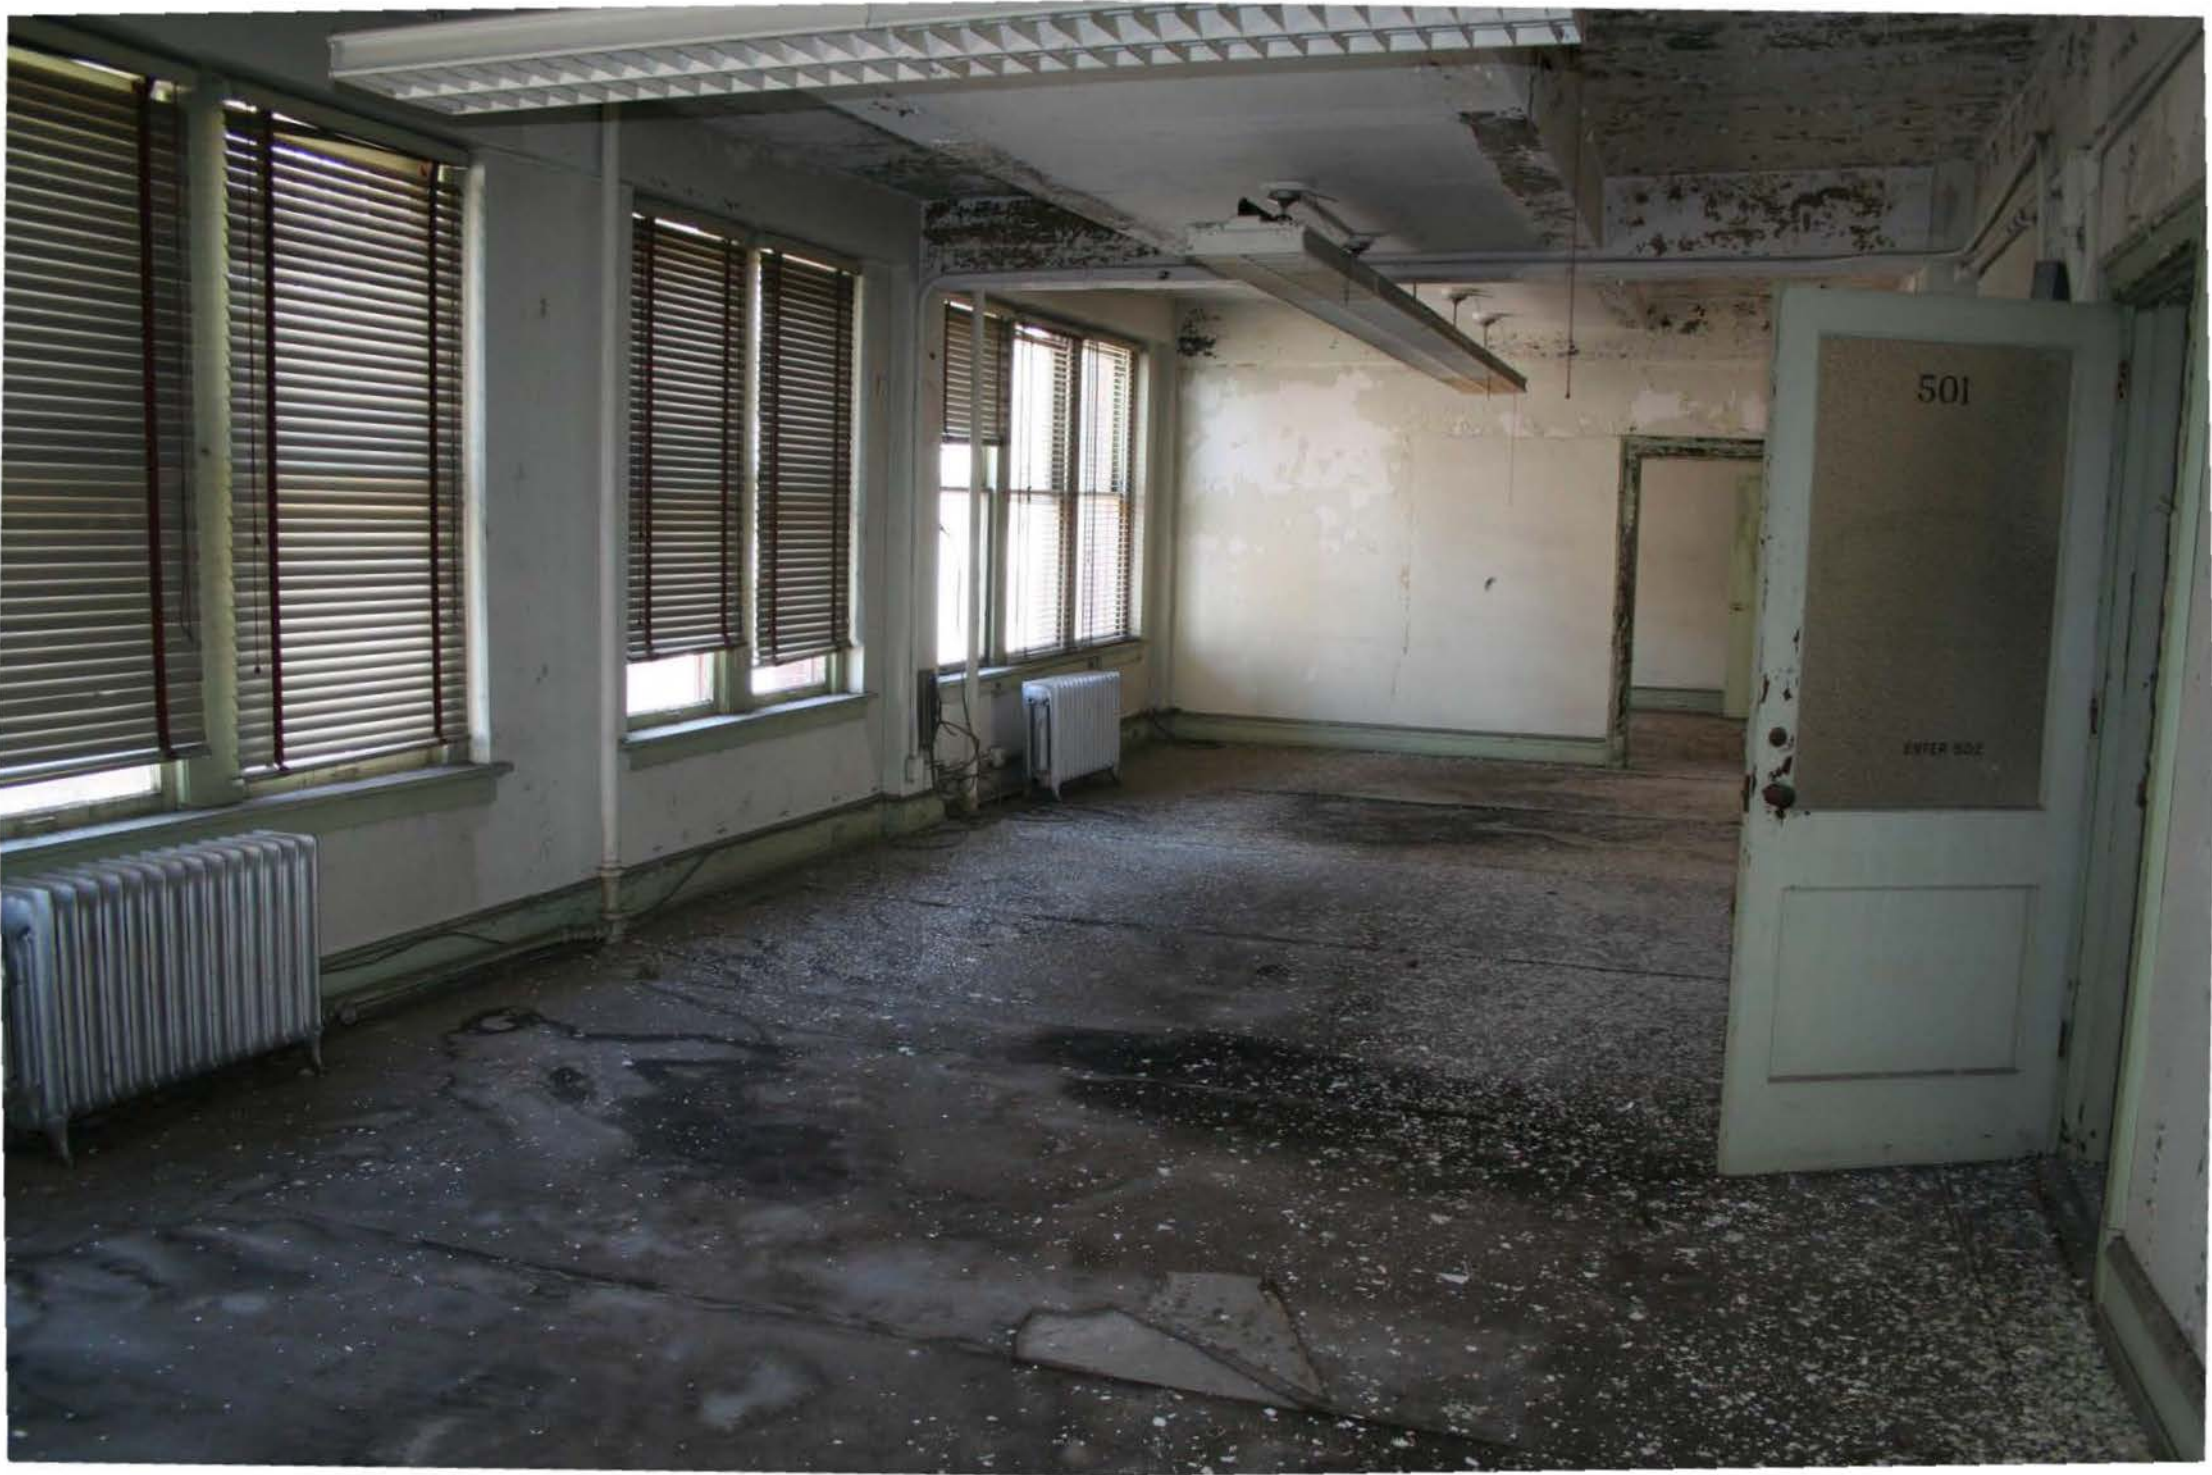
Photo #11 (OH_ FranklinCounty_OhioFinance_0011)

Fourth floor, office interior, camera direction northwest

floor all have a restroom in the central core off the stairwell, typical of the original building configuration. The fourth floor reflects occupancy in the 1950s as office space (Photo 11). A terrazzo floor, wood trim, and crown molding define the stairwell at this level. A solid wood door opens to the elevator lobby, with matching wood trim and paneled ceiling typical of the entire floor. The windows were boxed out to form a wide pointed arch with a decorative radiator grill beneath the sill. Crown molding, baseboards, decorative trim, and paneled ceilings dating to the 1950s remain throughout the partitioned offices of the fourth floor.
