National Register of Historic Places Registration Form

Historic name: Ohio Finance Building
Other names/site number: Peters Power Building, Crumrine Building, 43 W. Long St.
Name of related multiple property listing:
N/A
(Enter "N/A" if property is not part of a multiple property listing)

Street & number: 39-47 W. Long Street
City or town: Columbus State: Ohio County: Franklin
Not For Publication: N/A Vicinity: N/A

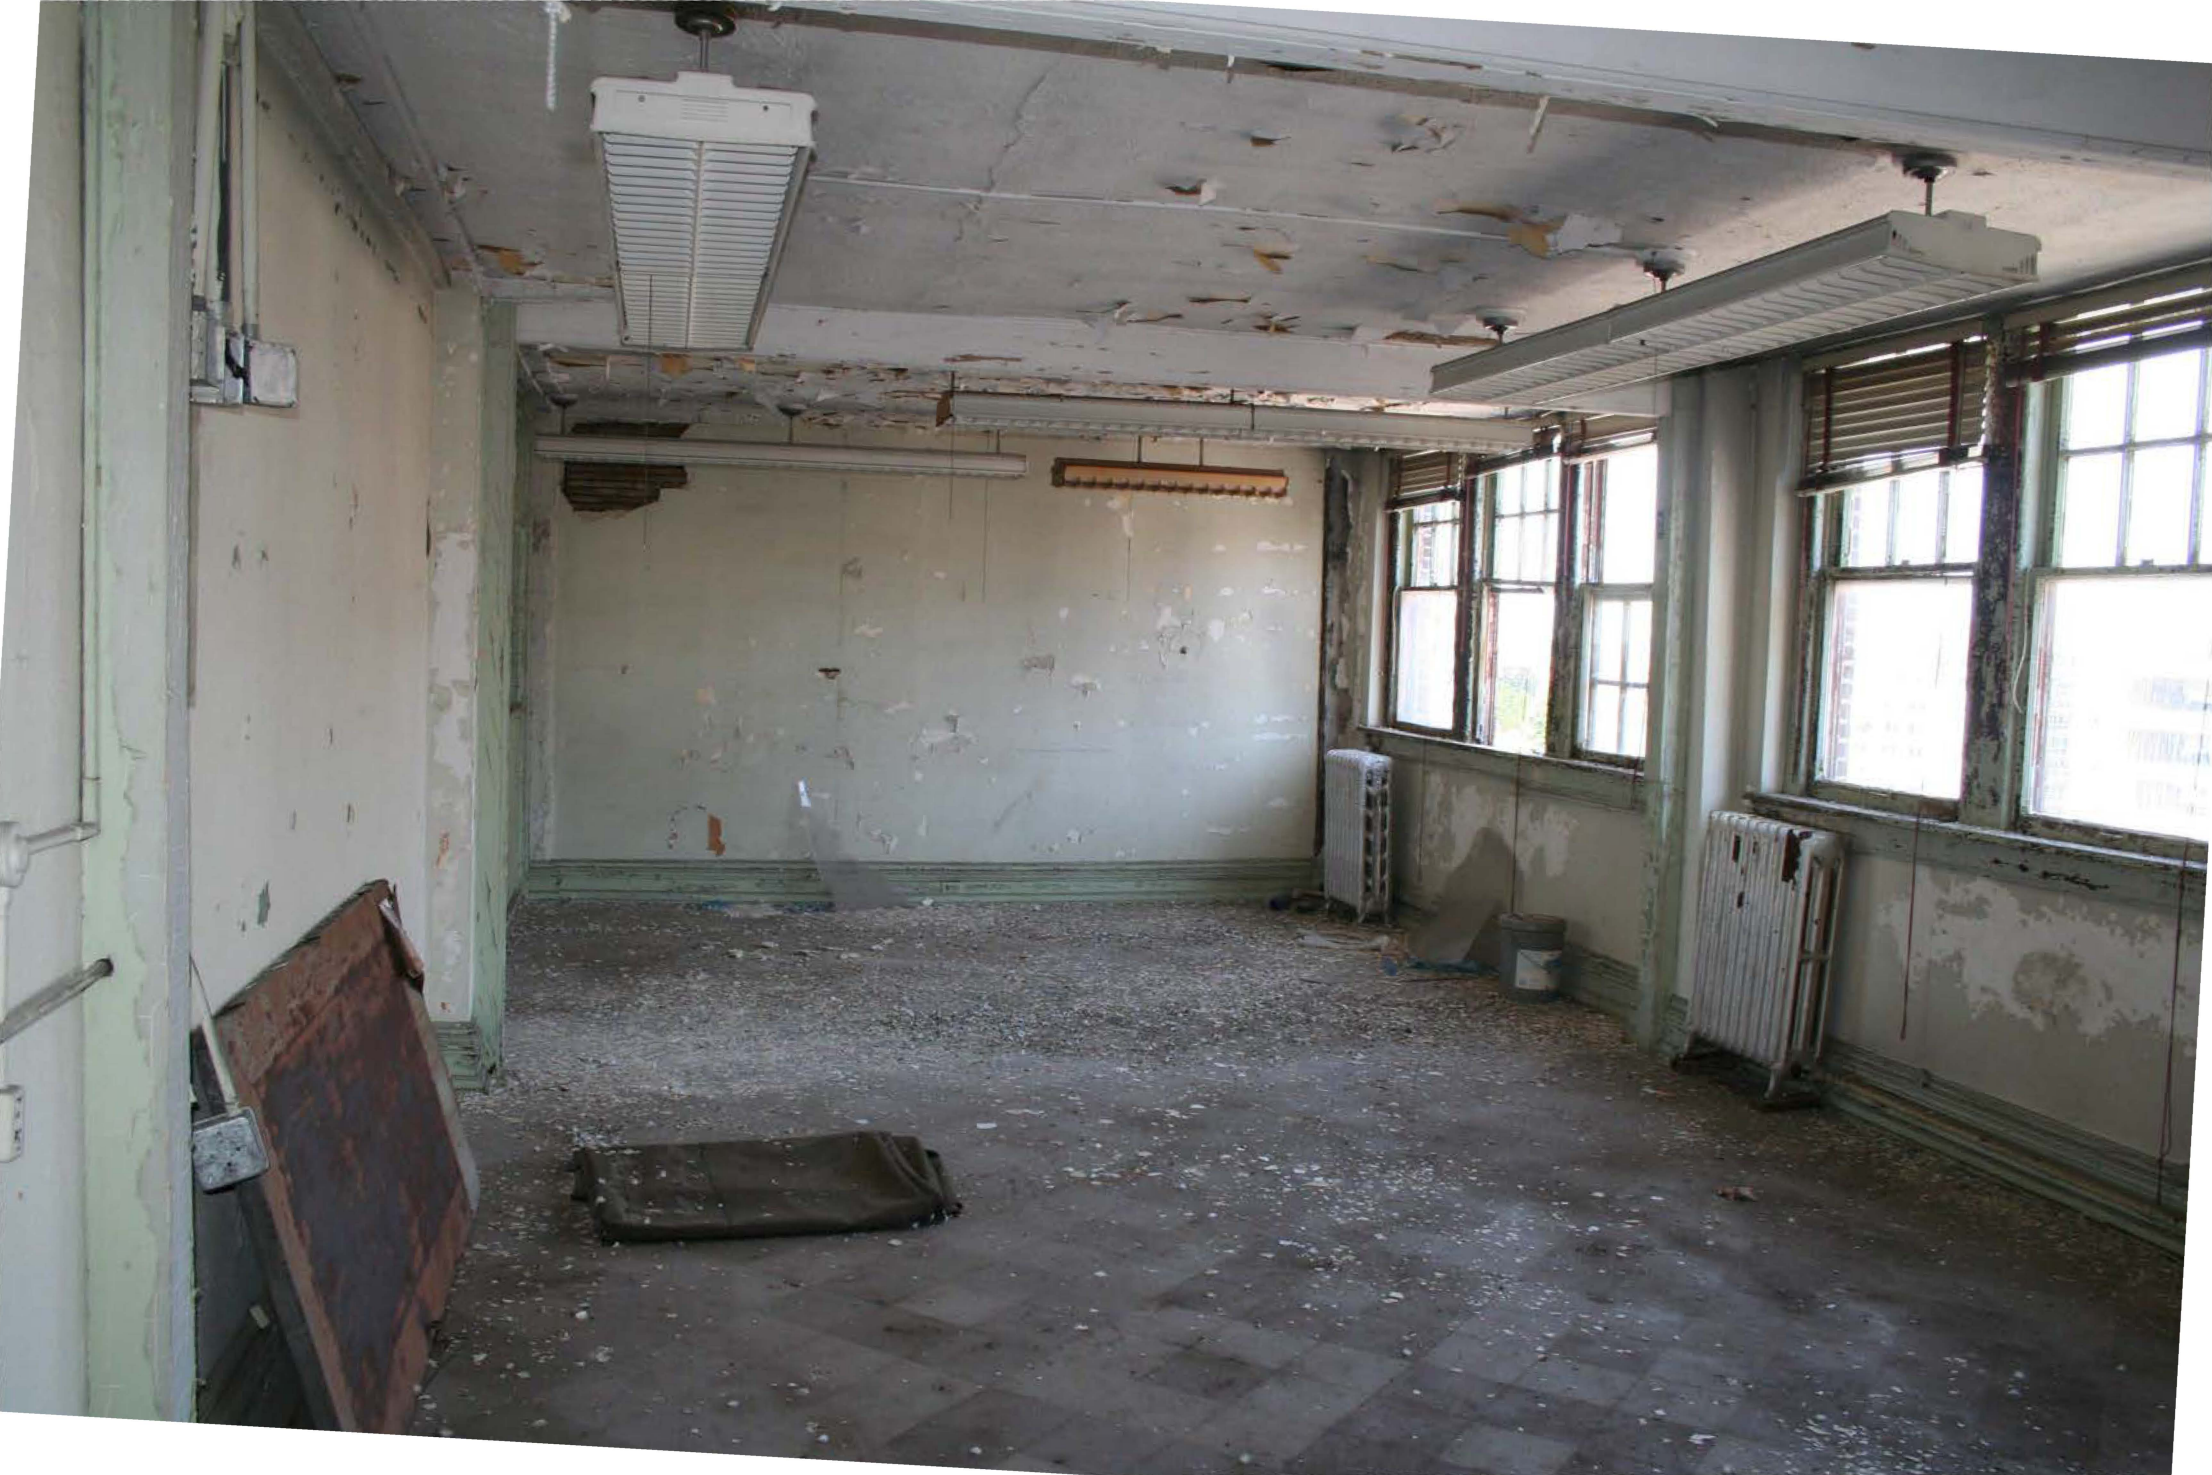
Photo #12 (OH_ FranklinCounty_OhioFinance_0012)

Fifth floor, typical office interior of 5th and 6th floors, camera direction east

The fifth floor maintains the original office characteristics of the Ohio Finance era when the company assumed occupancy in 1925 (Photo 12). The stairs lead to an open corridor in the east-west orientation with the adjacent elevator. Half-light doors with patterned glass open to partitioned office spaces that vary in size. The majority of the larger offices are undivided open space, while smaller enclosed spaces delineate the corners of the building. Historic baseboards, window trim, and plaster walls on wire lathe remain through the floor and are typical of the fifth and sixth floors in the building. The original flat ceilings with expressed concrete beams have been covered by panels measuring approximately 12"x 24". Uncovered radiators remain throughout the office spaces. While the sixth floor consists of the typical characteristics described above, the hall doors include operable transoms with matching patterned glass. The original windows on the north elevation are defined by the rounded arch top spanning all window units of each bay. A ladder extends from the switch-back landing between the sixth and seventh floor, providing access to the roof. The seventh floor has a solid door separating the stair from the elevator and office space (Photo 13). This large undivided space spans the majority of the building's width, with a small enclosed room at the east end. Boxed columns, baseboards, radiators, patterned tile, and a flat concrete ceiling define the top level. The basement consists of storage rooms of concrete walls, floors, and slabs above. The large boiler is housed in the east half of the building. All floors have evidence of extensive water damage on the rear exterior wall. The original wood windows on the south elevation on floors three through seven were all replaced with vinyl units in the mid-1980s. Despite efforts to address water infiltration, the interior of the south elevation walls are primarily exposed brick as all plaster has been lost. The north façade maintains all original double-hung wood windows. Minor patches of plaster delamination are consistent throughout the building.
