National Register of Historic Places Inventory—Nomination Form

1. Name)			
historic Bank o	f Commerce			7000
and/or common				
2. Locat	ion			L. J. J. Black
street & number	200 North Washing	gton St.	Ŋ	∕A not for publication
city, town E] Do	rado	N/A_ vicinity of	congressional district	4th
state Arkansas	code	05 county	Union	code 139

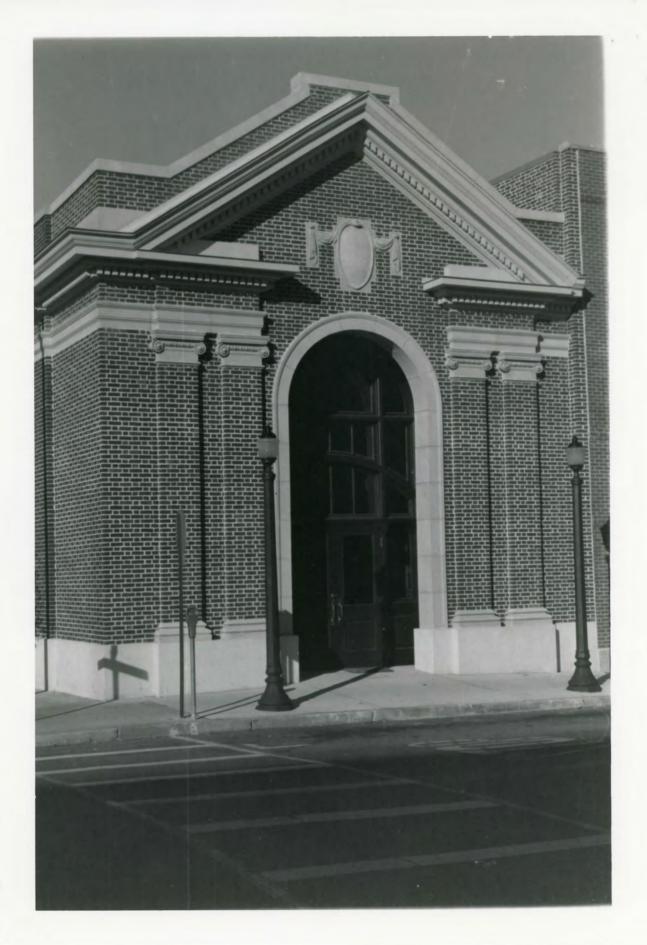
Bank of Commerce El Dorado, Arkansas Richard Mason, Photographer September, 1981 Negative at Arkansas Historic Preservation Principal (east) elevation Number 1 of 6

The principal (east) facade of the Bank of Commerce building clearly conveys the monumental potential of the Classical styles. This entry facade is eminently articulated with a temple front that reflects the impact of early twentieth-century Neo-Classicism and Renaissance Revivalism alike. Two prominent features create this impression and thus dominate the elevation: a projecting metal triangular pediment with broken base and a two-story Roman-arched entrance. Formed by a cornice-like projection, the pediment protrudes from the gabled parapet with truncated peak which rises slightly above it and spans almost the full width of the elevation. This distinctive feature is enriched by dentiling and a cartouche that appears in its tympanum on the central axis of the facade. The pediment base breaks to frame this cartouche. Although the base resembles gableend returns, it is actually created by an entablature that wraps around the building, extending the full length of the south (side) elevation, and serves to organize and unify the building's two exposed elevations. This entablature consists of a banded stone architrave, brick frieze and over hanging dentiled metal cornice. On the principal facade, the entablature is carried on two pairs of brick Ionic pilasters which flank the two-story tall Roman-arched entrance. Emphasized with a cast stone surround, the arch articulates and frames the bank's main entrance, a deeply recessed double-door arrangement. The doors are composed of single lights over panels and are framed by wood pilasters. They are further accented by sidelights over panels and are capped by double segmental multi-light transoms. Vertical and horizontal lights fill the remaining upper extremes of the archway.

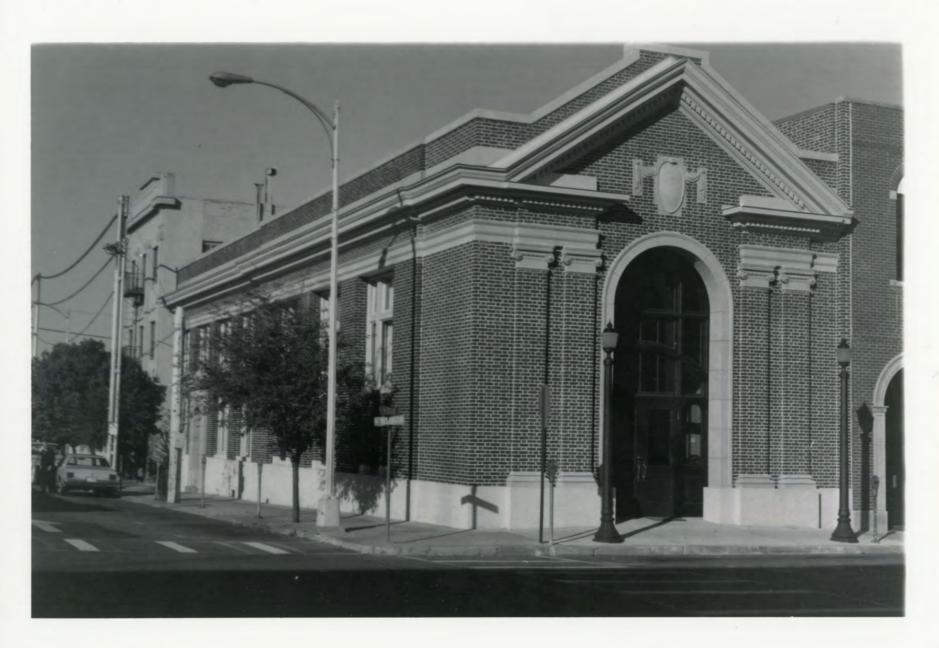
Bank of Commerce
El Dorado, Arkansas
Richard Mason, Photographer
September, 1981
Negative at Arkansas Historic Preservation
Program
East and south elevations taken from
southeast
Number 2 of 6

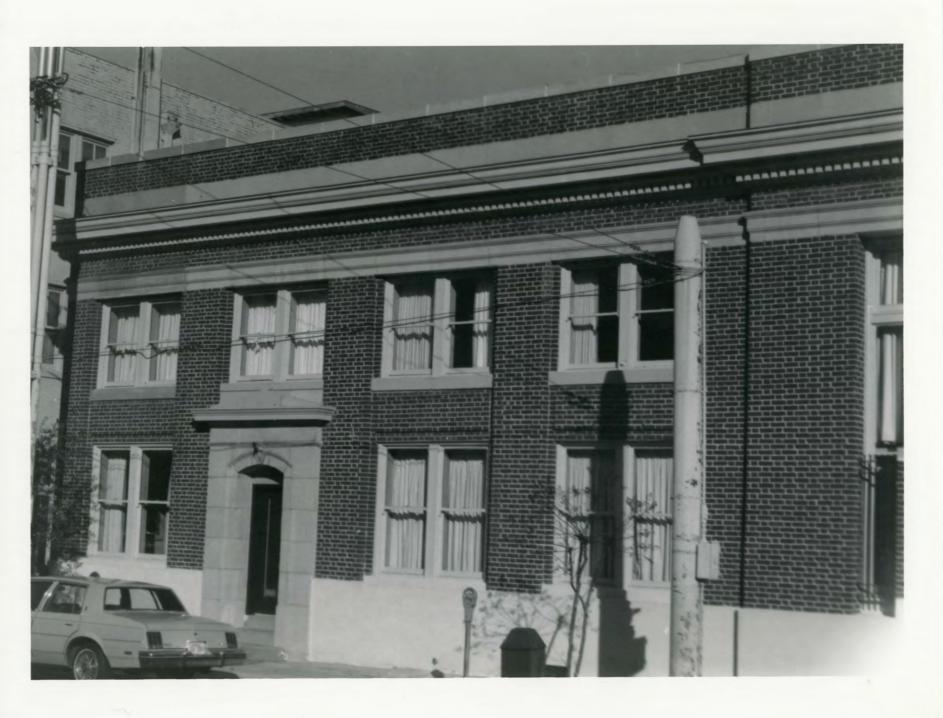
Bank of Commerce
El Dorado, Arkansas
Richard Mason, Photographer
September, 1981
Negative at Arkansas Historic Preservation
Program
South elevation showing side entrance
Number 3 of 6

The remaining bays of the south elevation reflect the interior design of the rear of the building which is comprised of two stories of office space. A secondary entrance to the building, providing direct access to the offices, is asymmetrically located in the second bay from the west end of the facade. Though not as monumental as the principal entrance, it is carefully and Classically detailed. This entrance is faced with ashlar blocks and capped with an unembellished frieze and an overhanging cornice that is surmounted by a small triangular pediment. The doorway is recessed in a segmental arched opening with articulated keystone and is raised above grade with three steps offering access. Fenestration of the rear section of the south elevation, like the east end, is dominated by the rhythm of recessed windows and brick pilasters. The first and second stories are pierced by pairs of double-hung one-over-one light windows in each bay. However, the second story windows are slightly shorter than those below and have articulated cast stone sills. Raised brick panels appear between the first and second story windows. The building's aforementioned full entablature greatly enriches this facade. The parapet rises above it to cap the elevation. The north and west walls of the Bank of Commerce abut adajacent buildings and therefore are not visible.

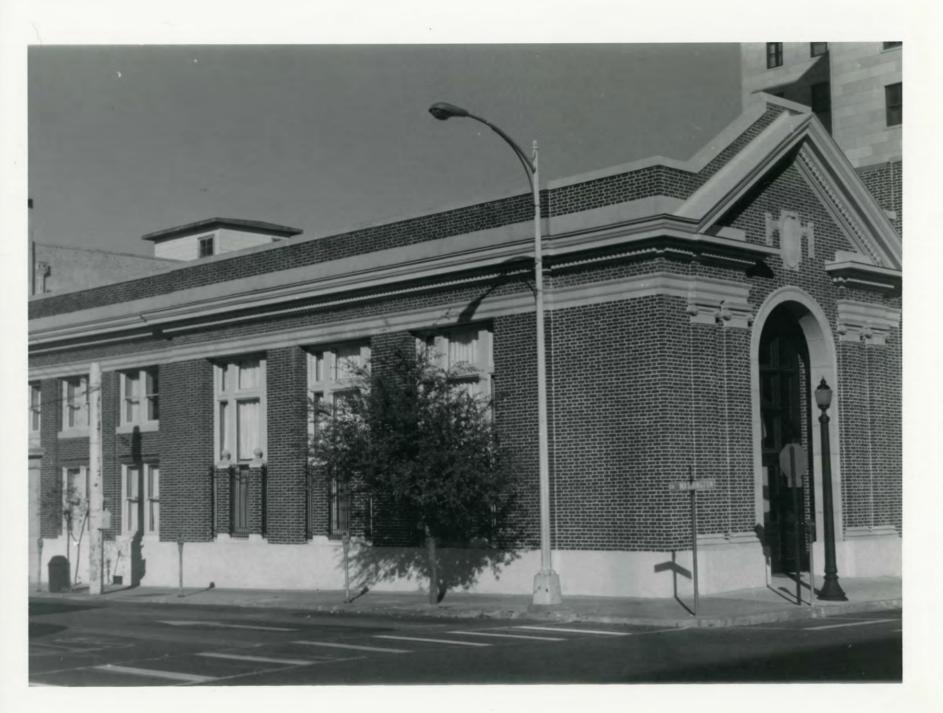
Bank of Commerce
El Dorado, Arkansas
Richard Mason, Photographer
September, 1981
Negative at Arkansas Historic Preservation
Program
South elevation
Number 4 of 6

The seven bay, secondary (south) elevation is visually divided into two sections which distinguish the public banking room from the supporting office space. The three east bays of this elevation project slightly to identify the banking room, a two-story high space. The configuration of this area is communicated by the fenestration of this section of the facade. Each one-over-one double-hung window is almost floor-to-ceiling in height, extending from the elevation's ashlar base to its architrave, and has sidelights and a three light transom. The windows are slightly recessed in the Flemish bond brick wall. Most interesting and unusual features of these windows are the pairs of low brick piers with cast stone bases and copings that appear in front of each window on axis with the window frame. These piers are capped with a cast stone sphere.

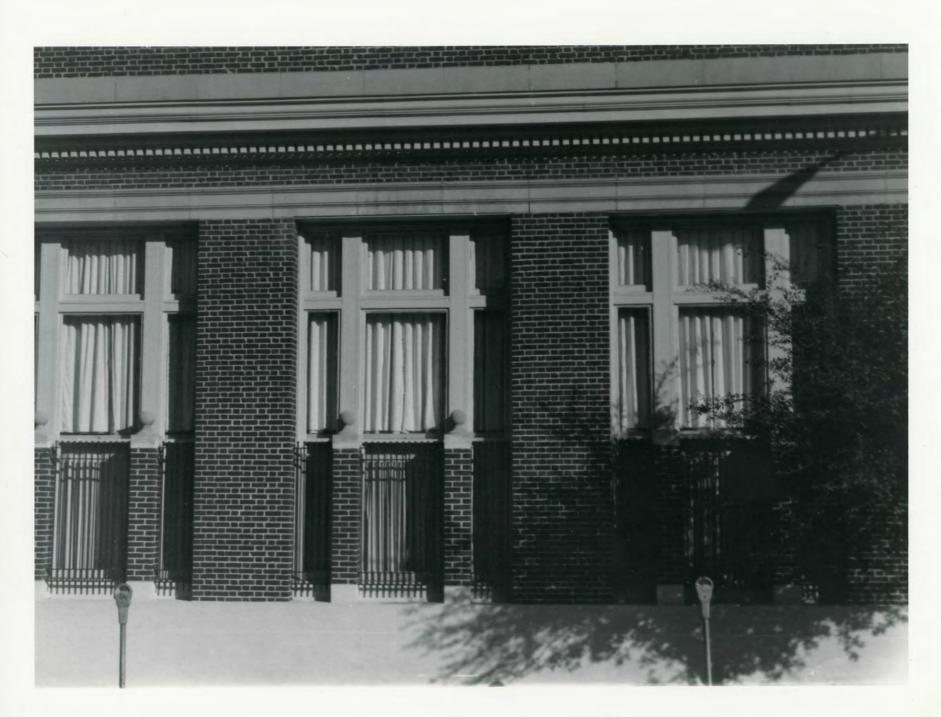
Bank of Commerce El Dorado, Arkansas Richard Mason, Photographer September, 1981 Negative at Arkansas Historic Preservation Program Detail: windows on south elevation Number 5 of 6

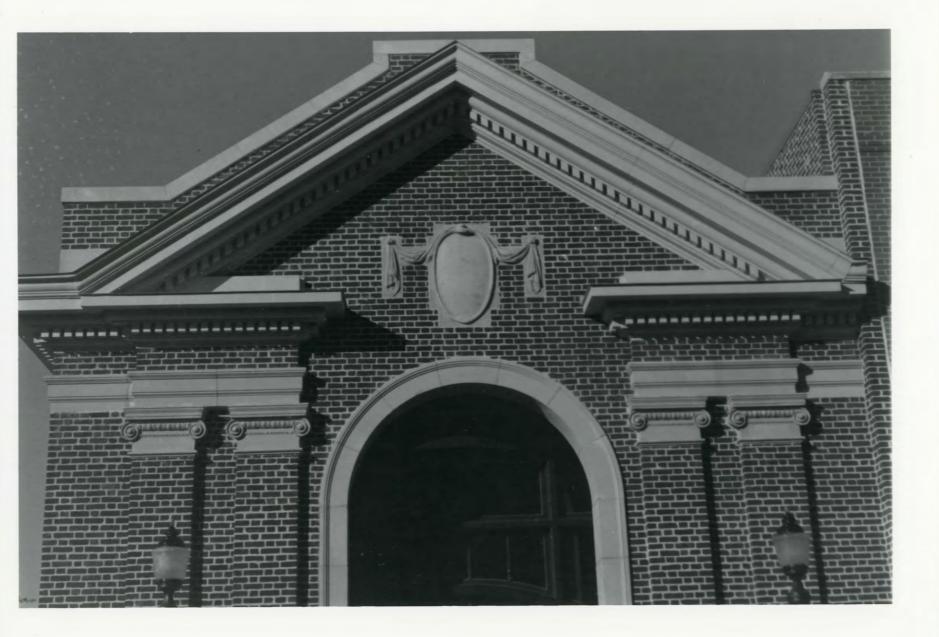
Bank of Commerce
El Dorado, Arkansas
Richard Mason, Photographer
September, 1981
Negative at Arkansas HIstoric Preservation
Program
Detail: entrance
Number 6 of 6
