BADGELEY HOUSE + SITE - *Union Co., New Jersey*

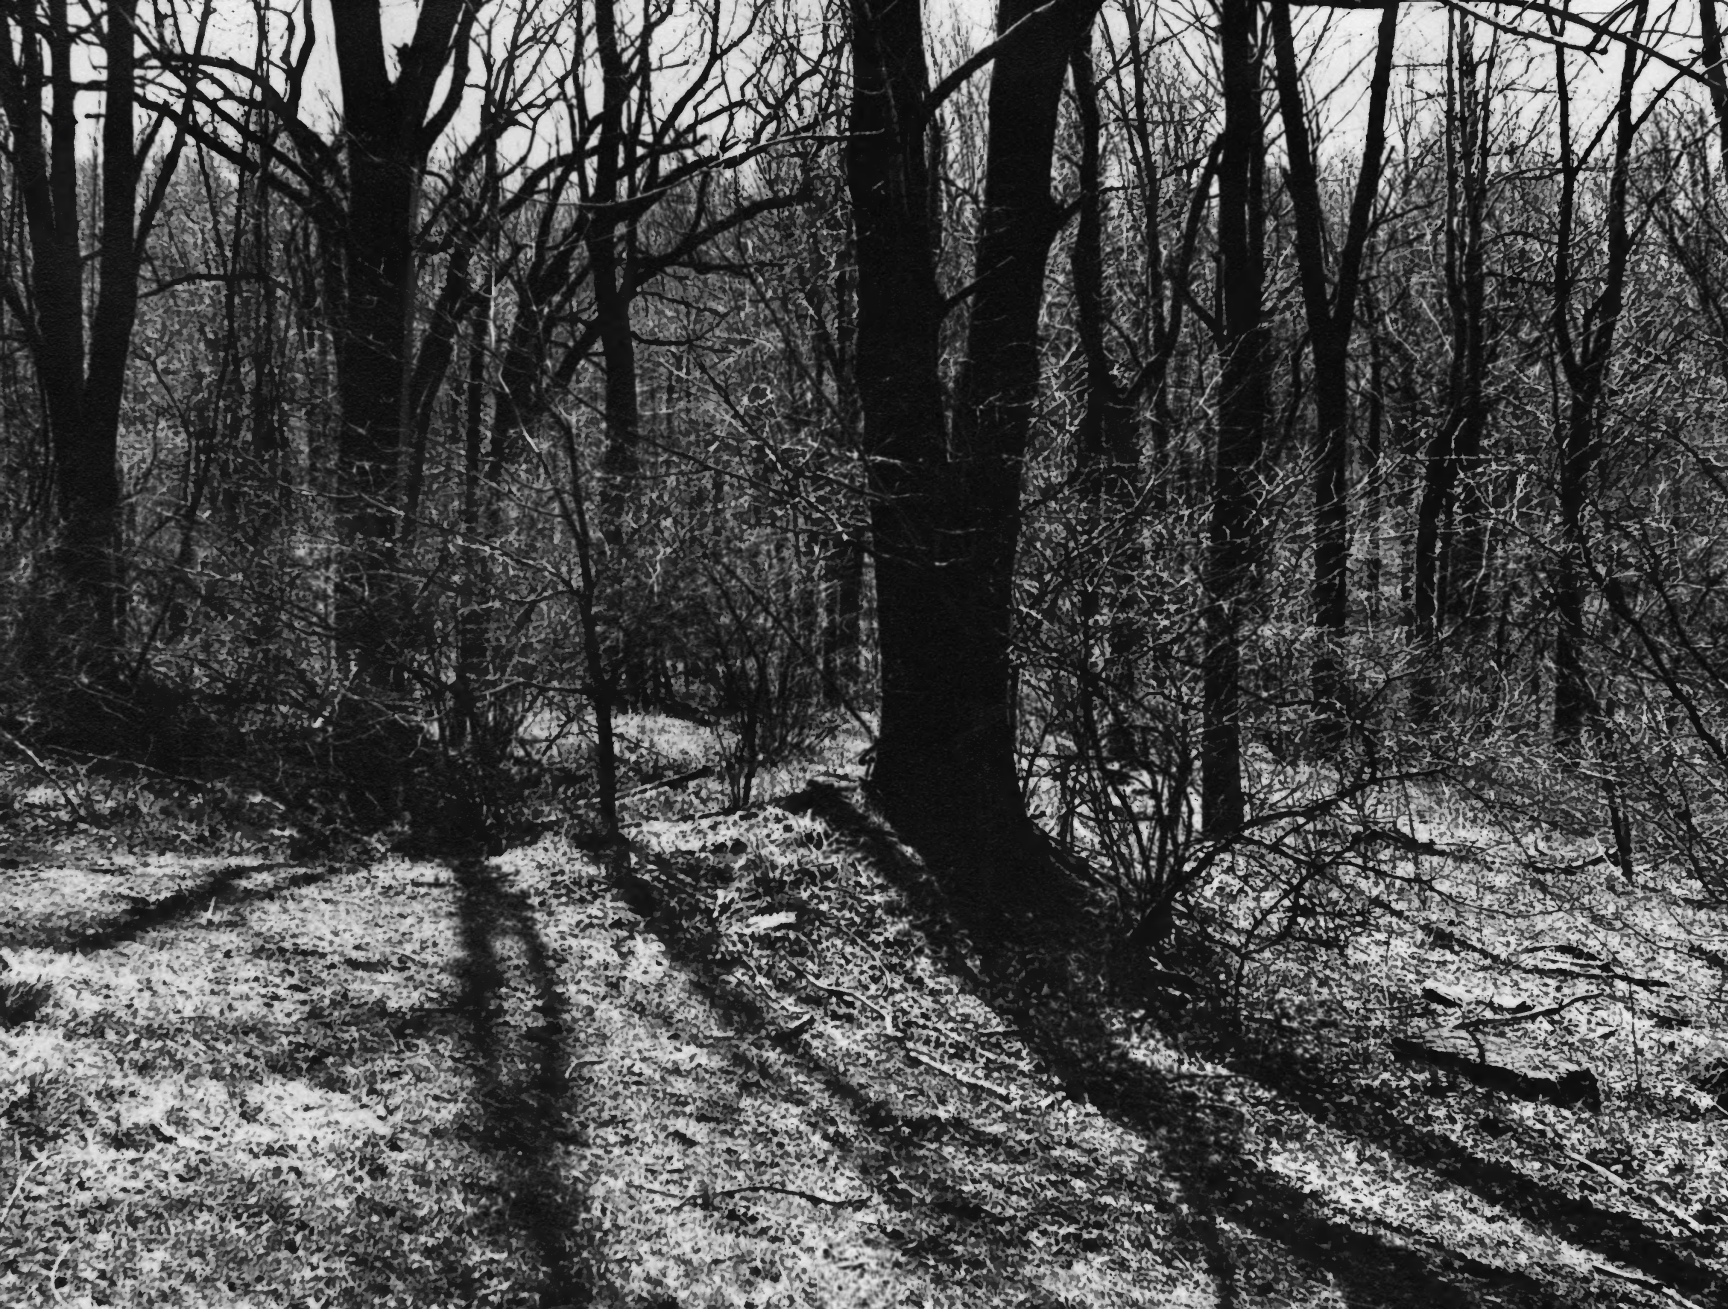
Original location of building showing old cellar hole and some of the old sandstone foundation block. 300 ft. to the West of present building.

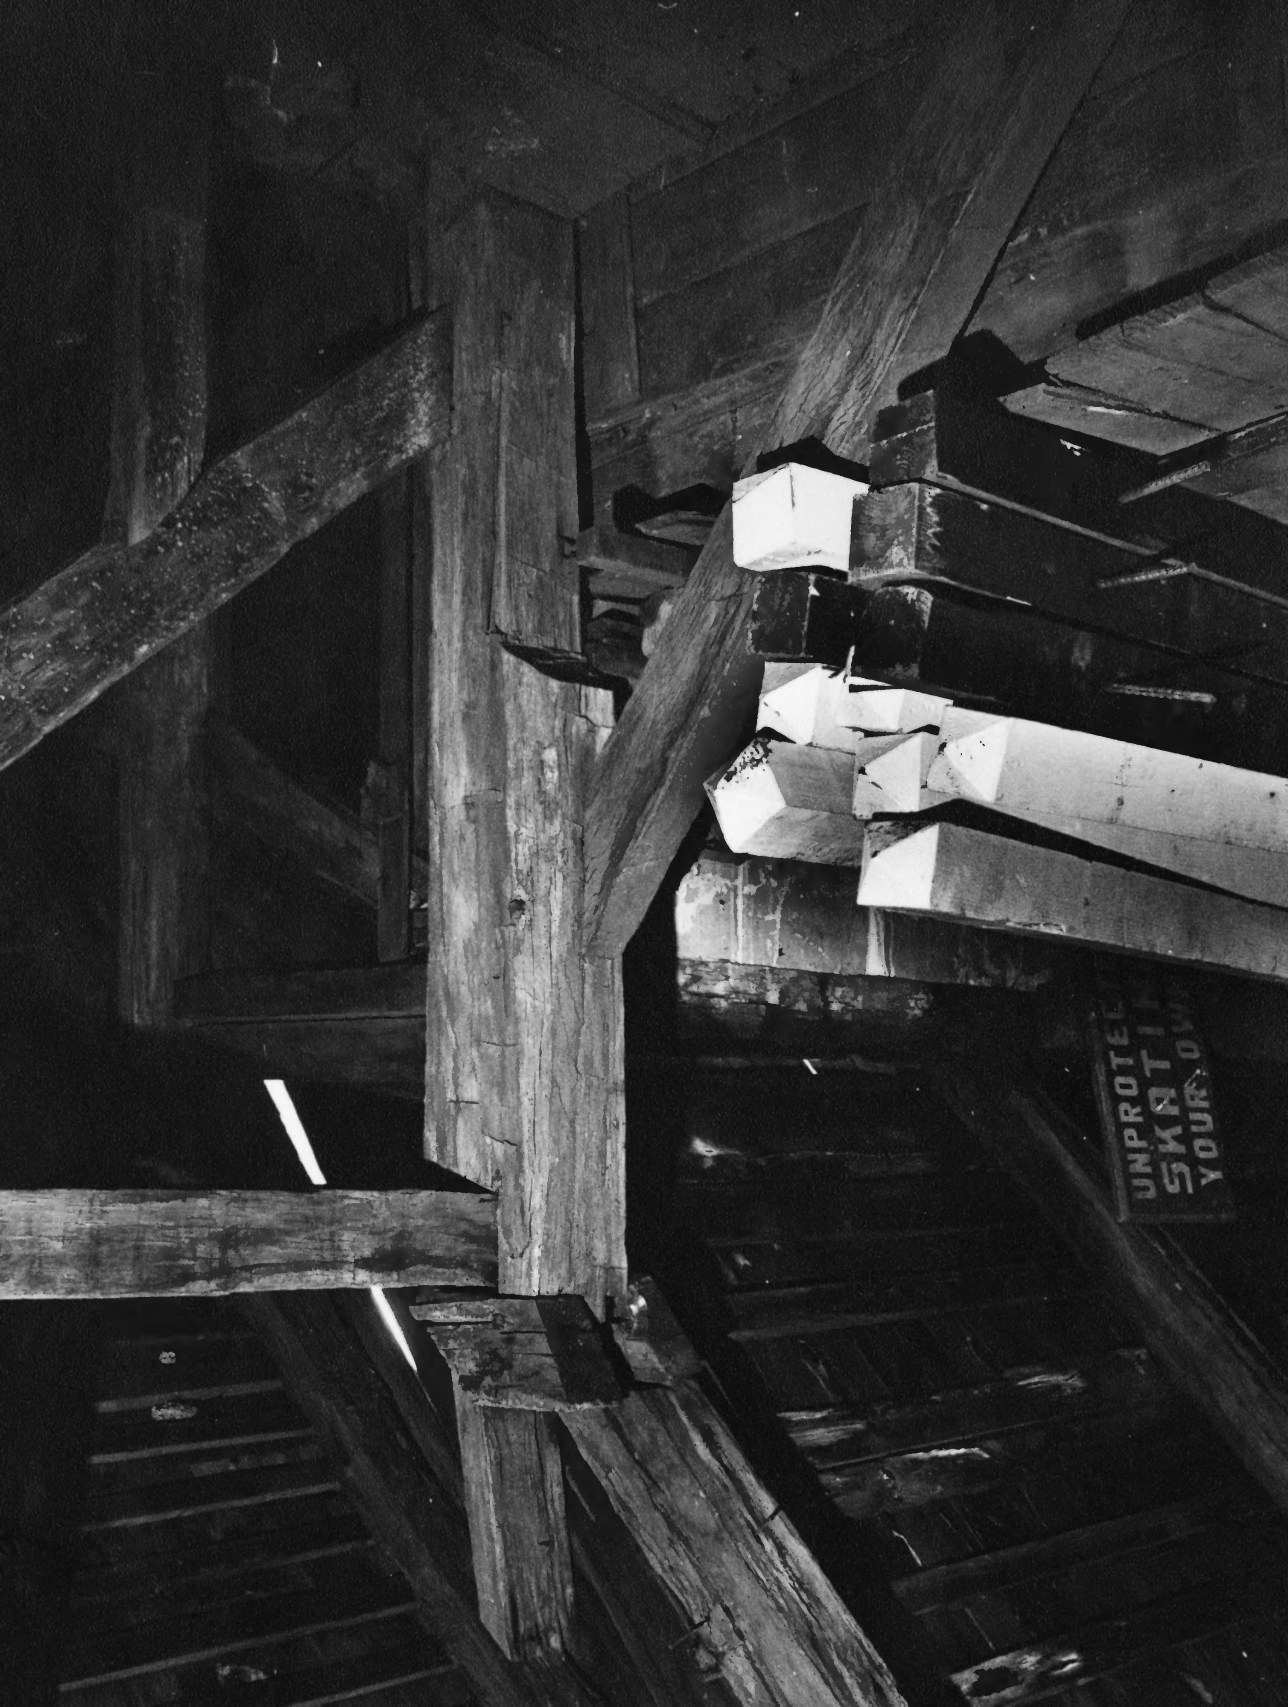
**Gunstock posts in corner of original building with sawed off end plate still in place.
Step up for 18th Century addition.**

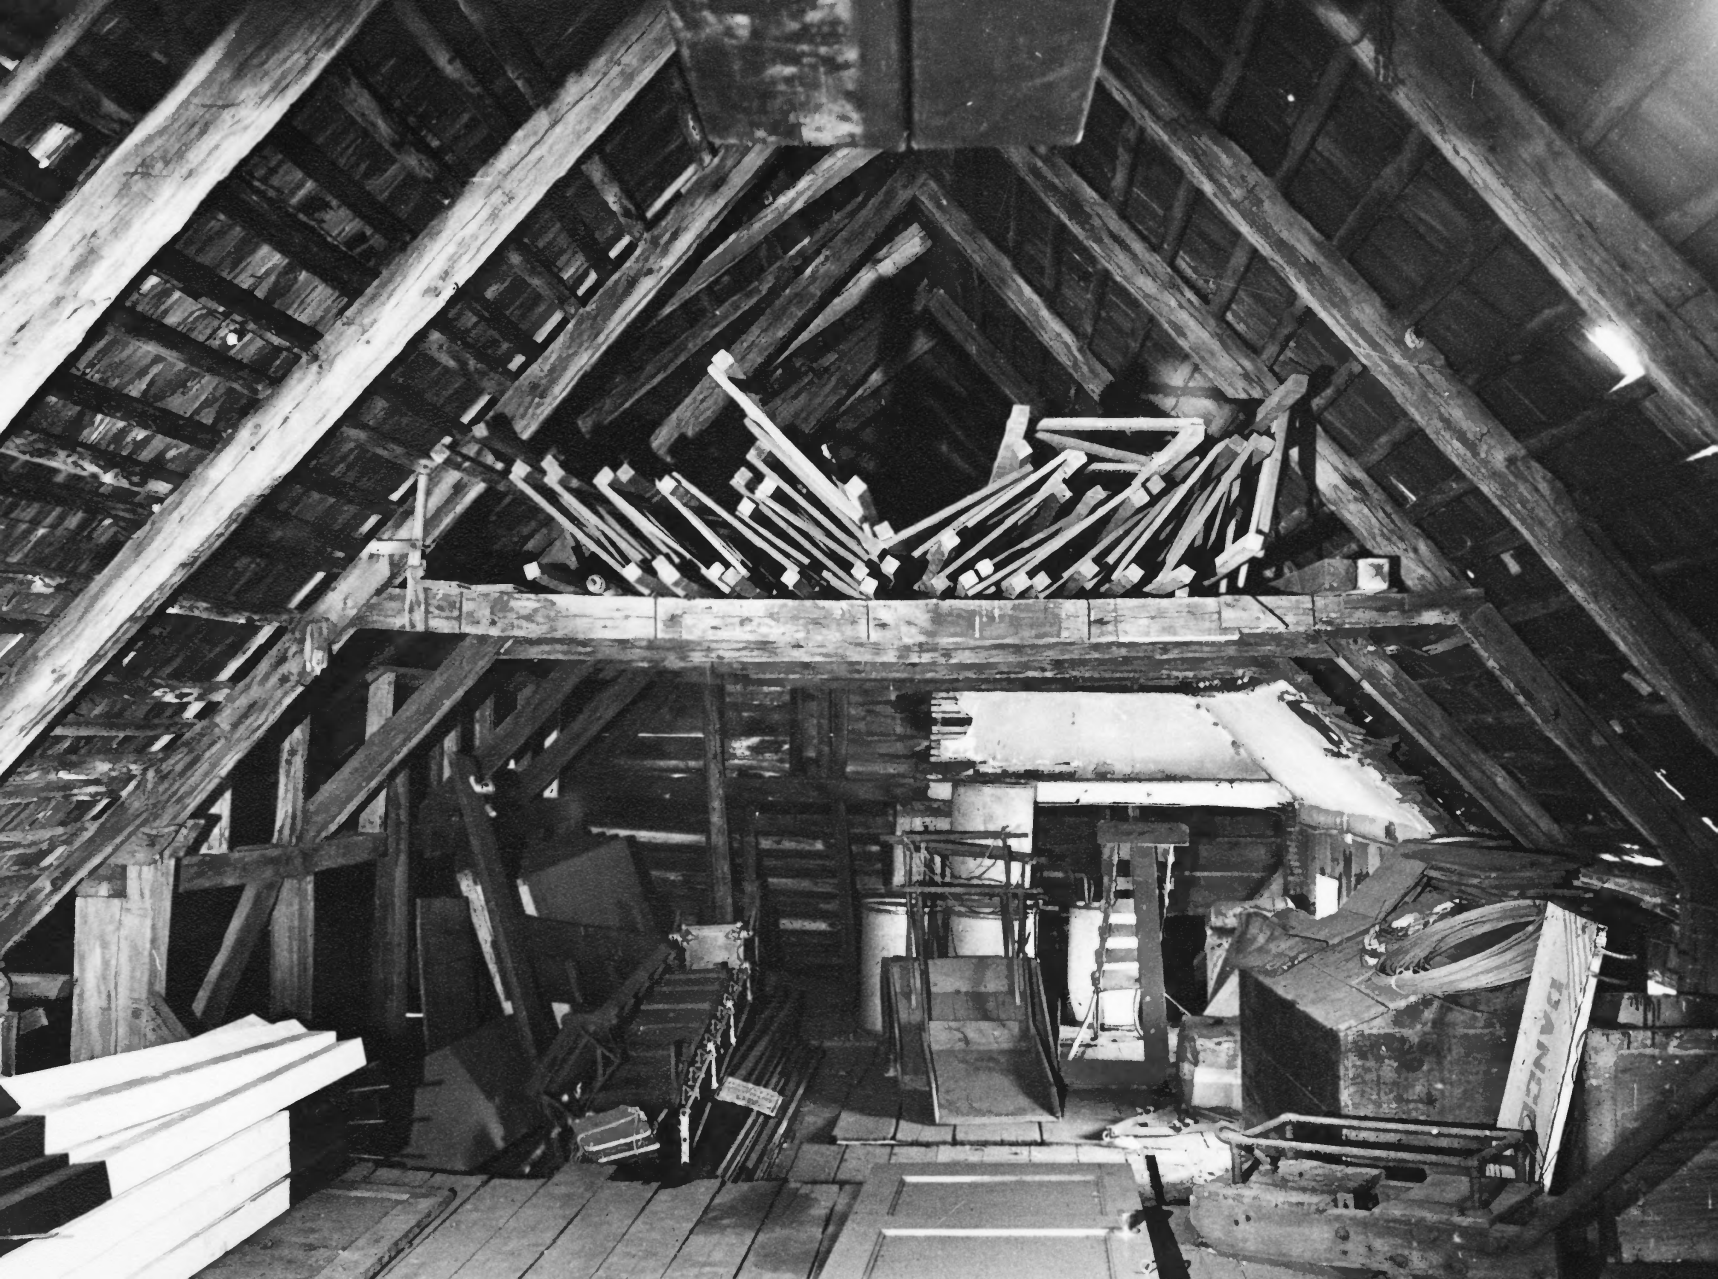
Interior of attic showing roof rafters and joining of 18th Century addition. Notches for end wall studs still discernible on end of collar beam. Also original rafters of lean-to show in the rear currently covered with another roof.

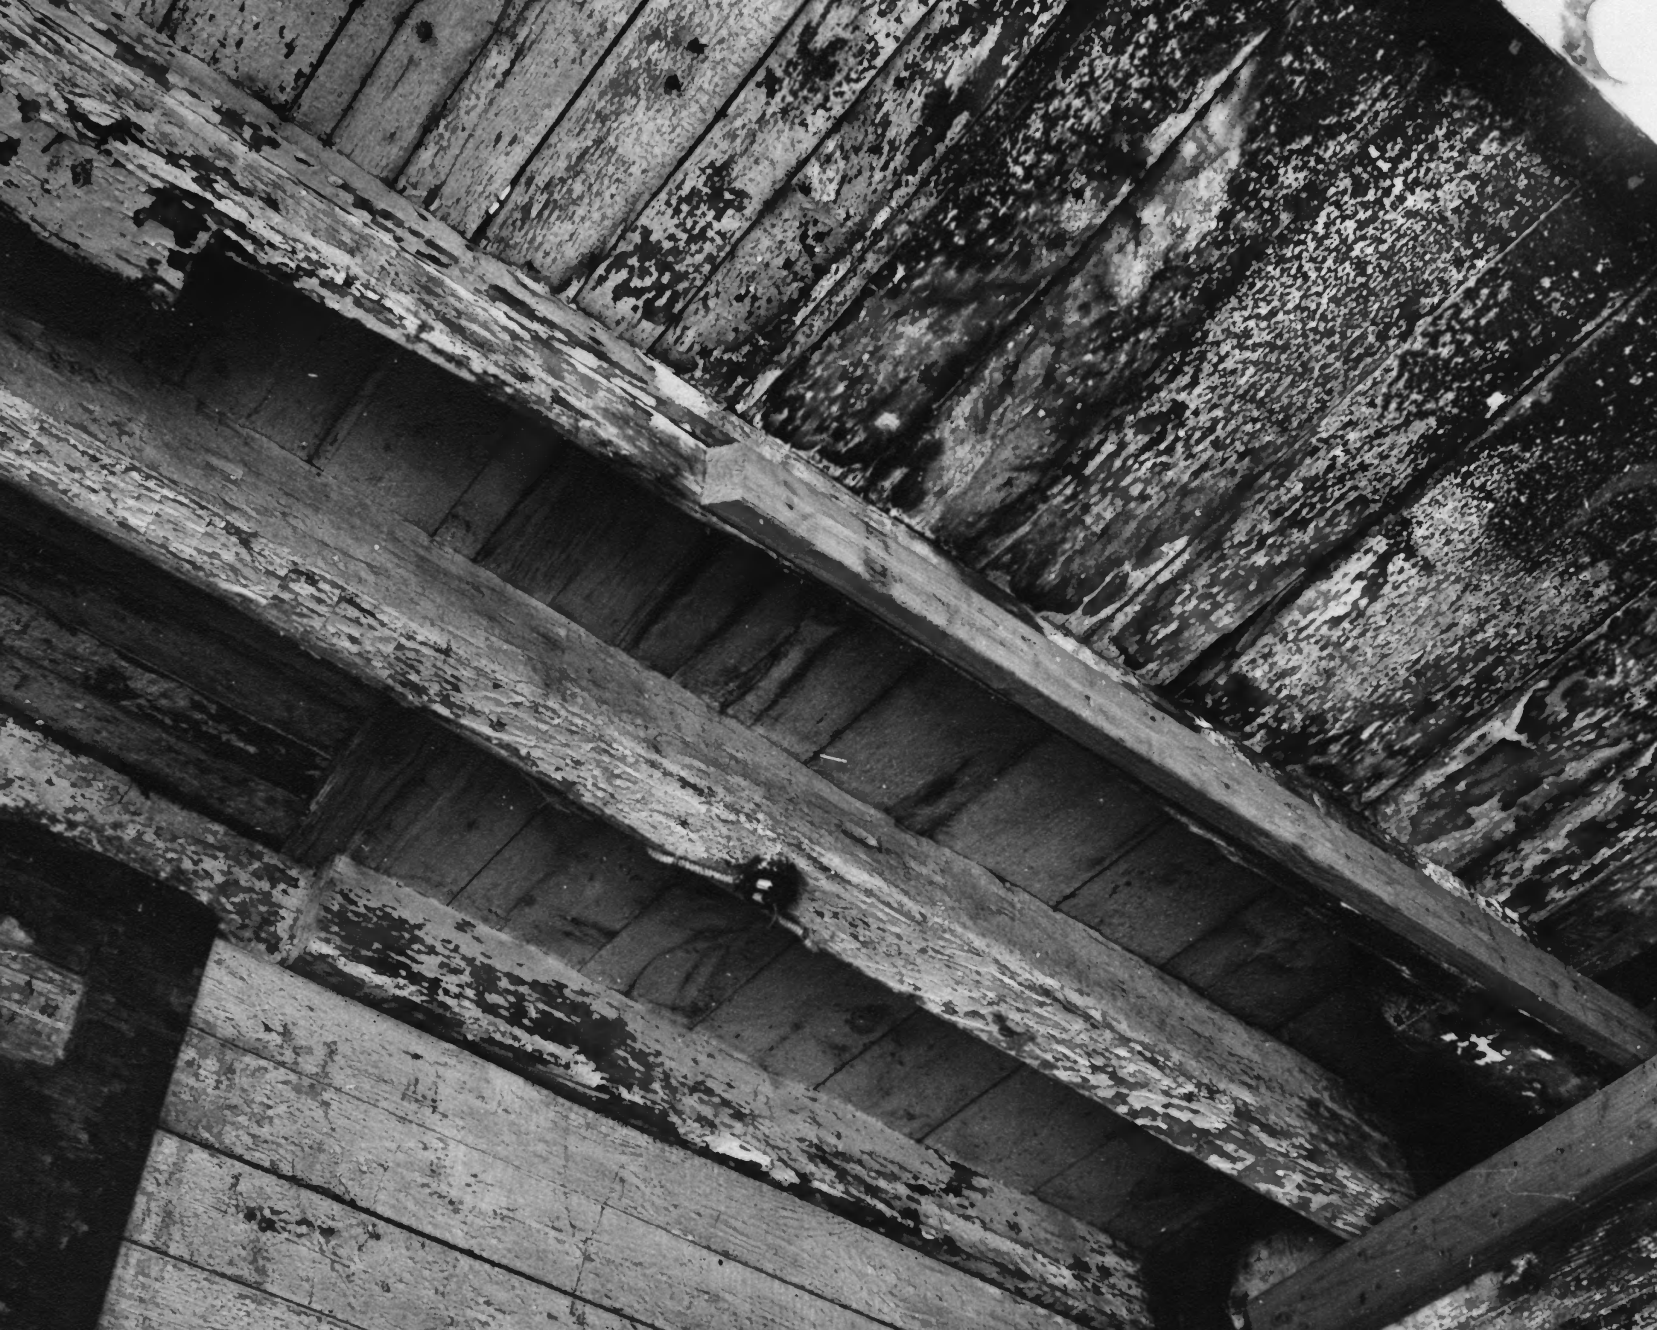
4 of 7

Floor beams of second floor showing beveled cut for original fireplace approximately 8 ft. wide and opening conceivably at ceiling height in the old Dutch manner, showing original whitewashing and flooring boards above. Hole for chimney and fireplace has been filled as apparent in photo.

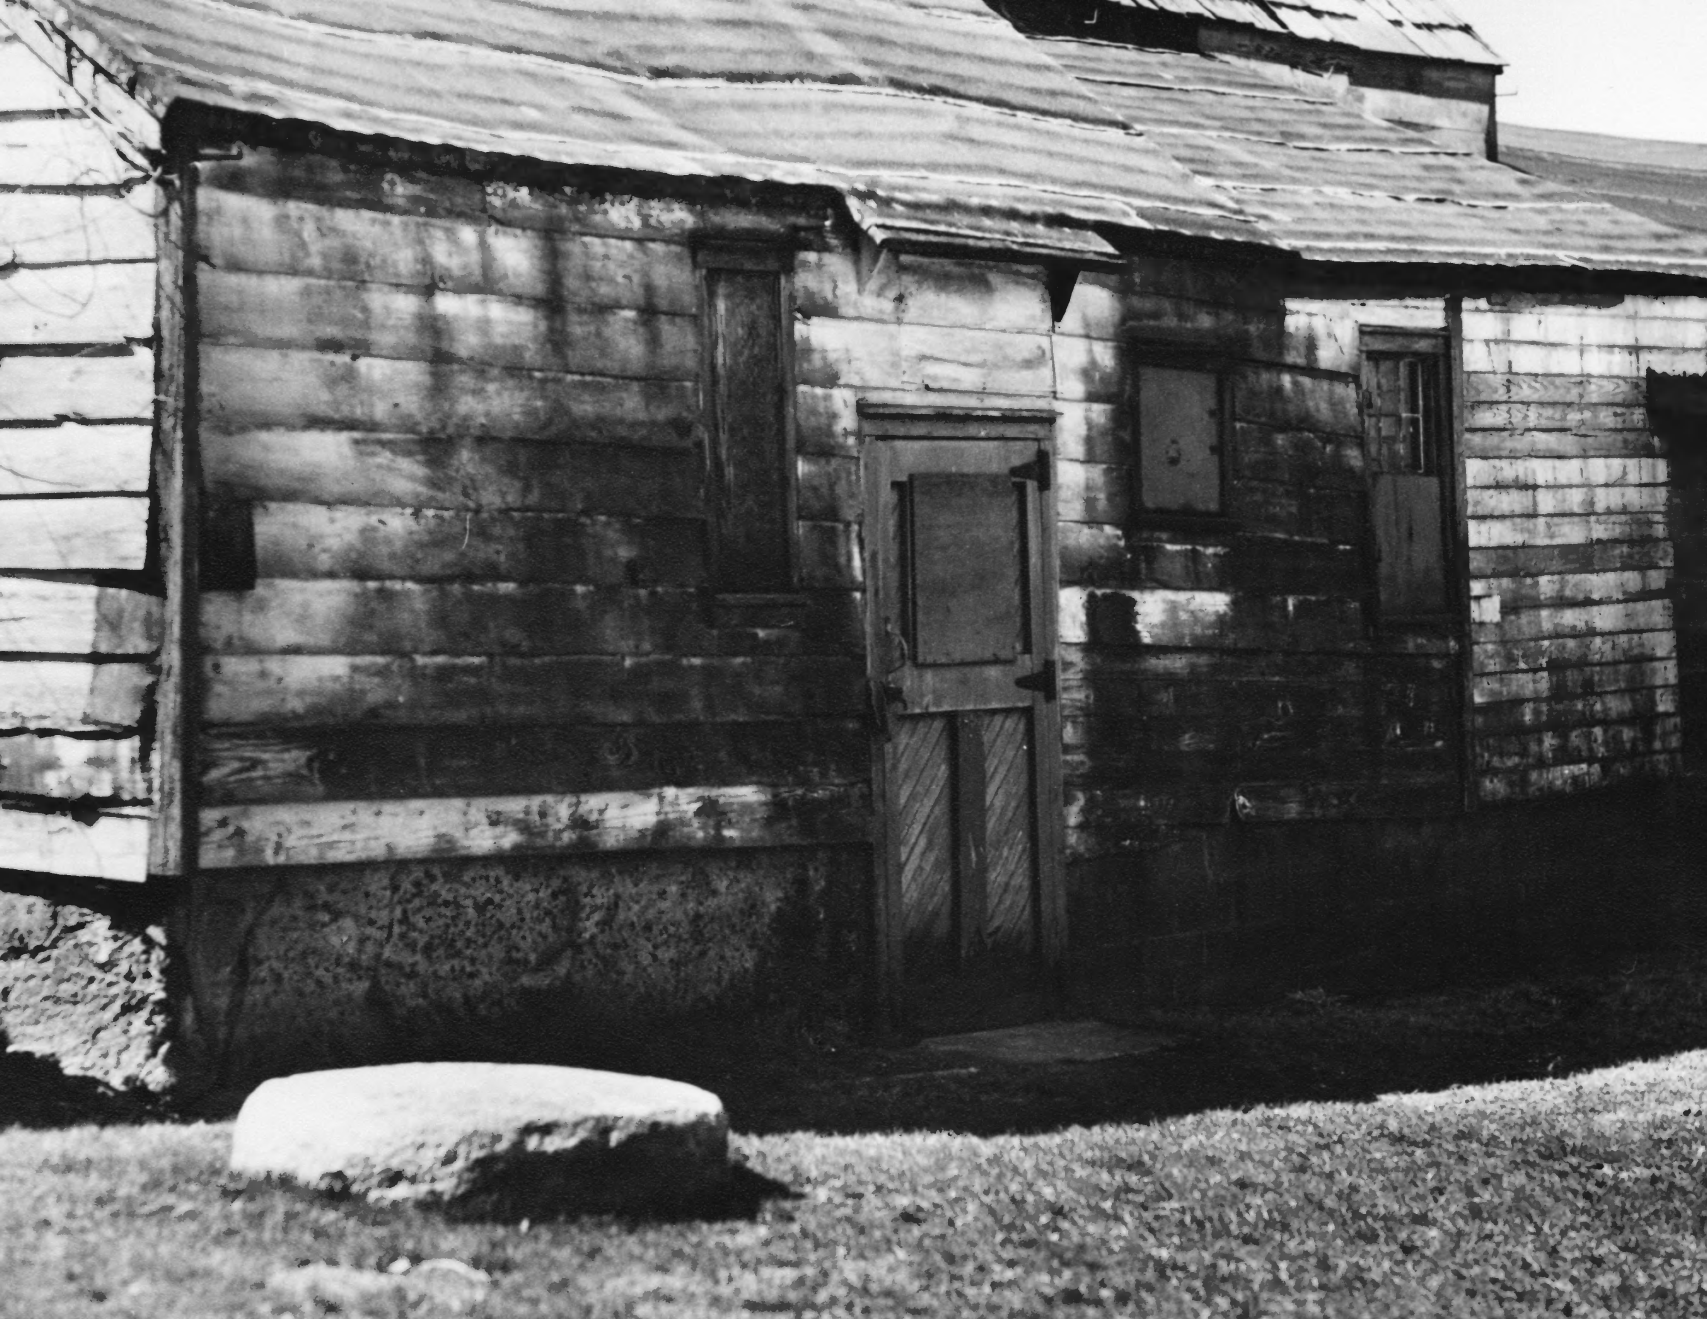
Rear of lean-to shed showing original narrow window and doorway. Old millstone in foreground.

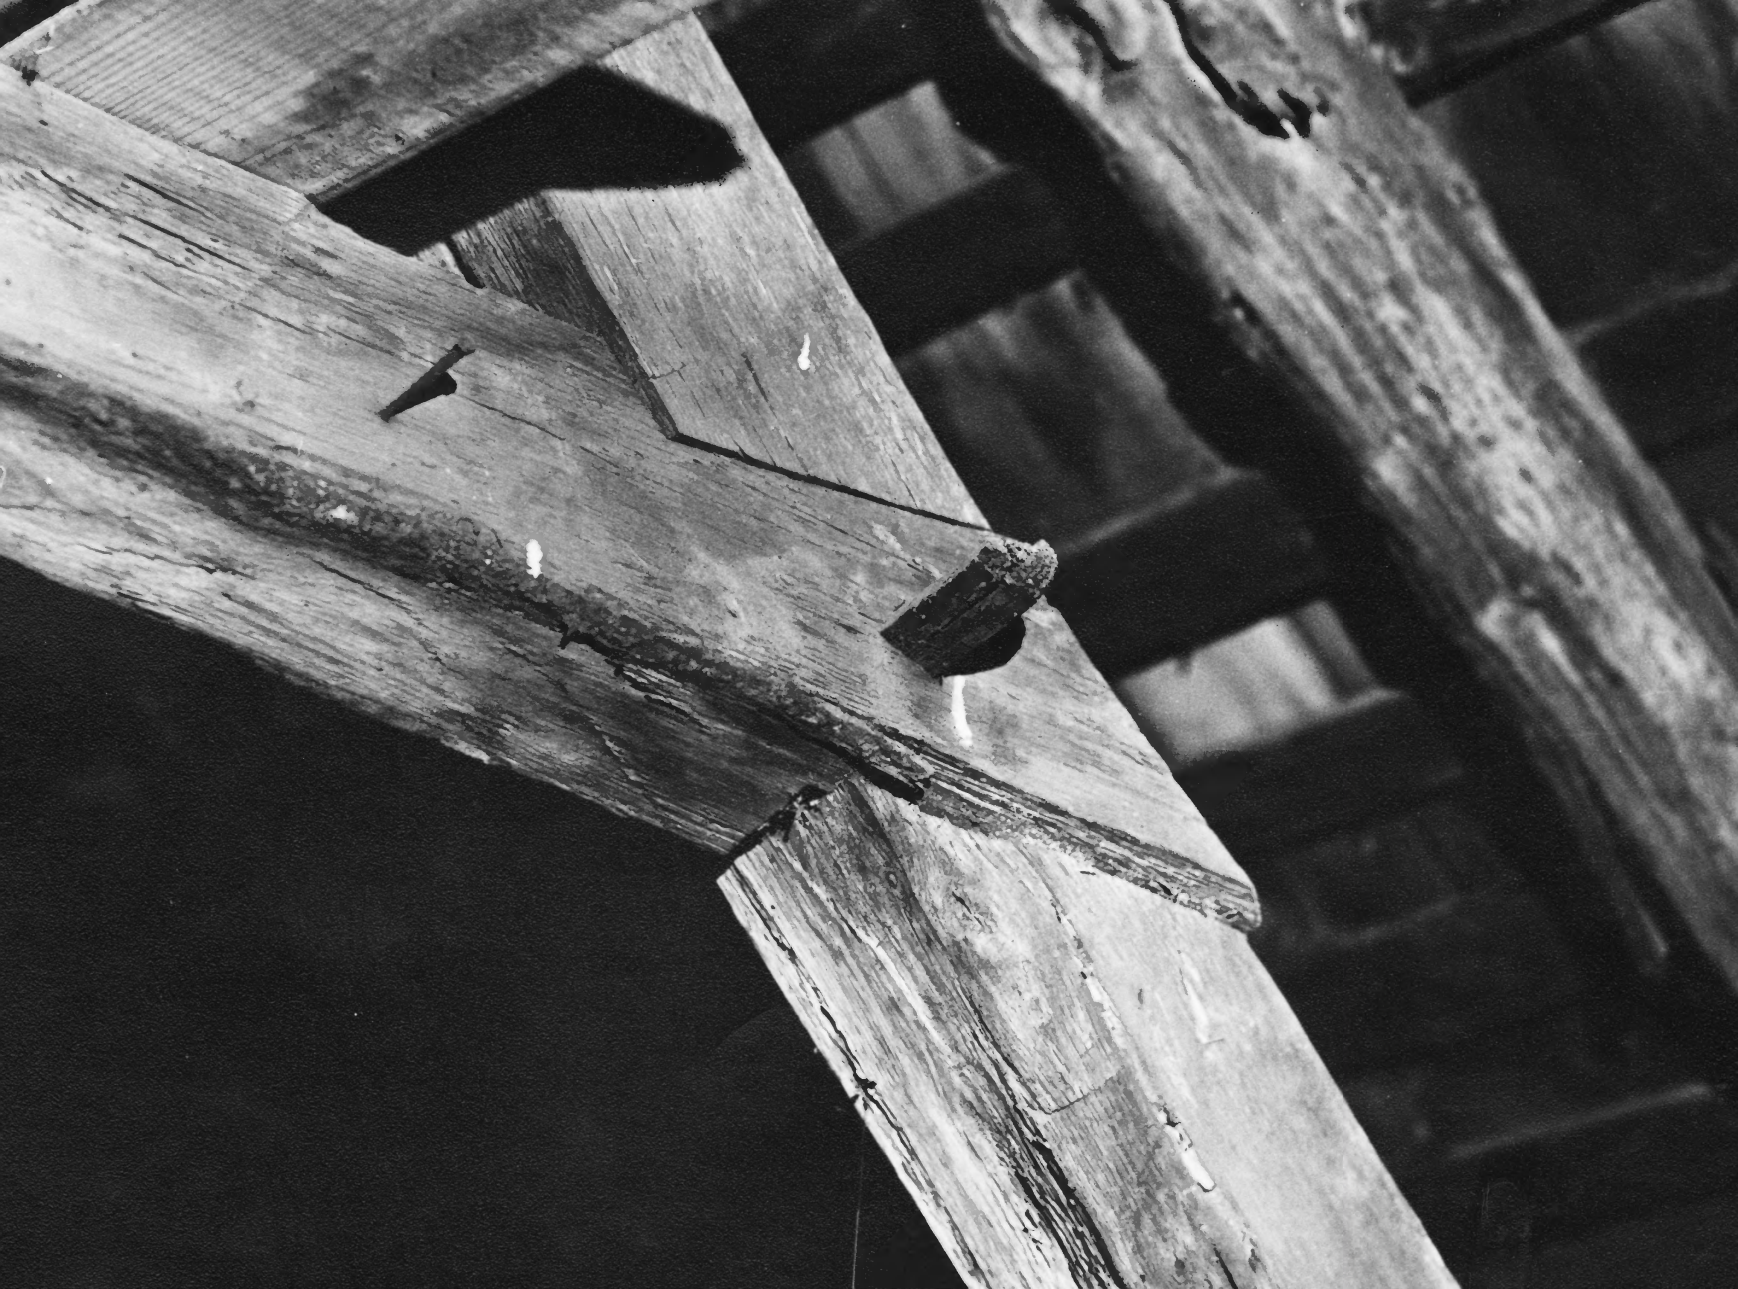
End of collar beam mortised into rafter with dovetail shape fitting flush with end of rafter.

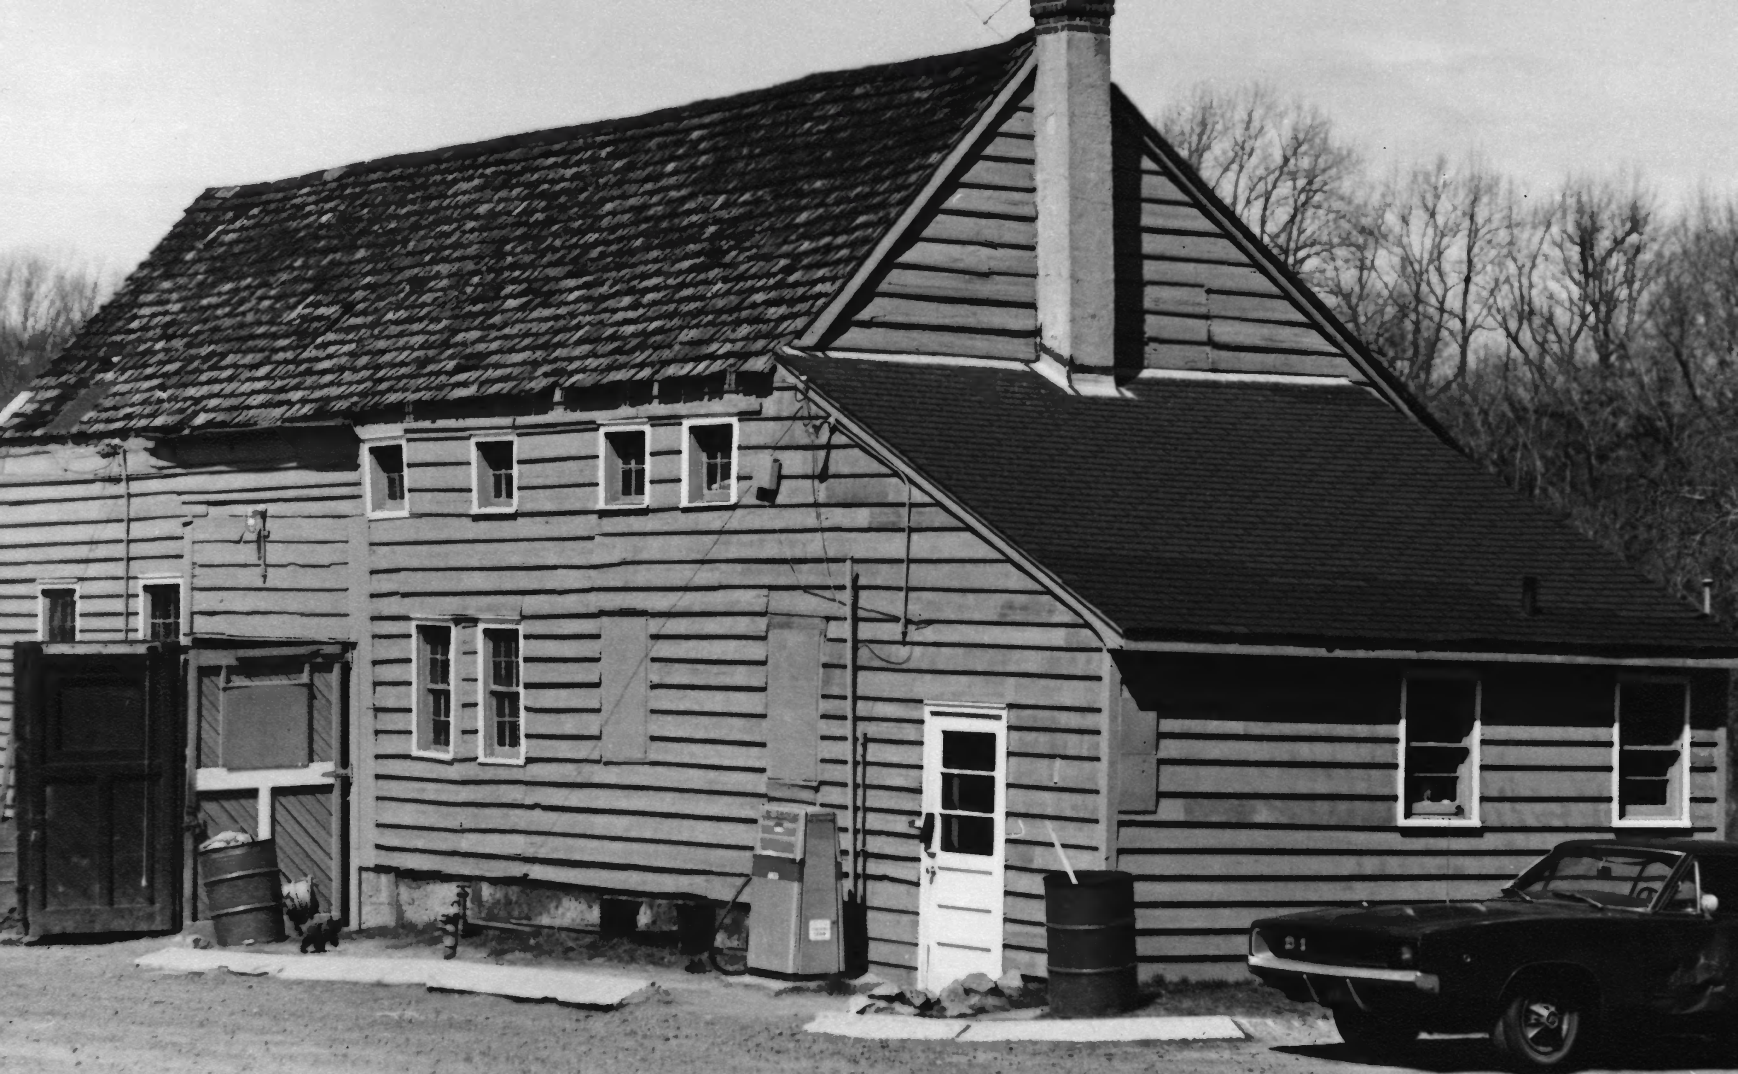
Exterior of building which has been raised approximately 2 ft. above grade and 20th Century lean-to on end. Early windows and siding still in place.
