NATIONAL REGISTER OF HISTORIC PLACES
REGISTRATION FORM

historic name: Herried House

other name/site number: Grow House, AHRs Site No. ANC-198

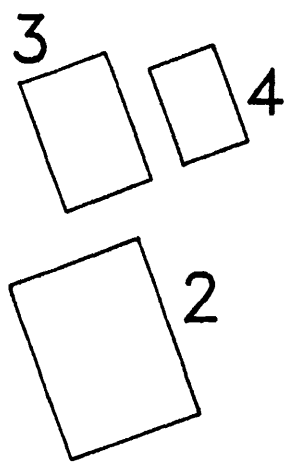
HERRIED HOUSE
(NOT TO SCALE)

CONTRIBUTING STRUCTURE

NON-CONTRIBUTING STRUCTURE

1. HOUSE

2.-4. SHEDS

The boundary includes the farm house built in 1935. The farmstead has been subdivided.
