National Register of Historic Places Registration Form

Historic name: District No. 5 Schoolhouse
Other names/site number: Underhill Center School
Name of related multiple property listing:
Educational Resources of Vermont
(Enter "N/A" if property is not part of a multiple property listing)

Street & number: 32 Pleasant Valley Road
City or town: Underhill State: Vermont County: Chittenden
Not For Publication: Vicinity:

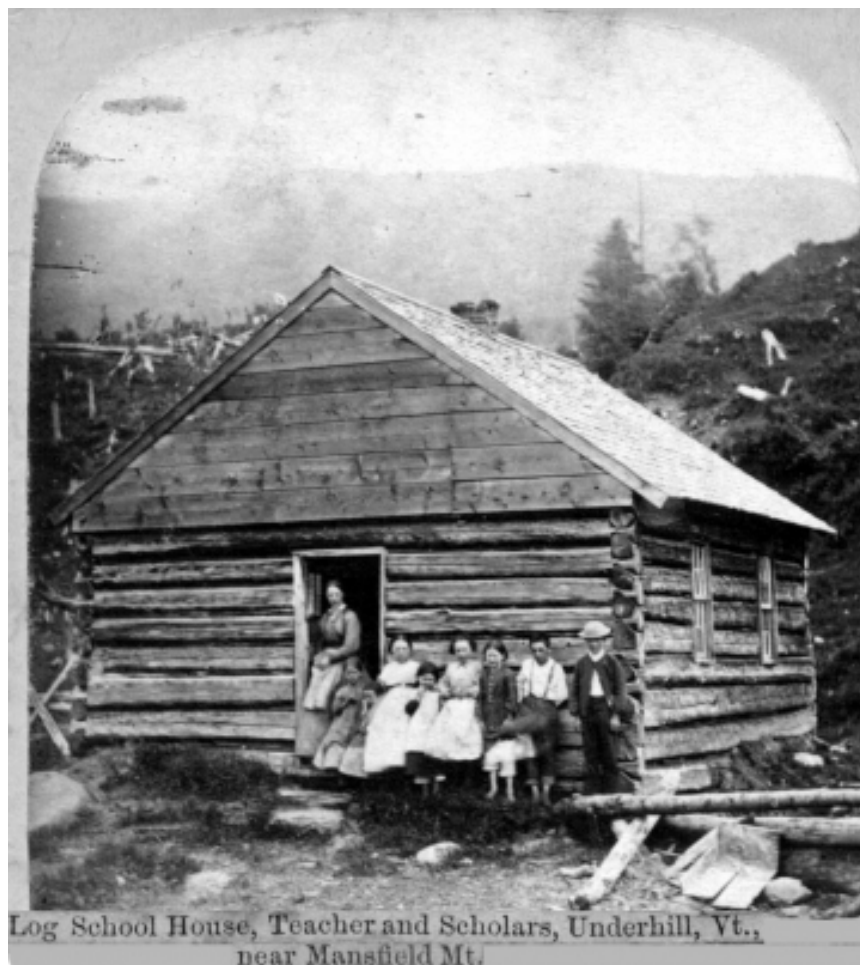
Figure 1. Log Schoolhouse, Underhill, VT.
Courtesy of UVM Landscape Change Program

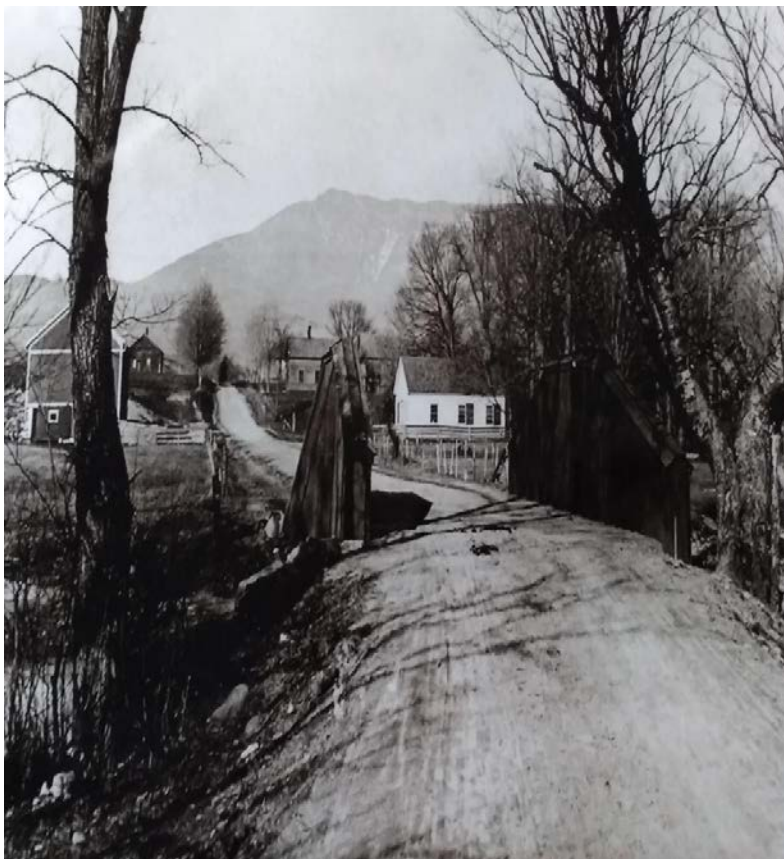
Figure 2. View looking east at the District No. 5 Schoolhouse, in the center of the image. Due to the lack of a second story, this photo was taken pre-1915. Courtesy of the Underhill Historical Society.

After the destruction of the 1835 District No. 5 Schoolhouse in 1861, the need for a new, updated building became obvious. The new building, constructed in 1861 and known as the Center School, was another one story, one room school. The district minutes briefly describe the building: "A 24' x 36' building with the end facing the road, door center front, two windows in front, three on each side, twelve lights 10" x 14", with a wood shed, 12' x 16' on the grounds." The cost for the building was \$616.91, slightly under the \$700 budget. Unlike its log predecessors, however, the 1861 building was of frame construction with wood clapboard siding and numerous windows. This building is shown in Figure 2.

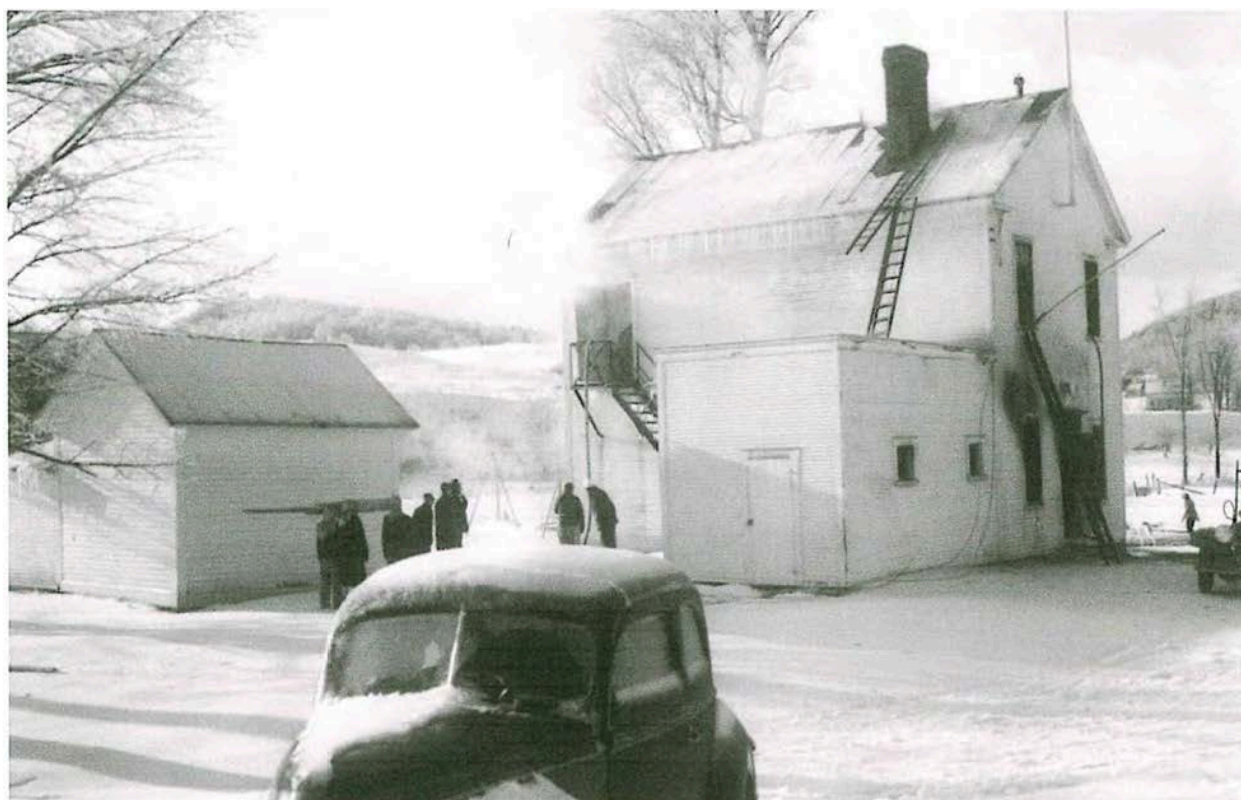
Figure 3. View looking west during the fire in 1951. The flat-roofed addition housed a woodshed and chemical toilets. Courtesy of the Underhill Historical Society.

Between 1915 and 1951 additional changes to the building occurred, including small additions to serve the needs of the growing student population and the installation of a metal fire escape on the west elevation. Figure 3 shows a flat-roofed, 12' x 16' addition on the northeast elevation of the building. This addition was built in 1926 and contained a woodshed and chemical toilets. This addition is no longer present. Electricity was brought into the building in the early 1930s, although it lacked indoor plumbing and continued to be heated by woodstoves. In 1951, a fire that began in the first-floor woodstove caused extensive damage to the building.
