# **National Register of Historic Places Registration Form**

historic name Union Stables							
other names/site number							
2. Location							
street & number 2200 We	estern Aven	ue					not for publication
city or town Seattle							vicinity
state WA	code	WA	county	King	code	033	zip code 98121
2 State/Endered Agenes	Cartificatio

7. Description Architectural Classification (Enter categories from instructions.) LATE 19th & 20th-CENTURY REVIVALS / Italian Renaissance	Materials   (Enter categories from instructions.)   foundation: CONCRETE   walls: BRICK		
	roof:   SYNTHETICS     other:   Cast stone & terra cotta decorative details

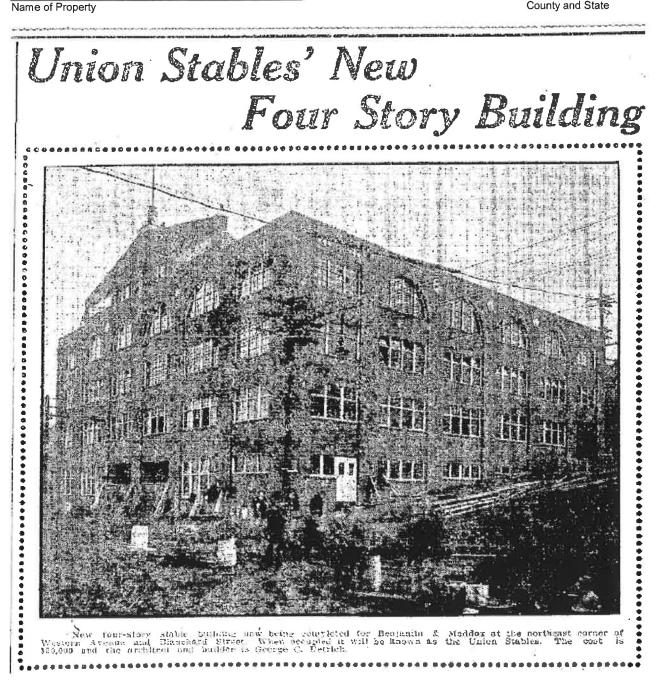
A newspaper photograph shows the nearly-complete Union Stables in January 1910. (Seattle Daily Times, January 16, 1910, p. 34)

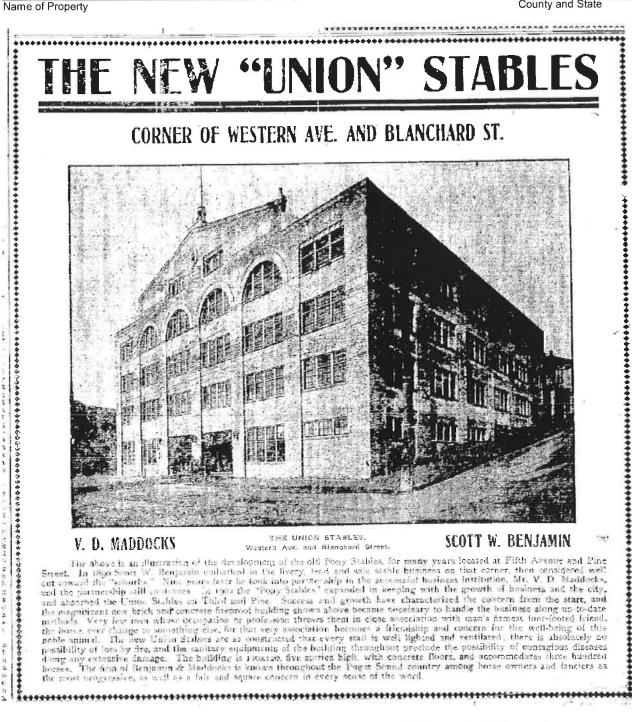
A photograph of the newly-completed Union Stables was accompanied by a brief history of the proprietors and a description of the building. (Seattle Sunday Times, February 27, 1910)

According to a feature in a local newspaper, the Union Stables once accommodated 300 horses and was constructed so that "...every stall is well lighted and ventilated, there is absolutely no possibility of loss by fire, and the sanitary equipments of the building throughout preclude the possibility of contagious diseases doing any extensive damage..." (*Seattle Daily Times*, February 27, 1910, p. 55).
