National Register of Historic Places Registration Form

historic name Pleasant View Stock Farm Historic District

Shelby County, Iowa

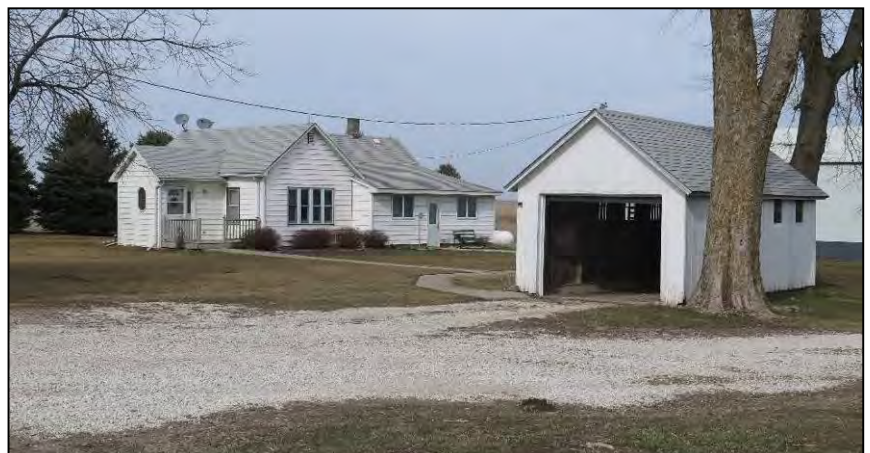
Figure 2. Gable-front-and-wing house built in 1884 to left and single-stall garage built circa 1920 to right looking NE. Photograph taken by Tallgrass Archaeology LLC, 04/12/2018.

A concrete sidewalk extends from the wooden deck south towards a circa 1920 single-stall, front-gabled automobile garage. A second concrete sidewalk extends from the rear enclosed porch south towards the farm buildings. Both sidewalks intersect with another east-west sidewalk that curves south at its west end to the front of the garage and driveway (see Figure 2). The frame garage is built on a poured concrete foundation. The roof is covered with asphalt shingles, and the walls are clad with the original, wooden board-and-batten siding. The garage door is now a modern overhead door. There are three small, fixed-pane windows just under the eaves on the north and south sides of the building.

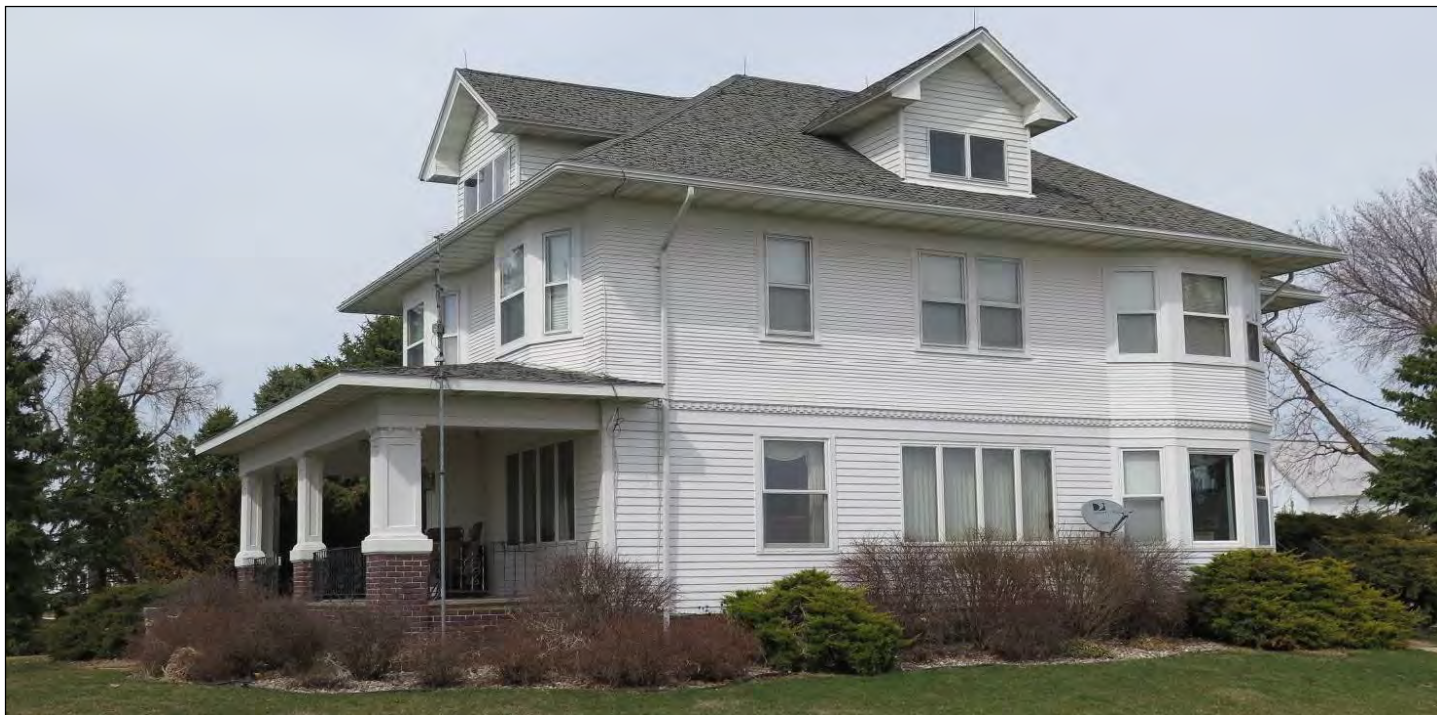
Figure 3. 1913 farm house looking NNE. Notice the west-facing front porch with brick detailing, west- and south-facing dormers, the two-story rounded bay window on the south side and the two single-story rounded bay windows above the front porch; and the denticulated board separating the first and second stories on the exterior of the house. *Photograph taken by Tallgrass Archaeology LLC, 04/12/2018.*

The second farm house still standing on the farmstead was built in 1913 by Earl Ryan (Thomas J. Ryan's son) and his wife, Bertha (Sessions) Ryan. Recollections of the farm indicate that the financing and building of the house was not solid, and may have been held up for a time, as cash flow ebbed and flowed with the volatile farm economy and precarious business of selling on margin (Barratt 1996:15), as will be discussed below. While not finished entirely as originally planned, the executed design was stylish and well-appointed inside and out. It stood out in this rural neighborhood and reflected the wealth of the owners (Figure 3).

South Side: The south side of the home features the same style as the front of the house (see Figure 3). The primary feature of the south side is the two-story bay window at the east side of the wall. This bay window is similar in style to the front bay windows, with the second story having the same windows as on the front bays. However, the first-floor portion of the two-story bay window has a centered window that has been replaced with a rectangular glass pane, but the flanking windows appear to be the original 1/1 sash windows. The other windows across the first story of the south side include a single 1/1 sash window at left, with a modern, four-pane replacement window, like the same window on the façade under the porch. The second floor has an original 1/1 sash window to left and a paired 1/1 sash window in the center. There is a gabled dormer on the south-side roof slope of the same type as the front dormer and also is clad with vinyl siding and a two-pane, replacement window insert. The southeast corner of the house is set back nine feet from the rest of the house and extends nine feet eastward. Six carpet-covered concrete steps rise to a small landing enclosed in a wrought-iron railing. There is a modern door off this landing that provides access to the home’s kitchen. Historically, this would have been the access point for employees and family members onto the back porch. Reportedly this porch had a tin floor, likely to make cleaning up after muddy boots easier and to save wear and tear on wooden floors. Above the porch, was a second-story porch that had screened windows and was used as a sleeping porch. The modern door on the south side of the rear ell has a side window and the second story on the south side features one single-pane, rectangular window. Originally, the first-floor rear porch was entered from the east (rear) side; therefore, the south-side entry, porch stoop, and sidewalk to the garage are additions.

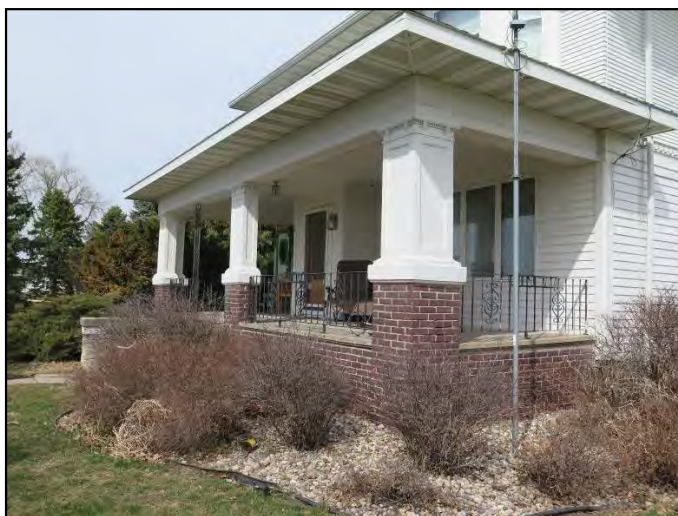
Figure 5. Front porch of 1913 house looking NNE.

West Side/Facade: A concrete walkway runs from the road to the front steps of the porch. Five concrete steps ascend onto a concrete porch with a brick-veneered foundation (Figure 5). The brick is dark red in color and forms the square piers of each of the three posts across the porch. These piers support the square wooden columns that, in turn, support the low-pitched, hipped roof which overhangs beyond the edge of the porch. Wrought-iron railings were added between the supports and the house as well as along either side of the front porch steps. These railings were likely added in the mid-to-late 20th century. The wooden posts have flat capitals and bases, with dentils and small corbels just under the capitals on each post. The faces of each post have inset panels.

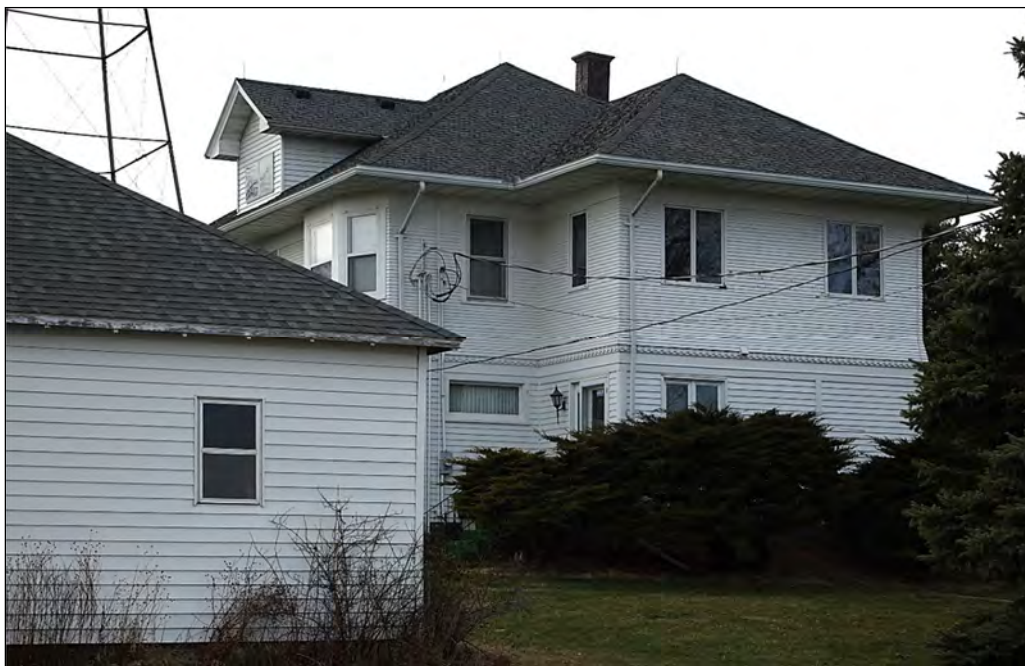
Figure 6. Rear (east side) of 1913 house looking WNW with garage and windmill to the left.
Photograph taken by Tallgrass Archaeology LLC, 04/12/2018.

East Side: The rear (east side) of the house is dominated by the 21 feet wide by 9 feet deep ell that extends eastward from the building’s largely rectangular footprint (Figure 6). One long rectangular window is to the left towards the top of the first floor on the main body of the house, with a single 1/1 sash window above it on the second story of the house. The rear ell has a single set of paired, rectangular-pane, open-out or sliding windows on the left (west) side of the first floor and two sets of the same type of windows symmetrically placed across the second story. These windows are modern inserts. The original rear entry on the east side is now enclosed with clapboard siding but a vertical board frames the former opening. A concrete sidewalk extends east, down a single concrete step from the former back door, and through a planting of what have become large, mature pine trees. Evergreen shrubs have grown up at the former back door entry masking this former entry.

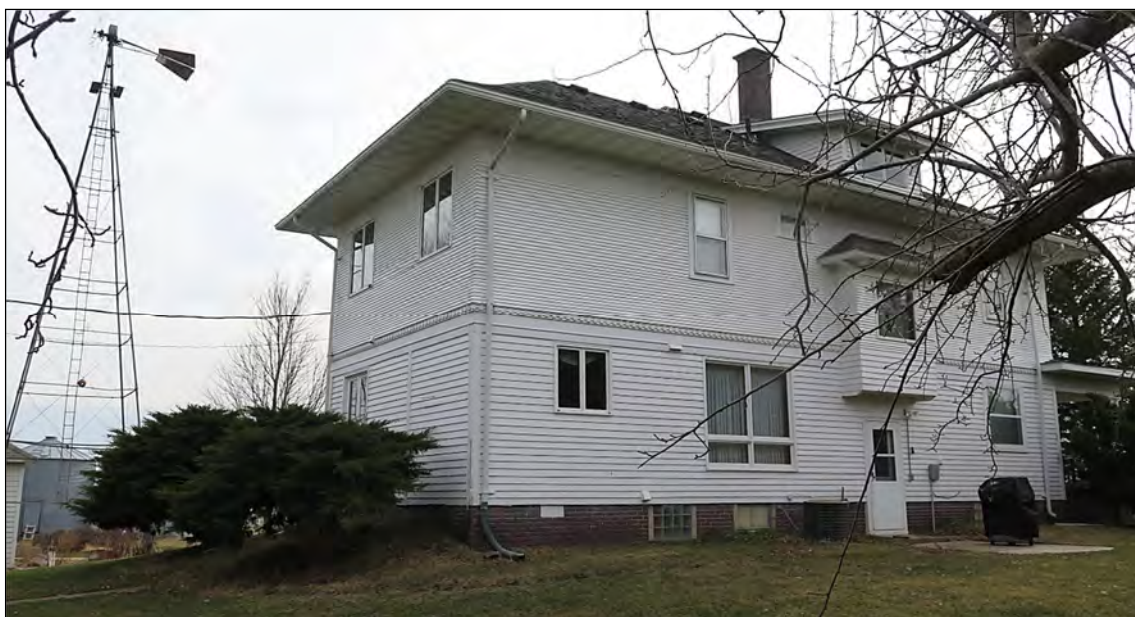
Figure 7. Rear (east) and north sides of 1913 house looking SSW. Note the windmill structure to the left side of photo.
Photograph taken by Tallgrass Archaeology LLC, 04/12/2018.

North Side: Two sets of semi-clear glass blocks break up the brick foundation on the north side of the farm house providing light into the basement of the home (Figure 7). A door provides direct access into the basement of the home and is slightly off-center on the north side of the house. The cantilevered, rectangular bay window is directly above the basement door and provides light into the interior staircase landing at the first/second floor juncture. It features a window seat on the interior and has a single pane of glass that is a replacement window. The bay window has an asphalt-shingled hip roof overhang that has corbels under the eaves. The bay window is clad in narrow siding at the second level and the normal-width clapboard on the first level. The main body of the house has a modern two-pane window (like those on the rear ell) to the left

side and a modern four-part window (two tall rectangular panes over two short rectangular panes) in the center on the first story. To the right of the basement door is an original, rectangular 1/1 sash window. The second story of this side retains original single 1/1 sash windows, one just left of center and the other directly above the single 1/1 window on the right side of the wall. A small, rectangular, single-pane window just under the frieze board to the left of the bay window provides light into a bathroom on the second floor. A shed-roofed dormer clad with vinyl siding and a modern, two-part, square-pane window is on the north roof slope. A tall, brick chimney rises from the roof peak on the north side of the roof.

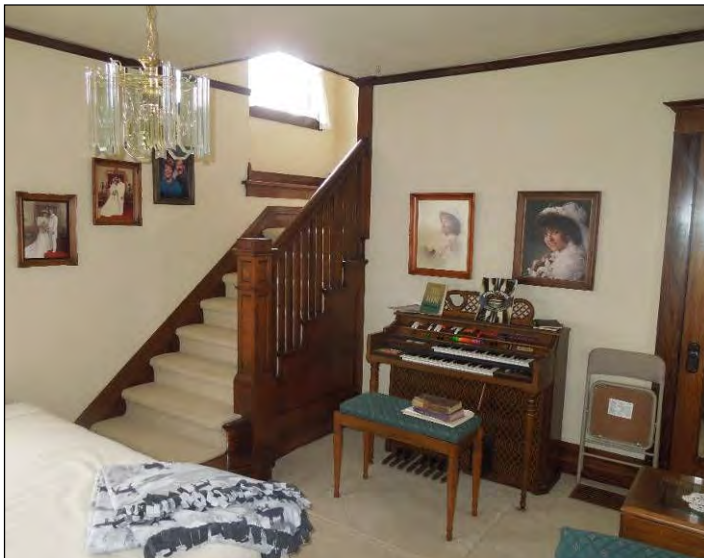
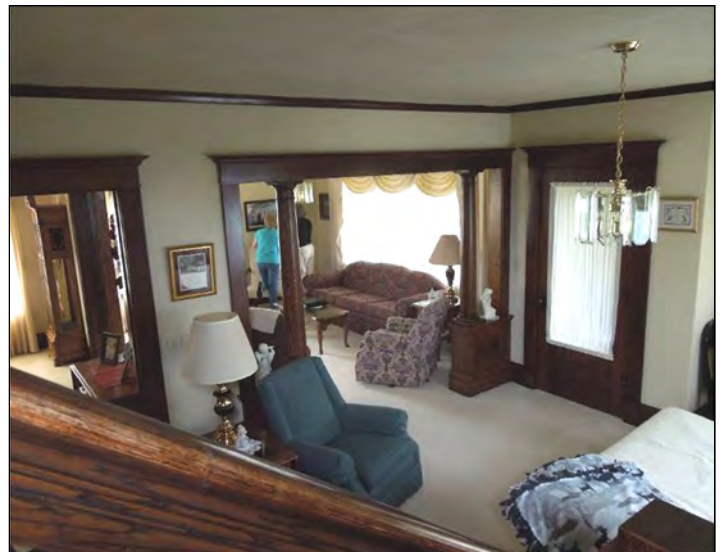
Figure 8. Left: staircase to second floor from the living room; Right: front door and colonnade. Note the original oak woodwork and trim.
Photographs taken by Nathan Buman, West Des Moines, Iowa, 2017.

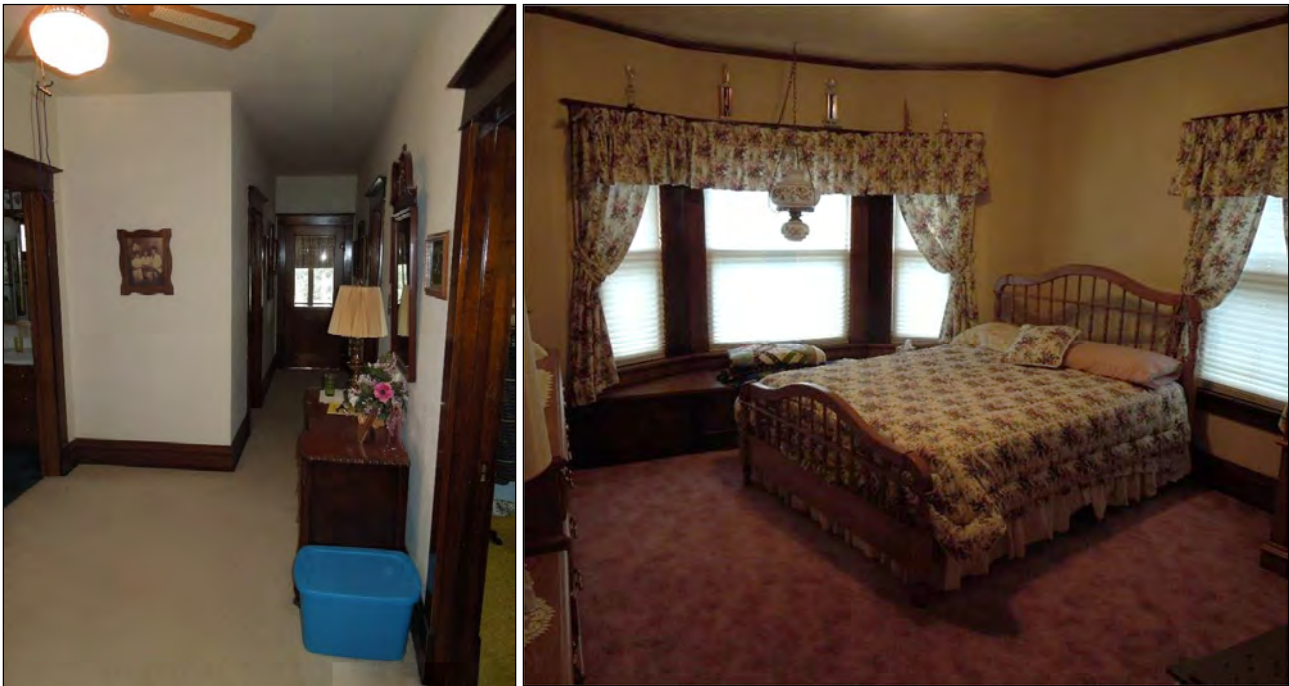
Figure 9. Interior views of the second-floor hallway and the northwest bedroom showing original woodwork, trim, and doors.

The second story contains five bedrooms, all accessed by a central, L-shaped hallway (Figure 9). Each bedroom has a closet. The enclosed sleeping porch now serves as an upstairs den area at the end of the hallway on the east end of the home. The interior of the sleeping porch has been covered with wood paneling added when the sleeping porch was enclosed. A bathroom can be found at the top of the staircase immediately to the left while attic access is gained through a doorway immediately to the right at the top of the stairs. The second-floor features three bedrooms with large bay windows, and most of the rooms maintain their original trim, doors, and fixtures. Many of the rooms on the first and second floors have wall-to-wall carpet over what is assumed to be the original hardwood floors.

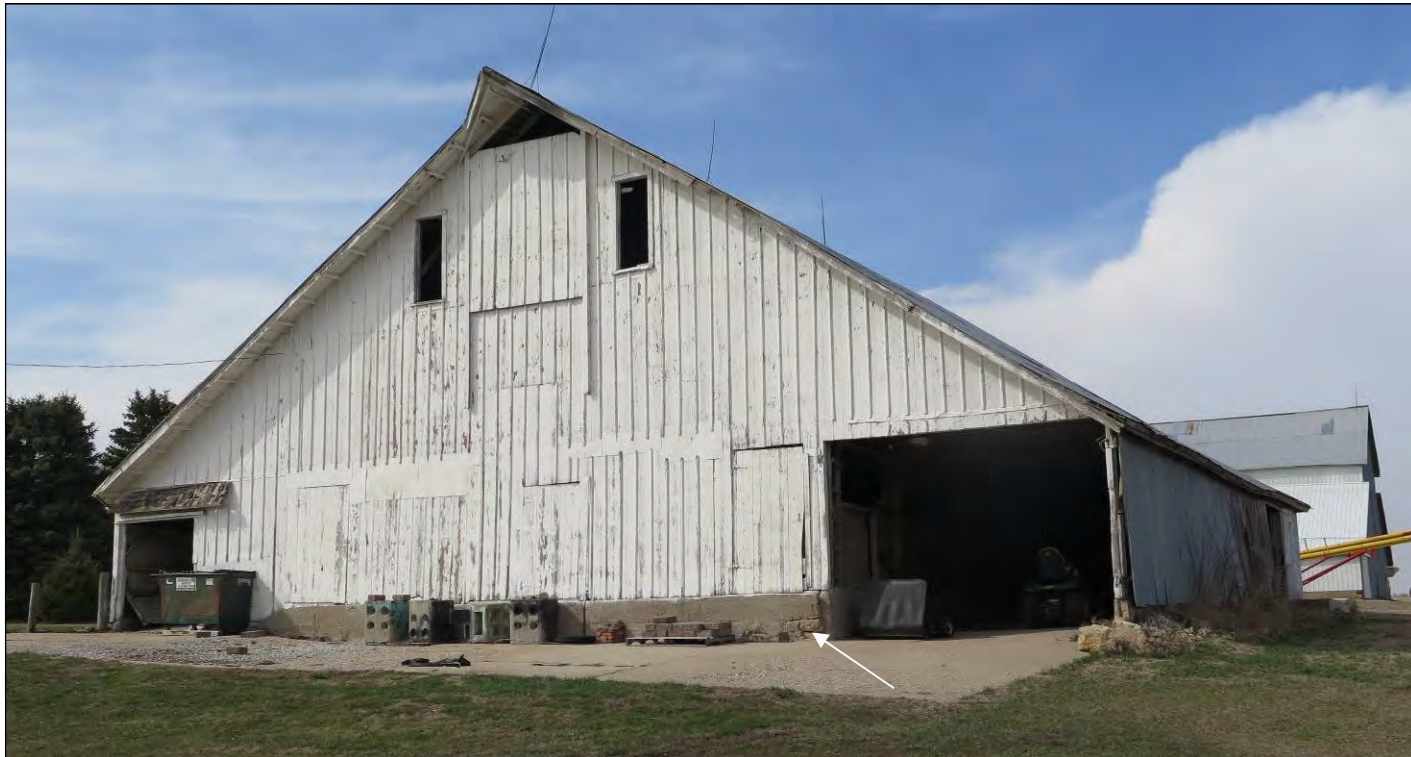
Figure 10. The south face of the late 19th-century Middle Barn looking NNW. It is called the show barn because it was used to provide cattle shows for prospective buyers who would visit from around the state and country. Show days at the Pleasant View Farm were festive events. The original stone foundation is visible through the concrete on this side of the barn (white arrow).

This is the middle of the three barns and is believed to have been built in the late 19th century, probably in the 1880s-1890s. It is an extended-gable, three-portal barn with rear shed and a gabled hay-mow dormer on the west roof slope (Figures 10-11). The barn is clad in the original, wooden board-and-batten siding but has been covered over or replaced with metal siding in a few places. It has a corrugated metal roof. The original foundation was made of stone, which has been repaired with concrete in several places. The floors are both dirt and poured concrete. In addition to being a feeder barn, this building served as a show area for prospective buyers coming from across the United States at the peak of the Pleasant View cattle operation. This barn is a traditional shape that adheres to standard of this style but features an unusual dormer facing west where hay could be put into the loft. Three alleyways create a U shape around the central space with three pens alongside this area. The three alleys and central space are entirely open; the hay mow is open as

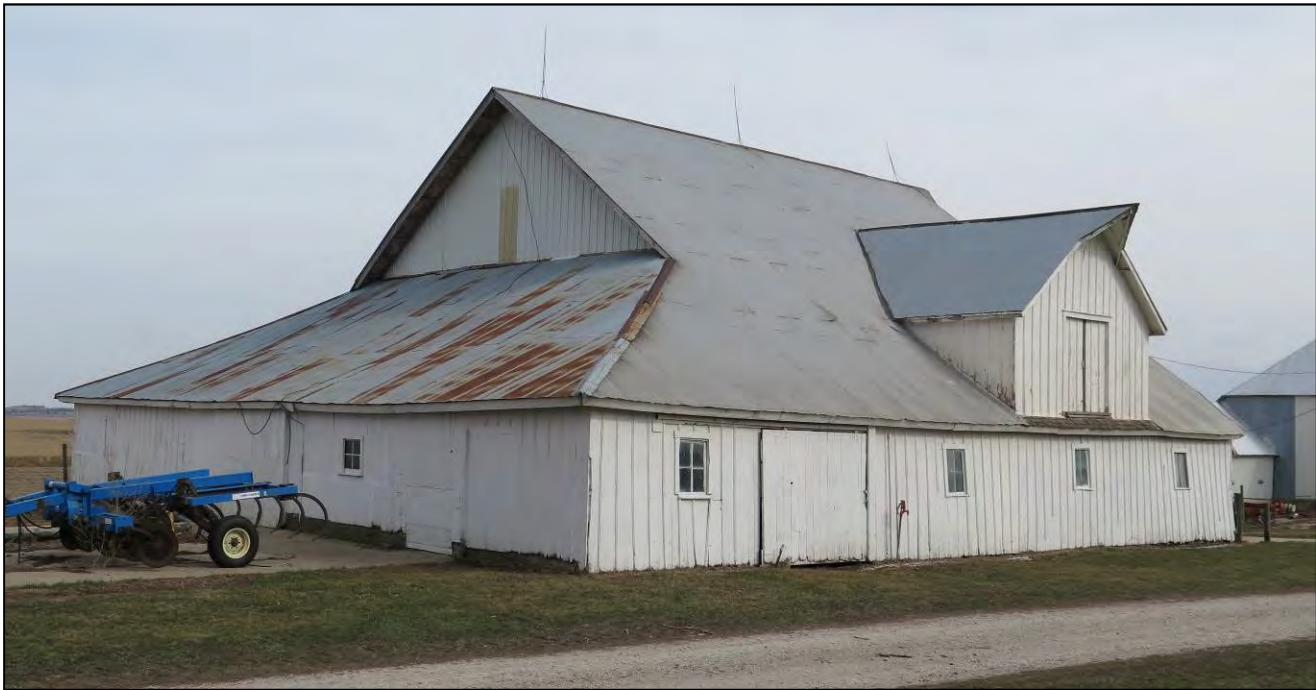
Figure 10. The Middle Barn looking SE showing hay mow dormer.
Photograph taken by Tallgrass Archaeology LLC, 04/12/2018.

West Face: The west face of this barn is dominated by the large, front-gabled dormer off-center on the roof slope. This dormer has a metal roof and is also clad in wooden board-and-batten siding, painted white. Centered on the dormer is a loft door that consists of two board-and-batten sided wooden doors (Z-braced on the interior) that open into the loft. The dormer also has a triangular hood that extends out over the doors. Three lightning rods are evenly spaced along the roof ridge. The main floor of the west face has four fixed, four-pane, rectangular windows along the length of the barn. Two of the windows flank a wide opening that is covered by a wooden sliding door. This door enters into the aisle formed by the rear shed (see Figure 10).

North Face: There is a single, fixed, 4-pane window situated near the center of this side. There were once three door openings on this side, one a regular entry door on the west side of this wall, one a small animal-sized opening immediately to the left of the regular entry door, and the third a larger opening that had a sliding door that now appears to be fixed in place. The hipped roof over the shed is covered in corrugated metal roofing and extends upward towards the gabled end of the main barn. The board-and-batten siding is painted white and has been patched in places with metal siding. Above the shed roof, the gable end of the main barn is clad with white metal siding (see Figure 10).

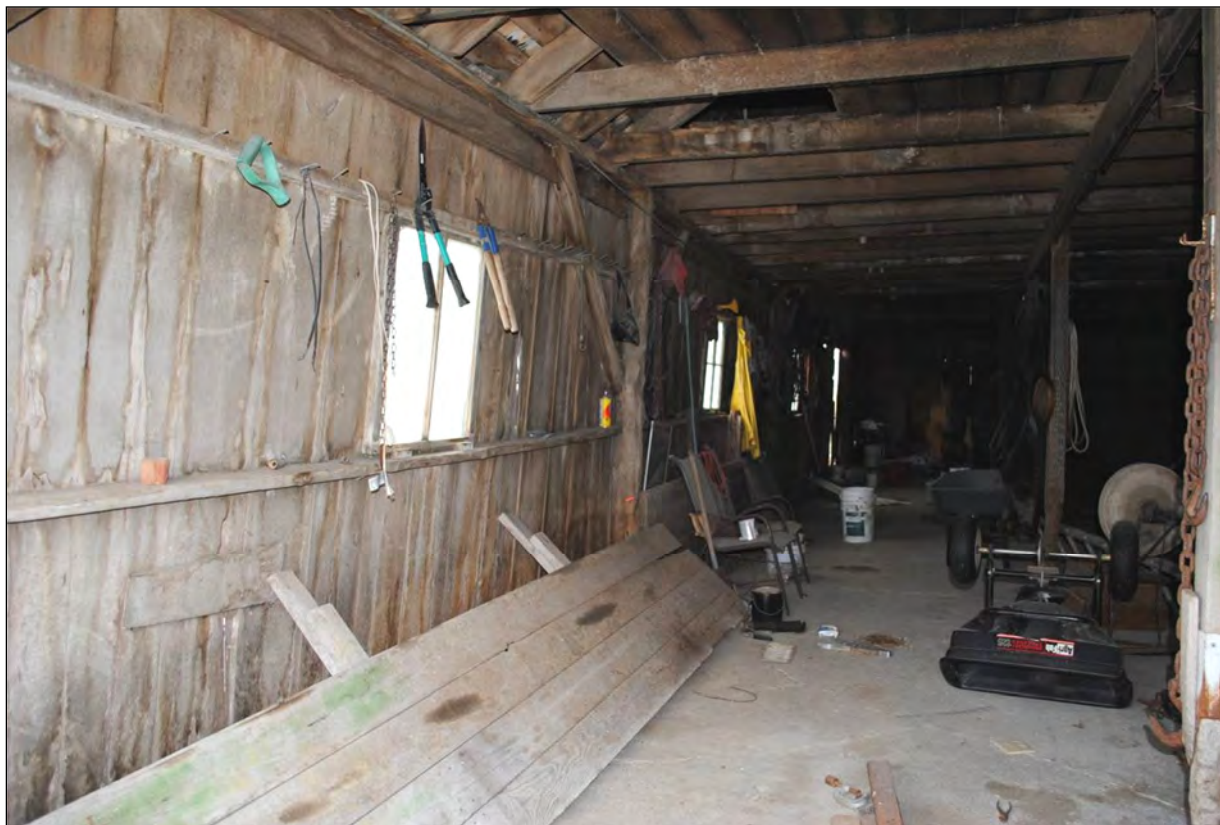
Figure 11. Interior view of the Middle Barn's west wall and alley looking north. The vertical posts along the exterior of the alley walls are debarked poles. Photograph taken by Tallgrass Archaeology LLC, 04/13/2018.

Interior: The ground floor of this barn is covered in poured concrete on three sides of the barn, creating a U-shaped, concrete floor along the west, north, and south exterior alleys. The south ends of the two east and west alleys are accessed by entrances without doors. The east alley slopes downward to about two feet below the west alley. The central area is a patchwork of frame supports and wooden partitions that provided subdivided holding pens for cattle during the shows. For that reason, the central area has a dirt floor. Loose hay is still present in some places. The interior framing is heavy timber frame using sawn posts, beams, and cross bracing (Figure 11). The joinery is pegged mortise and tenon. The lower level has some vertical posts that are debarked poles (Figures 11-14). Some of the cross bracing added to the ground level is nailed to the posts. These braces were likely added because the hay in the loft grew heavy and additional floor support was needed (Figure 12). This type of heavy timber frame construction is consistent with a late 19th-century date of construction, with the sawn elements indicating that sawmills were present locally or sawn timbers were available via the railroad in nearby Irwin.

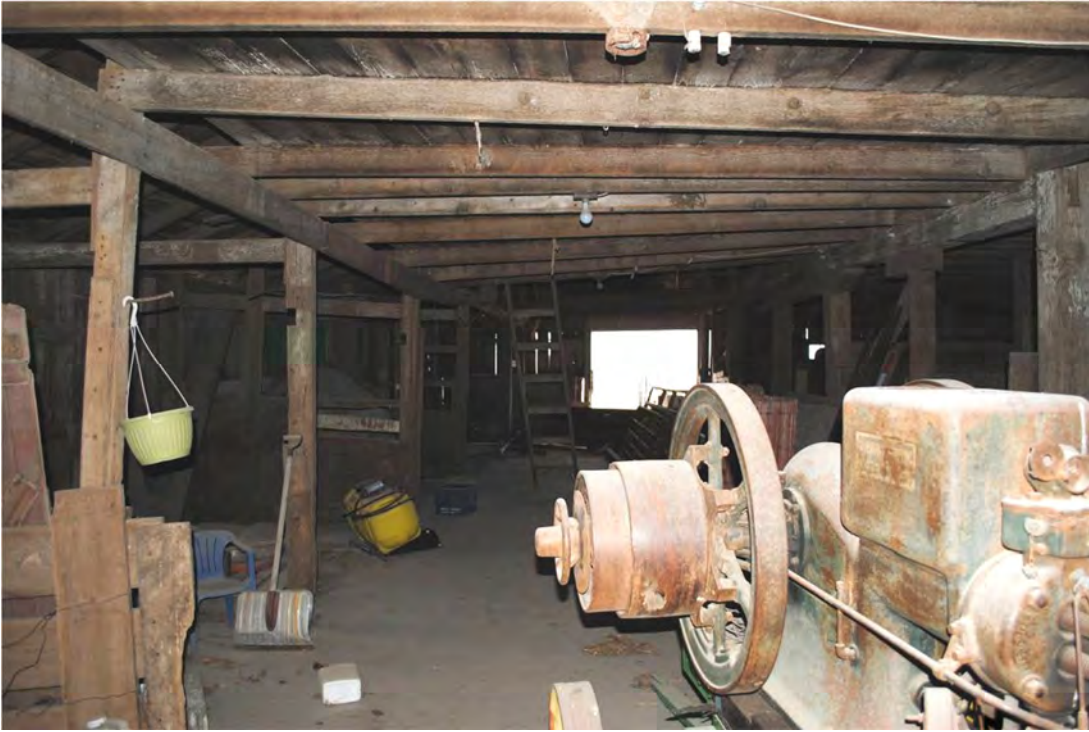
Figure 12. One of the interior alleys of the Middle Barn, where animals were often showed. A variety of joining methods were used in the construction of this barn. Mortise-and-tenon can be seen with some of the heavier framework, whereas simple nails hold some of the cross-beams together, here to add support to the loft floor from underneath. *Photograph taken by Tallgrass Archaeology LLC, 04/13/2018.*

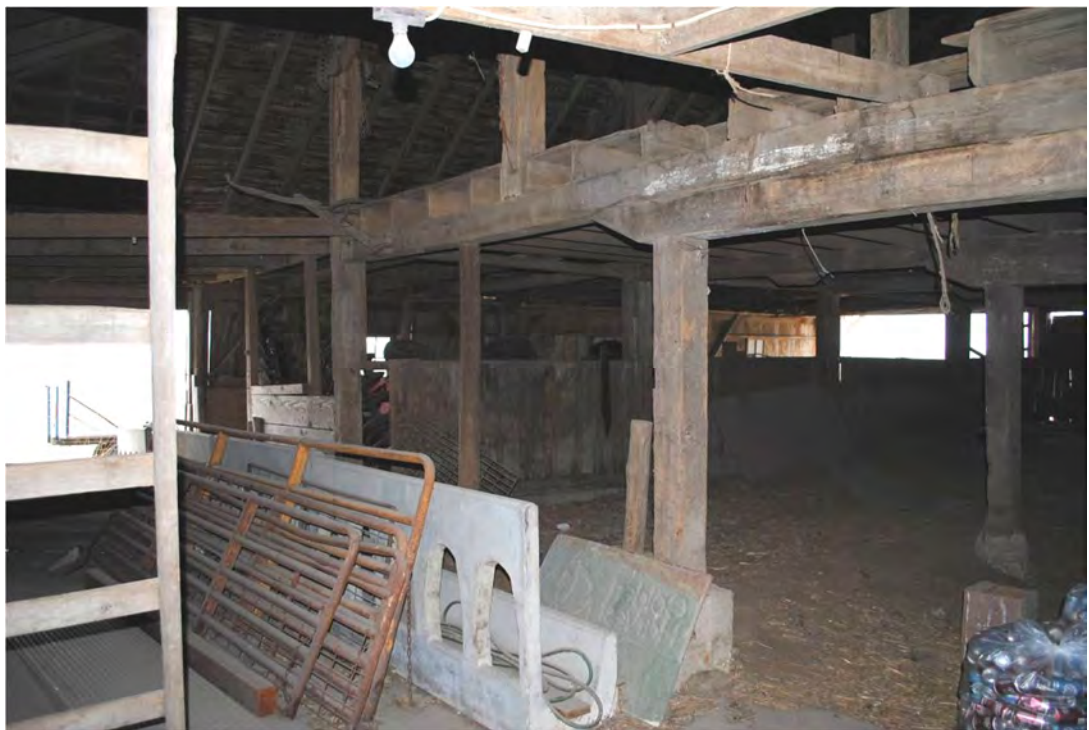
Figure 13. The north alley of the Middle Barn, with an exit to the east side of the building. The farthest alley, along the East wall leads to another exit. Interior alleys all connect to this section. A ladder leading up to the large hay mow can be seen as well at left. *Photograph taken by Tallgrass Archaeology LLC, 04/13/2018.*

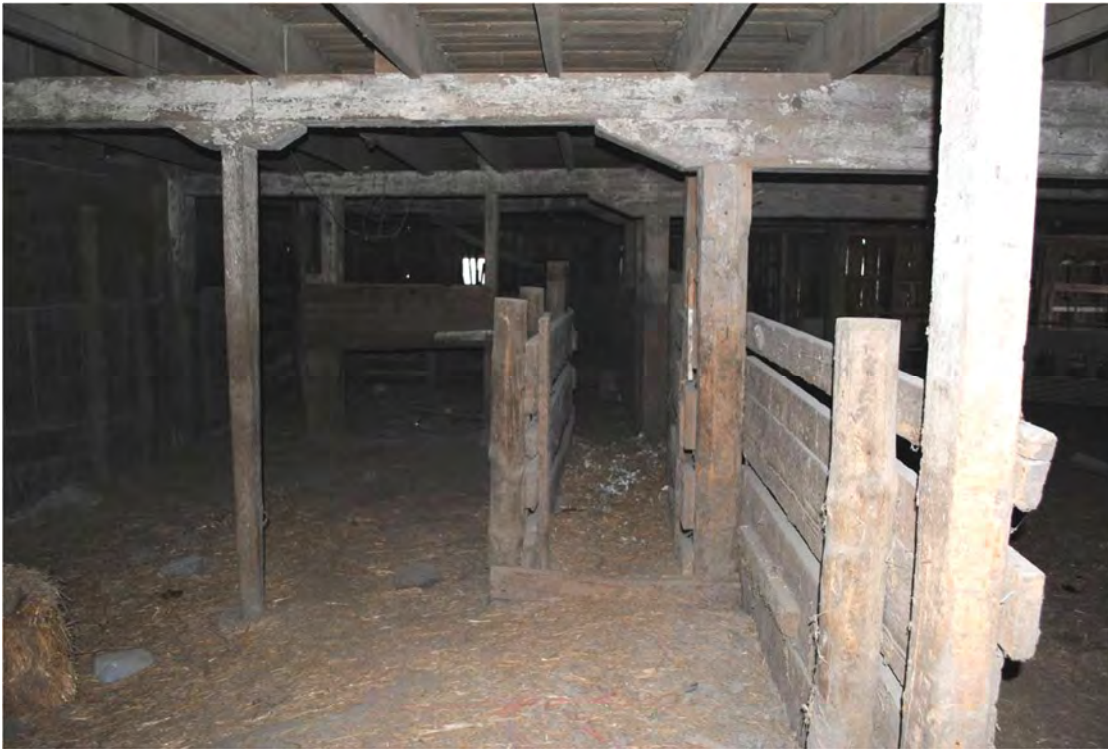
Figure 14. Another photograph of the Middle Barn's interior alleys showing the partitions for pens and chutes.
Photograph taken by Tallgrass Archaeology LLC, 04/13/2018.

It is suspected that the wooden bleachers on which prospective cattle buyers would sit during the shows were in the north aisle-section of the barn. This area would allow for movement of the cattle into and out of the barn via the east concrete ramp and west alley and into the central holding pens without interfering with the audience.

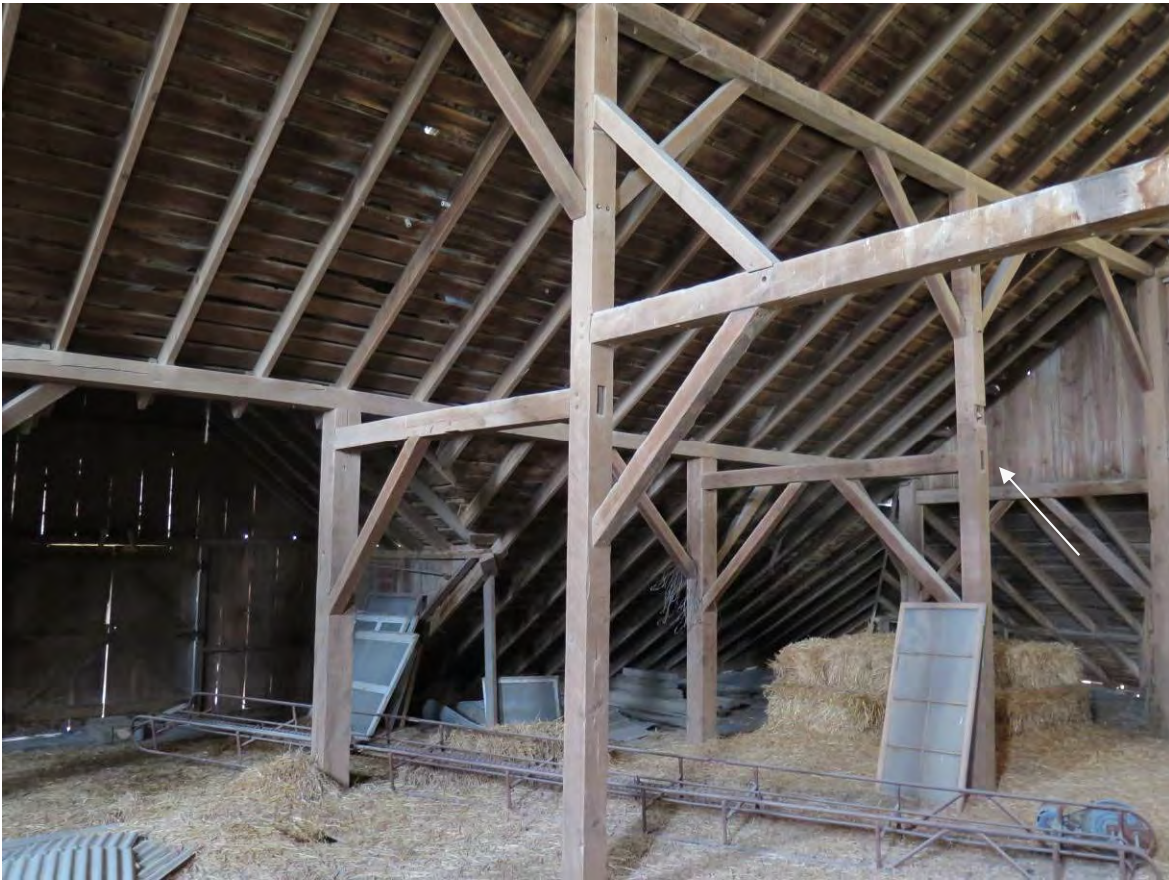
Figure 15. Interior framing of the loft in the Middle Barn's looking NW. Note the gabled dormer at the left in this photograph. White arrow points to a location where the cross beam is now missing between the center set of posts.

The hayloft is accessed by a wooden ladder near the north end of the barn. The upper framing shows five bents: two end bents and three interior bents (Figures 15-16). The wooden floor boards are still covered in a thin layer of loose hay. To the south, the gabled end of the barn is open in three locations and a door covers what is the main access to the hay mow. To the north, the hipped roof of the lower shed area ascends quickly to meet with the south gable of the barn. The west-facing dormer creates a large area for additional hay storage and has another primary access covered by a door. The heavy timber framing in the loft area shows the long beams were spliced with a simple angled Z-splice. There is at least one middle cross beam in the framing that is missing indicating some deterioration or purposeful removal to make more head-room in that location (see Figure 15).

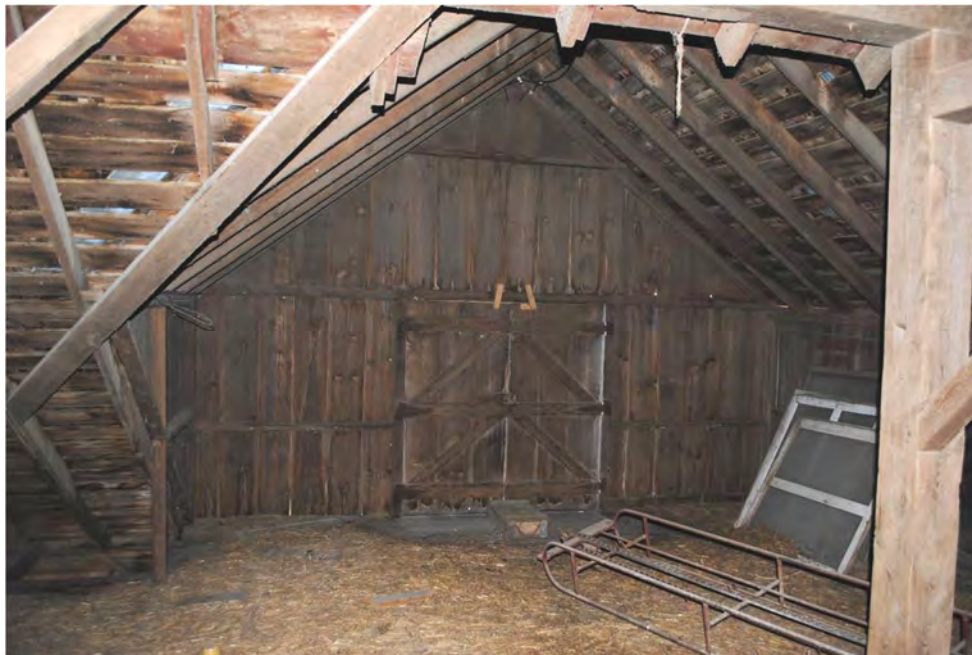
Figure 16. Interior of the gabled dormer in the Middle Barn's hay mow. *Photograph taken by Tallgrass Archaeology LLC, 04/13/2018.*

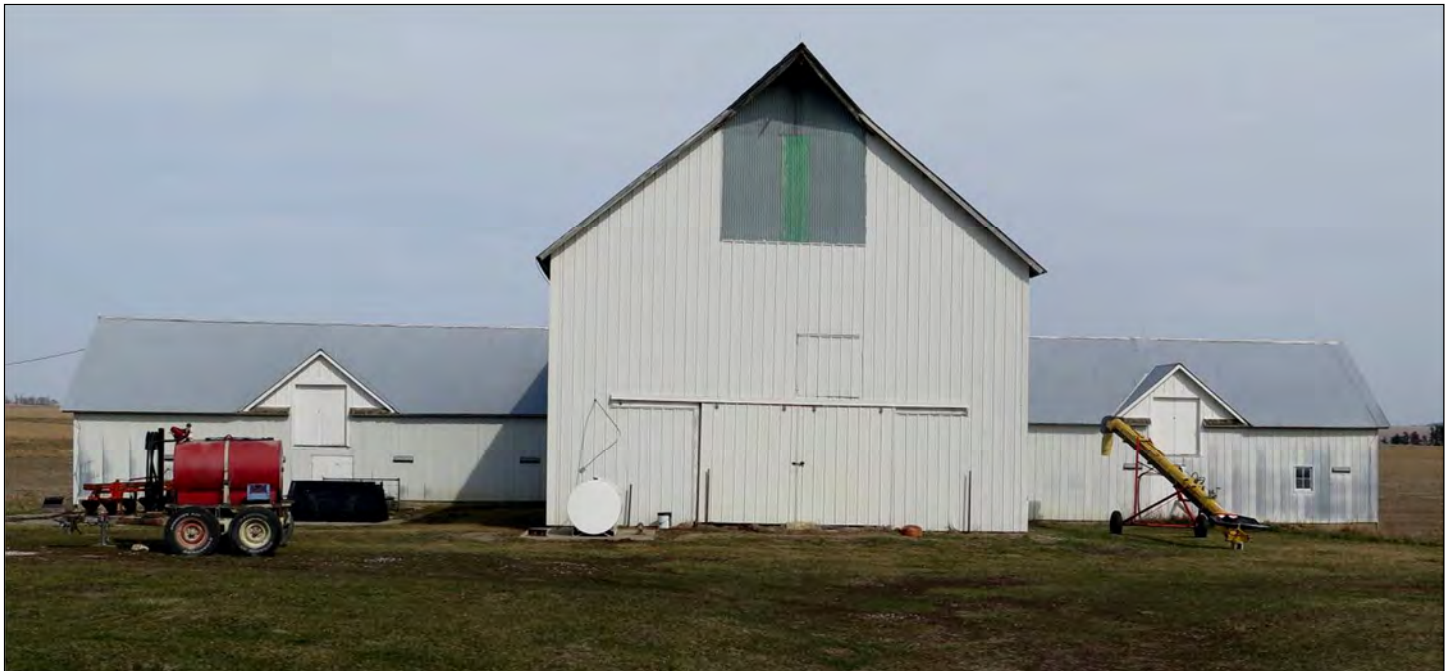
Figure 17. West elevation of the circa 1910 T-shaped South Barn. Notice the hooded hay mow and gabled dormers centered on each of the north and south wings. *Photograph taken by Tallgrass Archaeology LLC, 04/12/2018.*

West Face: The western elevation of this barn reveals the three main sections of this unique barn: the original main body of the barn that extends to the west and the two perpendicular wings that extend north and south off the rear (east end) of the main barn, respectively (Figure 17). The main body of the barn is clad in metal "board and batten" siding, which covers over some of the original window and door openings. There is a sliding double-door centered on the west end of the gabled barn and a small portal above to the hay mow, and a larger portal higher up to reach the upper portion of the loft. The original mow door is covered in metal siding and no longer opens. The highest portal is the only portion of the barn covered in grey metal siding. The roofline is capped with a classic Midwestern hay track hood. The two wings of the barn have several features in common. Each is covered in white metal siding, each has vents and fans inserted from the hog raising operation, and each has a west-facing gabled wall dormer, each with a small double door that accesses the loft above these wings from the exterior. The south wing has two fixed, four-pane windows on this side, though the north wing no longer has exposed windows, having been covered with metal siding or having vents inserted.

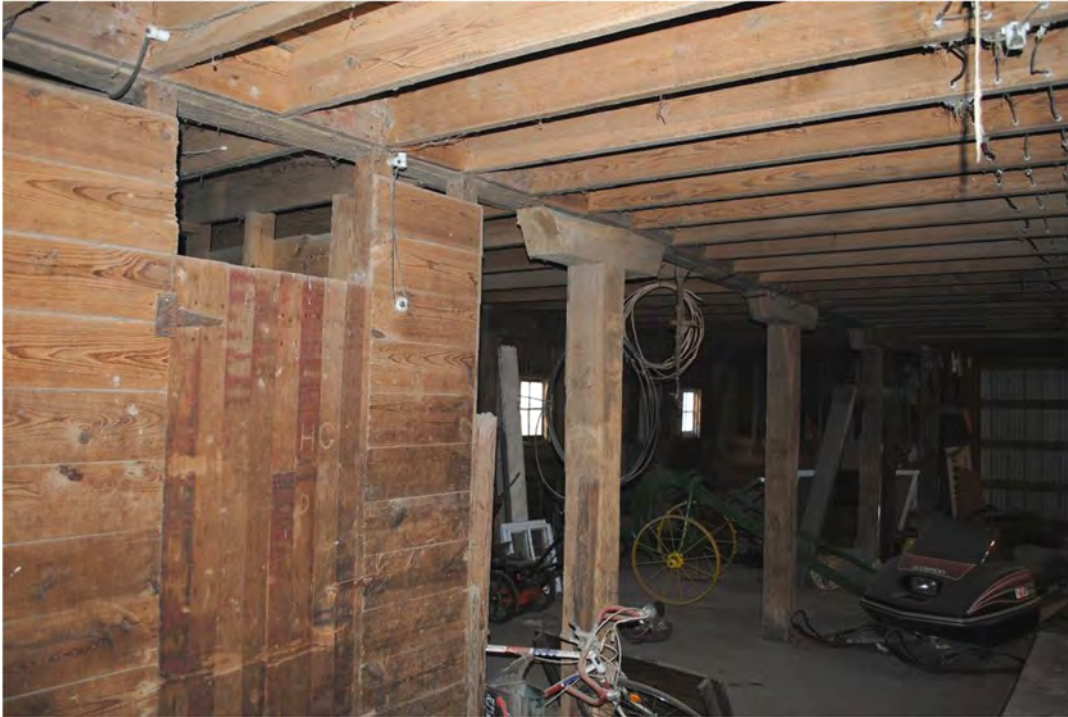
Figure 18. Main level of the South Barn's front-gabled original section looking WSW. Four rows of posts support the hay mow above. The oat bin is to left, with horse stalls to the west. Photograph taken by Tallgrass Archaeology LLC, 04/13/2018.

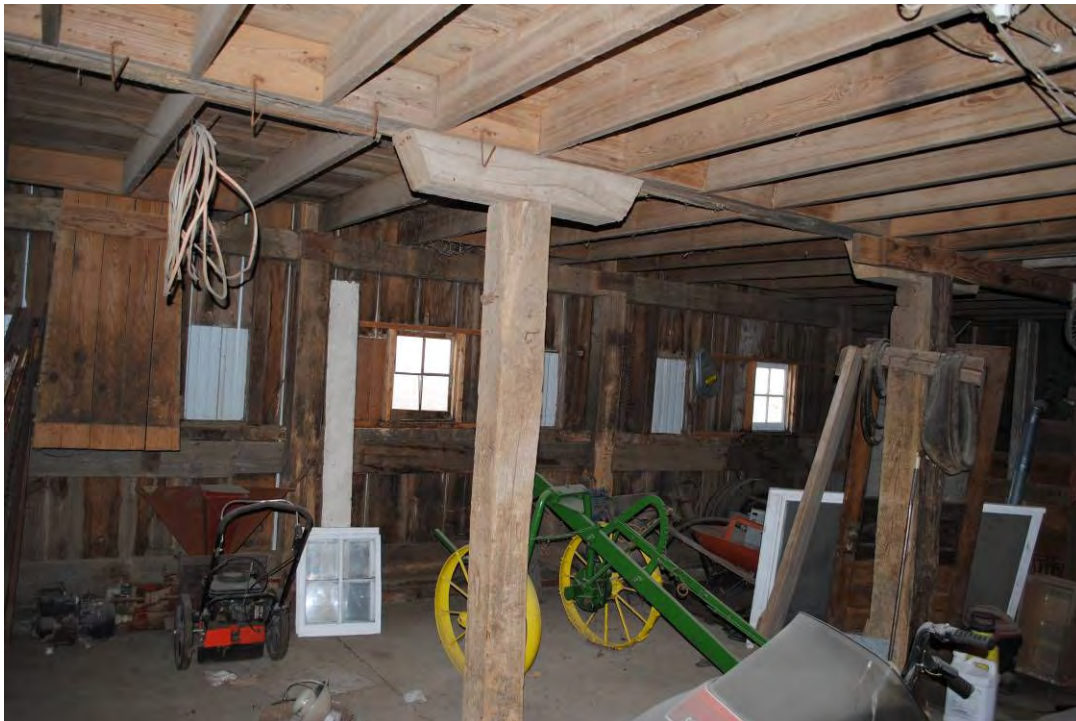
Figure 19. Another view of the South Barn's main floor in the front-gabled original portion of the barn looking NE. Photograph taken by Tallgrass Archaeology LLC, 04/13/2018.

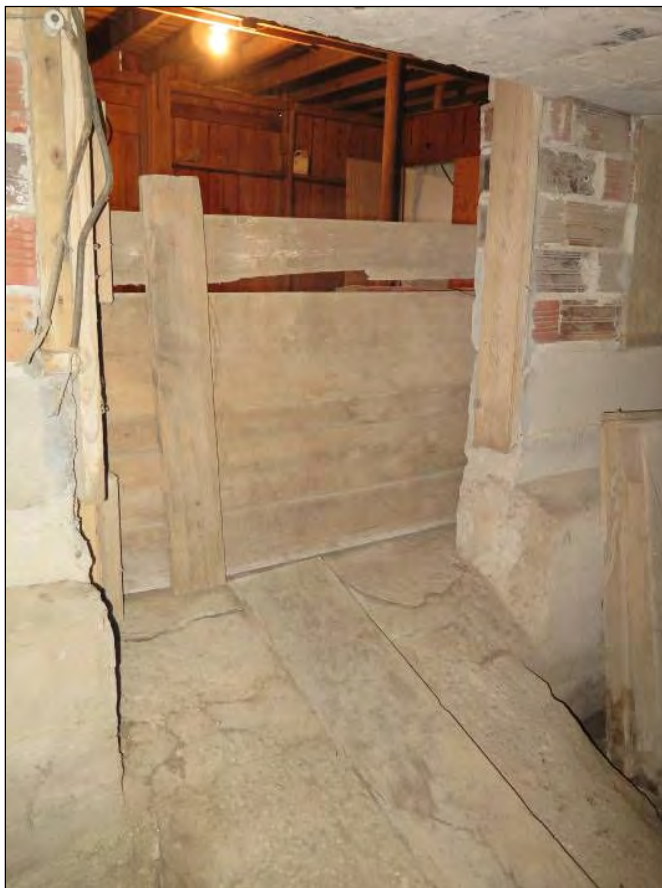
Figure 20. Ramp that descends into the basement alley below the main barn connecting to the middle room of the winged east sections of the barn. Photograph taken by Tallgrass Archaeology LLC, 04/13/2018.

Below the east half of the main barn are the added subterranean rooms that are walled with clay tile blocks and are reached by the alley described above (Figures 20-21). This basement level consists of two rooms that have open doorways into the perpendicular alley that is reached either by the ramp (see Figure 20) or the stairs noted above (Figure 22). These rooms have dirt floors with the lower part of the exterior walls being poured concrete up to the ground level where five courses of clay tile blocks are laid. The west wall is made entirely of clay tile blocks, while the north outer wall is entirely poured concrete (see Figures 20-21). There is now an opening in the upper part of the south wall that was not there originally (see Figure 21). The ceilings of the basement rooms are poured concrete that had board forms for the pouring that were later removed.

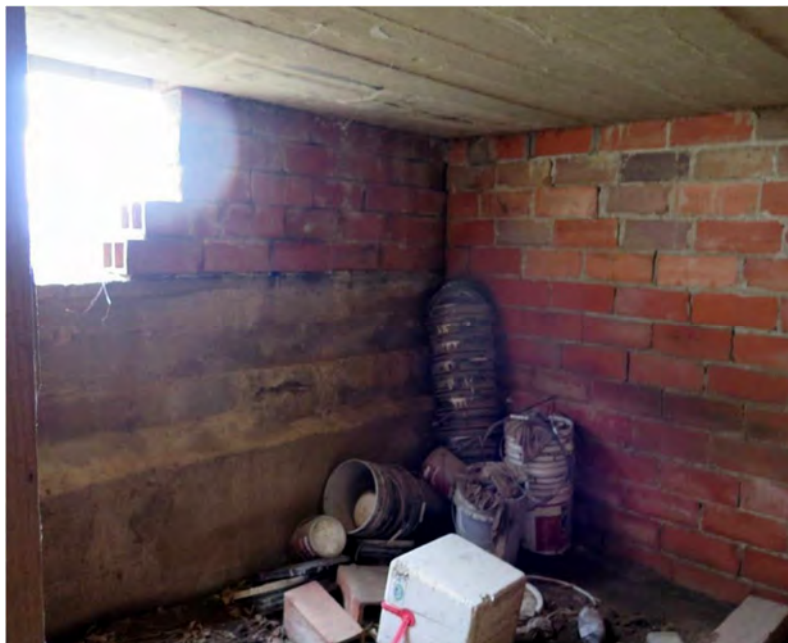
Figure 21. Interior of one of the two rooms in the central lower level below the front-gabled barn section. Photograph taken by Tallgrass Archaeology LLC, 04/13/2018.

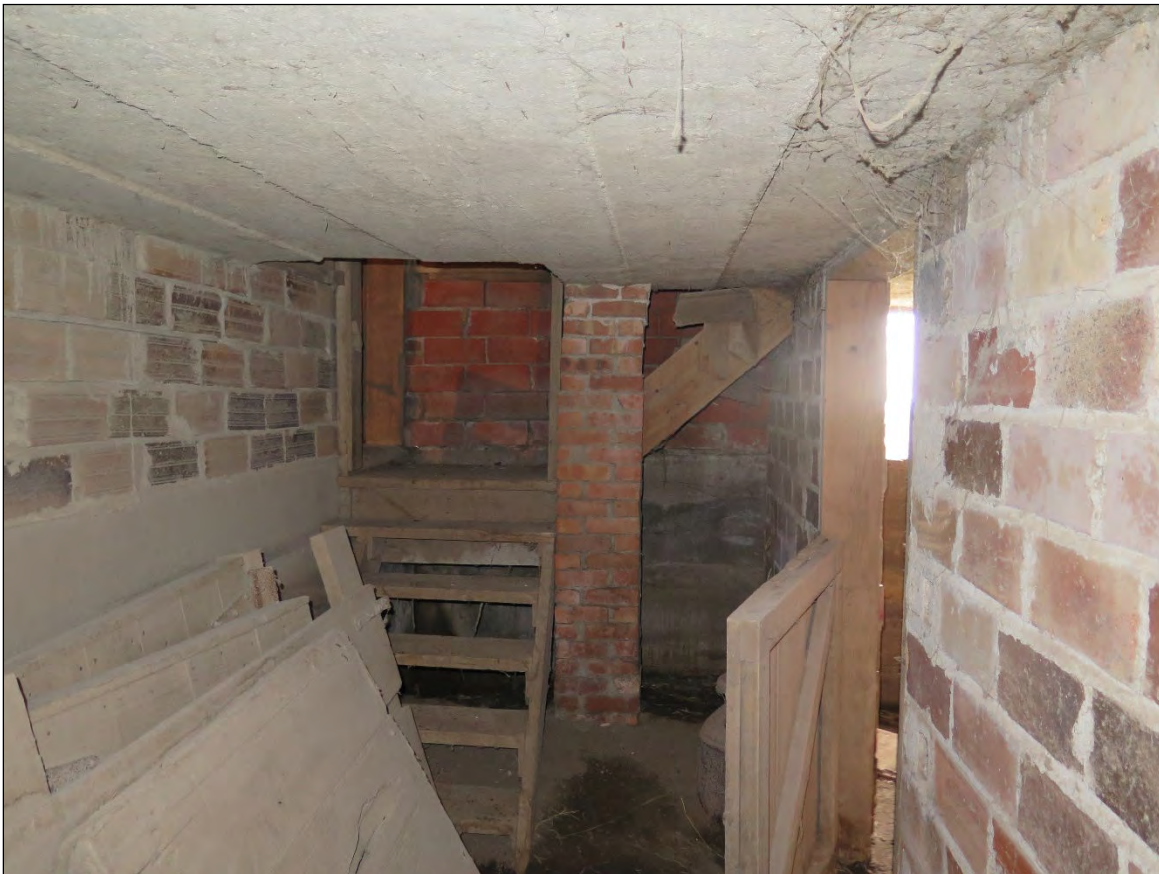
Figure 22. Interior of basement alley looking south at the wooden stairs and landing that lead down to the basement alley and up to the ground level of the main barn. Note the brick pier that supports the concrete ceiling above and to which the staircase is fixed.
Photograph taken by Tallgrass Archaeology LLC, 04/13/2018.

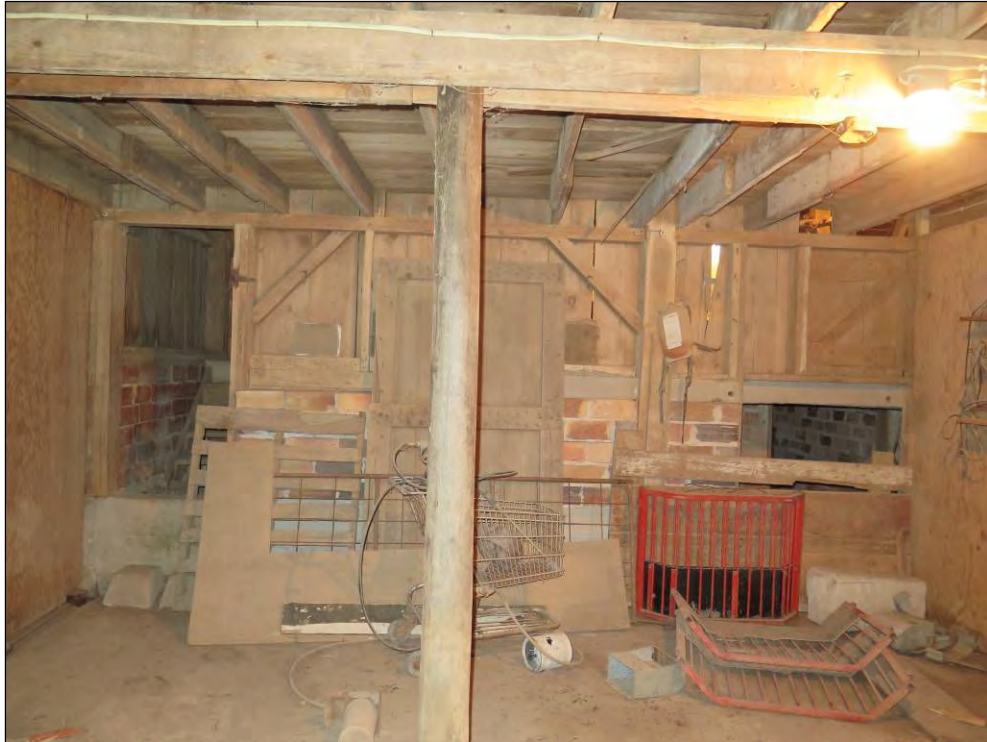
Figure 23. Center room of the South Barn off the east end of the front-gabled barn and connecting the north and south wing additions looking west. Beyond that wall is the main part of the barn, the north and south wings can also be accessed from this room, to the right and left of this room. *Photograph taken by Tallgrass Archaeology LLC, 04/13/2018.*
