National Register of Historic Places Registration Form

historic name Pleasant View Stock Farm Historic District

Shelby County, Iowa

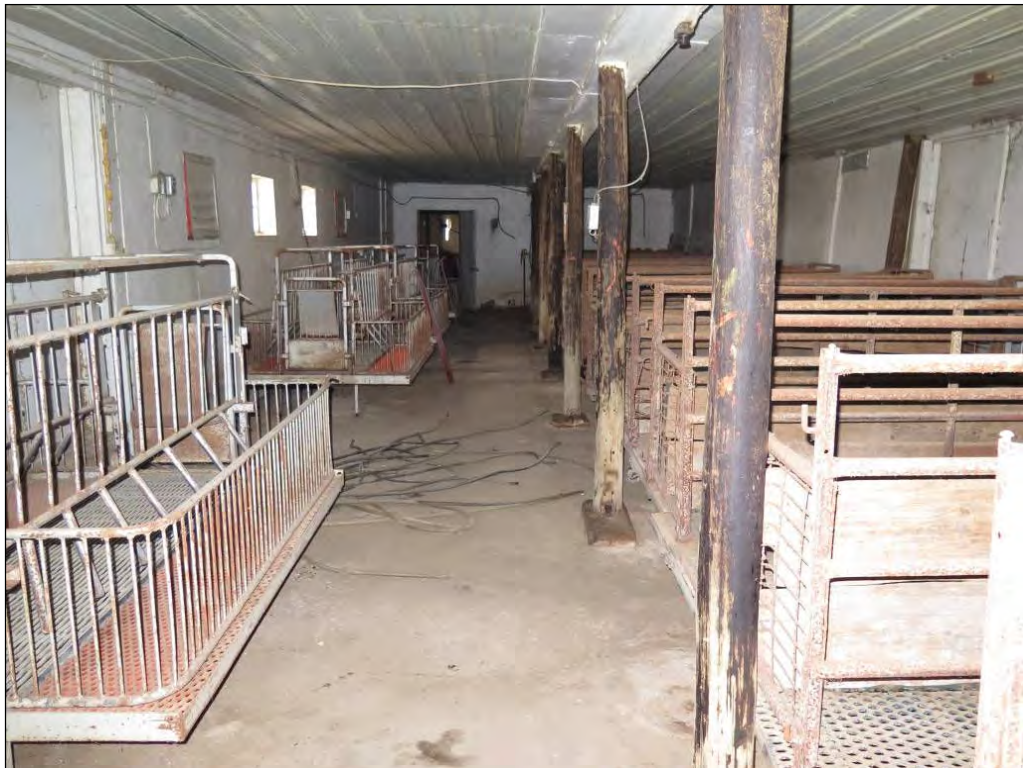
Figure 24. Main level of the north wing of the South Barn looking south. The wing is lined with metal farrowing pens for the later hog operation. Here the center poles are metal. *Photograph taken by Tallgrass Archaeology LLC, 04/13/2018.*

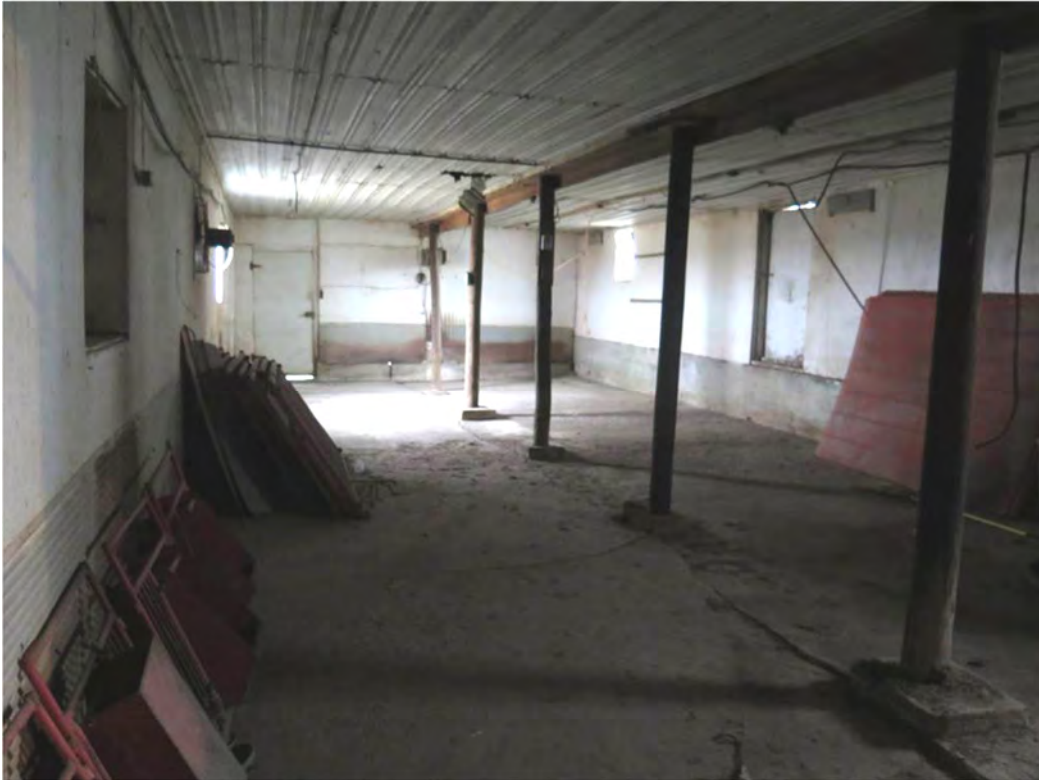
Figure 25. Open interior of the south wing of the South Barn looking south. Here the center poles are wooden.
Photograph taken by Tallgrass Archaeology LLC, 04/13/2018.

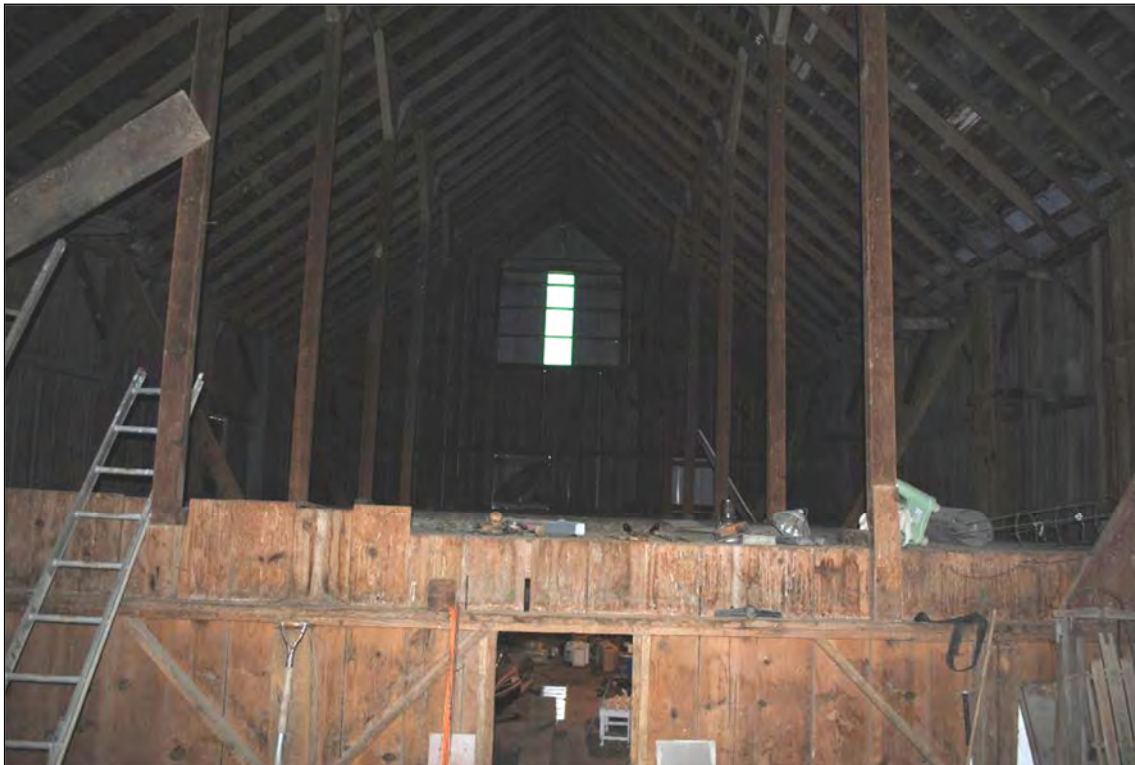
Figure 26. Hay mow above the main body of the barn looking west into the loft from the lower loft of the wings. The small portal visible in the east wall just below the loft opening is the current access from the ground level of the front-gabled barn to the loft.
Photograph taken by Tallgrass Archaeology LLC, 04/13/2018.

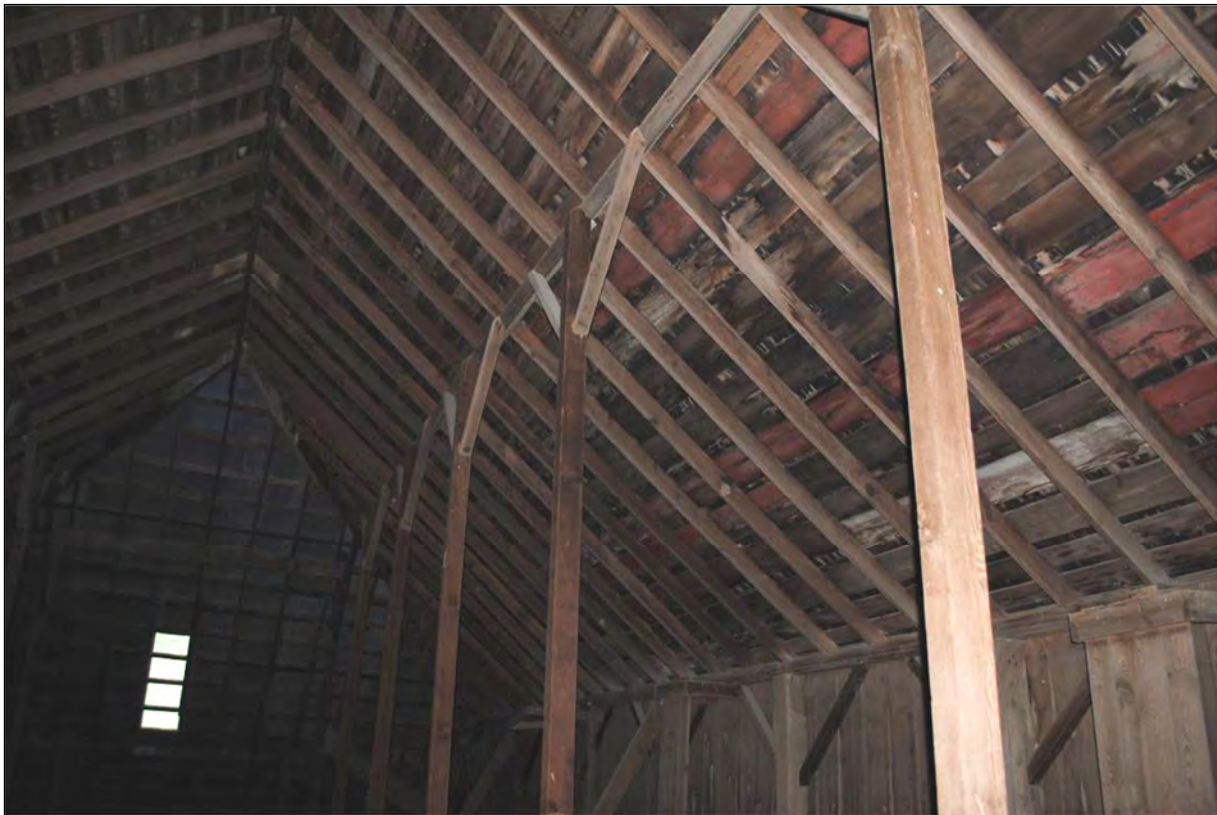
Figure 27. Interior framing of the front-gabled section of the barn looking east. Photograph taken by Tallgrass Archaeology LLC, 04/13/2018.

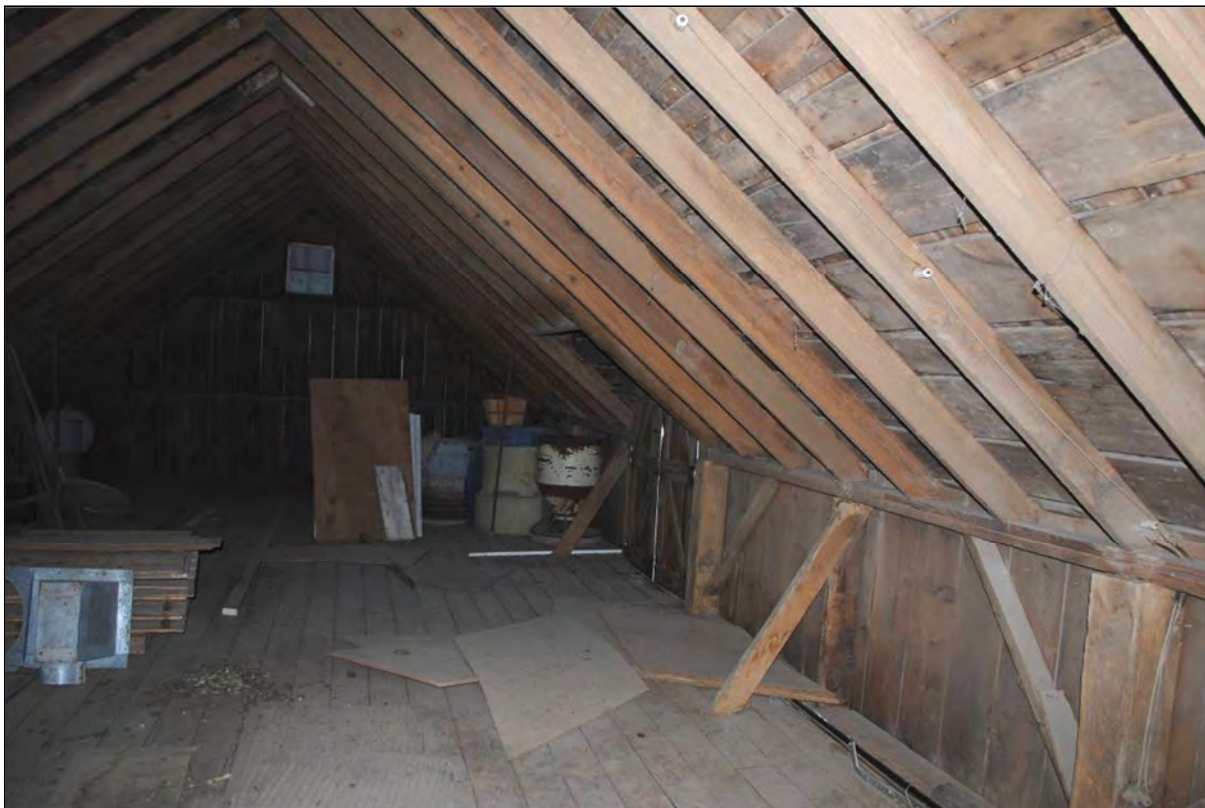
Figure 28. Loft above the south wing looking south. Photograph taken by Tallgrass Archaeology LLC, 04/13/2018.

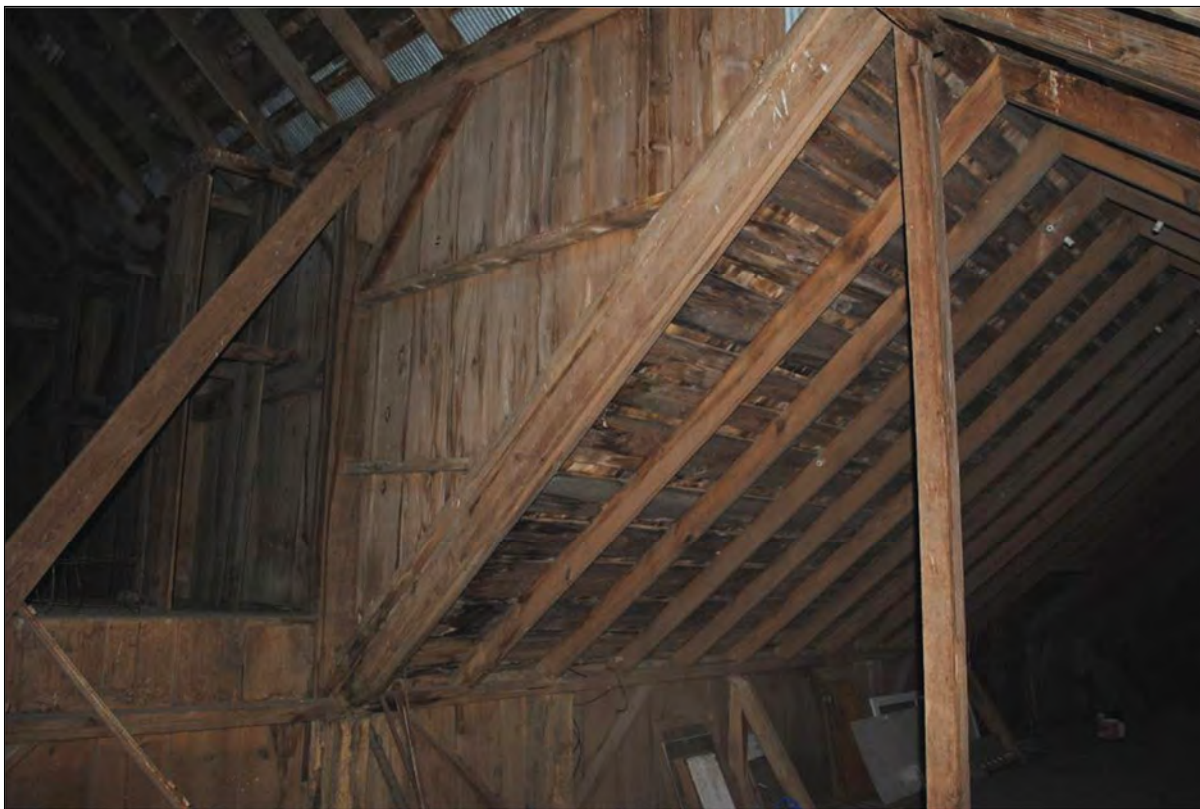
Figure 29. Loft of South Barn where the north wing (right) meets the main body of the barn (left) looking NW.

Some vertical posts are placed at several locations in the loft space over the north wing for additional support but may have been added later.

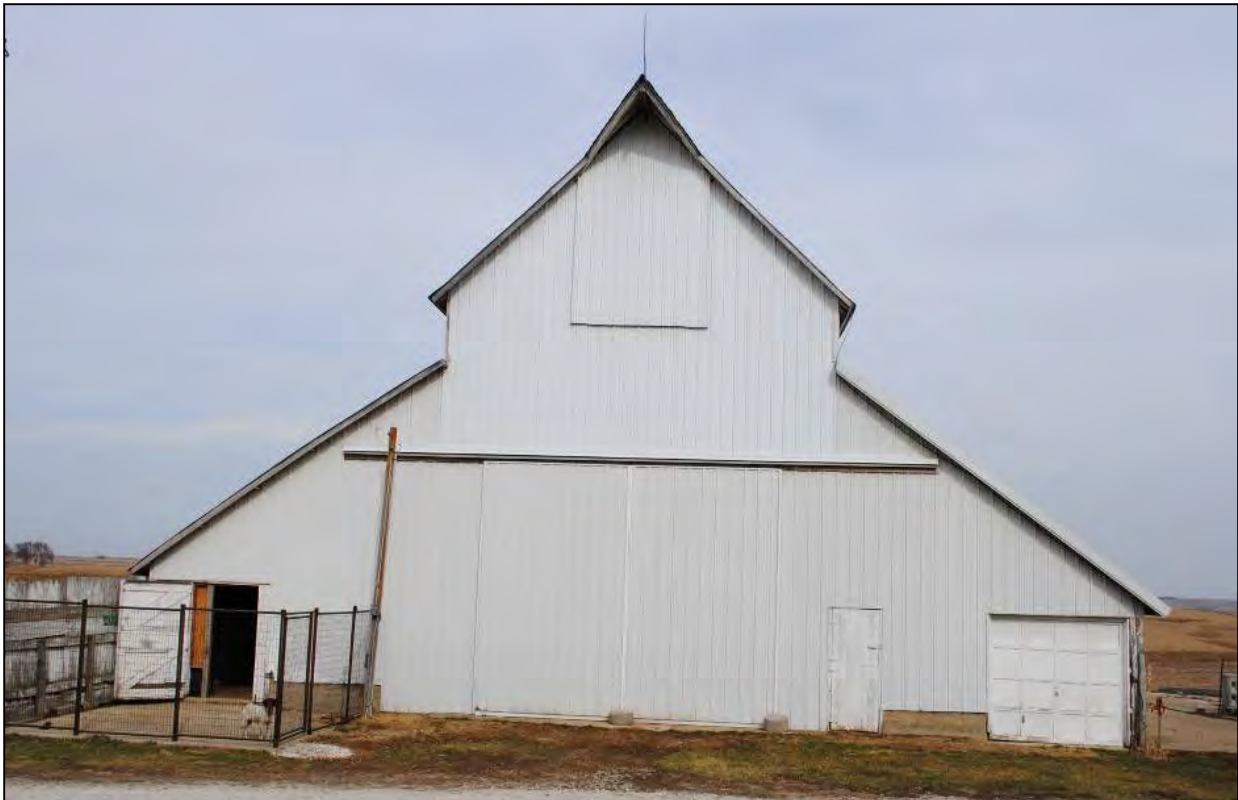
Figure 30. Façade (west end) of North Barn looking East. Taken by Tallgrass Archaeology LLC, 04/12/2018.

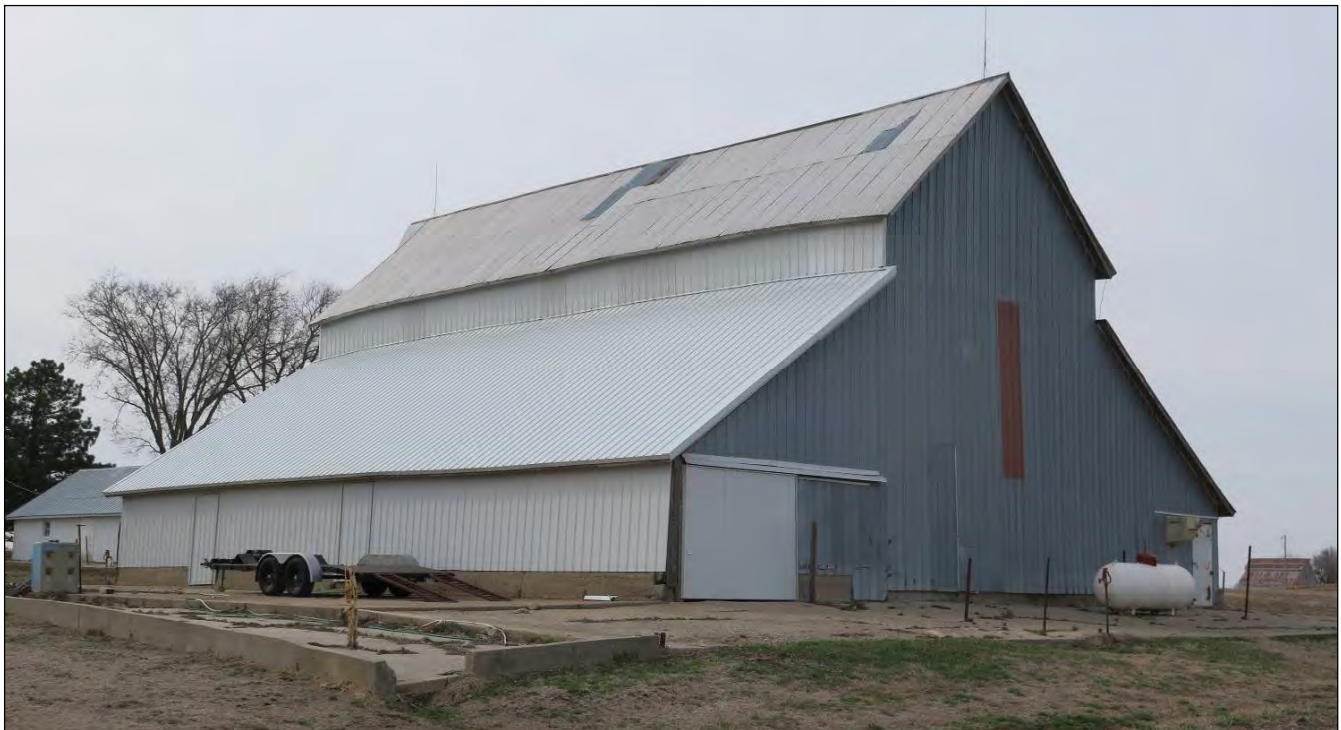
Figure 31. This circa 1910 barn is clad in modern metal siding but characterized by its distinctive monitor roof. It was originally a calving and feeding barn, but, much like the other buildings at Pleasant View, it is currently used for equipment storage.

East Face: The concrete pad for the cattle yard extends around the east side of the barn as well (see Figure 31). The majority of the east face of the barn is covered in grey metal siding. Much like the west face, there are two portals at the north and south ends of the ground floor. The south door is a wider opening like the one opposite on the west face but is covered with a sliding door rather than an overhead door (see Figure 31). The north door is a regular entry door that has a metal fan inserted to the left of the door (see Figure 31). This door and fan are part of an interior room in the northeast corner that was later used for the hog operation.

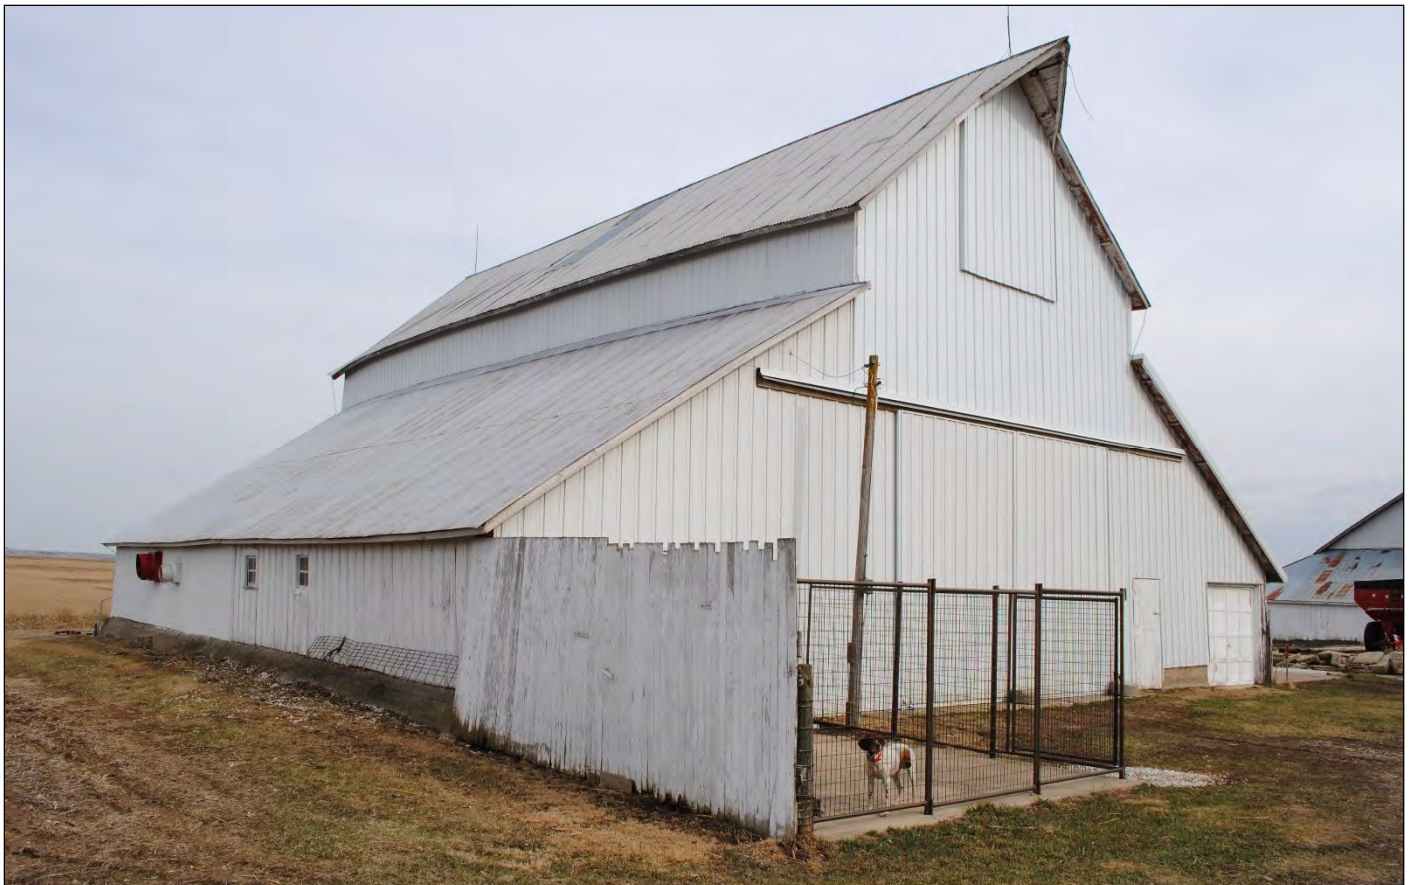
Figure 32. Monitor roof barn looking ESE at the façade and north side of the barn. Photograph taken by Tallgrass Archaeology LLC, 04/12/2018.

North Face: The north face differs from the rest in that half of the ground-floor wall has the original wooden board-and-batten siding exposed along with two four-pane, fixed windows placed near the center of the wall (Figure 32). The east window still retains its original peaked lintel board and wooden sill and surrounds, while the west window has lost all but one piece of its surround (see Figure 32). The rest of this wall appears to be clad with modern, vertical board siding painted white into which a large, metal fan and a metal vent were inserted for the hog operation in the southeast interior room.

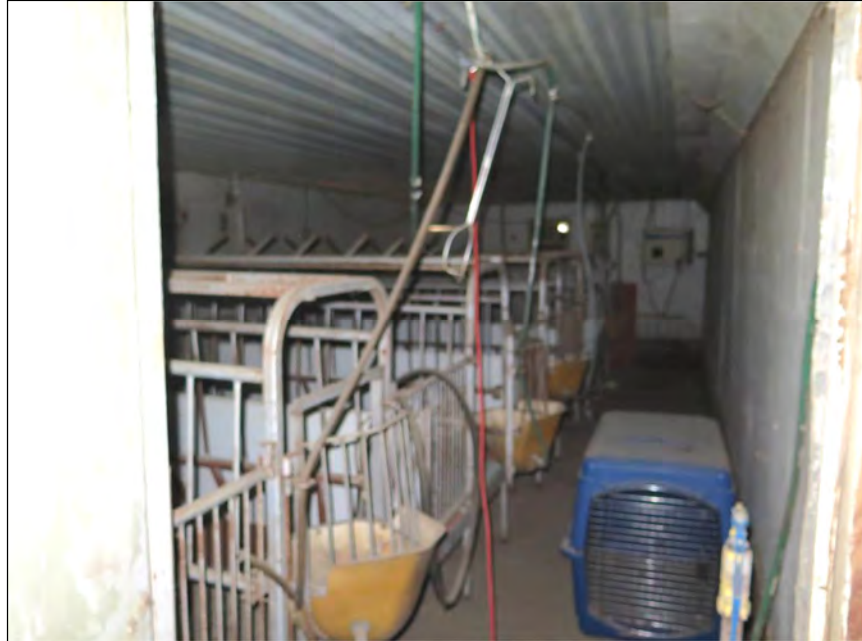
Figure 33. Metal stalls for hogs in northeast interior room in the North Barn looking east.
Photograph taken by Tallgrass Archaeology LLC, 04/13/2018.

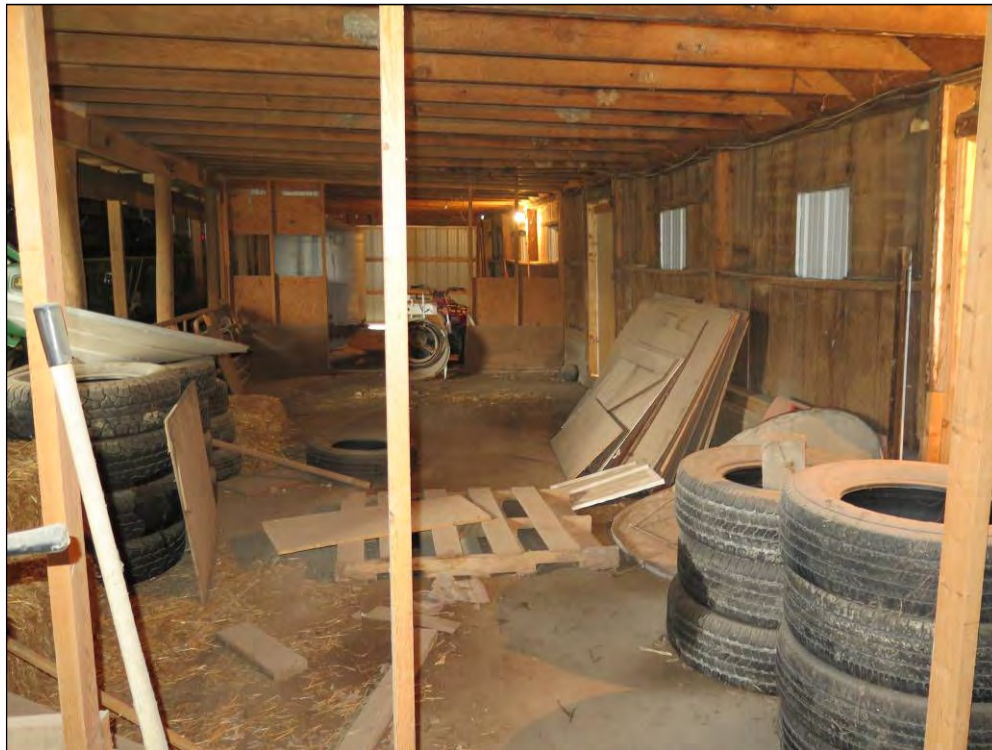
Figure 34. Interior of south section of North Barn. Note the former window openings now covered over by exterior metal siding.
Photograph taken by Tallgrass Archaeology LLC, 04/13/2018.

are not equal in size; one being longer than the other (Figure 34). The ceiling above each lower section forms the floor of the loft spaces above, which are open to the center aisle (Figure 35).

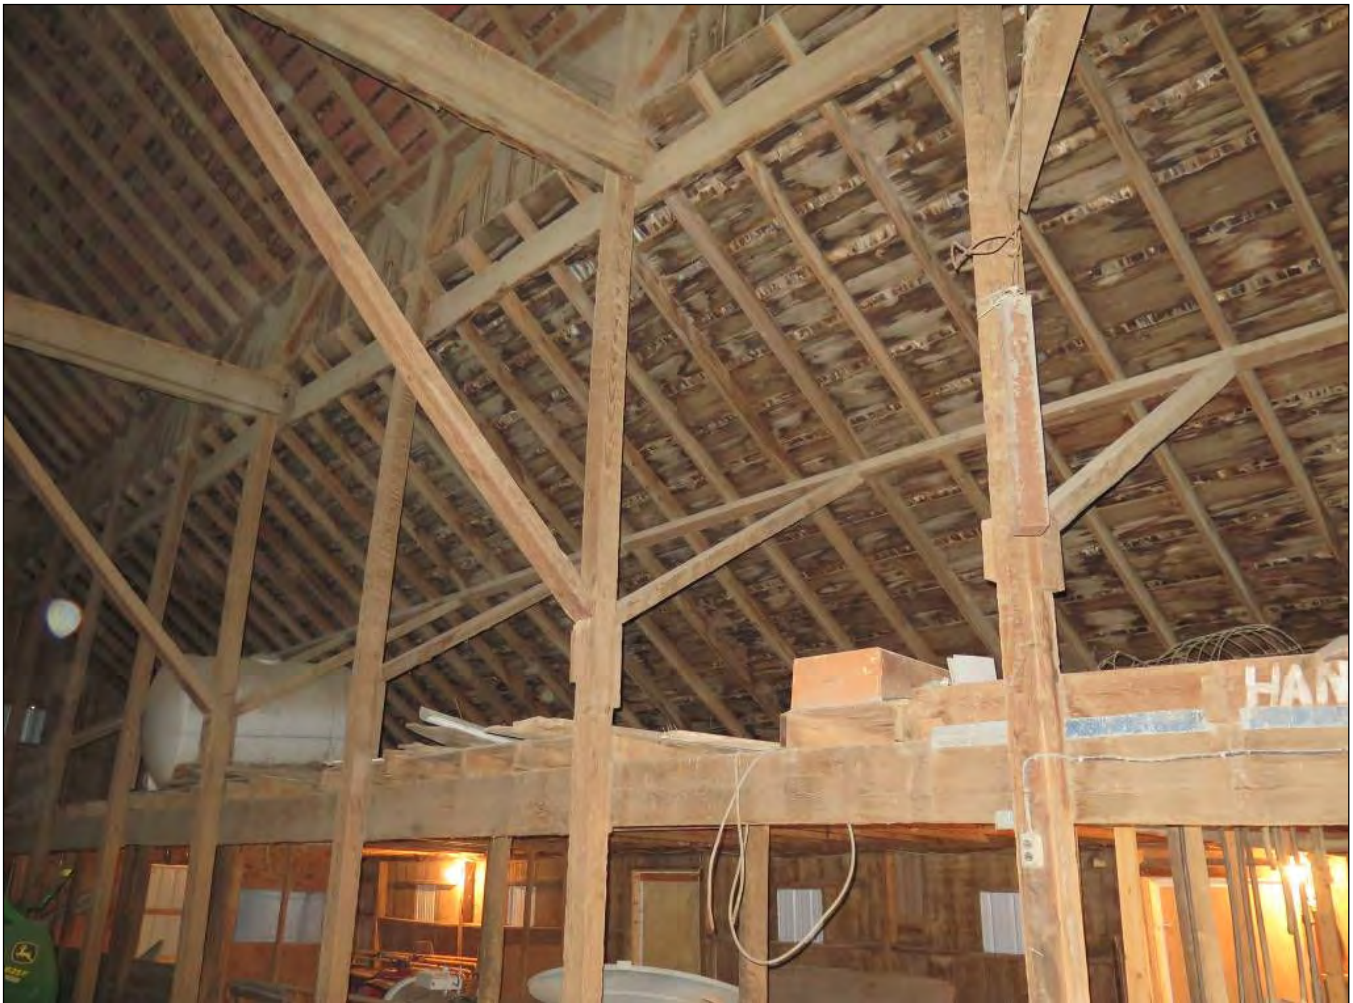
Figure 35. Interior framing of North Barn looking NW towards the loft space on the north side of the barn.

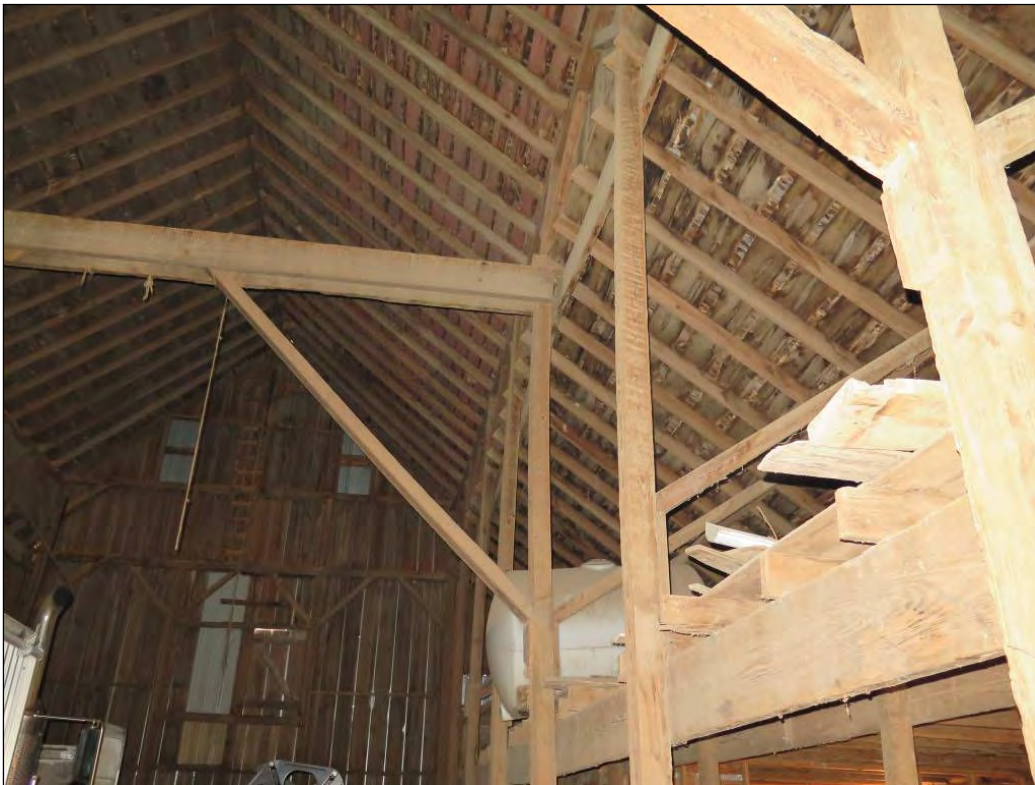
Figure 36. Interior bent and framework on the interior of the North Barn looking east. Note the two windows in the gable end of the barn that are now covered over with exterior metal siding. *Photograph taken by Tallgrass Archaeology LLC, 04/13/2018.*

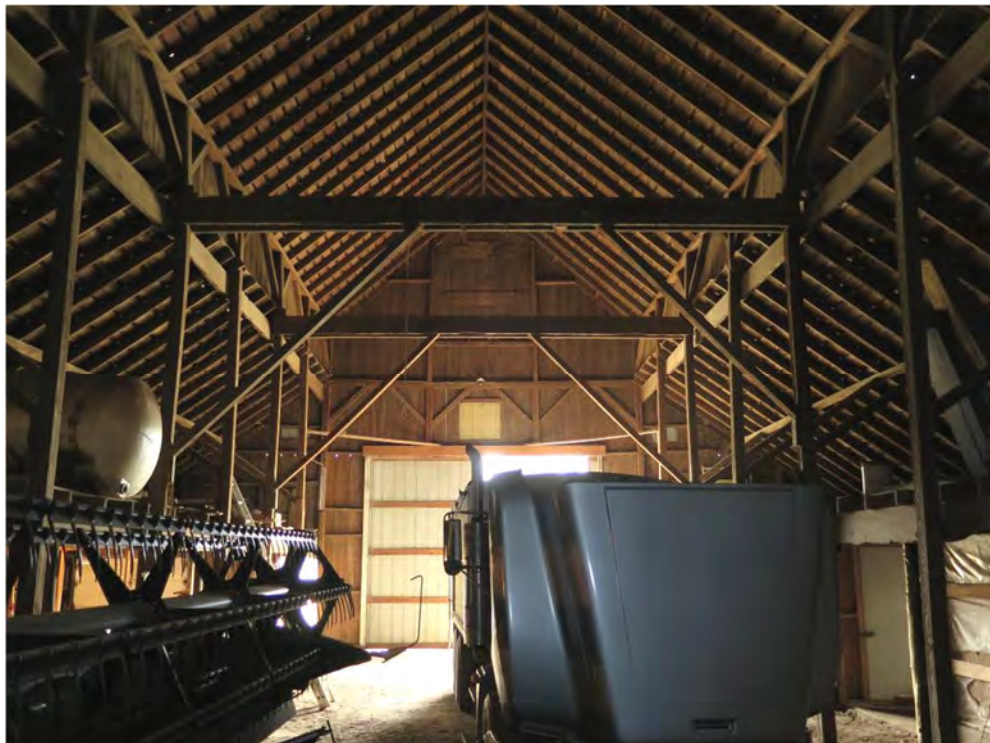
Figure 37. Interior of North Barn looking west in the center aisle and showing the two full interior bents. *Photograph taken by Tallgrass Archaeology LLC, 04/13/2018.*

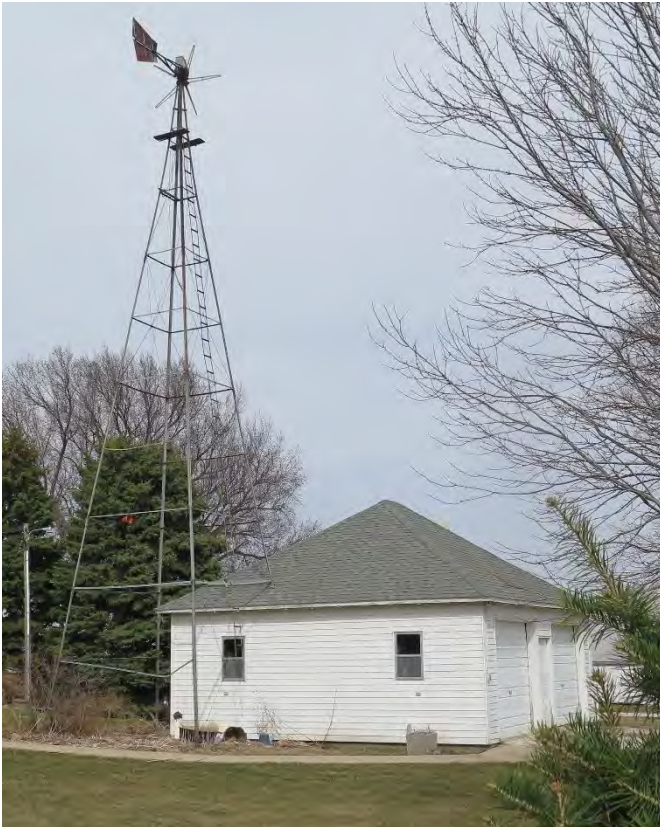
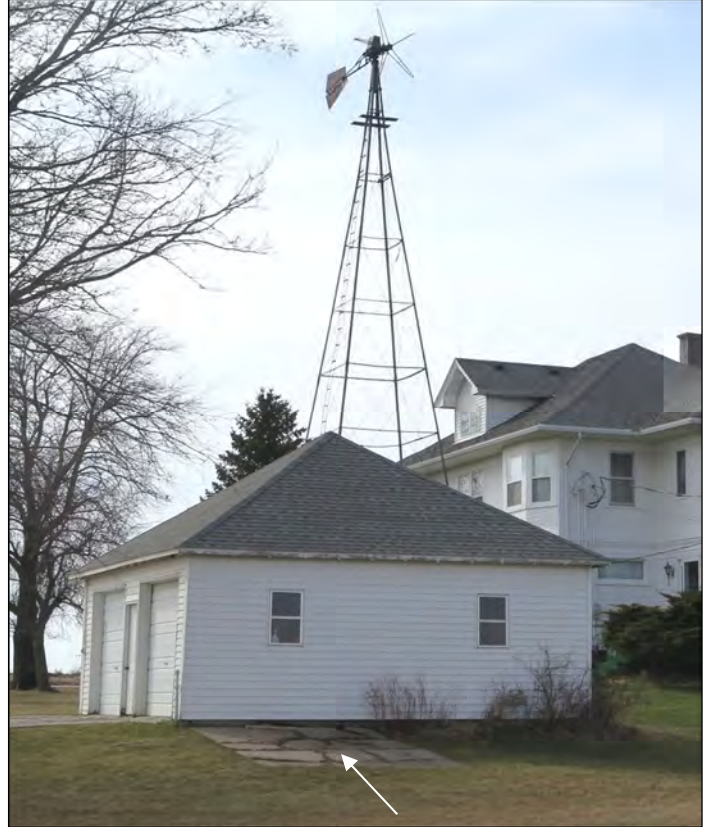
Figure 39. Windmill and 1913 garage looking east (right) and looking WNW (left) with the old concrete driveway (white arrow) indicating where the original garage entry door was located. Photographs taken by Tallgrass Archaeology LLC, 04/12/2018.

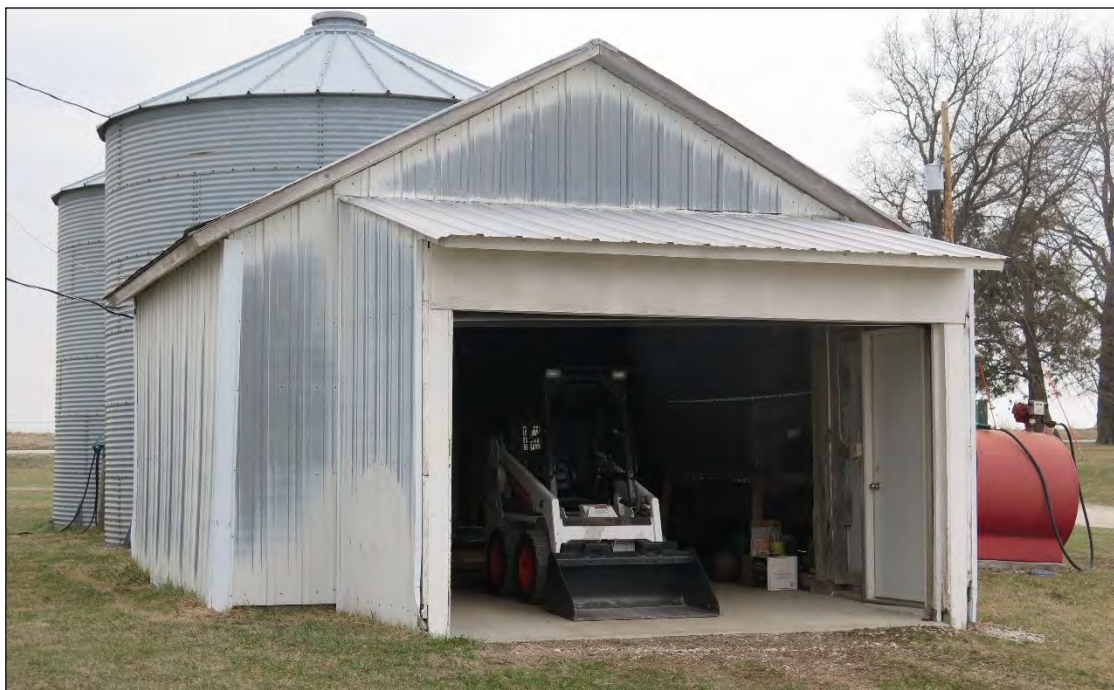
Figure 40. Circa 1920 garage #2 looking WNW. Photograph taken by Tallgrass Archaeology LLC, 04/12/2018.

Circa 1920 garage #2: This broad, front-gabled, frame garage is roughly 13 ft. by 16 ft. The front (east side) has a small section that juts out for an overhead garage door. It has metal siding and metal roofing (Figure 40).

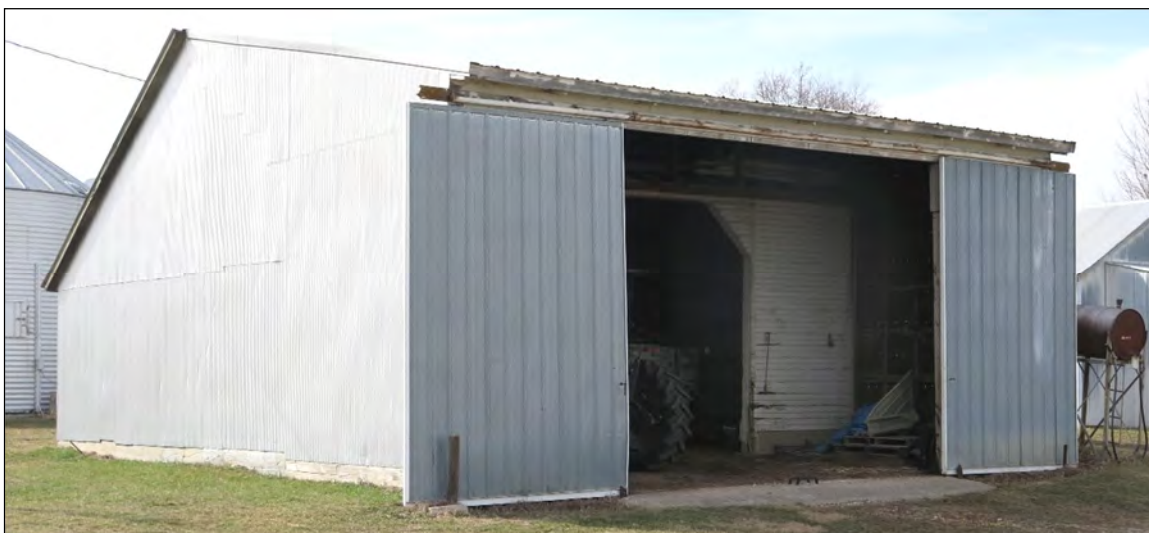
Figure 41. Machine Shed looking WNW and showing the older frame machine shed on the interior of the outer metal shed shell.
Photograph taken by Tallgrass Archaeology, 04/12/2018.

Machine Shed: This machine shed was built circa 1960 according to the Shelby County Assessor; however, the outer metal-sided and roofed machine shed is built over an older frame machine shed that is still largely intact on the interior of the shed. It is visible from the exterior on the east side of this building when the two metal sliding doors are open (Figures 41-42). The frame machine shed is sided with horizontal drop siding and has a poured concrete form foundation. It has a side-gabled roofline from which the cladding material has been removed the framing left in place (see Figure 42). This machine shed could date from the district's period of significance; however, the late 1930s aerial shows no building at this location. Therefore, it was either an older building moved to this spot or was built after the late 1930s. As such, it is considered non-contributing because of its uncertain age and associations.

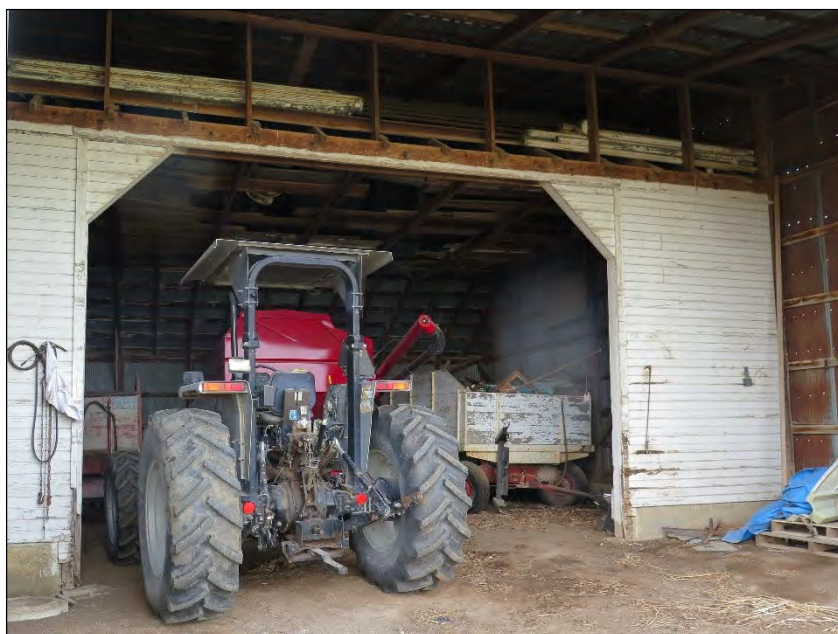
Figure 42. Older frame machine shed on the interior of the metal-sided/roofed machine shed looking west.
Photograph taken by Tallgrass Archaeology LLC, 04/12/2018.

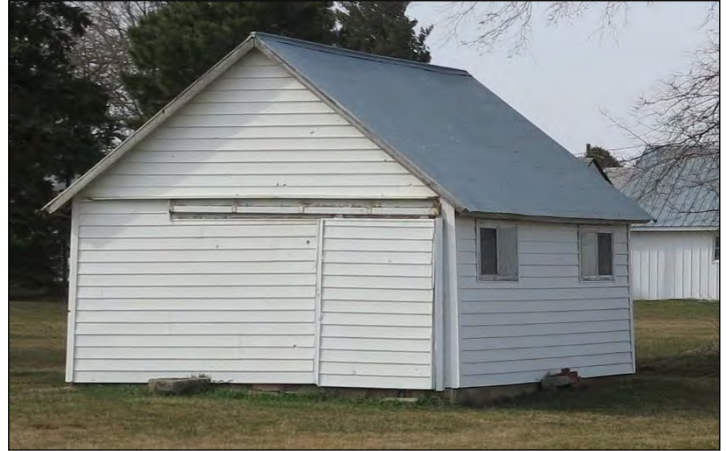
Figure 43. Tool Shed looking NNW.
Photograph taken by Tallgrass Archaeology LLC, 04/12/2018.

Tool Shed: This 16 ft. by 14 ft. front-gabled building has been covered in vinyl siding and has a corrugated metal roof (Figure 43). It was constructed circa 1940 and is considered non-contributing because it was built outside of the district's period of significance. It sits to the east of the 1913 house near the circular drive that extends through the farmstead (see Figure 38). There is a small prefabricated shed to the north of this tool shed that is not counted as a component of the district because of its small size and modern construction.

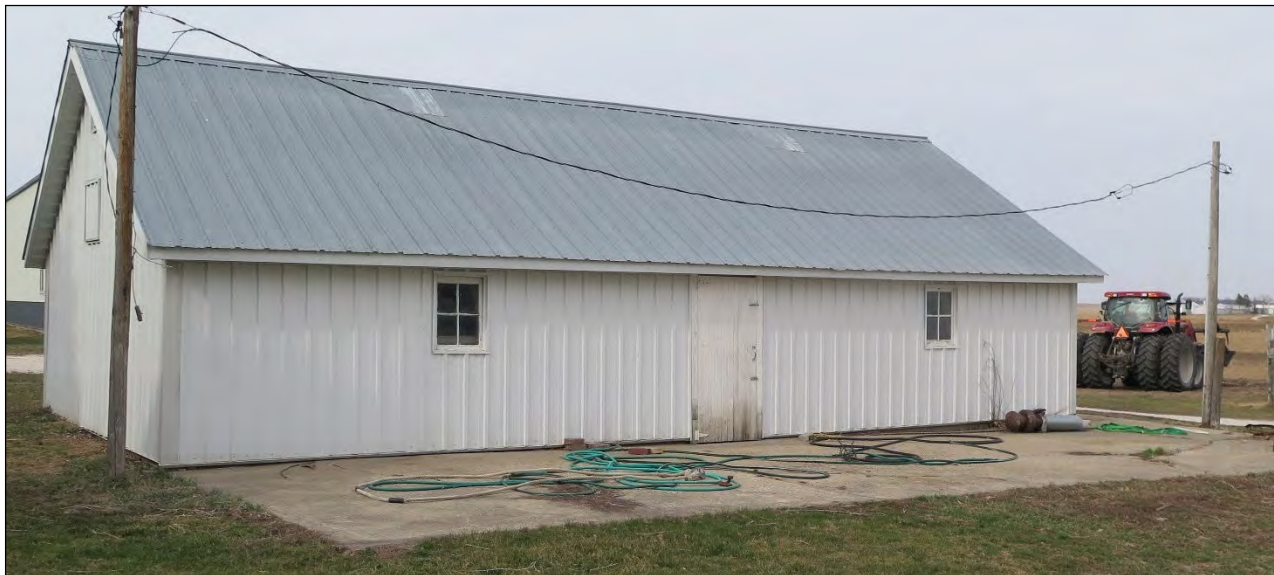
Hog House: The hog house was constructed circa 1940 and lies to the northeast of the home toward the northernmost barn. This side-gabled, one-story building has been covered with metal siding and metal roofing (Figure 44). There is a cement pad to the south of the building. The building measures 20 ft. by 40 ft. It is considered non-contributing because it was built after the period of significance for the historic district and was not associated in any way with the significant cattle operation of Pleasant View Stock Farm in the early 20th century.

Figure 44. Hog House looking NNE. *Photograph taken by Tallgrass Archaeology LLC, 04/12/2018.*

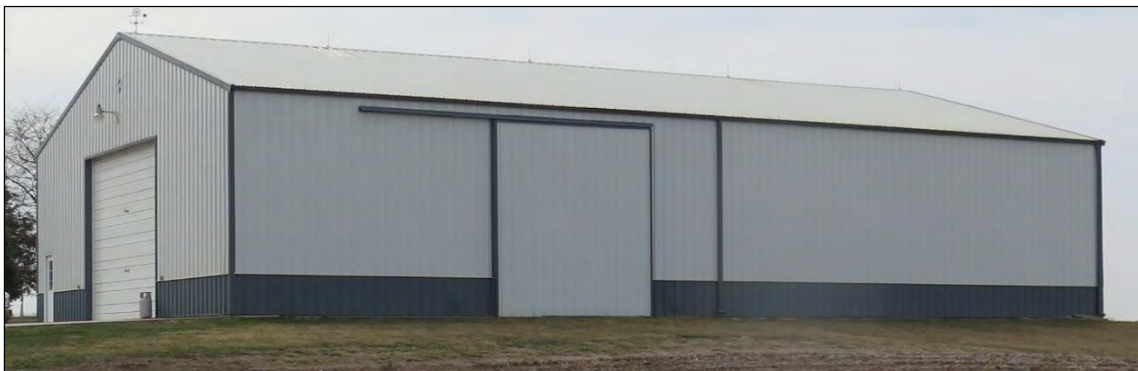
Metal Machine Shed: This front-gabled machine shed was built in 1999 (Figure 45). It is a modern, prefabricated, pole-frame building with metal siding and a metal roof. A large door is on the south end, with the building housing large, crop-raising equipment. It is 90 ft. by 54 ft. in size. It is considered non-contributing because it is modern in construction (i.e., less than 50 years of age) and unrelated to the historic period of the Pleasant View Stock Farm.

Figure 45. Modern machine shed looking NW. Photograph taken by Tallgrass Archaeology LLC, 04/13/2018.

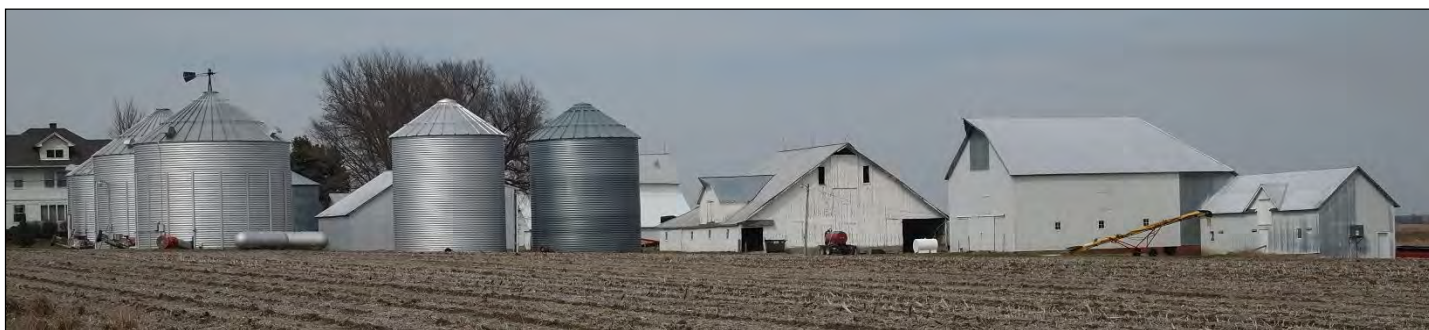
Seven grain bins: These steel grain bins are placed in a three-sided, roughly U-shape configuration in the farm's southwest corner. Numbers one and two form the north side of the U-shape; numbers three through five form the west side; numbers six and seven form the south side of the U-shape (see Figure 38). These are steel cylindrical bins with metal cone-shaped tops (Figure 46). The table below is a summary of their manufacturing brand name, their diameter, and the year built according to the Shelby County Assessor.

Figure 46. Metal grain bins in southwest corner of farmstead looking NNE. Photograph taken by Tallgrass Archaeology LLC, 04/12/2018.

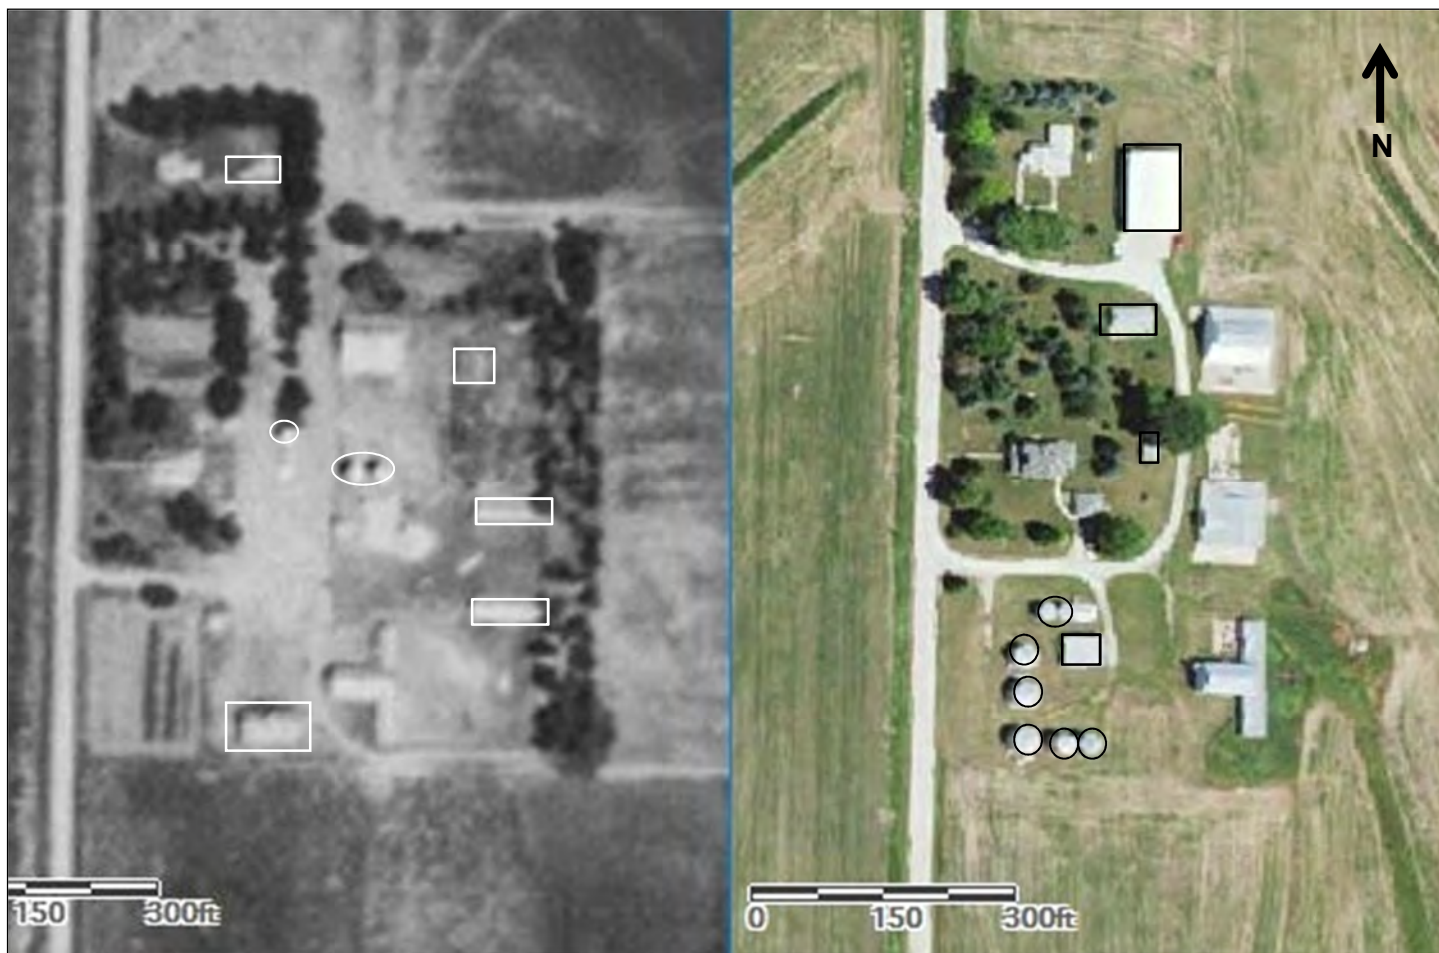
Figure 47. Left: Late 1930s aerial photograph with buildings and structures that appear to have been removed outlined in white. Right: 2017 aerial photograph with buildings that have been added since the 1930s outlined in black. Maps obtained from the Iowa Geographic Map Server 2018.

The aerial photographs show the following changes from the late 1930s aerial of this property: one small outbuilding east of the 1884 house near the north edge of the property (possibly one of the non-extant hired hand's houses?); two silos north of the Middle Barn (probably the tile block silos); the water tower ENE of the 1913 house; the large corn crib on the south edge of the property just west of the South Barn; and two long, narrow sheds perpendicular to the east edge of the farmstead east and southeast of the Middle Barn (Figure 47). Other buildings may be present in the late 1930s image but are obscured by the tree cover. In addition to these removals, it appears that fenced-in animal areas and other smaller objects have been removed. A number of trees along the north and west boundaries of the farm site have been removed as well.

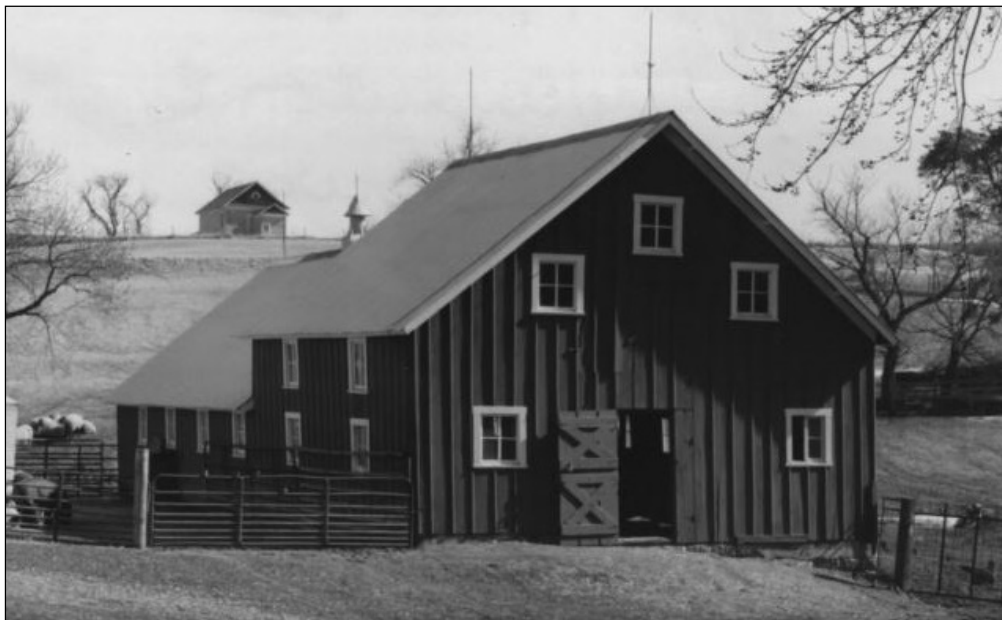
Figure 60. Hog Show Barn on the Clover Leaf Stock Farm in the Poplar Rural District in Shelby County, Iowa. This property is listed in the National Register of Historic Places and is still standing. Source: Johnson 1991.

The barns and other agricultural buildings also tell the story of developing farming practices and the outward image of financial success throughout its existence. The oldest of the three barns, the Middle Barn (Show Barn), served double-duty as a hay and feeder barn and the location where the cattle shows and sales were held at Pleasant View. While not unique in the region, a barn used for livestock shows was not common. Other examples include the related farming operation of Long Branch (the Escher farm) and the purebred hog operation of the Clover Leaf Stock Farm in northeast Shelby County (where a two-story building was constructed to serve as a show ring for that farm's hog sales) (Johnson 1991; Rogers and Johnson 1991). Figure 60 is a photograph of the show ring/hog house on the Clover Leaf Stock Farm, with Figure 61 being a historic photograph of the barns at Long Branch, including a distinctive cross-shaped barn. The Clover Leaf building was built circa 1911-1914 and is listed in the National Register of Historic Places as part of the Poplar Rural District in Shelby County and a small part of Audubon County (Johnson 1991). This show barn is still extant, but the cross-shaped barn at Long Branch burned down circa 2010 and a new machine shed erected in its place. Long Branch is located roughly nine miles east-northeast of Pleasant View, while the Poplar Rural District straddles the Shelby/Audubon county line north of Kimballton, Iowa, southeast of Pleasant View.
