National Register of Historic Places Registration Form

historic name Pleasant View Stock Farm Historic District

Shelby County, Iowa

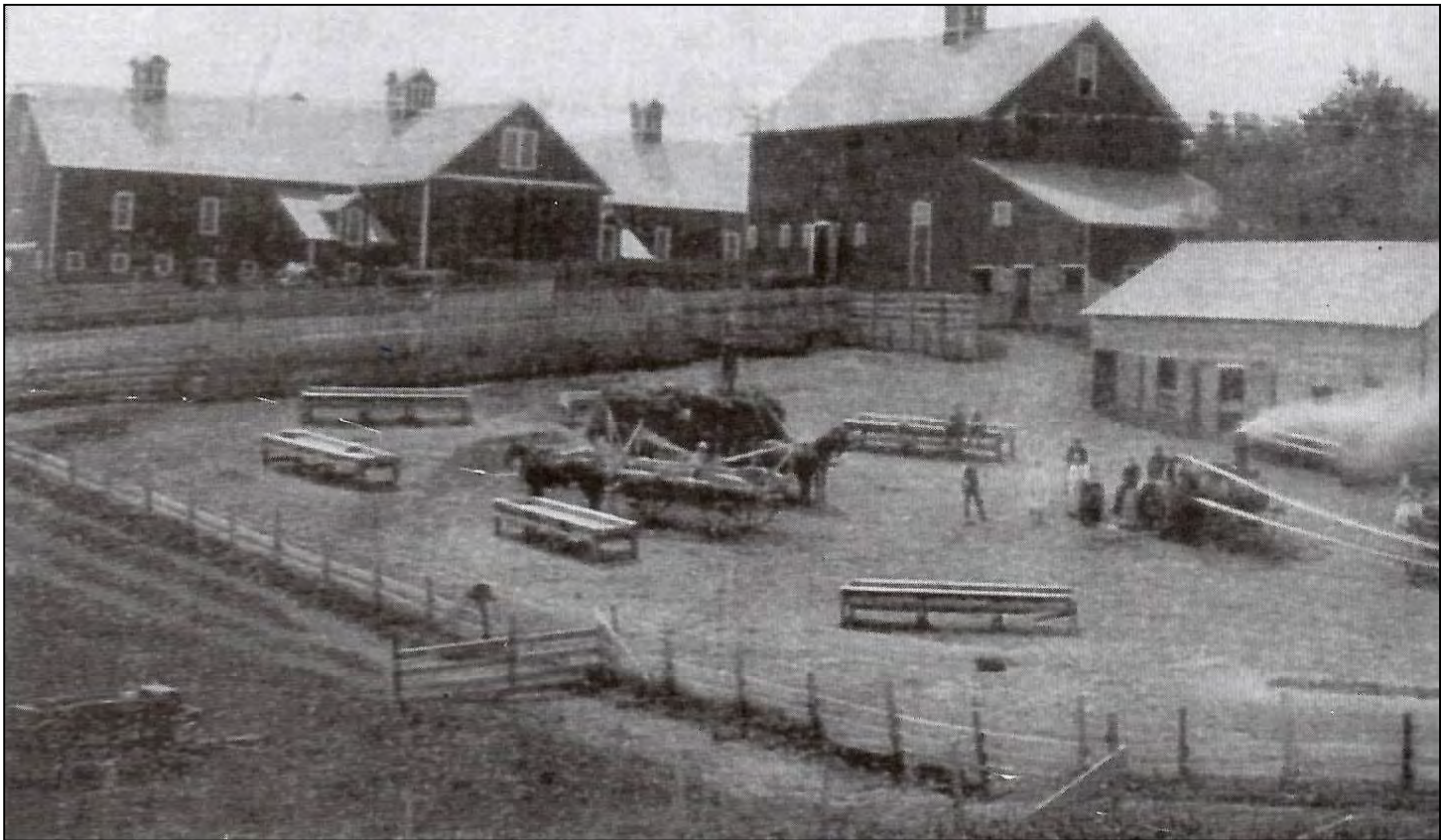
Figure 61. This 1898 photograph of the barns on the Long Branch Farm shows the cross-shaped barn (upper left) and a gabled transverse frame barn (upper right) that may have inspired the T-shaped barn construction on Pleasant View Farm. The cross-shaped barn had become a T-shaped barn by the late 20th century and burned down circa 2010. The above view was taken from the north looking southwest. What is now 2200th Street in Shelby County is the lane that extends between the two barns. *Source: American Angus Hall of Fame.*

The large barns on the Long Branch Farm were built by 1898, as seen in the photograph in Figure 61. They are larger in size than those on Pleasant View but the inspiration for the T-shaped barn on the subject farmstead may have come from the large cross-shaped and front-gabled transverse frame barns on Long Branch (see Figure 61). The former Long Branch Farm is now split into two separate parcels north and south of 2200th Street in Jefferson Township. The cross-shaped barn site is on the south parcel and now has a modern Ranch house just west of the barn site and a large machine shed on the barn site. The north parcel still retains the Escher house built circa 1915, but this large, two-story, Eclectic Revival-style house has been greatly modified on the exterior in the modern era. However, the front-gabled barn visible in the 1898 photograph appears to still be standing but now has a wrap-around shed added to three sides (Figure 62). Figures 63-64 shows the locations of Long Branch in Sections 13 and 24 of Jefferson Township and Pleasant View in Sections 34-35 in 1911, while Figure 65 is a county map showing the location of all three stock farms: Long Branch, Pleasant View, and Clover Leaf.

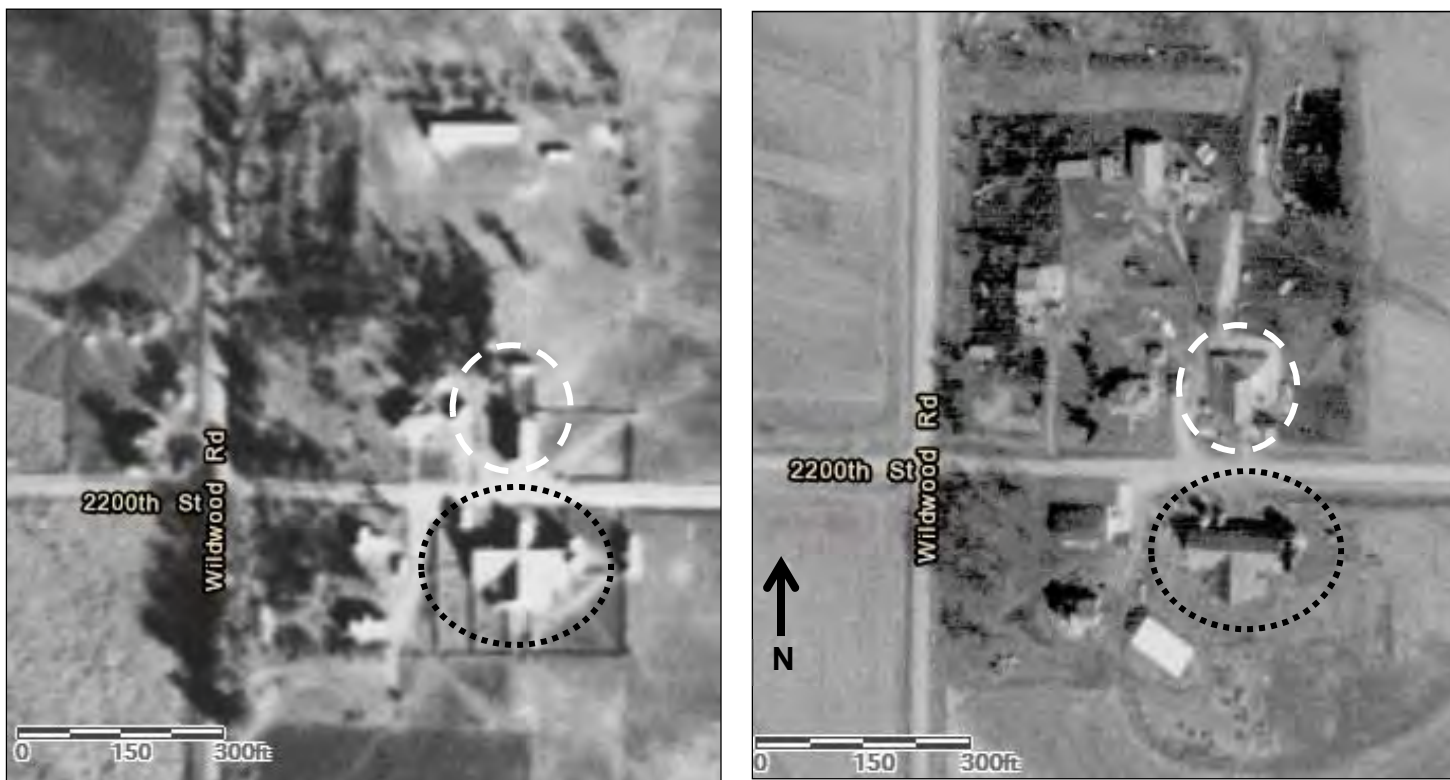
Figure 62. A late 1930s aerial photograph (left) and a 1990s aerial photograph (right) show the location of the cross-shaped barn (black dotted circle) and the front-gabled transverse-frame barn (white dashed circle) at Escher's Long Branch Farm. Note that by the 1990s, the cross-shape of the barn had been altered to a T-shape and a large wrap-around shed had been added to the front-gabled barn. The cross-shaped barn was destroyed by fire circa 2010 and later replaced by a modern shed; the front-gabled barn is extant. Source: Iowa Geographic Map Server, 2018.

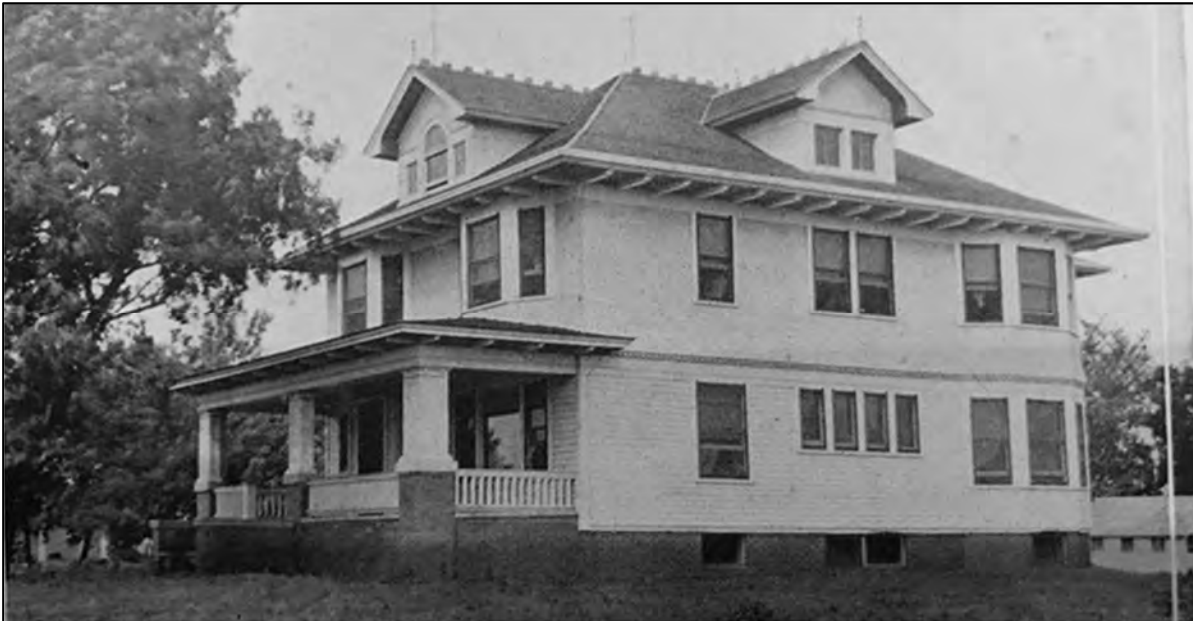
Figure 65. Historic photograph of the Ryan house at Pleasant View Farm. Note the Palladian window in the front dormer, the original windows on the front porch and on the south side center, the roof ridge cresting, and the wooden railing on the front porch, now replaced or removed. The corbels under the eaves so visible in this photograph are still in place but not as highly visible in the current photograph in Figure 66 because of the gutters. Copy of photograph provided by Abbie Ryan Nelson.

The architecture of the two main houses of the Pleasant View and Long Branch stock farms both reflect the wealth and status of the Ryan and Escher families at the time of their respective construction. Earl and Bertha (Sessions) Ryan lived in the large house on the Pleasant View Stock farm from 1913 until 1924 (Information provided by Abbie (Ryan) Nelson, 2018). The couple was married in 1907. The house was likely designed by an architect, and reportedly was to be an even grander residence but some items had to be scaled back due to costs. The house is a vernacular architectural type (a variant of an American Foursquare), with stylistic details from Classical Revival and Craftsman styles then popular (Figures 65 and 66). The style and size of this home reflect the success of the farm's operators.

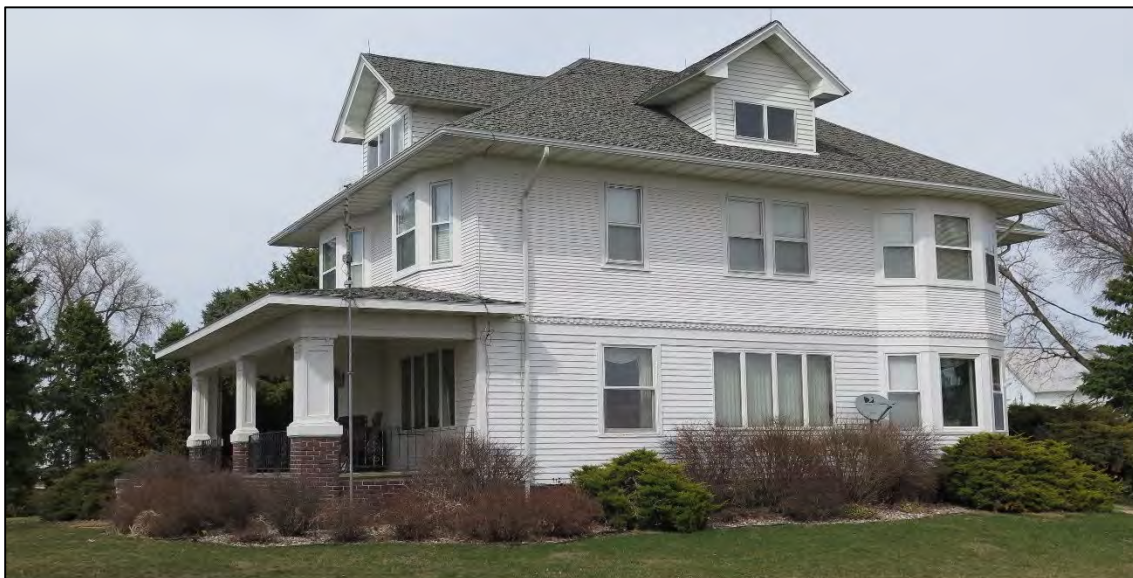
Figure 66. Current view of the Ryan house at Pleasant View Farm. Photograph taken April 12, 2018.

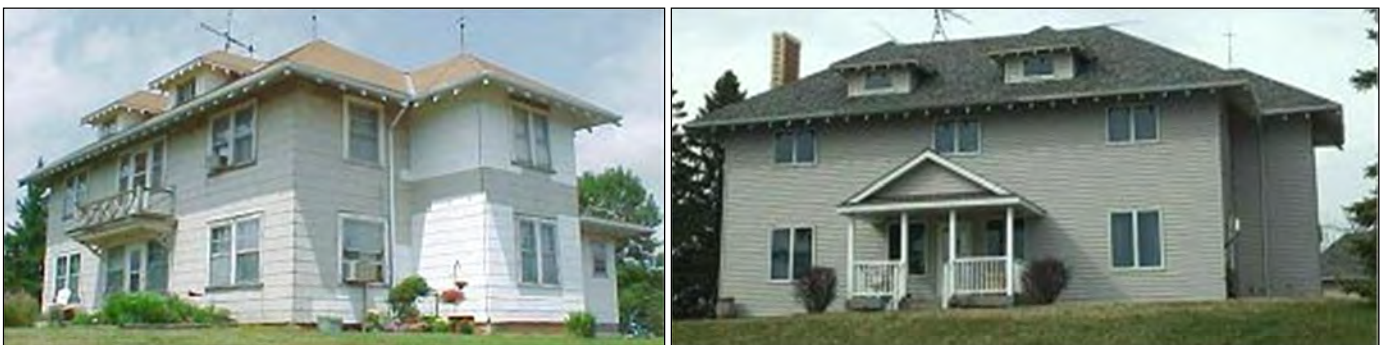
Figure 68. Escher House built circa 1915 on Long Branch Stock Farm. These two different views show the modifications this house has undergone in the modern era, from wide replacement siding and window replacements at left to the current vinyl siding, modern window inserts, and two different front porch additions. The only original elements that remain on the exterior are the roof with wide eave overhang and exposed rafter ends, and the hipped dormers on the front roof slope that have the same roof/eave treatment.

The home of Charles Escher, Jr. was also built circa 1915 (Figure 67). It was noted in Escher's 1915 biographical sketch, that he was then "planning the erection of a handsome home in the near future" (White 1915:675-678). While the quote did not specifically state "on Long Branch Farm," the biography was in the Shelby County History book and included a description of Long Branch Farm, which was his residence in 1915.⁶ Of course, there was an older home on this farm where his father had lived before and where he was living in 1915, but that house is no longer standing. This Eclectic Revival-style house would have been architect-designed. This house is still standing but has been modified extensively in the modern era (Figure 68).

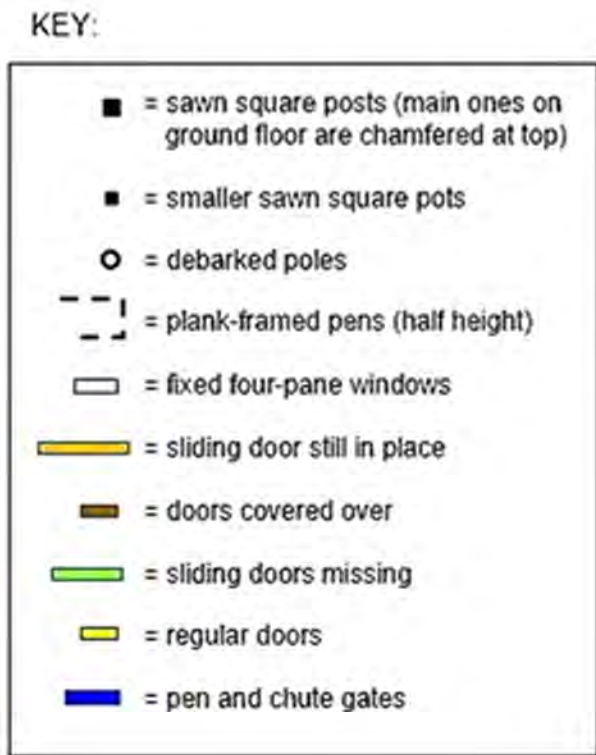
Sketch maps of Bent Configuration and Floor Plan of Middle Barn (Show Barn) on Pleasant View Stock Farm. Measured sketch by Tallgrass Archaeology LLC, 2018.

The hayloft is accessed by a wooden ladder near the north end of the barn. The upper framing shows five bents: two end bents and three interior bents (Figures 15-16). The wooden floor boards are still covered in a thin layer of loose hay. To the south, the gabled end of the barn is open in three locations and a door covers what is the main access to the hay mow. To the north, the hipped roof of the lower shed area ascends quickly to meet with the south gable of the barn. The west-facing dormer creates a large area for additional hay storage and has another primary access covered by a door. The heavy timber framing in the loft area shows the long beams were spliced with a simple angled Z-splice. There is at least one middle cross beam in the framing that is missing indicating some deterioration or purposeful removal to make more head-room in that location (see Figure 15).
