| | 157. |
|---|---|
| NATIONAL REGISTER OF HISTO REGISTRATION FORM | INTERAGENCY RESOURCES DIVISION |
| historic name: Roes Creek Campground Camptender's | s Cabin |

Rising Sun Campground Camptender's Cabin, Glacier Co., MT.

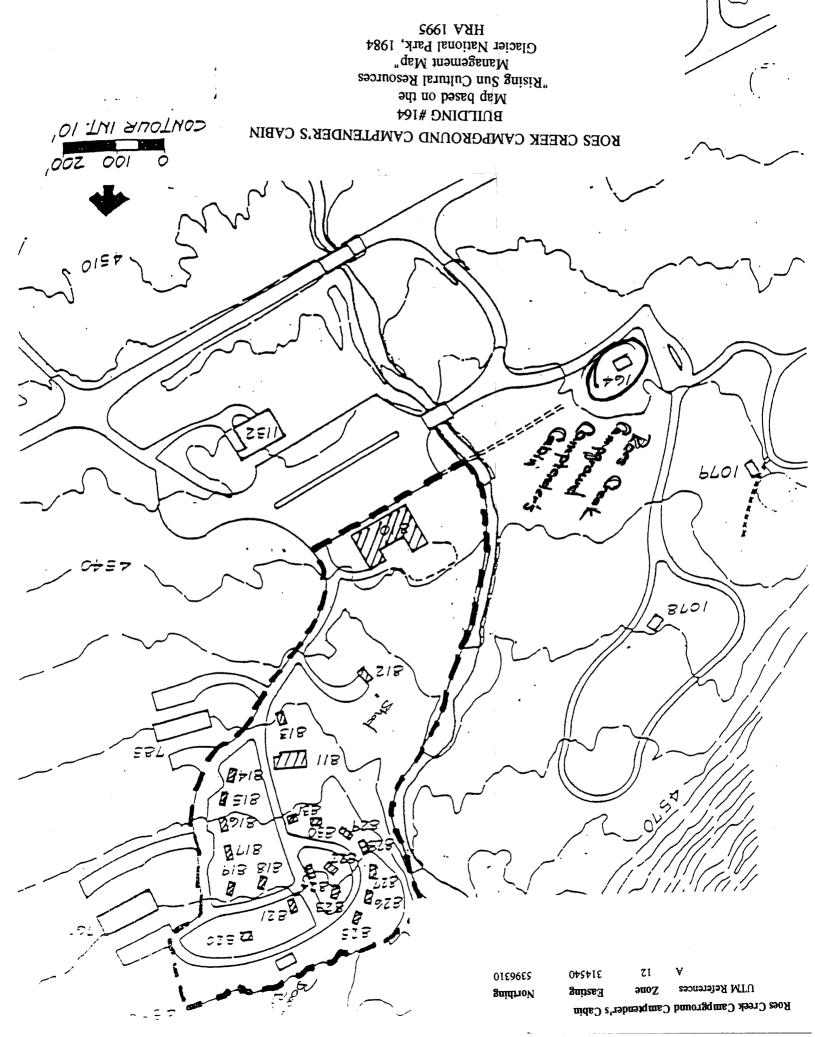
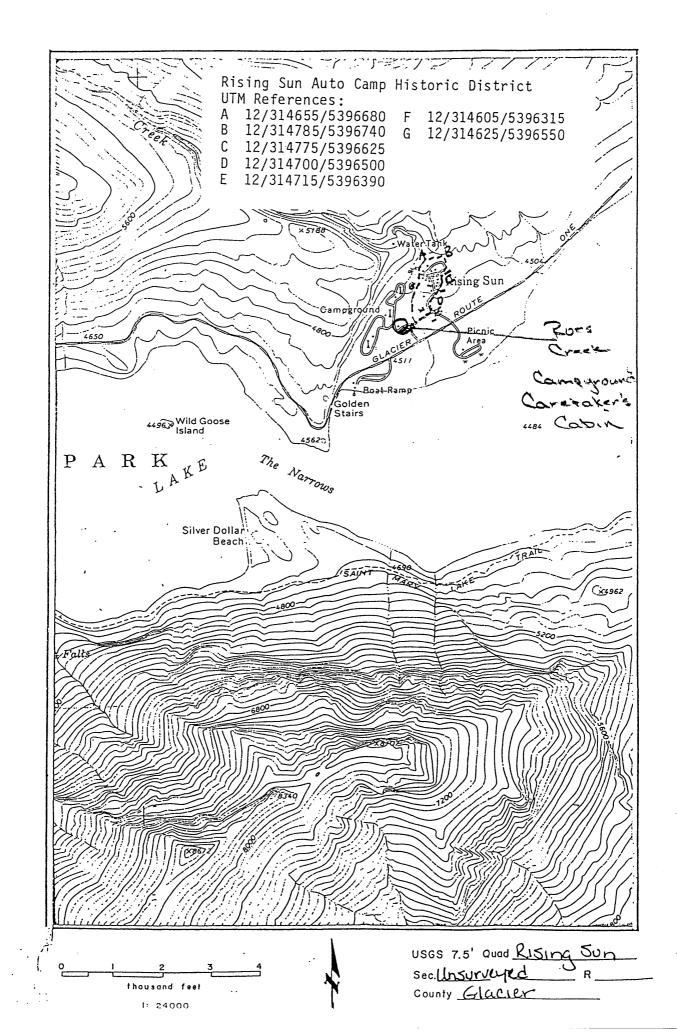
burerz Sum Cant CCC Project Computed 1939 Pors Creek renders Cabin

REAR SLEVATION .

FRONT ELEVATION

L. S.DE ELEXATION .

The following site plans can be found at the Denver Service Center's Technical Information Center, Denver, Colorado.
