National Register of Historic Places Registration Form

Historic name: Bain Cabin

Other names/site number: Levine Cabin; Eagle's Nest -121 Rollinsville Summer Home Group / 5GL.2124

City or town: Rollinsville State: Colorado County: Gilpin Zip Code: 80474

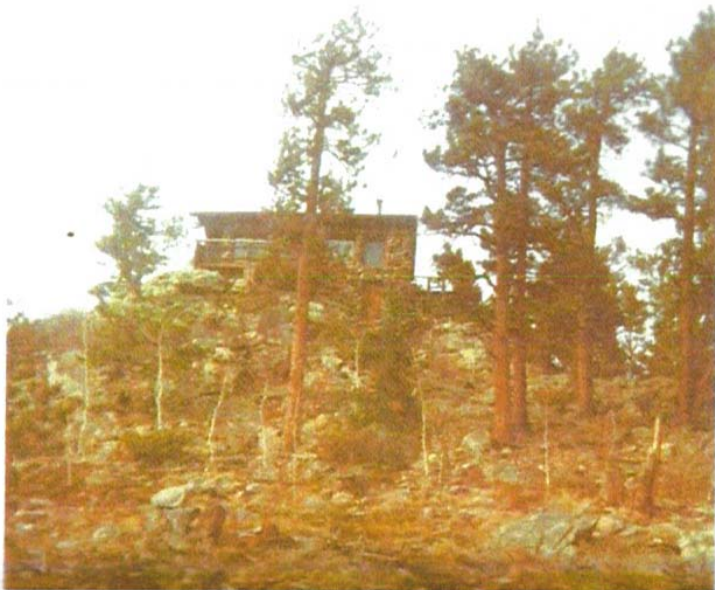
HP1 - Bain Cabin in 1973, camera facing northwest (USFS files, copy in site 5GL.2124 file, on file with History Colorado Office of Archaeology and Historic Preservation).
