National Register of Historic Places  
Registration Form

historic name United States Border Station  
other names/site number \_\_\_\_\_

street & number State Highway 31, Colville National Forest  not for publication  
city or town Metaline Falls  vicinity  
state Washington code WA county Pend Oreille code 051 zip code 99183

METALINE FALLS BORDER STATION  
National Register Nomination  
January 5, 1995

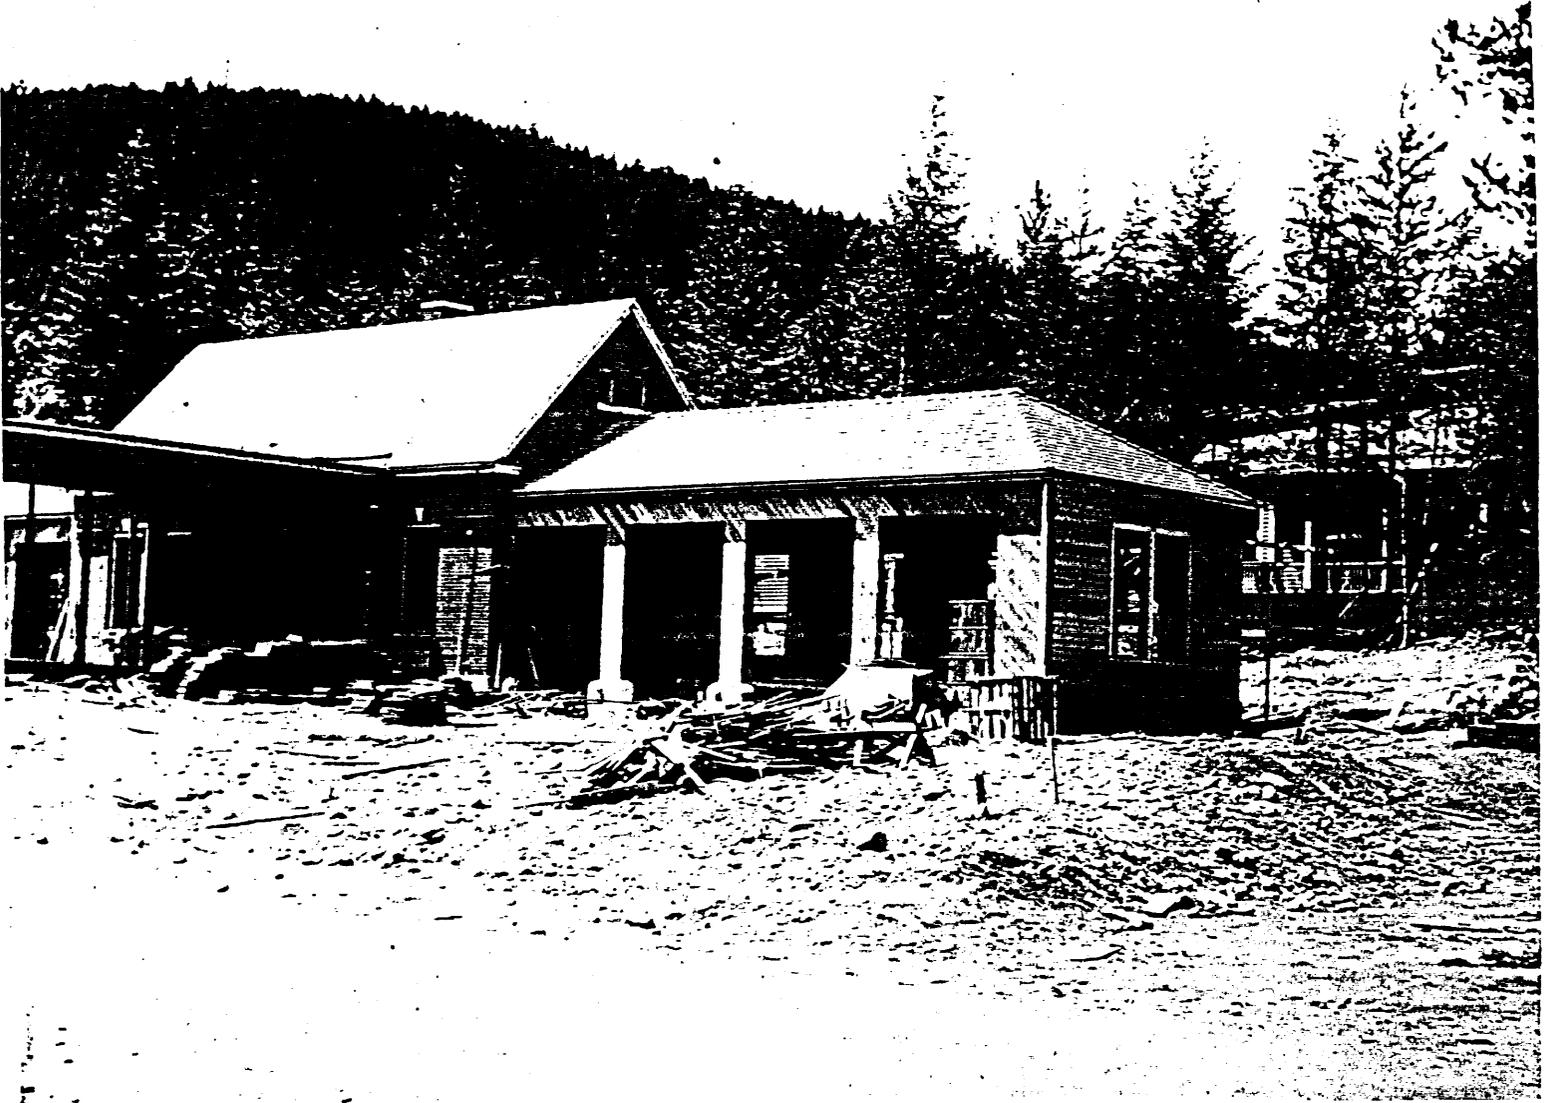
**Image No. 11**

Historic photograph, construction of the Metaline Falls Inspection Station, view from the northeast of the north garage wing, 7/2/1932.

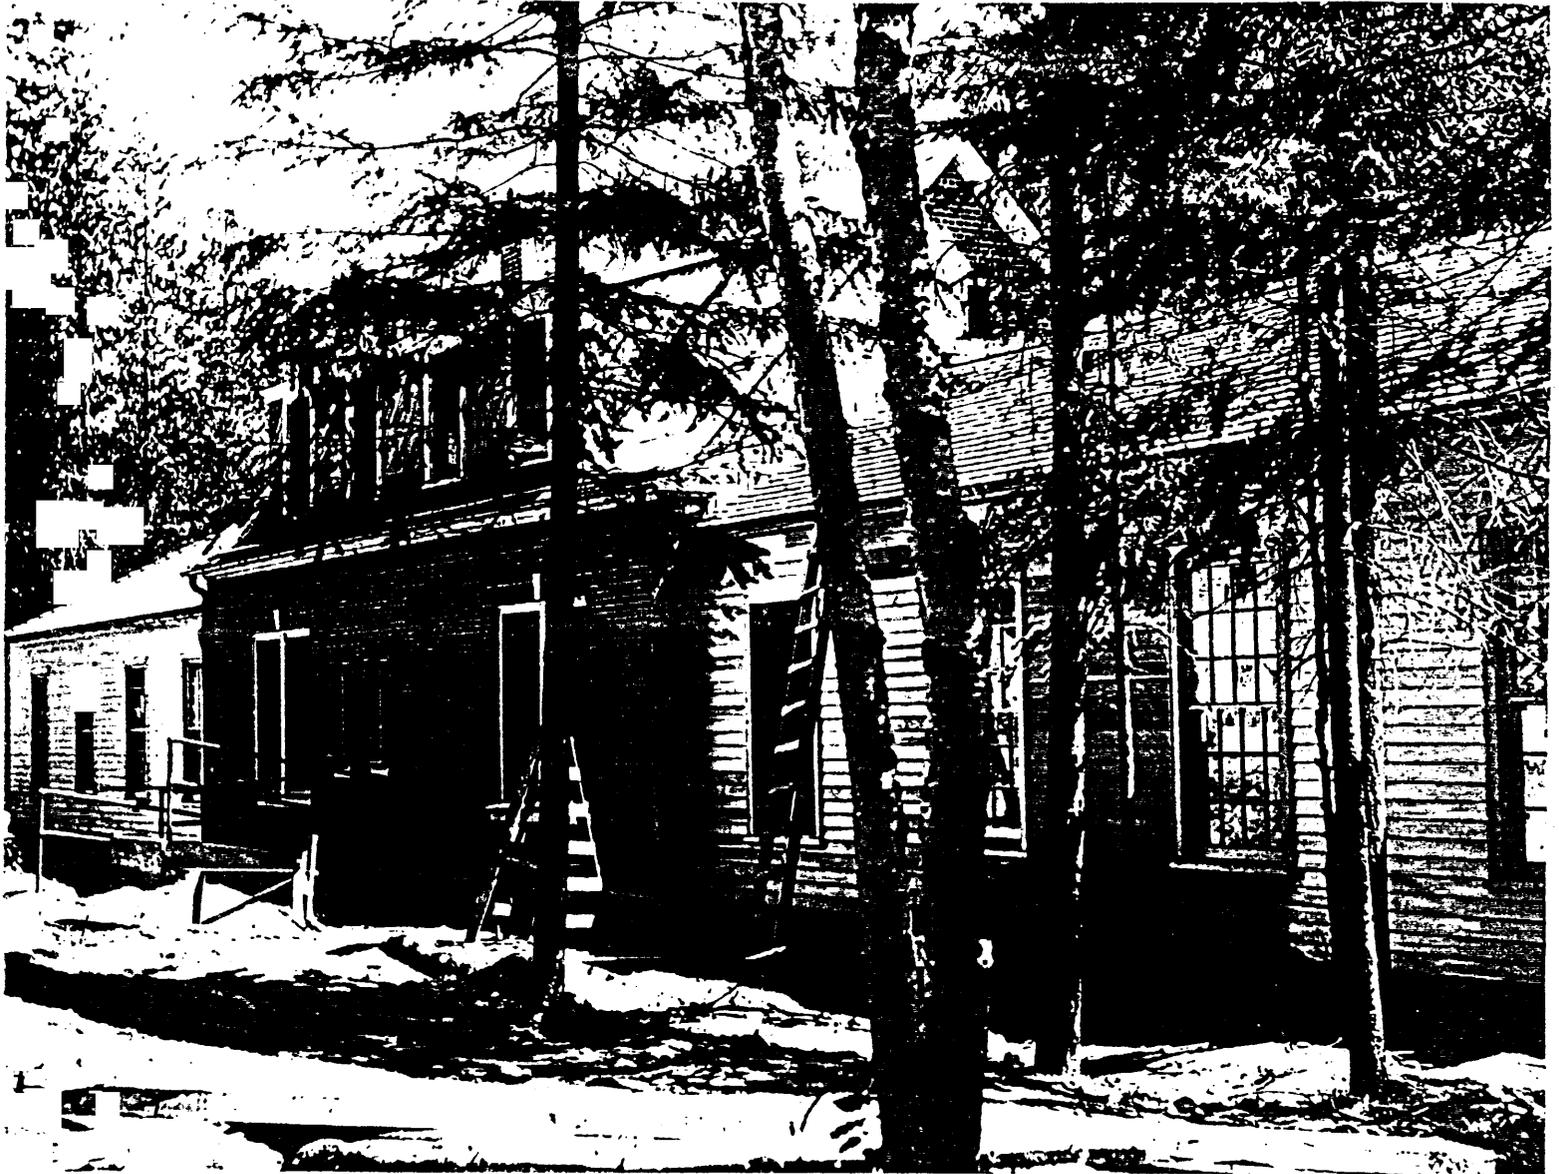
**Image No. 16**

Historic photograph, construction of the Metaline Falls Inspection Station, view of the back of the building, 8/3/1932.

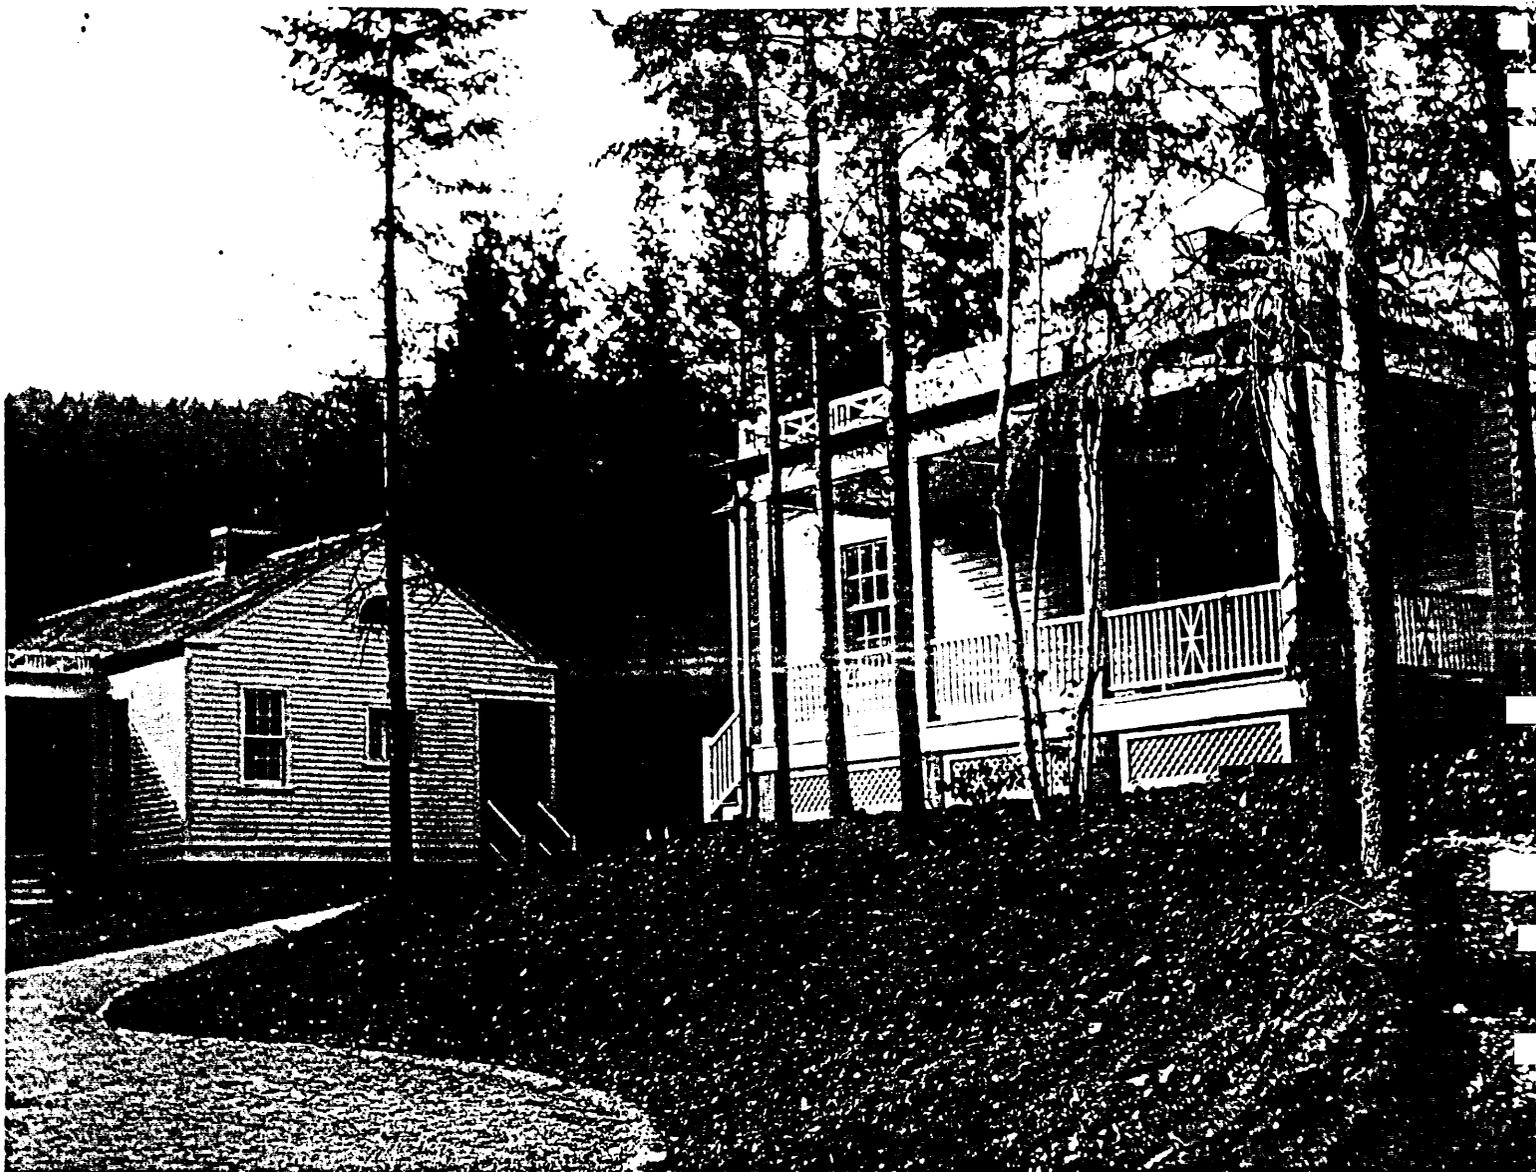
**Image No. 17**

Historic photograph, construction of the two residences, Metaline Falls Inspection Station, view from the northeast, 11/1/1932.

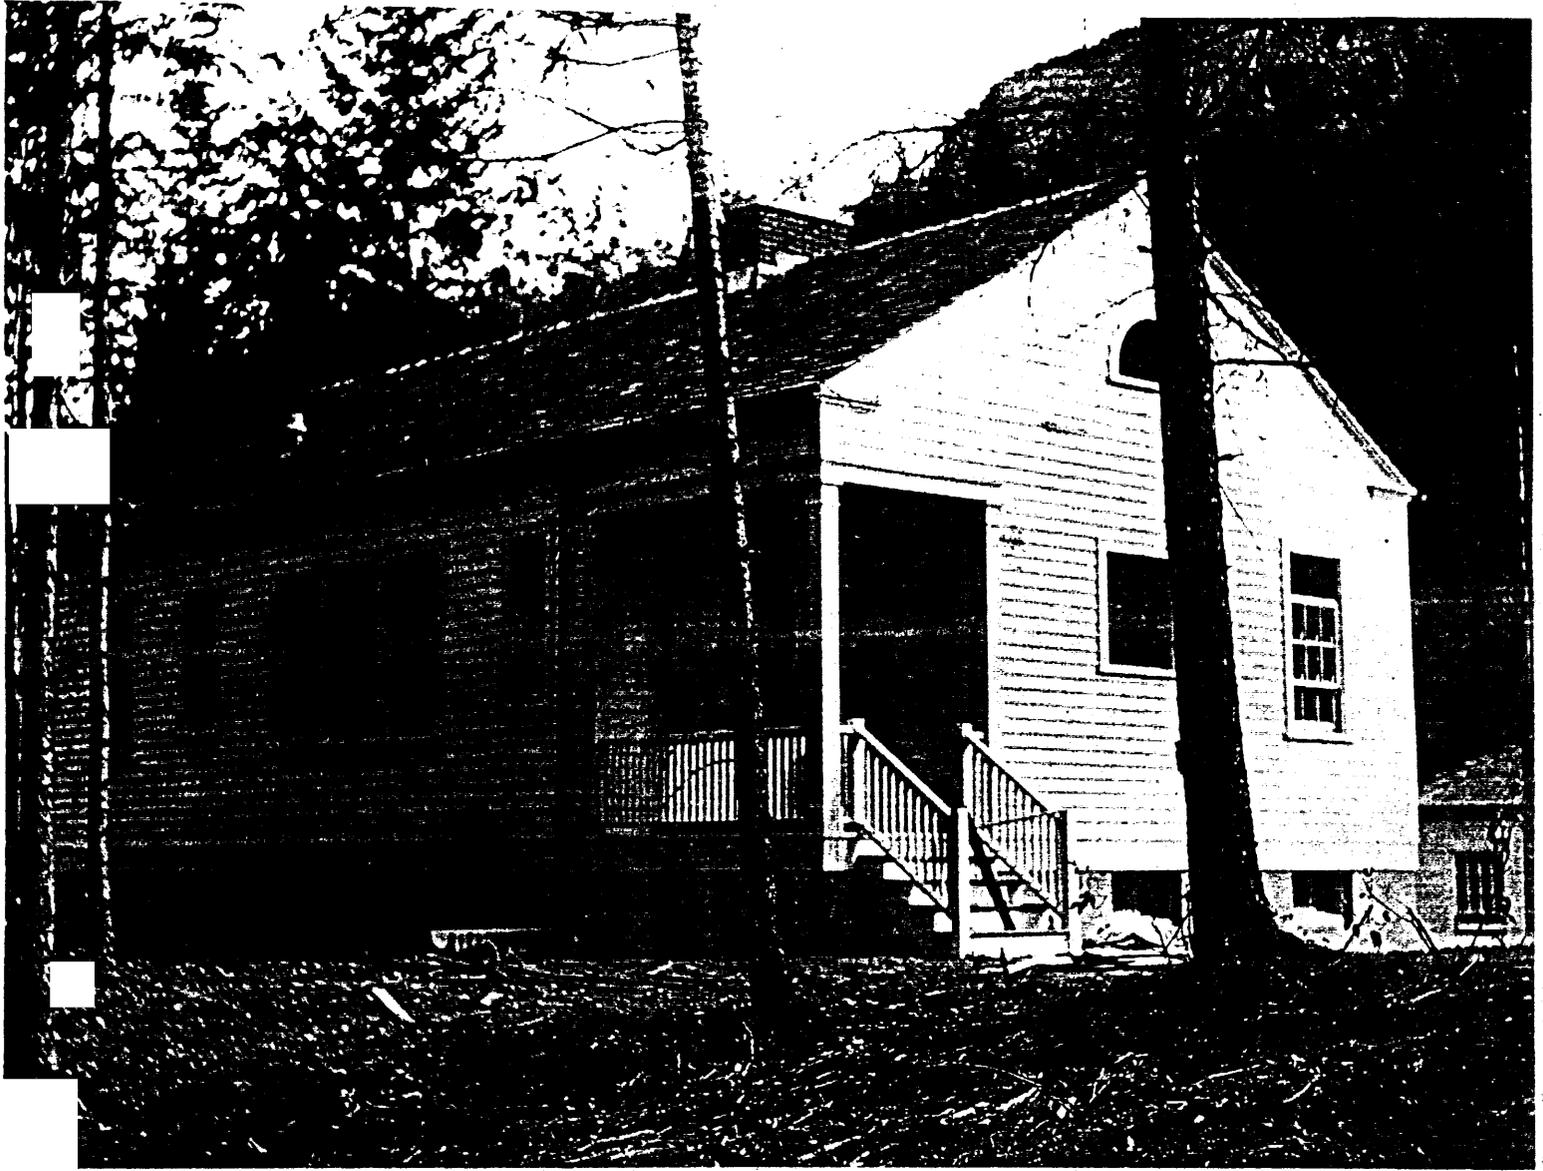
Image No. 18

Historic photograph, construction of the back of the Customs Service Residence, Metaline Falls,  
10/1/1932.

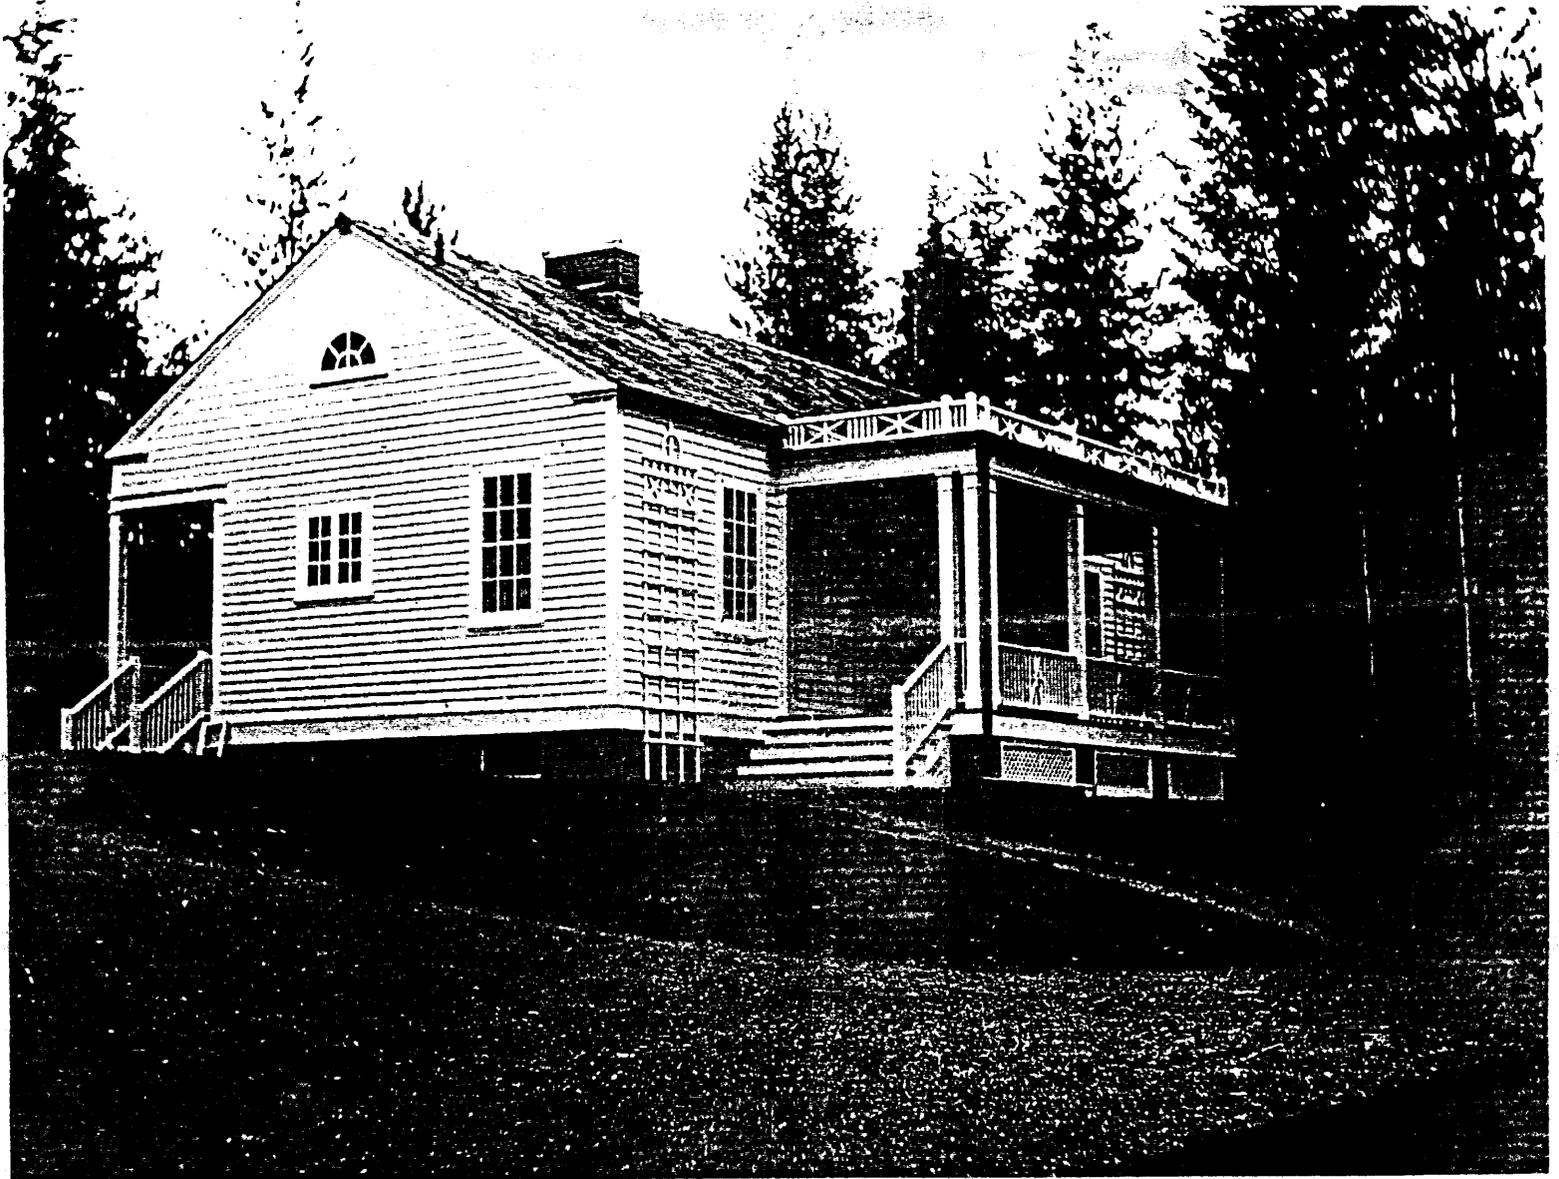
Image No. 21

Photograph of the Immigrations Inspector's Residence, view from the southeast, 9/1/1982  
showing the flat-roofed sun porch.

Originally each of the houses was designed with a covered front porch which was detailed with painted wood pilasters, Doric capitals and wood railings, a relatively flat copper-clad roof with wood balustrades at the roof edge, wood panels below the porch railing, and wood lattice in front of the crawl space. A decorative lattice support for vines was installed on the front wall adjacent to the porch. Photographs, dating from 1932 and later, show that each of the 200± sq. ft. porches was enclosed to serve as a sun porch by the addition of undivided pairs of fixed and casement windows with transoms. Original porch railings were reused during the enclosure project as were decorative wood infill panels below the windows. Building plans from GSA indicate that the sun porches had been modified before 1963.

The sun porches of two houses were modified recently by the removal of the flat roofs and the replacement by gable roofs. At each house a new, 50± sq. ft., shed roofed porch with 4" x 4" columns, and vertical wood picket railings was added. Original decorative lattice panels below the windows were replaced with simpler ones. Back porches were enclosed also, and new wood framed windows and an aluminum storm door added to each. However, despite these exterior changes, the houses remain essentially as they were designed and constructed originally.
