# National Register of Historic Places Registration Form

Historic name Stillman P. Groat House

Street & Number 432 North 10<sup>th</sup> Avenue

City or town Broken Bow State Nebraska County Custer

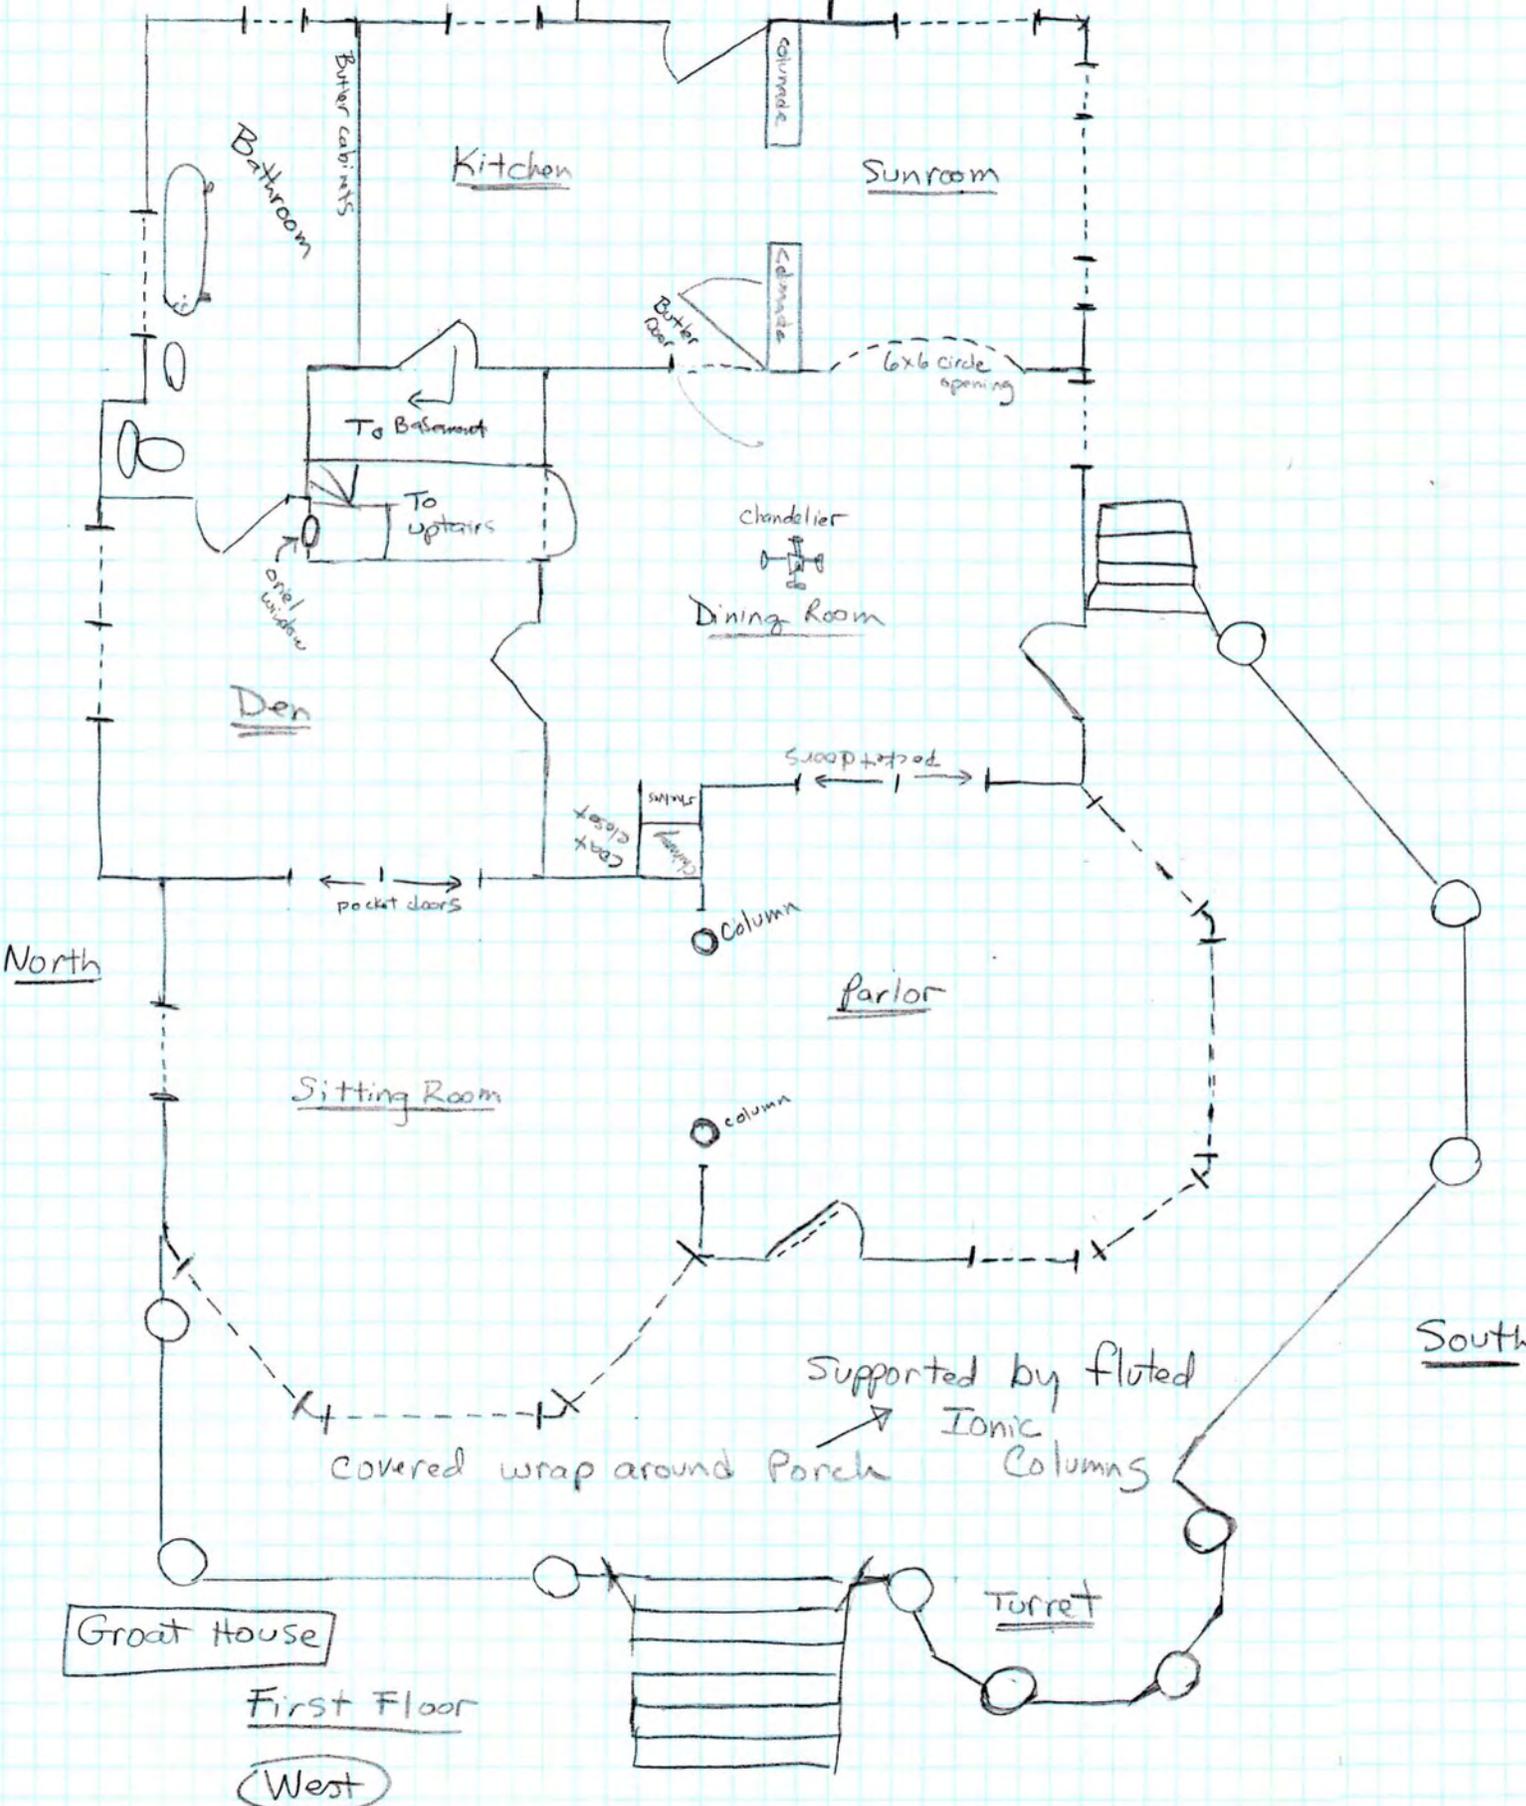
First Floor

Garage House

Upon entering this spacious and light filled house, the two large rooms situated along the front façade of the house are parlors or sitting rooms, separated by a wide open door way with two tall, fluted wooden ionic columns. The room with the front door has four large double hung windows, in addition to the large beveled glass opening in the door itself, which makes the room bright and airy. Three of these windows make up the entire south canted wall of the room, the center window being 74 inches wide and all windows are five feet tall. The house has broad baseboards and substantial trim around the doors and windows, including a cornice along the top, sometimes connected by a picture rail when there is space between them. The trim is all painted white. On the first floor, the hardwood floors are a bright long board maple. The light fixtures in the sitting rooms and dining room are all original. One features four laughing monks on the wrought iron fixture; the other features lights descending from the ceiling on chains with a wide metal girdle. Both of the sitting rooms have a canted wall with windows, one facing west and the other south. A pair of paneled pocket doors divides the northwest sitting room and the den, which shares the same trim. The floor of the den and kitchen, however, is a brightly finished Douglas Fir. The first floor bathroom is accessed through the den, and retains its original claw-footed tub. Other details may be present behind the wood paneled walls or above the dropped ceiling. The bath is one of the last rooms awaiting restoration by the owners.

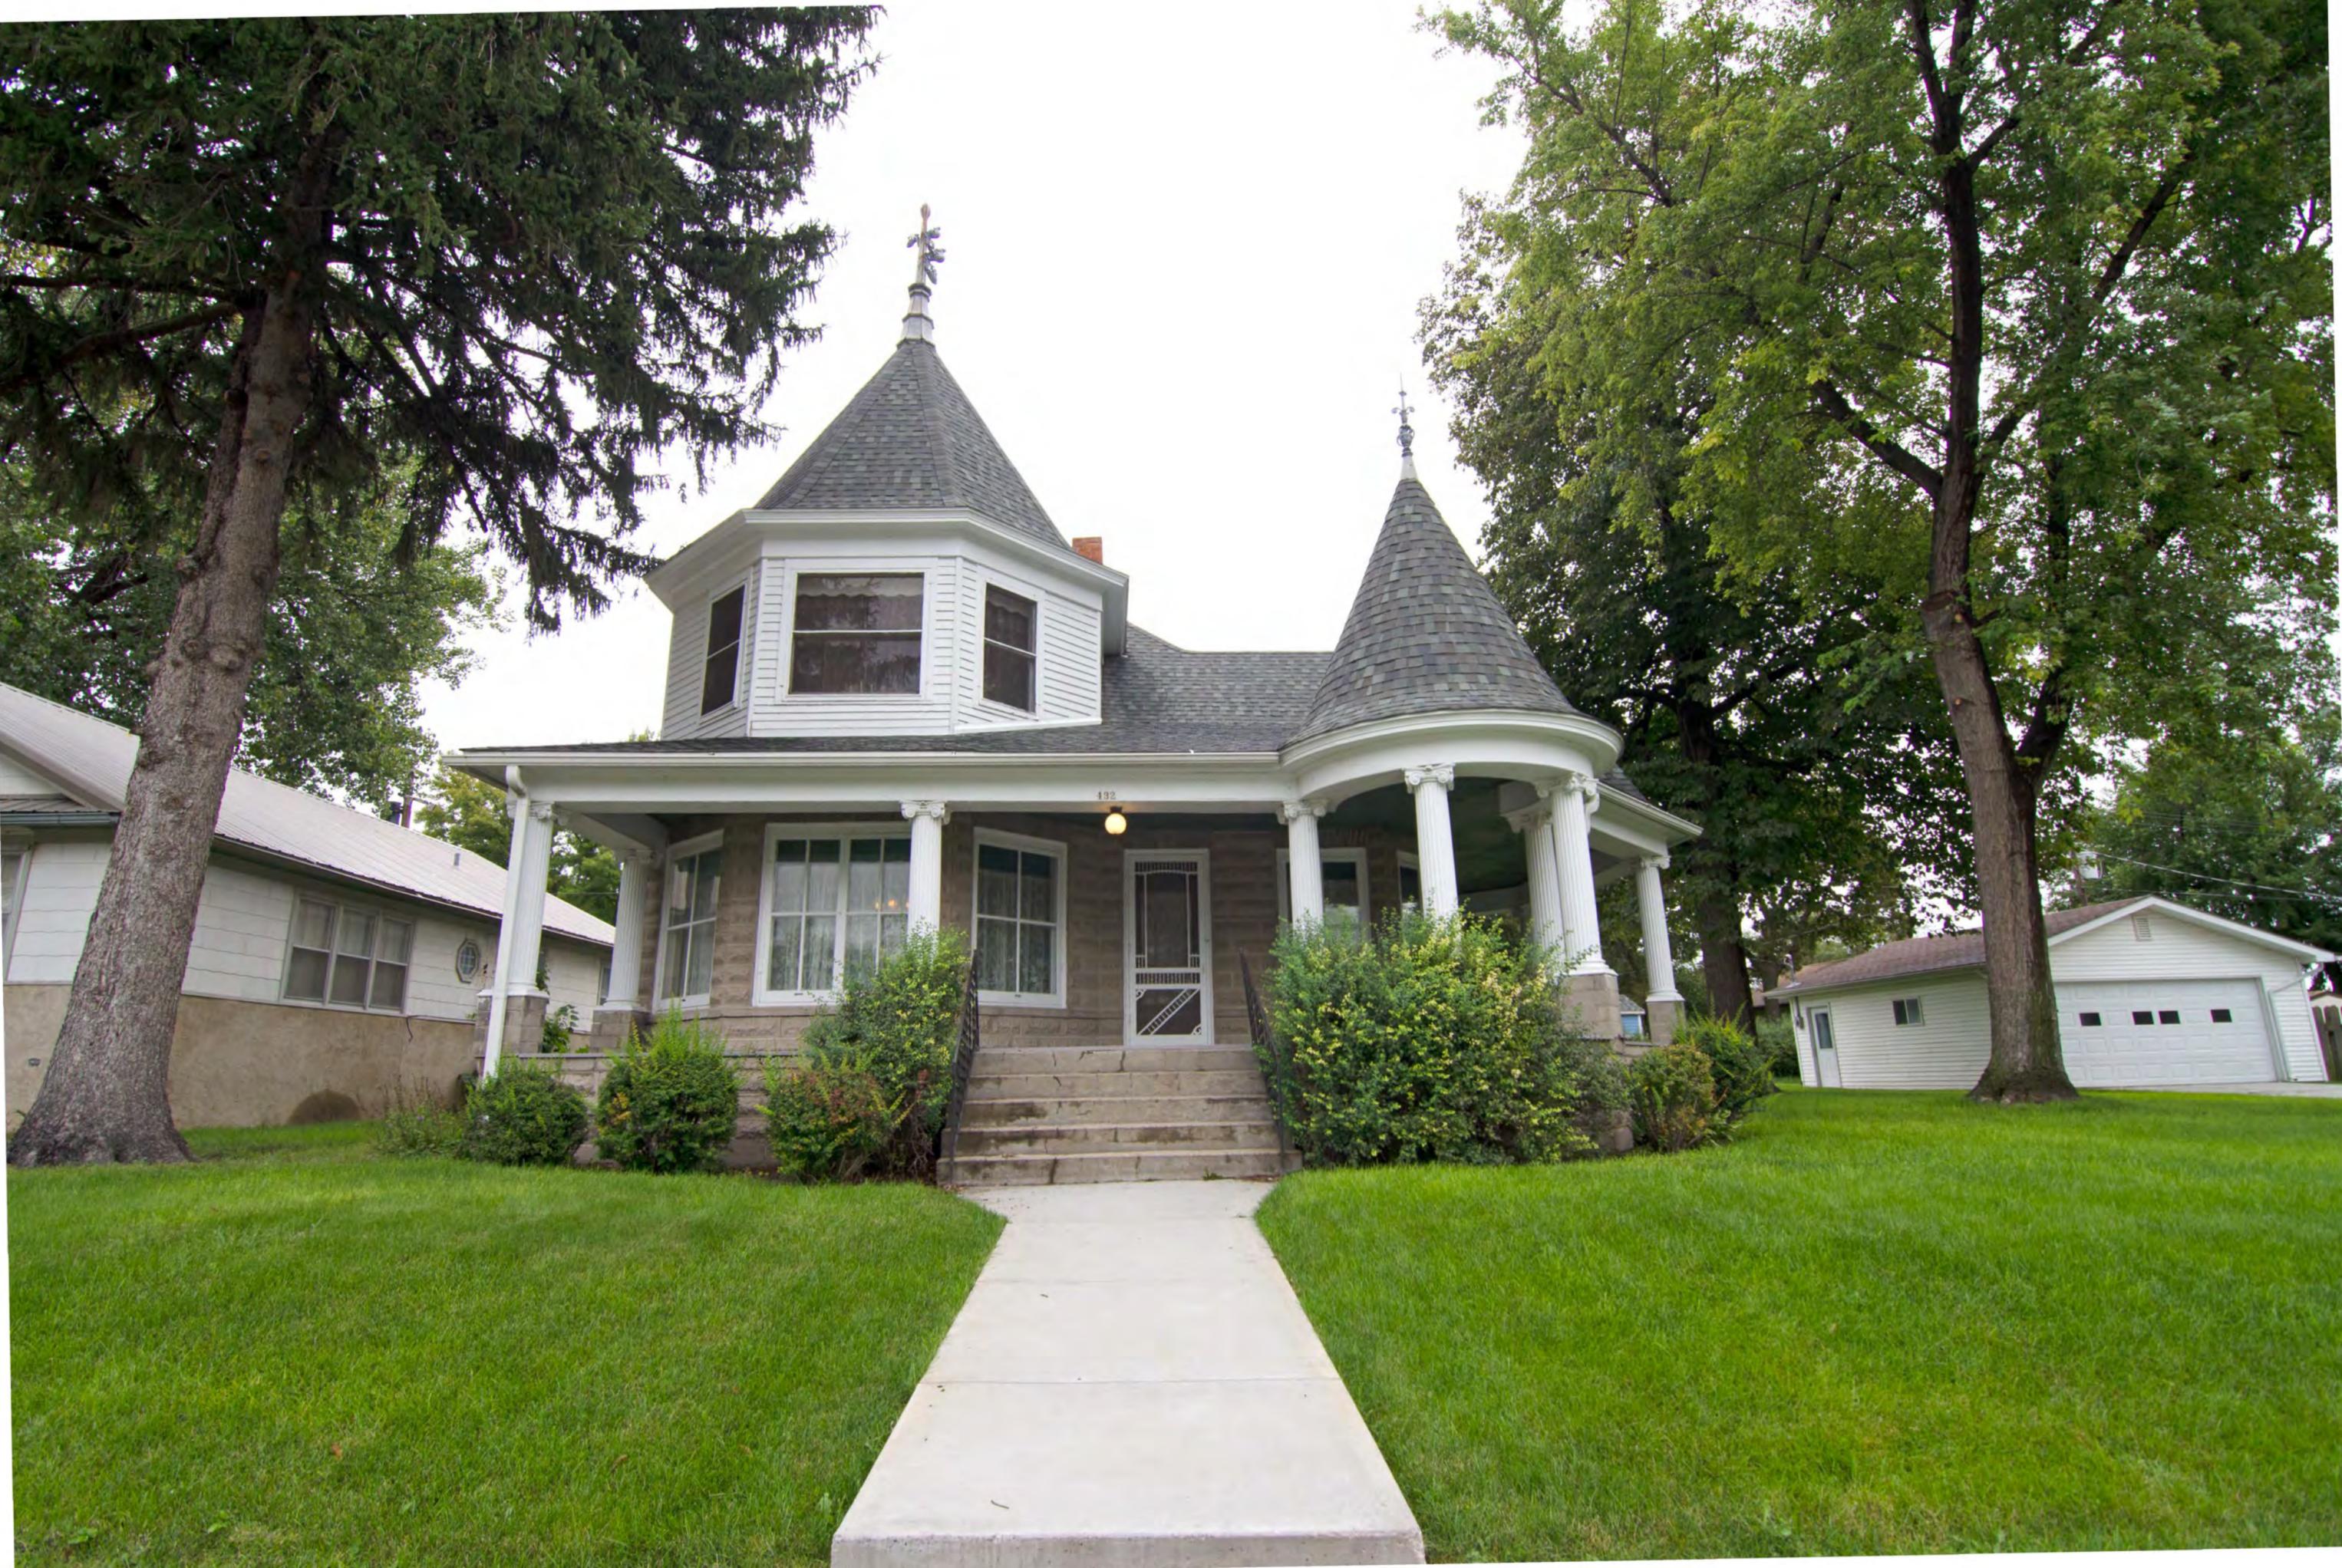
1. Front facade, view east.
2. Northeast ¼ view, view southeast.
3. South façade with gabled porch, view north.
4. River rock objects, view west.
5. Cellar entrance, view west.
6. Porch column detail, view northeast.
7. Front sitting room, view west.
8. Dining room, view southeast.
9. Entrance to stair, view northwest.
10. Stair, view north.
11. Paneled stair, view south.
12. Tower bedroom, view west.

The Groat House is a two story, rusticated concrete block building with a concrete block foundation and an asphalt shingle roof. The house is essentially a cross gabled structure with the highest ridgeline running east to west, or from the front to the back. The more submissive gables run north and south across the front of the house, with a small second story porch with a baluster railing and simplified fretwork under the gable that faces south toward downtown Broken Bow. The north gable is wood frame with a one over one double hung window. Upon the framework of this cross gabled form, the house also is graced with an upper story tower that features the planes of the octagonal room they form inside. The tower has three windows that are one over one double hung, with the widest one situated in the middle. The house also has a wraparound porch with its own conical turret, and is supported by fluted ionic columns set on concrete block bases. Both tower and turret have tin finials of different design. The floor of the porch is wood, with a wood ceiling overhead. The south and northwest walls are canted with large windows, and a door on the southeast end of the porch enters the house into the dining room.
