# National Register of Historic Places Registration Form

Historic name: Cox-Phillips-Mitchell Agricultural Complex

Other names/site number: Delaware CRS # N04085

Street & number: 1651 and 1655 Old Wilmington Rd

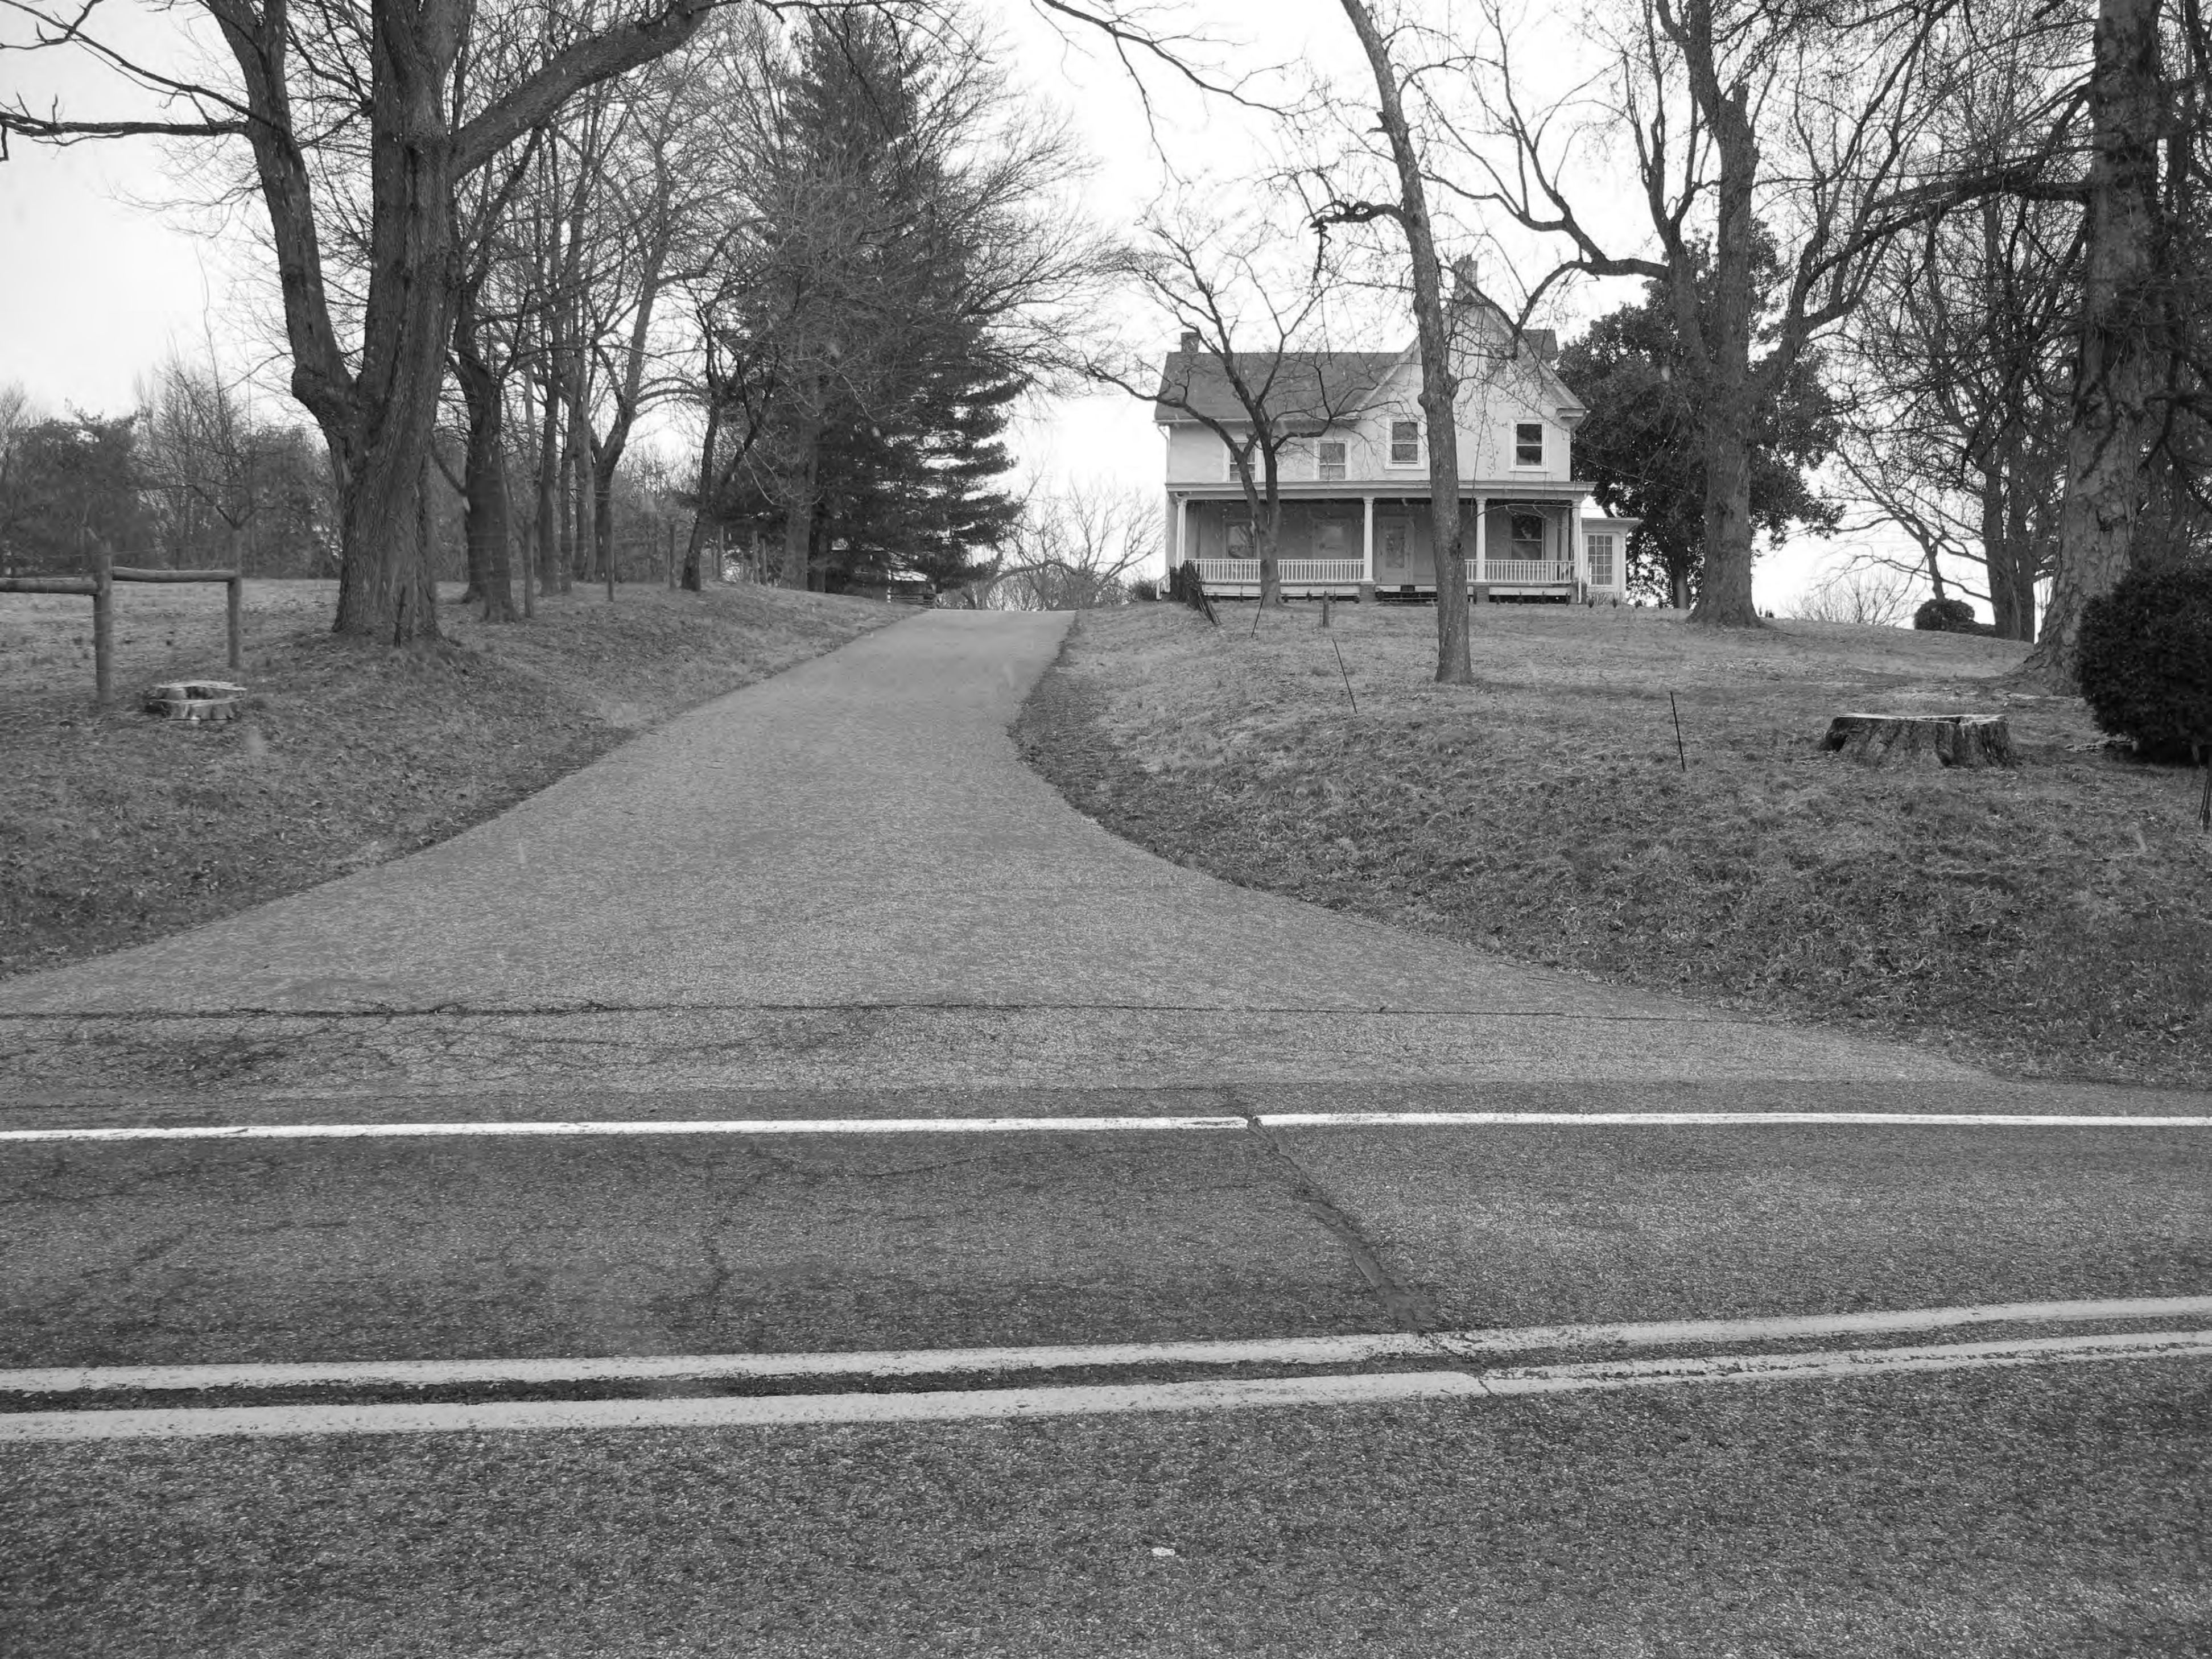
Cox-Phillips-Mitchell Agricultural Complex\_New Castle County\_DE  
Environmental view of southwest facade of house looking northeast

The southwest elevation of the dwelling, which is the current façade, fronts Old Wilmington Road and is a combination of the Period I (1726) and Period II (1760-1820) sections of the building. Together, they form a painted brick and stone, four-bay, two-and-a-half story structure. The southeastern two openings are on the gable end of the Period I, 1726 building, while the southwestern two bays are located on the Period II addition. A full-width, one-story porch spans the entire elevation, and has five Doric columns on brick piers supporting the structure. At the first level, two doors, located in the two middle bays, lead into separate rooms of the house and demarcate the Period I and II building phases. Flanking the doors, one one-over-one, and one six-over-six, double-hung, sash replacement windows make up the remaining bays of the first story. The windows on the first floor between the Period I and II buildings are at different heights reflecting the internal difference in the floor heights. On the second story two one-over-one, and two six-over-six, double-hung sash windows with simple white trim are placed over the openings on the first floor. The windows in the Period I portion are half a window height higher than the Period II windows. Only the Period I section is two-and-a-half-stories in height. The attic level is also two bays, and features two smaller, one-over-one windows double-hung sash windows with simple white trim. The Period I structure is gable-ended, while the Period II addition is orientated on longitudinally, running northwest to southeast.

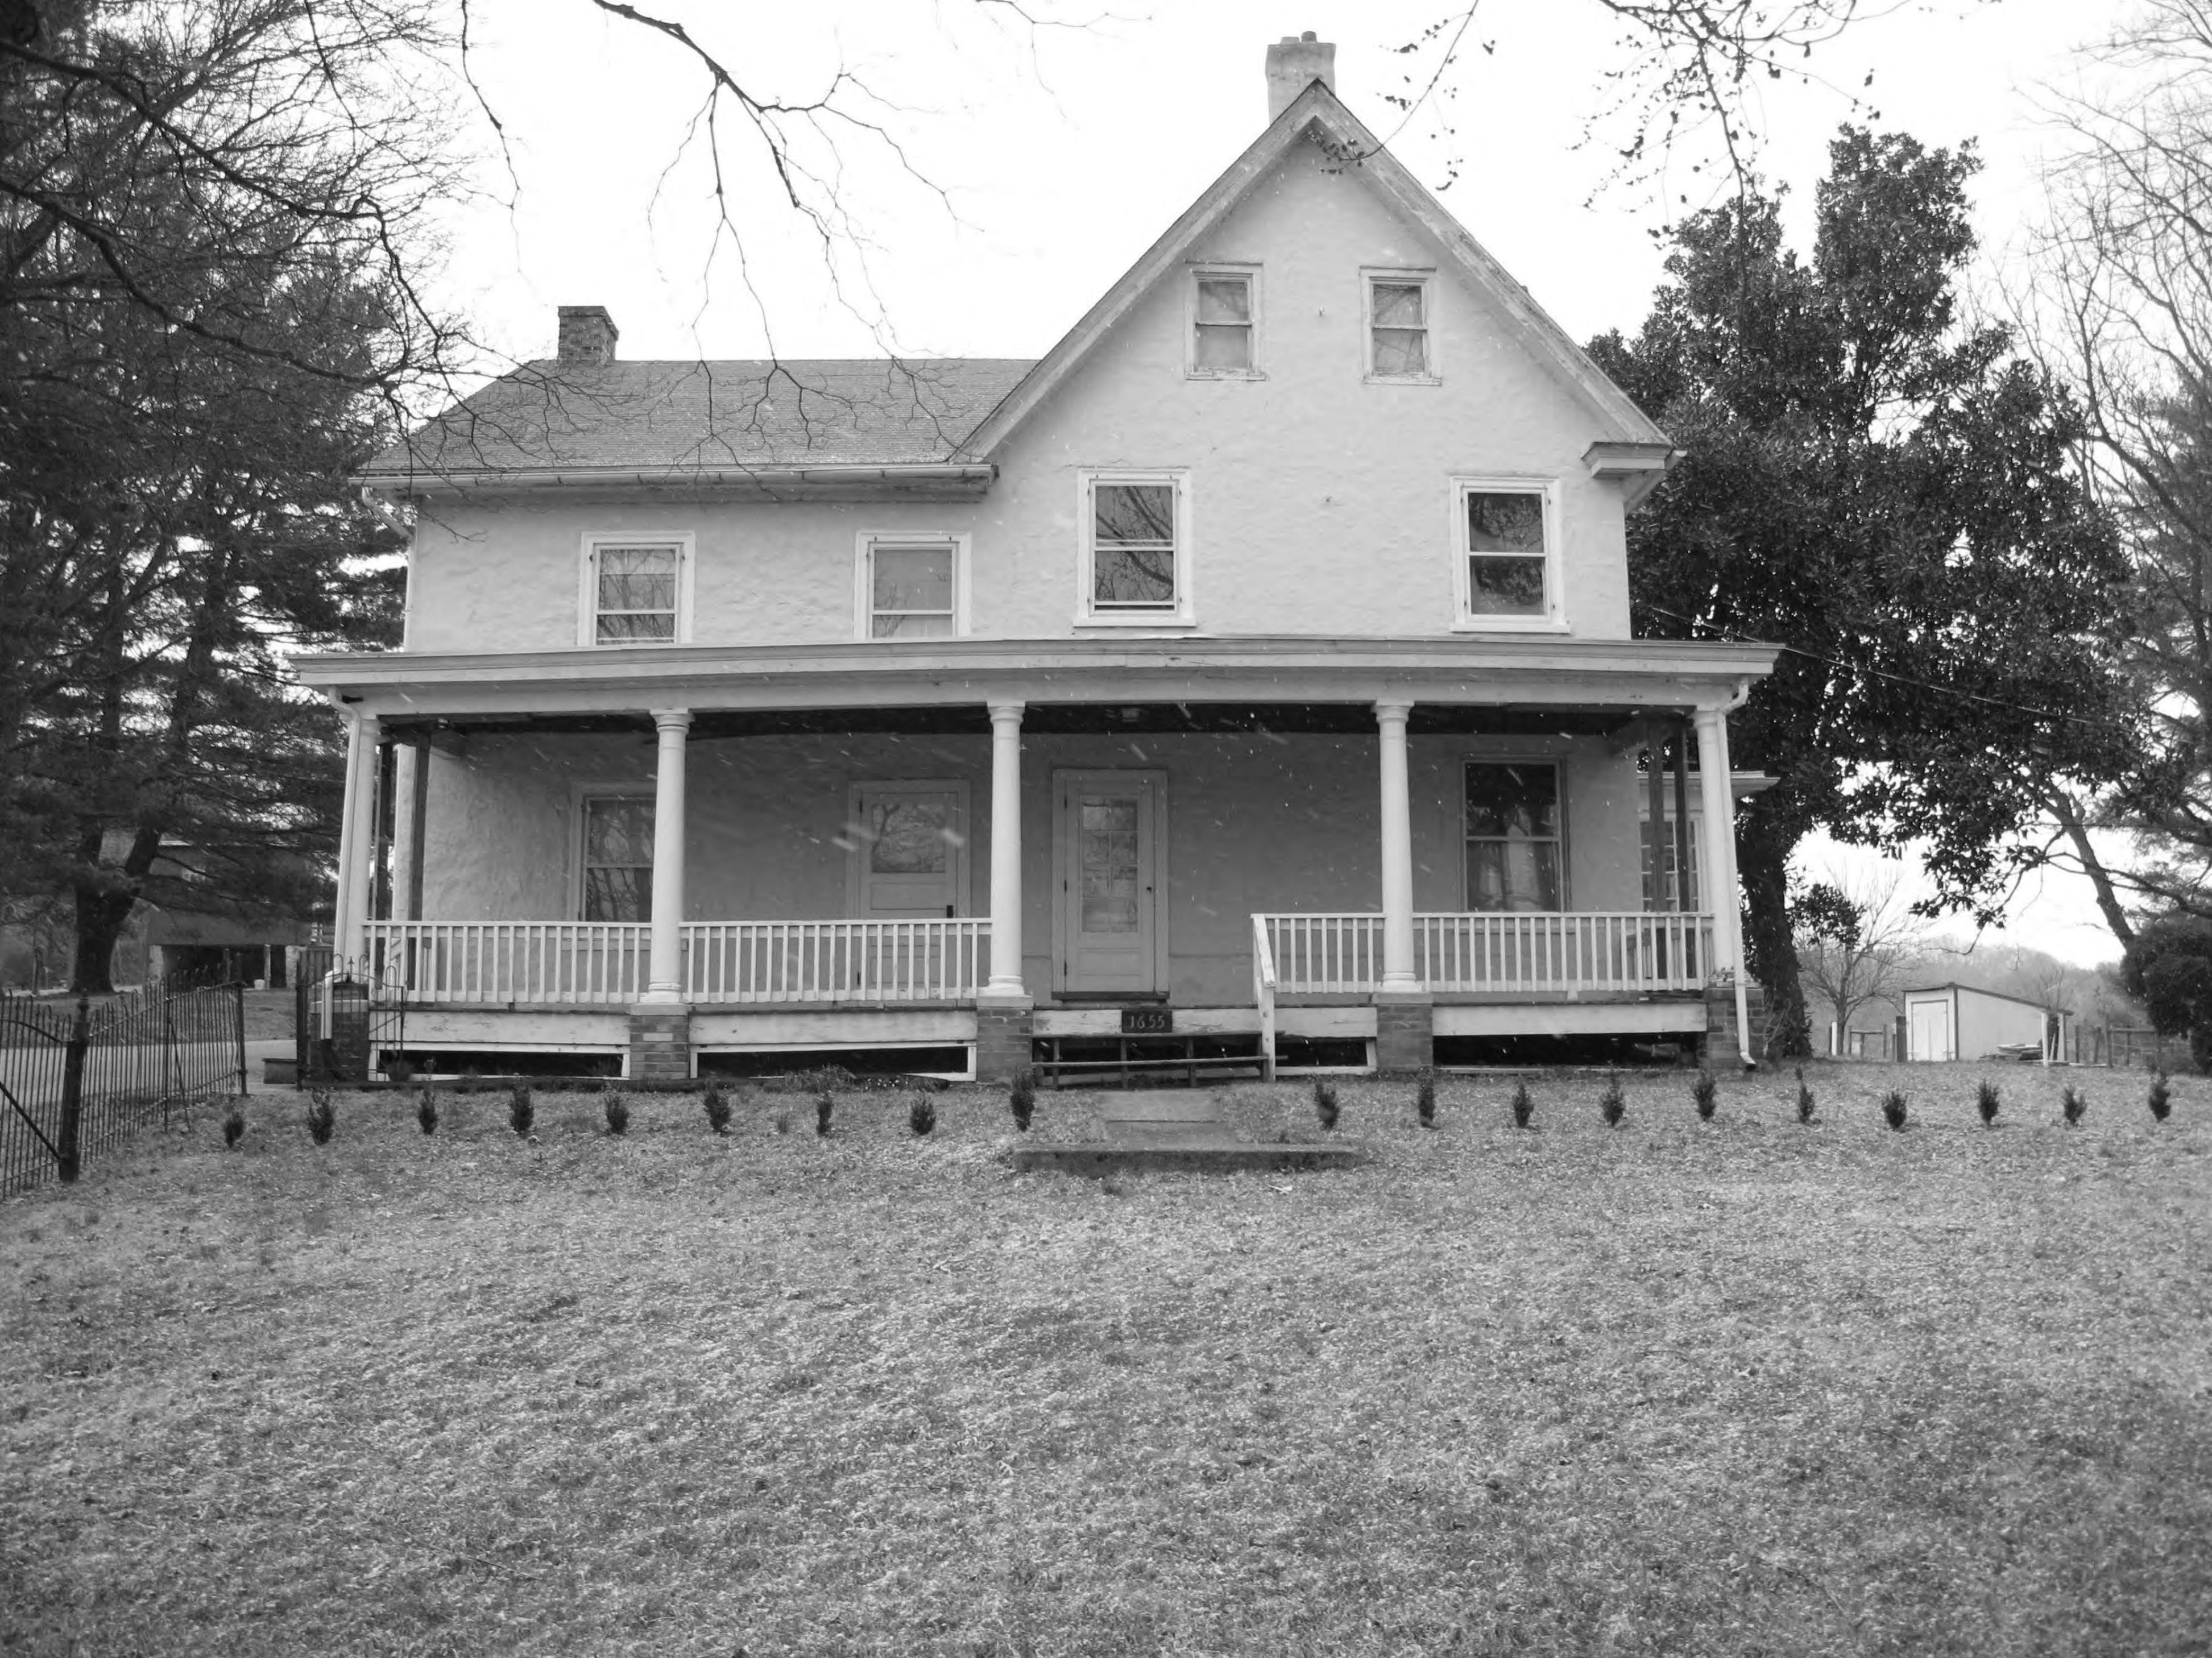
Cox-Phillips-Mitchell Agricultural Complex\_New Castle County\_DE  
View of southwest facade of house looking northeast

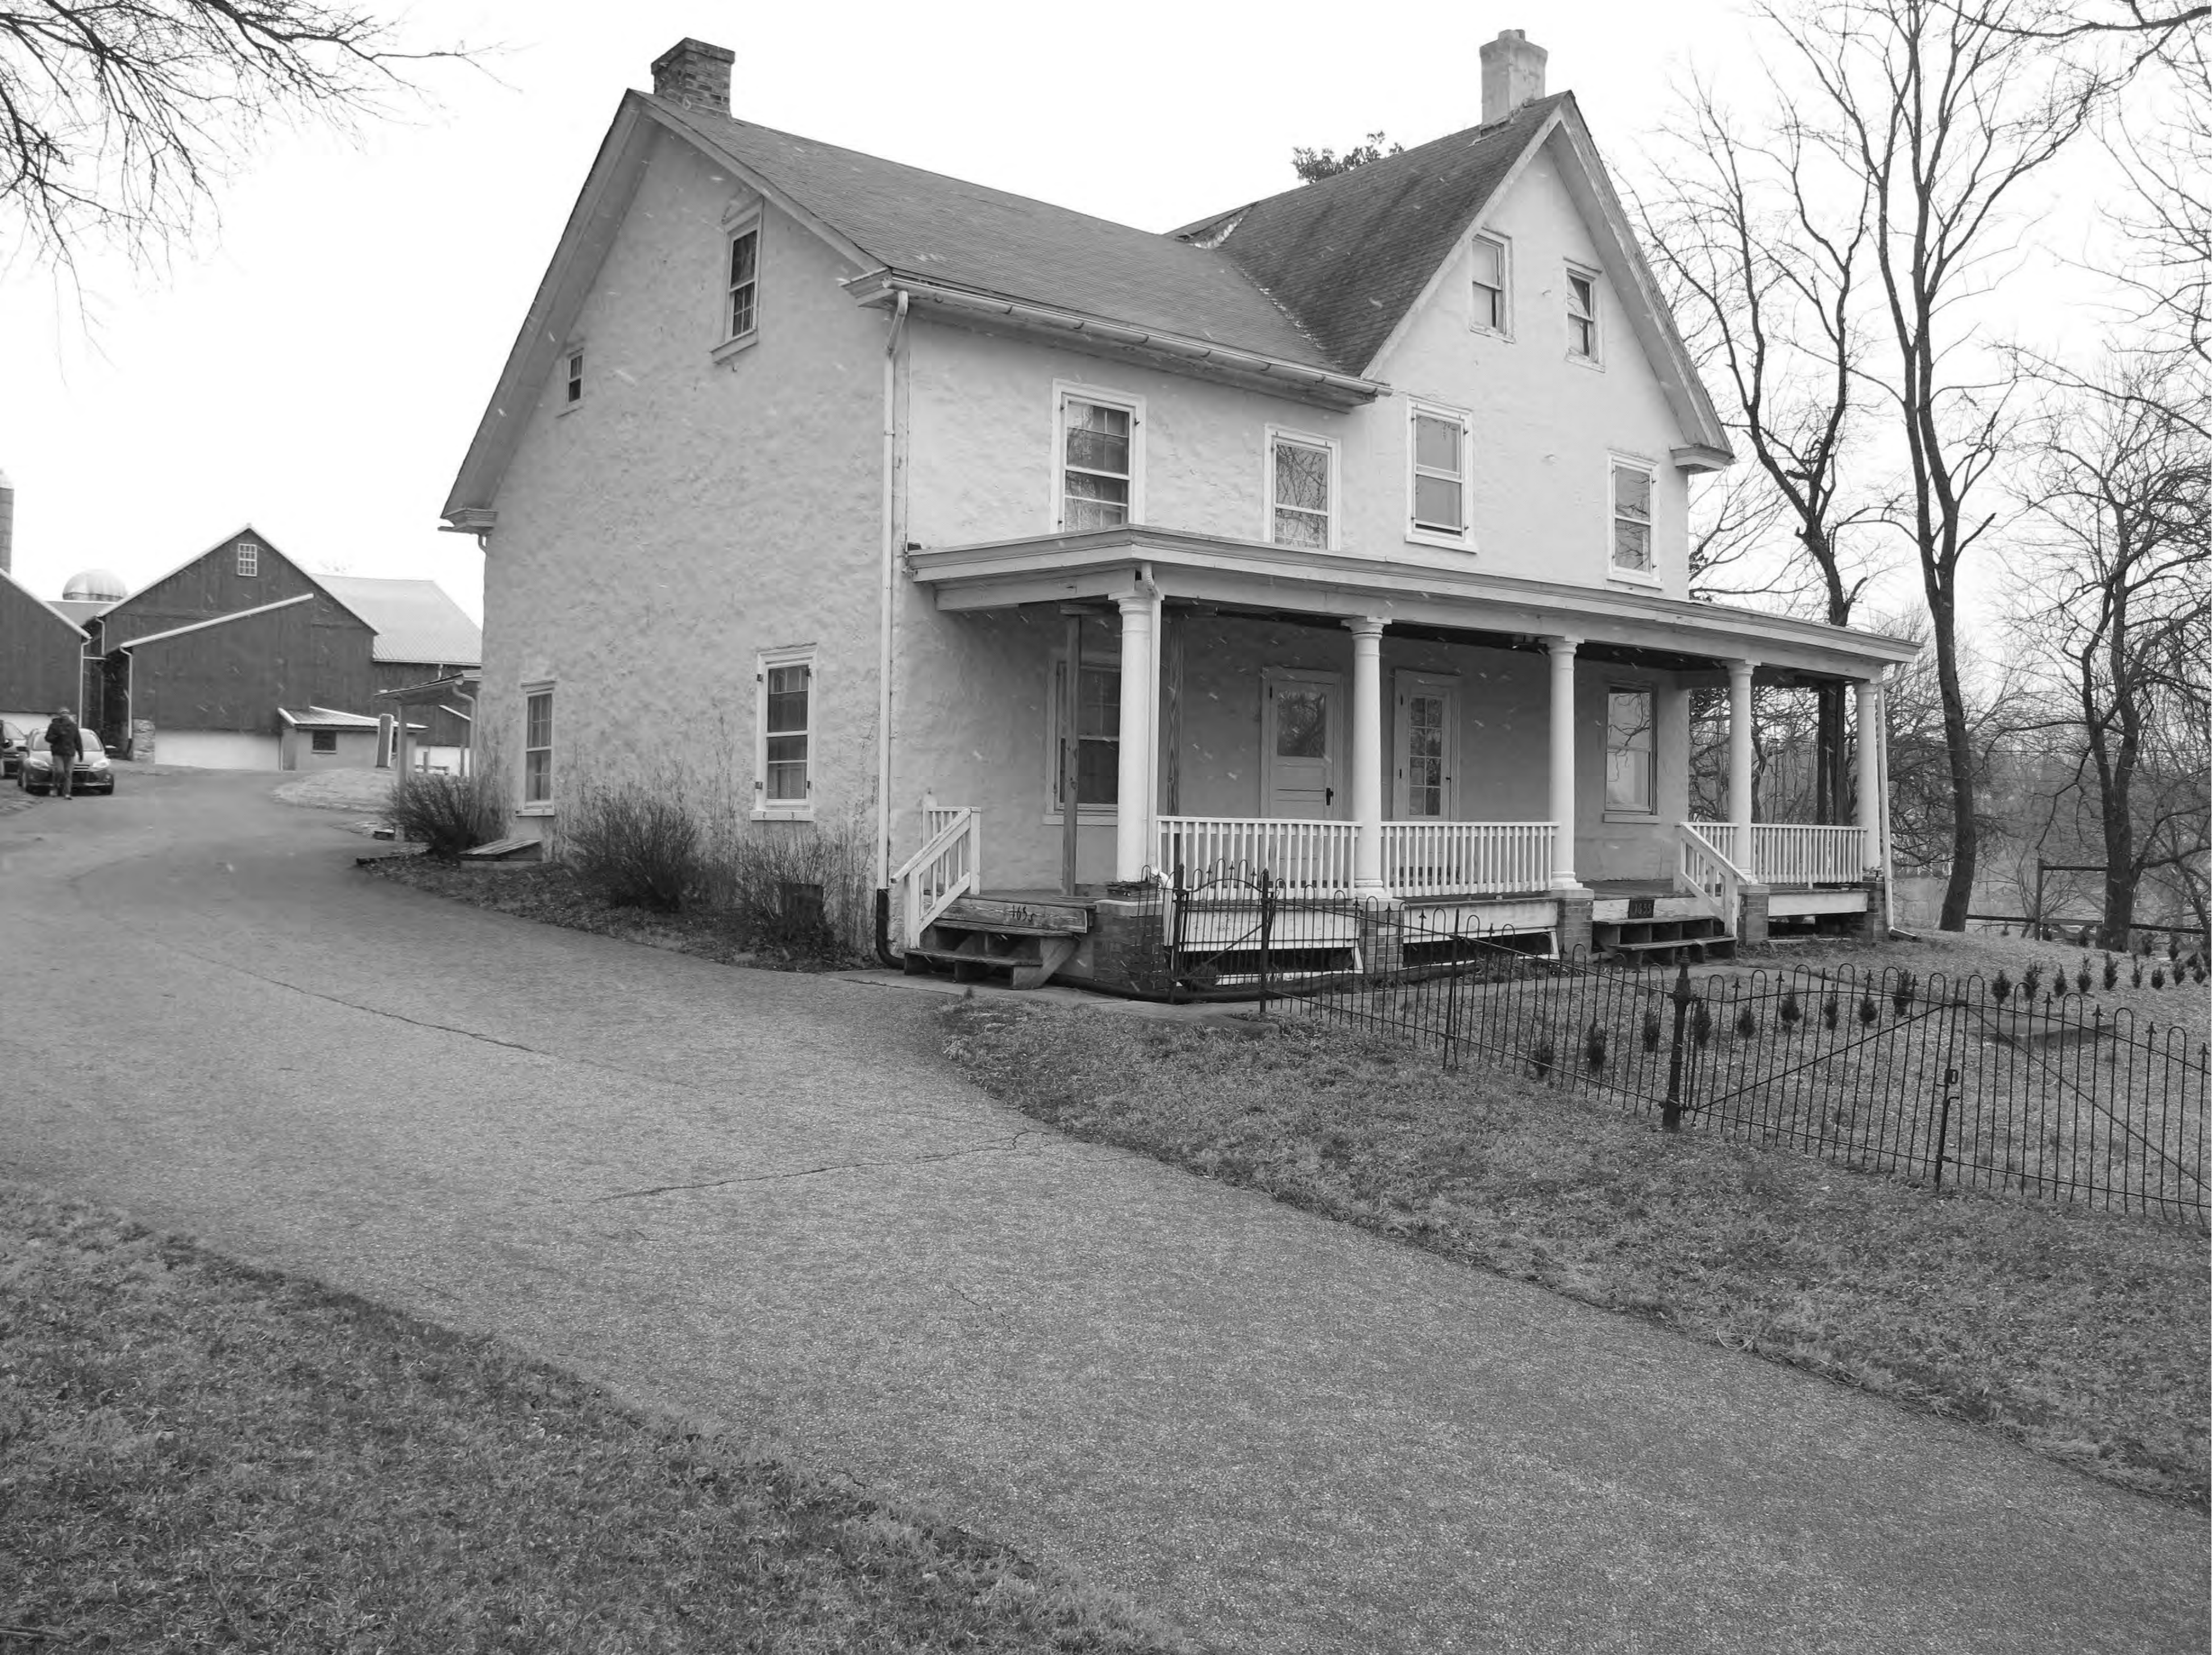
Cox-Phillips-Mitchell Agricultural Complex\_New Castle County\_DE  
Perspective view of northwest and southwest elevations of house looking east

The northwestern elevation, which is adjacent to the driveway and now features the principal entry, is visually divided into five-bays, and shows three different building phases. The southwestern Period II portion of the building is a stucco-covered, stone, two-bay, gable-ended

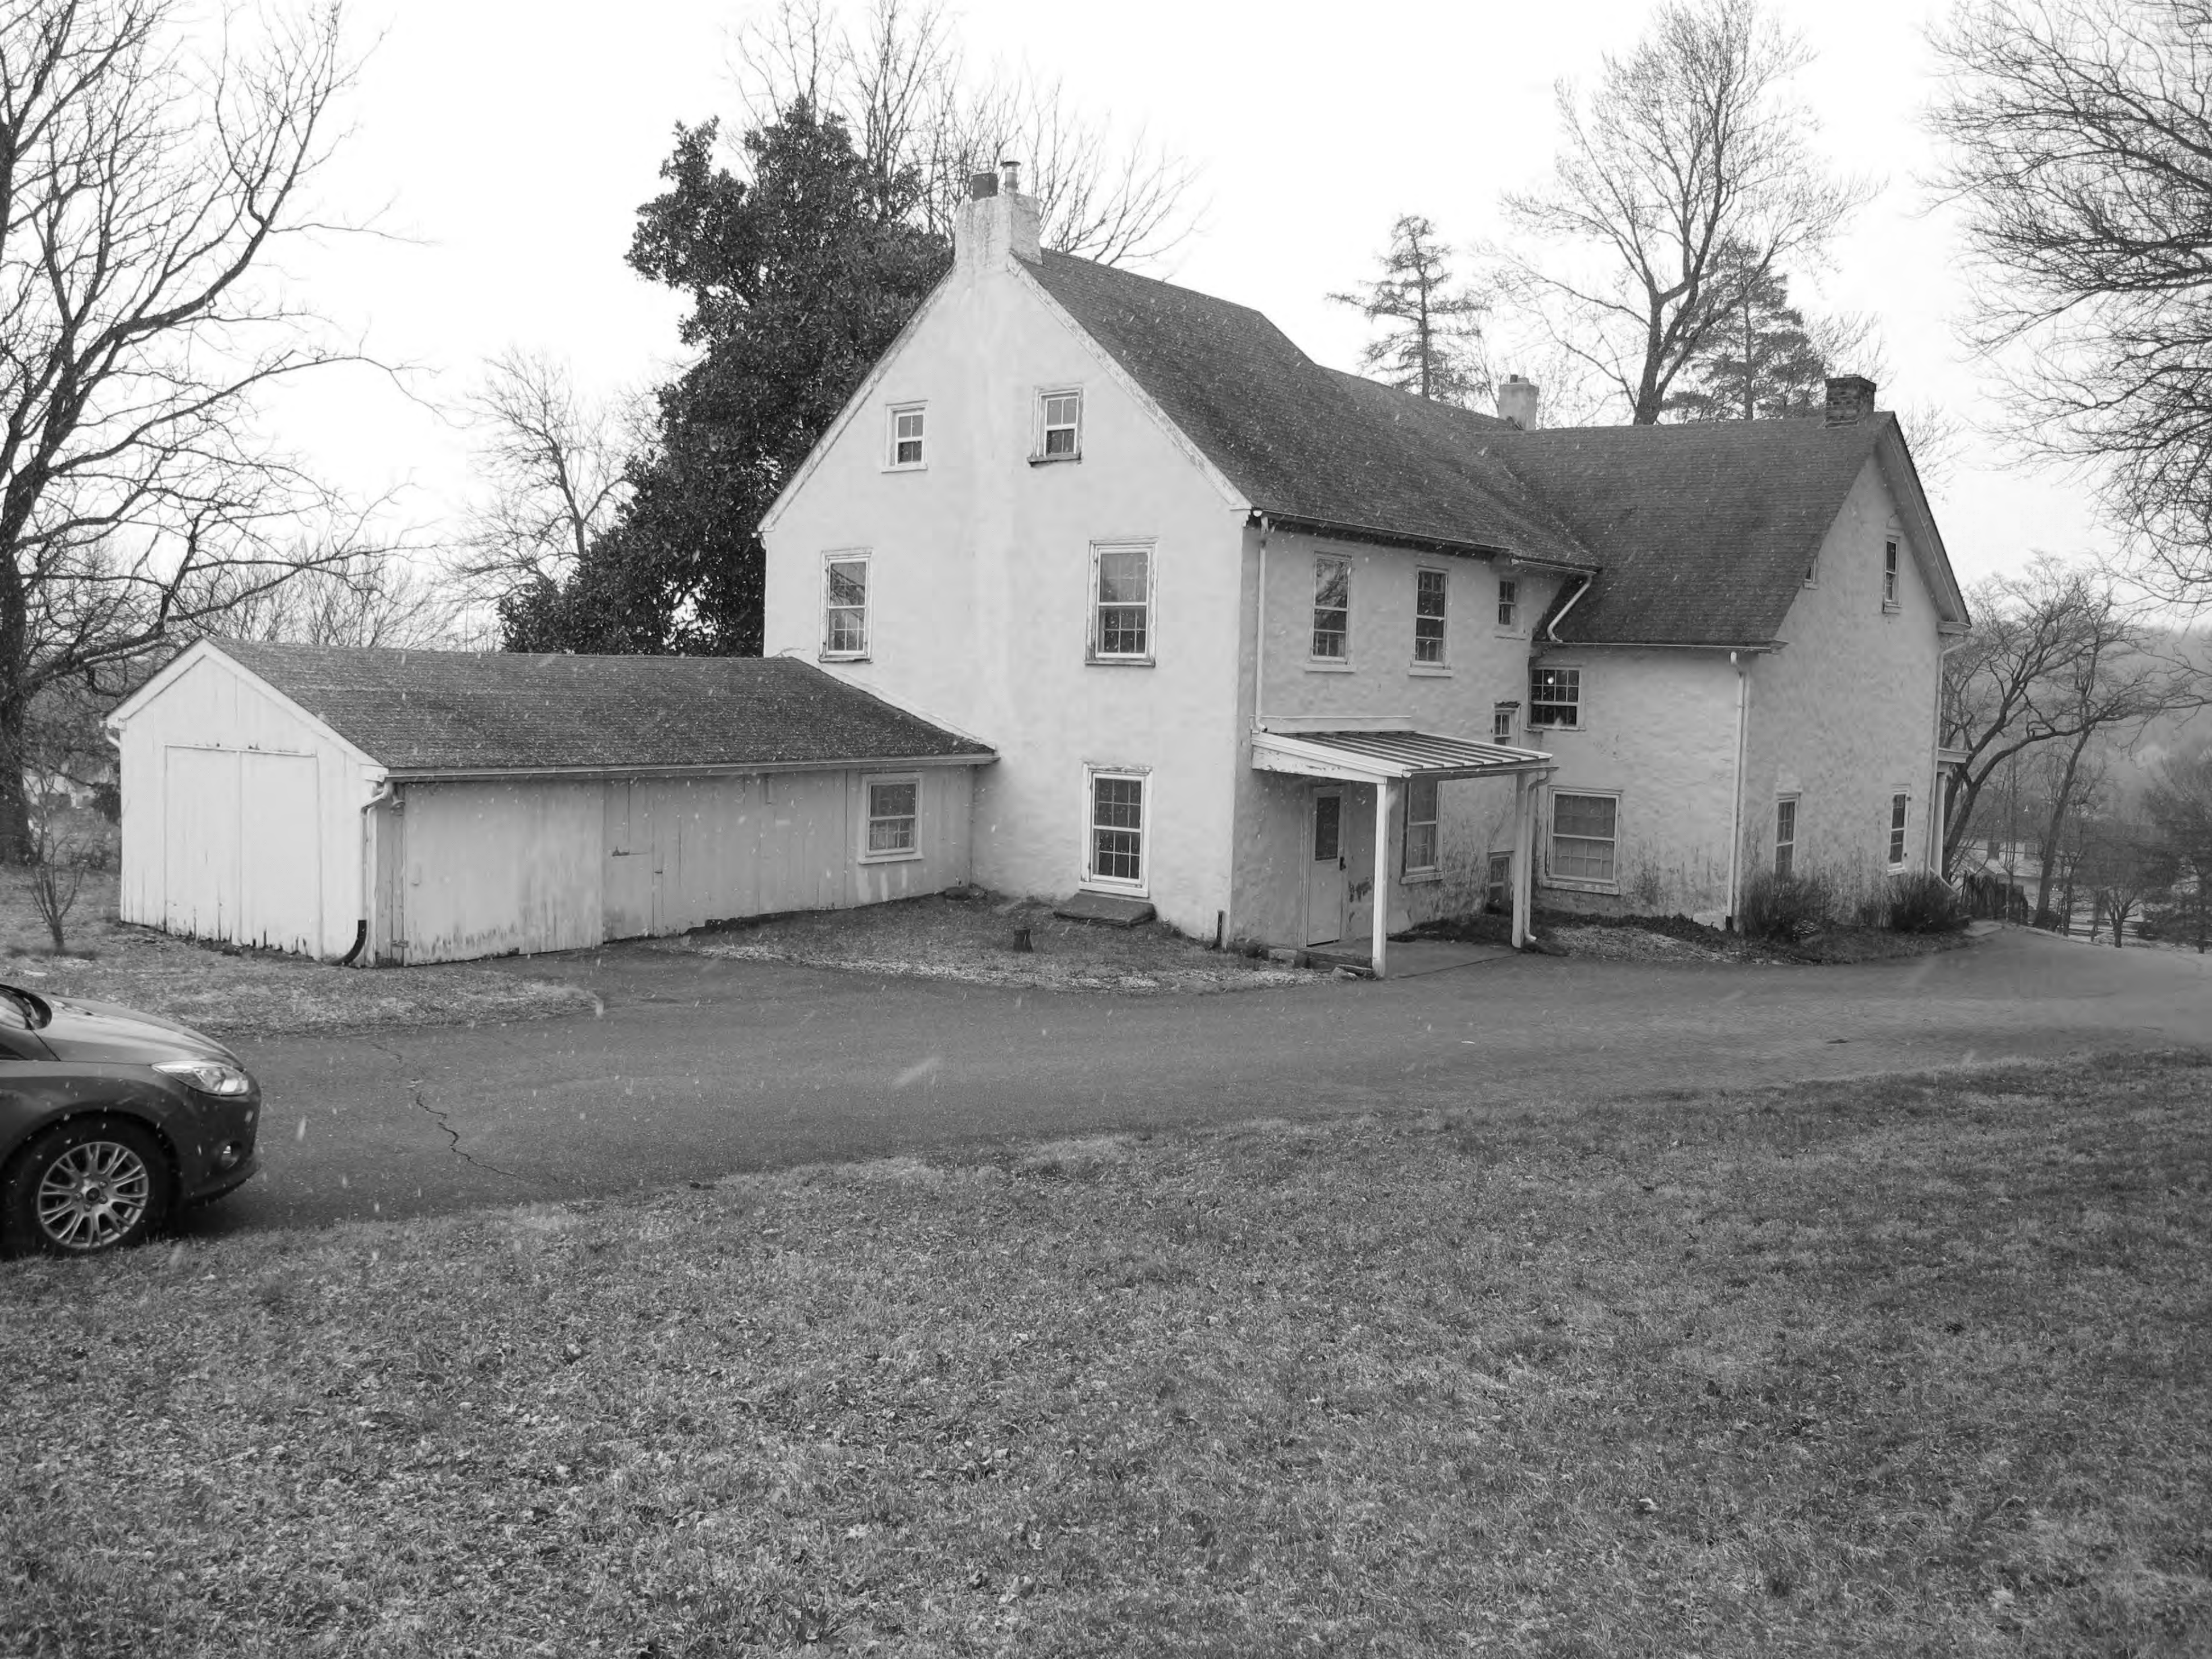
Cox-Phillips-Mitchell Agricultural Complex\_New Castle County\_DE  
Perspective view of northwest and northeast elevations of house looking south

The rear northeast elevation of the dwelling is comprised of the Period III addition and the Period IV shed. The Period III addition is stone and stucco, two-and-a-half story, gable-end ell, attached to the Period I and II structures. Only one bay is visible on the first floor, a six-over-six double-hung sash window. The second bay, a doorway, is covered by the shed addition. On the first and second floor the openings are spaced far apart to accommodate a large hearth. The two bays on the second floor are also six-over-six double-hung sash windows. At the attic level, there are two, two-over-two, double-hung, sash windows. This elevation has an off-centered gable and a large, centered plank door.

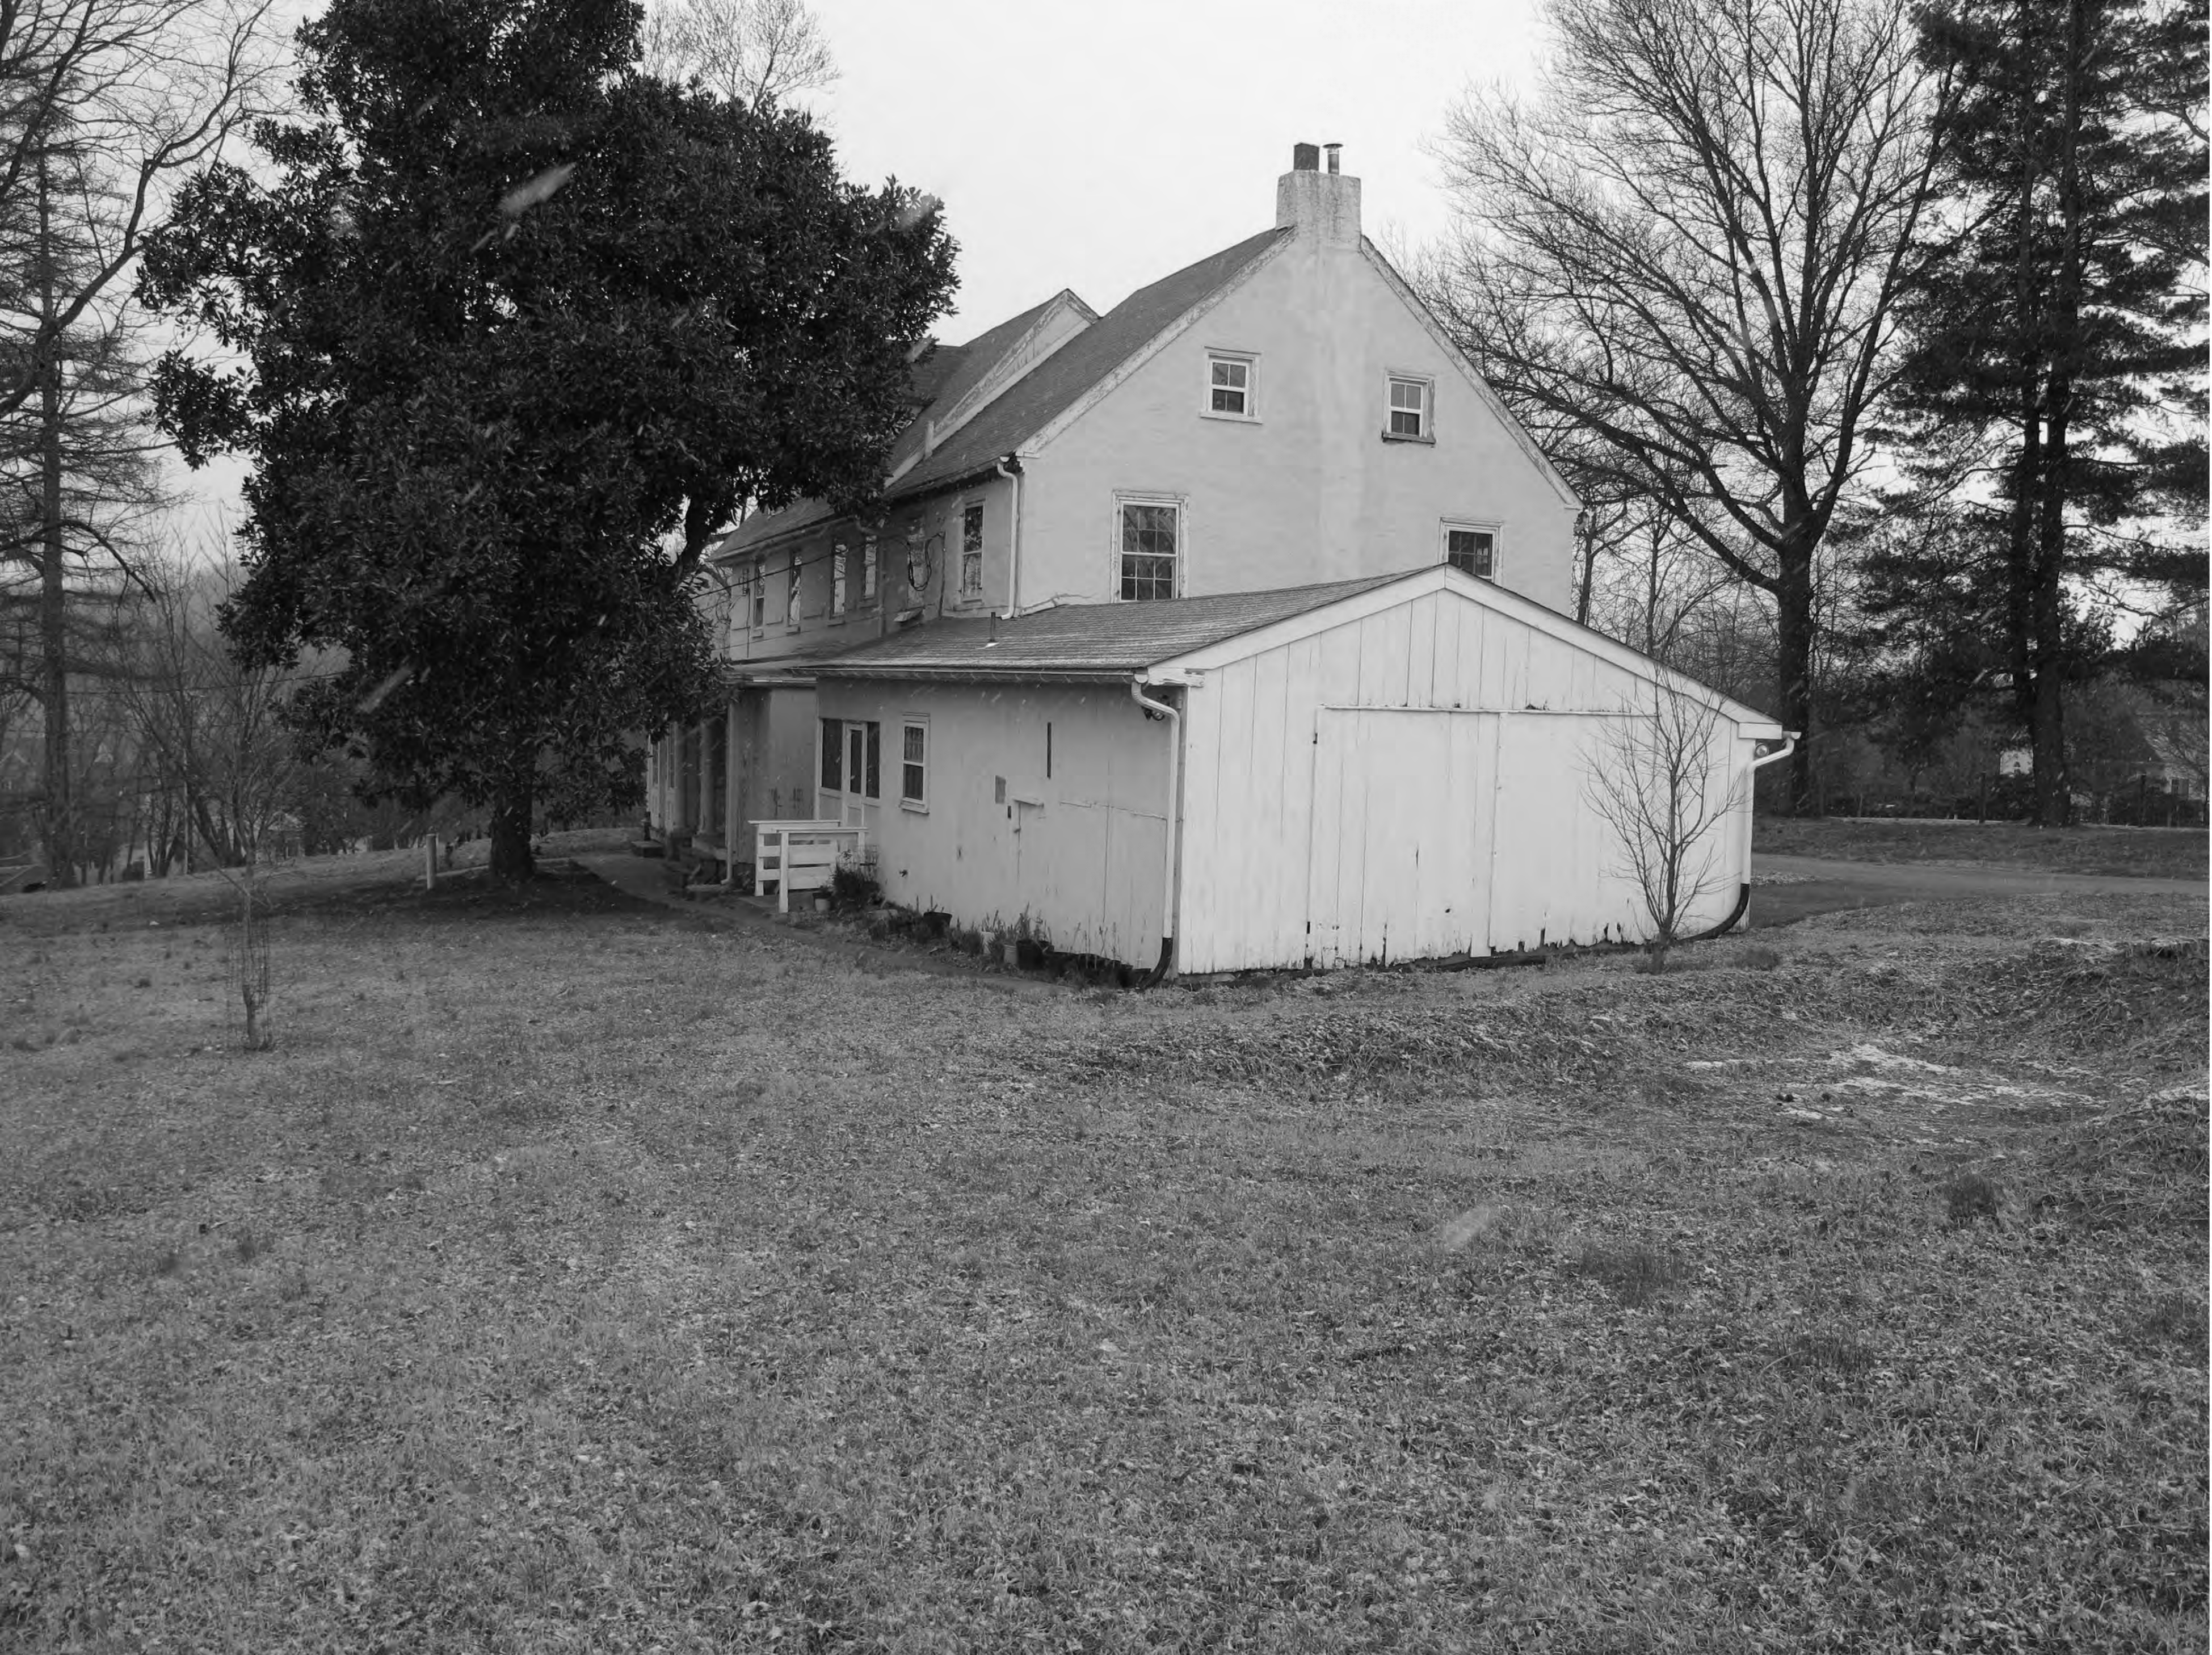
Cox-Phillips-Mitchell Agricultural Complex\_New Castle County\_DE  
Perspective view of northeast and southeast elevations of house looking west
