# National Register of Historic Places Registration Form

Historic name: Cox-Phillips-Mitchell Agricultural Complex

Other names/site number: Delaware CRS # N04085

Street & number: 1651 and 1655 Old Wilmington Rd

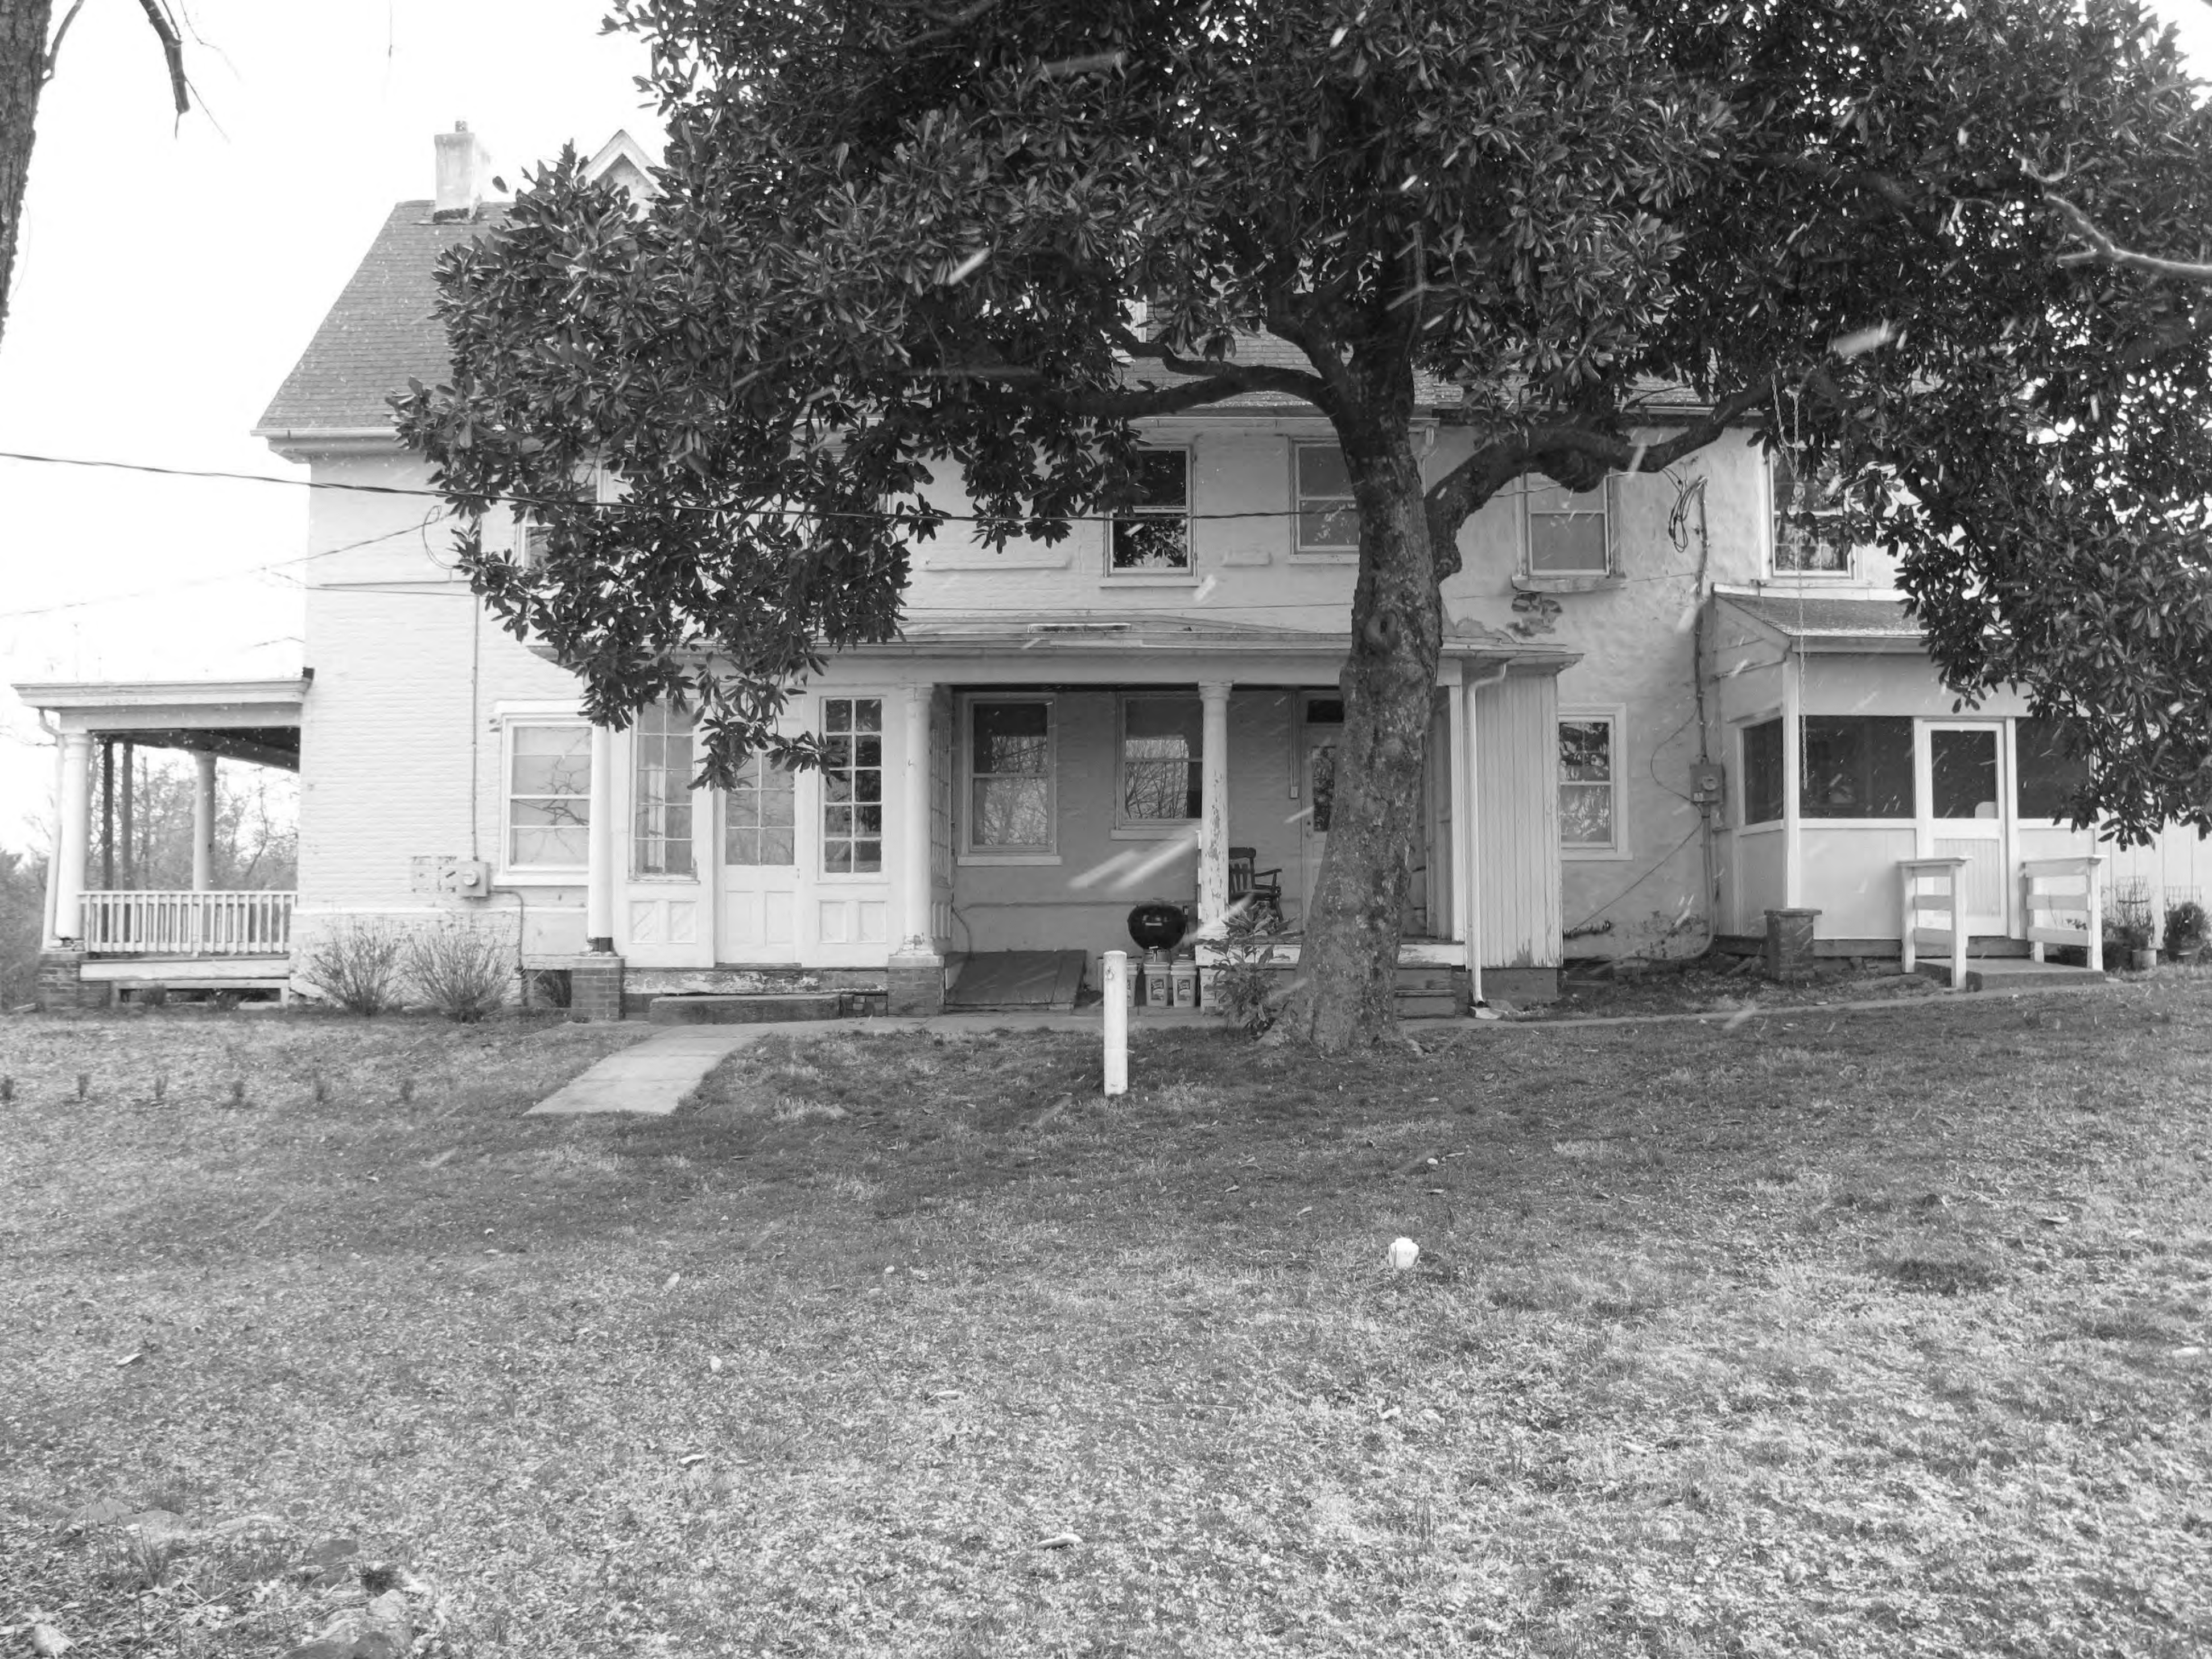
Cox-Phillips-Mitchell Agricultural Complex\_New Castle County\_DE  
View of southeast elevation of house looking northwest

The brick and stone, southeast elevation is seven-bays, two-and-a-half-story, and is a mixture of Period I, III, and IV building phases. The Period I historic façade is a four-bay, now two-and-a-half-story brick structure. It features a brick water-table and belt-course, one-over-one light, double hung sash windows, and a central door, and a door to the northeast, leading to the kitchen. Additionally, there is an extra, irregularly spaced and sized bay (likely added later) at the northeastern end of the Period I section. The central door on the Period I section now has an enclosed one-story porch. The roof of which extends along the face of this elevation to the seam between the Period I and III building phases. This structure forms an open porch along the rest of

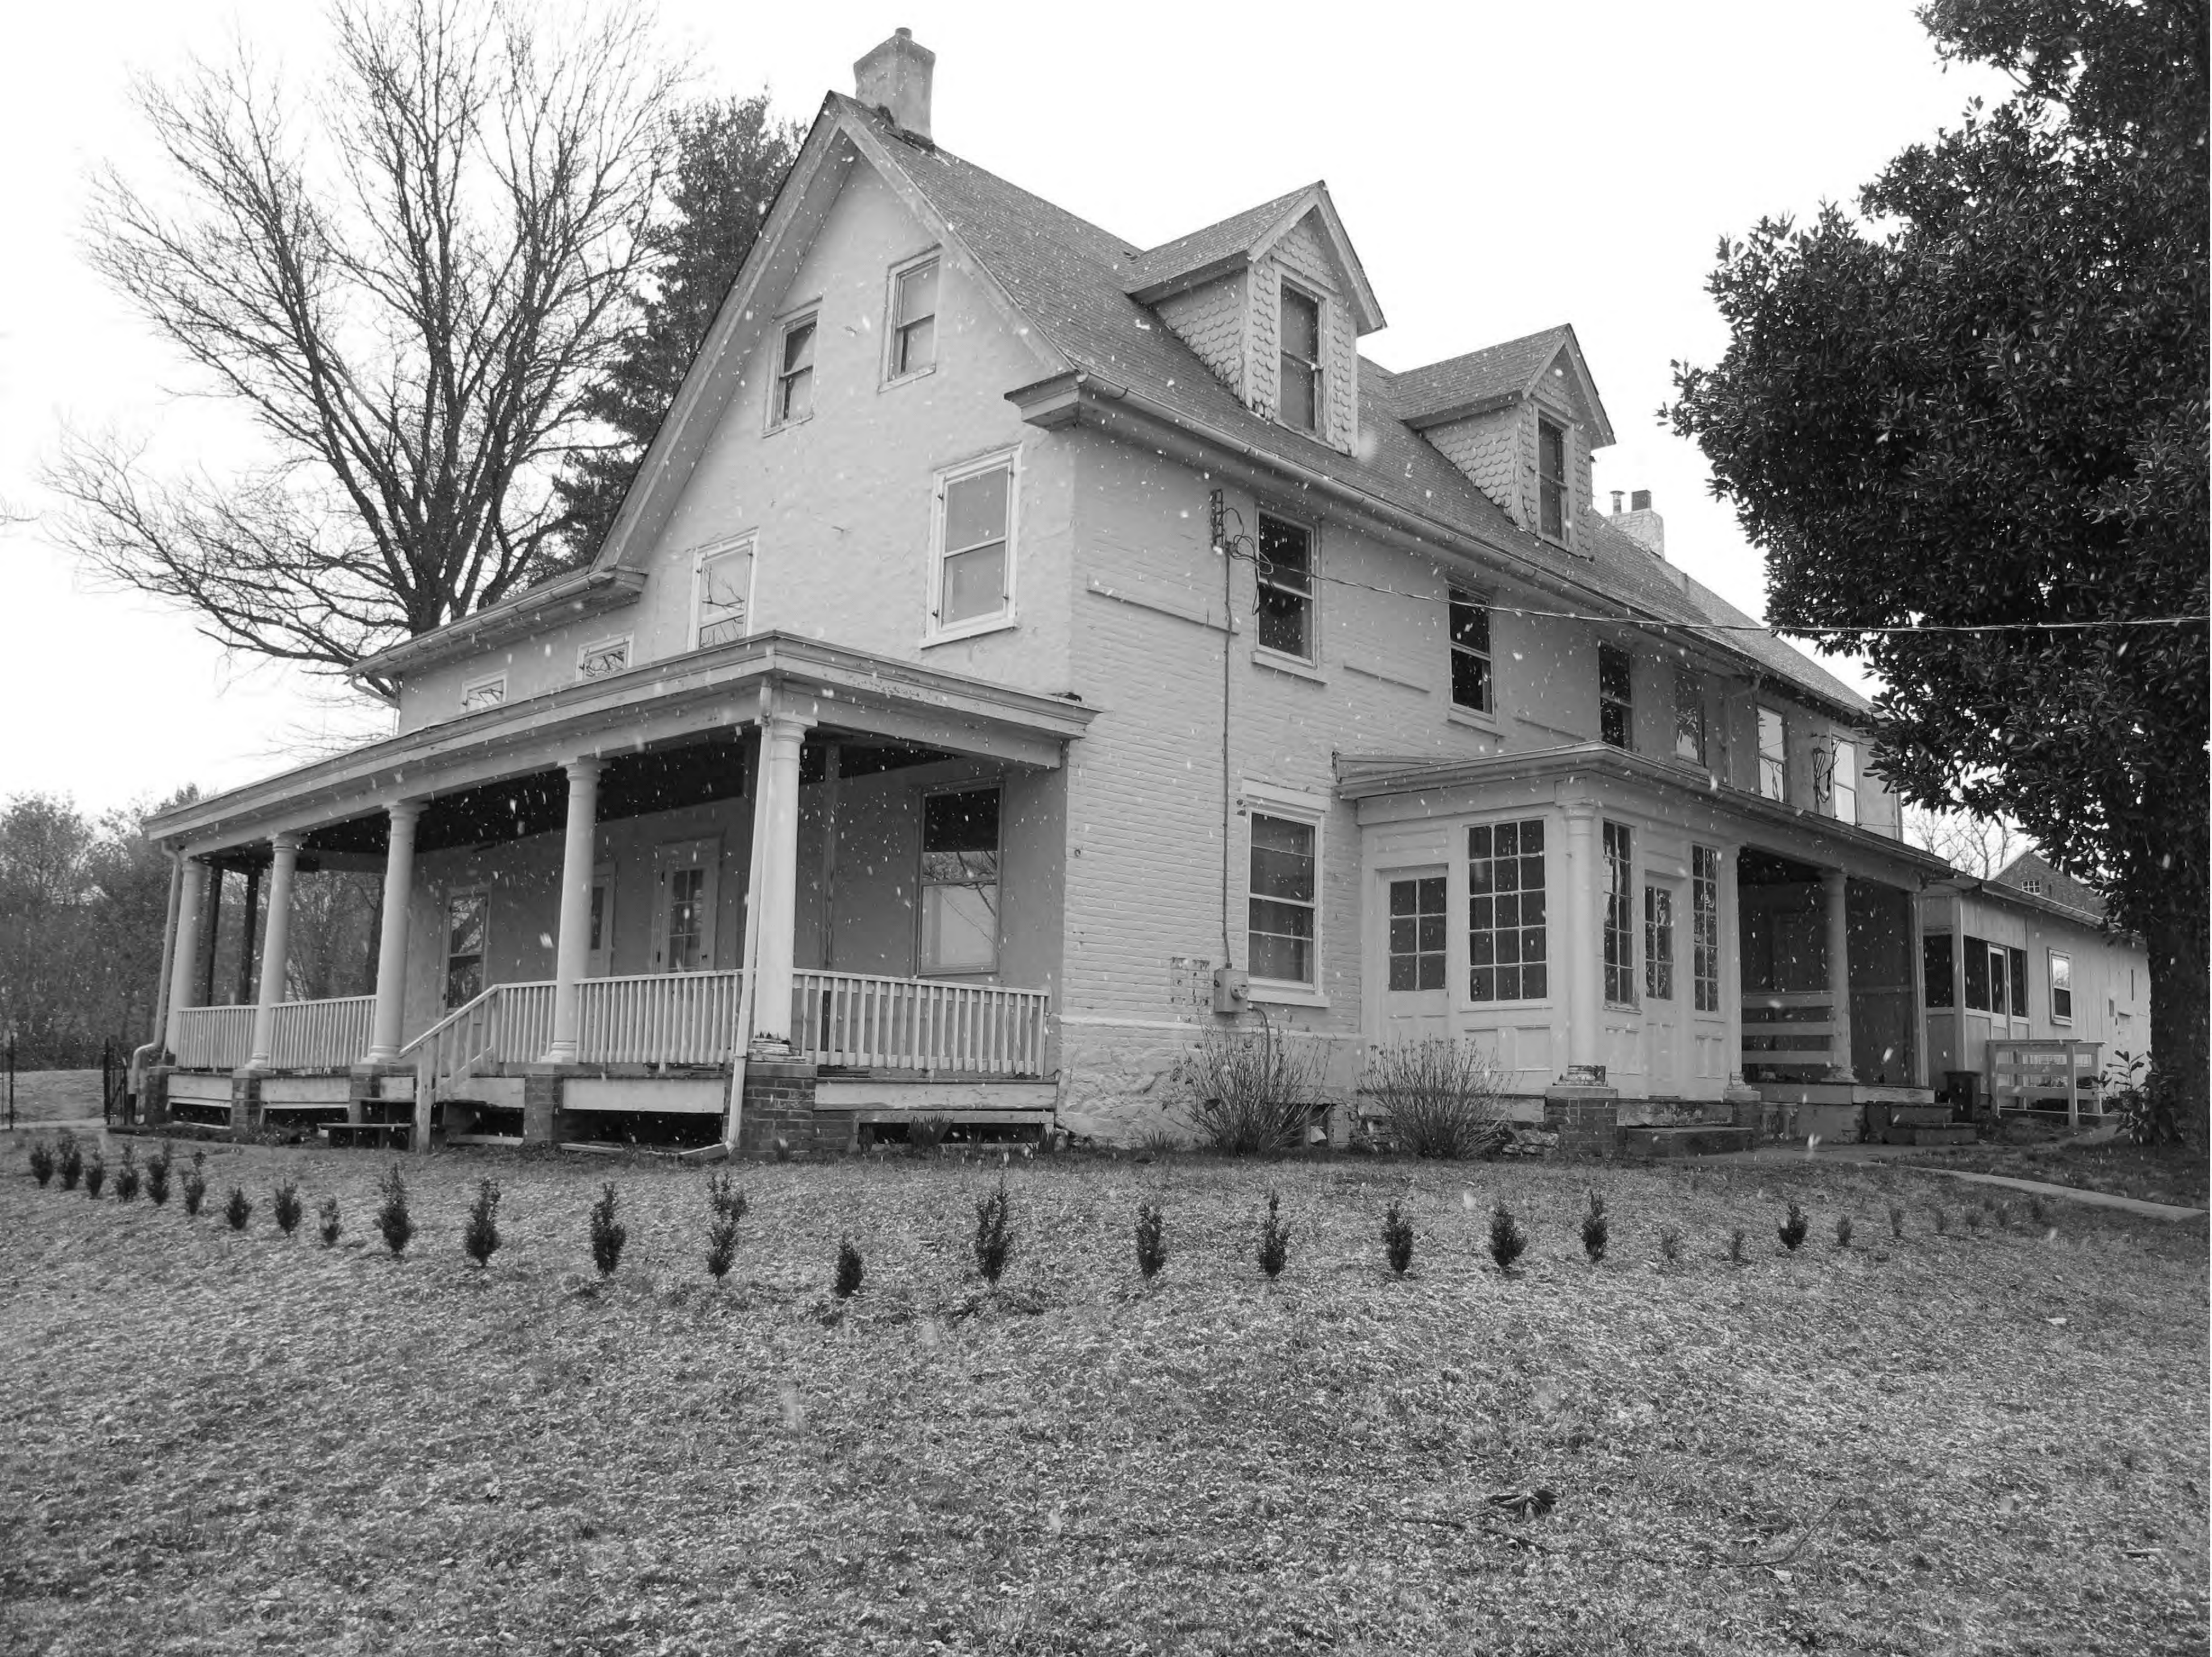
Cox-Phillips-Mitchell Agricultural Complex\_New Castle County\_DE  
Perspective view of southwest and southeast elevations of house looking north

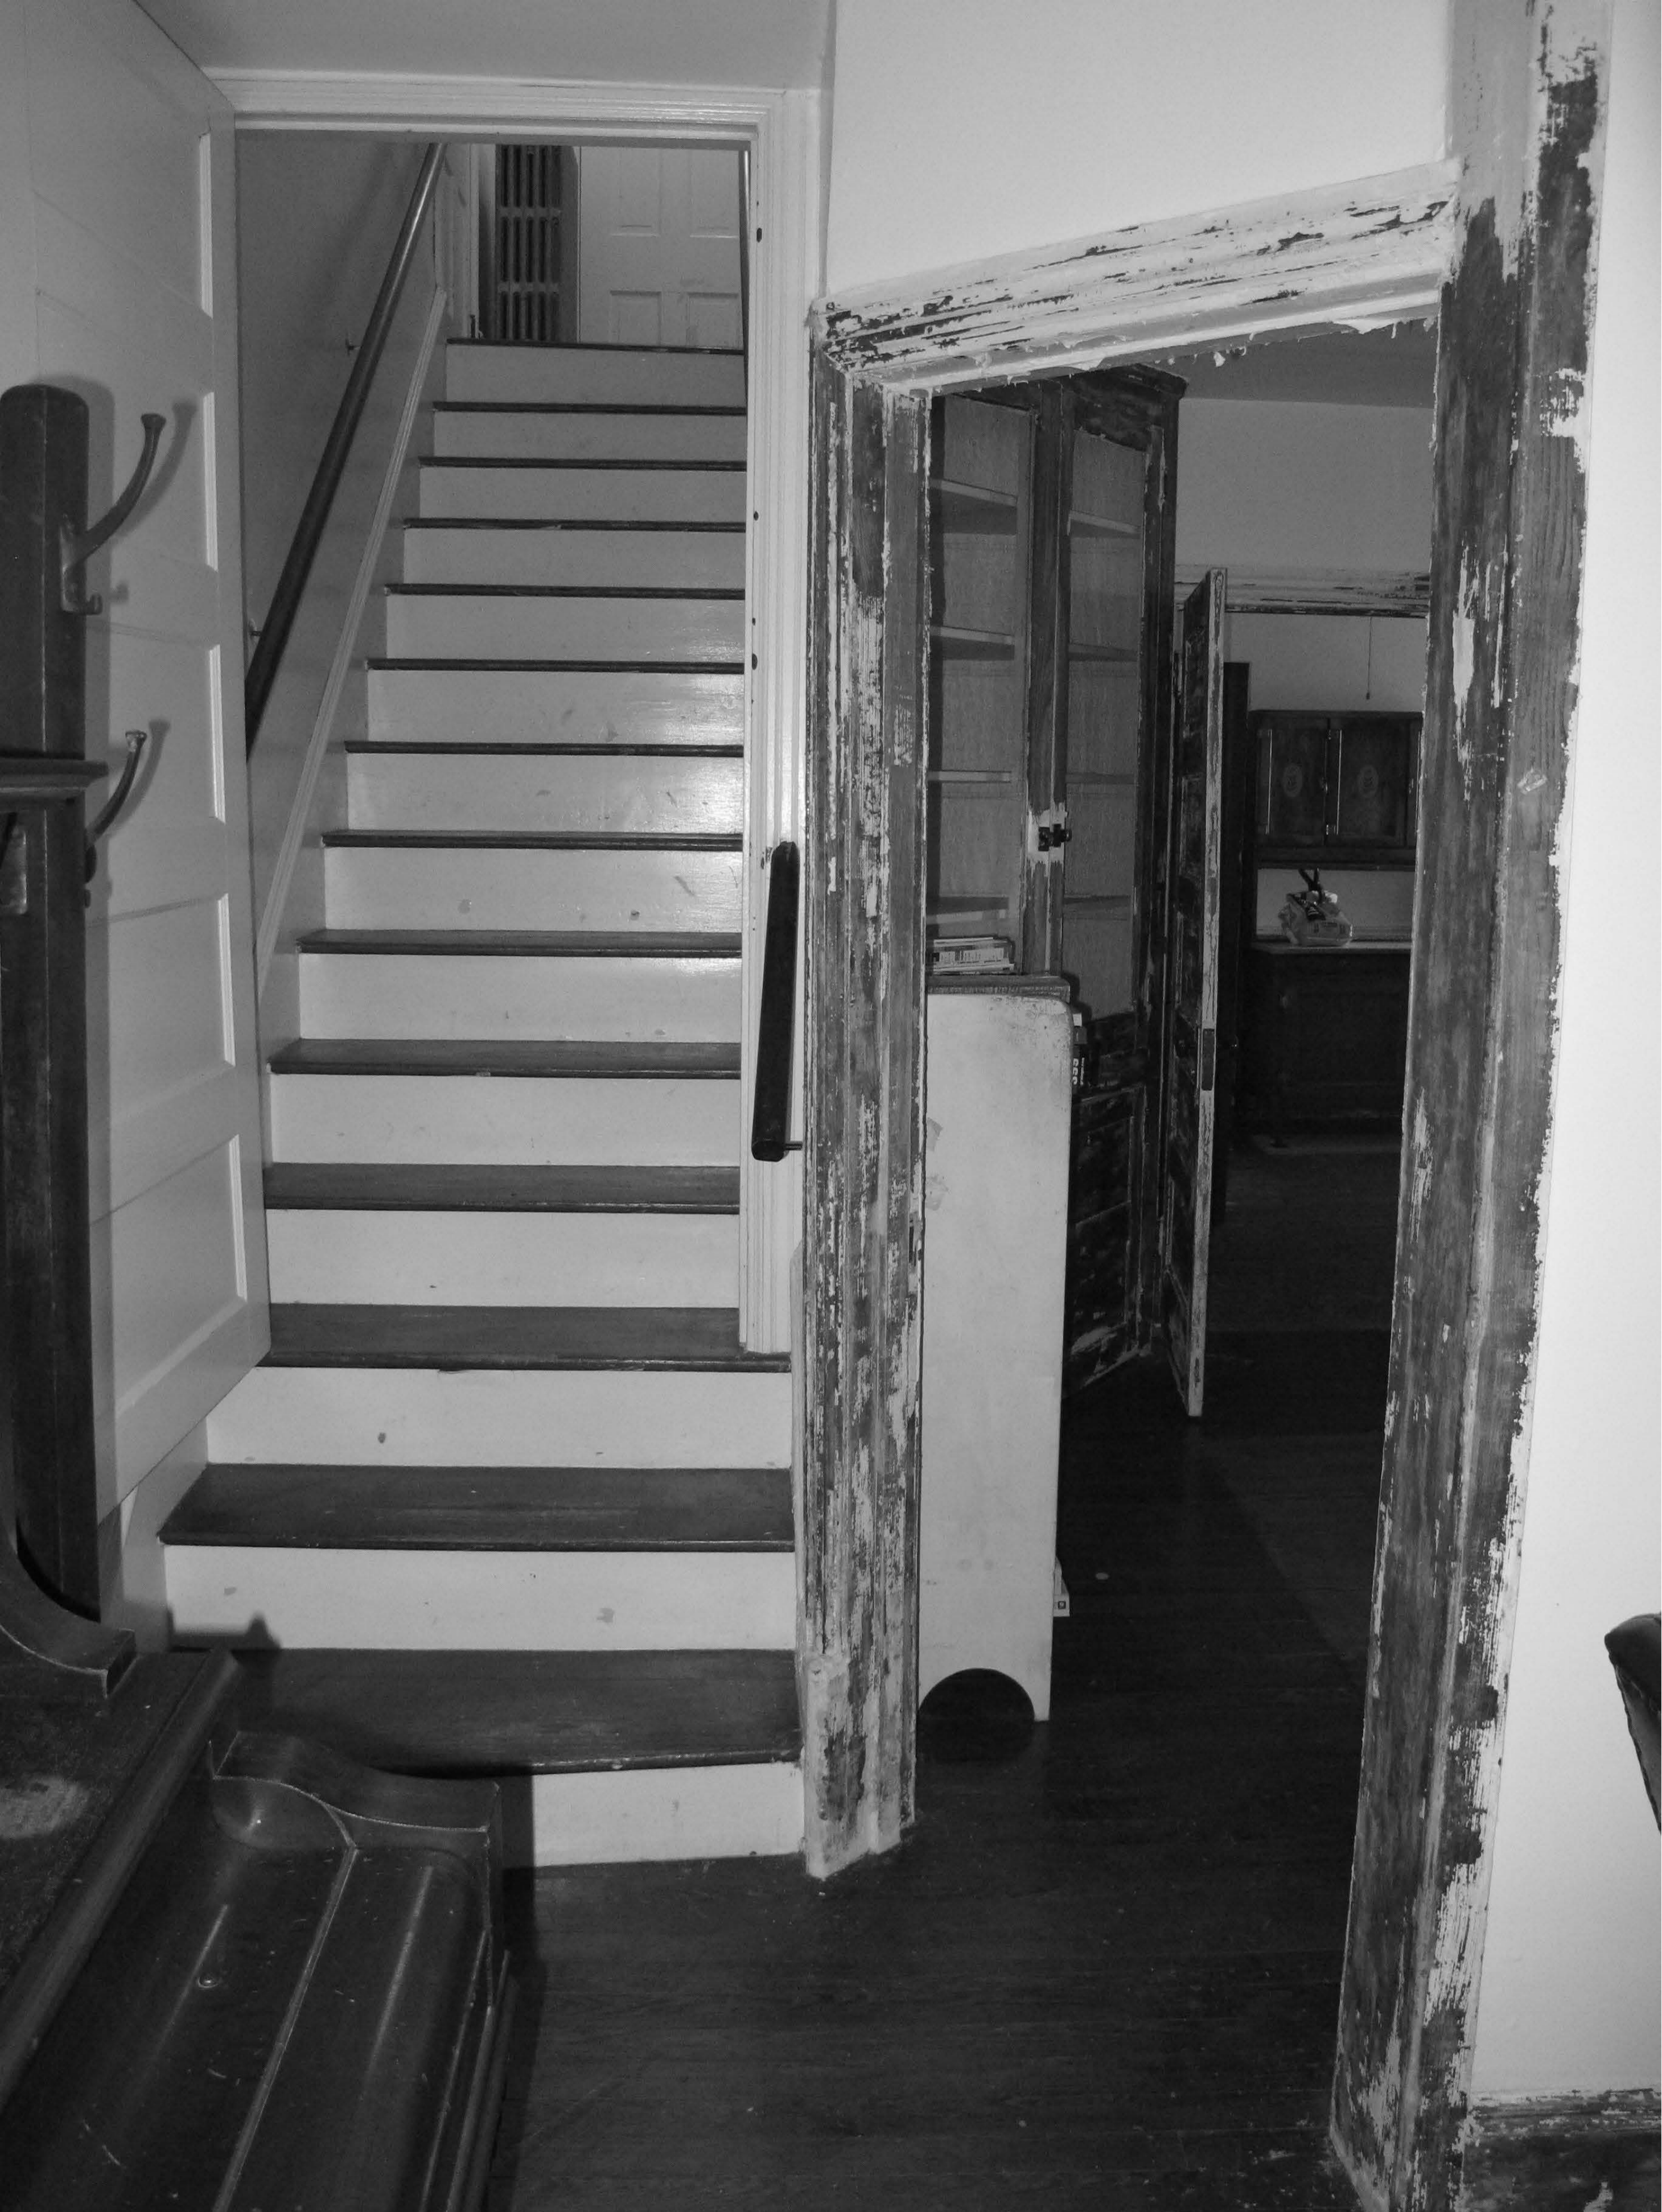
Cox-Phillips-Mitchell Agricultural Complex, New Castle County, DE  
Interior, first floor, Period I, view of room with staircase to second floor hallway, looking northeast

The second floor of the Period I section of the dwelling is accessed via a straight staircase in the northwest corner of the main Period I first floor living space. This stairway has been reworked; the 1726 house construction would utilize a winder staircase next to the fireplace. The current stairway leads to a hallway that spans the length of the Period I section along the western wall. A bedroom is located at the southern end of the hallway, spanning the width of the house. Two small rooms are also located on this floor. A boarded up doorway blocks the passage from the Period I section of the house to the Period III. The Period II second floor can be accessed by a doorway along the western wall at the southern end of the hallway. The second floor of the Period II addition is lower than the Period I section, and contains two rooms, which both feature historic built-in closets on their west walls. In the northern room in the Period II structure an enclosed winder stair leads to the third story attic space. A doorway in the north wall of the Period II addition opens into a hallway for the Period III addition. This hallway passes a stair leading to the first and third floors. In the Period III addition there are two bedrooms and a small modern bathroom.

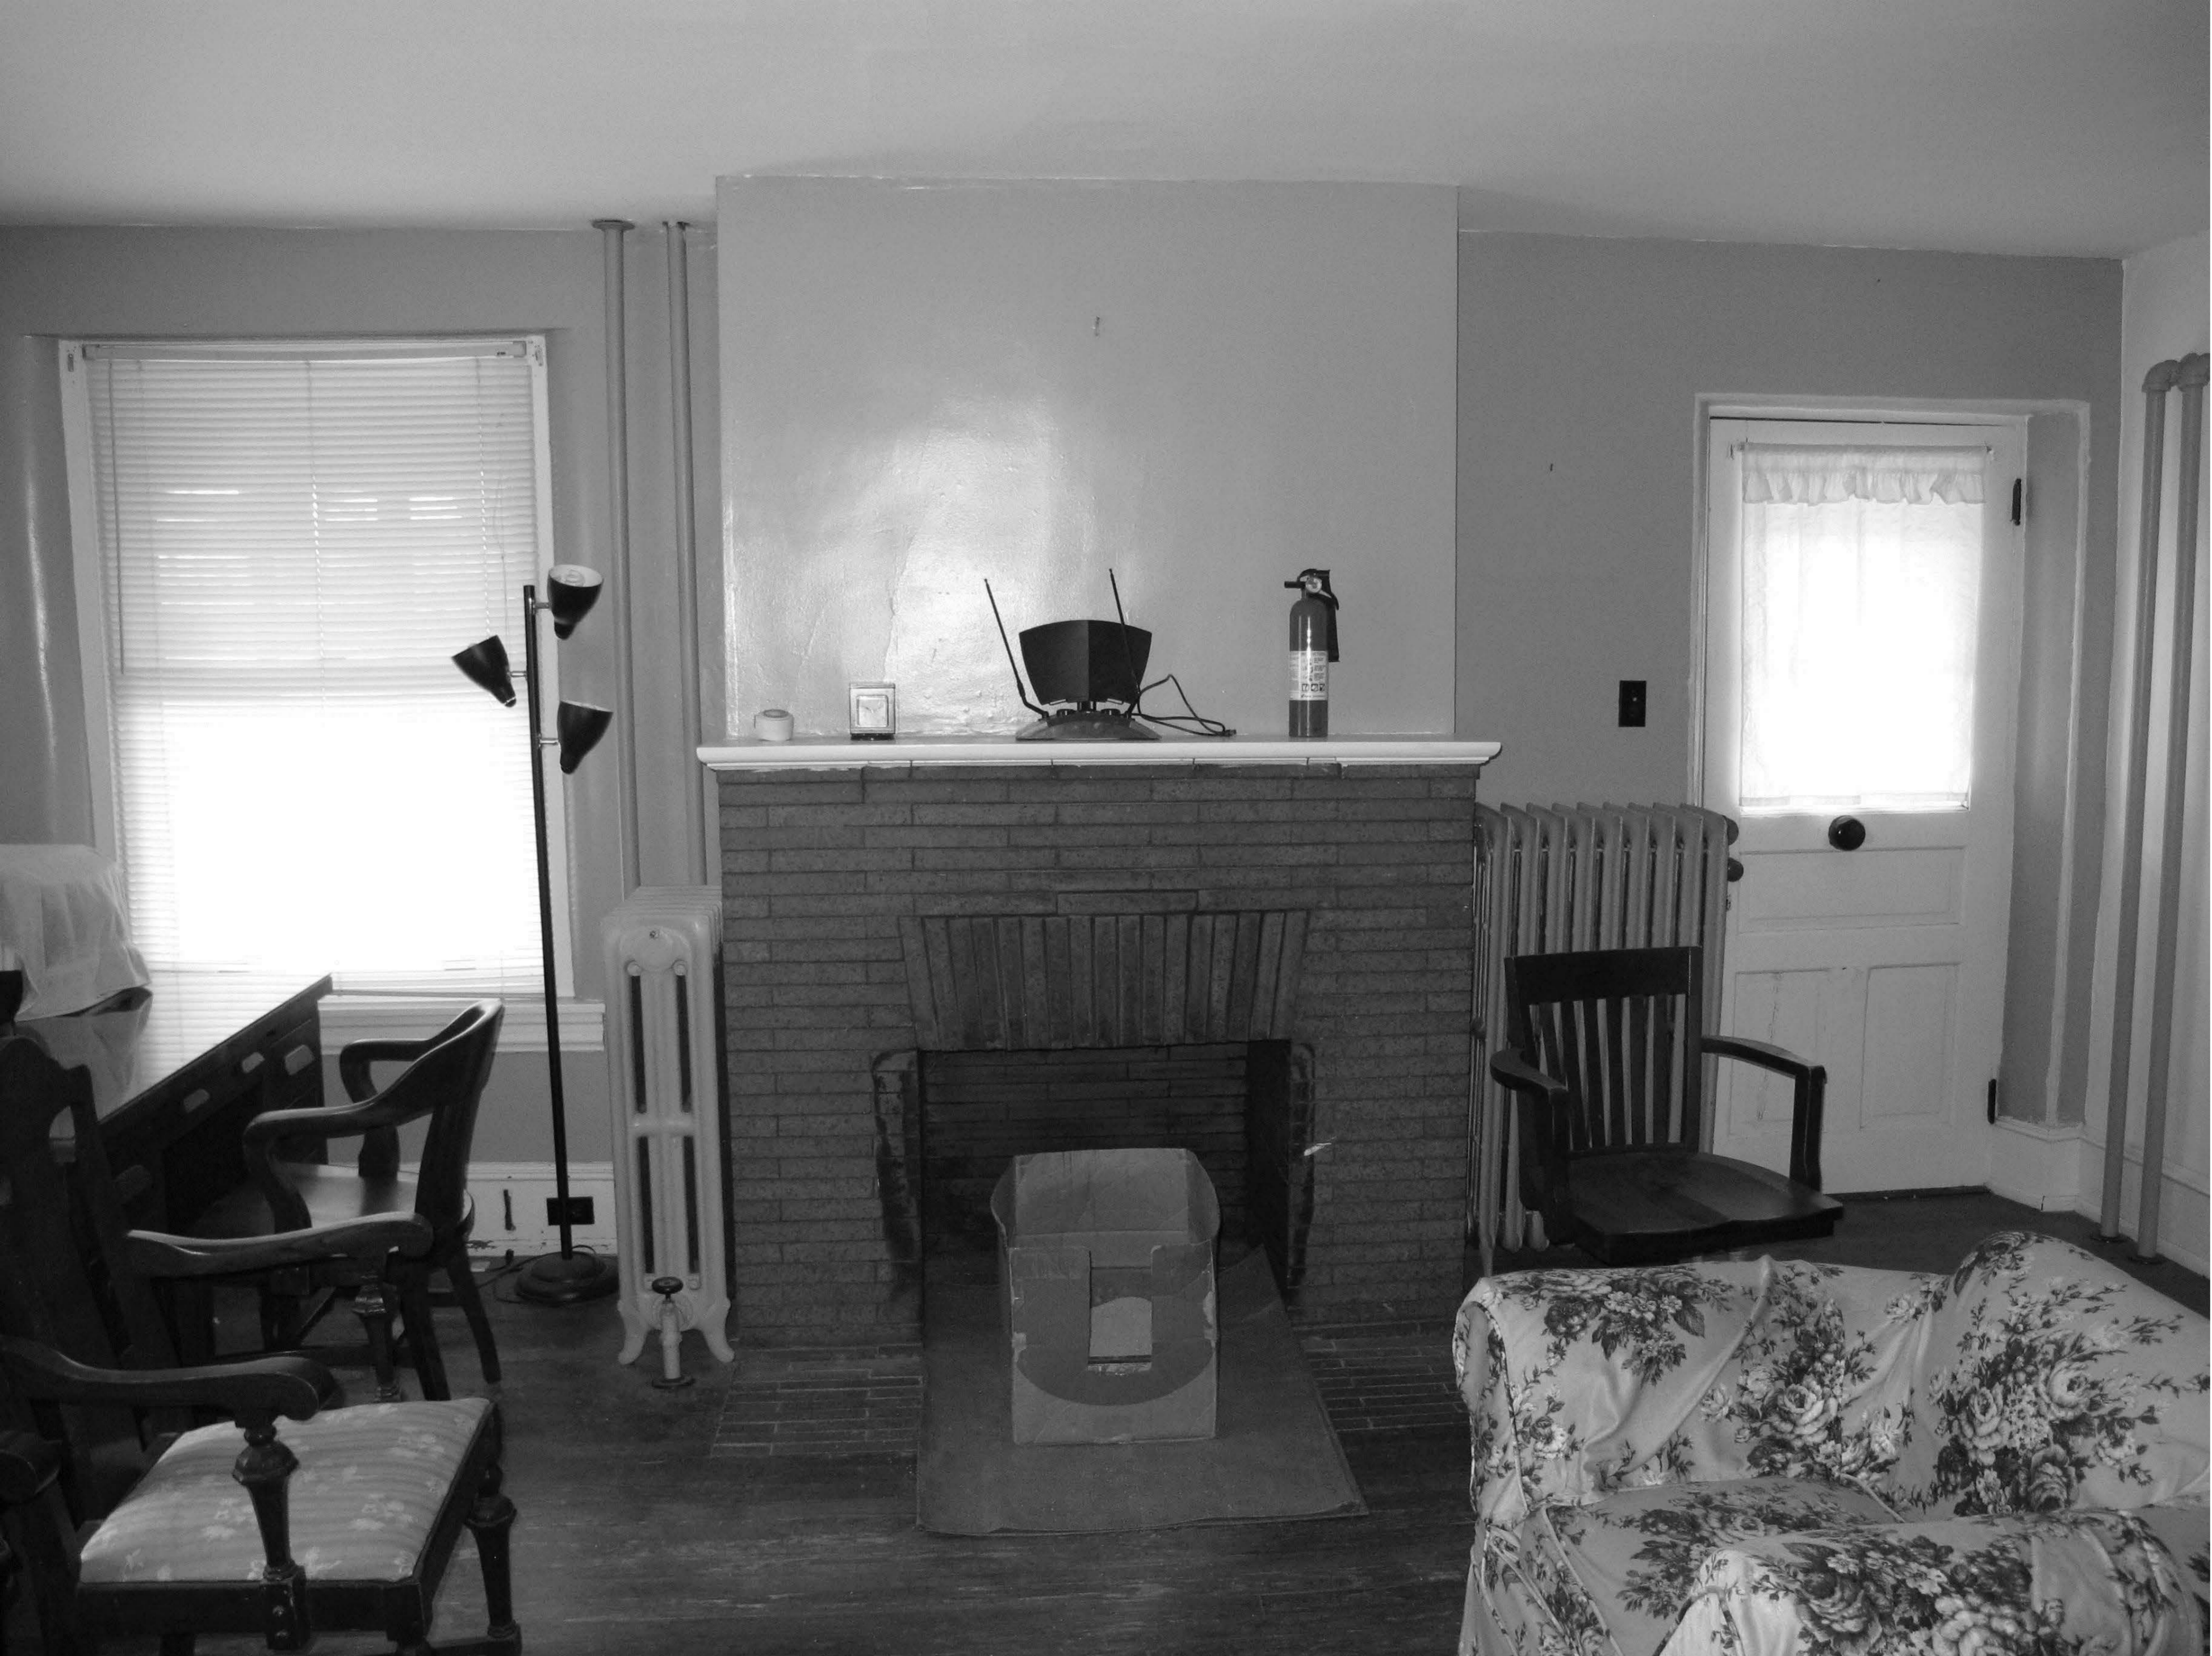
Cox-Phillips-Mitchell Agricultural Complex\_ New Castle County\_ DE  
Interior, first floor, Period I, showing mid-nineteenth century staircase leading to  
second story hallway looking northeast

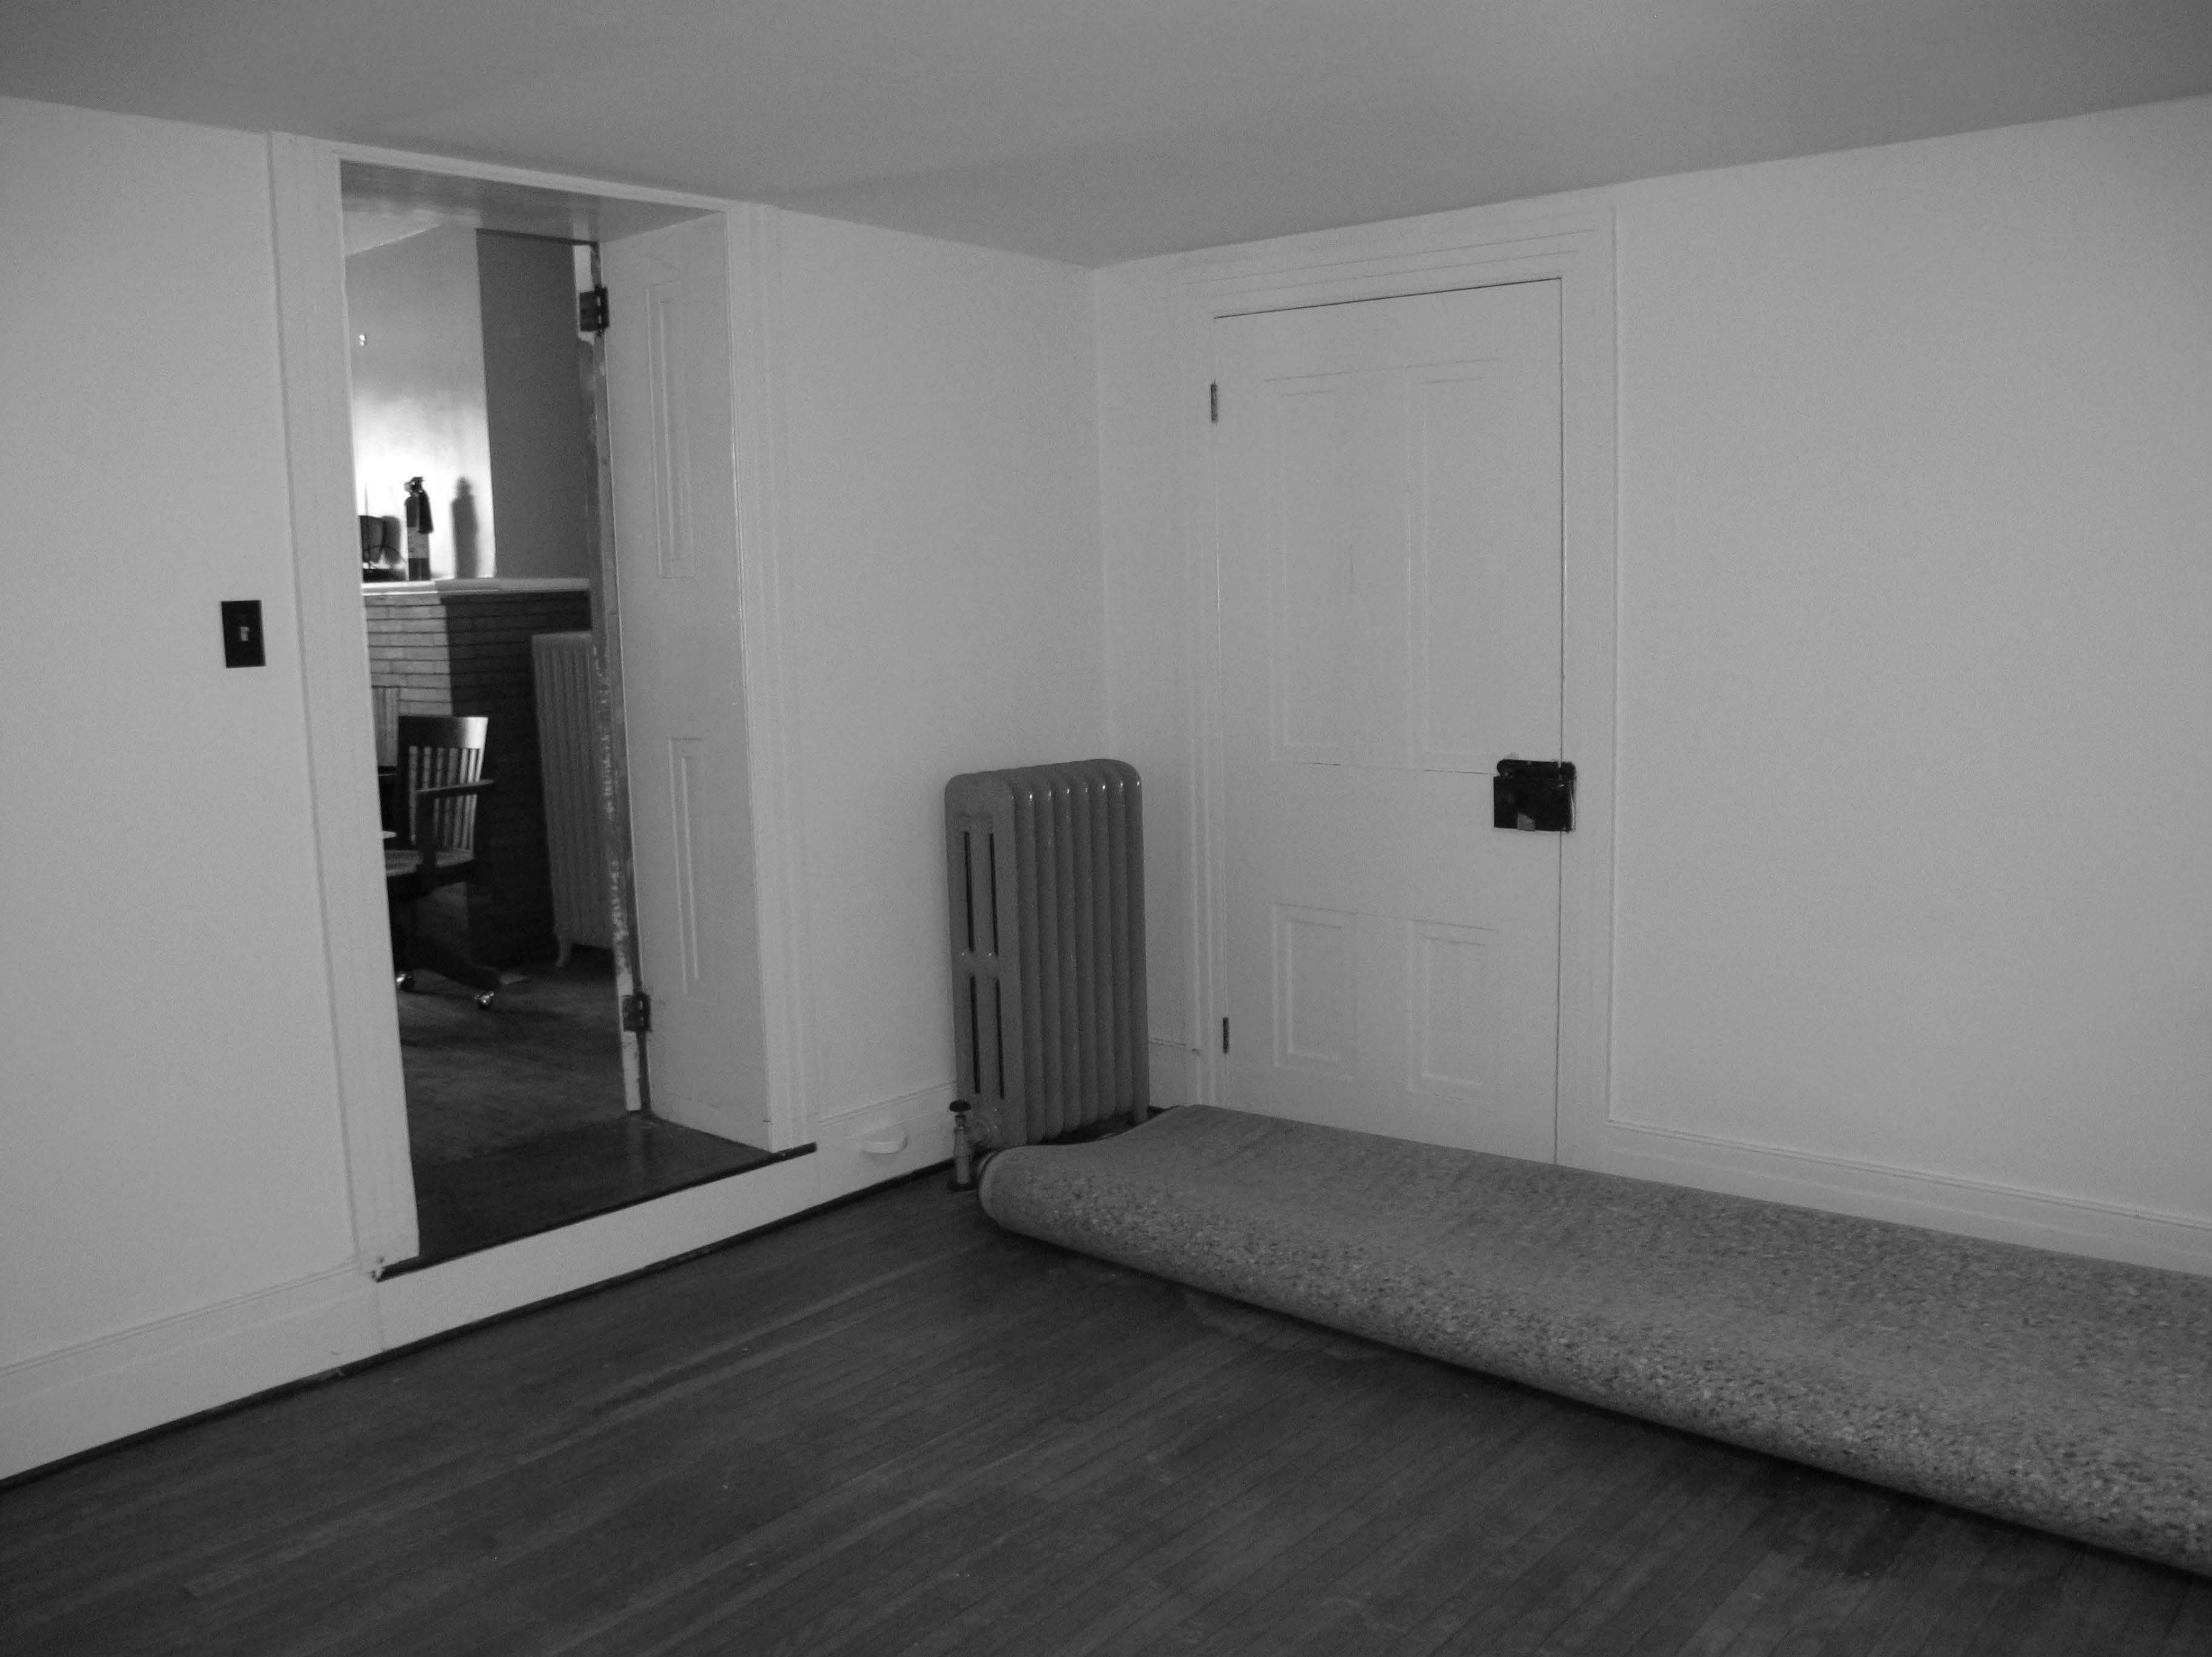
Cox-Phillips-Mitchell Agricultural Complex\_New Castle County\_DE  
Interior, first floor, Period I, view of southwest wall with fireplace looking southwest

The interior of the Period I house features three rooms on the first floor. The first is a main living space to the southwest, and has a reworked fireplace. The second room is a dining space that is partitioned from the main living space, by a wall with pocket doors. This middle room includes a built-in corner cabinet from the Period II remodeling of the dwelling. The third room in the Period I section of the house is a kitchen, accessed from a doorway leading from the dining space. A small hallway leads from the kitchen to the Period II addition and contains a closet, bathroom, and doorway to the basement. The Period II addition occupies two rooms to the west of the Period I portion. The Period II addition is at a lower floor height from the original portion of the house. The Period II addition is now one-large space, although evidence for a partition wall is visible in the floor, and ceiling. A large fireplace once existed to heat these two rooms, however it has been reworked and removed. This room retains a large amount of original fabric, including splayed windows and built in cabinetry. The Period III section of the house is located to the northeast of the Periods I and II portions, accessed through a hallway from the north room of the Period II section. This hallway leads from this doorway, past stairs to the basement and upper floors, into a large living space. This room also retains original fabric including a fireplace, built in closets, and splayed windows. The splayed window casings, are curved stone surrounds, found in stone houses. This construction technique is a regional vernacular technique found in northern Delaware in the Piedmont region, but not elsewhere in the state. A partition divides the Period III addition from a small space to the east, which features a doorway to the Period IV frame kitchen addition. This modern kitchen has a doorway on the north wall that leads to a large unfinished garage and storage space. One eight-over-eight, double-hung sash window exists closest to the Period III addition, and one large wooden rolling door located at the northeastern portion exists.
