# National Register of Historic Places Registration Form

Historic name: Cox-Phillips-Mitchell Agricultural Complex

Other names/site number: Delaware CRS # N04085

Street & number: 1651 and 1655 Old Wilmington Rd

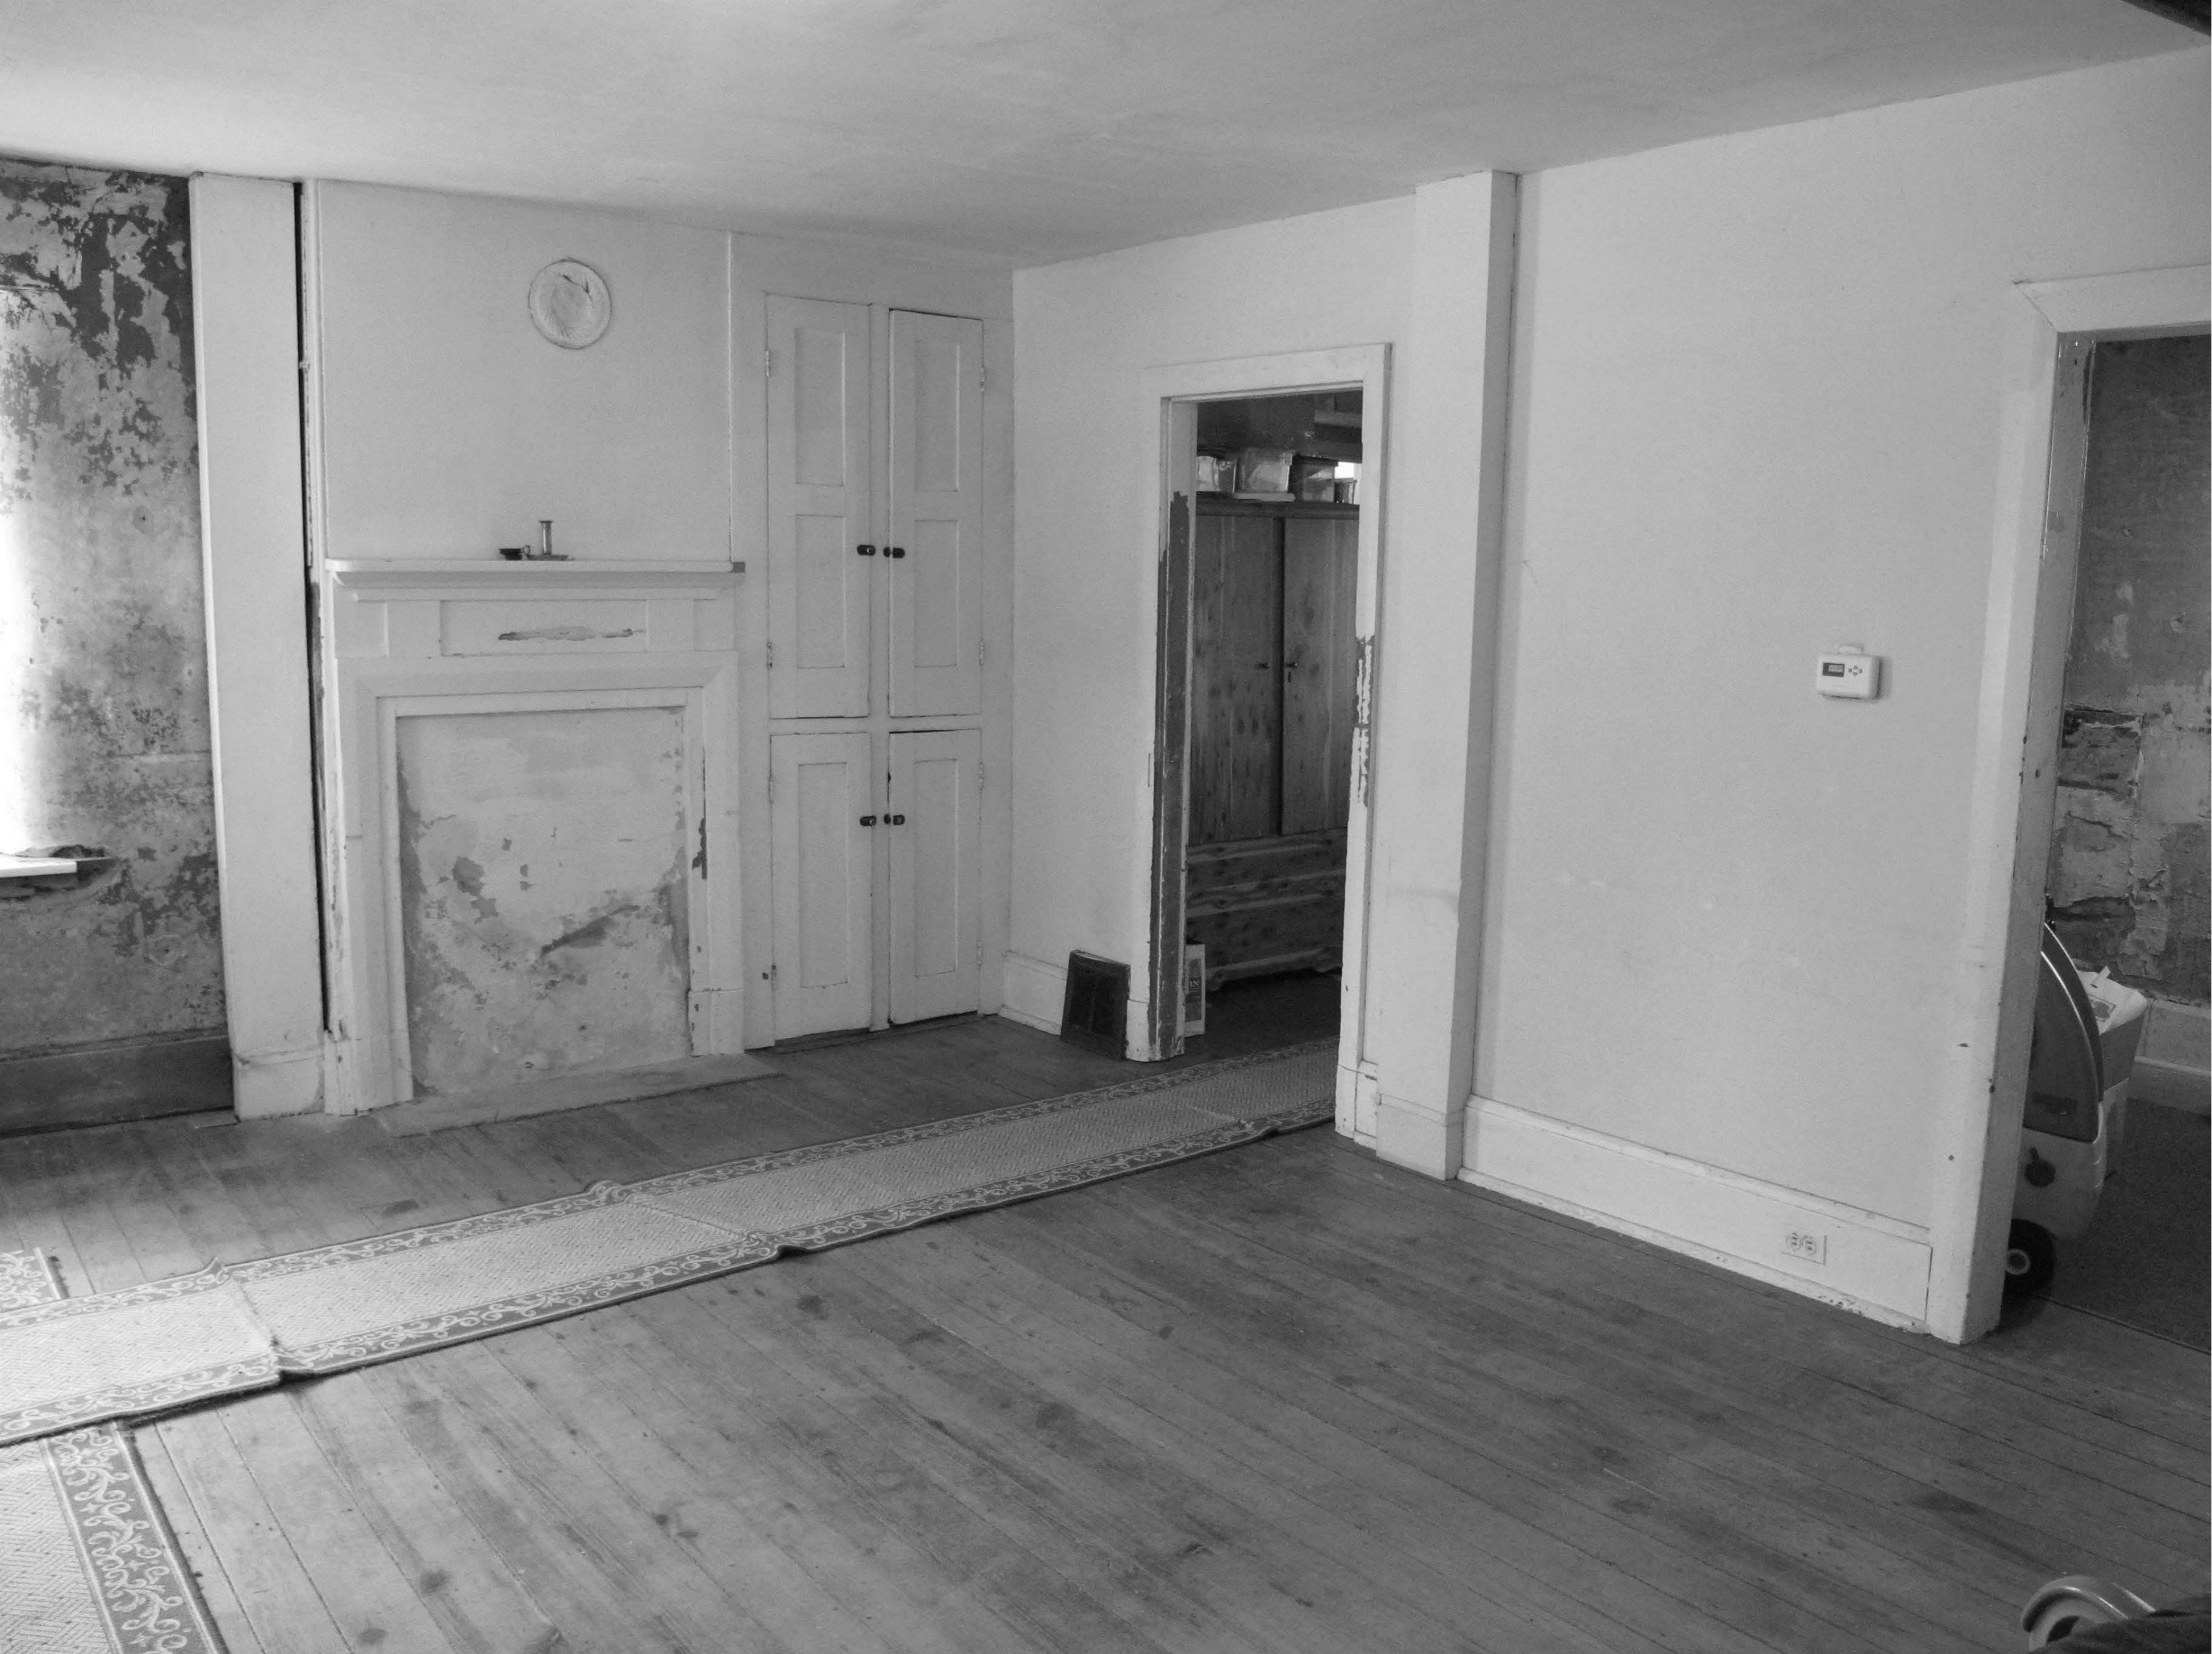
Cox-Phillips-Mitchell Agricultural Complex\_New Castle County\_DE  
interior, first floor, Period IV, view of southwest and southeast walls showing Greek  
Revival trim

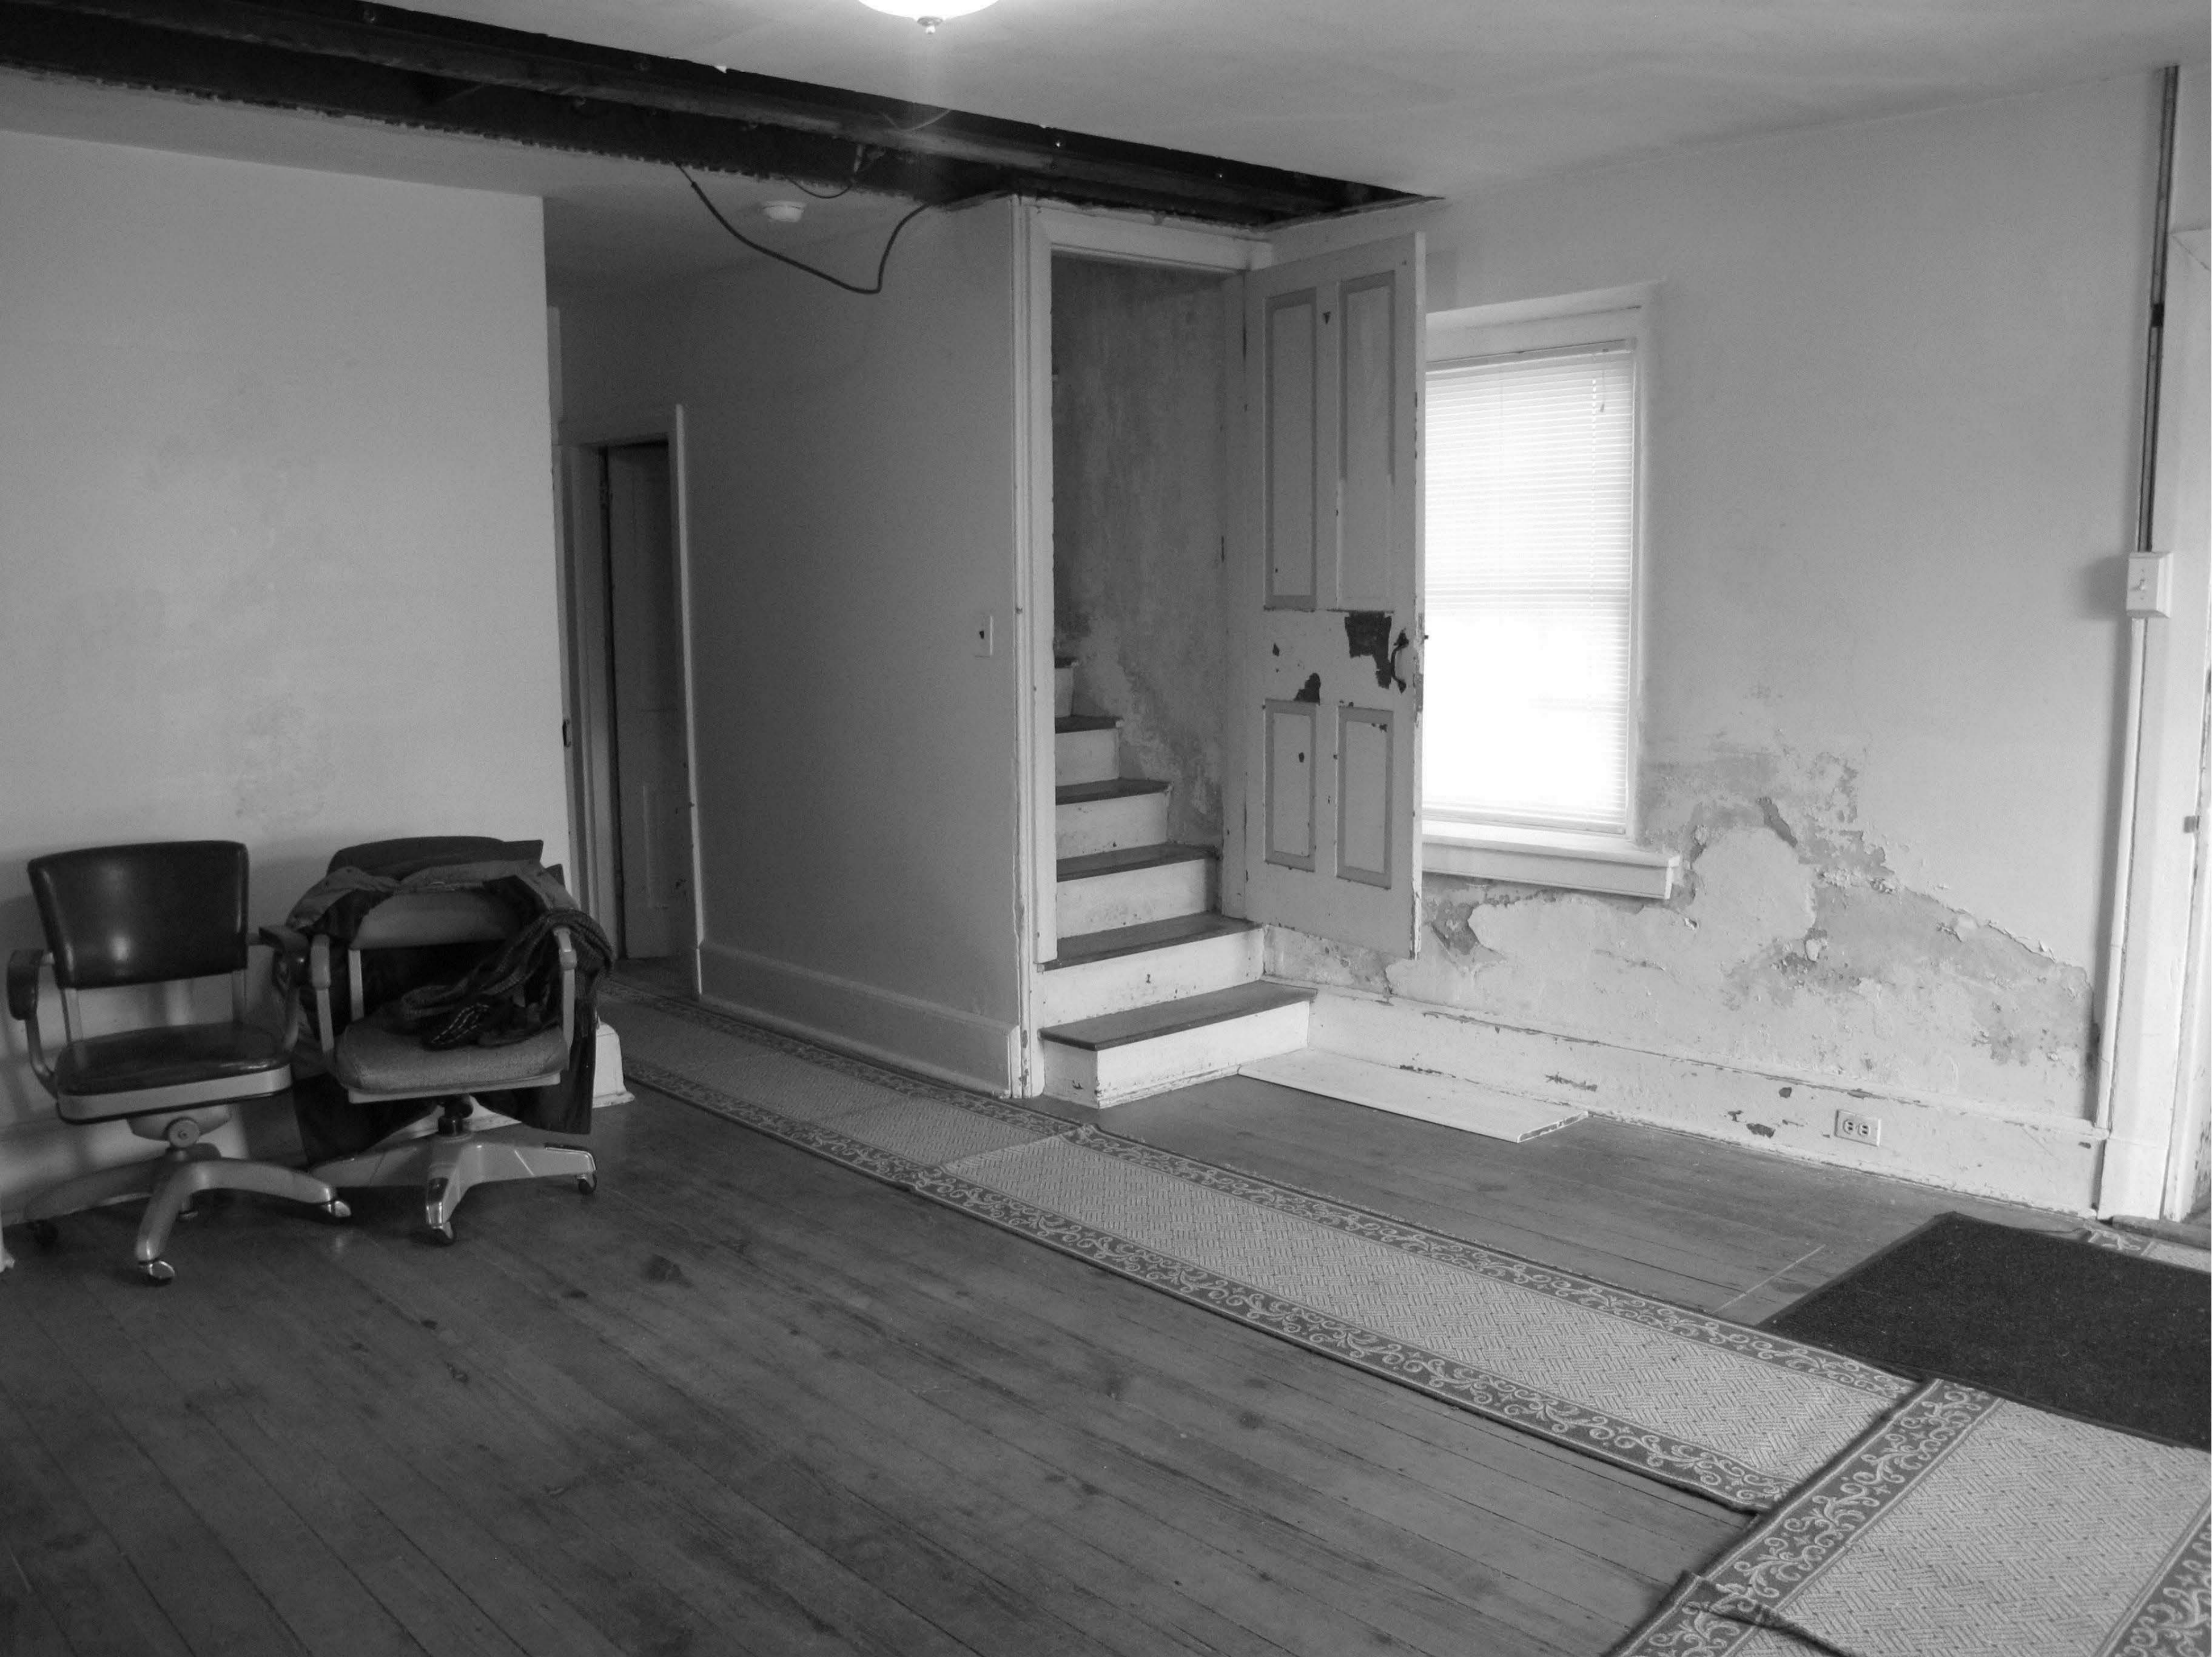
Cox-Phillips-Mitchell Agricultural Complex\_New Castle County\_DE  
Interior, first floor, Period III, view of southeast and northeast walls

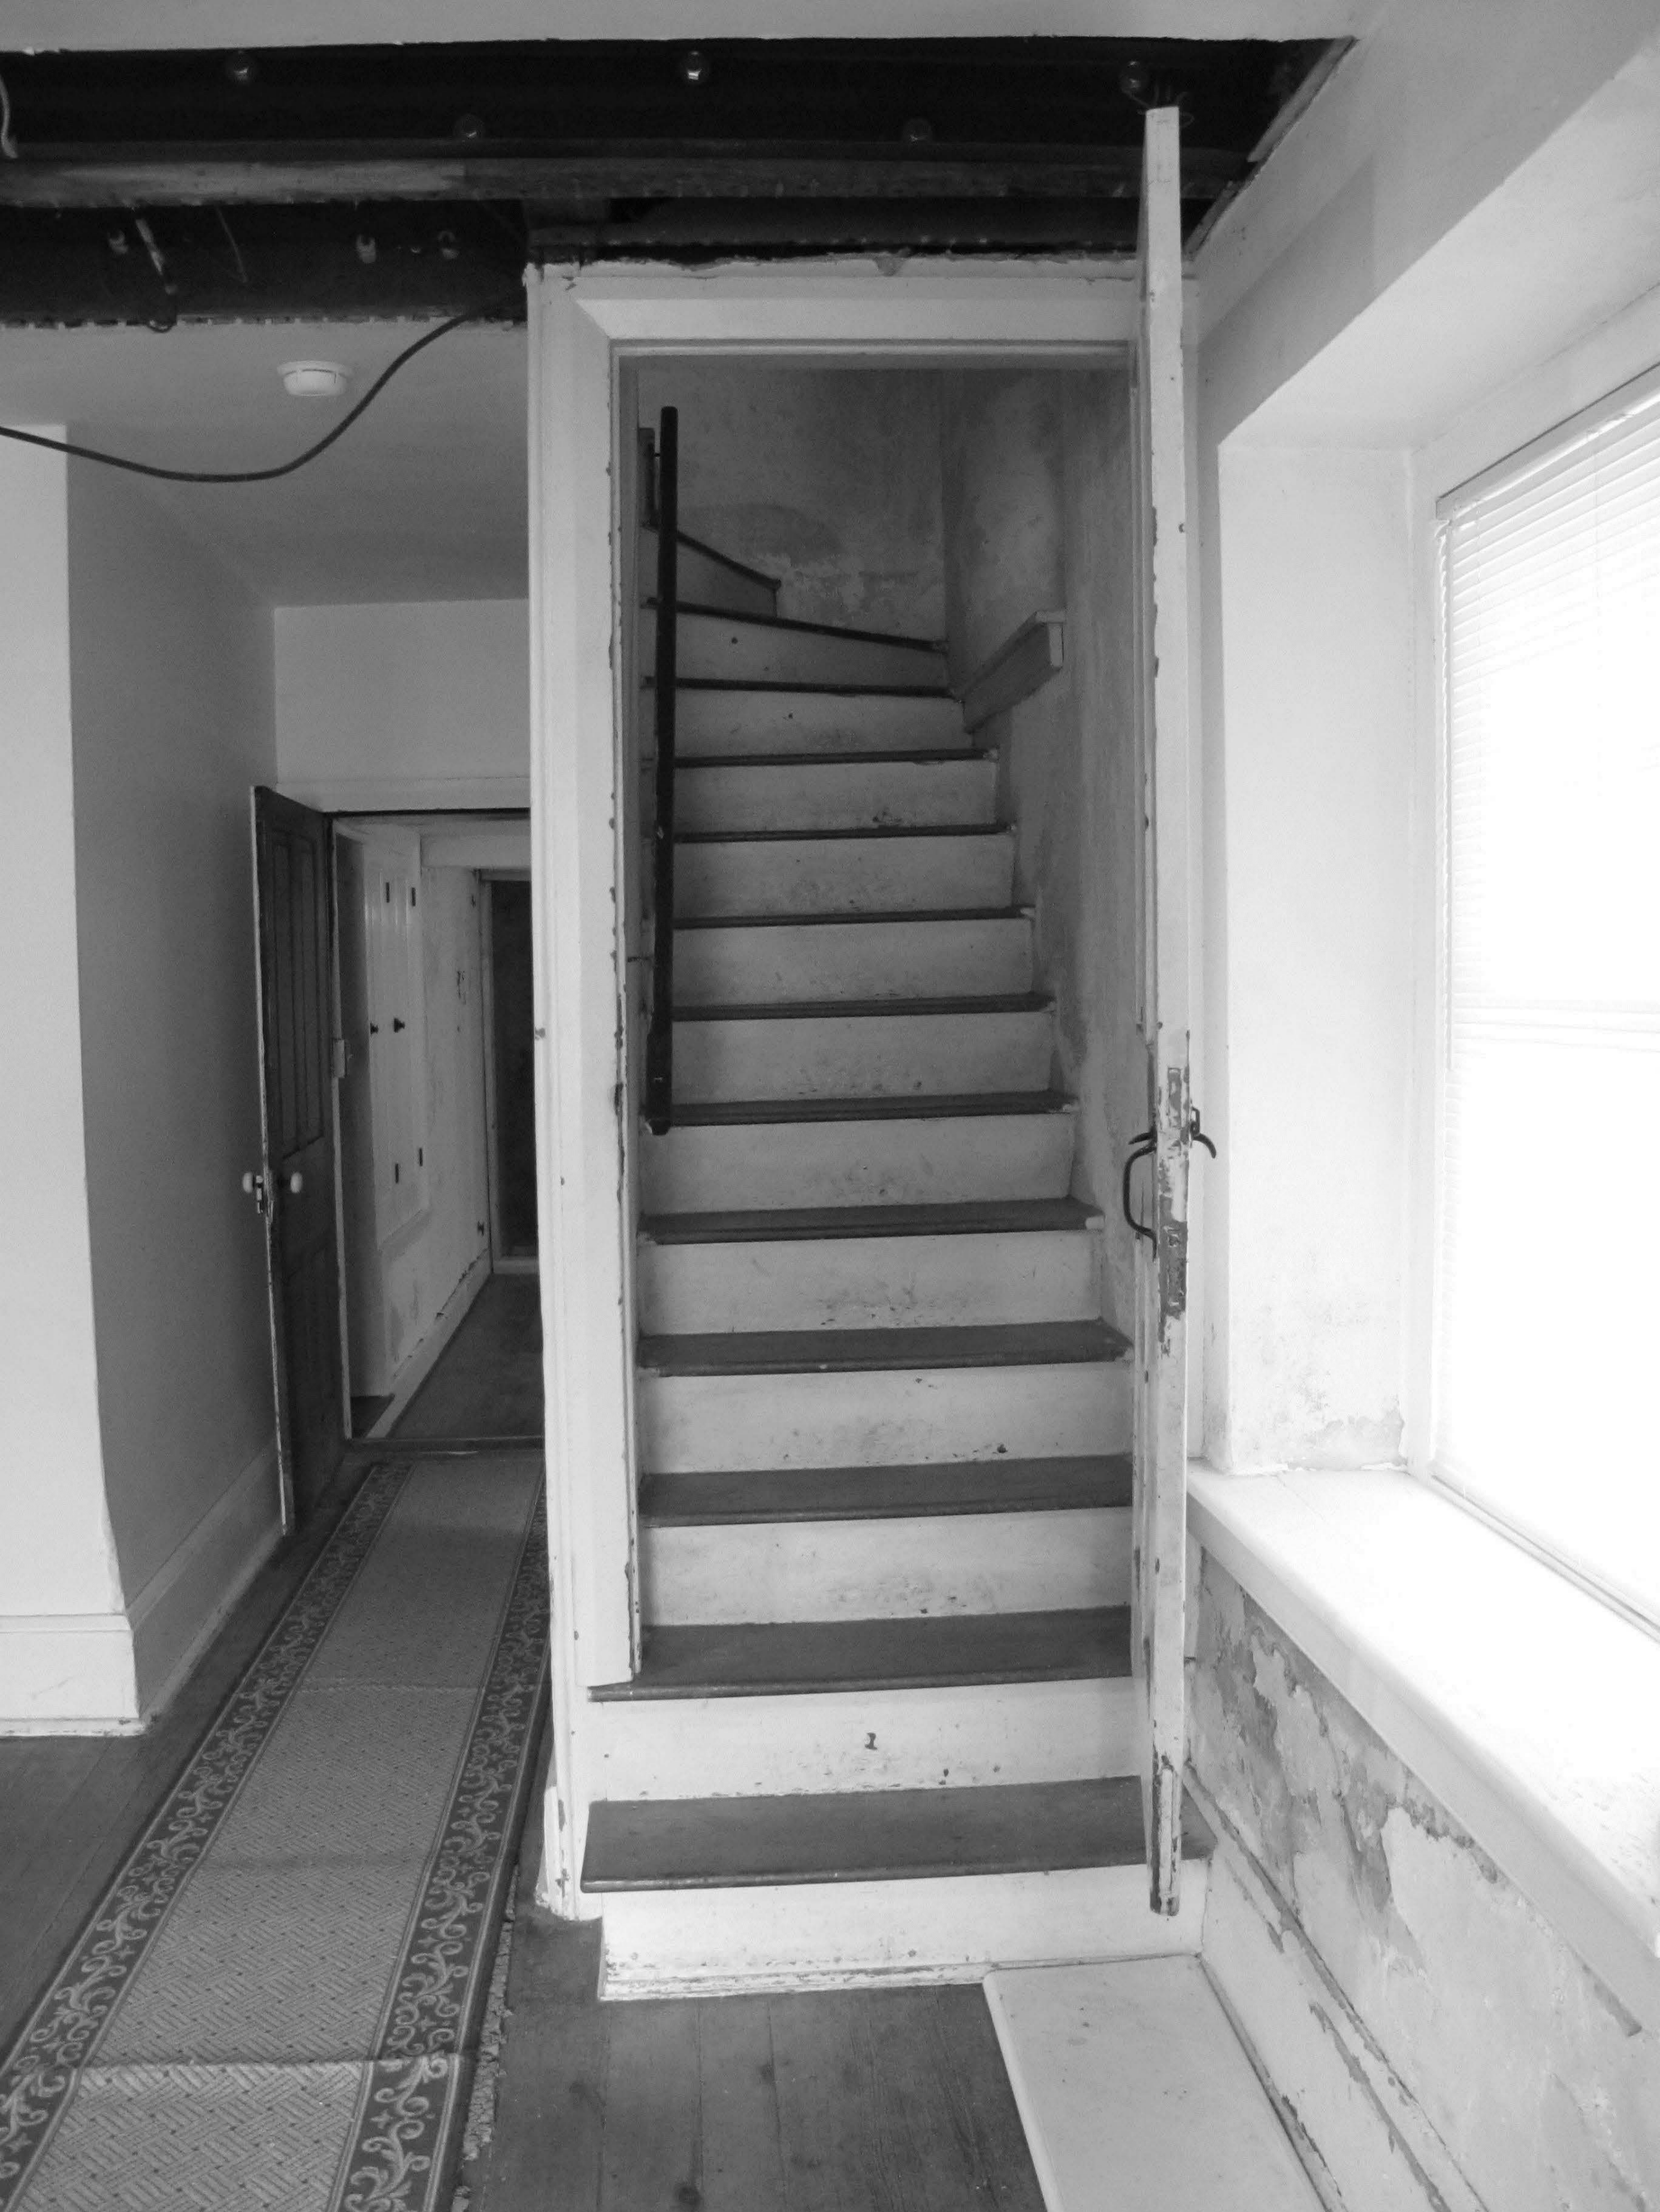
Cox-Phillips-Mitchell Agricultural Complex\_New Castle County\_DE  
Interior, first floor, Period III, hallway and staircase looking southwest

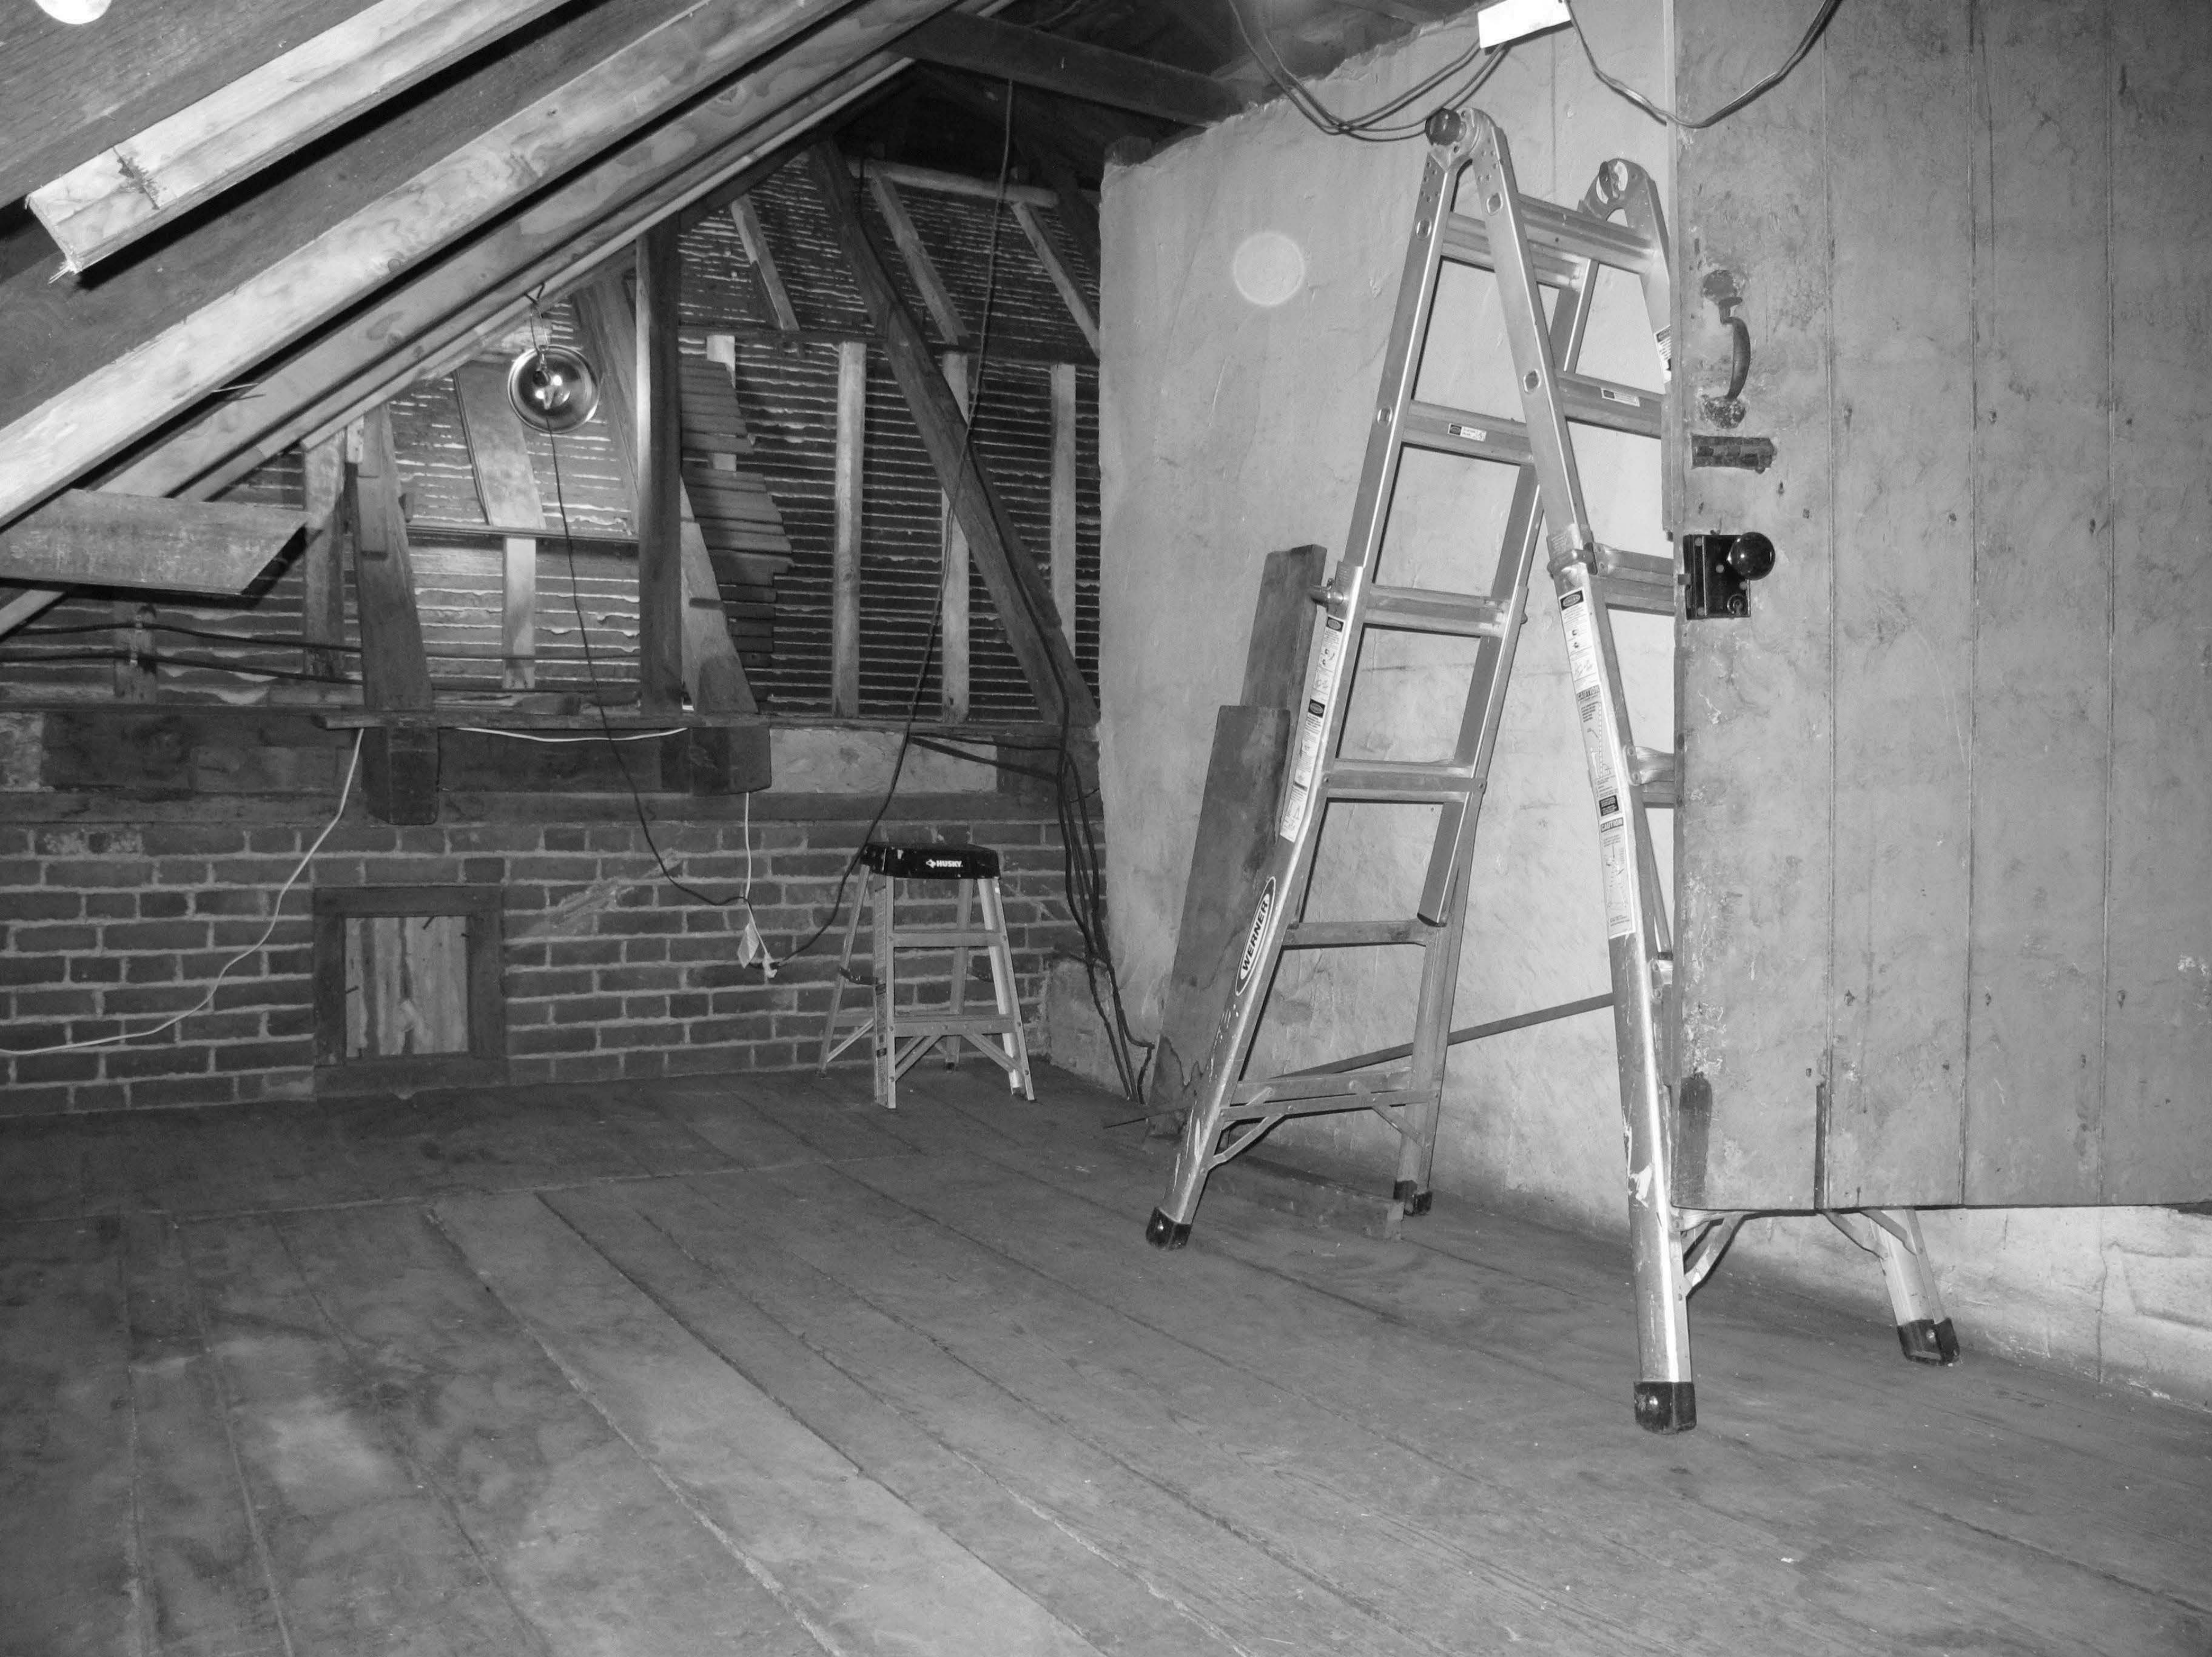
Cox-Phillips-Mitchell Agricultural Complex\_New Castle County\_DE  
Attic interior showing Period I roof framing system, looking south

The third floor of the house is split into two sections that are no longer connected. On the third floor of the Period I attic there are exposed rafters, and wide floorboards. At the north end of the hallway, a boarded up doorway once led to the Period III third floor. The Period II attic has two rooms, a small unfinished room with exposed rafters, was built over the abutting Period I roof structure. Brick, lathe and plaster, and the framing systems are all visible. Another finished and enclosed room is located within this space. The Period III portion of the third floor also contains one finished room at the northeastern end, containing a date stone "WCC 1726," on the northeastern wall of the original gable end of the Period I structure.

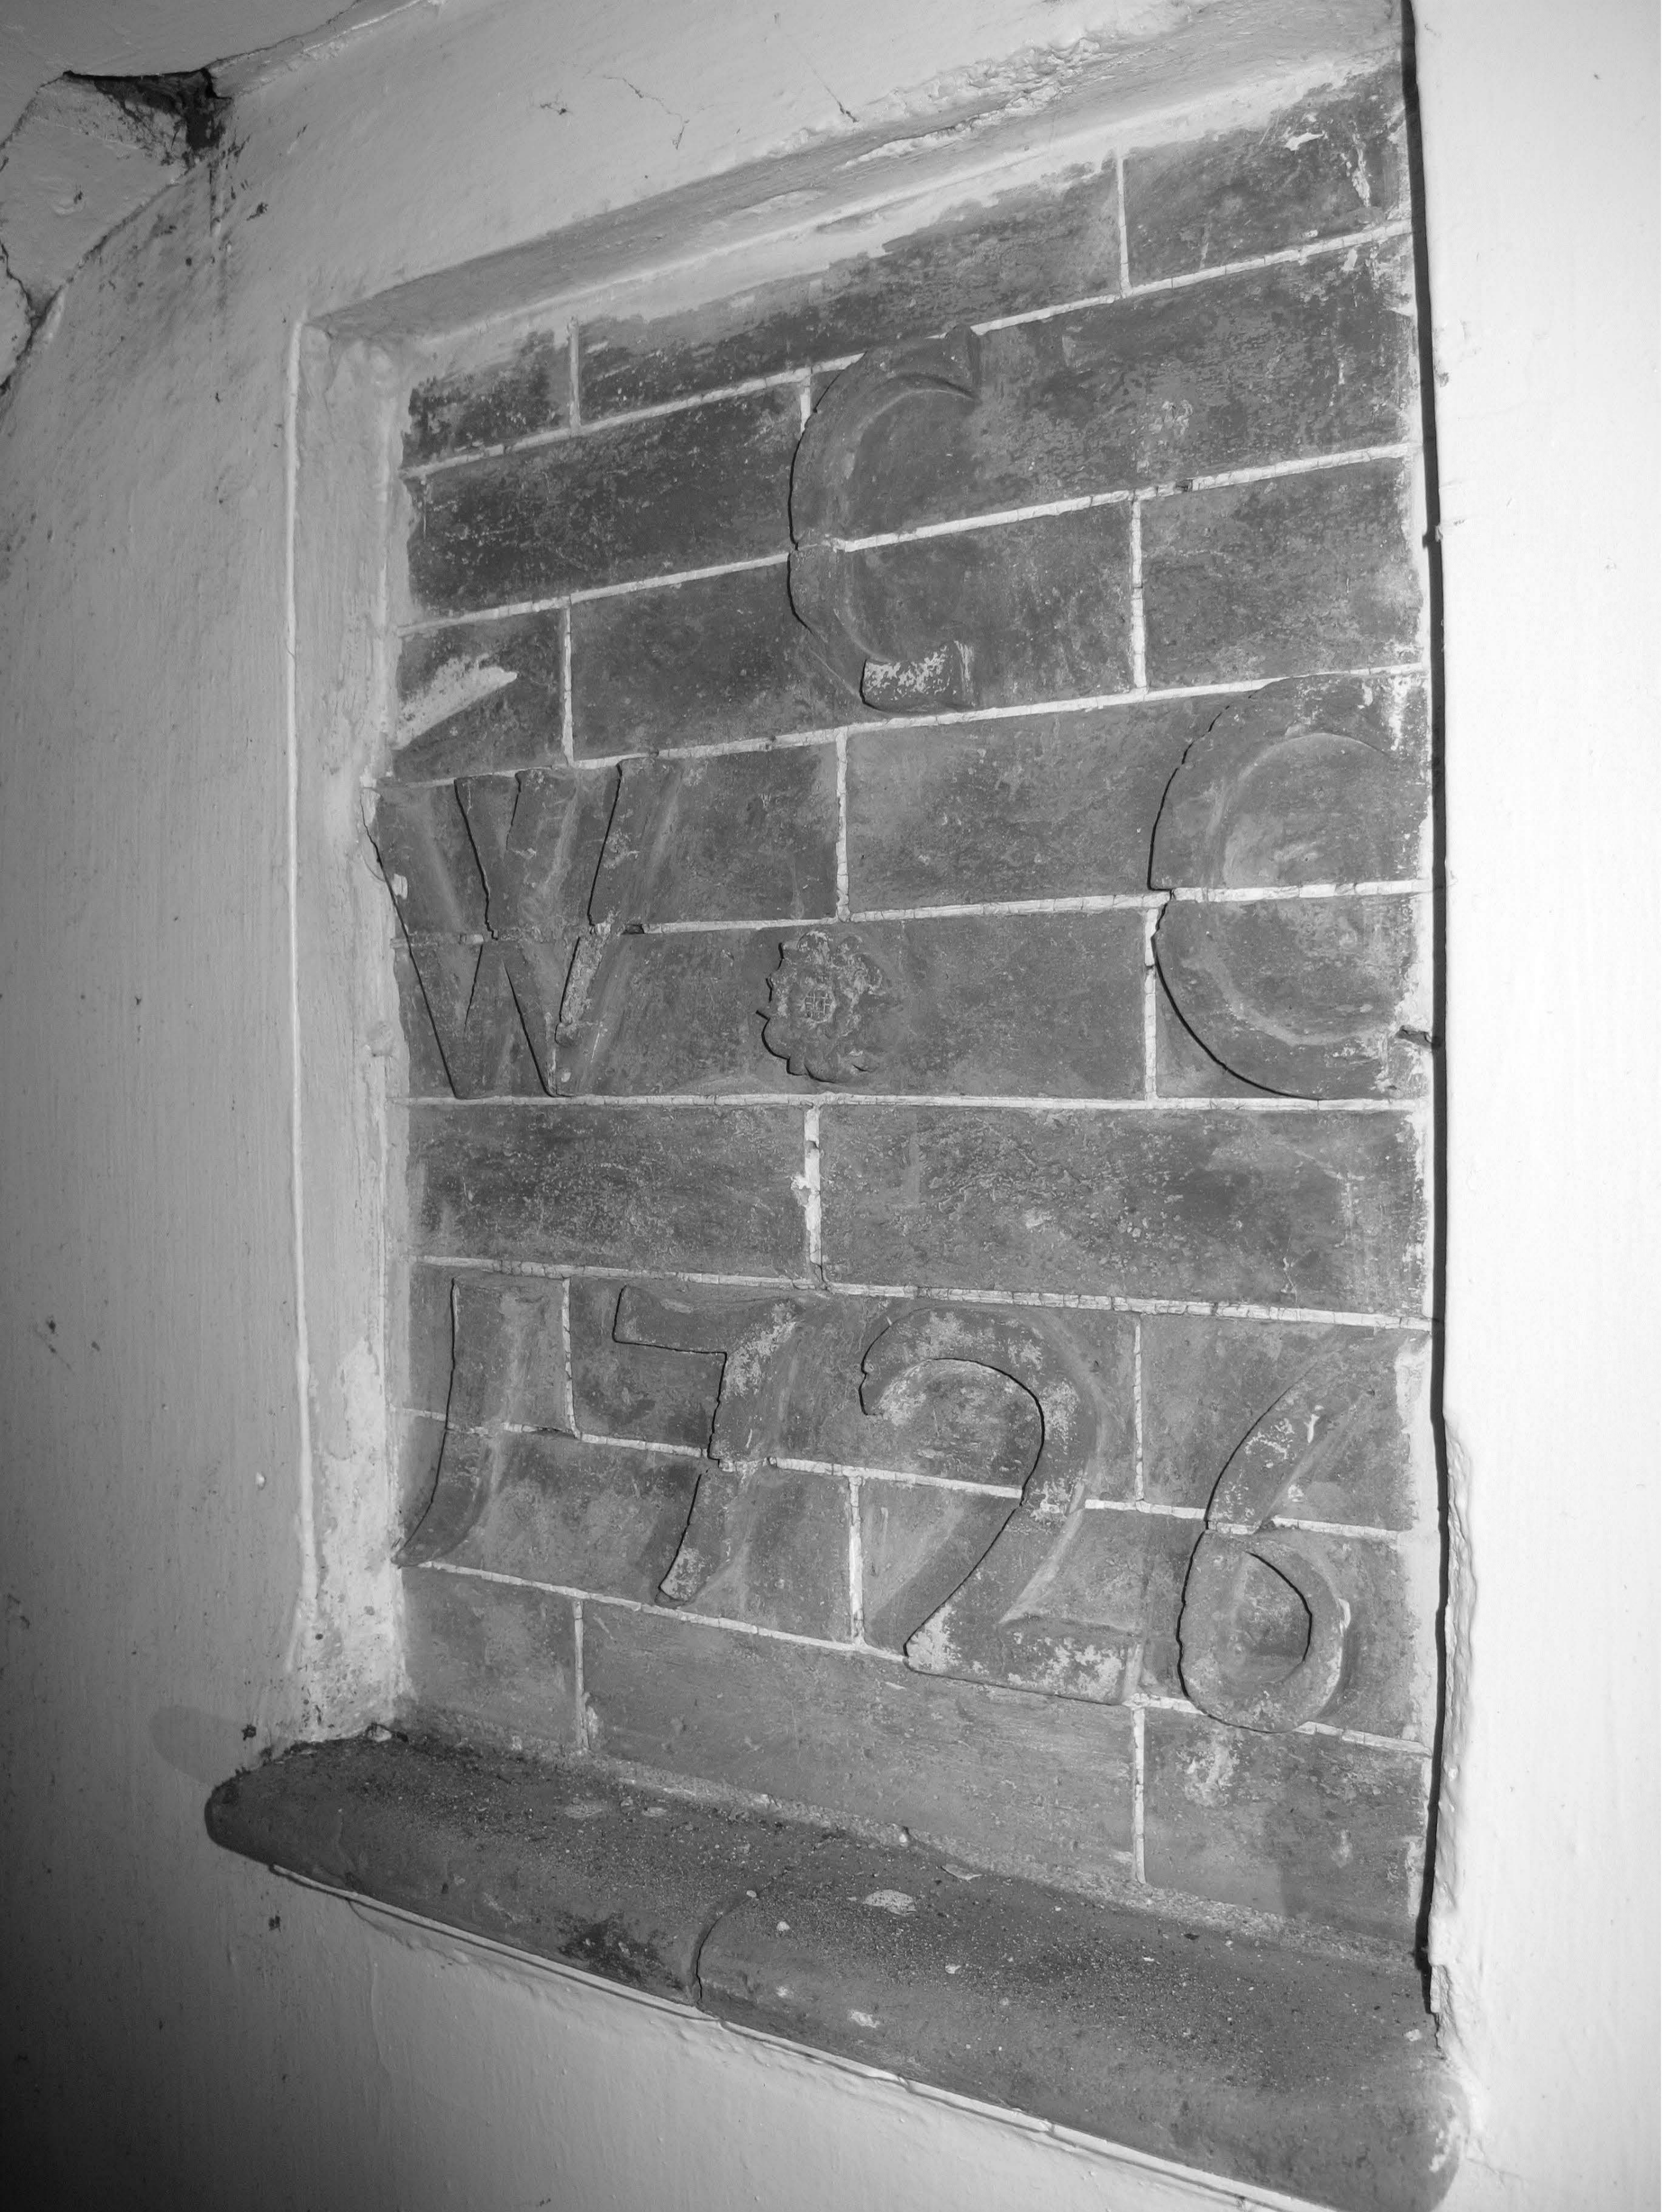
Cox-Phillips-Mitchell Agricultural Complex\_New Castle County\_DE  
Attic interior showing the now-enclosed Period I date stone dated 1726 looking south

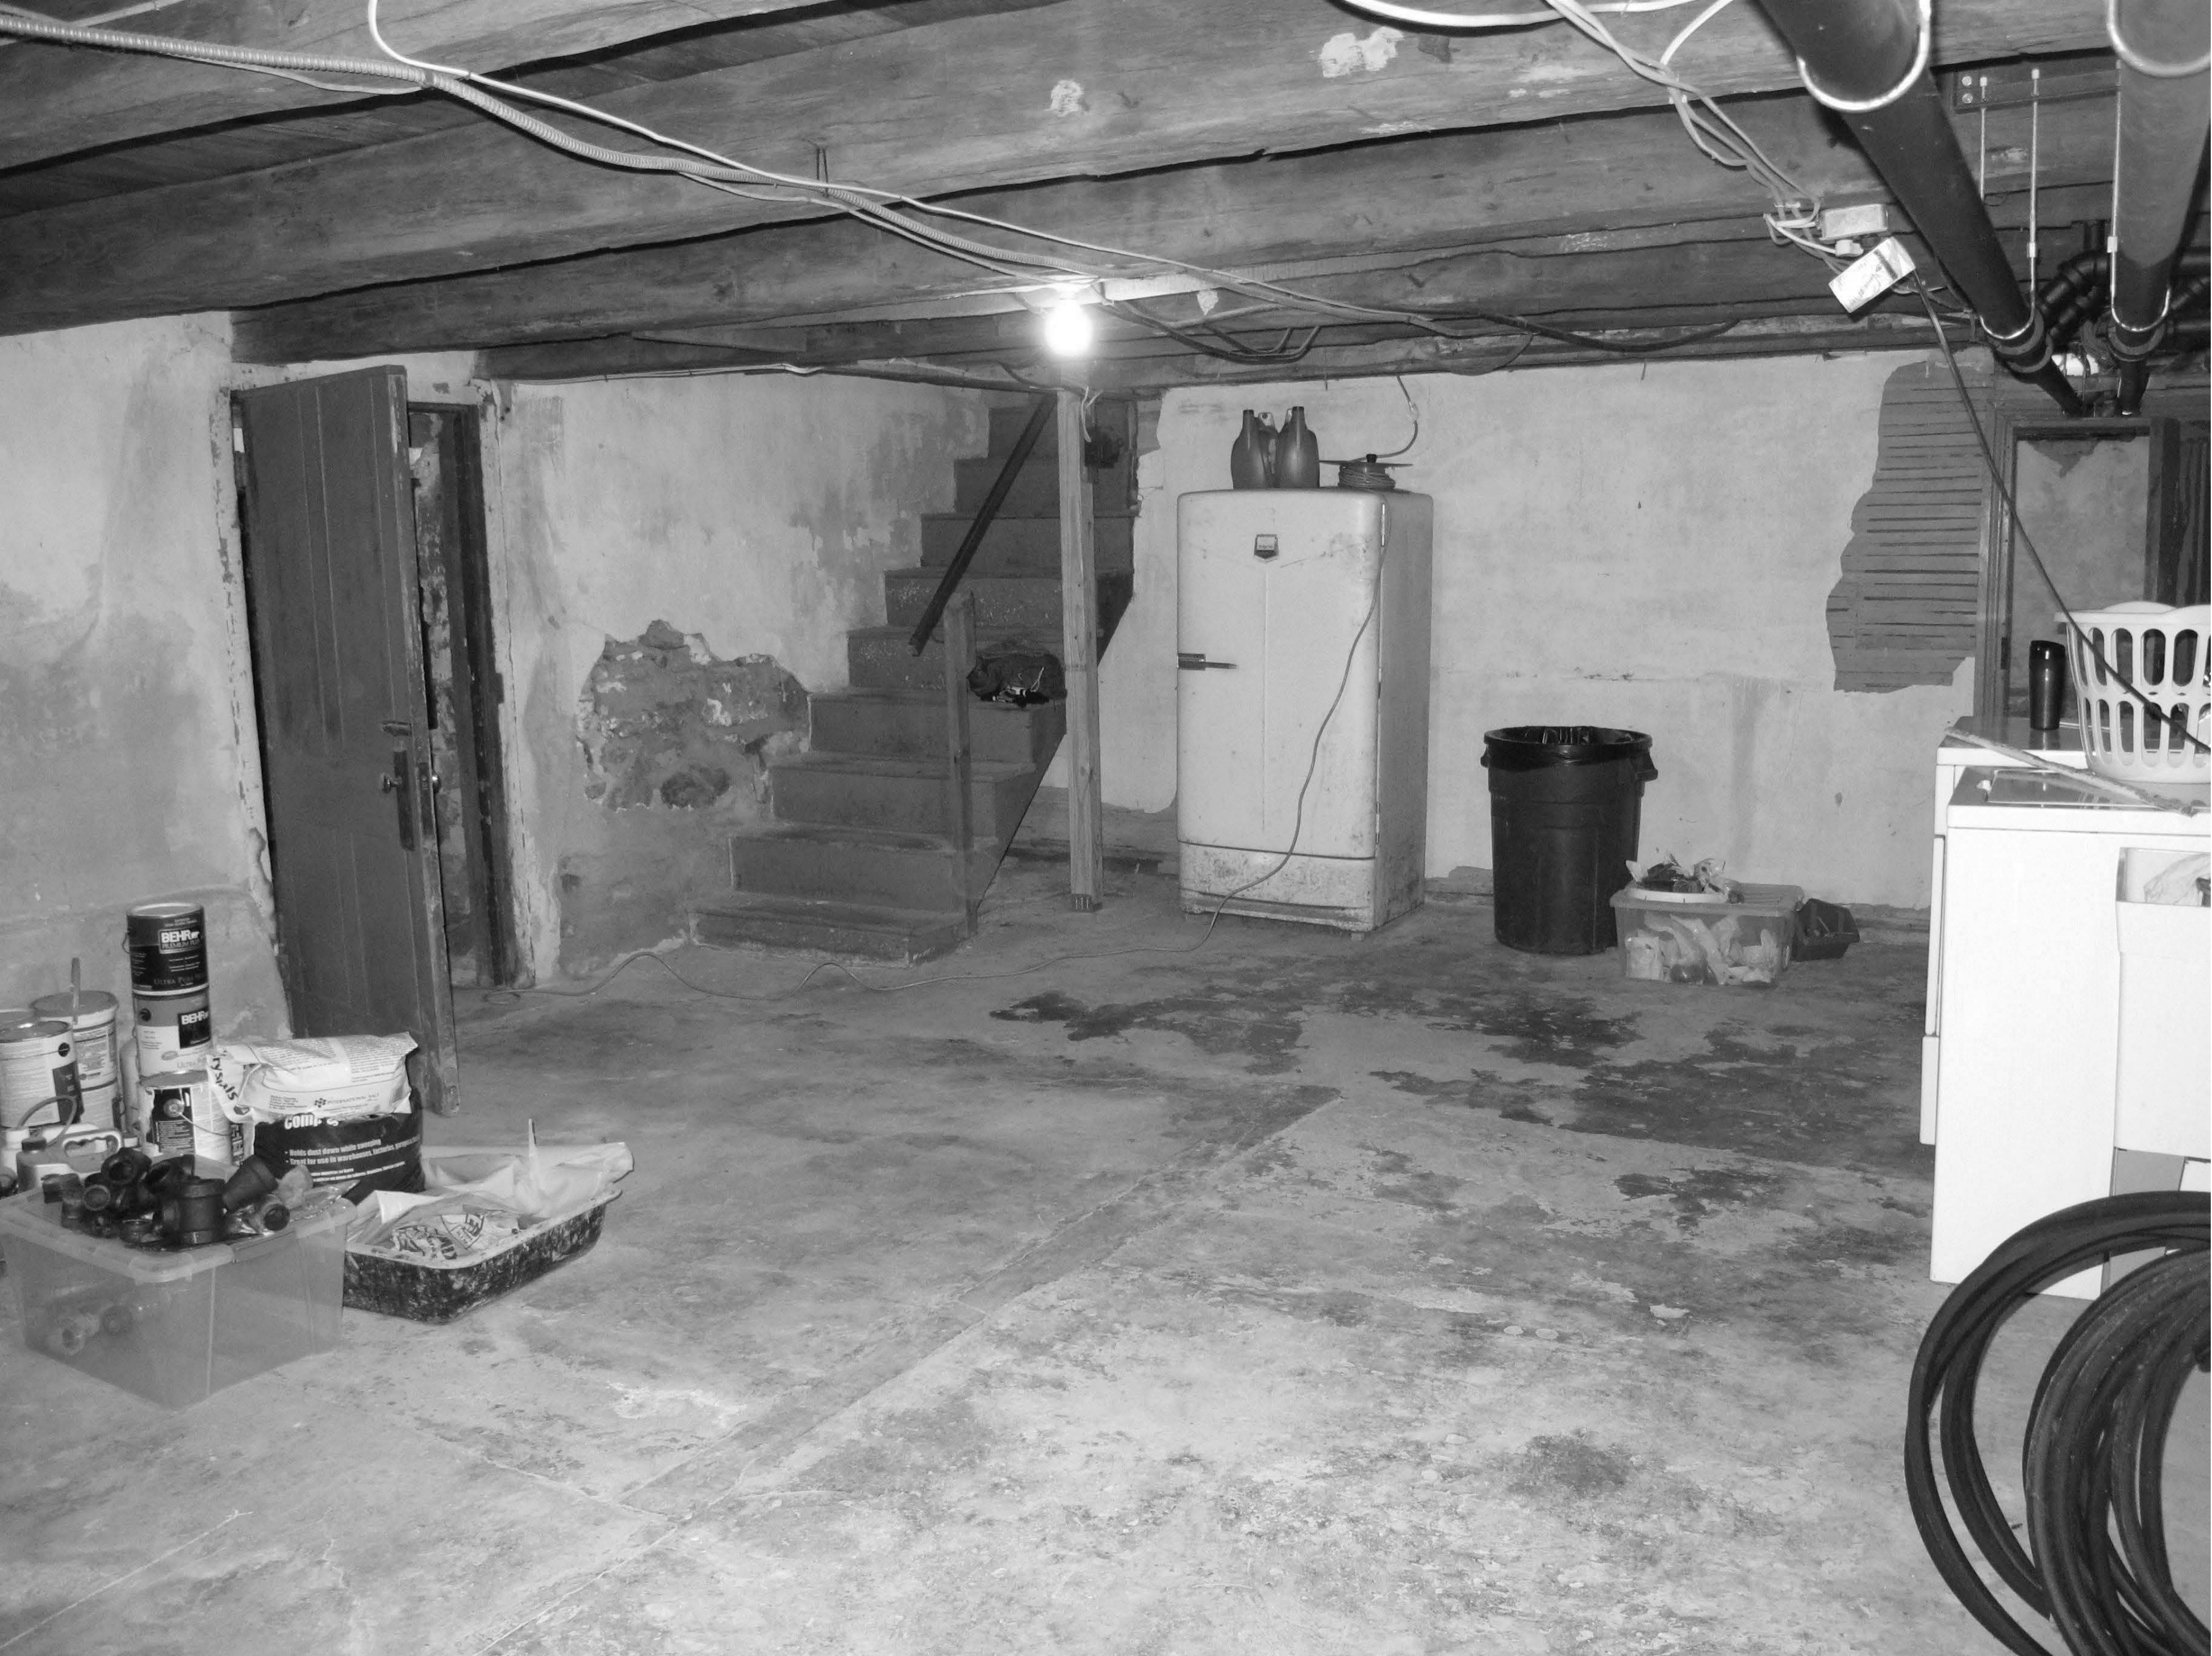
Cox-Phillips-Mitchell Agricultural Complex\_New Castle County\_DE  
Basement interior view of northeast and northwest walls showing stairs looking north

A set of stairs in the rear hallway of the Period I house leads to a large basement room, partitioned off from a smaller room to the north. The large room is accessible both from the stairs and from a bulkhead door in the east wall, and has a doorway on its north wall that leads to the smaller room. A fireplace-supporting arch is located in the south wall of the large room, a doorway in the west wall leads to the basement for the Period II portion of the building. The Period II basement is comprised of one large room, which spans the entire addition and has a fireplace support arch in the west wall. A hole cutout in the middle of the floor leads to a subterranean 18<sup>th</sup>-century root cellar. An enclosed stone stairs, and a barrel-vaulted stone room,
