# National Register of Historic Places Registration Form

Historic name: Cox-Phillips-Mitchell Agricultural Complex

Other names/site number: Delaware CRS # N04085

Street & number: 1651 and 1655 Old Wilmington Rd

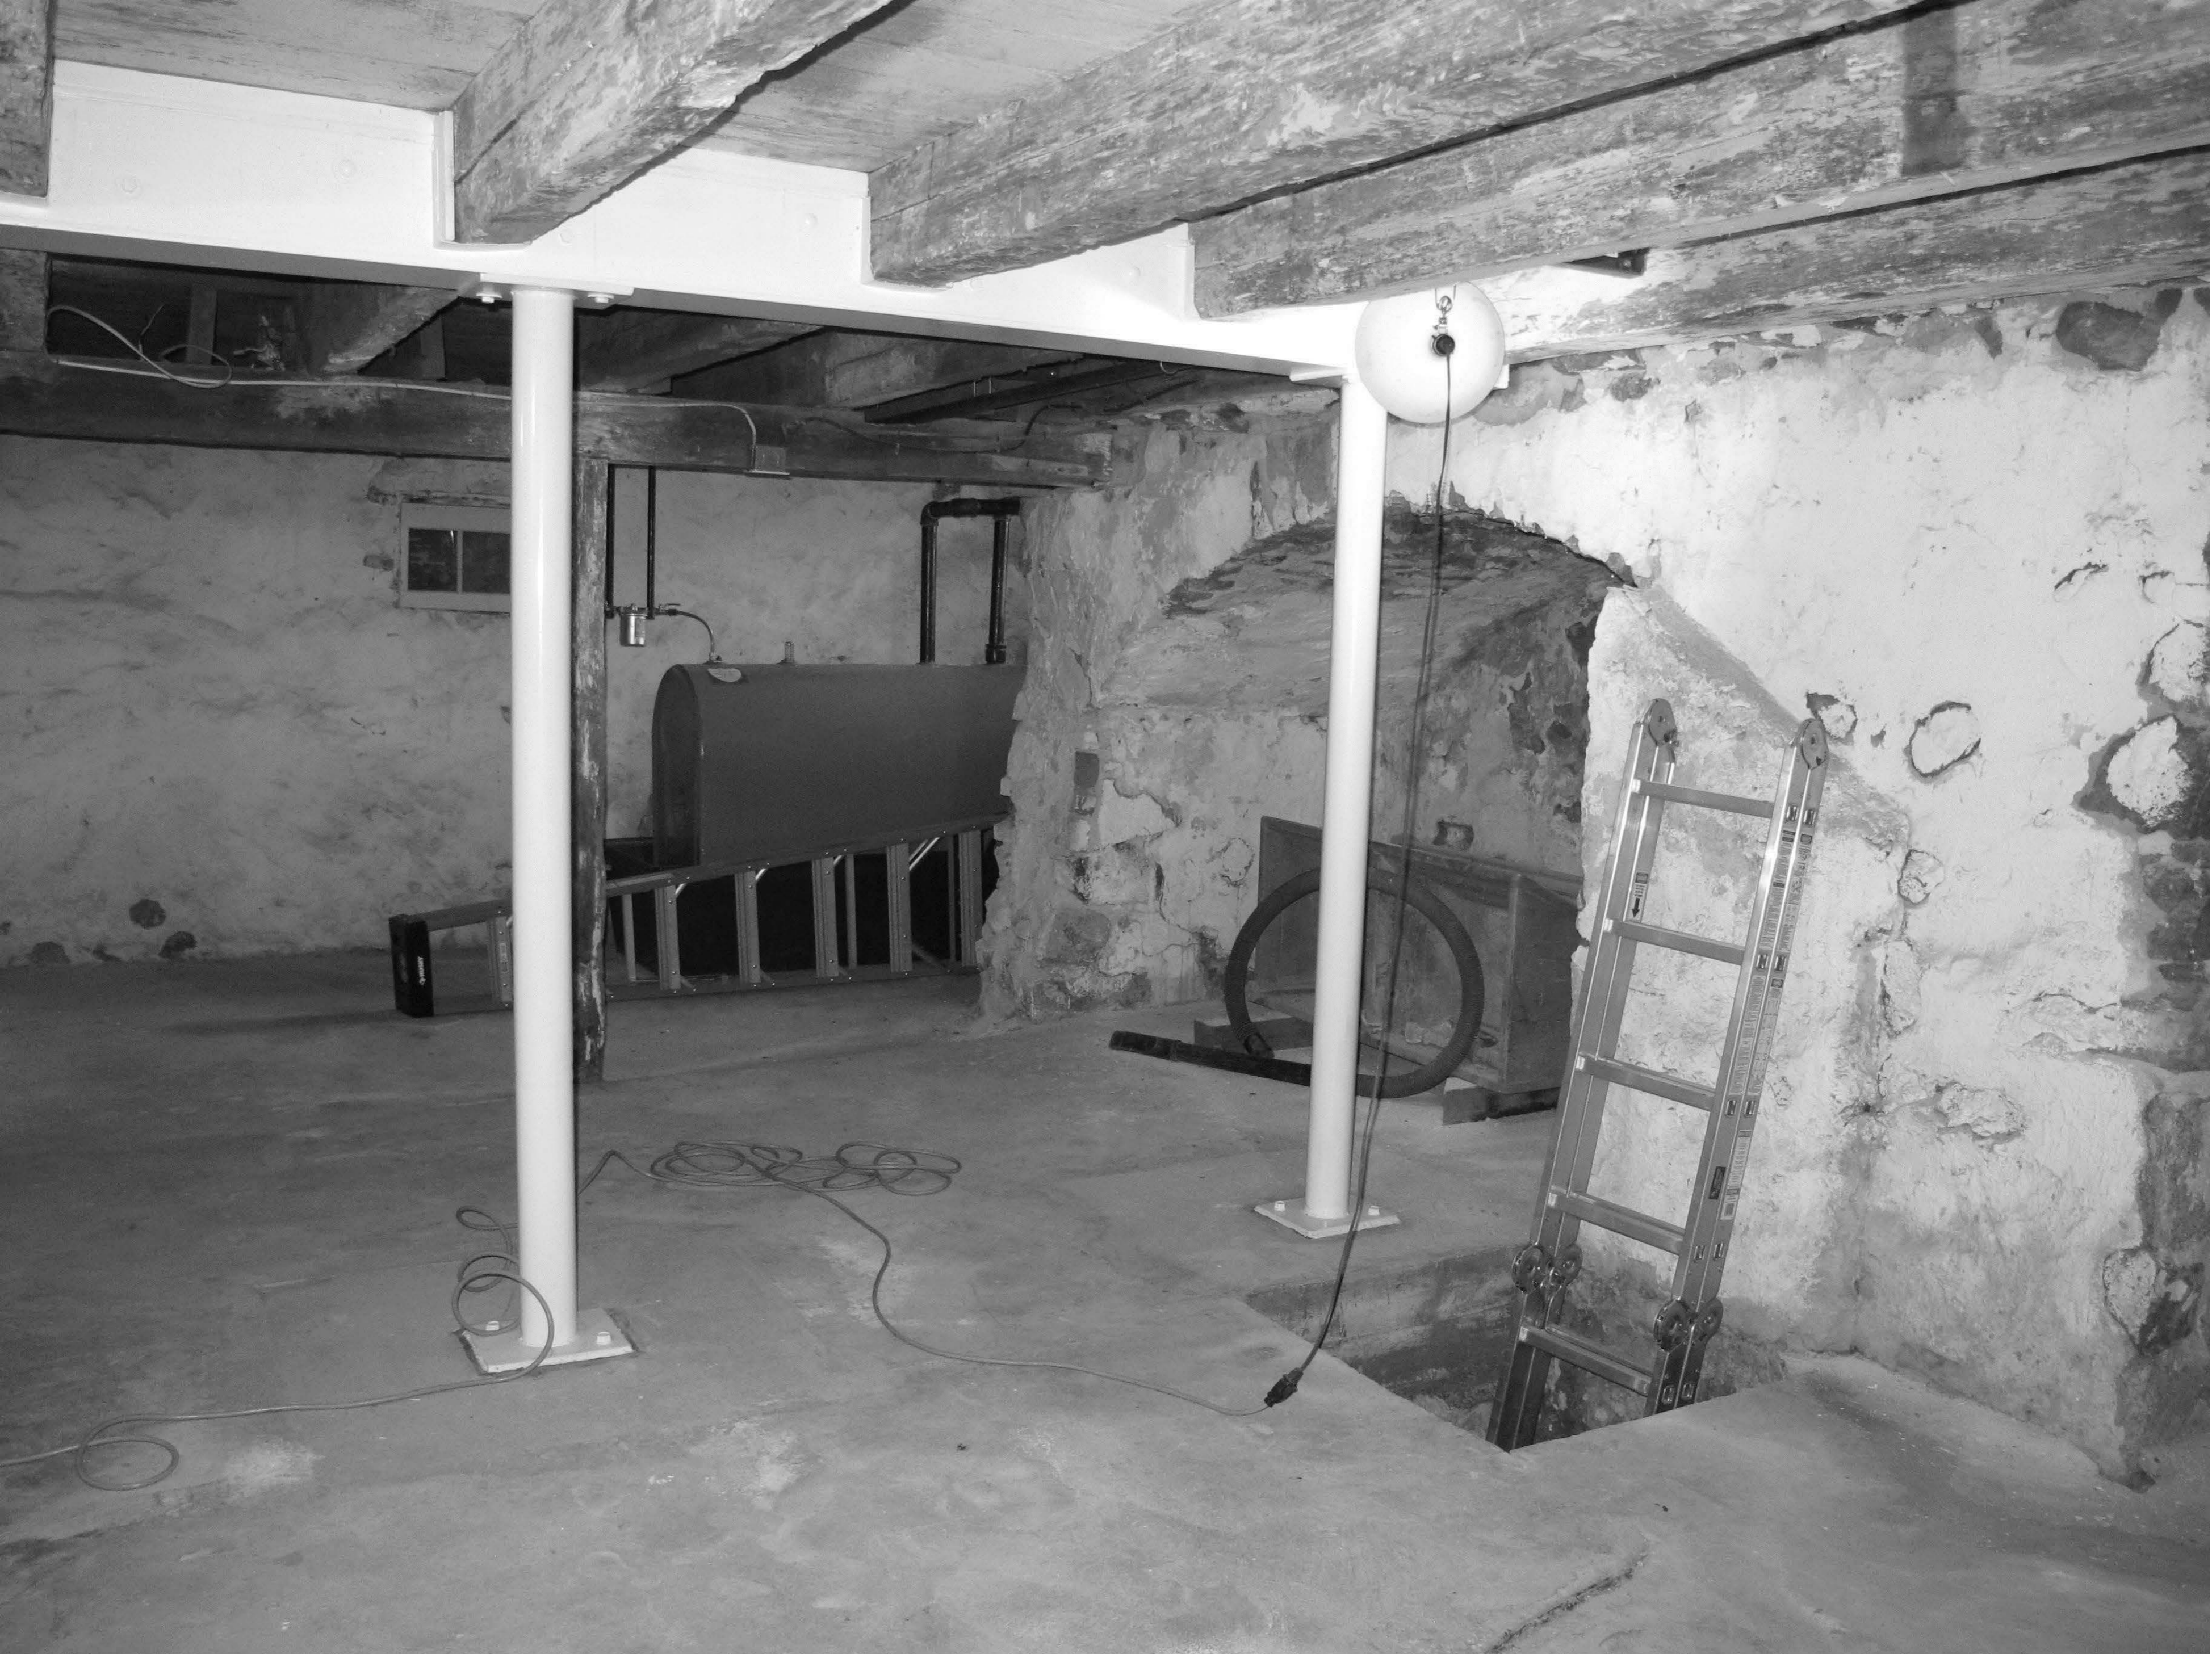
Cox-Phillips-Mitchell Agricultural Complex\_New Castle County\_DE  
Basement interior view of southwest wall, relieving arch on northwest wall, and floor  
opening to subterranean vault looking west

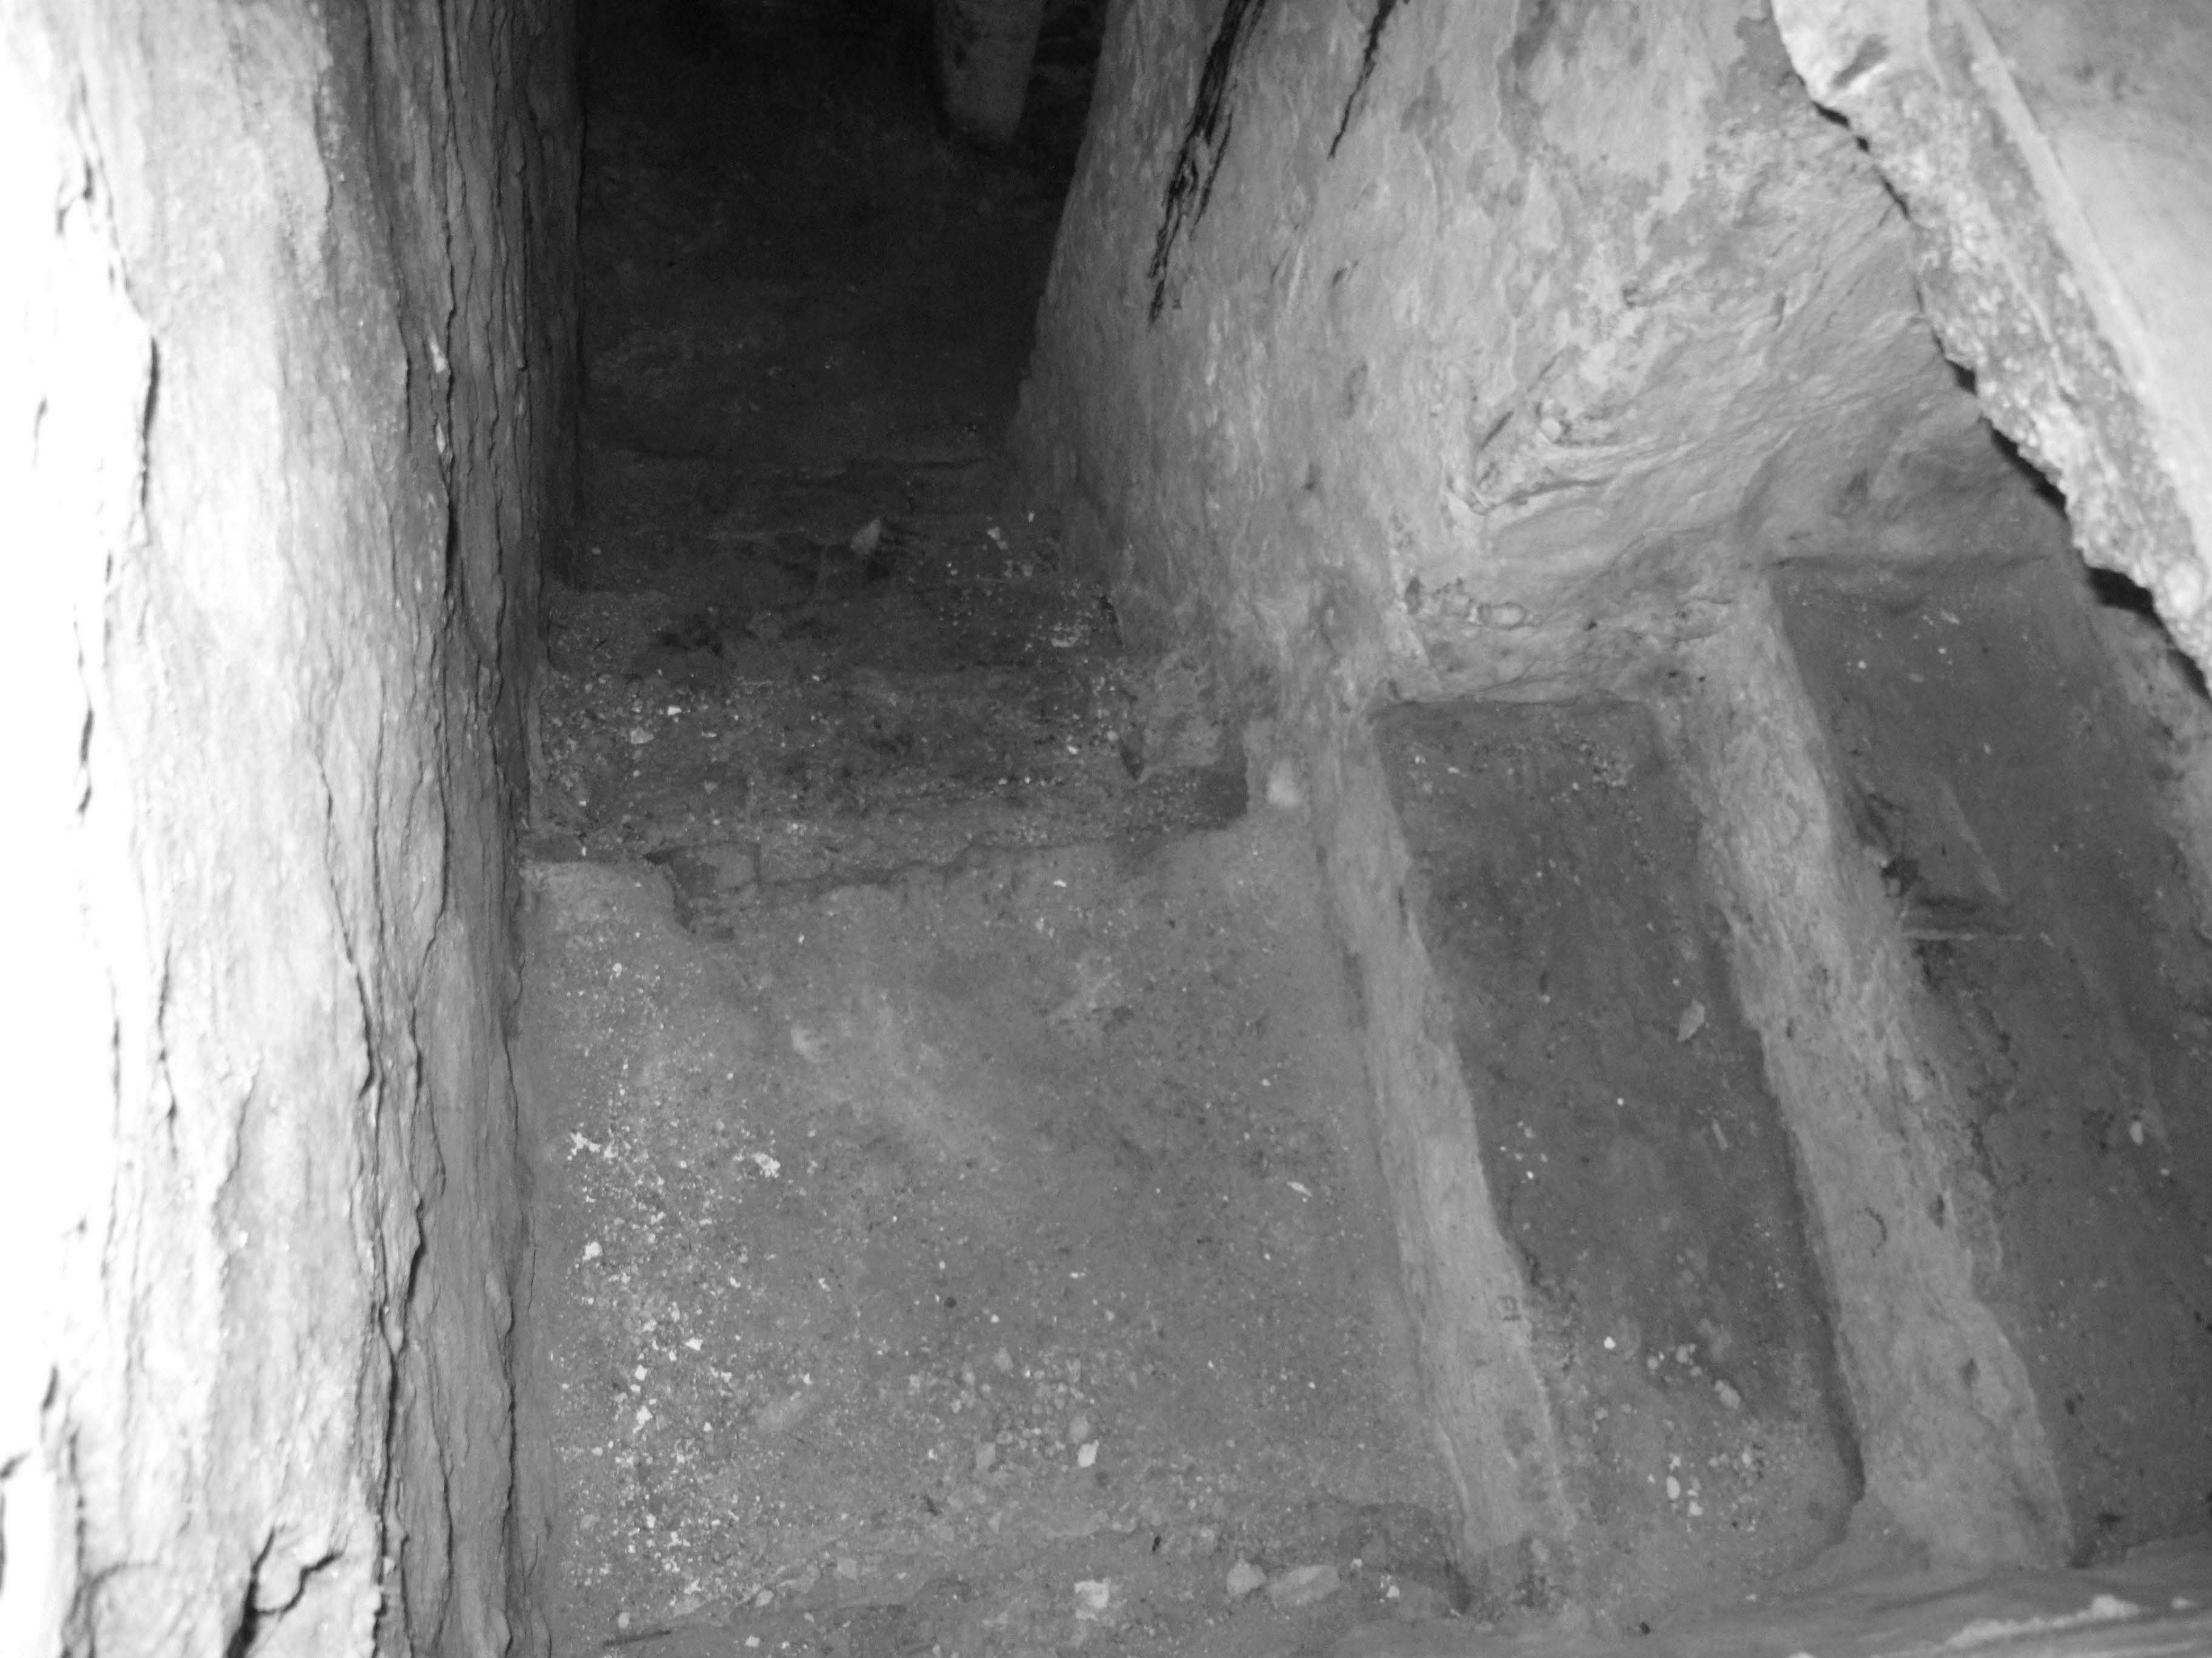
Cox-Phillips-Mitchell Agricultural Complex\_New Castle County\_DE  
Basement interior looking down the stairs into the subterranean vault looking northeast

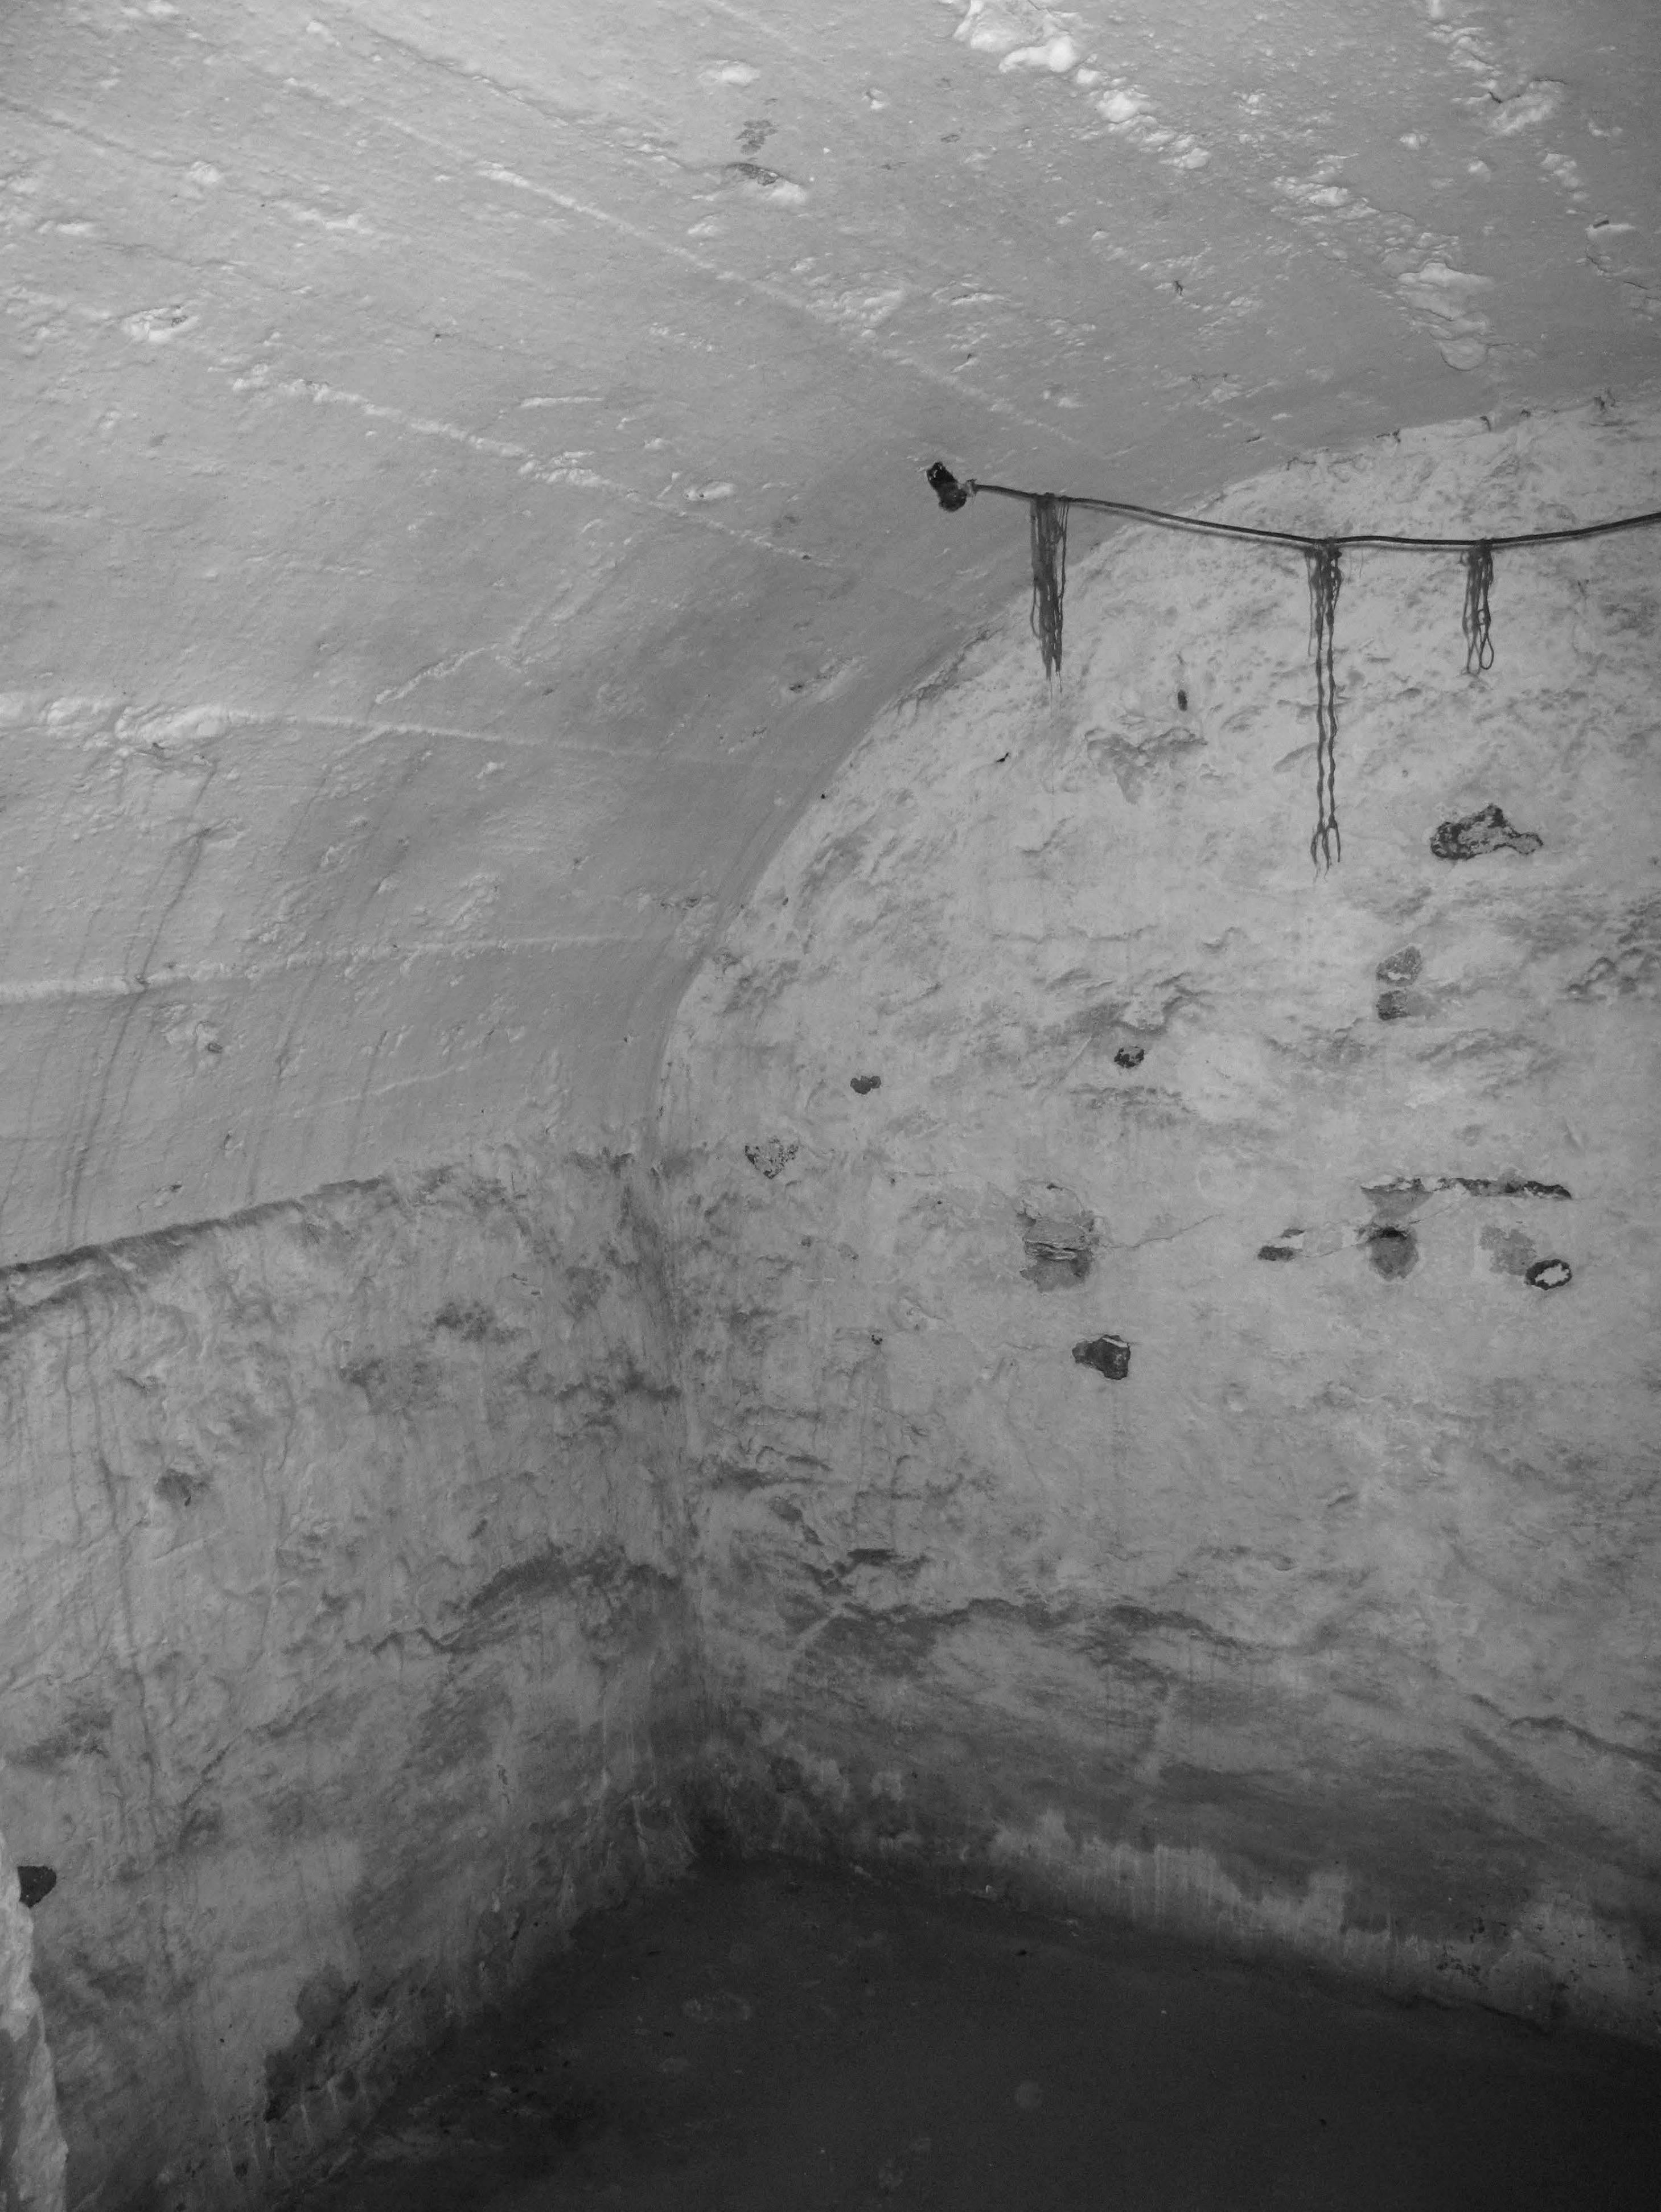
Cox-Phillips-Mitchell Agricultural Complex\_New Castle County\_DE  
Basement interior showing arched vault

with evidence of large hinges still exist in the space today. A doorway in the north wall of the Period II basement provides entry into the Period III basement. It is also comprised of a single room with another fireplace relieving arch in the north wall, and a staircase to the first floor.

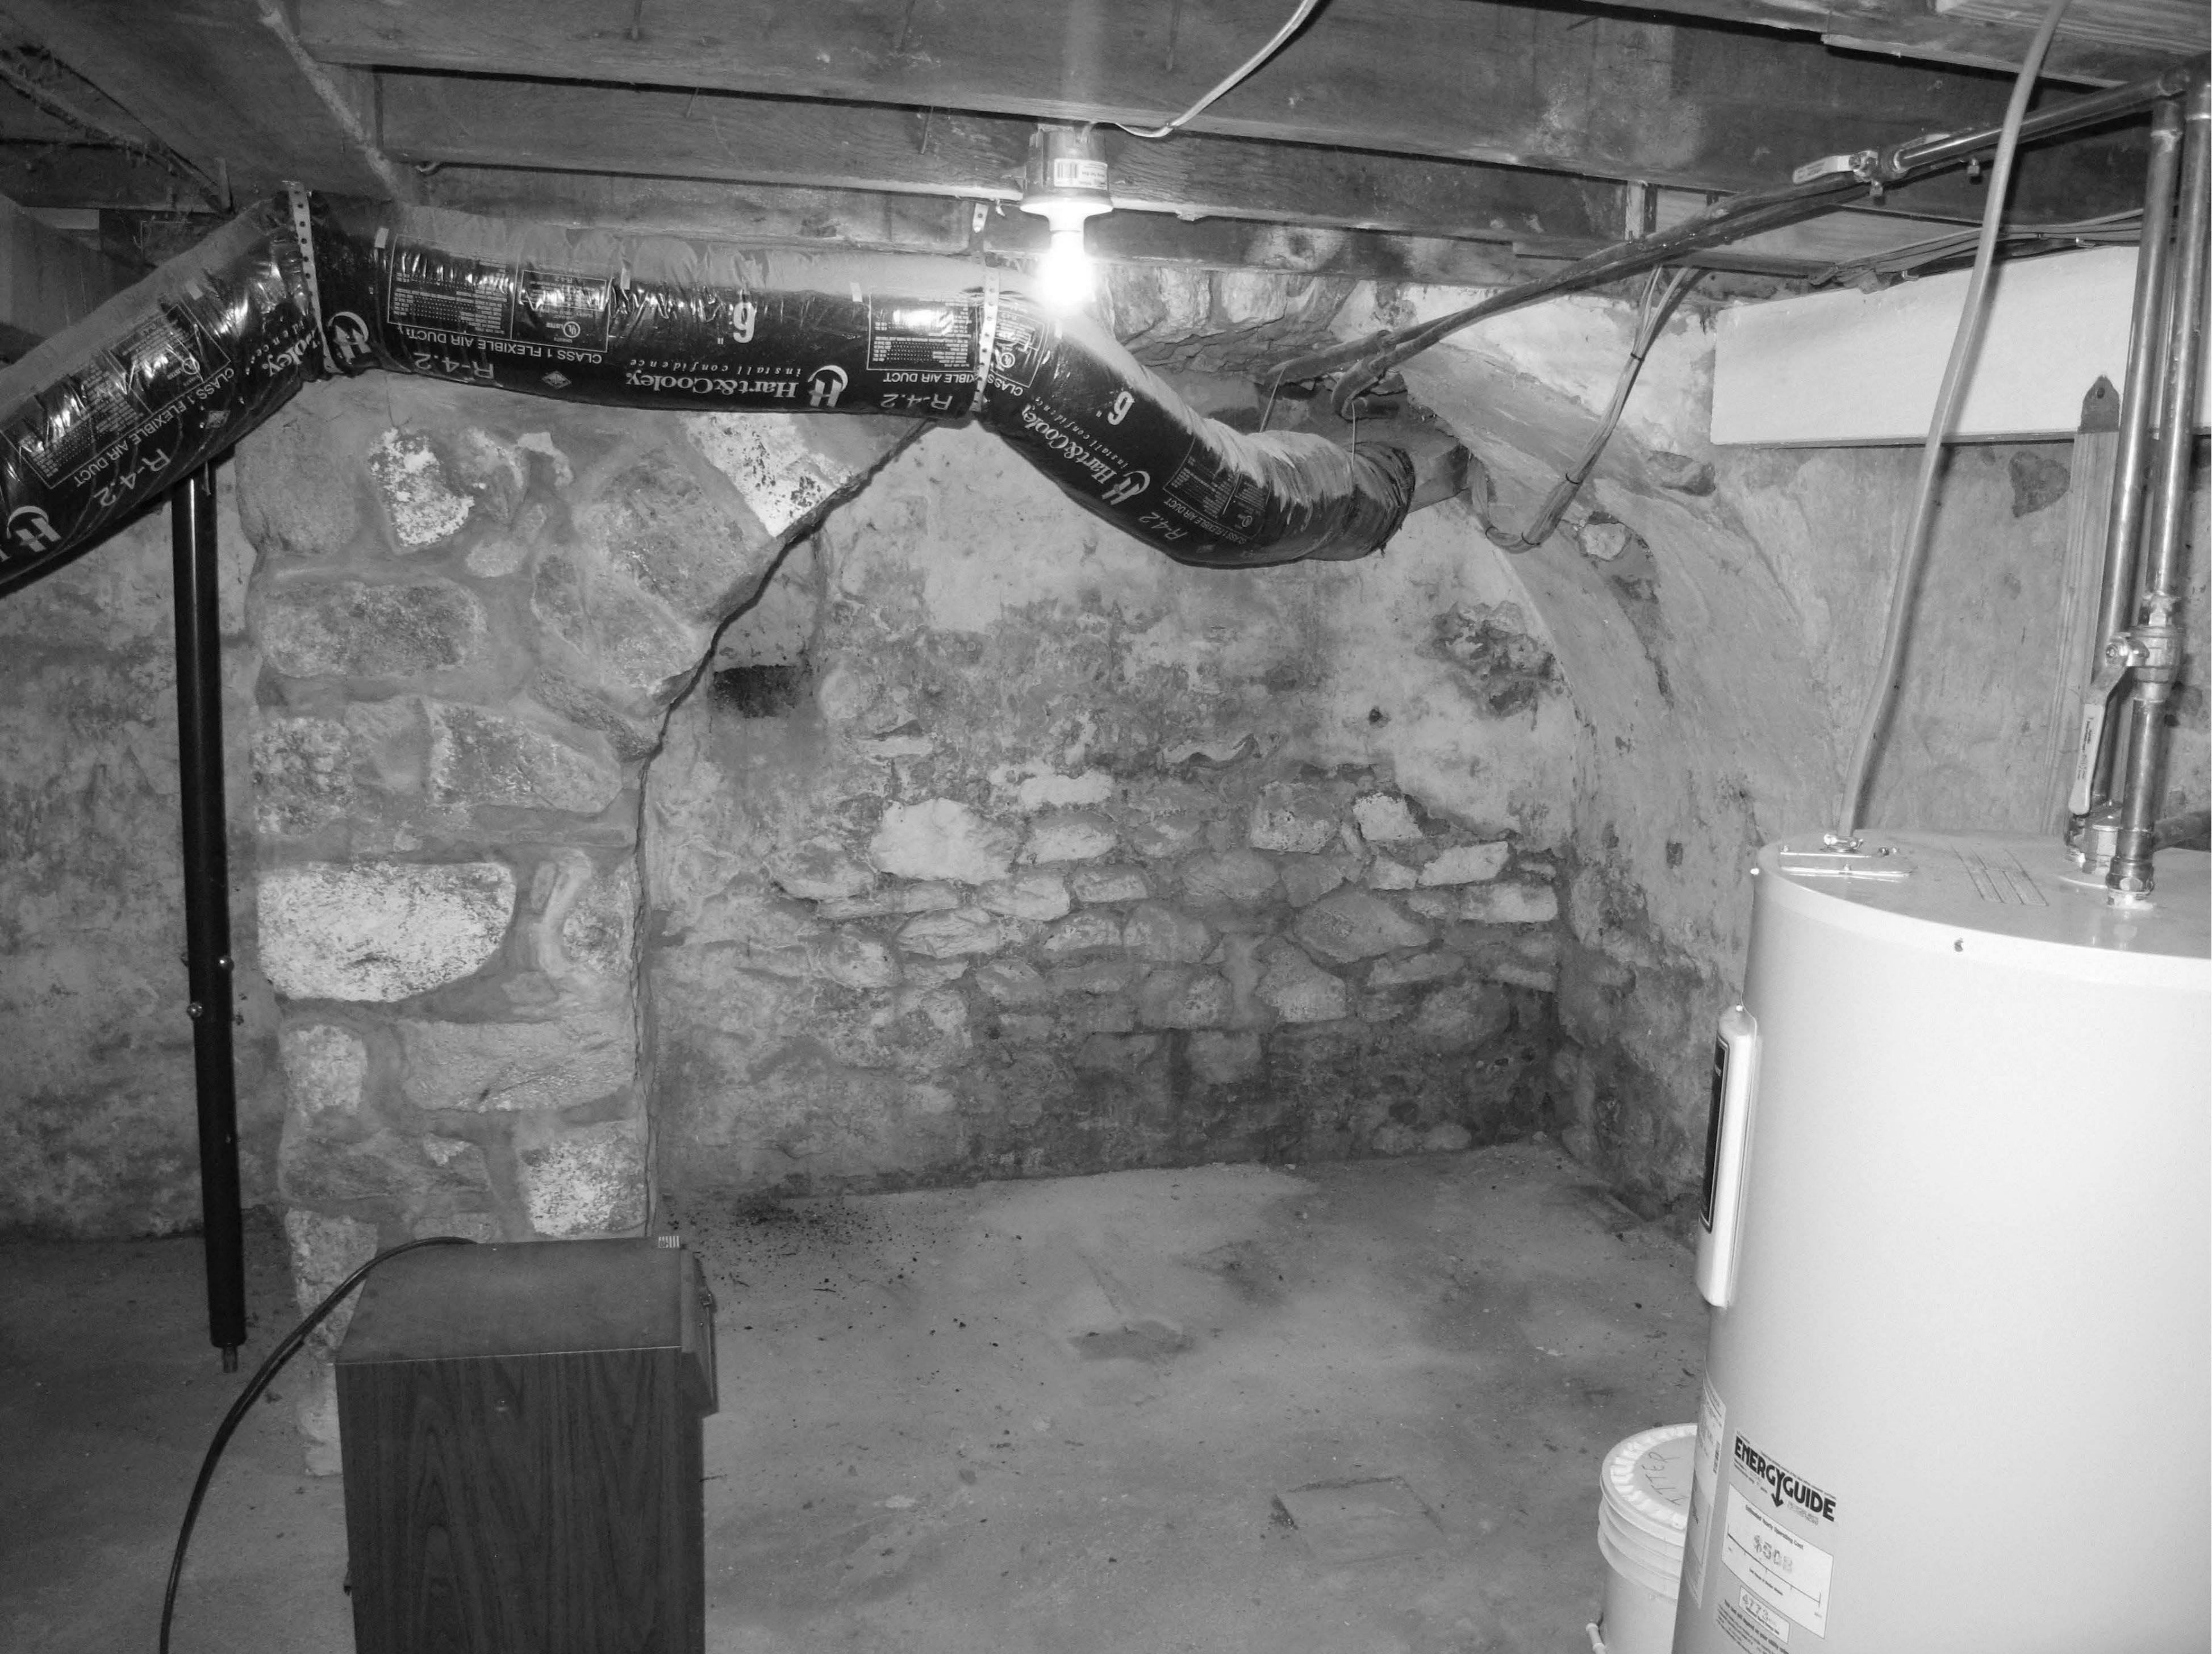
Cox-Phillips-Mitchell Agricultural Complex\_New Castle County\_DE  
Basement interior showing relieving arch on northeast wall looking northeast

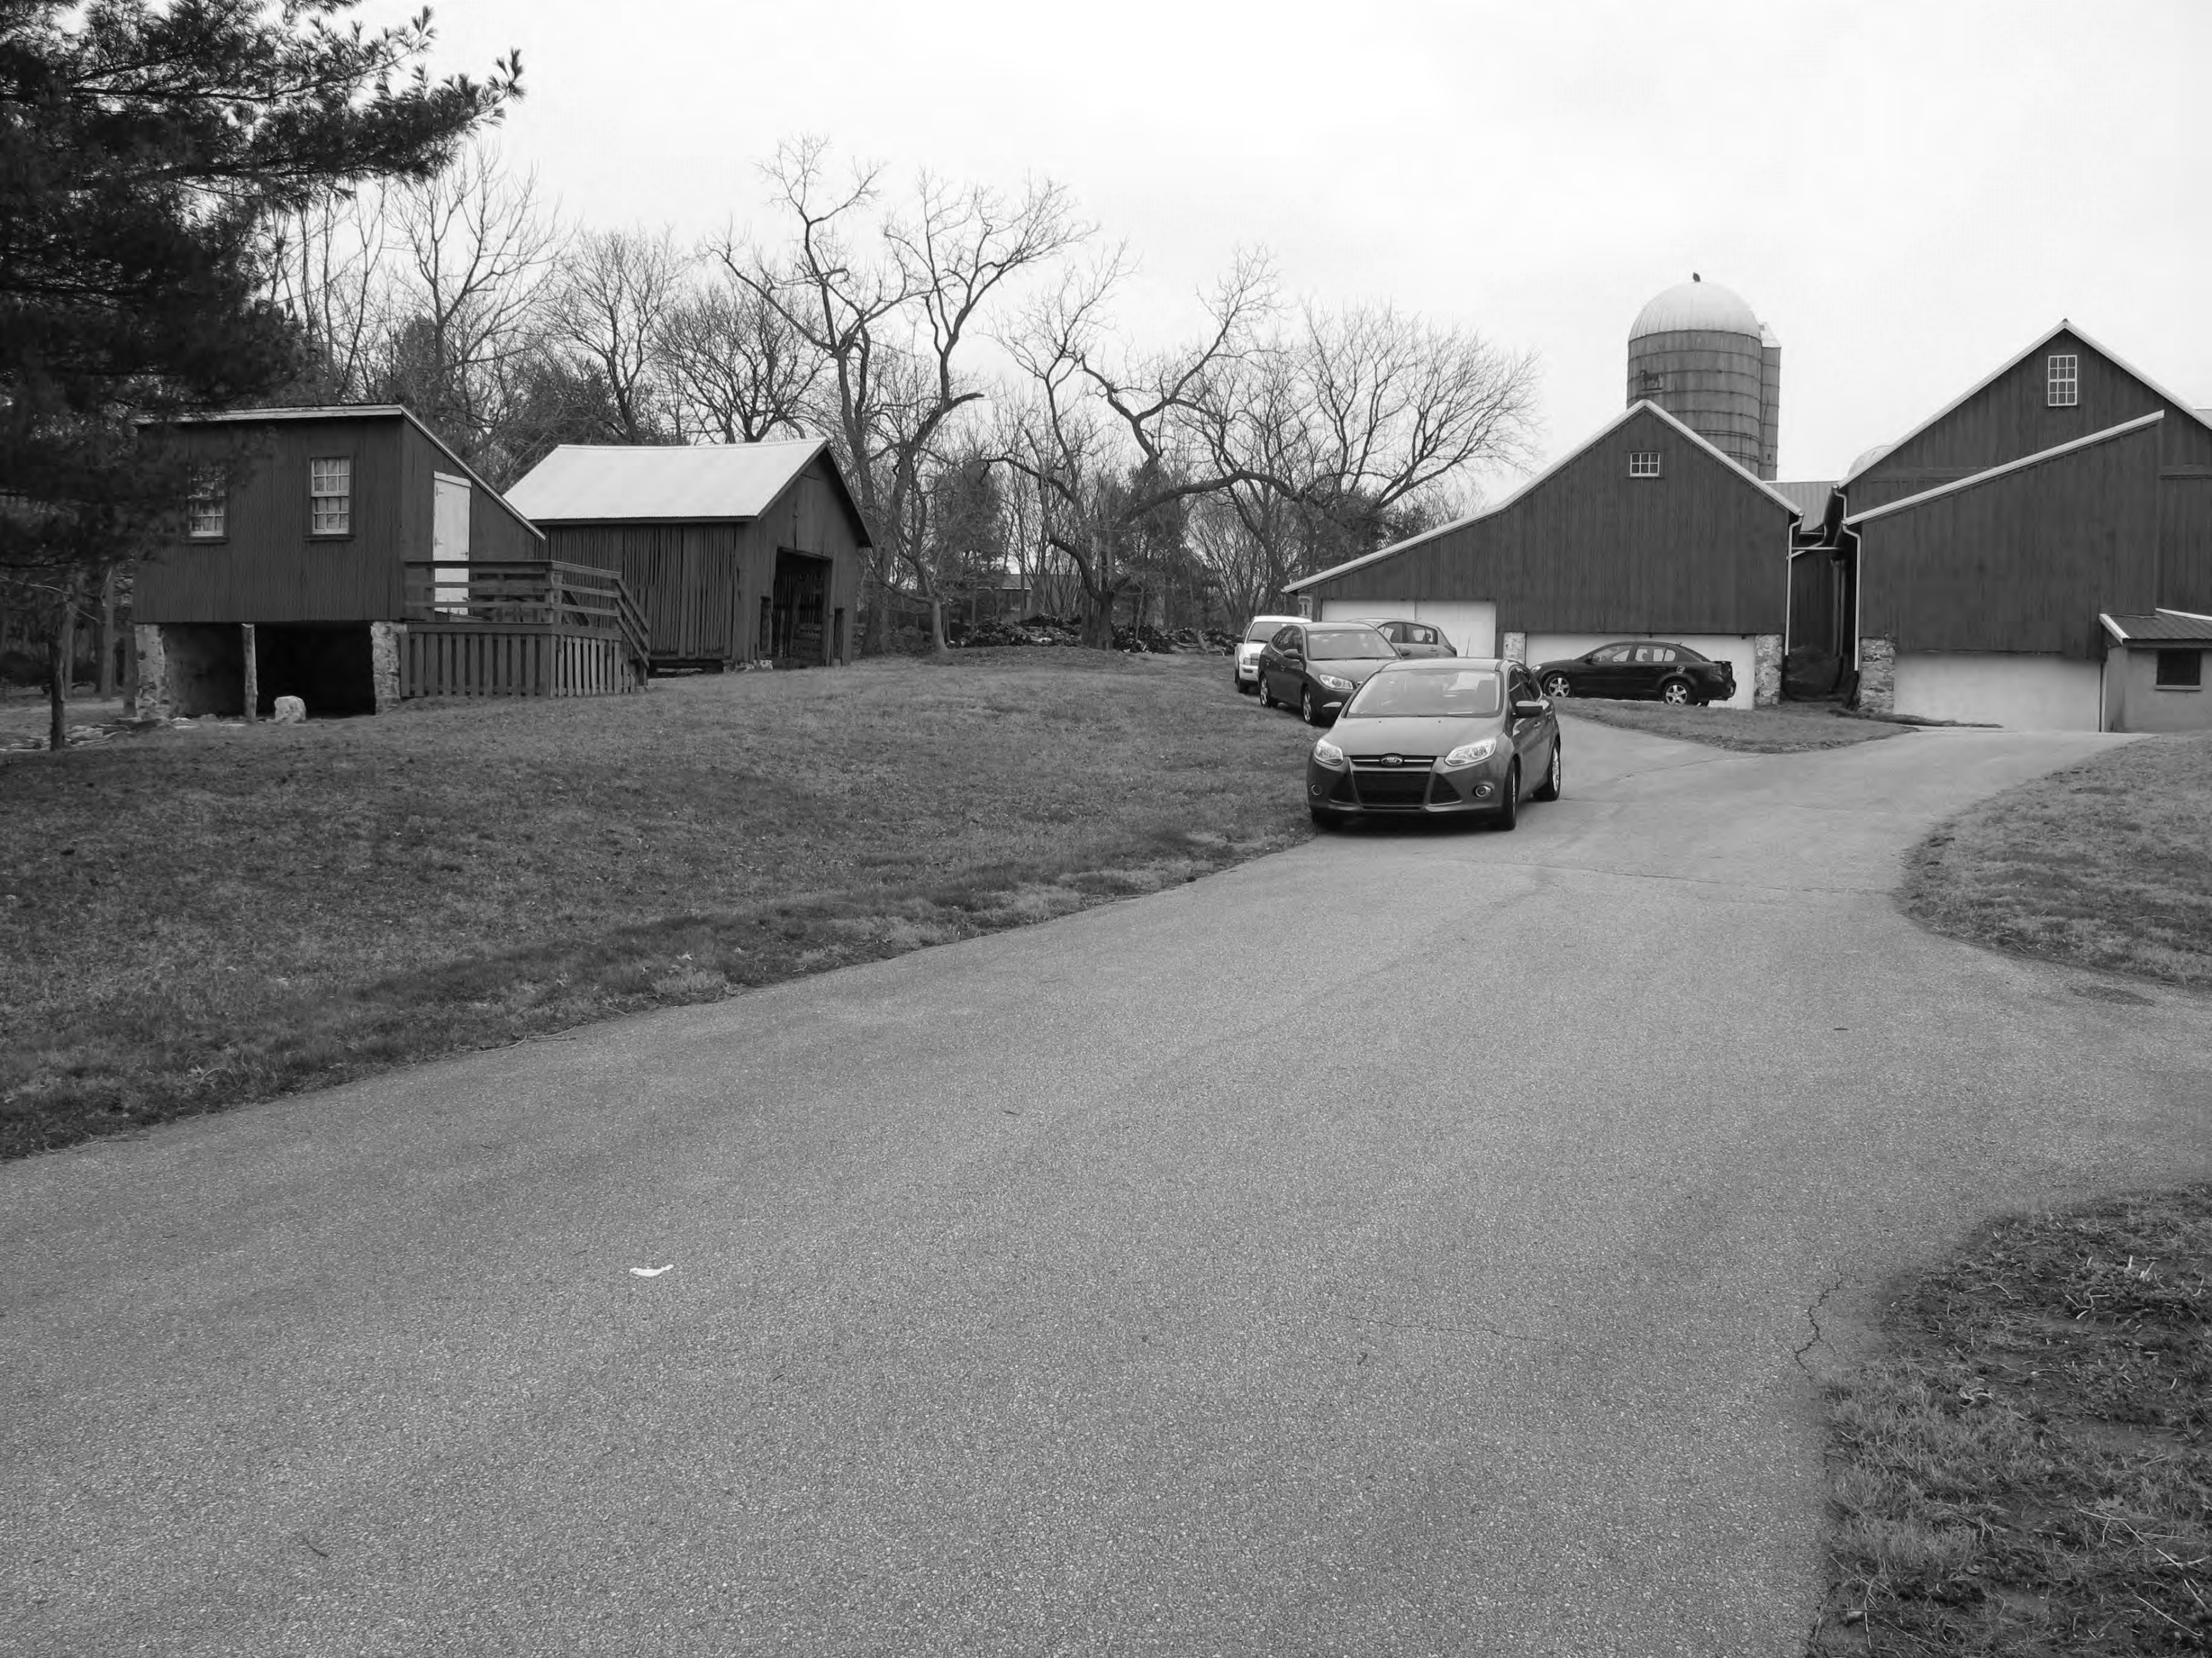
Cox-Phillips-Mitchell Agricultural Complex\_New Castle County\_DE  
Environmental view showing driveway and outbuildings looking northeast

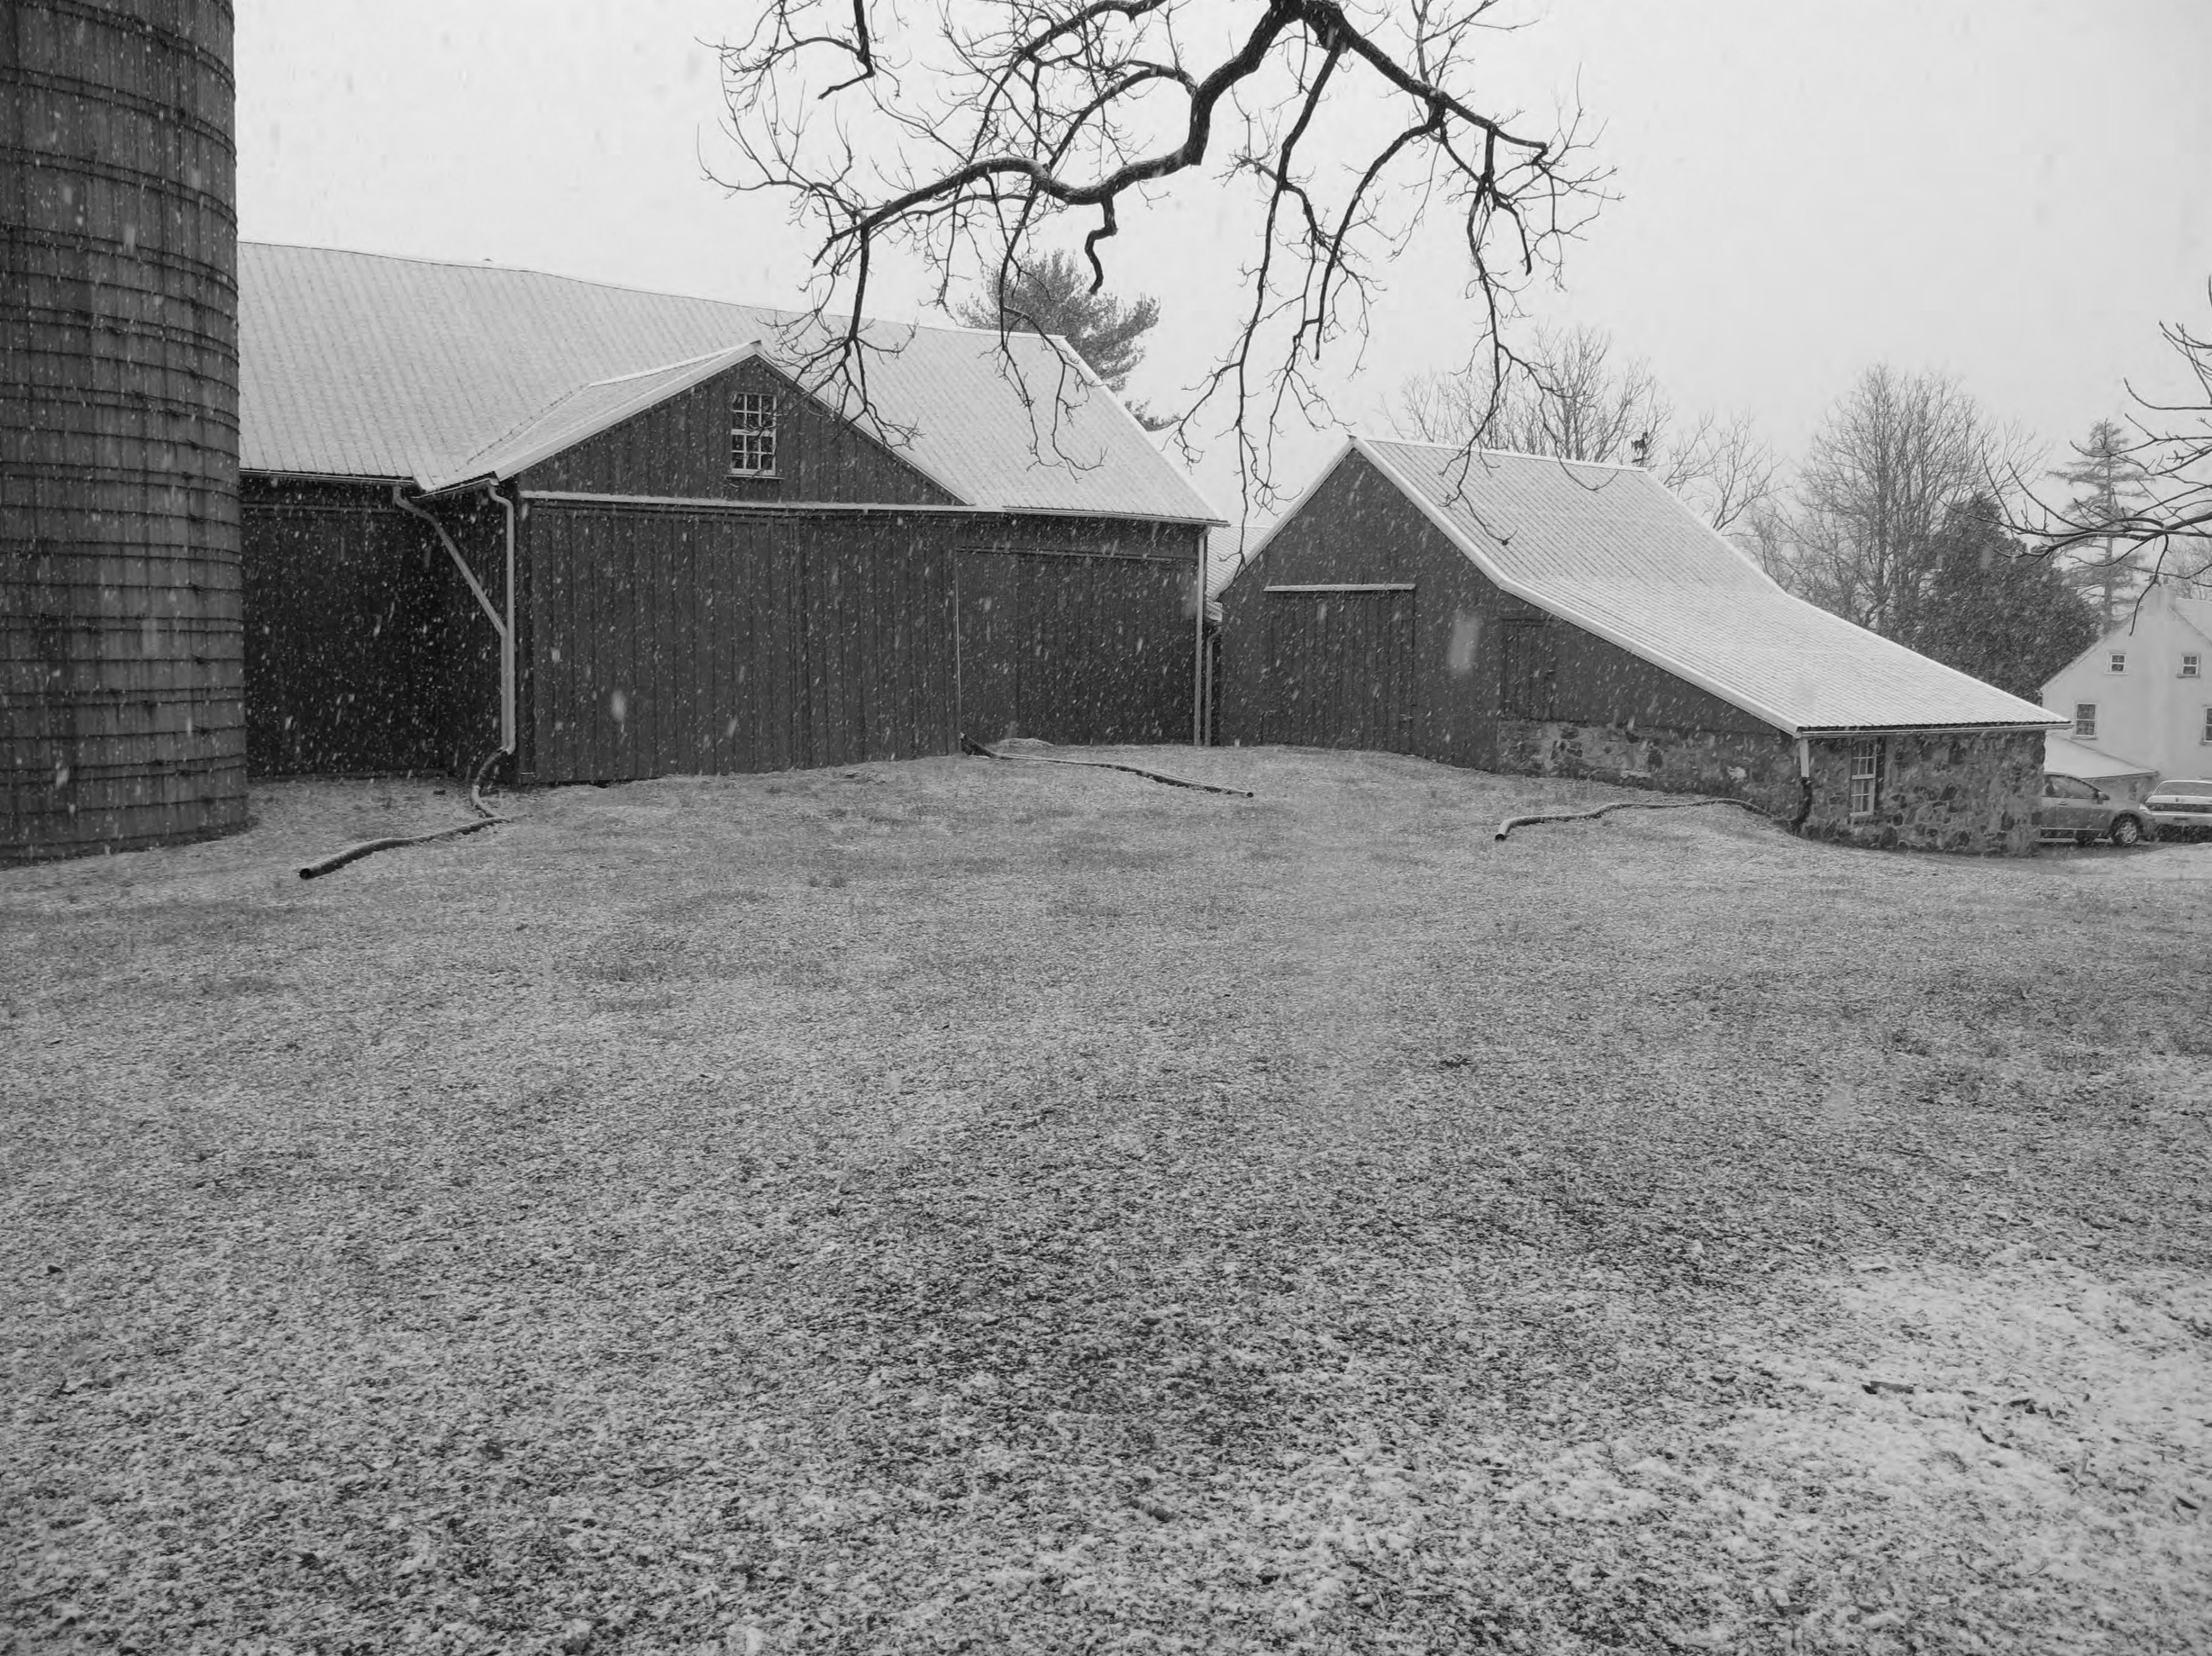
Cox-Phillips-Mitchell Agricultural Complex\_New Castle County\_DE  
Perspective view showing dairy barn, stable, and house looking southwest
