# National Register of Historic Places Registration Form

Historic name: Cox-Phillips-Mitchell Agricultural Complex

Other names/site number: Delaware CRS # N04085

Street & number: 1651 and 1655 Old Wilmington Rd

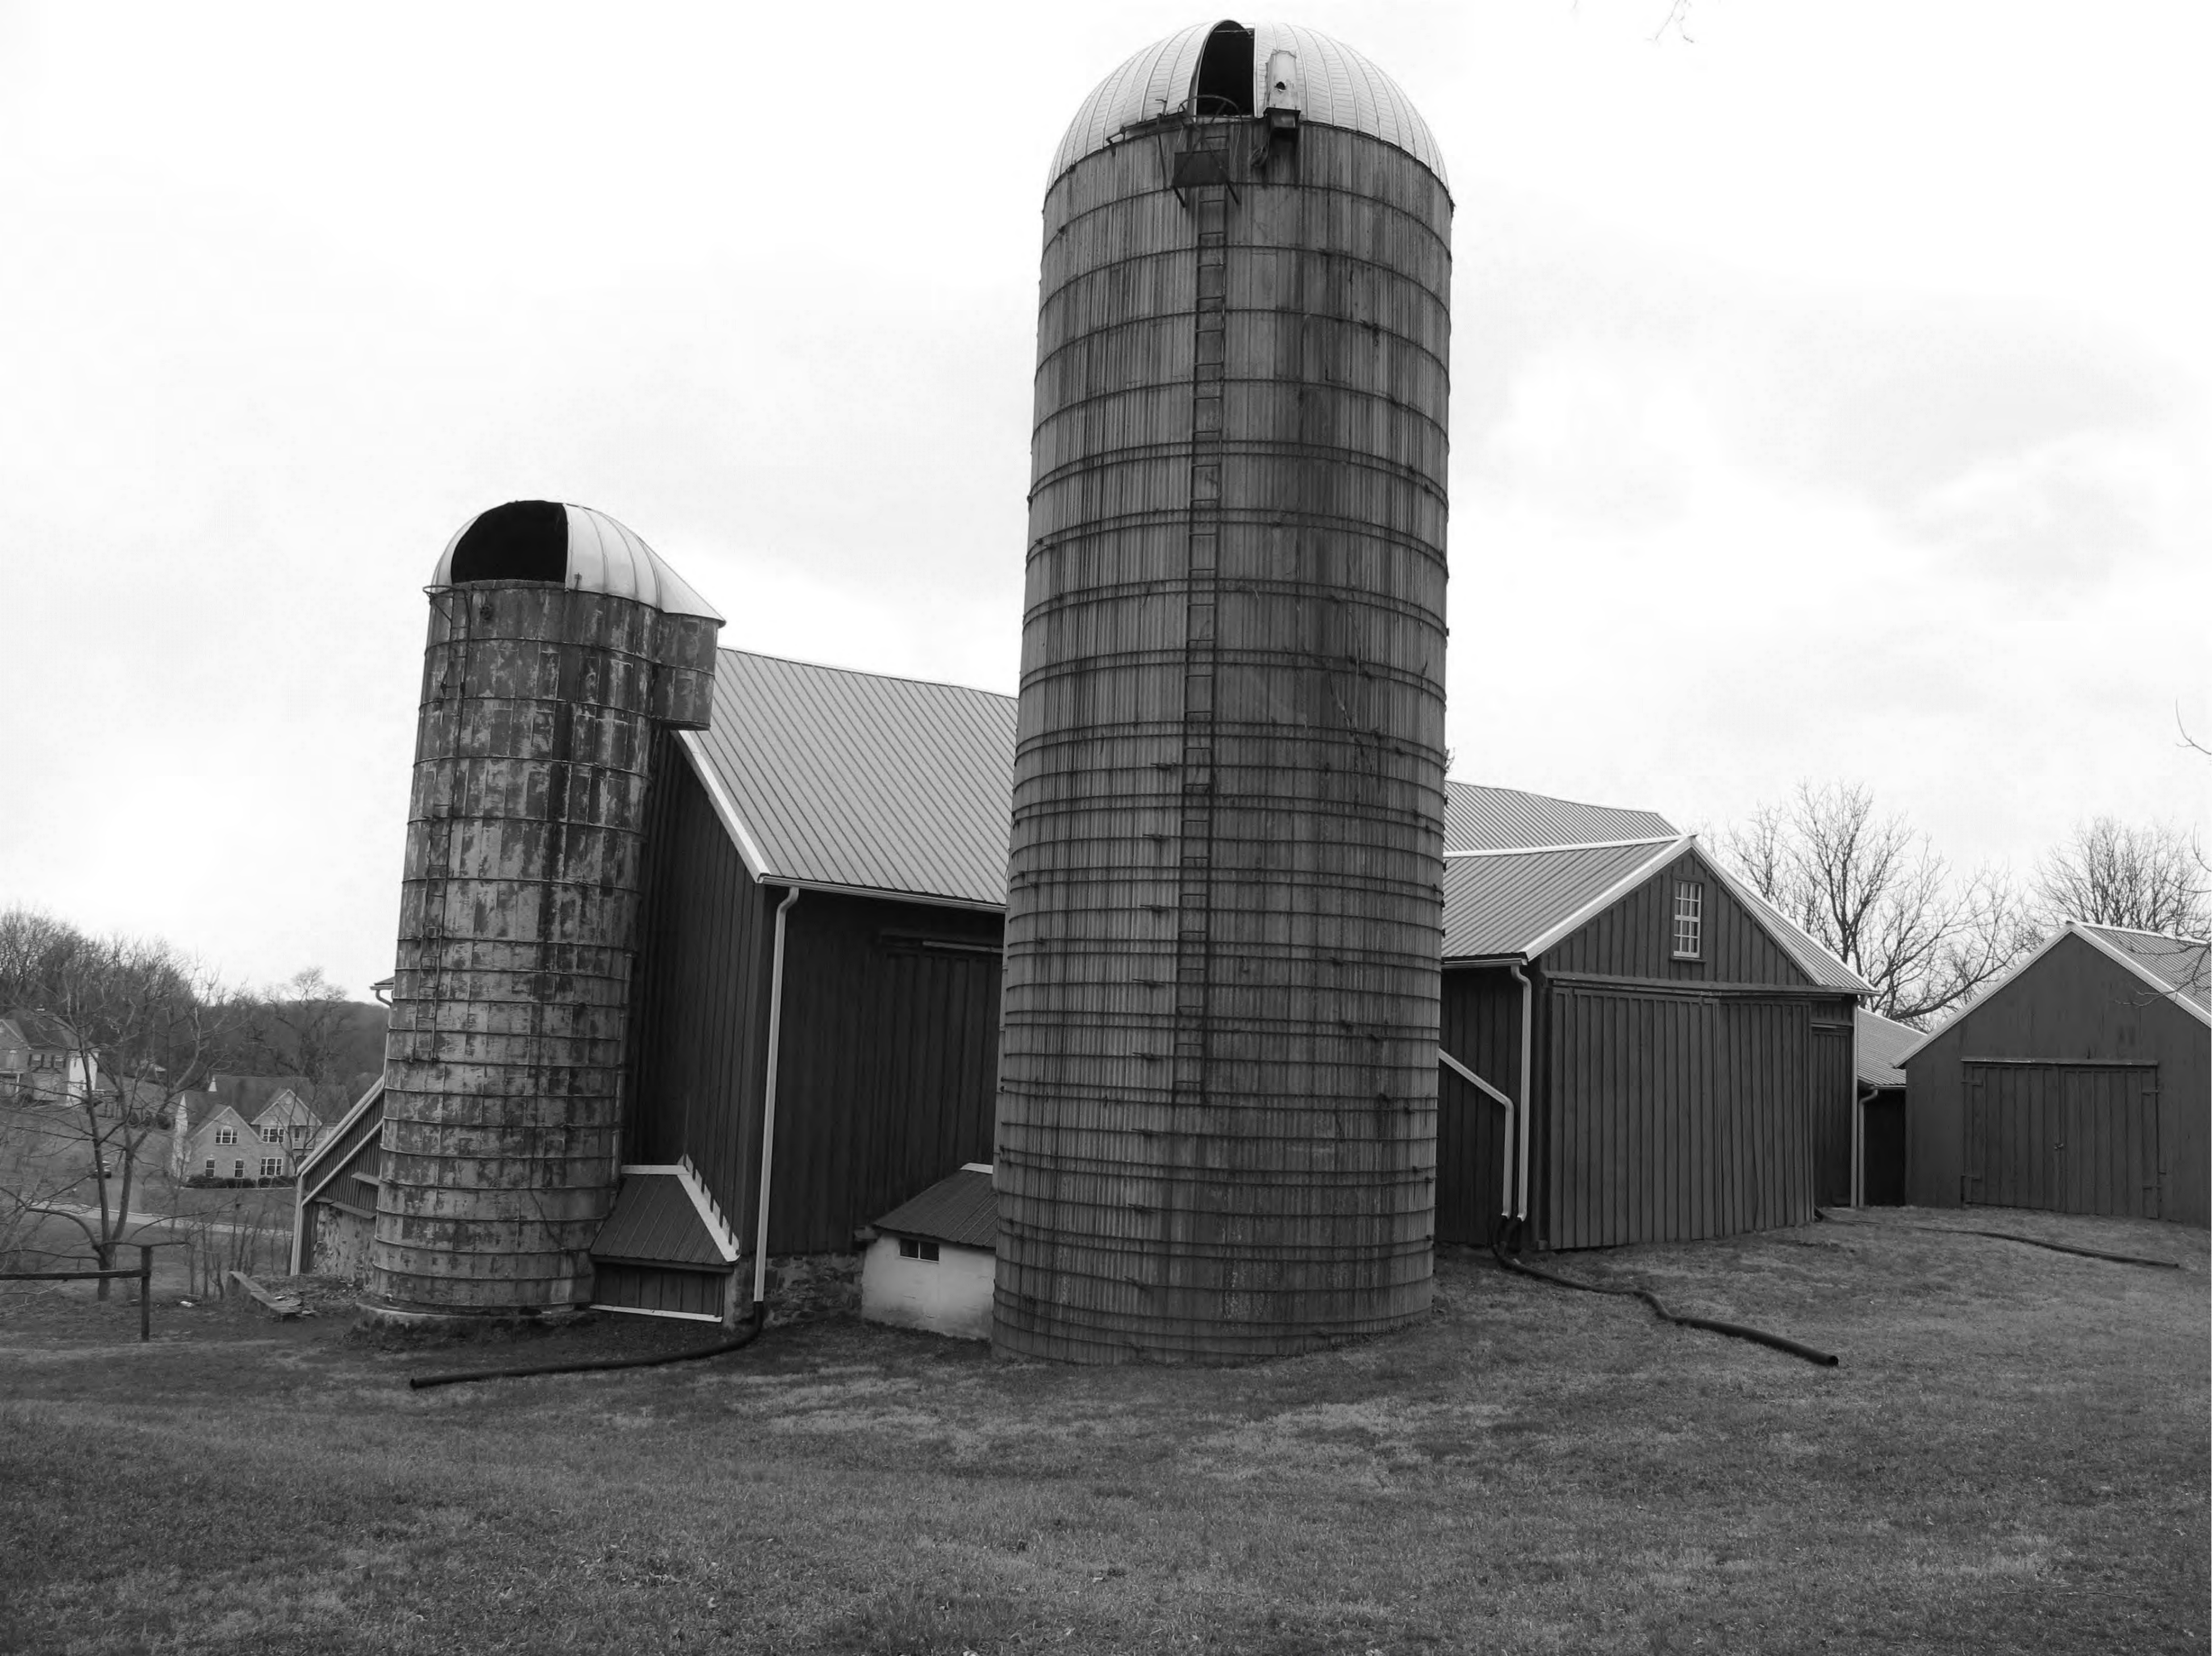
Cox-Phillips-Mitchell Agricultural Complex\_New Castle County\_DE  
Perspective View of dairy barn, stable, showing northwest and southwest elevations of  
dairy barn looking south

The large dairy barn, originally built circa 1760, and significantly expanded and renovated up through the mid-twentieth century, consists of four main sections, two floors, an additional milk house, and silos. The original 1760 section of the barn is the large central core with a northeast-southwest running roofline. Located on the southeast and southwest walls are small building additions with northwest-southeast running rooflines. A small shed roof addition is located along the southwestern wall. There are six-over-six, double-hung sash windows at the roof peaks on all of the projecting gable ends of the combined structure. Sliding barn doors are located on the northeastern, northwest, southwest elevations of the building, and a row of windows opening onto the first floor on both the northeast, northwest and southwest walls. A small shed roof and yard projects off of the southwestern end of the building. Two silos are located near the northeast corner of the barn, both of which is accessible from inside the structure. The milk house consists of a small, one story, hollow-tile structure attached to the southwestern end of the barn, and features two small, four-light windows on its southwestern wall, and a partially hipped roof, and one-over-one window to the southeast.

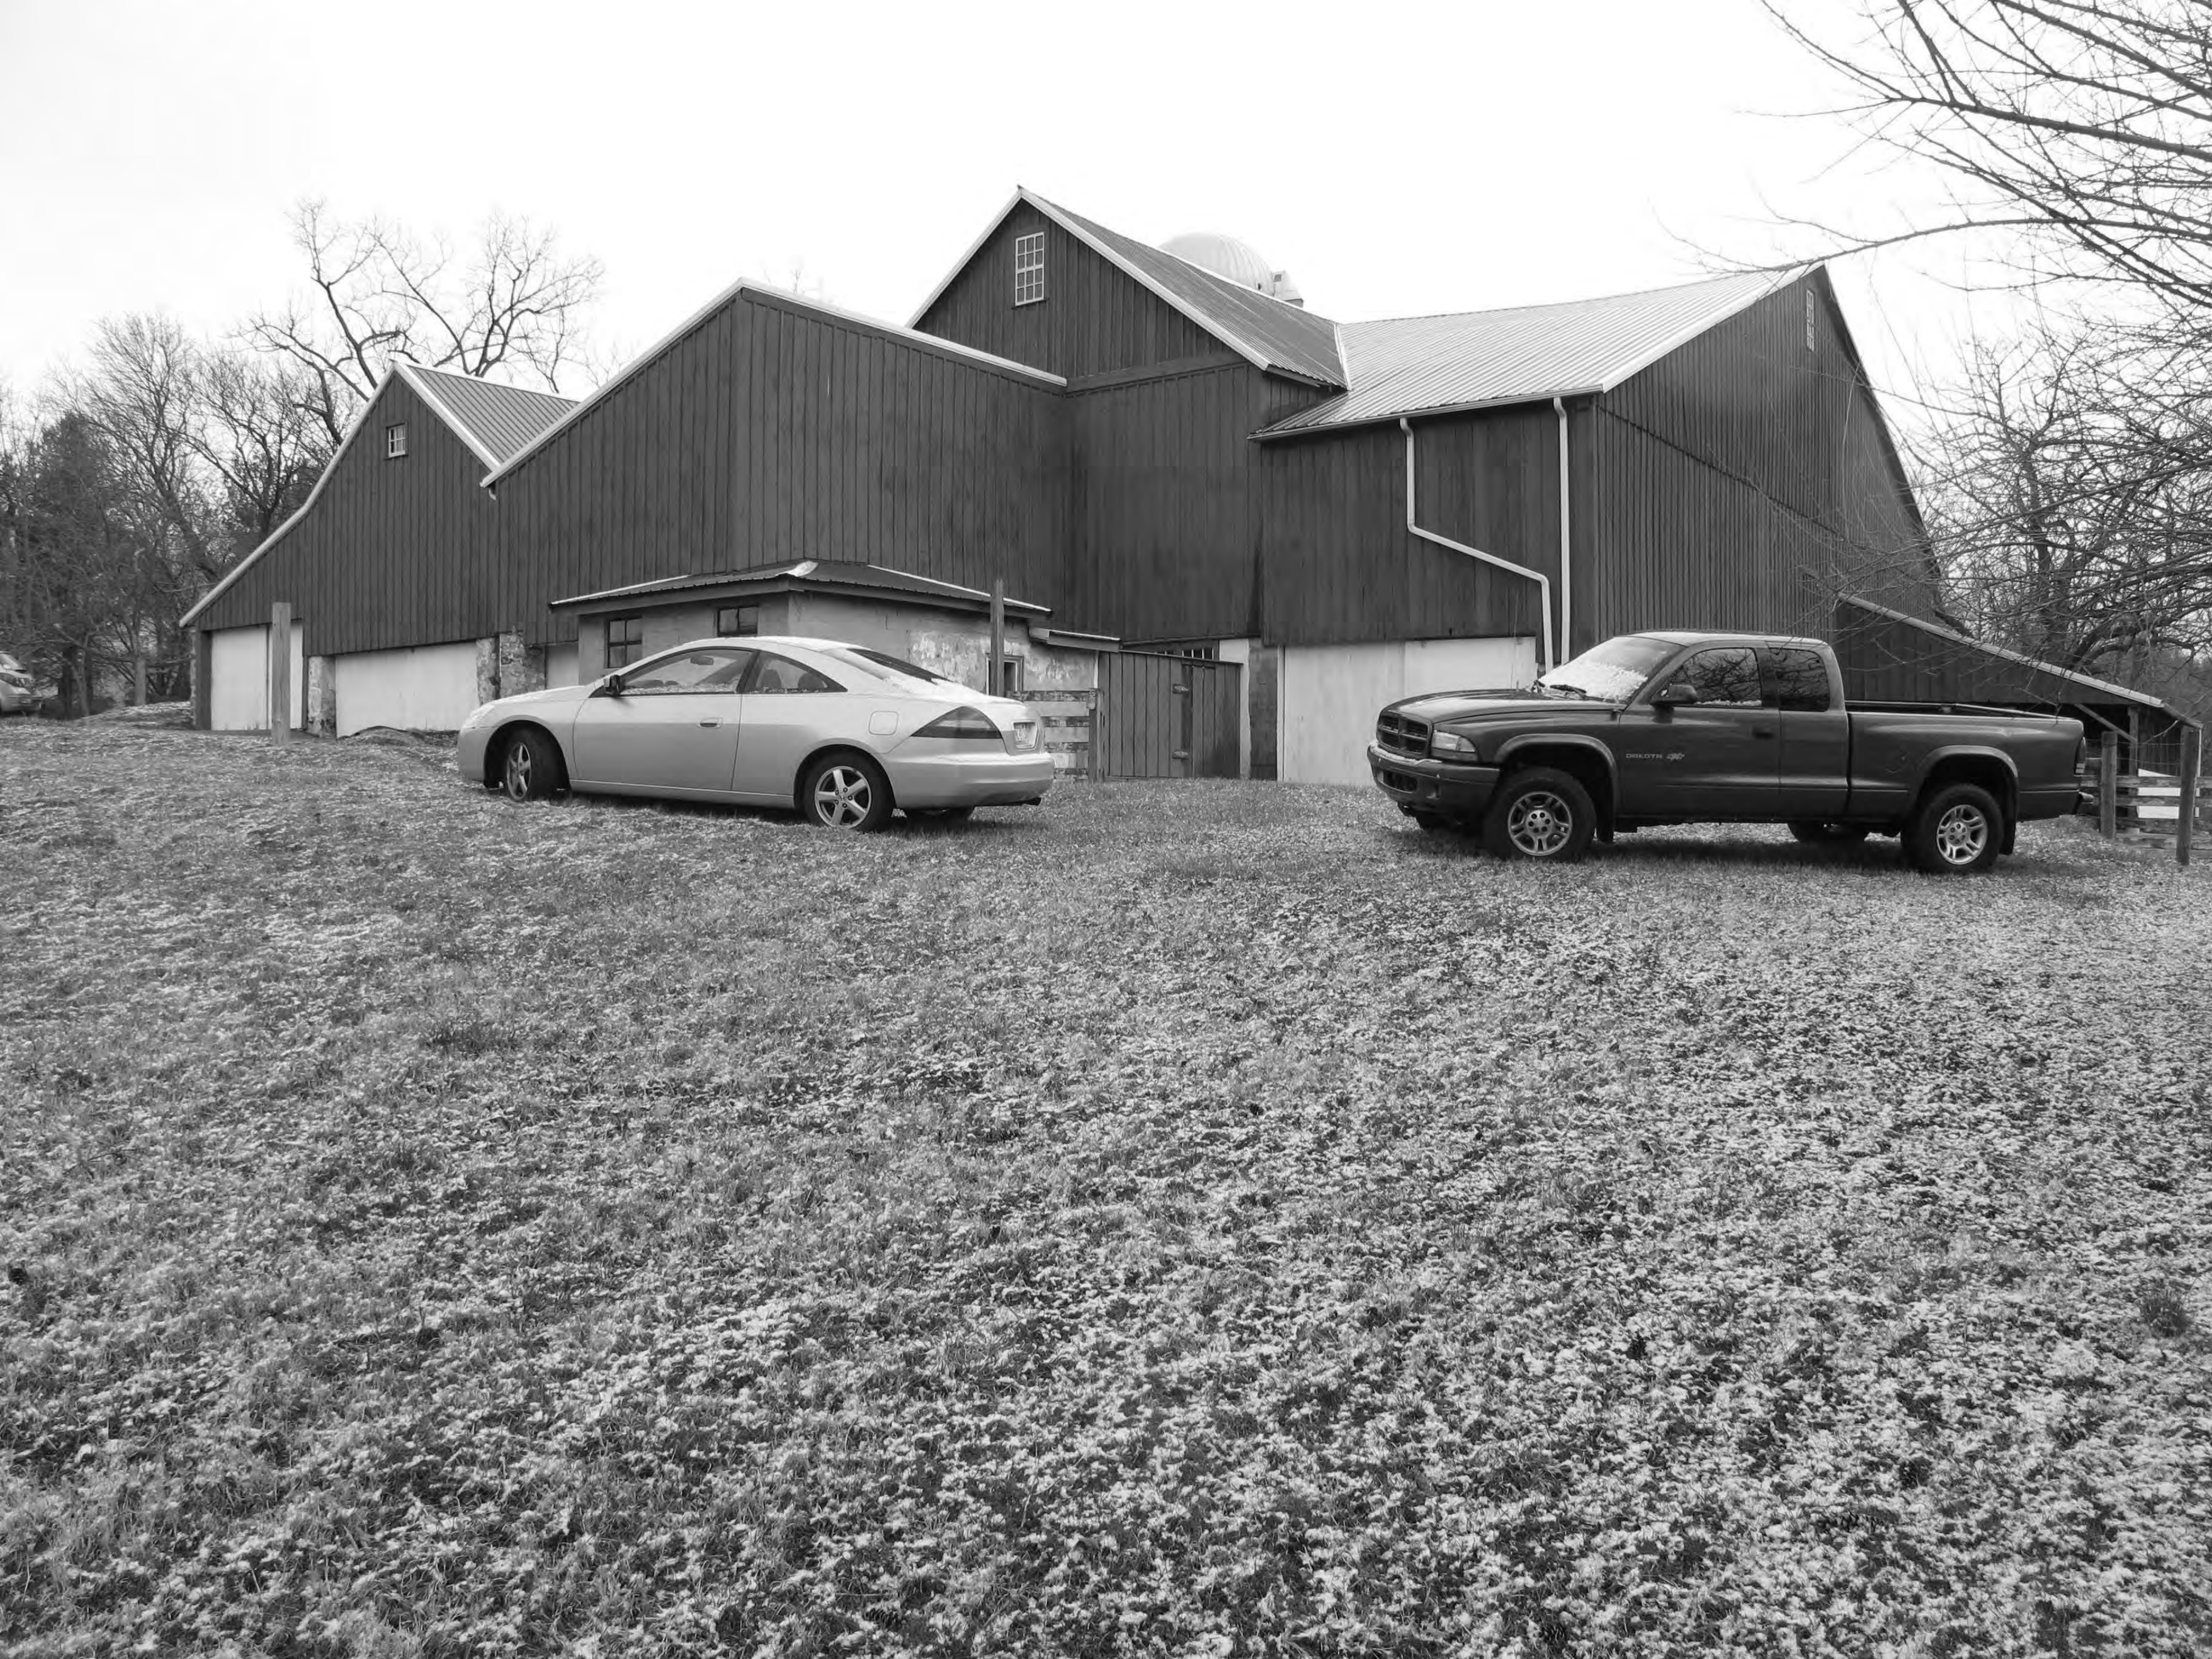
Cox-Phillips-Mitchell Agricultural Complex\_New Castle County\_DE  
Perspective view of dairy barn and stable looking north

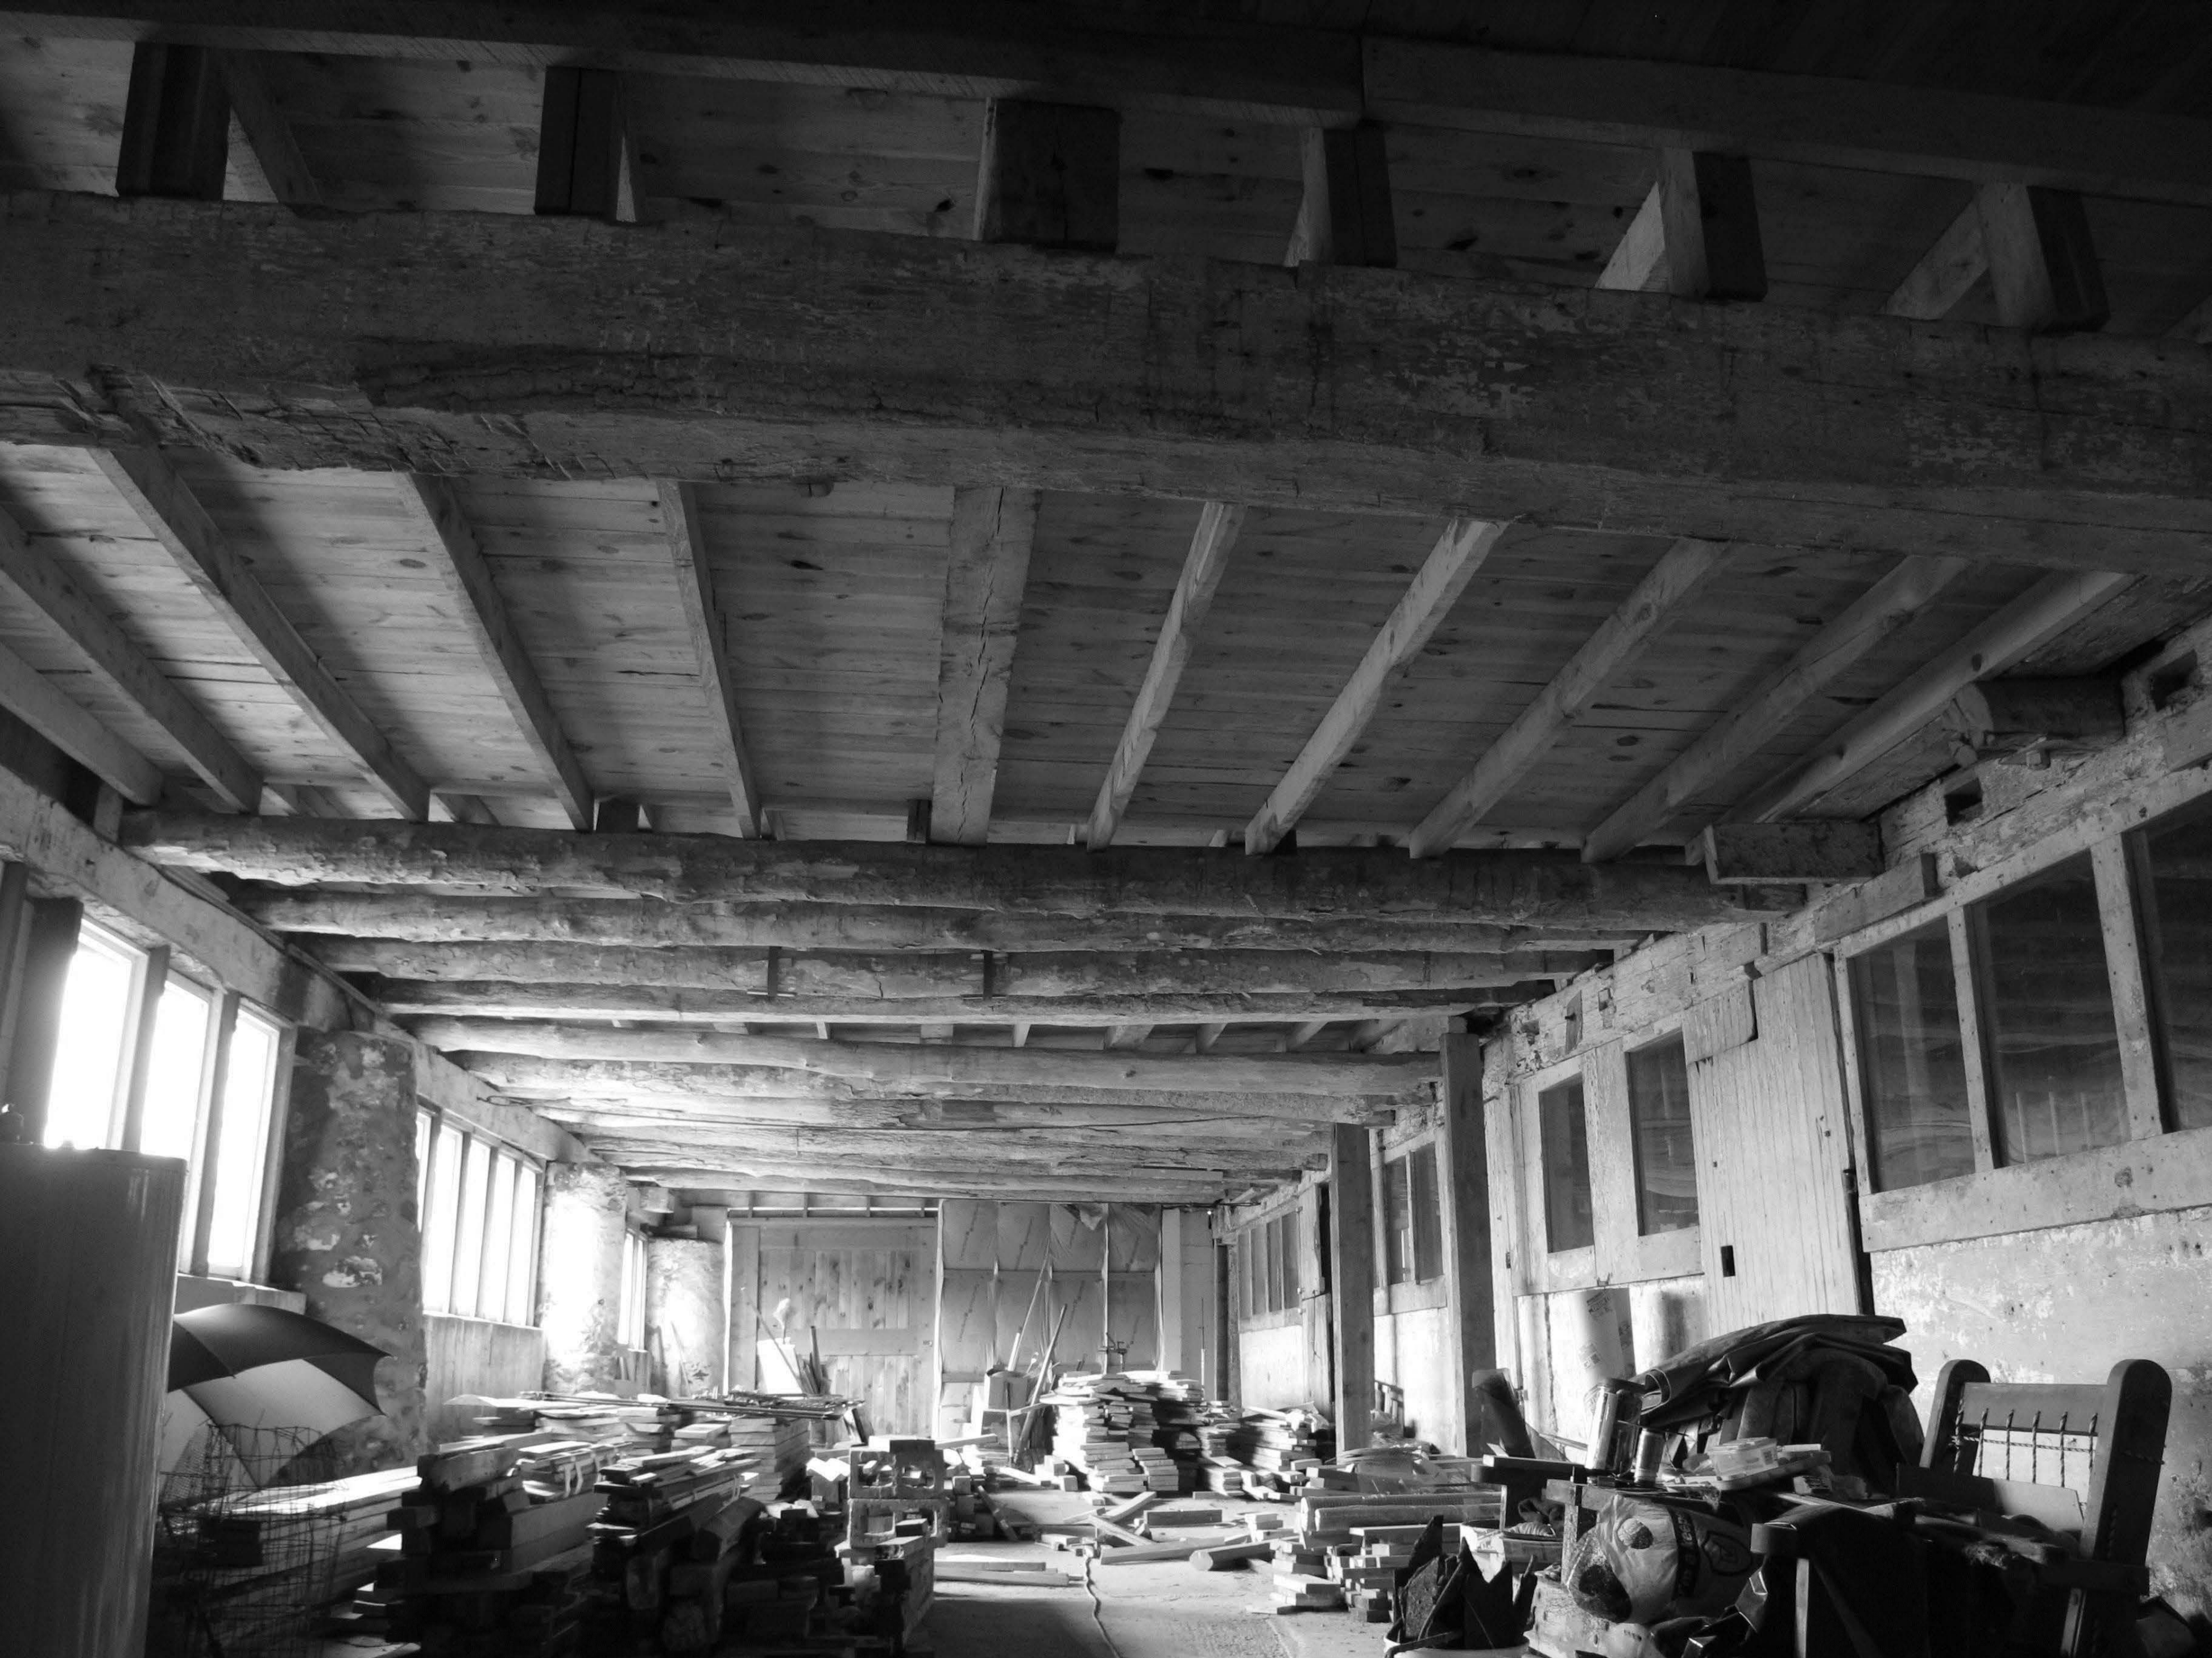
Cox-Phillips-Mitchell Agricultural Complex\_New Castle County\_DE  
Dairy barn interior, lower level, southeast room showing log joists looking southwest

The first floor of the dairy barn has one expansive central milking room with fieldstone walls, and large fieldstone columns, and is divided by half-height concrete partition walls. The northwestern room is subdivided by wooden and metal stanchions for milking, while the southeastern room is a large open utilitarian space. A massive summer beam spans the northeast-southwest length of the northwestern room, and joists, are either rough-hewn or logs-in-the-round. The southwestern shed addition contains closet space on the east wall, and a doorway that leads into the milk house on the southwestern. Along the northwestern wall of the historic core, a doorway to a stair provides access to the second floor. The second floor of the dairy barn is a large lofted space with a mixture of exposed structural framing bents and wooden partition walls. The framing combines collared principal rafters, clasped purlins, all supported with angling struts. In the historic core of the barn, some untreated riven clapboards are still

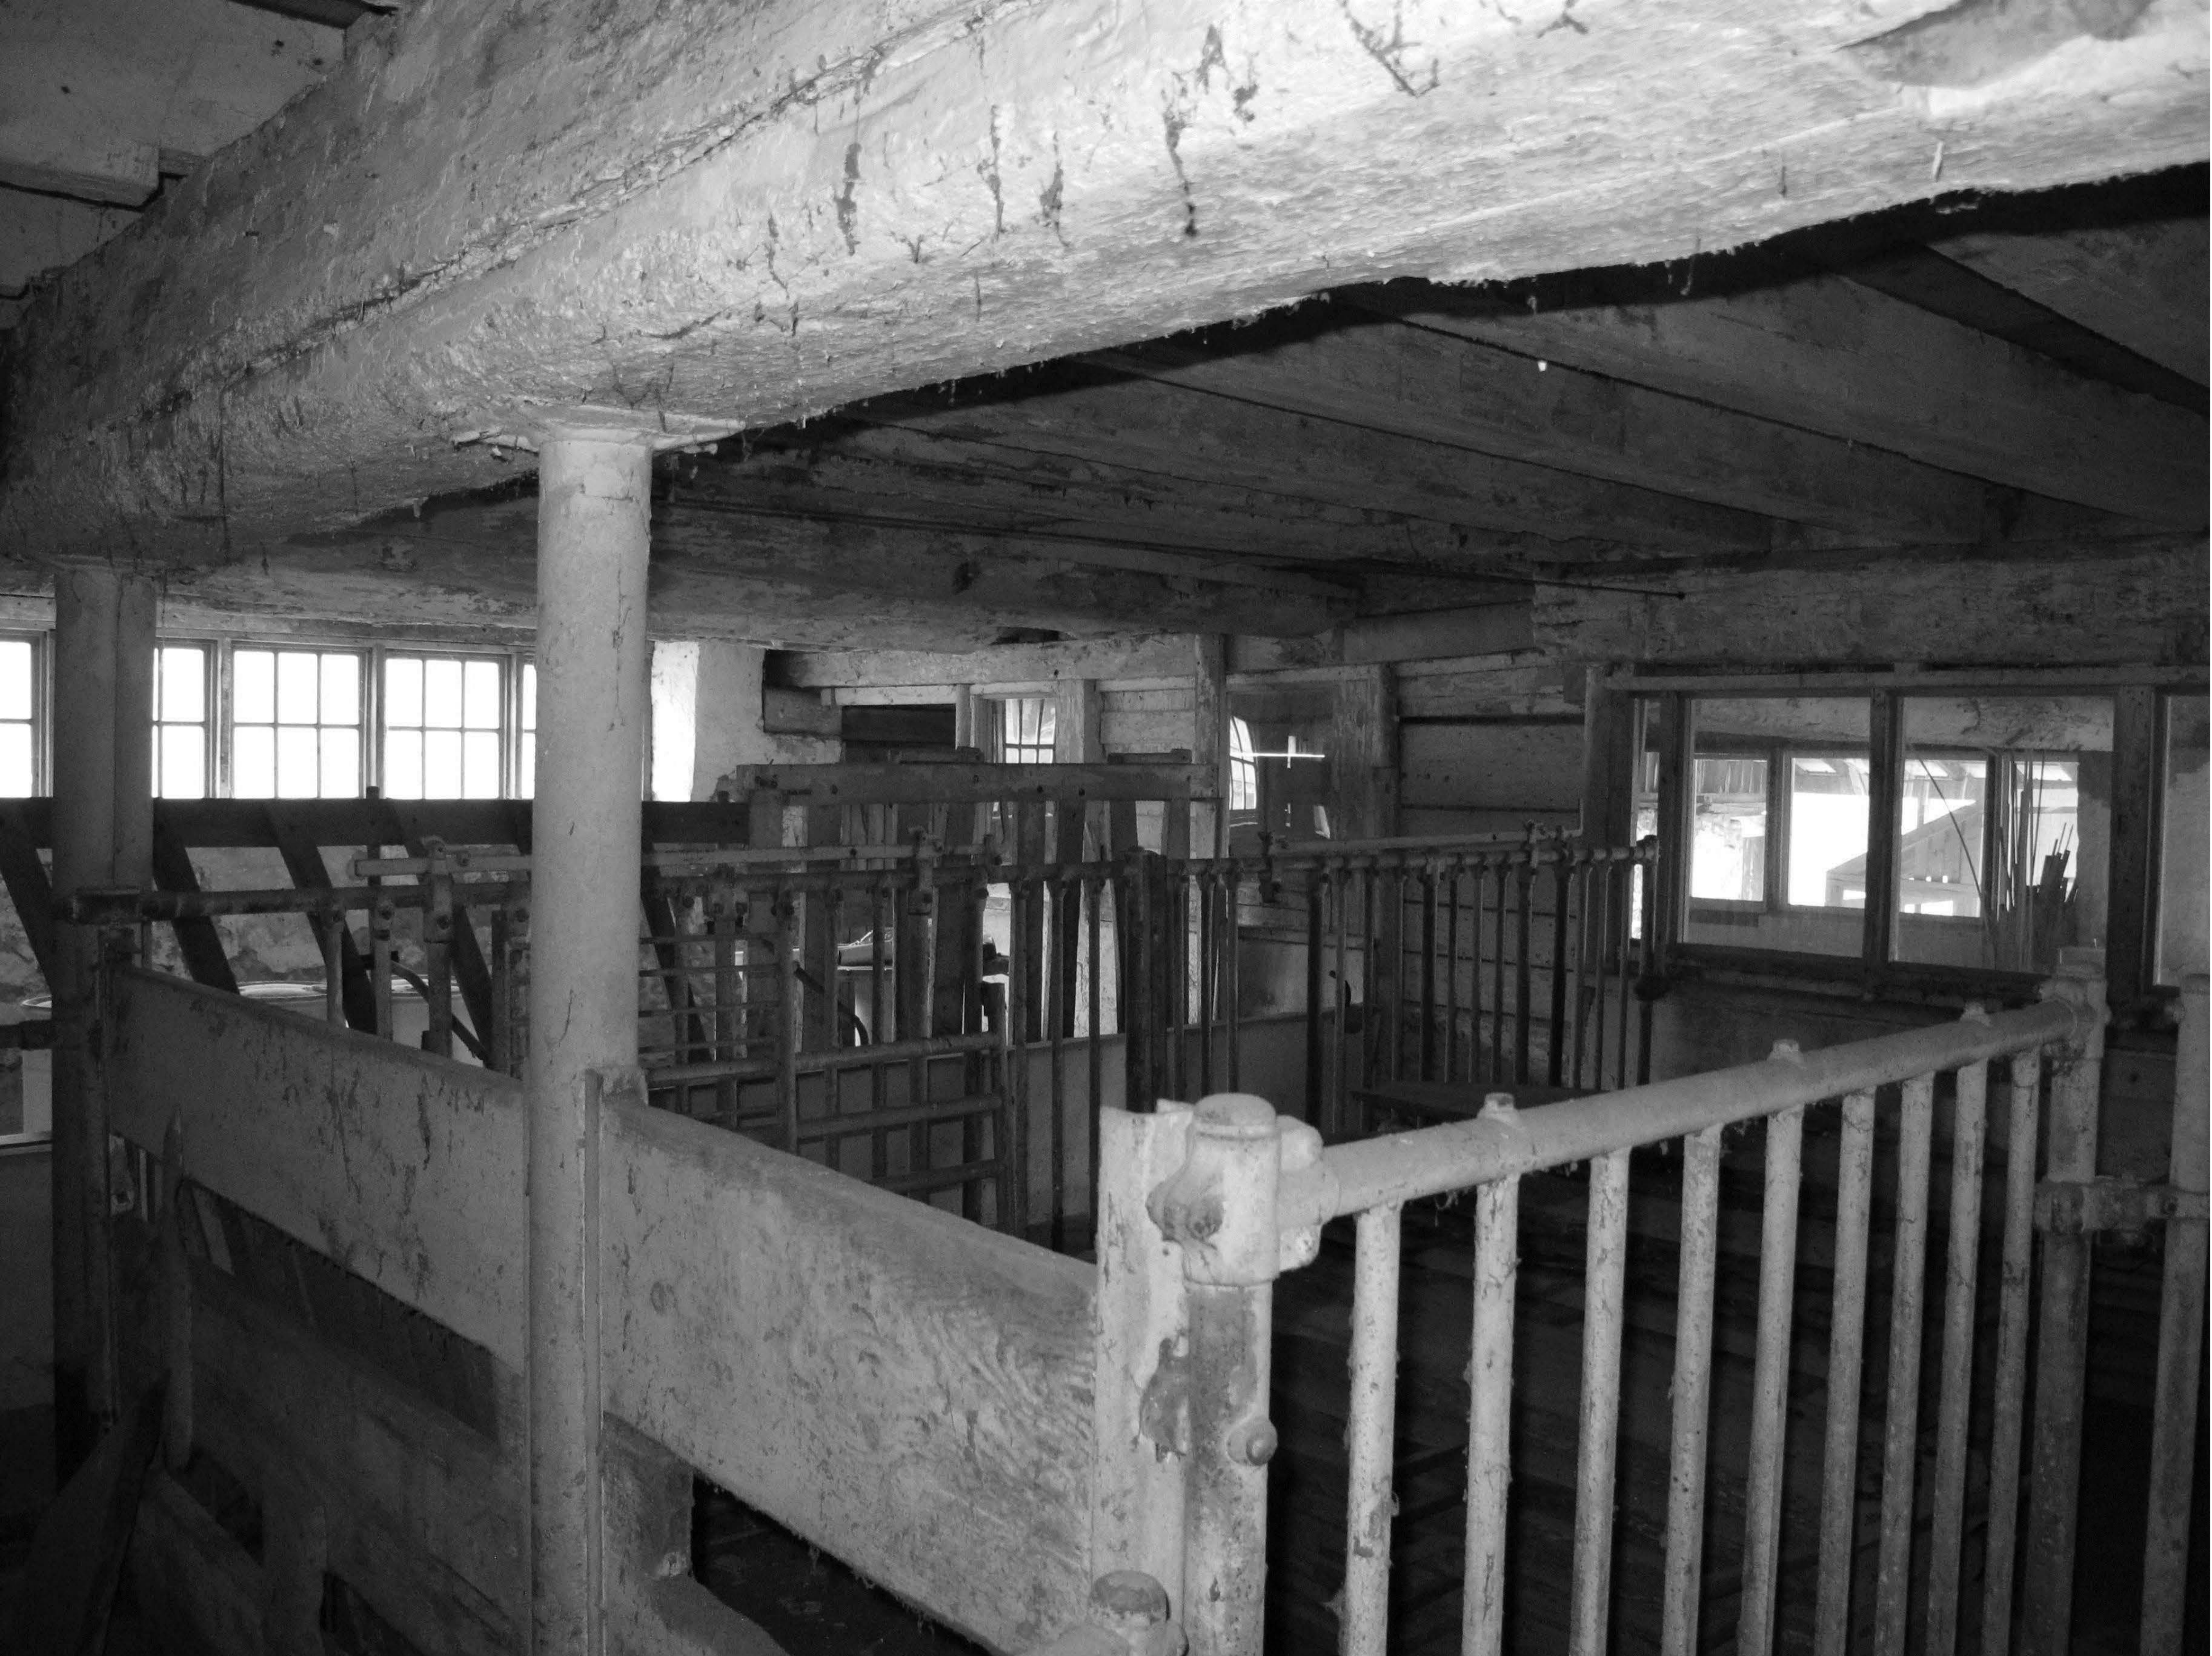
Cox-Phillips-Mitchell Agricultural Complex\_New Castle County\_DE  
Dairy barn interior lower level looking east

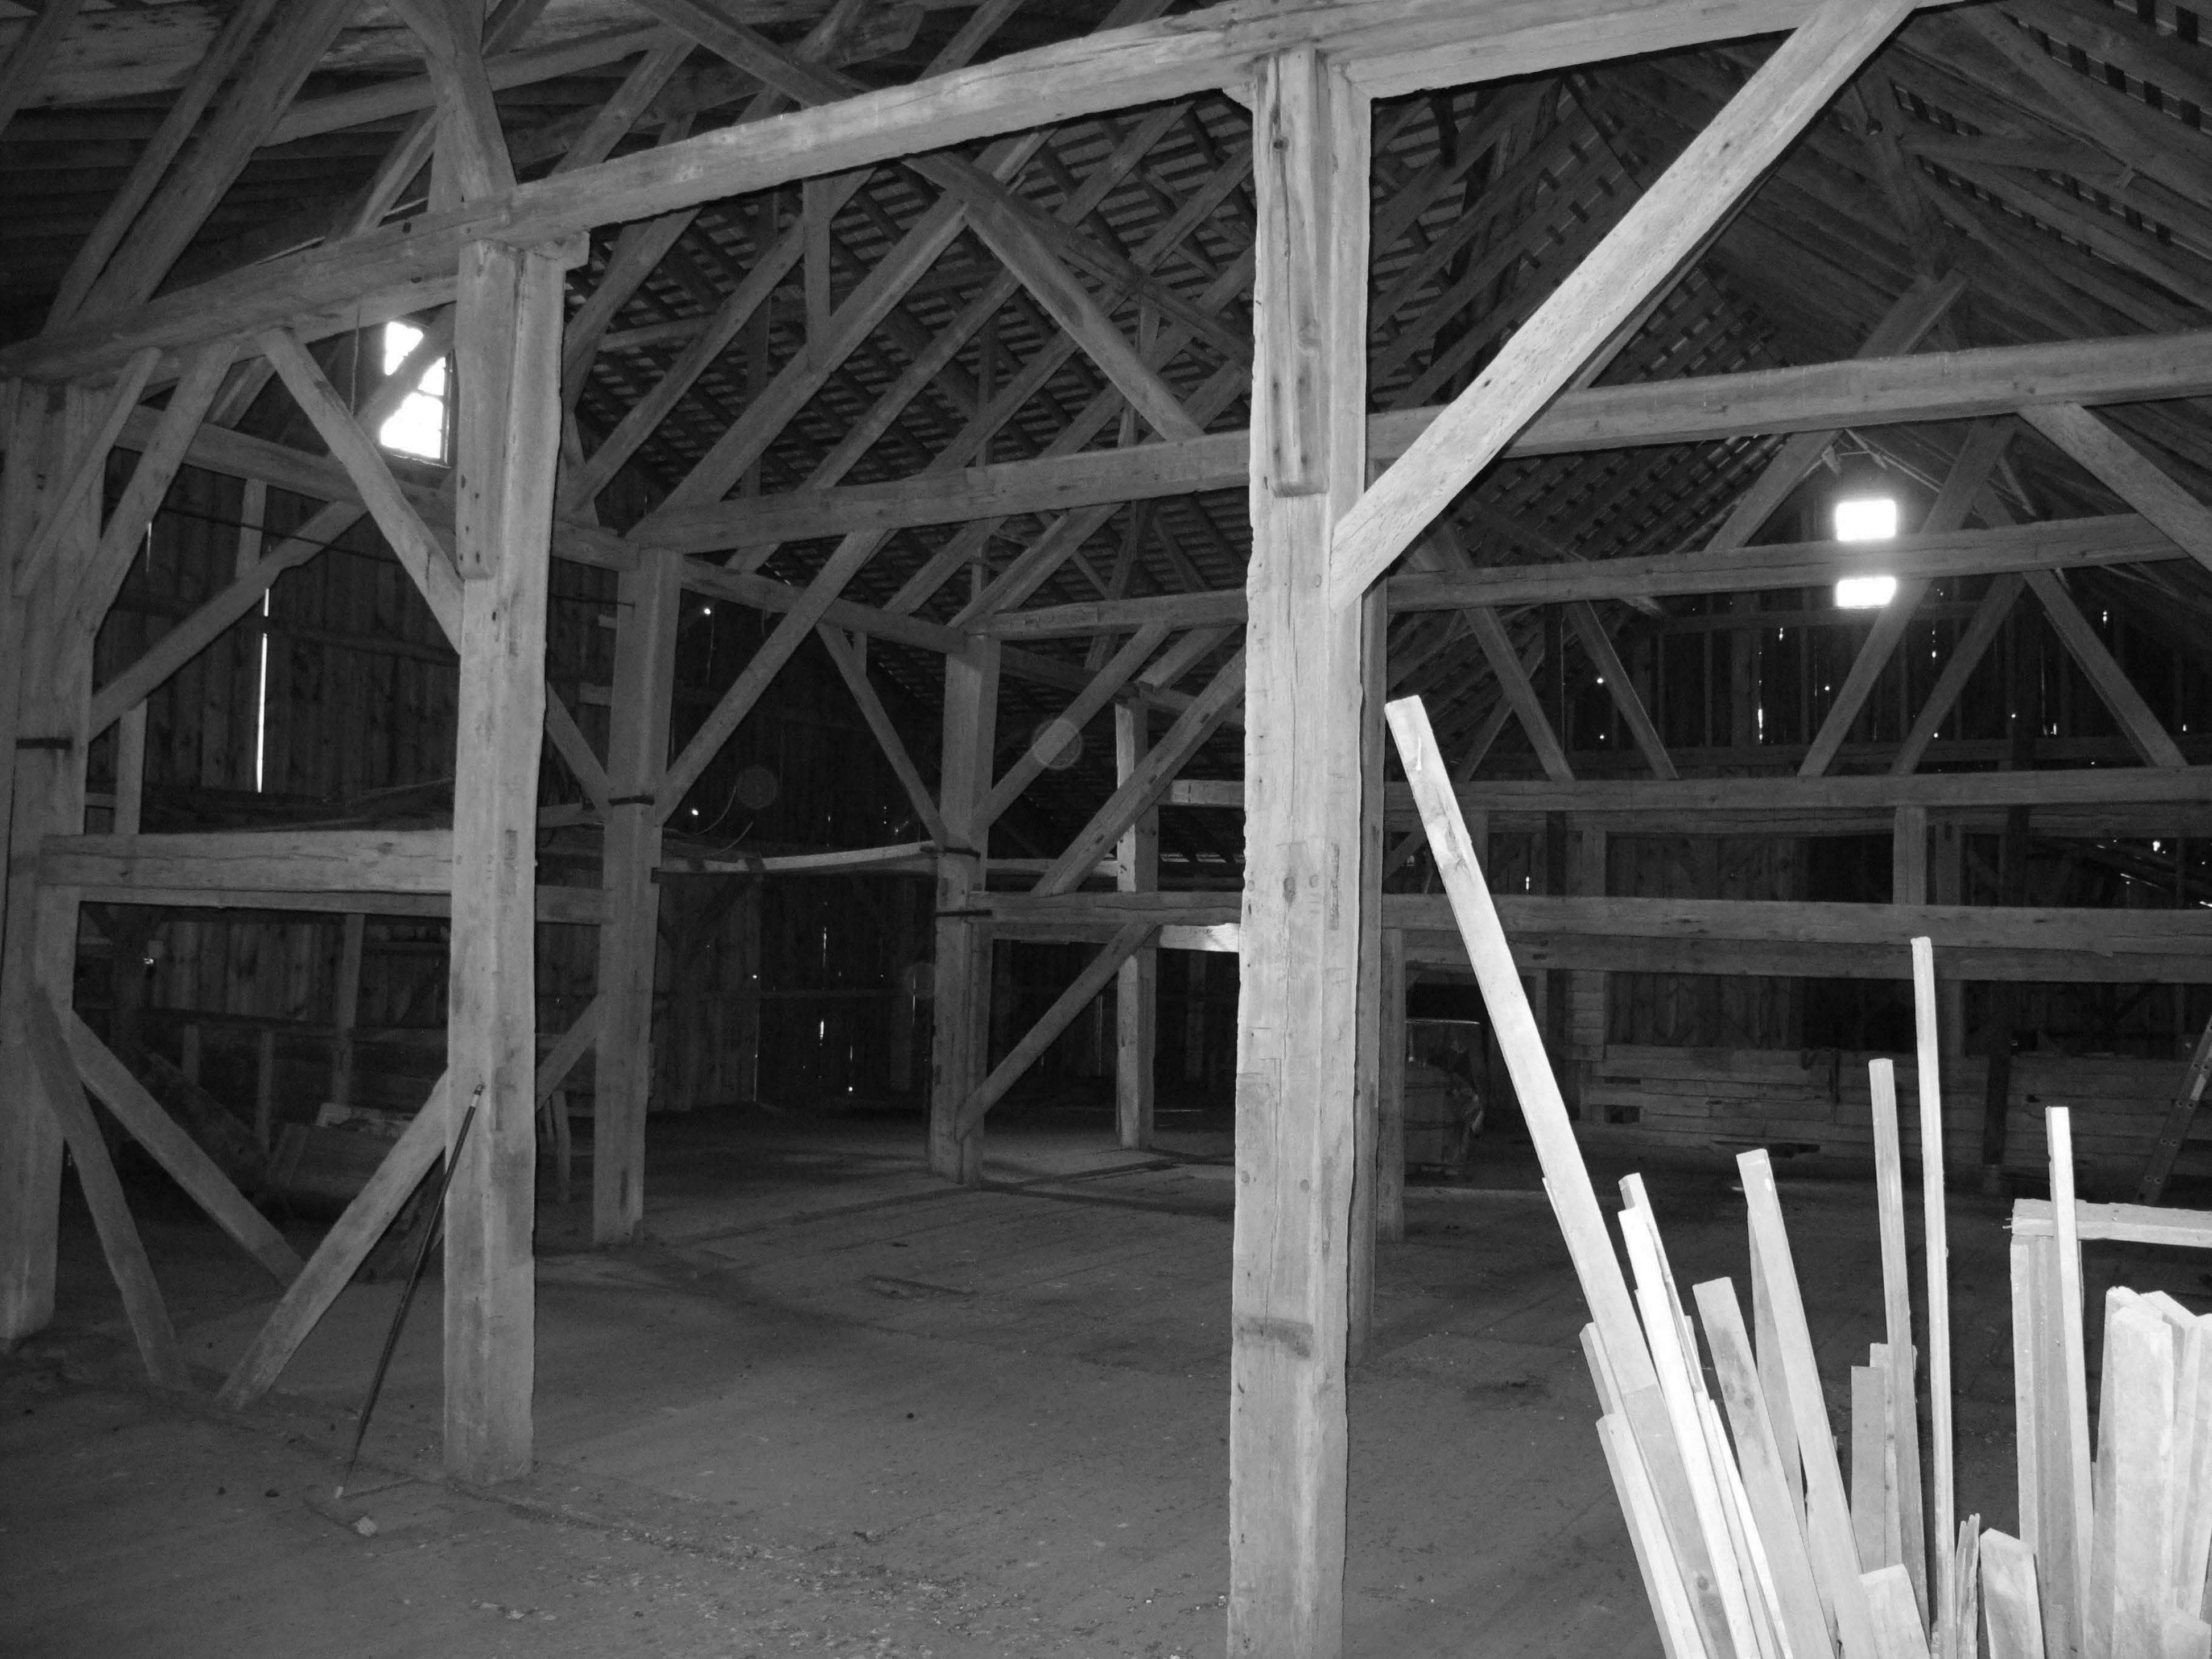
Cox-Phillips-Mitchell Agricultural Complex\_New Castle County\_DE  
Dairy barn interior upper level - threshing floor looking northeast
