# National Register of Historic Places Registration Form

Historic name: Cox-Phillips-Mitchell Agricultural Complex

Other names/site number: Delaware CRS # N04085

Street & number: 1651 and 1655 Old Wilmington Rd

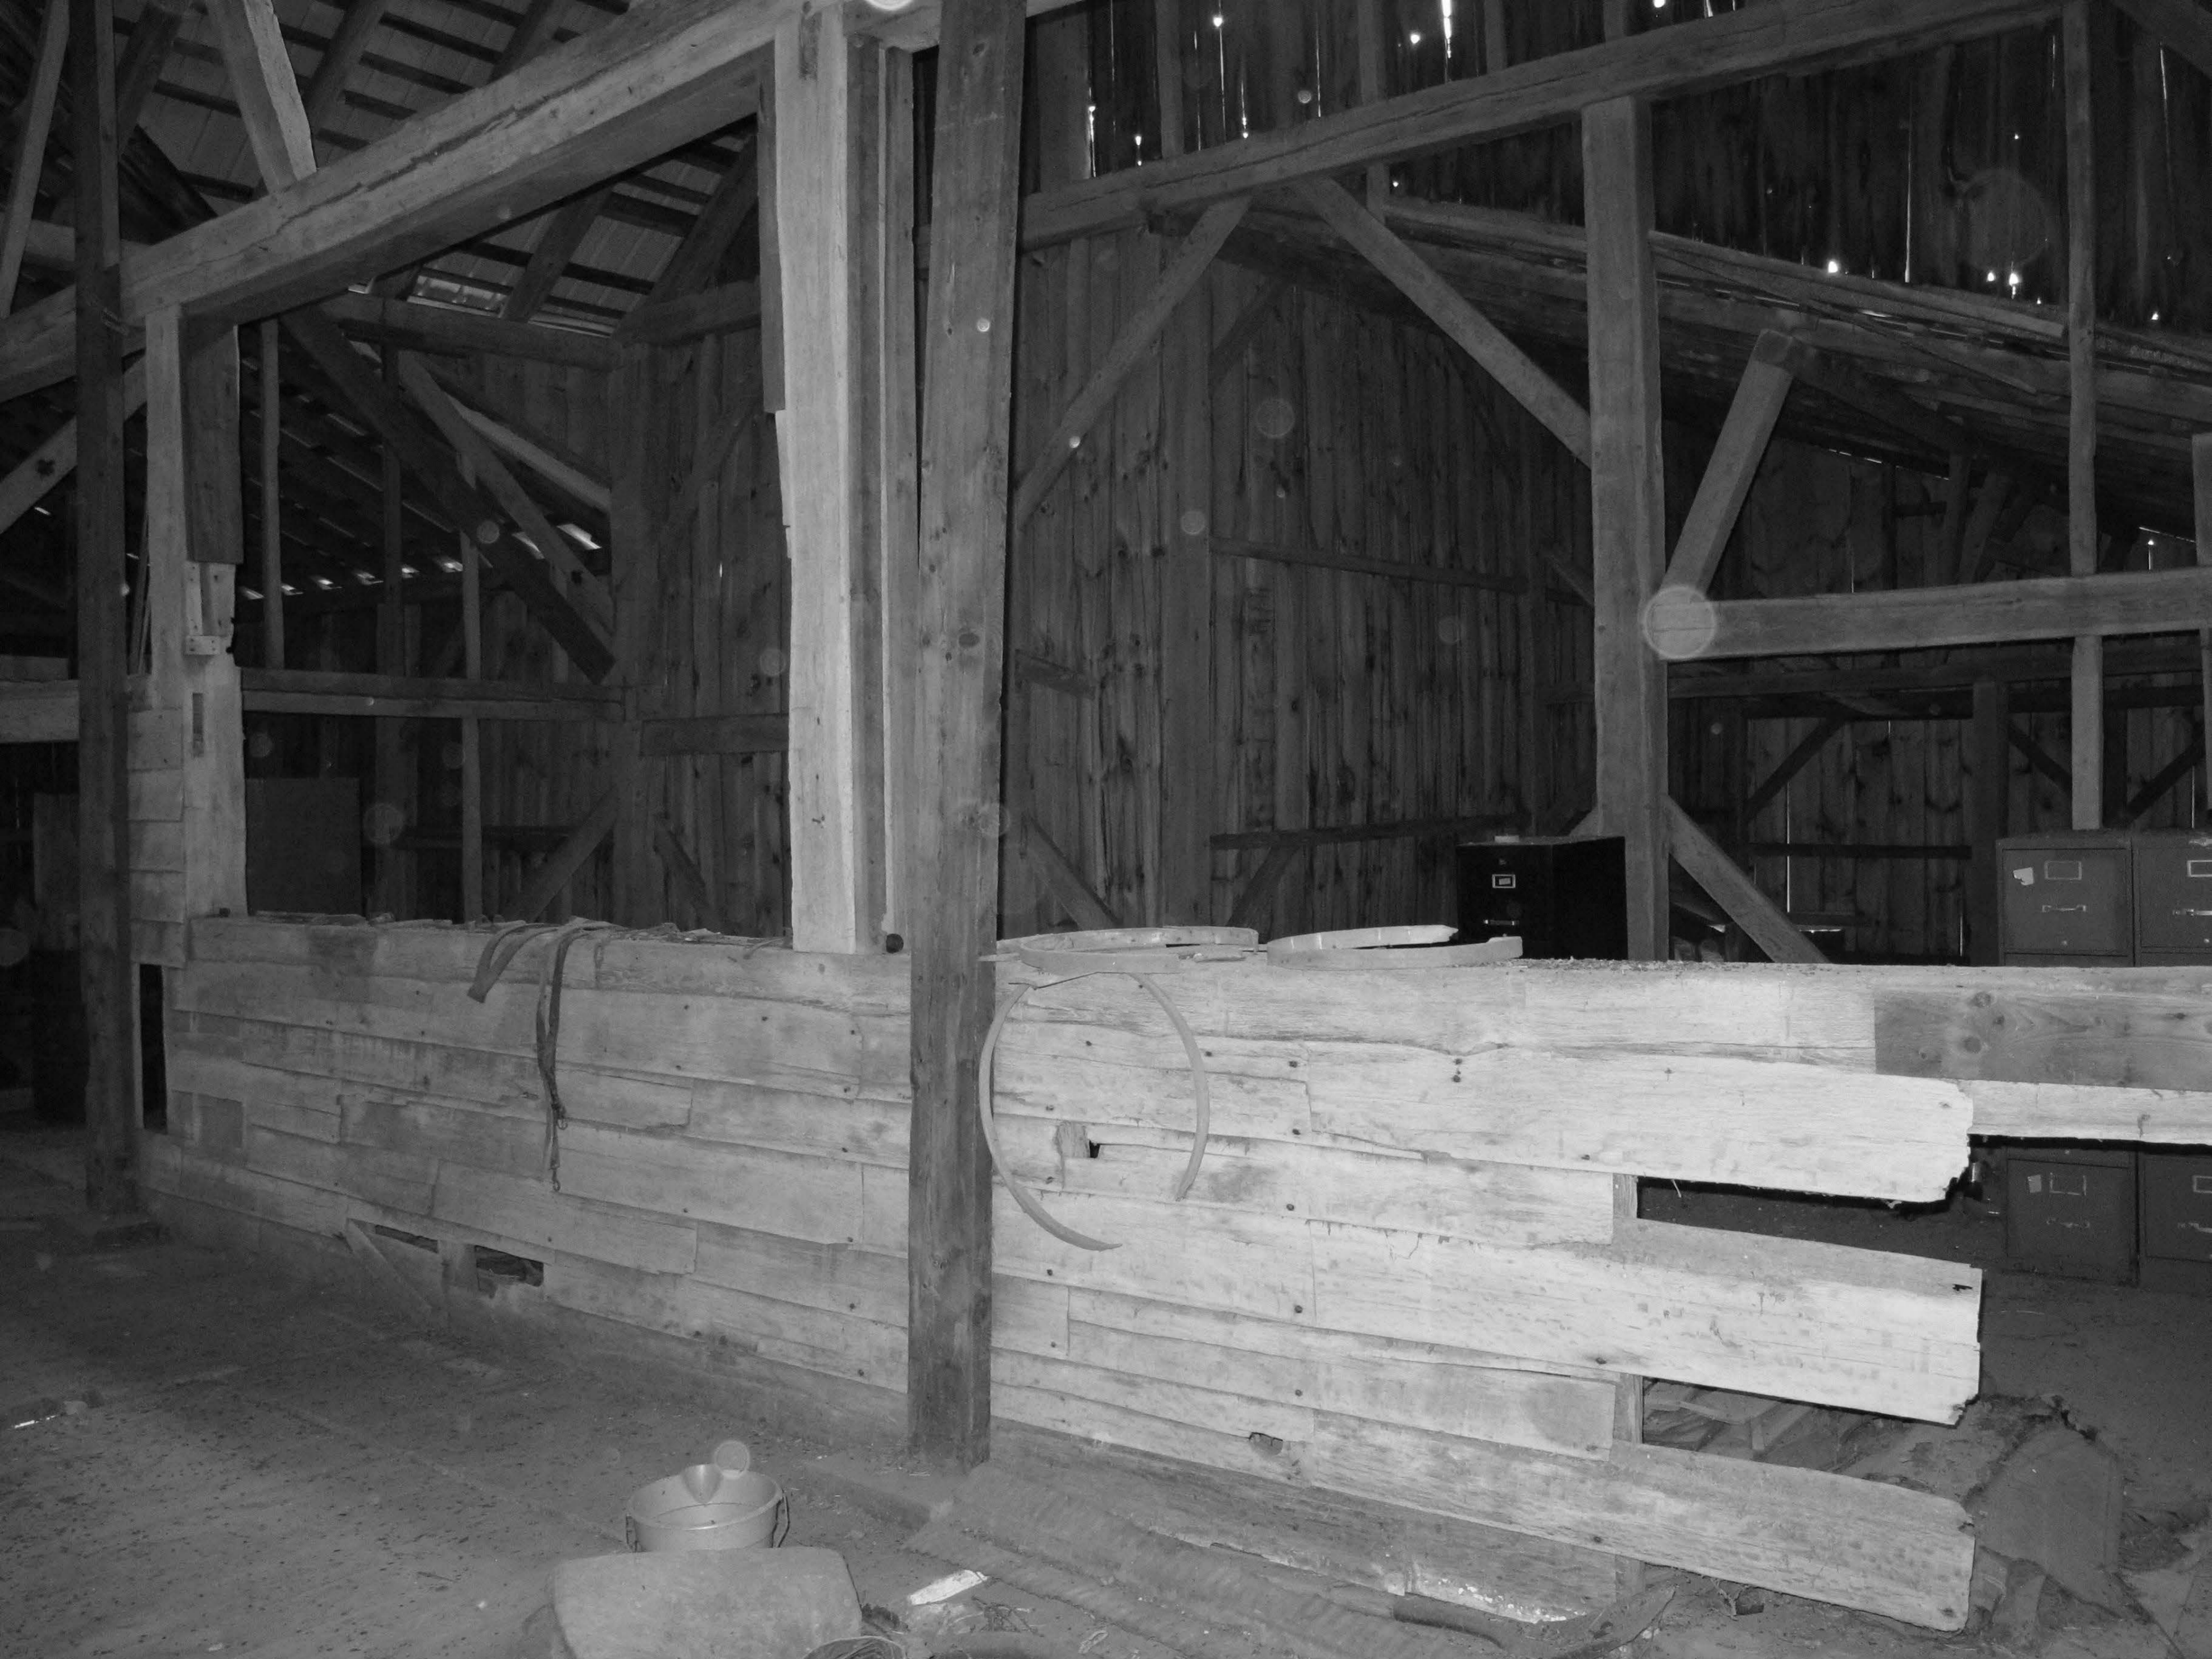
Cox-Phillips-Mitchell Agricultural Complex\_New Castle County\_DE  
Dairy barn interior upper level-threshing floor, riven clapboards looking south

visible. A variety of framing members on this level show numbered carpenter marks at their joints. A centered door on the upper level on the southeastern wall overlooks the side yard next to the barn, and there is one trap door in the floor at this end of the space.

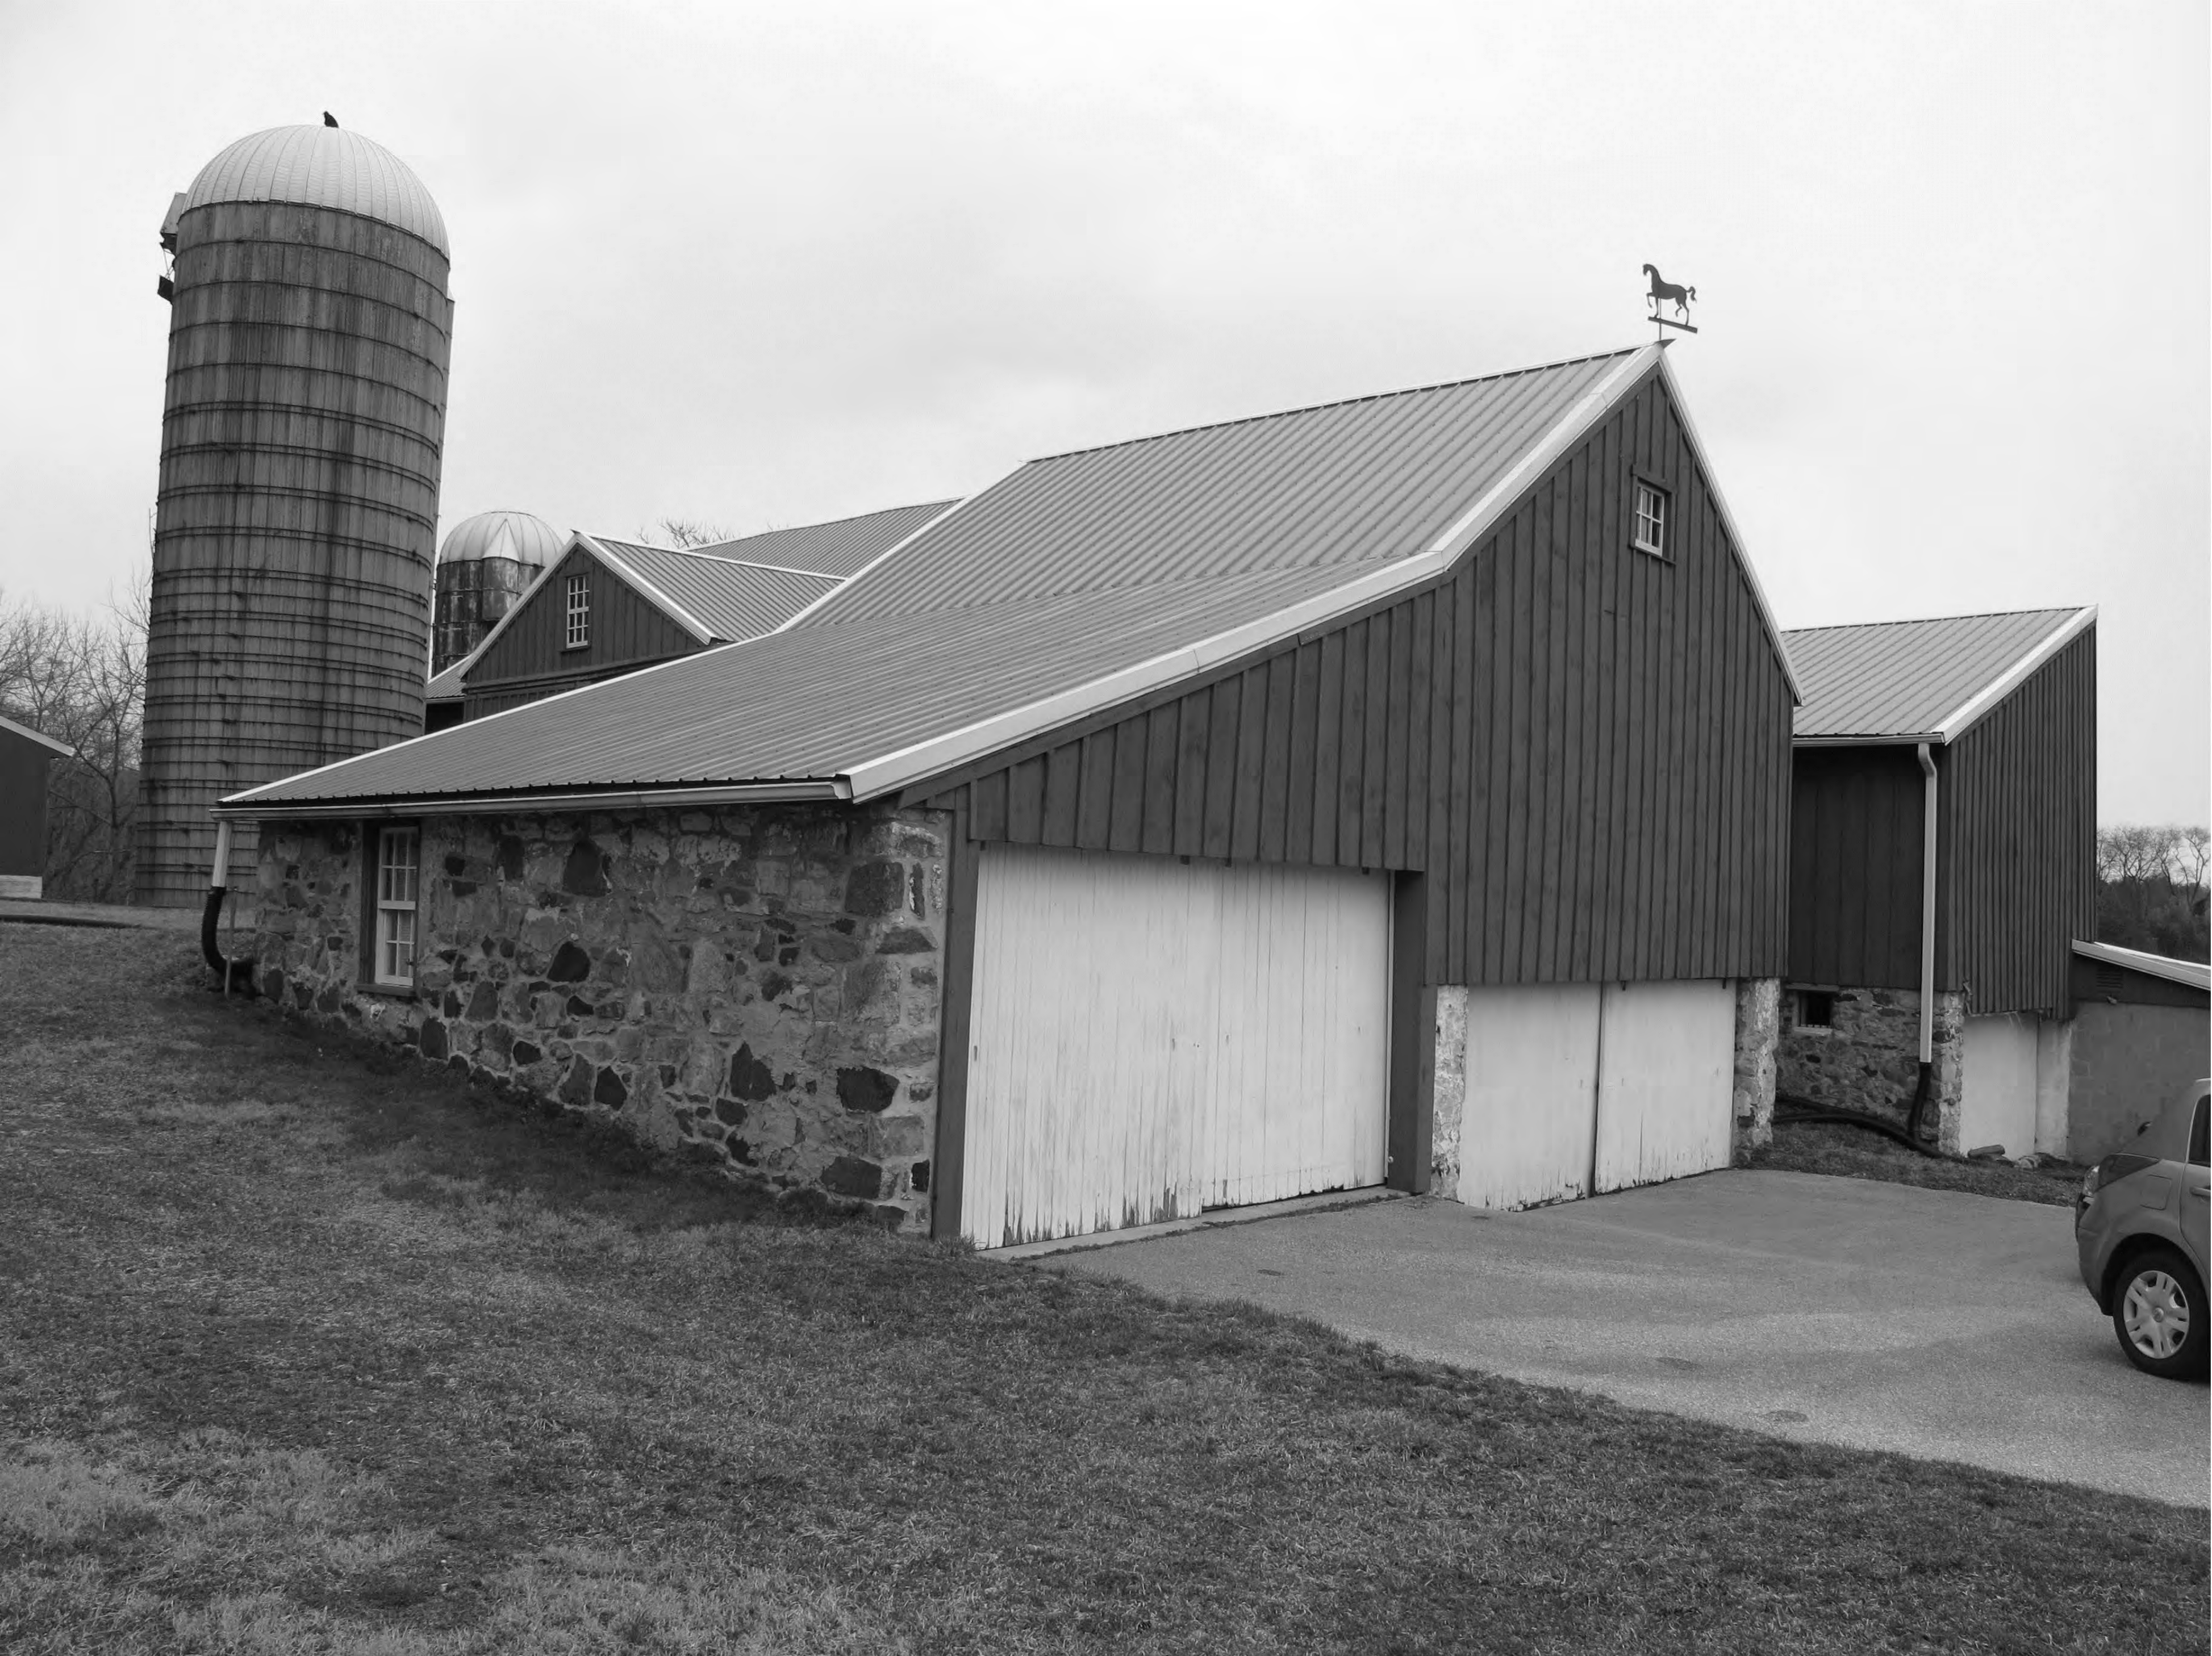
Cox-Phillips-Mitchell Agricultural Complex\_New Castle County\_DE  
Perspective view of stable showing northwest and southwest elevations looking east  
29 of 34

The combination granary and stable is a two-story, frame building, with a one-and-a-half story frame shed roof addition to the northwest. The entire structure sits on a stone foundation. The southwestern elevation has two doors on the lower level, each opening into a separate room, and has a fixed six-light window on the upper floor. On the southeastern elevation there are two window openings on the second story, these windows are fixed six-light windows. The

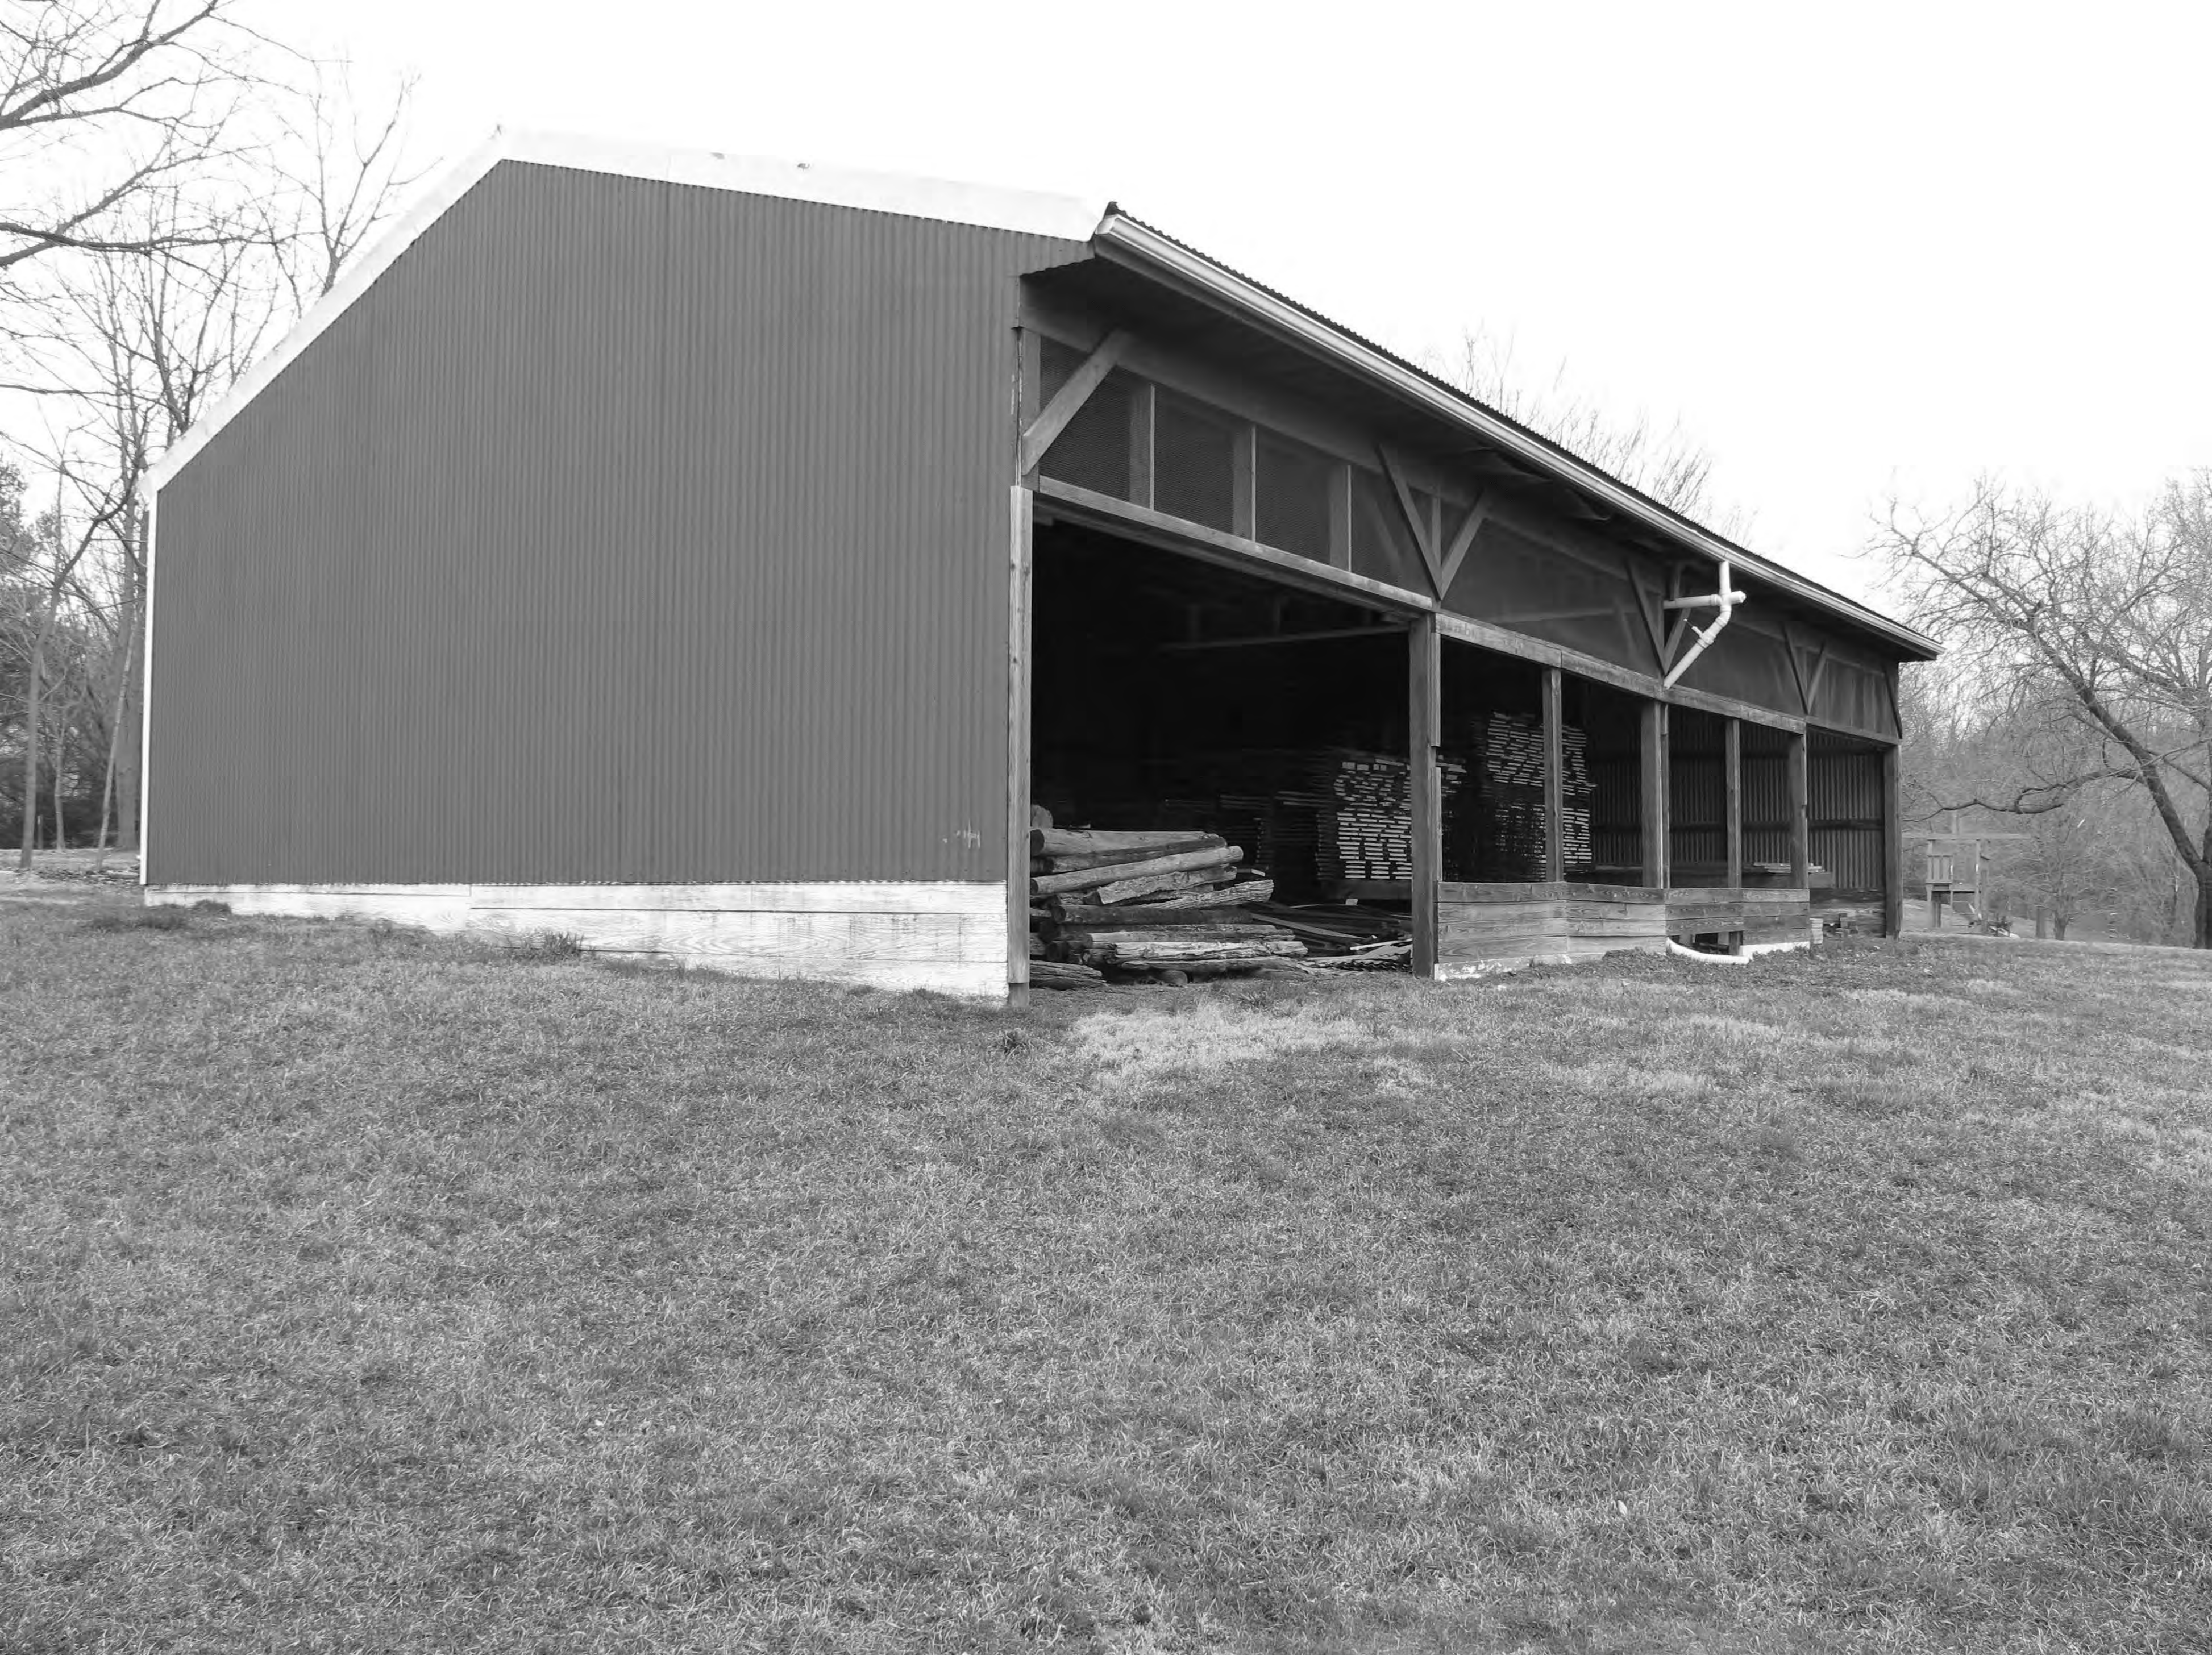
Cox-Phillips-Mitchell Agricultural Complex\_New Castle County\_DE  
Perspective view of machine shed showing southwest and southeast elevations looking  
northeast

The equipment shed is a mid-to-late 20<sup>th</sup> century addition to the complex, and is the only non-contributing structure on the property. The post-in-ground frame-structure is covered in corrugated metal on the roof and three sides, with the fourth being left open. The structure is

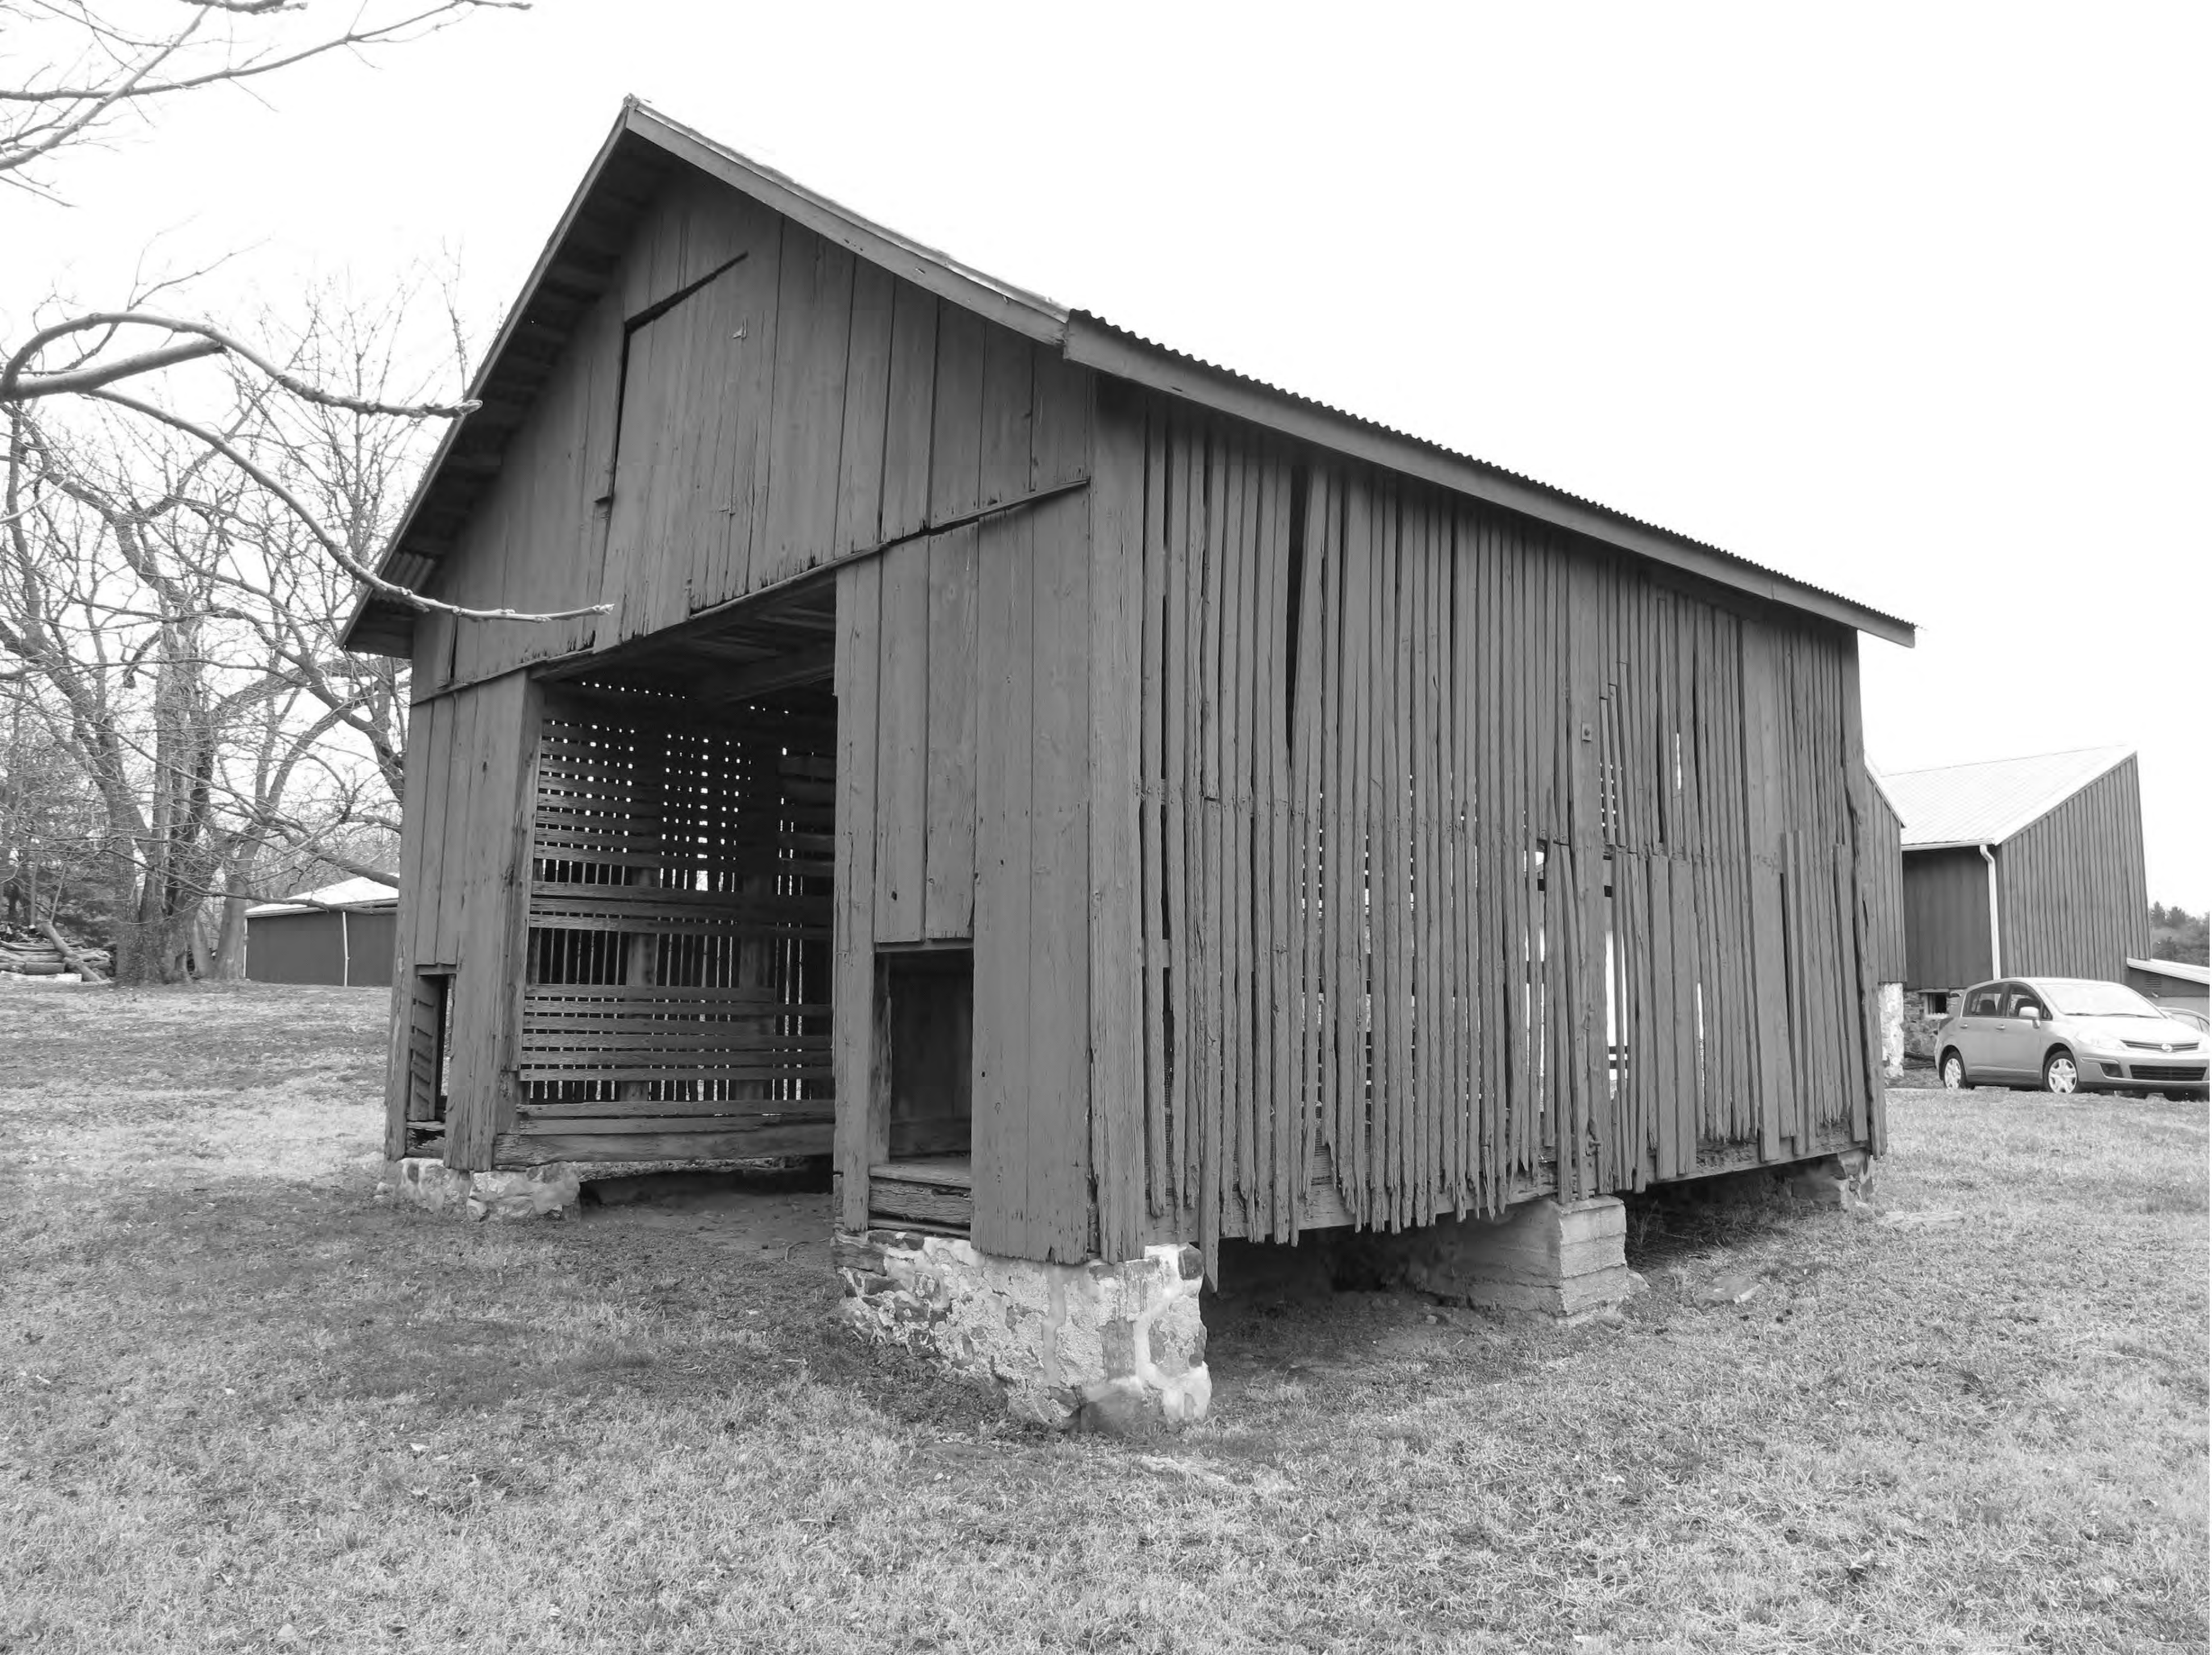
Cox-Phillips-Mitchell Agricultural Complex\_New Castle County\_DE  
Perspective view of corncrib and granary showing northwest and southwest elevations

The combination corncrib granary is a one-and-a-half story, red-painted frame structure, which rests on large wooden sills, on stone piers. The two gable-ends and two elevation ends are almost identical to one another. The gable ends feature two entries into the corncribs, with a center pass-through large enough to accommodate a wagon or truck. On the half story, a door centered under the gable provides access to the loft space above. Along the elevation sides, wooden slats run mostly uninterrupted from sill to eave. Neither longitudinal elevation has doors to the crib or loft spaces.

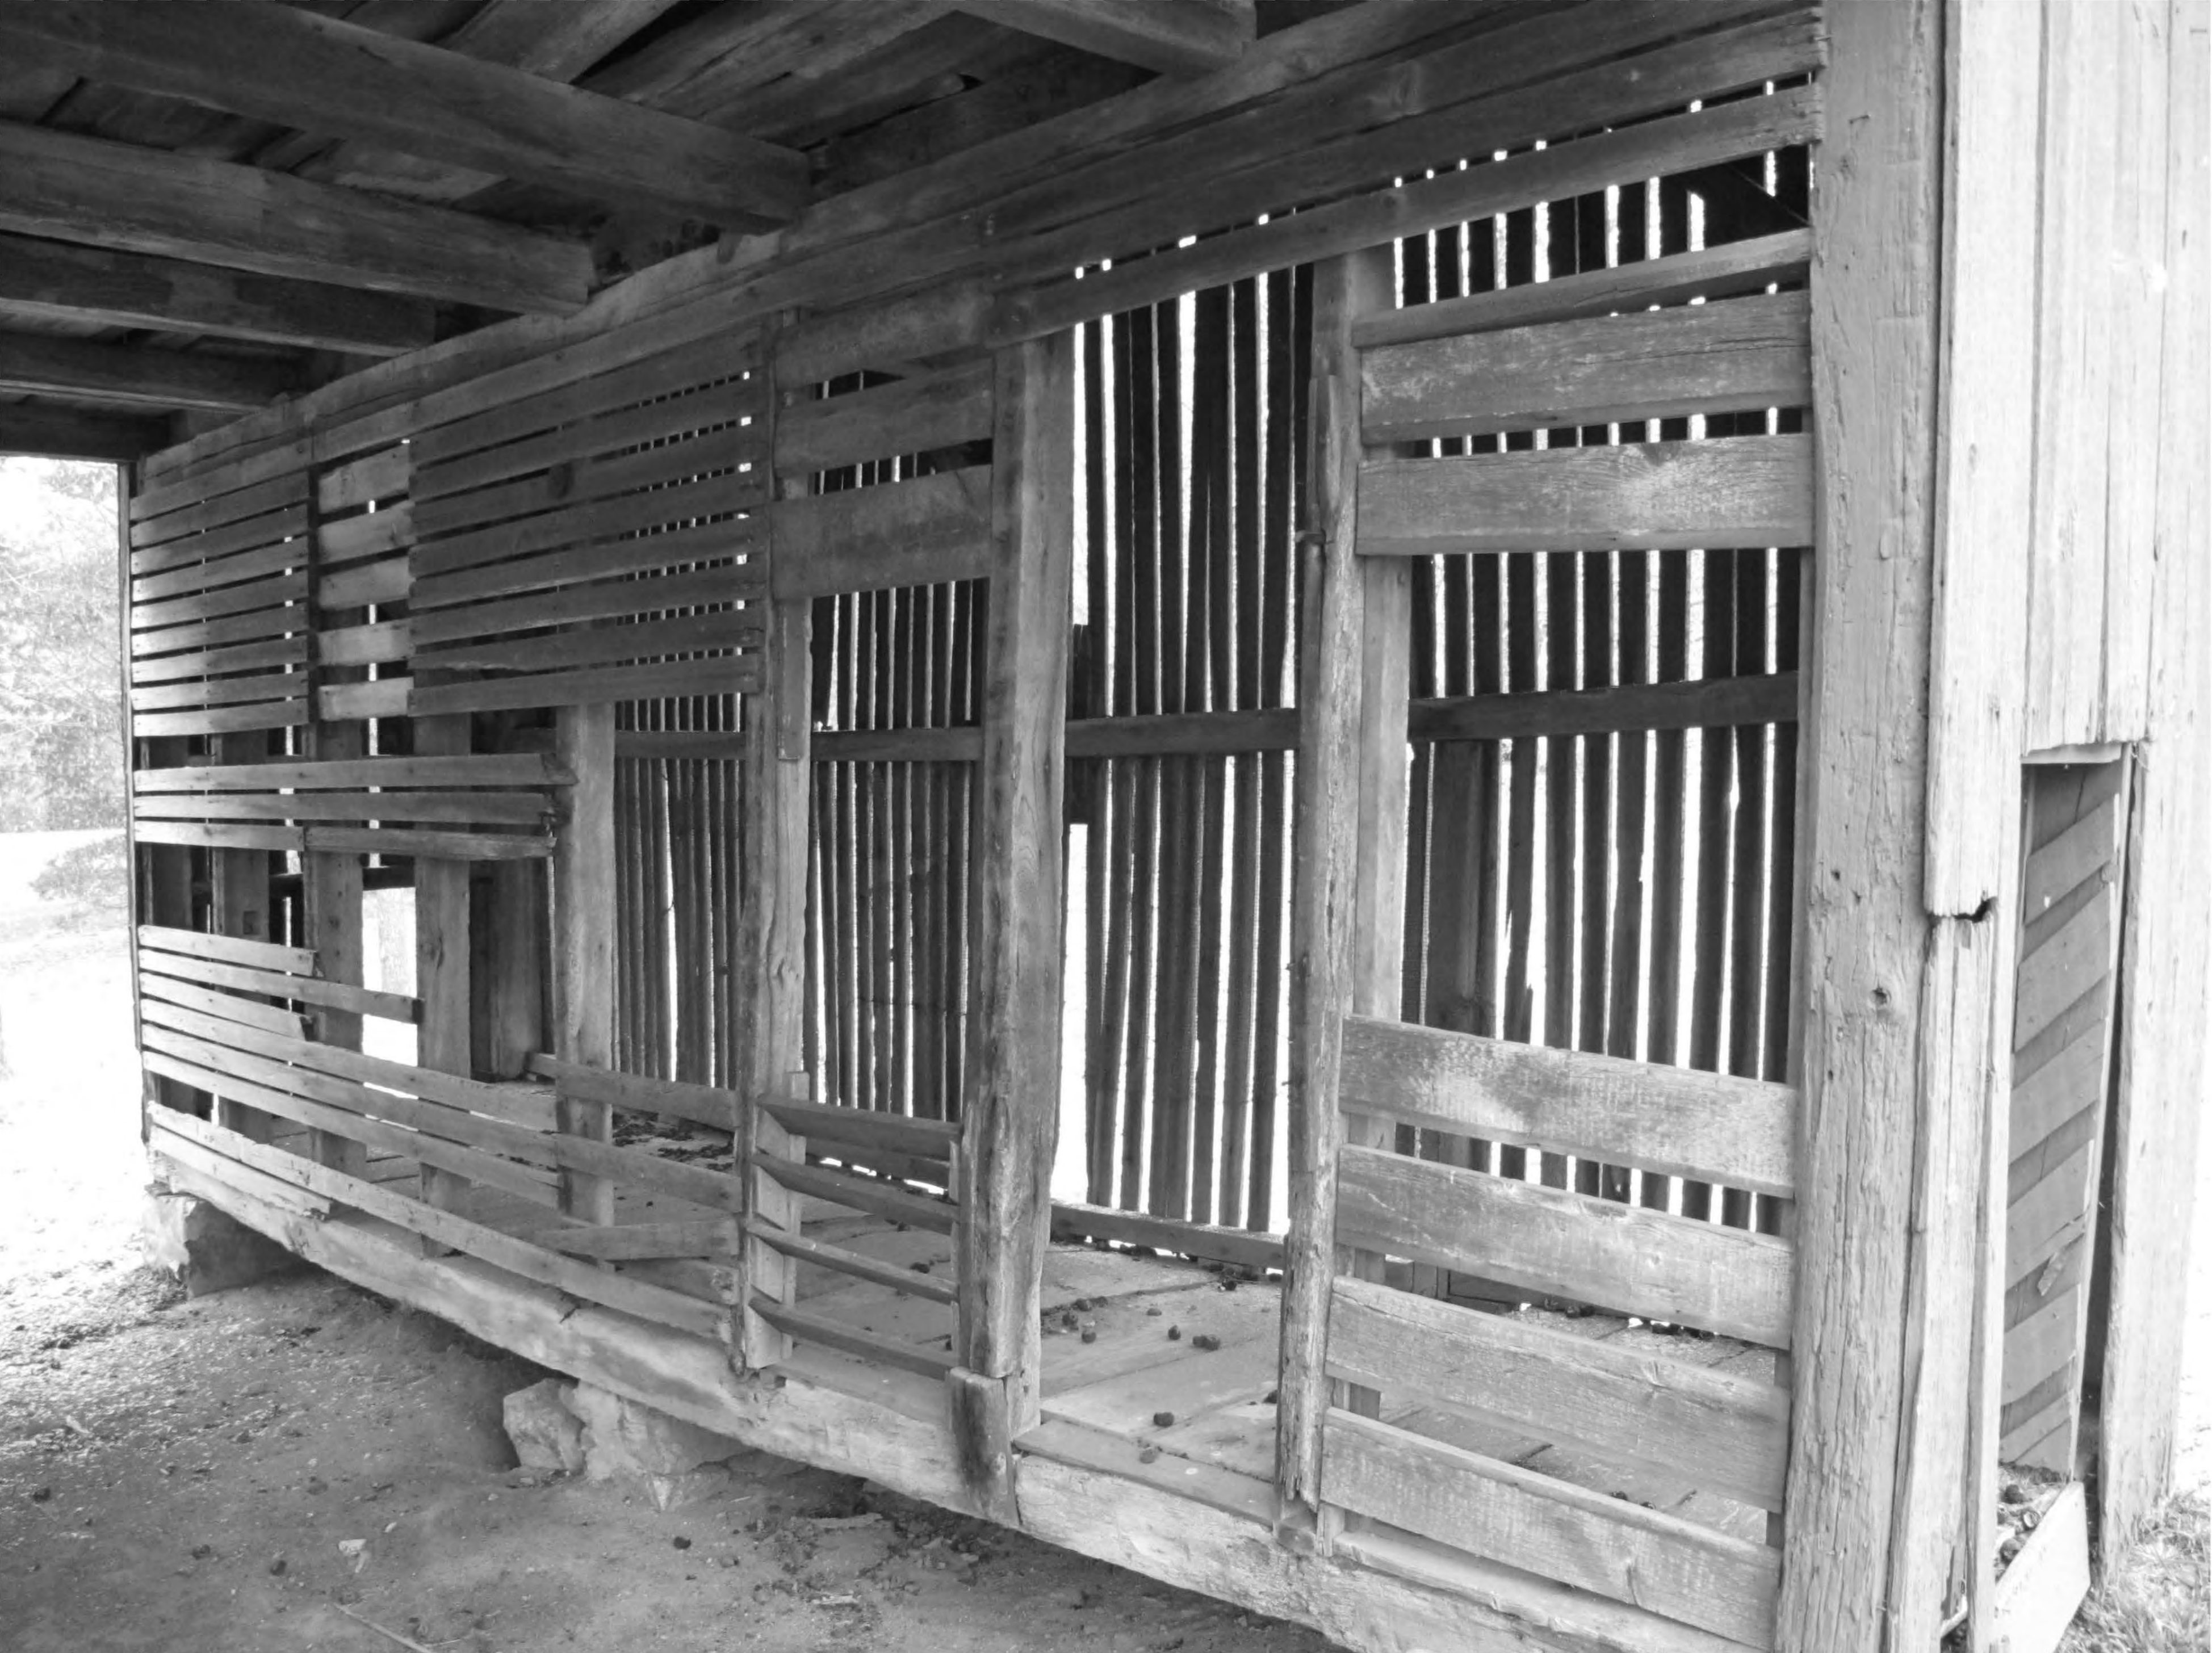
Cox-Phillips-Mitchell Agricultural Complex\_New Castle County\_DE  
Corncrib looking north

The interior consists of the large open passageway, and two corncribs. Both corncribs are heavily framed, showing architectural details like carpenter's marks on the framing members, mortised and tenoned with large wooden trenails. The crib slats on the interior run horizontally, and both cribs have an interior door entry. The loft space cannot be entered from the interior.
