# National Register of Historic Places Registration Form

Historic name: Cox-Phillips-Mitchell Agricultural Complex

Other names/site number: Delaware CRS # N04085

Street & number: 1651 and 1655 Old Wilmington Rd

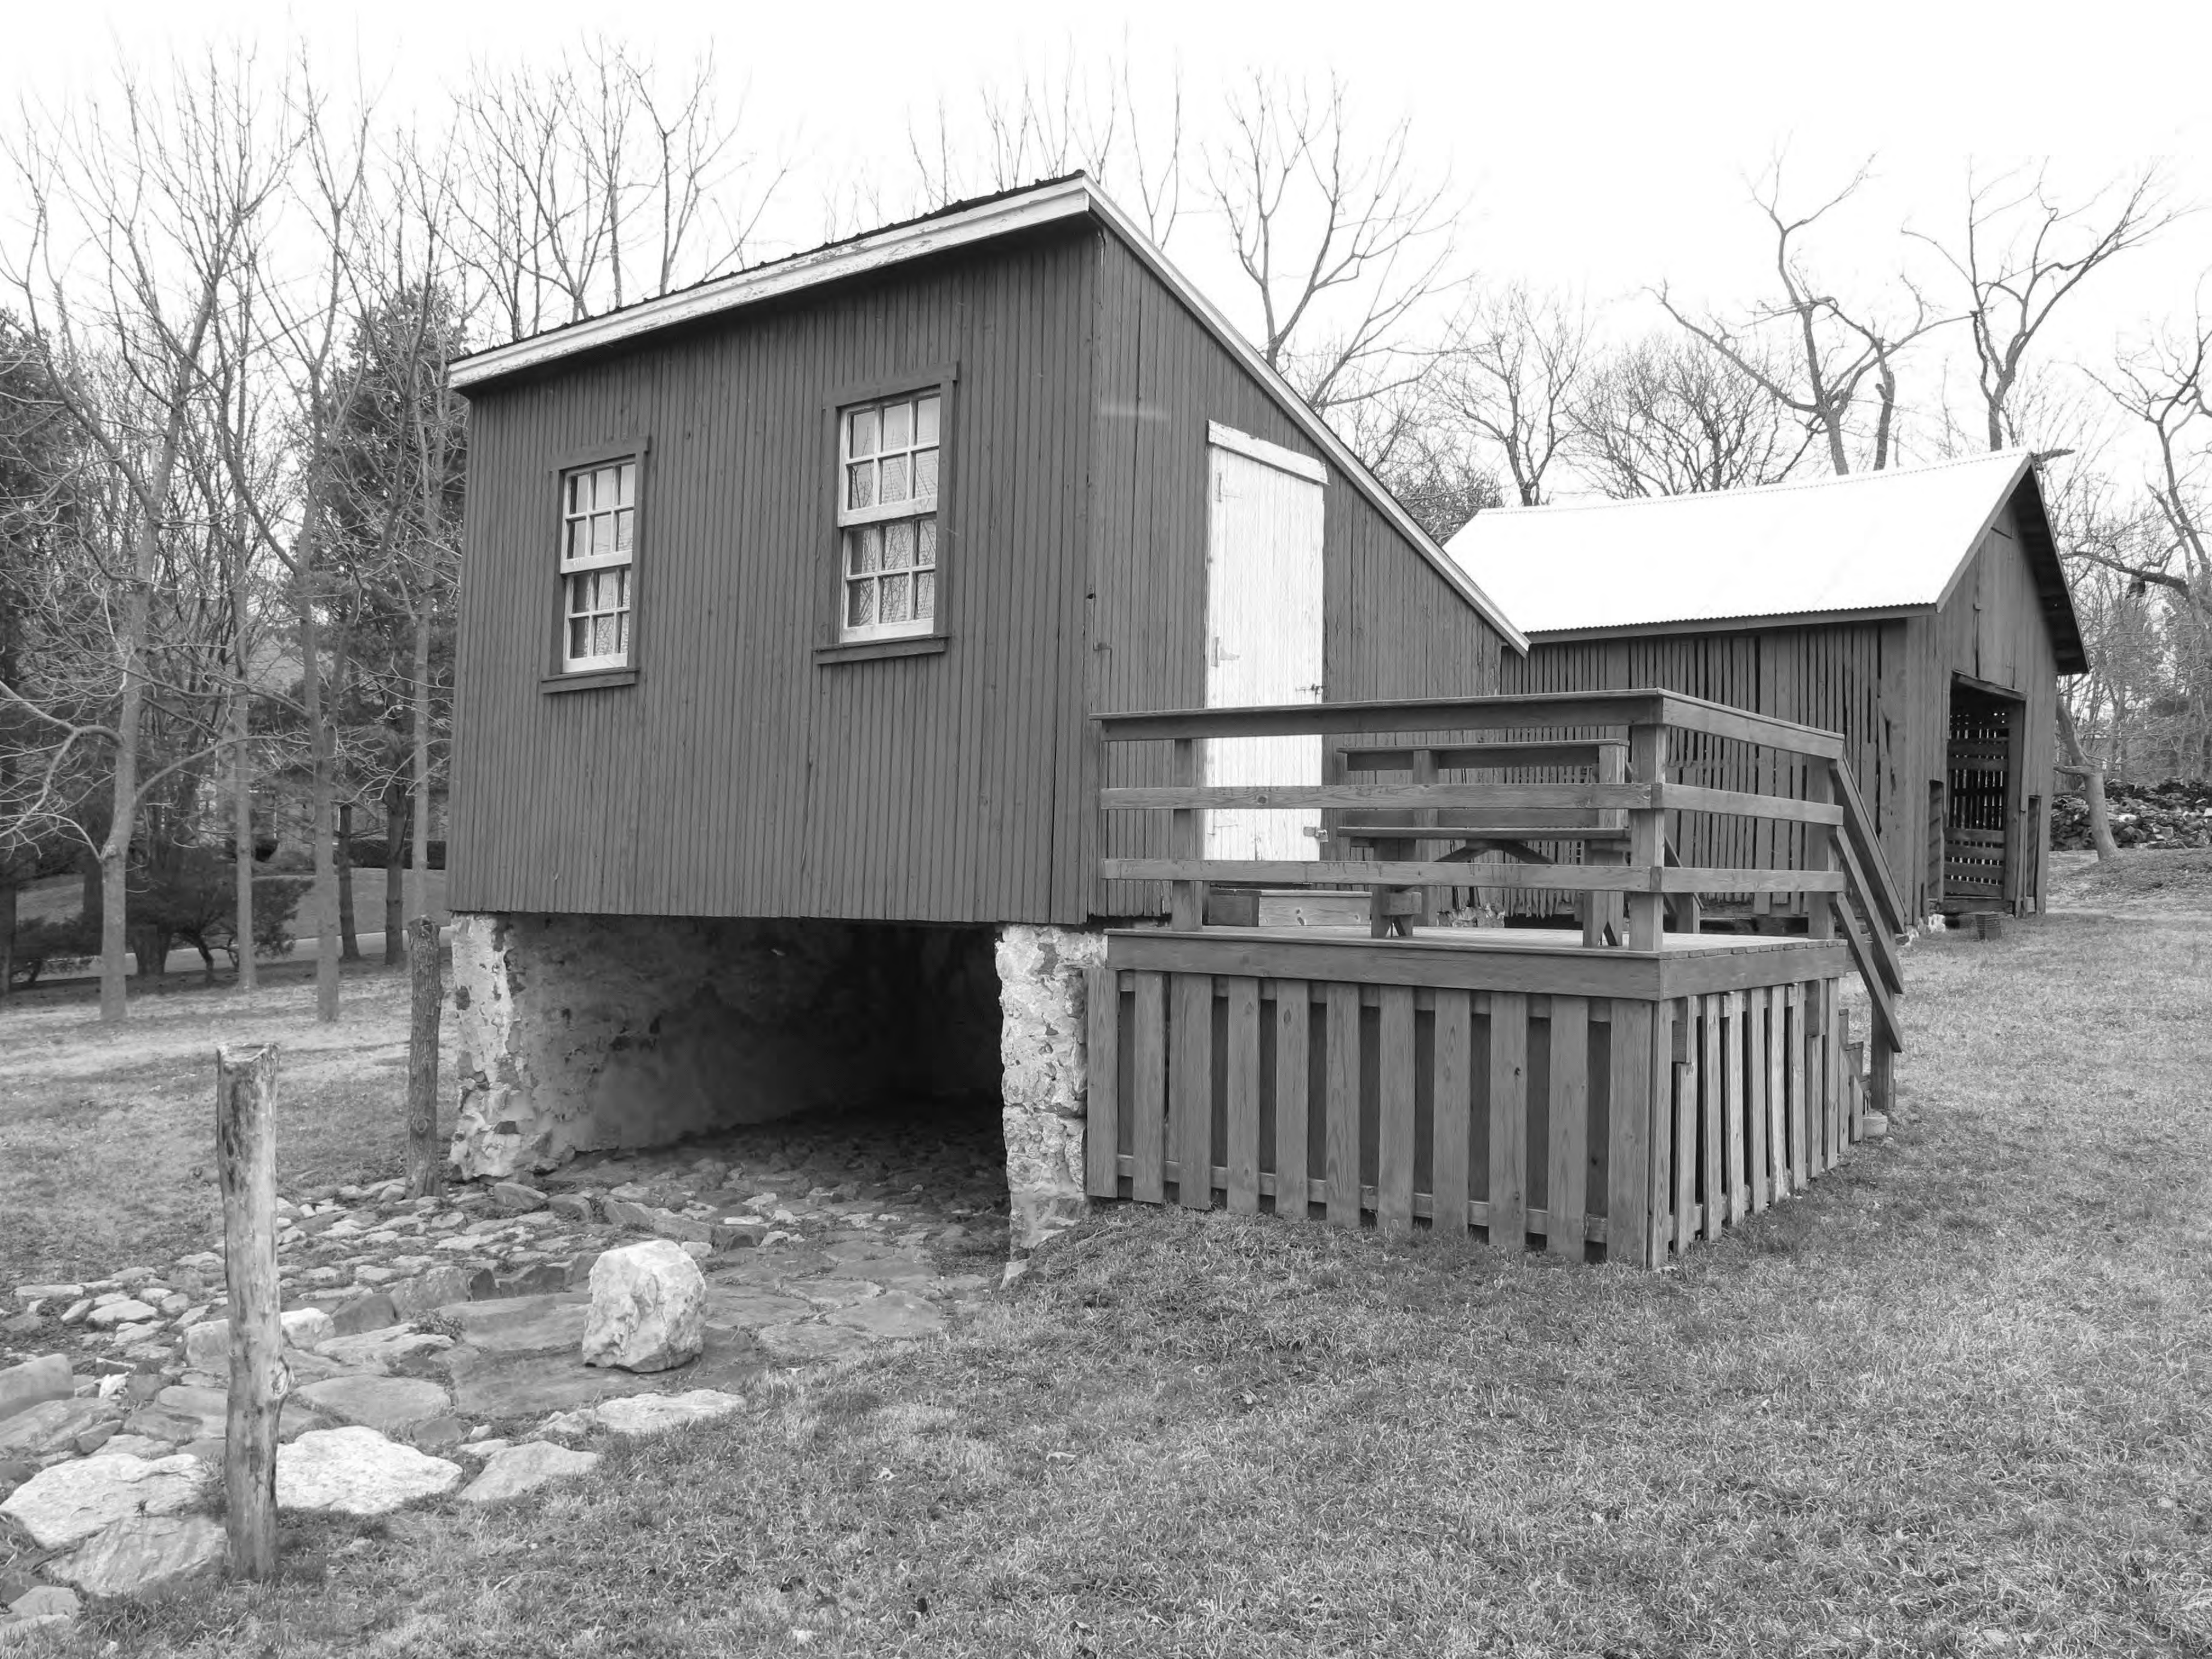
Cox-Phillips-Mitchell Agricultural Complex\_New Castle County\_DE  
Perspective view of piggery showing southwest and southeast elevations looking north

The piggery is a two-story, stone and wood building with a metal shed roof. The first story is comprised of three fieldstone walls on the northwest, northeast, and southeast elevations while the southwestern elevation is open. A small yard paved with stones extends from the inside of the first story out towards the southwest, and spans the width of the building. A modern wooden stair leads up to a door on the southeast elevation to the second floor, providing access to the chicken coop space. Two six-over-six light double-hung sash windows exist on the southwest elevation. The interior of the second story is comprised of one room, lightly finished with floorboards and whitewash.

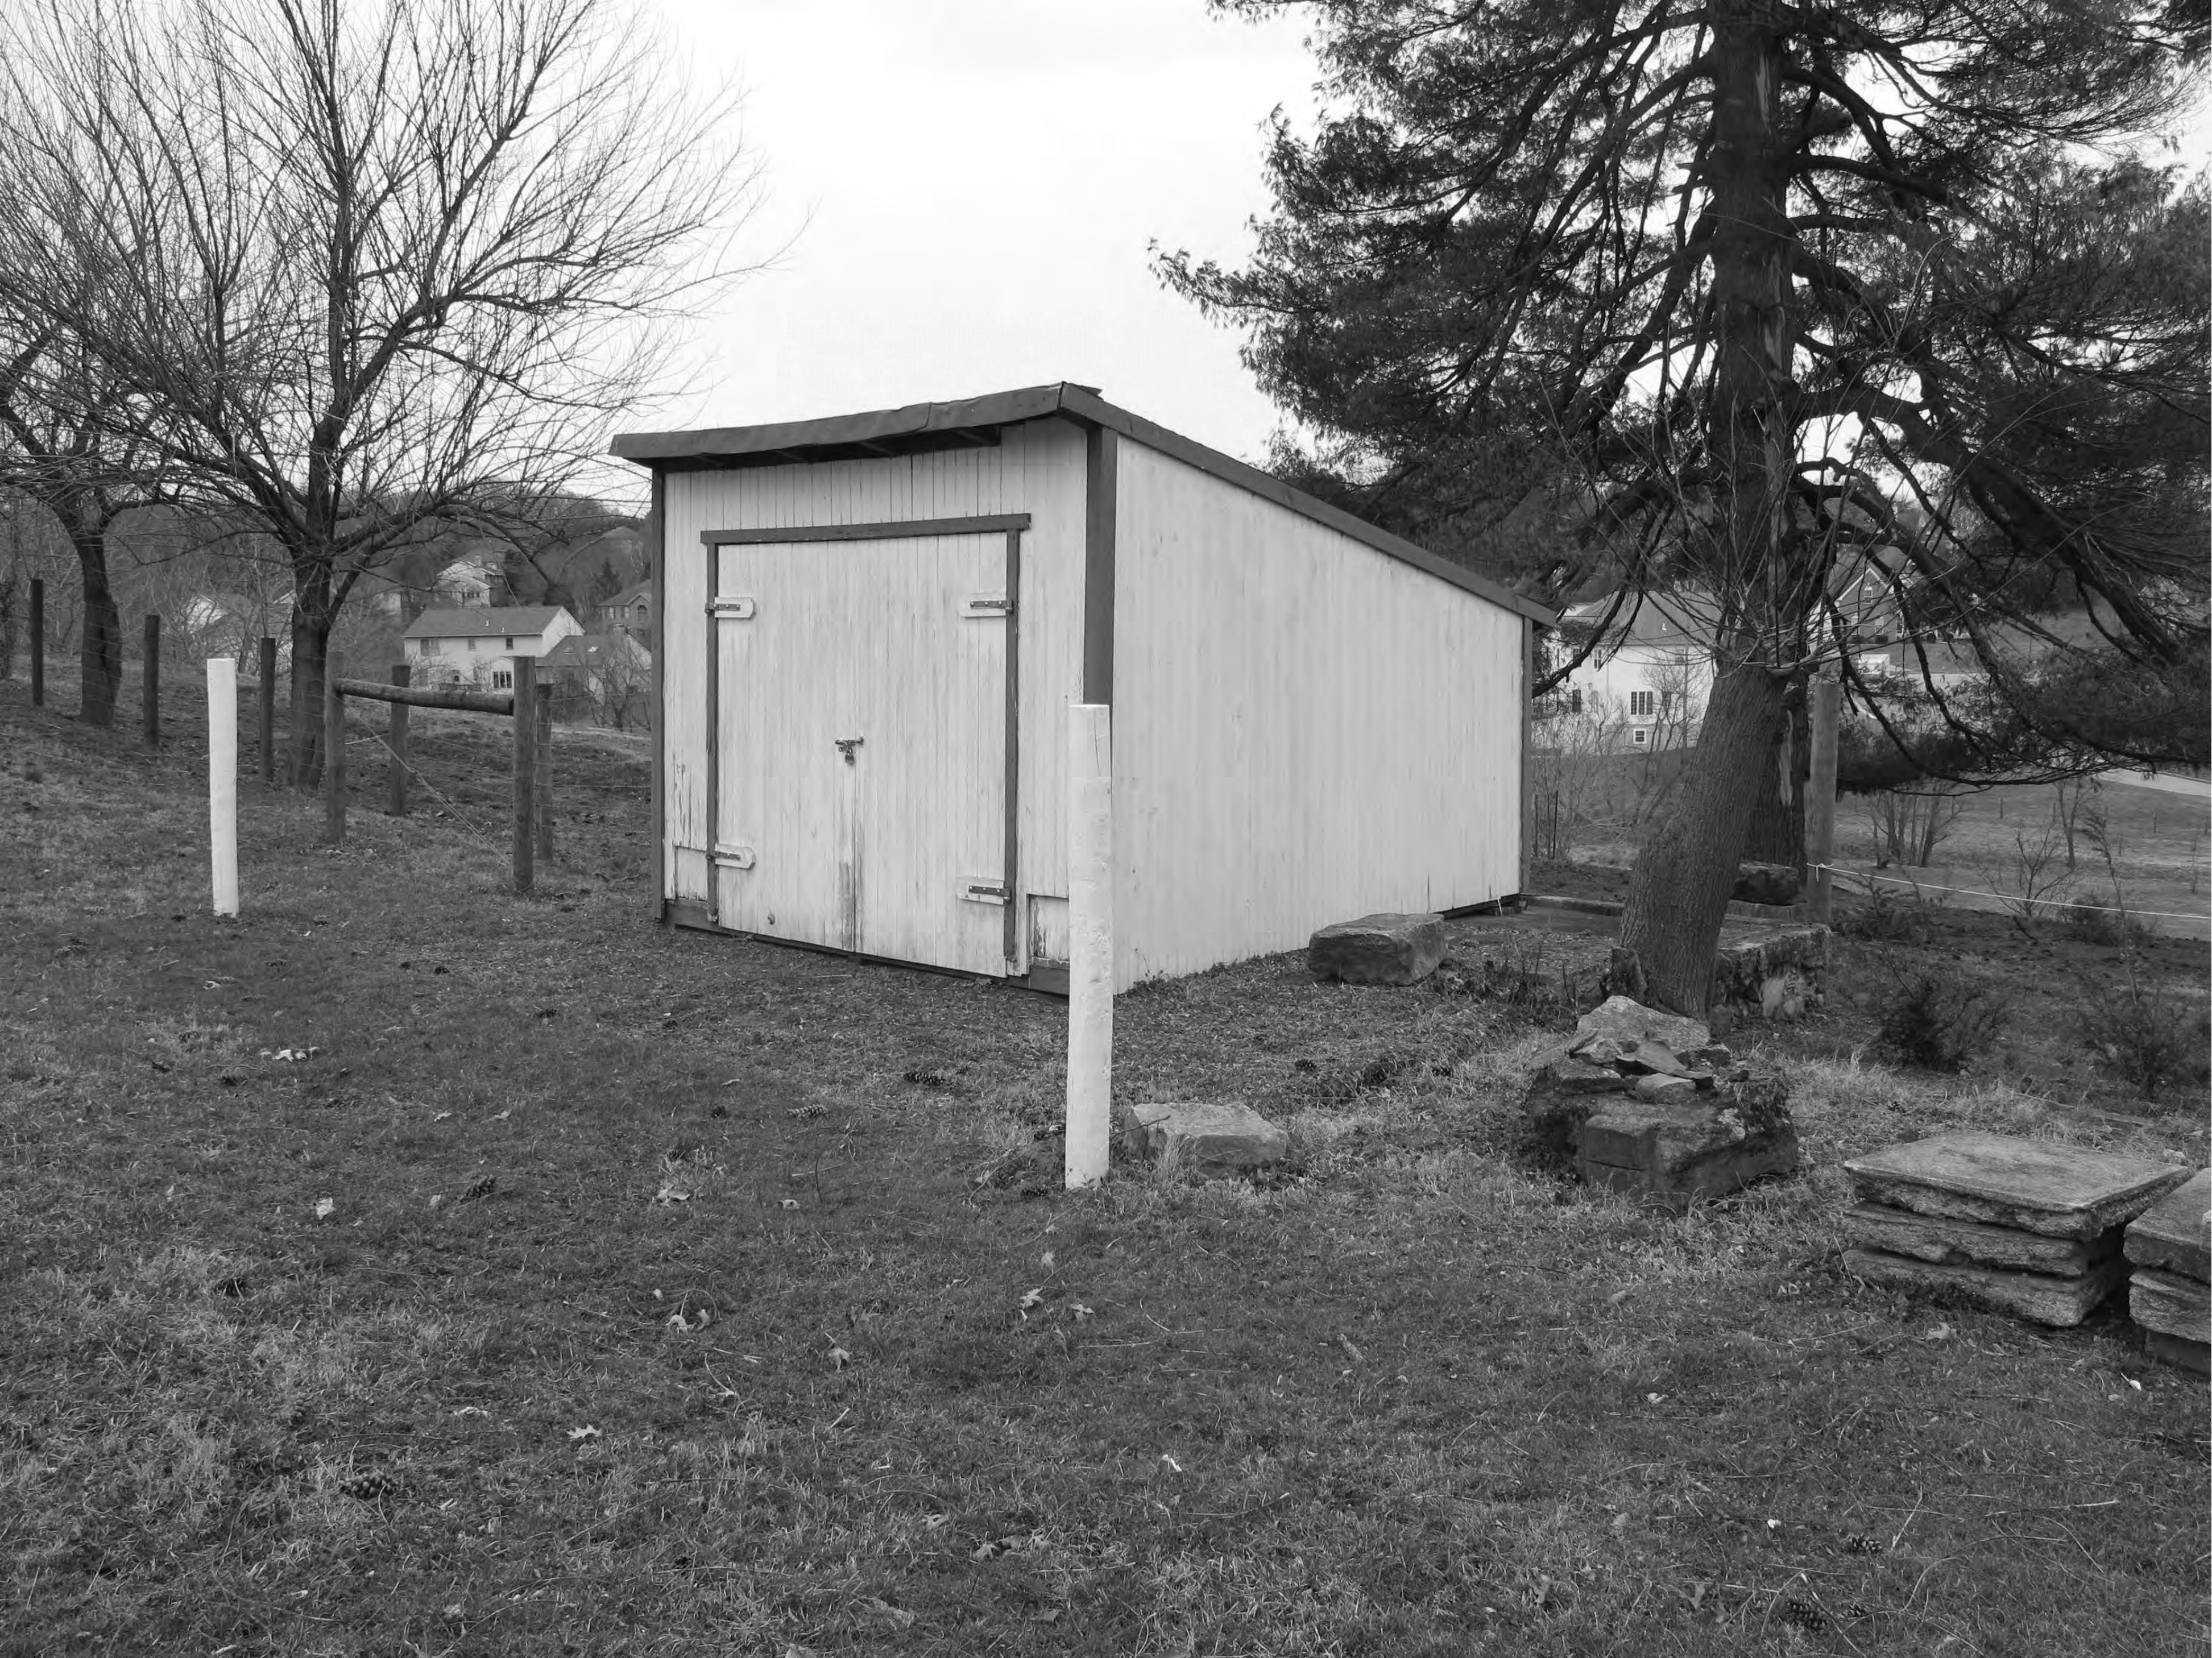
Cox-Phillips-Mitchell Agricultural Complex\_New Castle County\_DE  
Perspective view of shed showing northwest and southwest elevations looking east
