# National Register of Historic Places Registration Form

Historic name Ocean City, NJ Life-Saving Station  
Other names/site number U.S. Life Saving Station 30, Fourth Street Life Saving Station

street & number 801 Fourth Street  not for publication  
city of town Ocean City  vicinity  
State New Jersey code NJ county Cape May code 009 zip code 08226

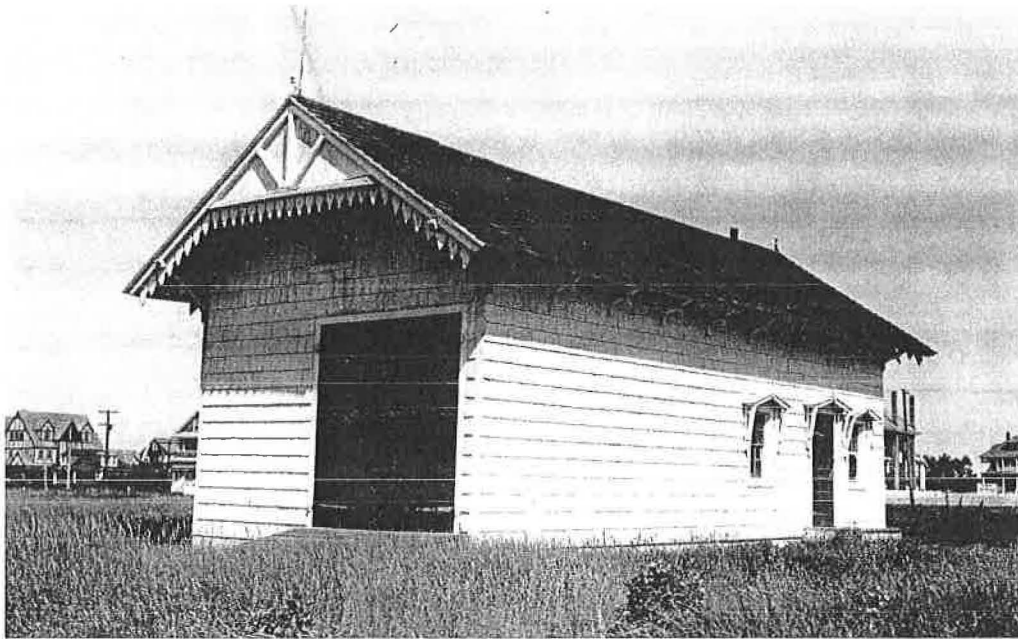
**Figure 3: Cold Spring Life-Saving Station, Cape May, NJ**  
 Station is believed to have been similar to the 1853-1854 Ocean City boathouse  
 U.S. Coast Guard

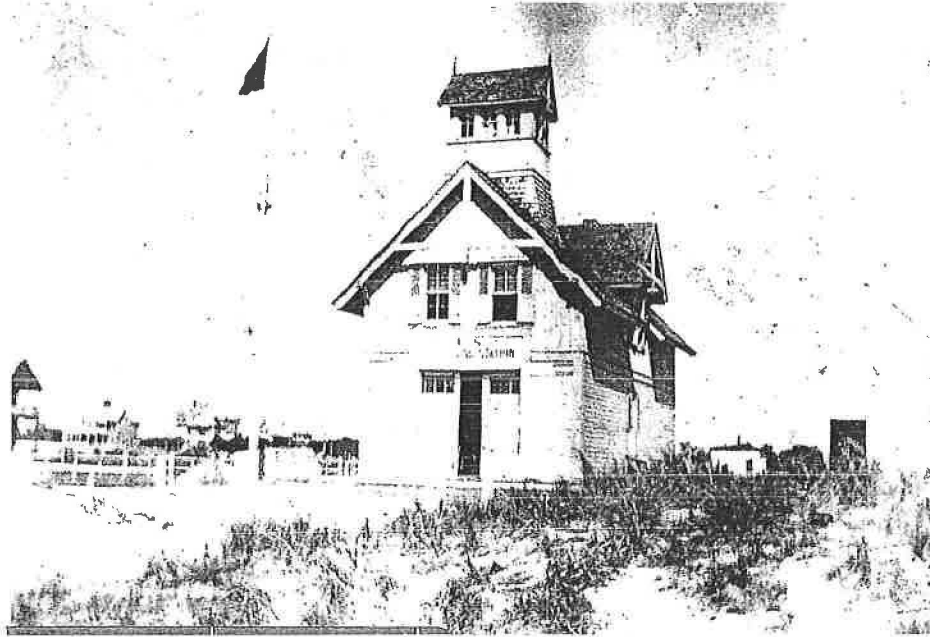
Figure 6: Ocean City Life-Saving Station, ca. 1890  
Ocean City Historical Museum

*House in center is at 4<sup>th</sup> & Central  
Looking West from 4<sup>th</sup> & Atlantic Life-Saving Station*

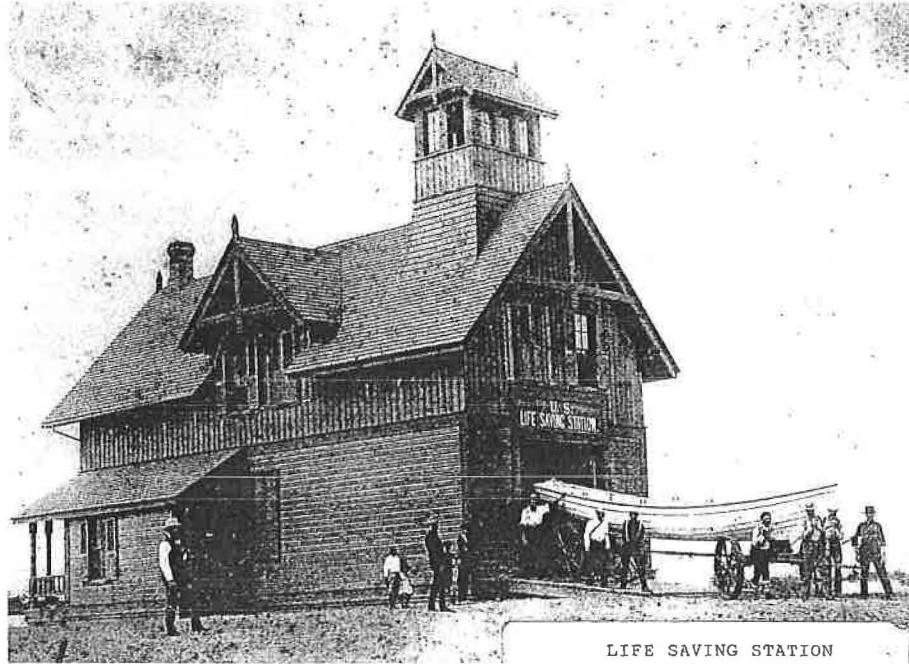
**Figure 8: Ocean City Life-Saving Station, ca. 1890**  
Ocean City Historical Museum

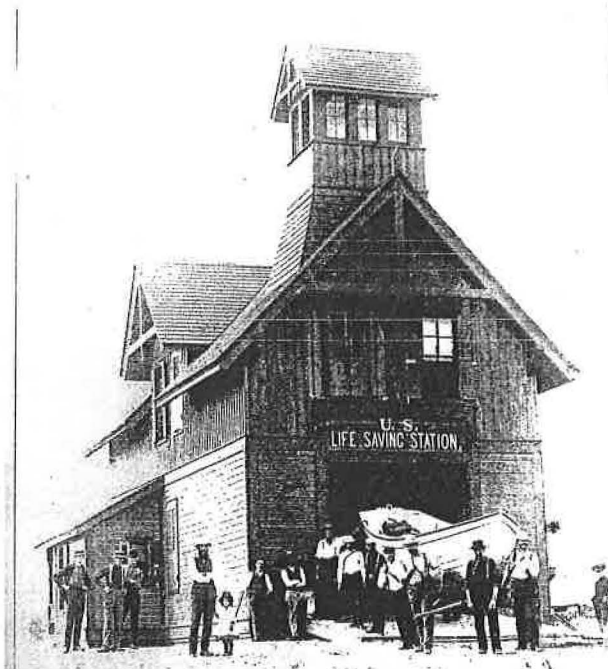
**Figure 9: Ocean City Life-Saving Station, ca. 1890**  
Ocean City Historical Museum

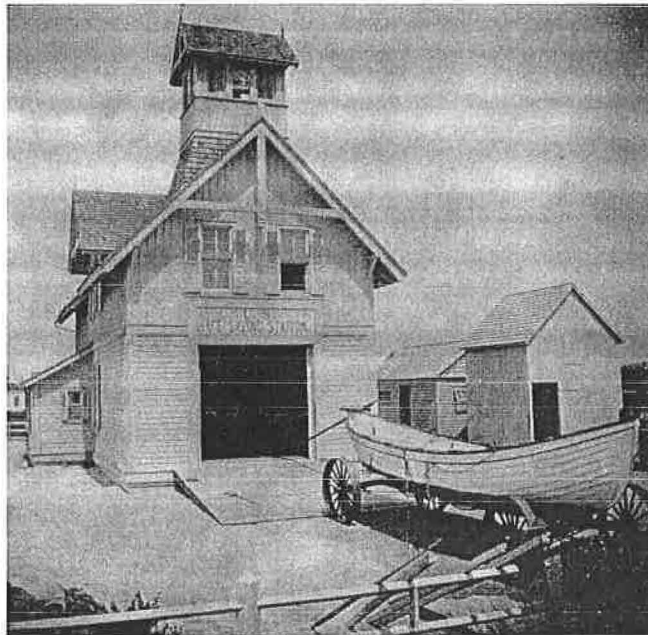
Figure 10: Ocean City Life-Saving Station, ca. 1895  
Ocean City Historical Museum

The west (back) section may have originally been part of the larger of two sheds that were located north of the Station (figure 10). A drawing of a similar outbuilding for an 1886 station design shows it divided into four areas with a privy and an oil and paint closet at one end and separate areas for coal and wood at the other end (figure 11). The two rooms at the back of the garage were probably originally the privy and the oil and paint closets, and may survive from the ca. 1895 shed.

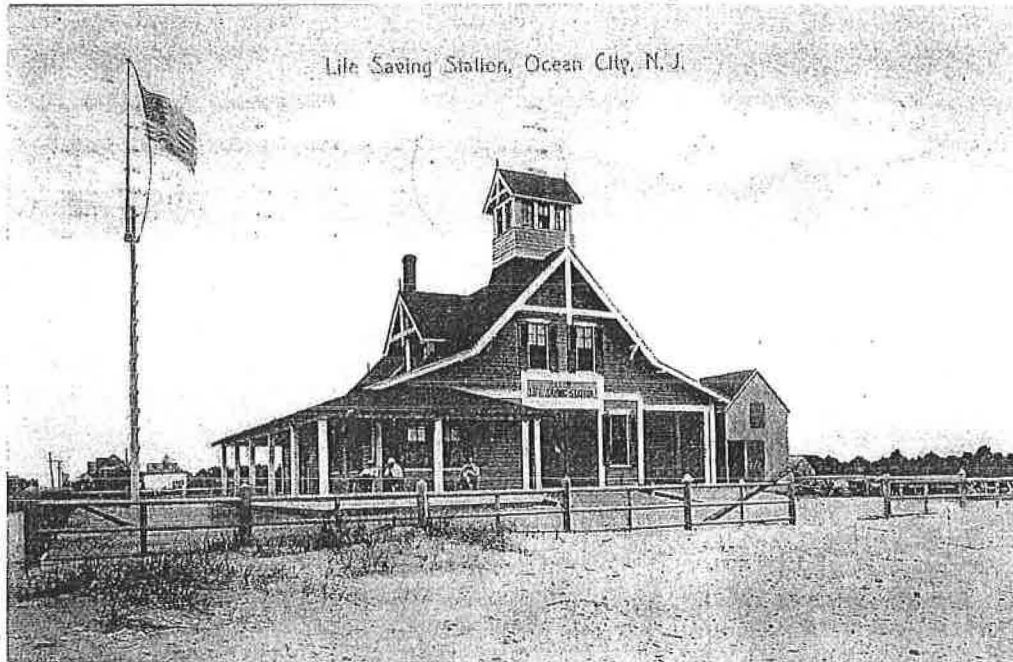
Figure 12: Ocean City Life-Saving Station, ca. 1910  
Ocean City Historical Museum

The outbuilding to the east, which no longer stands, was probably a storage shed. The outbuilding to the west, part of which may survive as part of the larger garage, may have had a privy and storage for coal and/or wood and for oil and paint (figure 11). An outbuilding of the same design was also found at the Corson Inlet, New Jersey Station (figure 4). It's believed the two sheds were built after 1890 because they are not shown on an 1890 Sanborn Map of Ocean City.<sup>23</sup> The surviving west outbuilding was probably enlarged to its present size sometime after ca. 1910 because the east outbuilding (which would have been demolished or moved before the west one could be expanded) appears in two photos taken in that year (see figures 12 and 13).

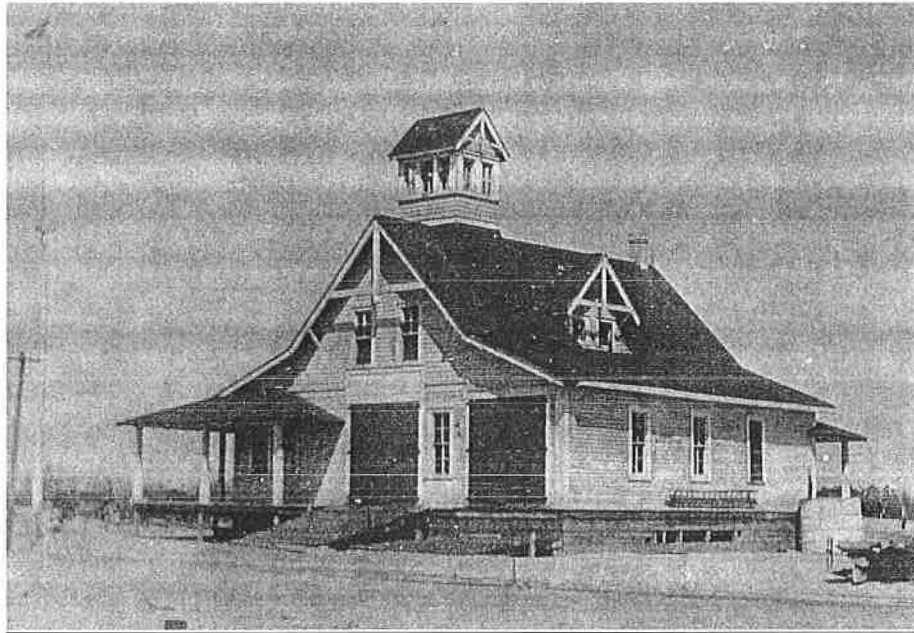
**Figure 16: South Brigantine Life-Saving Station, Brigantine, NJ**  
Station had the same alterations as those at Ocean City  
National Archives

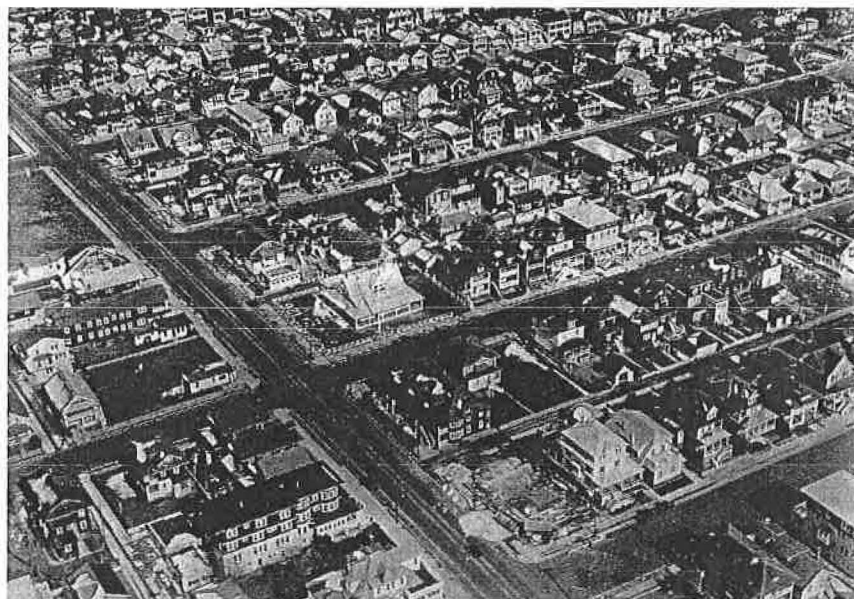
**Figure 20: Ocean City Life-Saving Station, 1931  
Station is in the center left of photo**

The Ocean City Life-Saving Station is in its original location, though the beach and ocean have receded about a quarter of a mile to the east since 1886. The setting has changed significantly since the building was constructed directly on the beach, but it had already changed by the time the wings were added in 1906 (figure 19), and by the end of the Period of Significance, the density of the surrounding neighborhood was essentially the same as at present (figure 20).

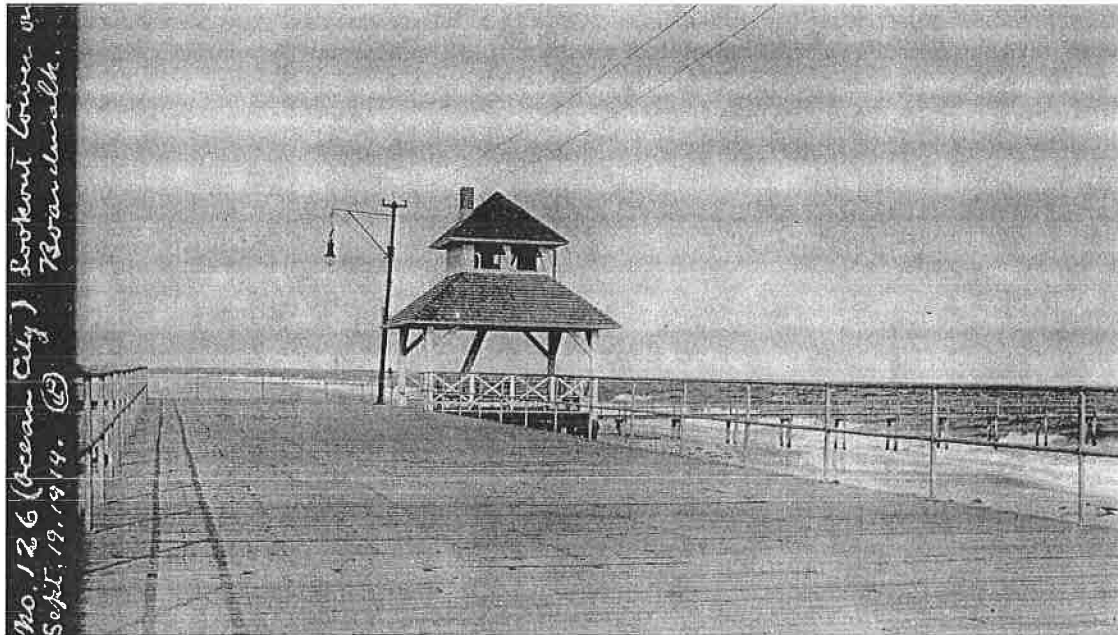
**Figure 21: Ocean City Life-Saving Station Auxiliary Lookout Tower, 1919**  
Tower was located at the north end of the boardwalk and North Street  
U.S. Coast Guard
