Trinity Church

Thomaston, CT

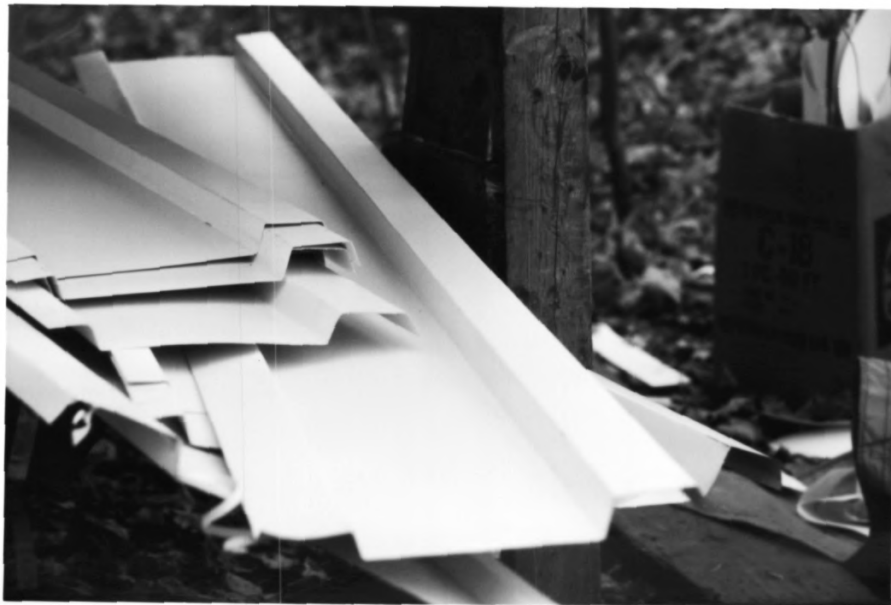
Photo 4. Sheet aluminum pieces shaped
to fit over board and battens.

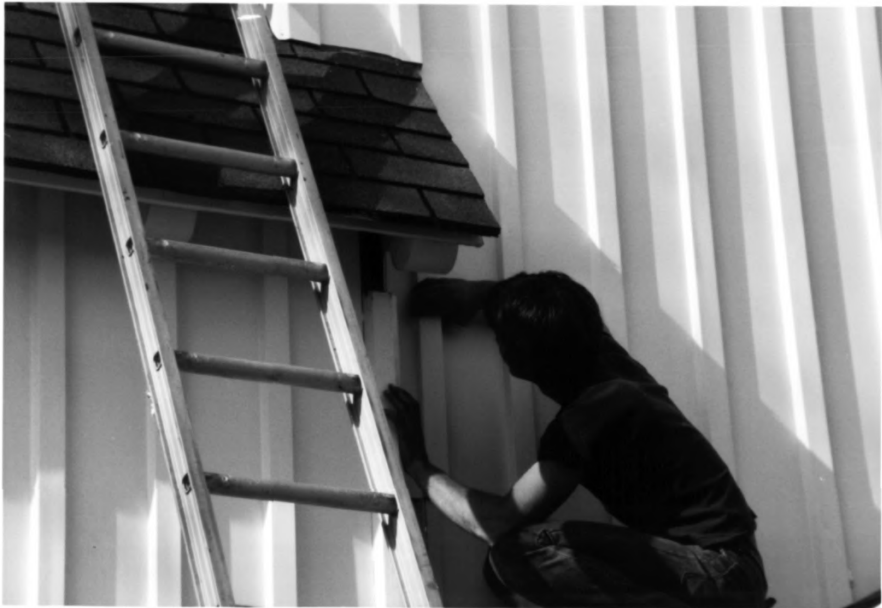
Photo 6. Fitting the piece into place.

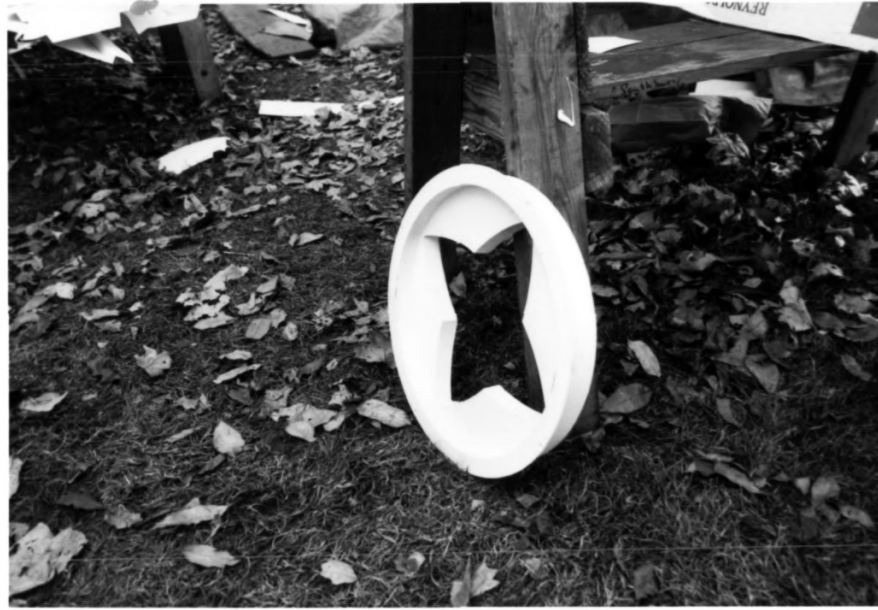
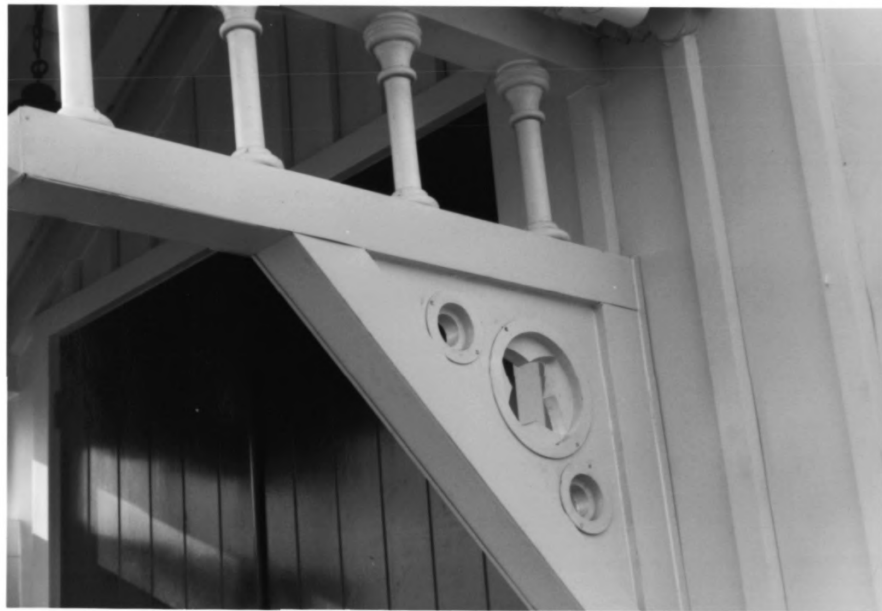
Photo 7. Star casting.

Photo 8. Star casting put into place with its flange overlapping the flat sheet.

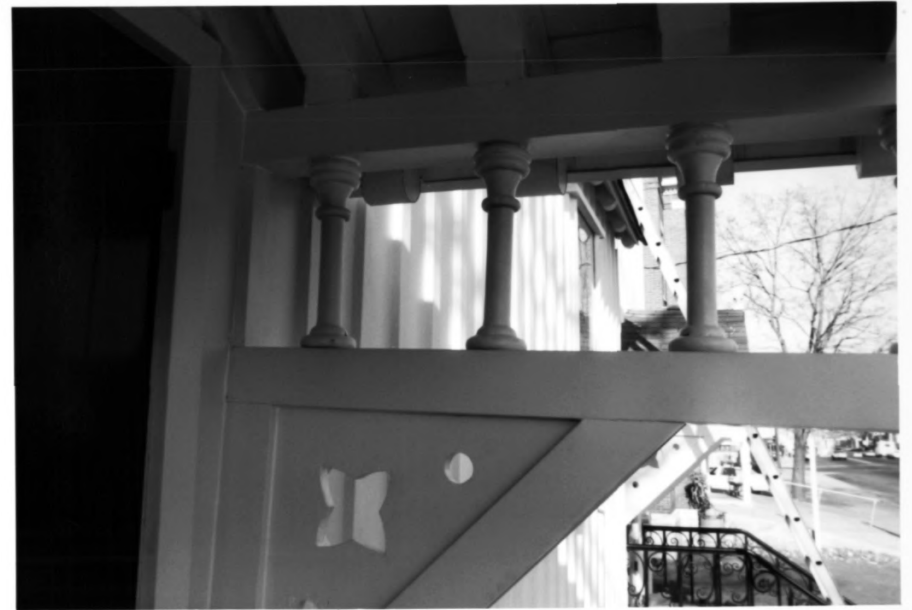
Photo 9. Obverse of Photo 8. Spindles also are cast.

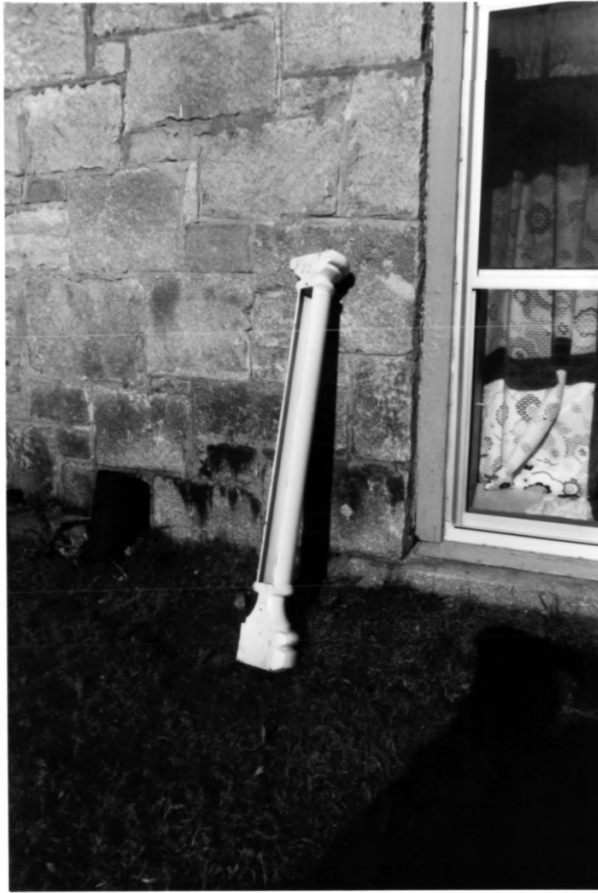
Photo 10. Belfry attached column,
showing hollow constuction.

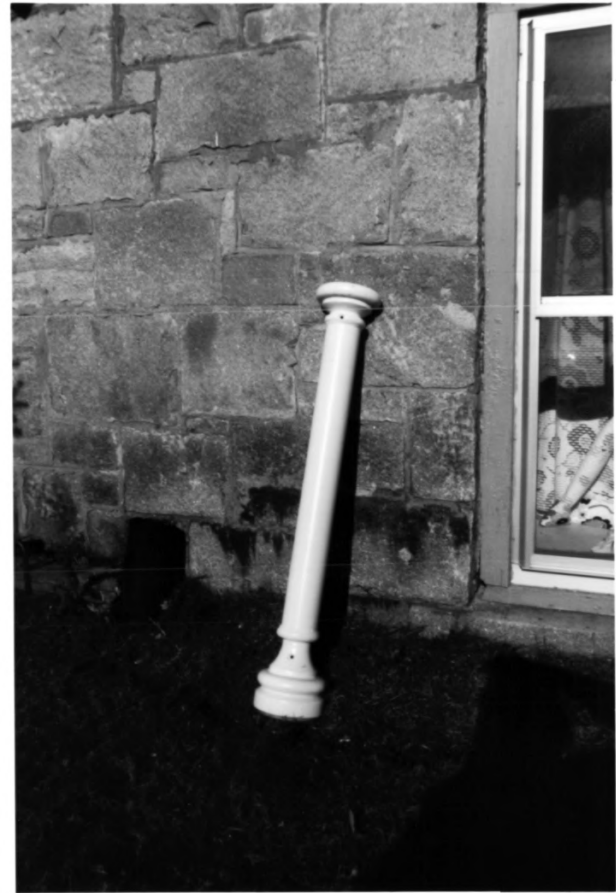
Photo 11. Belfry attached column,
normal view.

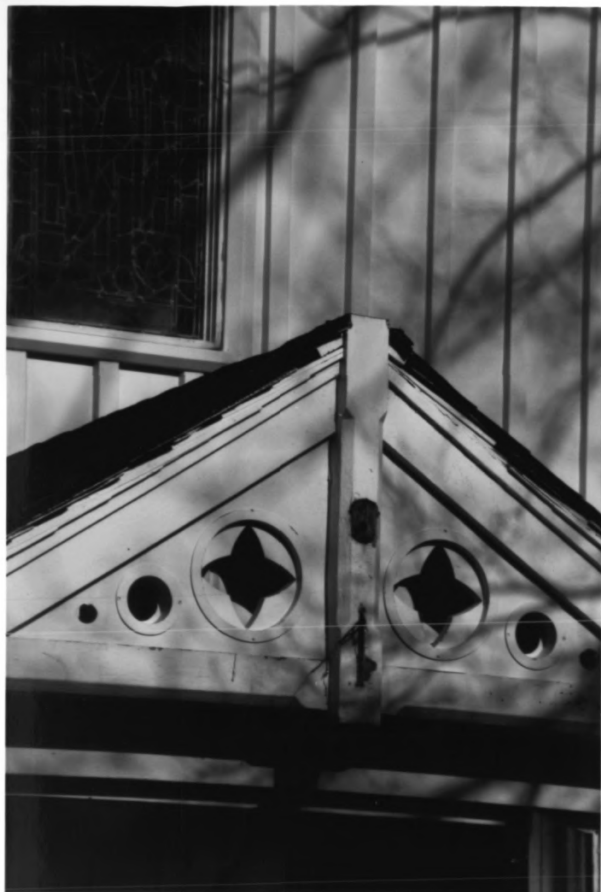
Photo 12. Post with finials removed.

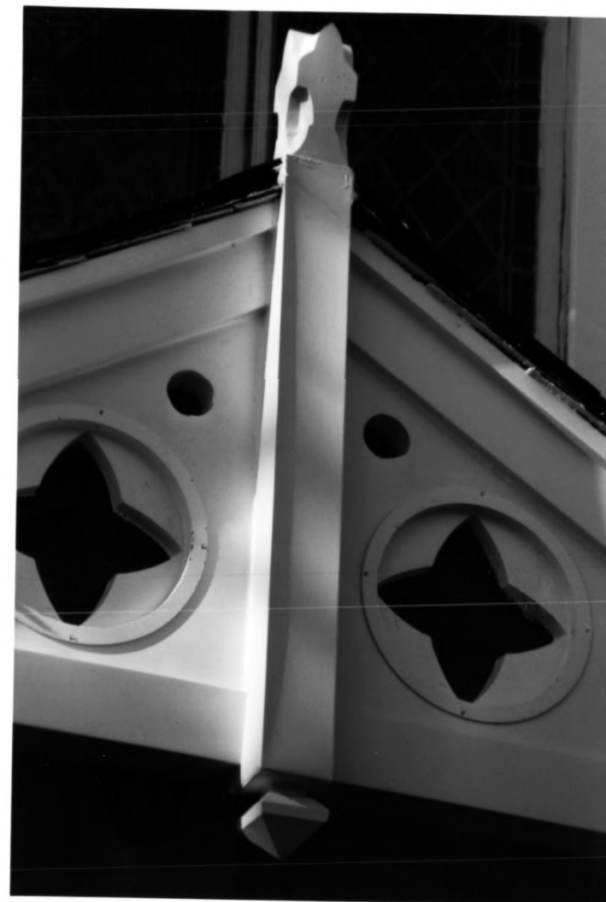
Photo 14. Post with new finials in place.

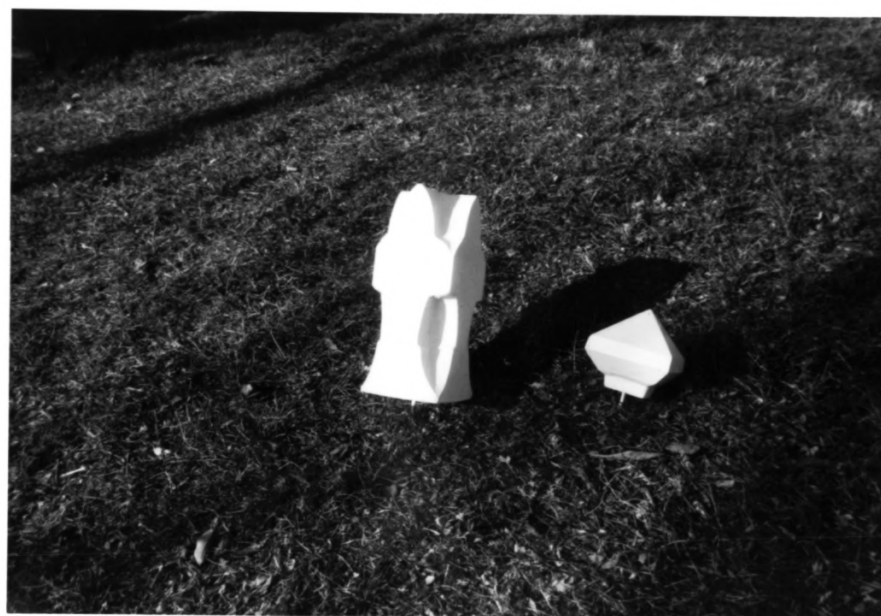
Photo 13. New cast finials.

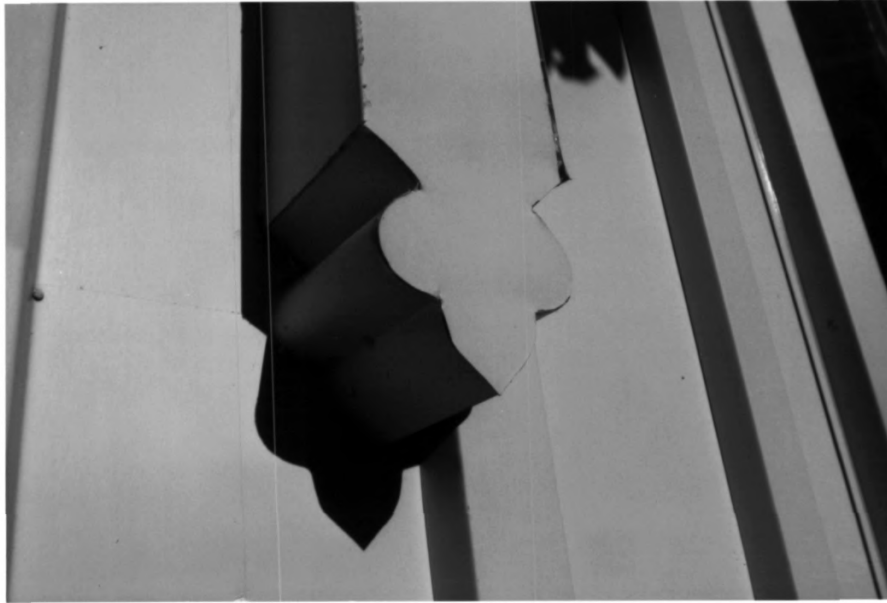
Photo 14. Detail near west door on south elevation, showing the shaping of aluminum to fit the wood part.
