# National Register of Historic Places Registration Form

Historic name: Goodwin, Edmund E., House  
Other names/site number: E. E. Goodwin House  
Name of related multiple property listing: n/a  
(Enter "N/A" if property is not part of a multiple property listing)

Street & number: 503 Main Street  
City or town: Sanford State: Maine County: York  
Not For Publication: n/a Vicinity: Springvale

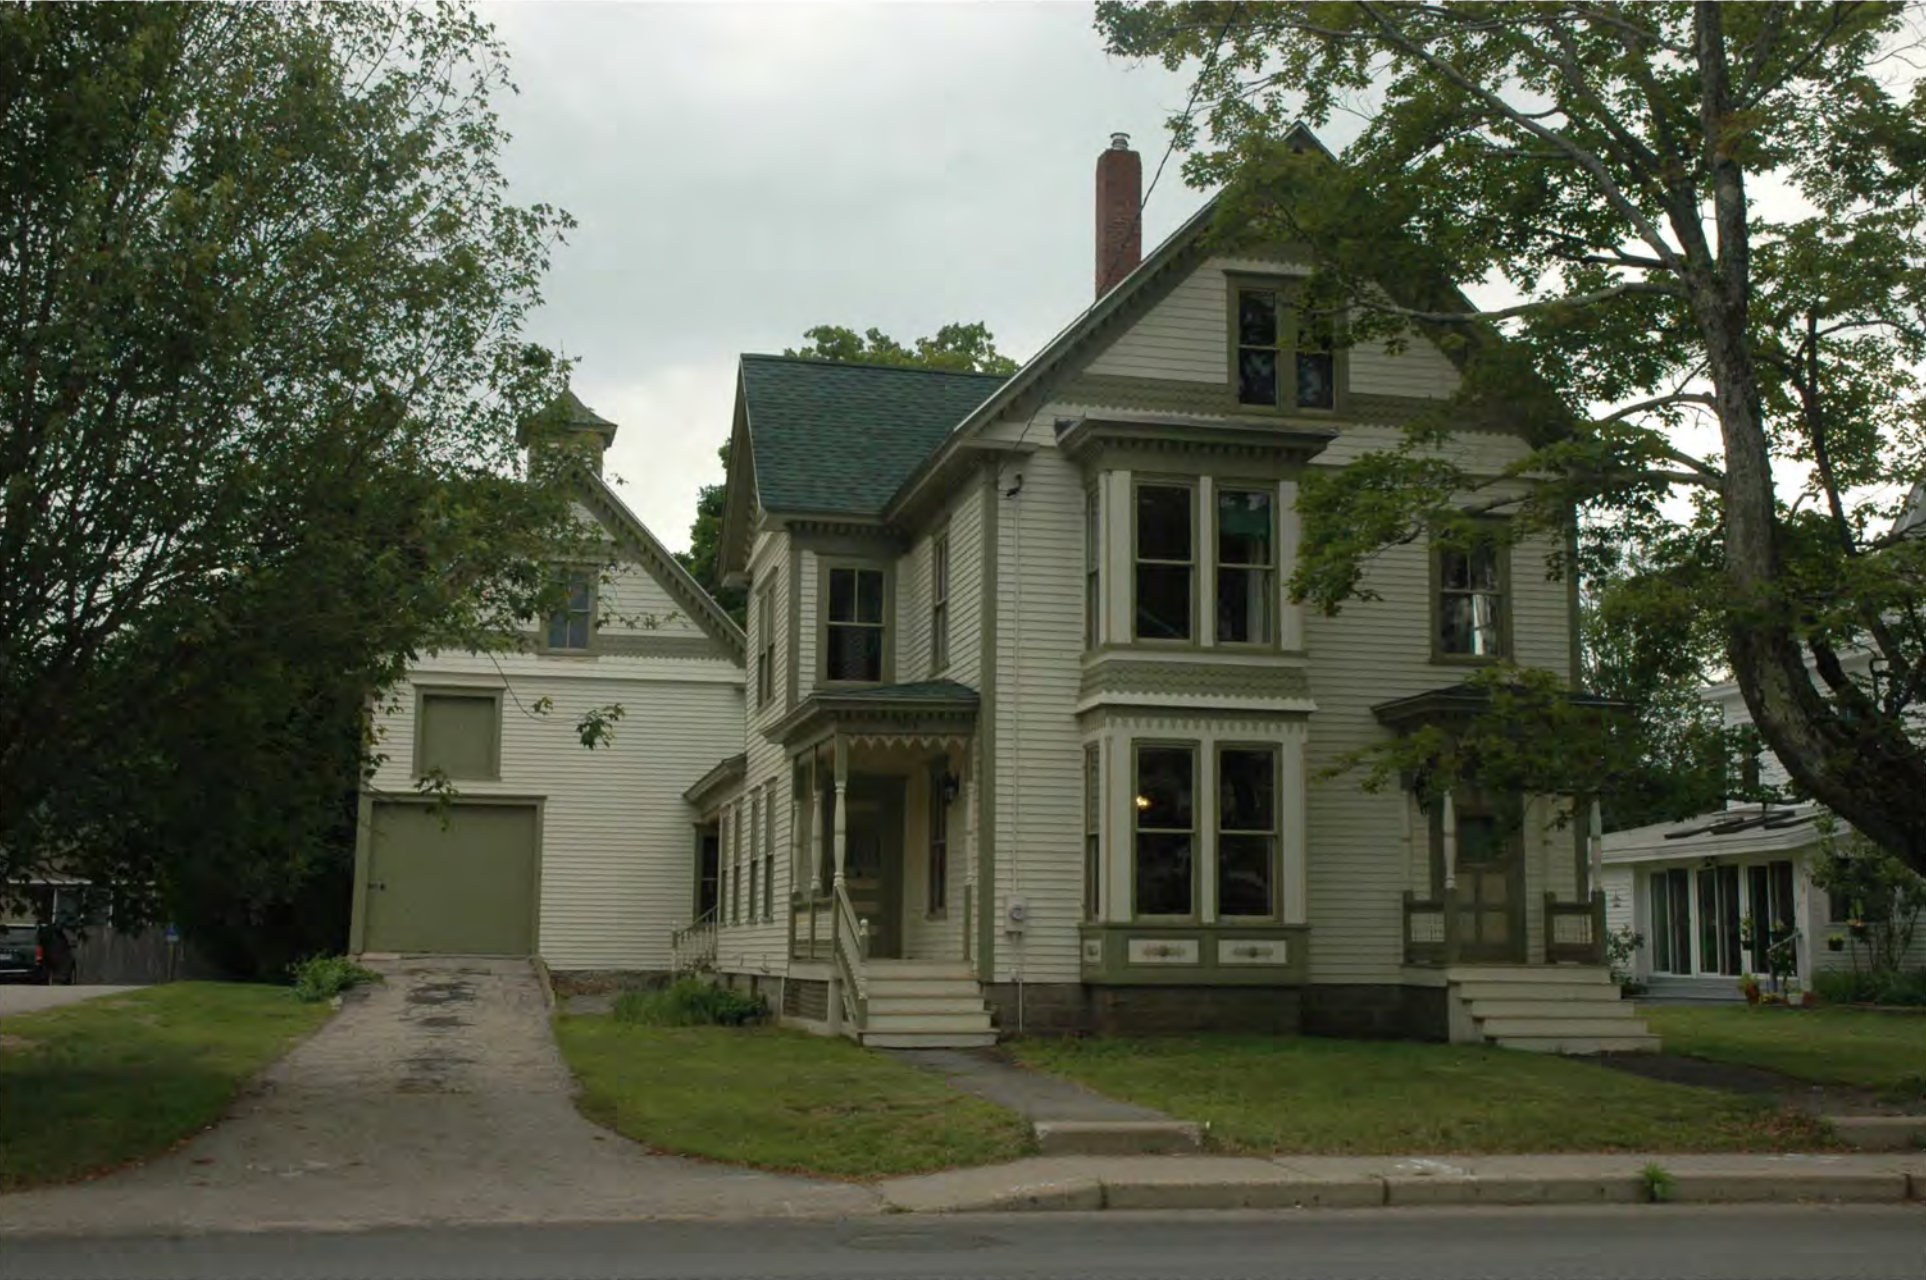
- 1 of 8 ME\_YORK COUNTY\_GOODWIN EDMUND E HOUSE\_0001.TIF  
*Façade of house and carriage house as seen from Main Street, facing west.*
- 2 of 8 ME\_YORK COUNTY\_GOODWIN EDMUND E HOUSE\_0002.TIF  
*Detail of front door and entry porch; facing west.*

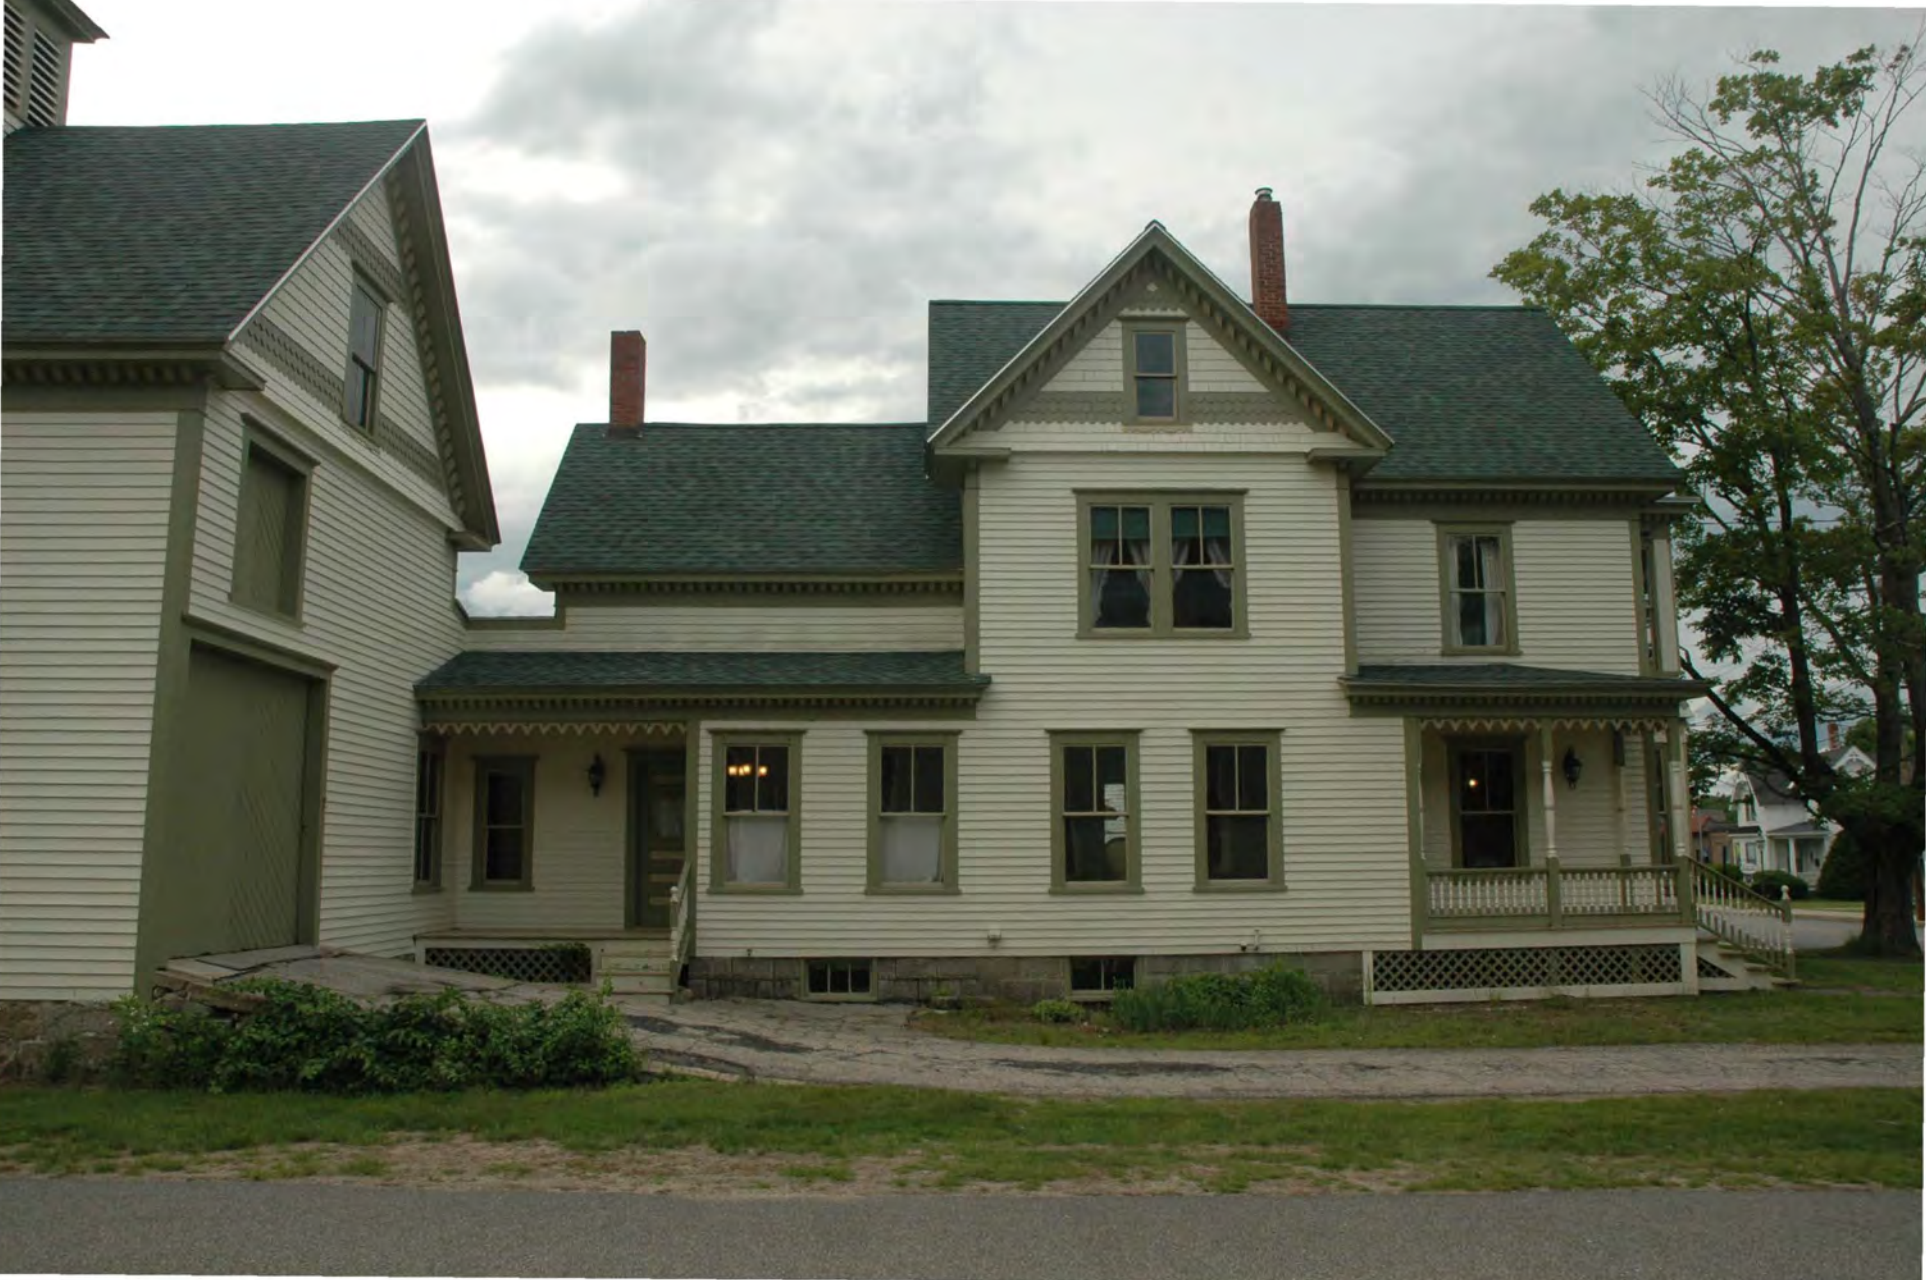
- 3 of 8 ME\_YORK COUNTY\_GOODWIN EDMUND E HOUSE\_0003.TIF  
*South elevation of house and east elevation of carriage house; facing north.*
- 4 of 8 ME\_YORK COUNTY\_GOODWIN EDMUND E HOUSE\_0004.TIF  
*Rear elevation of carriage house (right), shed(center), ell and main house; facing east.*
