## National Register of Historic Places Registration Form

historic name Towne Farm

street & number 55 Towne Road

city or town Boxford

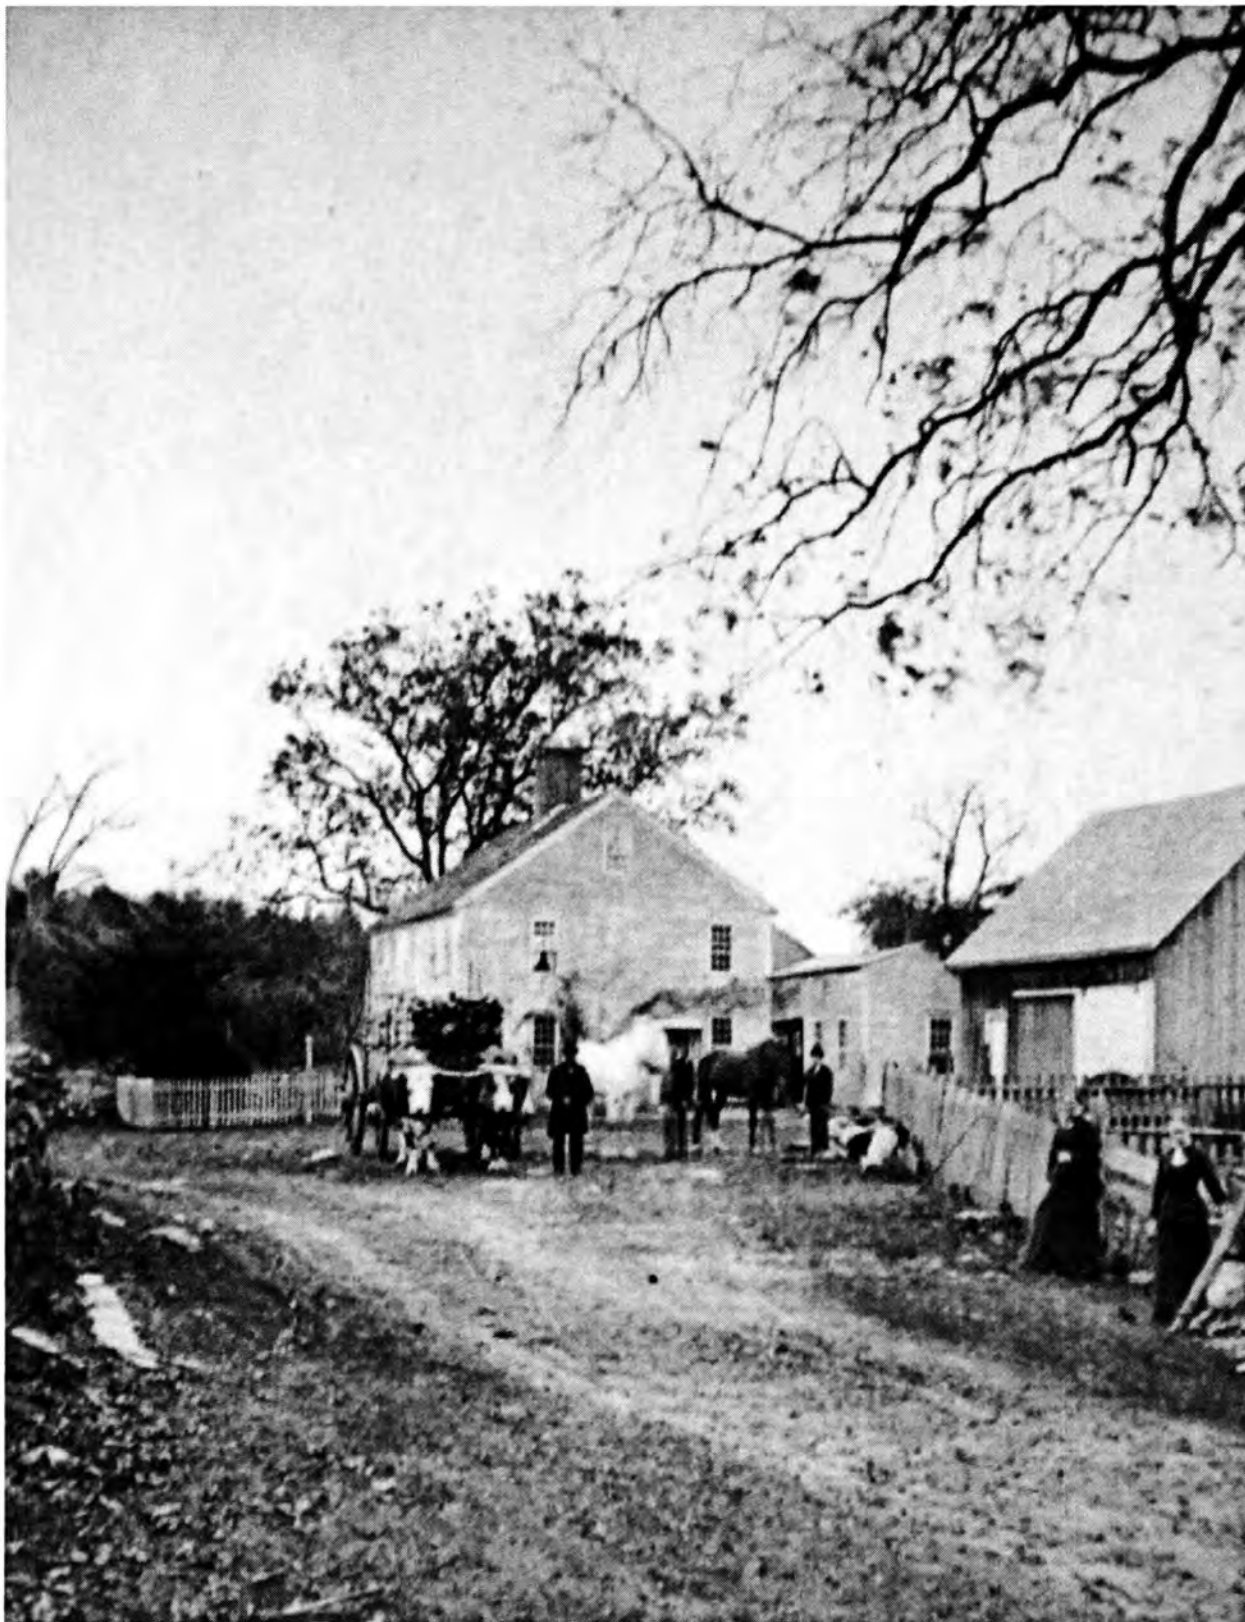
Late 19th century

Late 19th century: carriage house and shoe shop to right of house

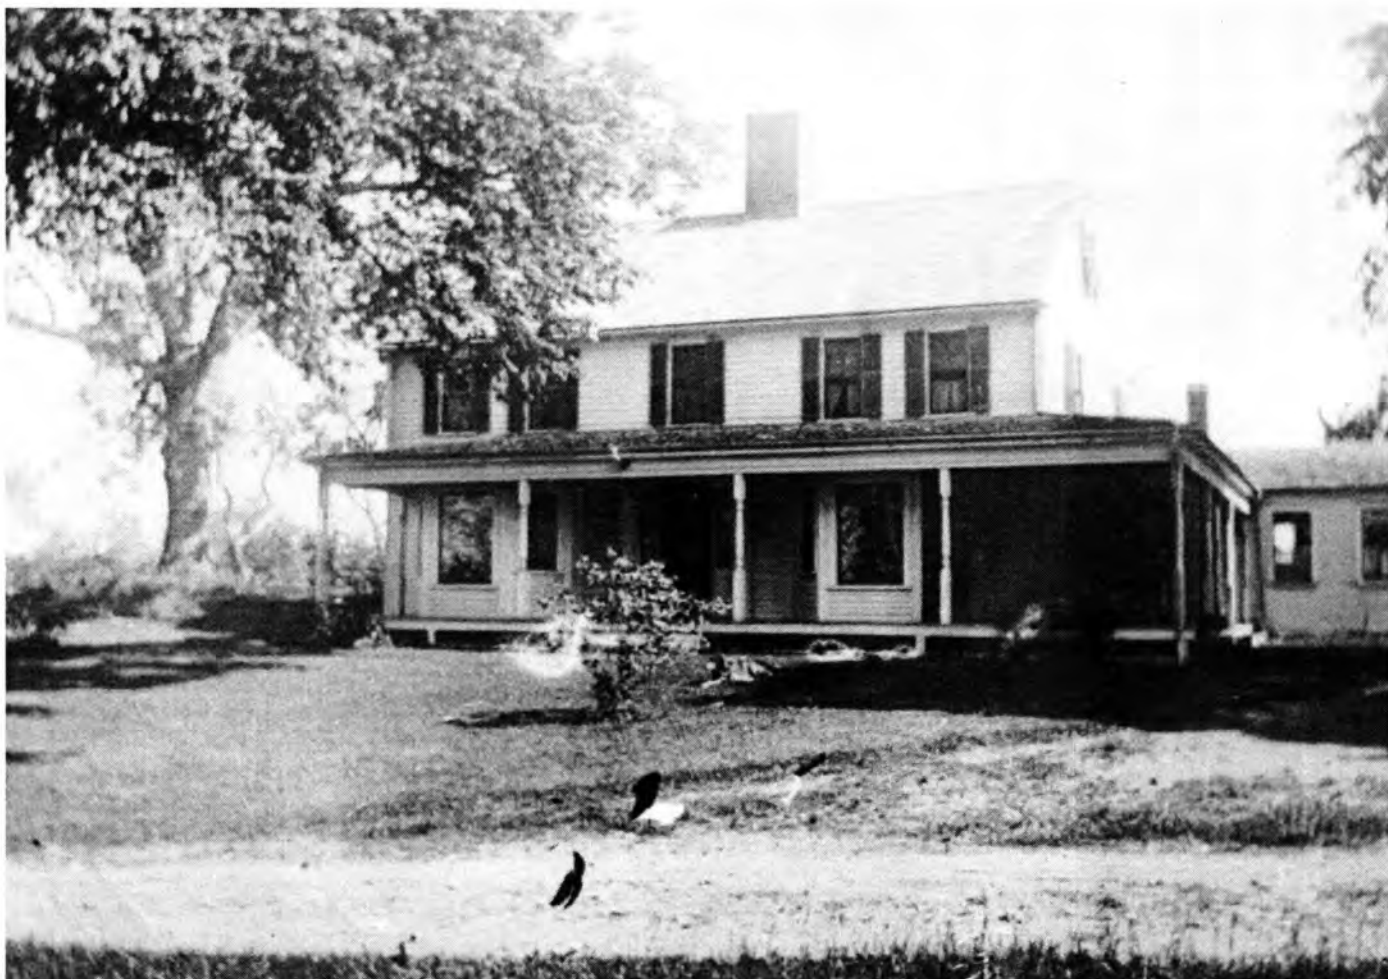
Farmhouse in 1936

although the original turned-wood posts were replaced by simple square posts (between 1936 and 1954). Fenestration has been modified in several locations. The existing door at the east elevation is in the location of an original window (changed between 1936 and 1954); today it holds a glazed wood door that appears to date to the mid 20<sup>th</sup> century. Historic photographs indicate that there had previously been a doorway at the center of this elevation, which was likely installed when the porch was first constructed around 1905, but had been removed between 1936 and 1954. In more recent years (ca. 1970s), a wide casement window was added in place of an original, smaller window at the north end of the east elevation (first floor). Changes to two window openings at the first floor of the rear elevation are also evident (dates unknown). A door, sheltered by a small gabled porch, was added at the west elevation (likely mid 20<sup>th</sup> century), and holds a glazed/paneled wood door. A single-story kitchen addition (ca. 1930s) with a shed roof covers approximately half of the rear elevation of the main block. This small, utilitarian addition covered by vinyl siding features little ornamentation, aside from a bay window on its north side. Adjoining the kitchen addition to the east is a small single-story ell that today connects the main house to the carriage house. There was formerly a mid 19<sup>th</sup>-century cobbler shop in this location (visible in attached historic photo from the late 19<sup>th</sup> century), but around 1910 it was either replaced or rebuilt to give us the existing structure (although it appears that the original foundation of the cobbler shop was reused). This has been altered over the years, with the addition of a small porch (east side) and modern doors and windows. It was later connected to the adjacent carriage house (see below).

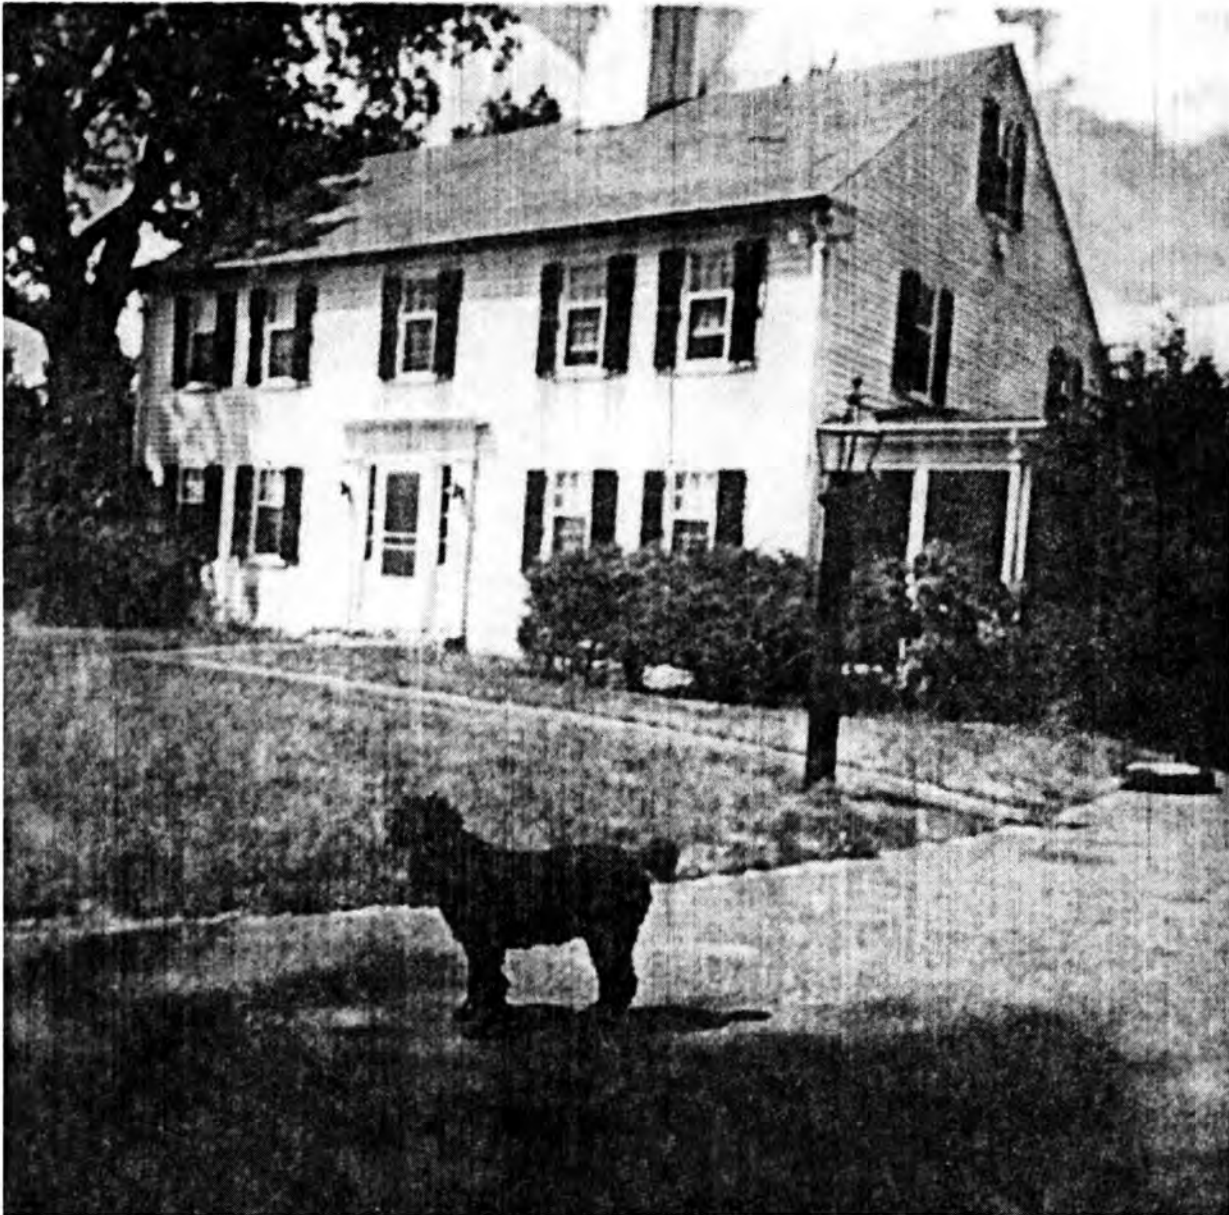
Farmhouse in 1966

Farmhouse (1790; Photos 1-5) – The farmhouse consists of a main block, a modern rear kitchen addition, and a small ell that connects the house to an adjacent carriage house. The main block is a two-story, Federal-style residence built in 1790 (see attached photo from late 19<sup>th</sup> century). It is a typical, late 18<sup>th</sup> century, five-bay house with a center entry and large central chimney, typical of houses built before 1830, when kitchens were still constructed within the main body of the house rather than in attached ells. It rests on a low fieldstone foundation and is enclosed by a gable roof finished with asphalt shingles. Most window openings hold 6/9 wood replacement sash to match the originals, and feature wood slatted shutters. Although shutters came into common use in the end of the 18<sup>th</sup> century, it does not appear that they were used on this house until much later. Historic photographs of the house indicate that shutters were not installed until after 1900. Vinyl siding now covers the clapboard exterior. Small sections of the vinyl were recently removed from the main house and carriage barn. The clapboards found beneath the siding on the house appear to be late 18<sup>th</sup> or early 19<sup>th</sup> century fabric (joints are skived and nails appear ca. 1800). The main entry appears to be original to the house, and consists of a historic eight-panel wood door flanked by partial sidelights with paneled aprons. Wide, paneled pilasters supporting a high entablature frame the doorway. Around 1905, the exterior of the house was “updated” with the addition of a single-story front porch across the façade (south elevation) and east elevation. About the same time, two bay windows were added at the façade (on either side of the entry), and one at the south end of the east elevation. The bay windows and porch along the façade were removed at some point between 1936 and 1954. The porch remains along the east elevation,

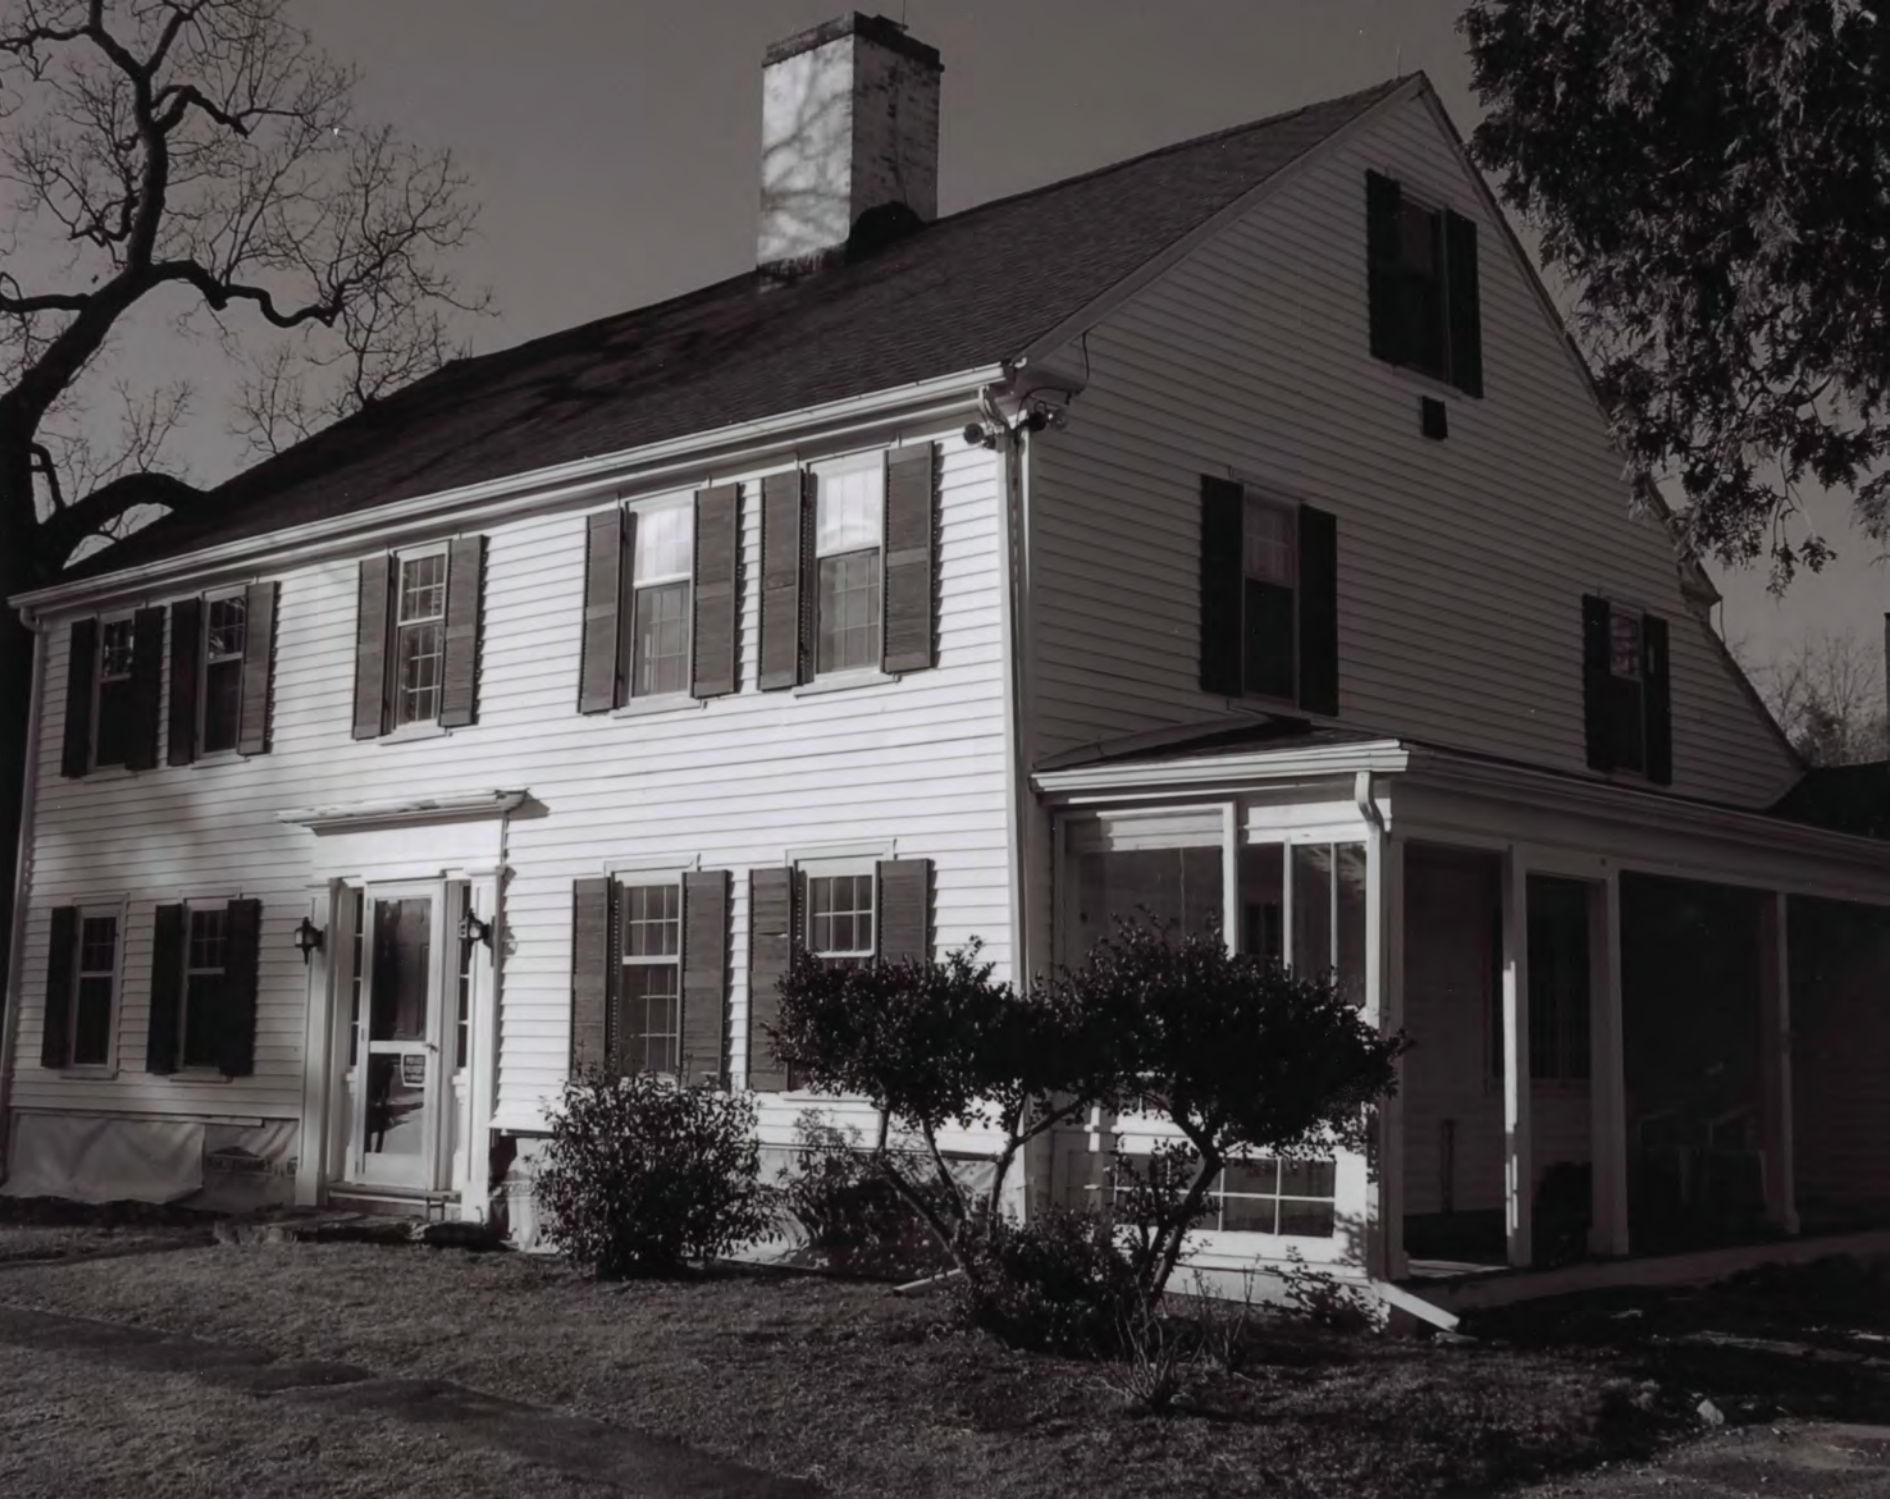
PHOTO #1

VIEW NW showing facade (R) and west elevation (L)

The main block follows the double-pile, central-chimney plan that served as the most common house type in New England between 1760 and 1830. The main entry opens into a small stairhall (or “porch” in early architectural terms) with a steep, narrow winder staircase backing up to the central chimneystack (Photo 3). The chimney appears to have been entirely reconstructed ca. 1830, reusing some of the older bricks from the first chimney. The interior of the main block remains remarkably intact, particularly the front rooms and front stairhall, where the original layout is preserved. Throughout the house, particularly in the front rooms, many features from the original 1790 construction remain, including wide wood flooring, pine-beam casings, hand-split lath, horse-hair plaster, four-panel doors, flat baseboards flush with the walls, and flush door casings with simple band moldings (Photo 4). Early 19<sup>th</sup>-century modifications to several fireplaces are also evident (reconstructed fire boxes and mantels). The use of oak framing members (for purlins and some posts), hand-hewn rafters (visible in the attic), and cut nails (found in upstairs flooring and beam enclosures) is consistent with the 1790 construction date. Typical of many Federal-period houses, the beams and posts were originally encased and the walls plastered to provide a more finished appearance. In the case of the Towne house, framing members in nearly all rooms are obscured by hand-planed pine casings assembled with hand-cut nails; however, in the original kitchen at the rear of the house, it appears the earliest period framing was whitewashed in lieu of finishing. Rooms at the rear of the house have undergone more significant alteration than those at the front but, overall, changes have been sympathetic to the historic character of the house.

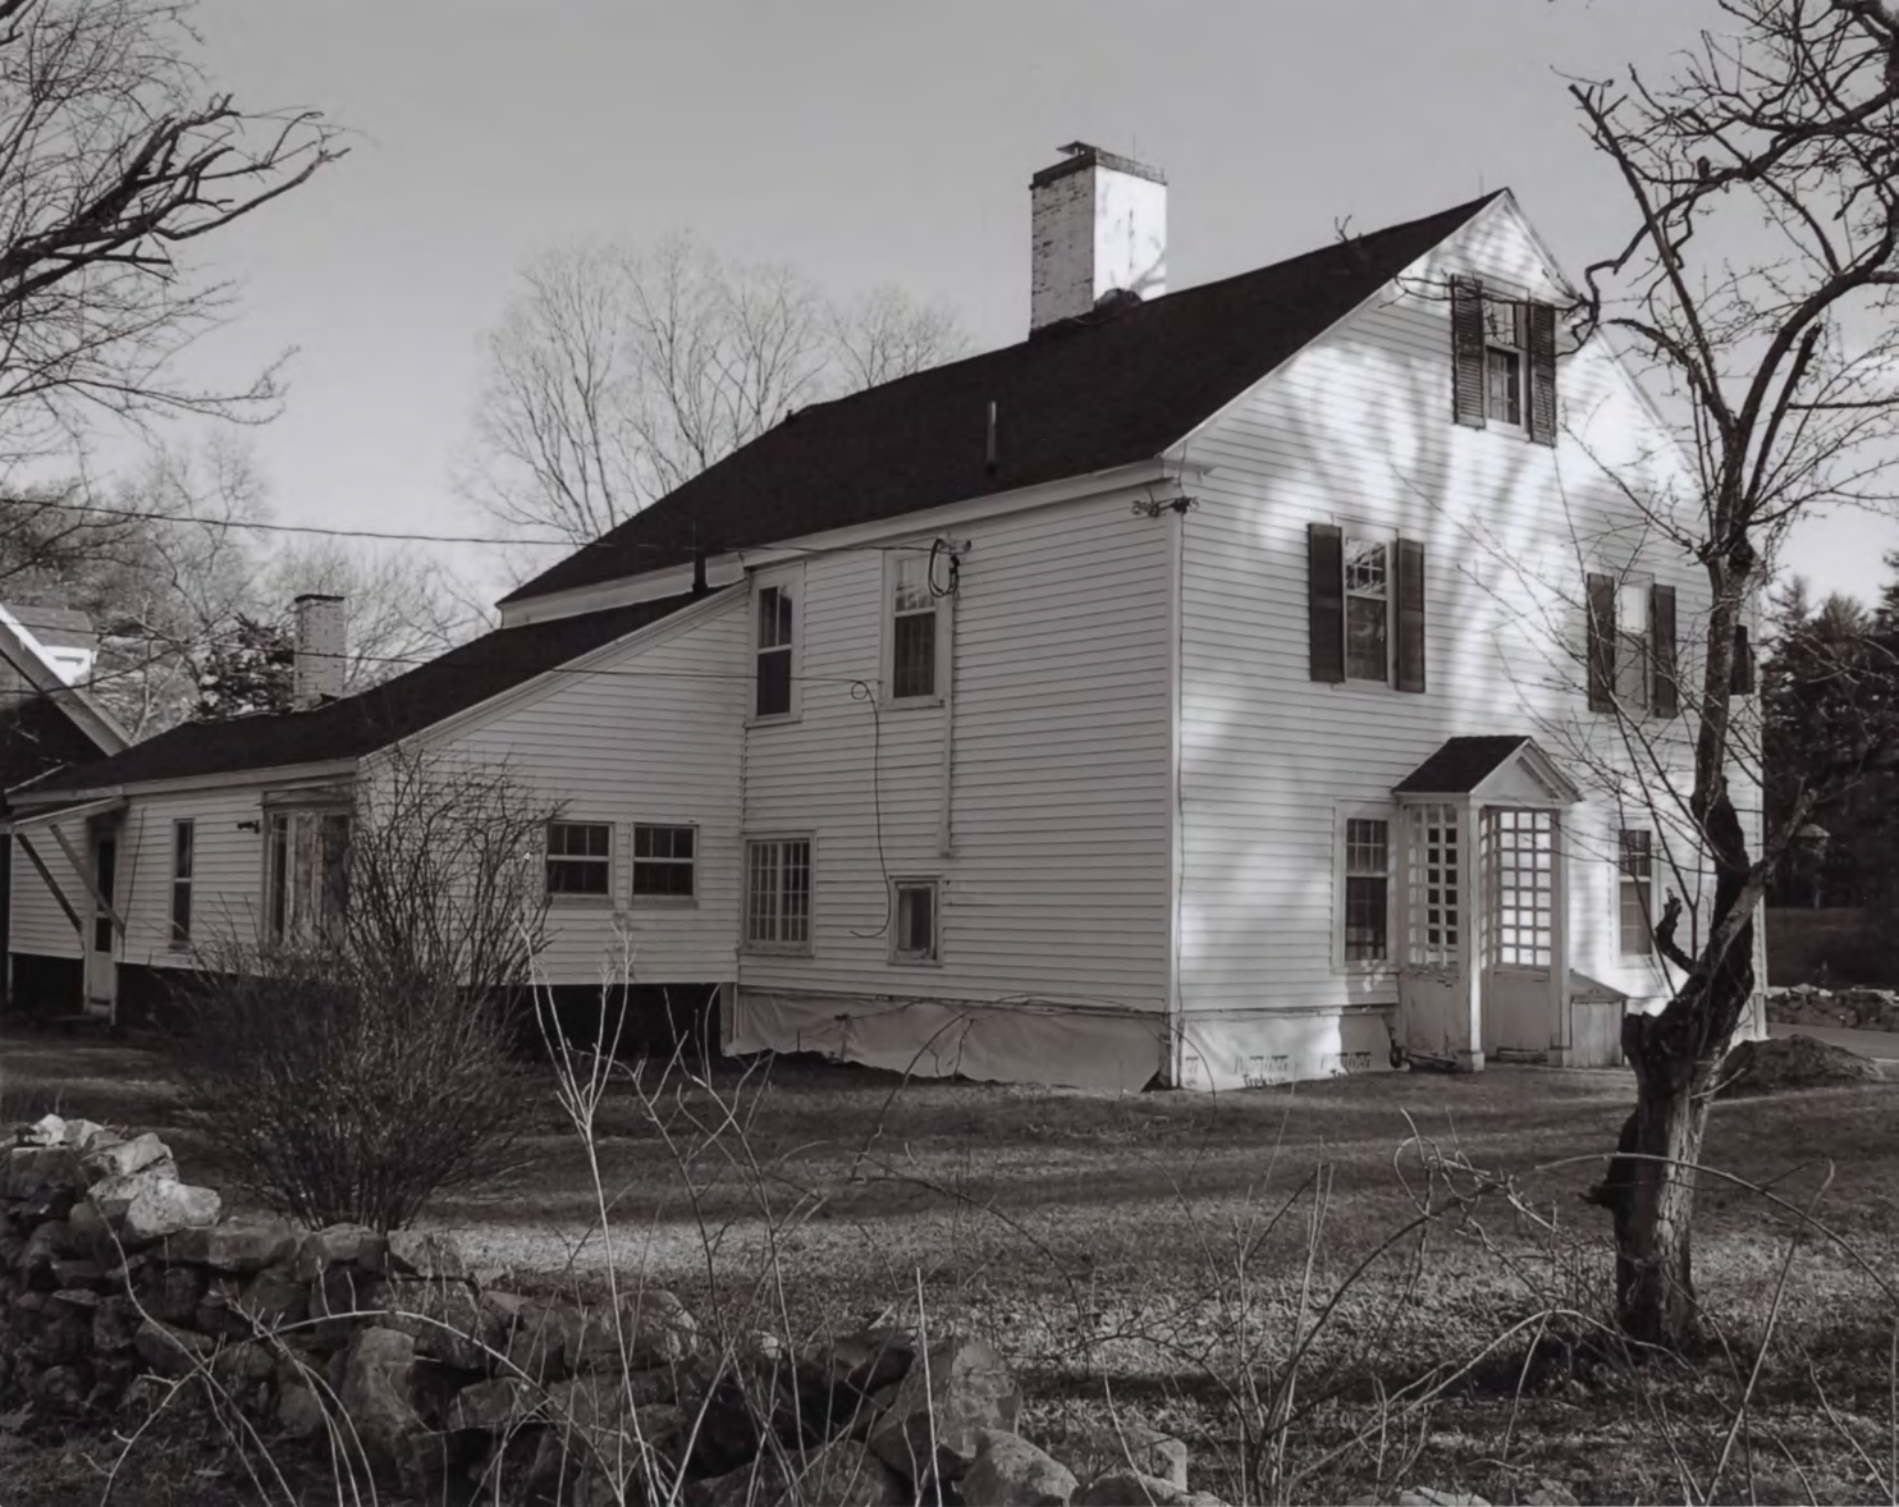
Photo # 2

View SE showing W elevation (R) and near elevation (L)

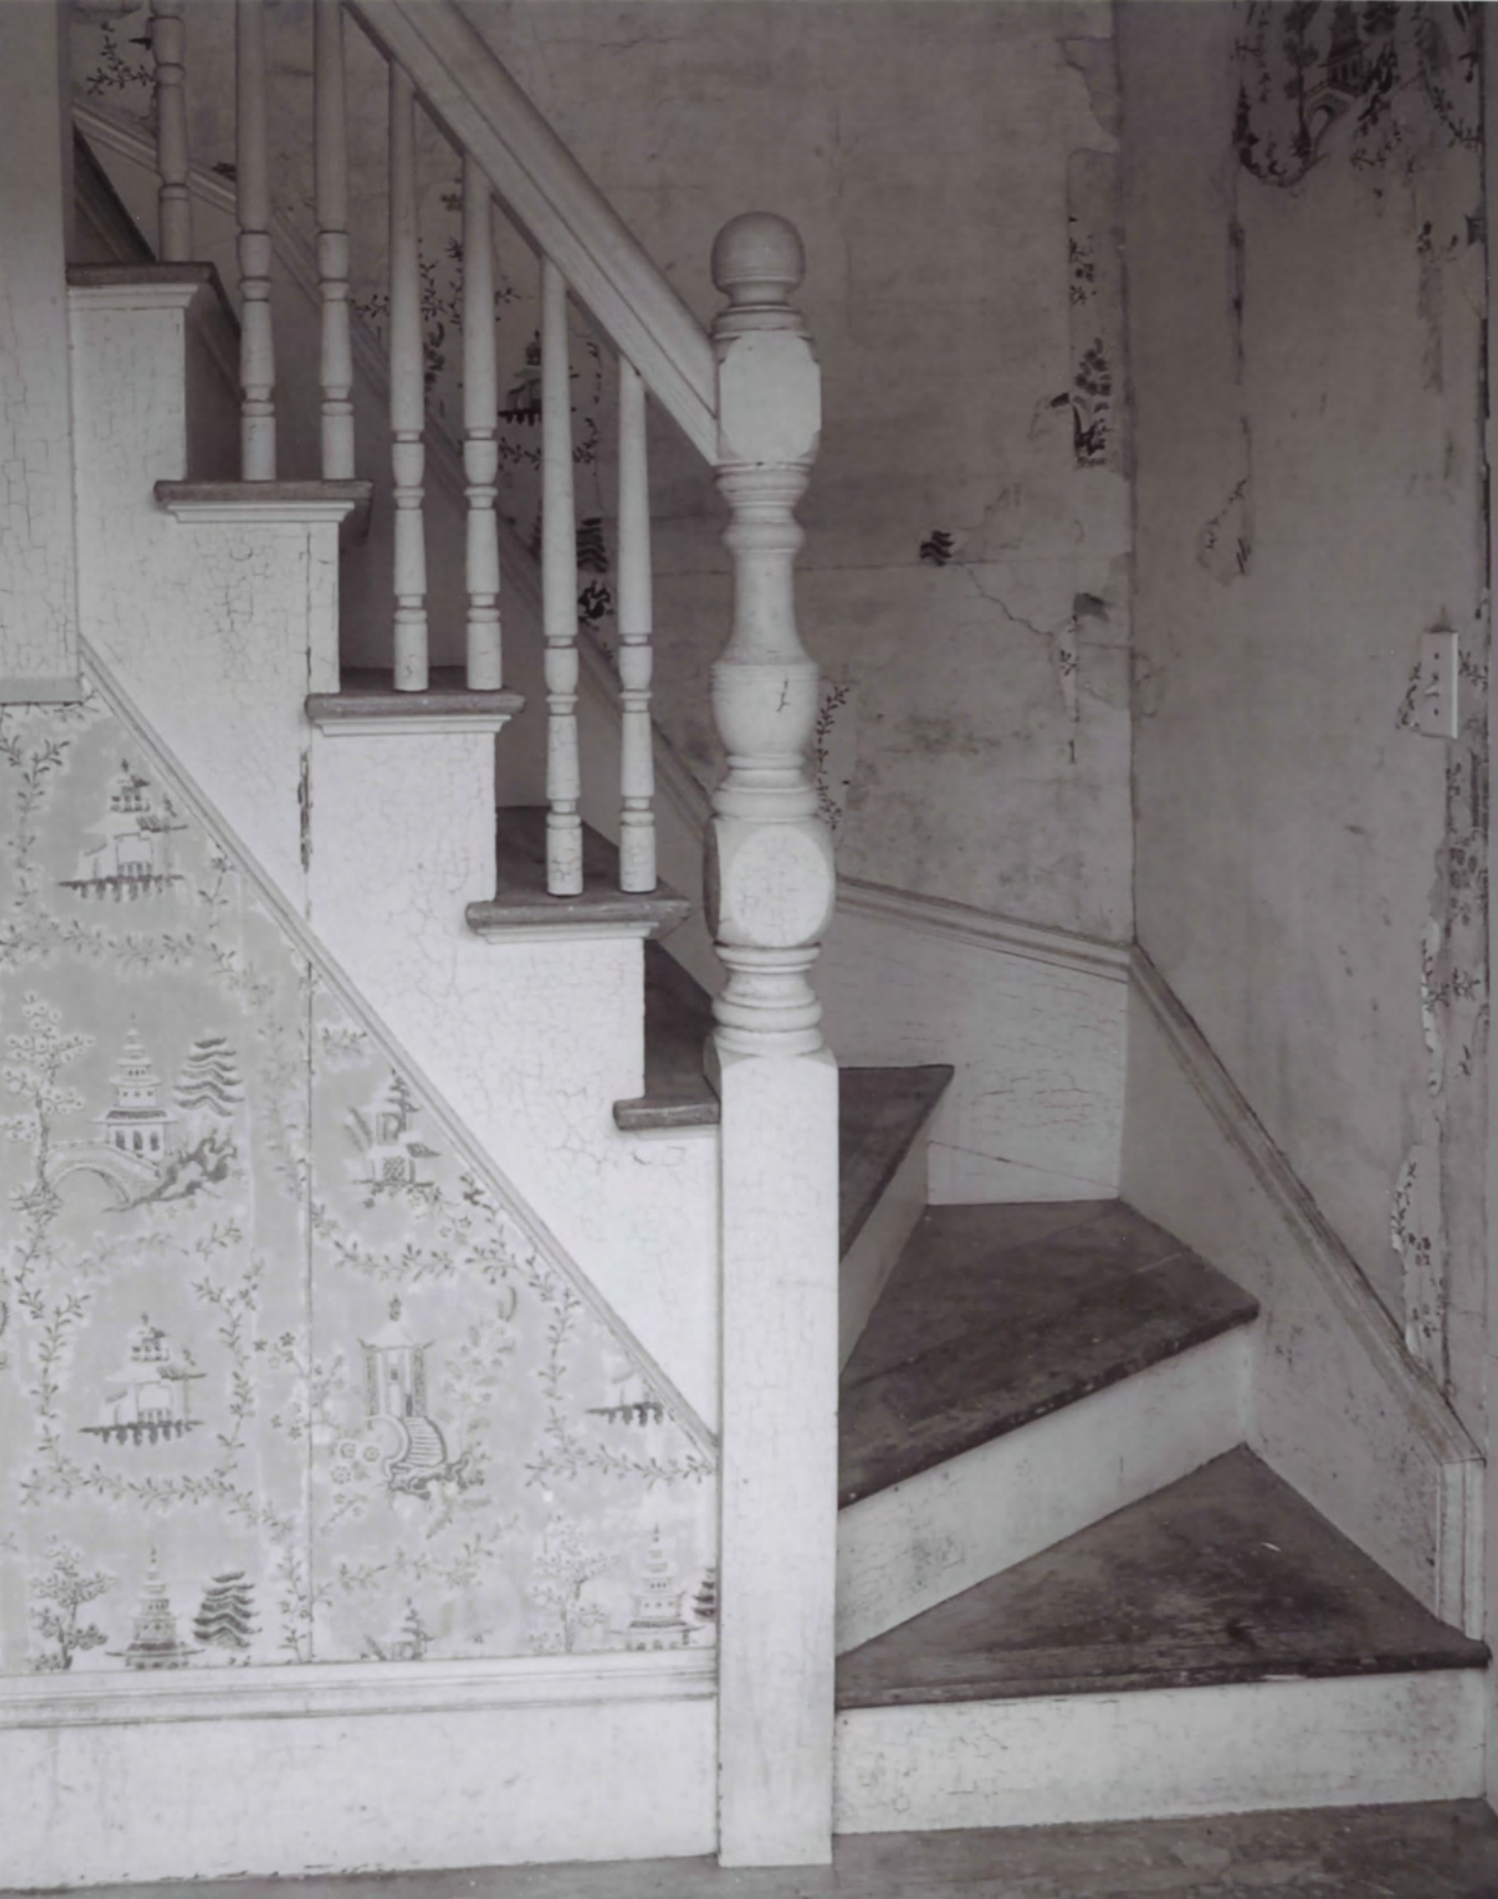
Photo #3

VIEW N showing stairhall at 1st floor

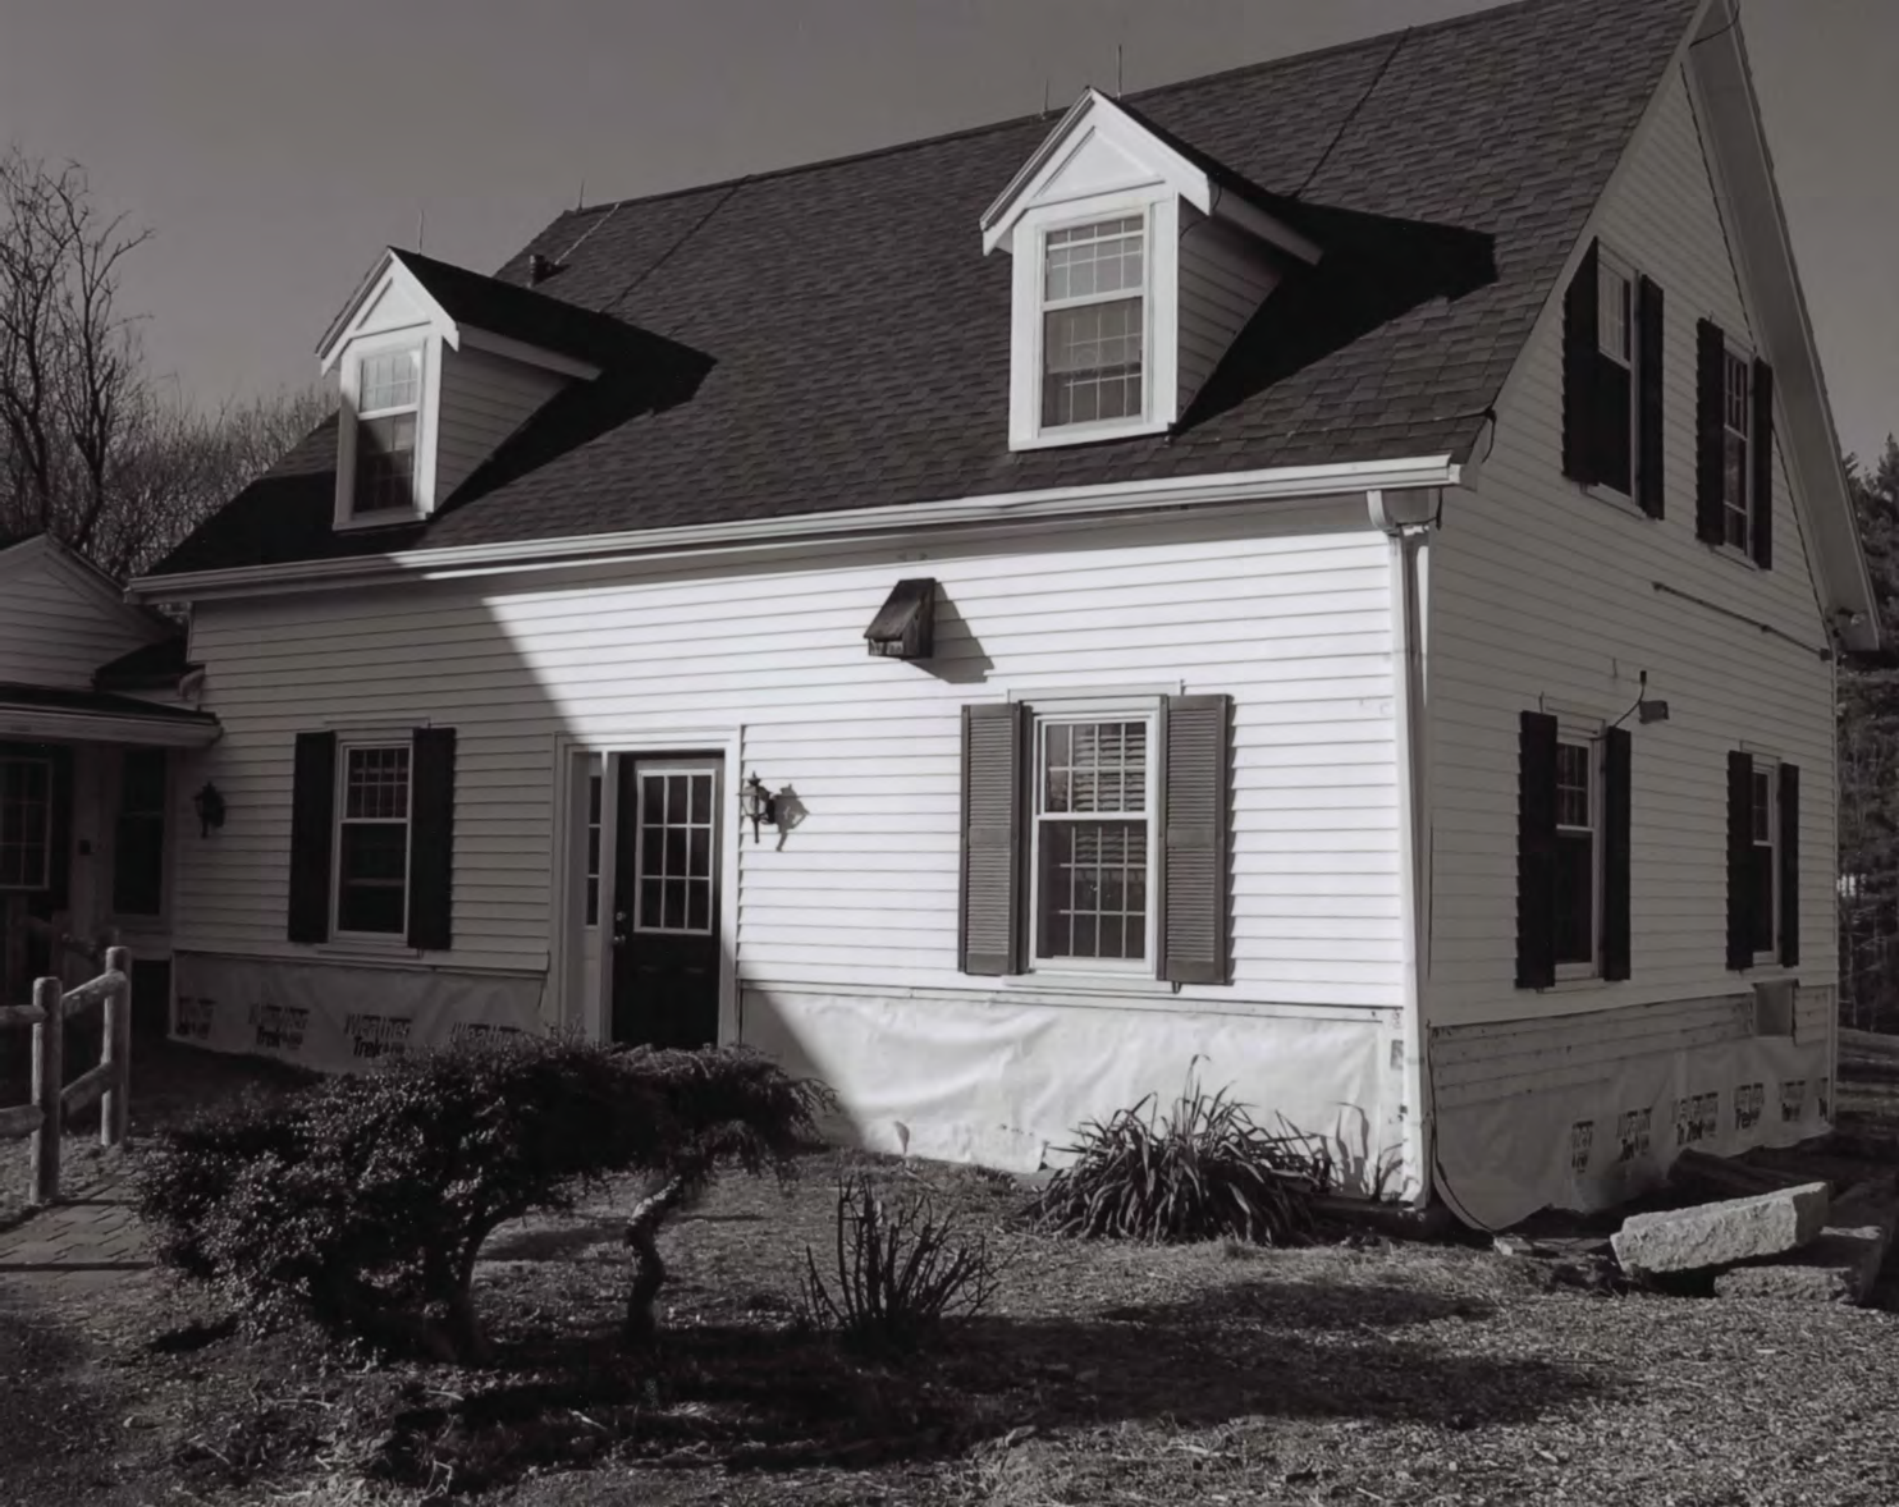
Photo # 6

Carnage House

Carriage House (1858; Photo 6)—The carriage house was originally a freestanding structure, and remained that way into the 20<sup>th</sup> century. The carriage house has a rectangular plan, and is enclosed by a gable roof finished with asphalt shingles. While the exterior has been altered significantly, the frame of the original building remains intact. The earliest photographs of the building (visible in attached historic photo from the late 19<sup>th</sup> century) show that it had narrow board-and-batten siding, and a large sliding barn door on its façade (south elevation). Later images show that painted clapboard had been installed on the front. Today, the front and east elevations are covered by vinyl siding, while the rear (north) and west elevations have wood-shingle siding. There are two layers of historic siding beneath the vinyl of the carriage house. These consist of 20<sup>th</sup> century clapboards over what appears to be the original 19<sup>th</sup>-century vertical board siding. Windows, dormers, an entry door, and rear chimney were all added to the building. The interior is divided into two floors, the lower level being a single large space with a later (ca. 2003) bathroom and closet space along one side. The upper floor holds two bedrooms, a bathroom, and various closets, and appears to have been finished as living space earlier (possibly in the early years of the 20<sup>th</sup> century). These rooms may have housed hired help—census records confirm that Hiram Towne had at least one farm laborer living on the property as early as 1900. Finishes in the bedrooms and hall include wood floors, chamfered wood baseboards, and two-panel wood doors, all consistent with early 20<sup>th</sup> century interiors. Although the first floor has recent wall paneling and a drywall ceiling, many of the historic framing members remain; the visible ceiling beams are purely decorative.

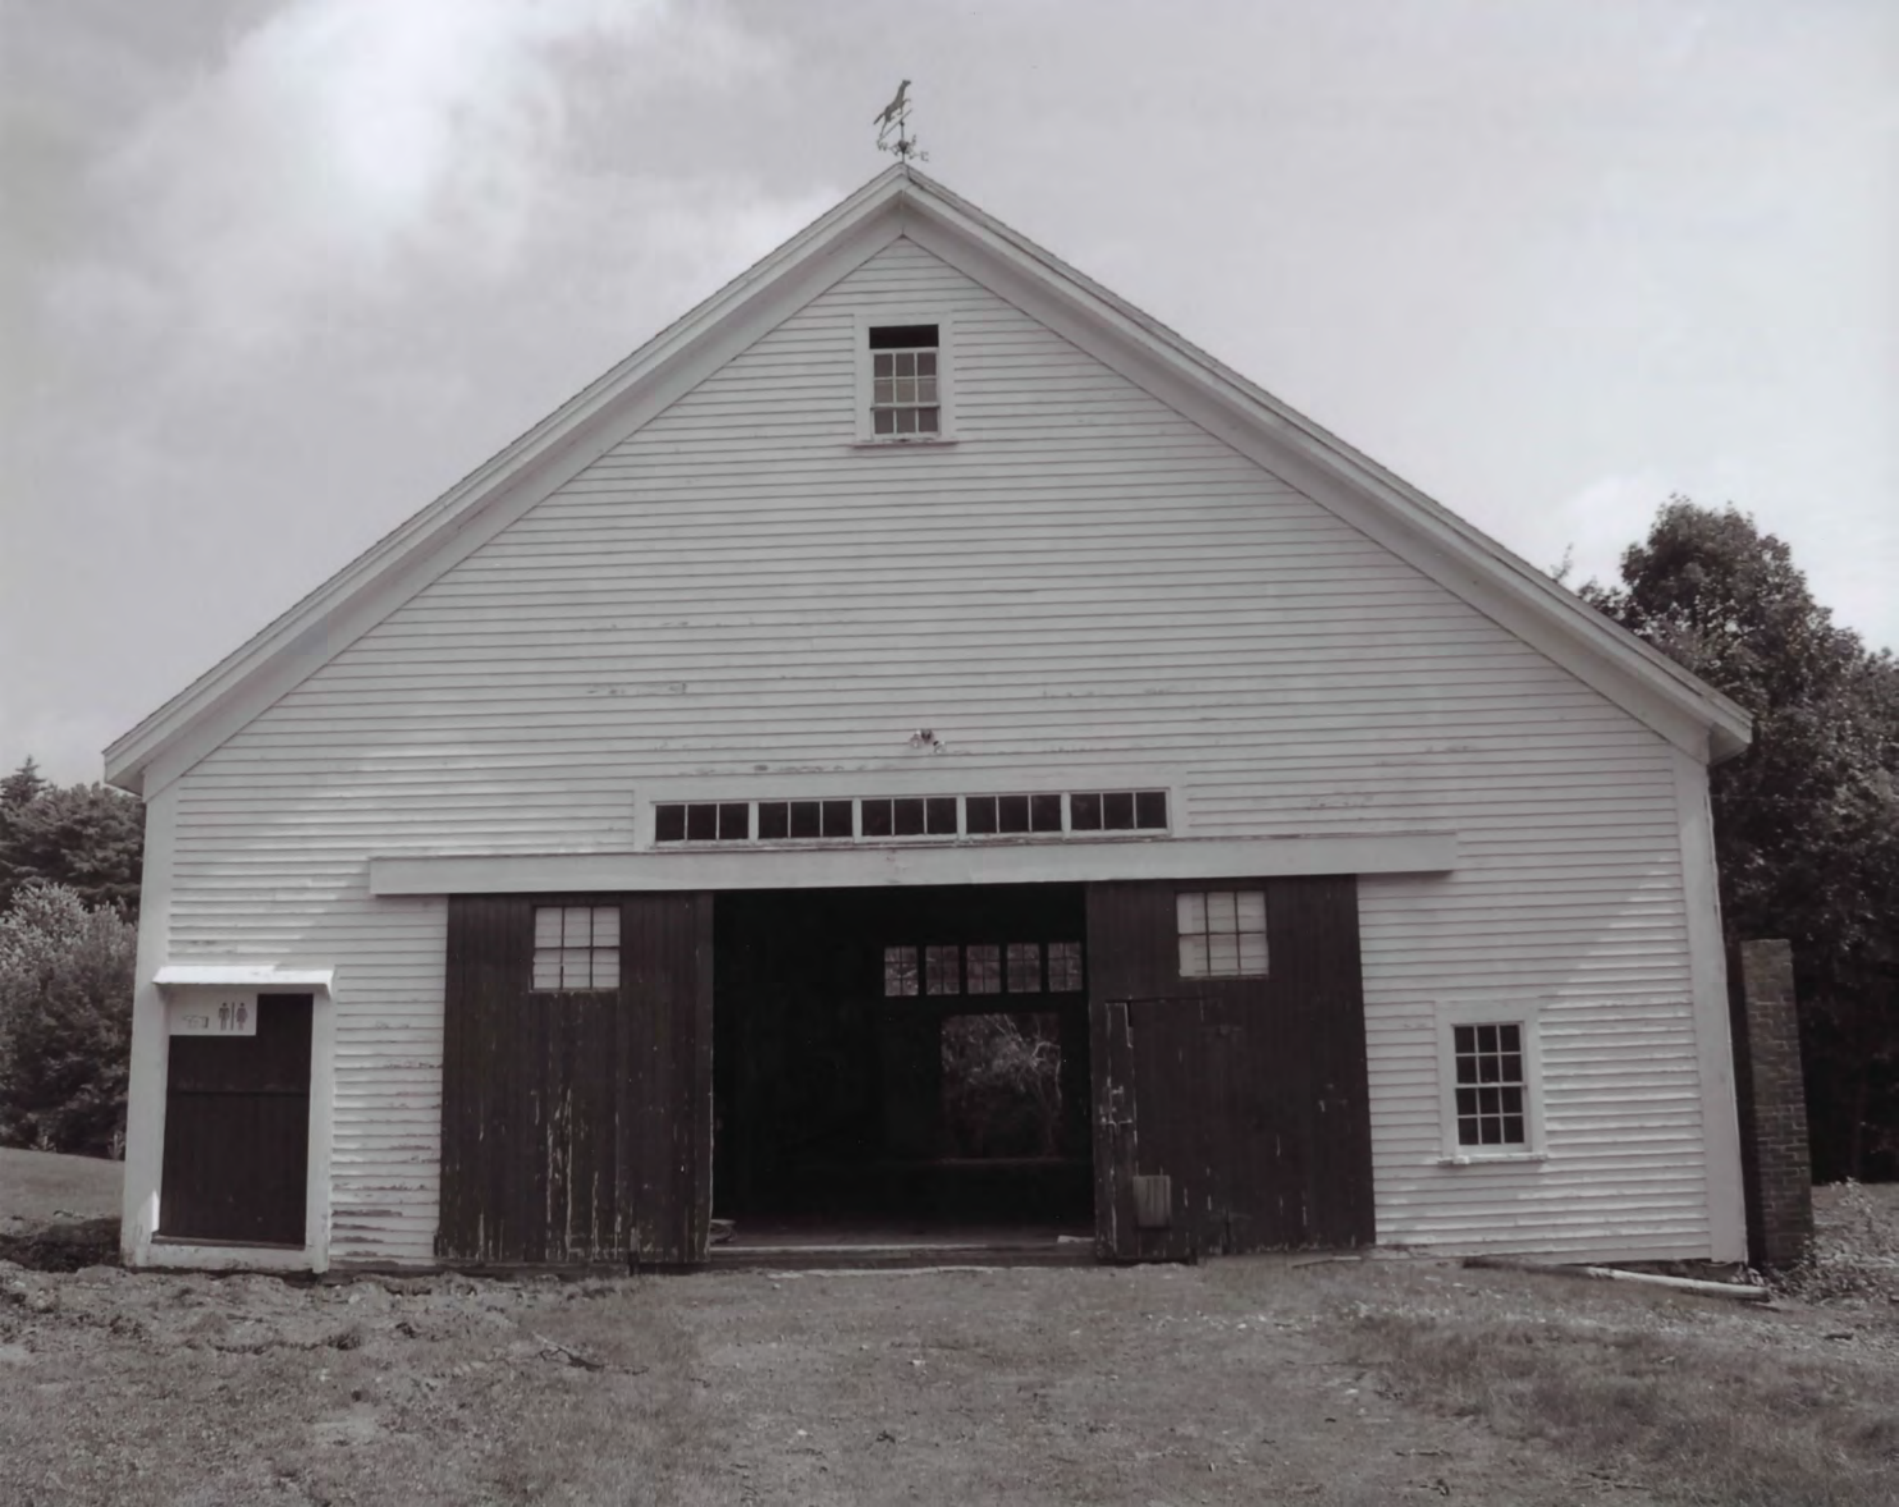
PHOTO # 7

Baru

Barn (late 18<sup>th</sup> century/late 19<sup>th</sup> century; Photo 7)—The barn that exists today is the result of the enlargement of an earlier structure, a ca. 1790 English tie-beam barn measuring 40'x 20' (according to the 1799 tax valuation). The earlier barn was set with its gable ends facing east and west, and featured a large entry along the eave side, facing south. In the late 19<sup>th</sup> century, the barn was enlarged by adding several bays to the rear (north) and changing the direction of the ridgeline to create a front-facing gable. The hand-hewn frame of the older barn remains visible, with most of the tie beams intact, although some of the post locations have been changed. The original hand-hewn timbers at the south end of the barn are clearly distinguishable from the later sawn timbers at the rear. Today, the barn is finished with painted clapboard siding at its facade (south elevation) and painted wood shingles at the remaining elevations, all covering the original sheathing. The massive gable roof is finished with asphalt shingles; however, the original roof sheathing is visible on the interior. The façade is dominated by a wide central entry holding a pair of sliding wood replacement doors. The entry is topped by a multipane transom that was added sometime after 1936. A similar entry is located at the north (rear) elevation. Access to the lower level of the barn from the exterior is by means of two large openings, one at the east elevation and another at the rear elevation. The main level of the barn is laid out with a broad central drive running from the front to the rear door. West of the drive are four horse stalls that were added in the 1950s. The area east of the drive is divided into a series of small workrooms and storage areas by a mix of wood-plank partitions installed at various times. An interesting feature of the late 19<sup>th</sup>-century construction is what appears to be an interior above-ground silo (measuring roughly 14 feet square) in the northeast corner of the barn.
