## National Register of Historic Places Registration Form

historic name Towne Farm

street & number 55 Towne Road

city or town Boxford

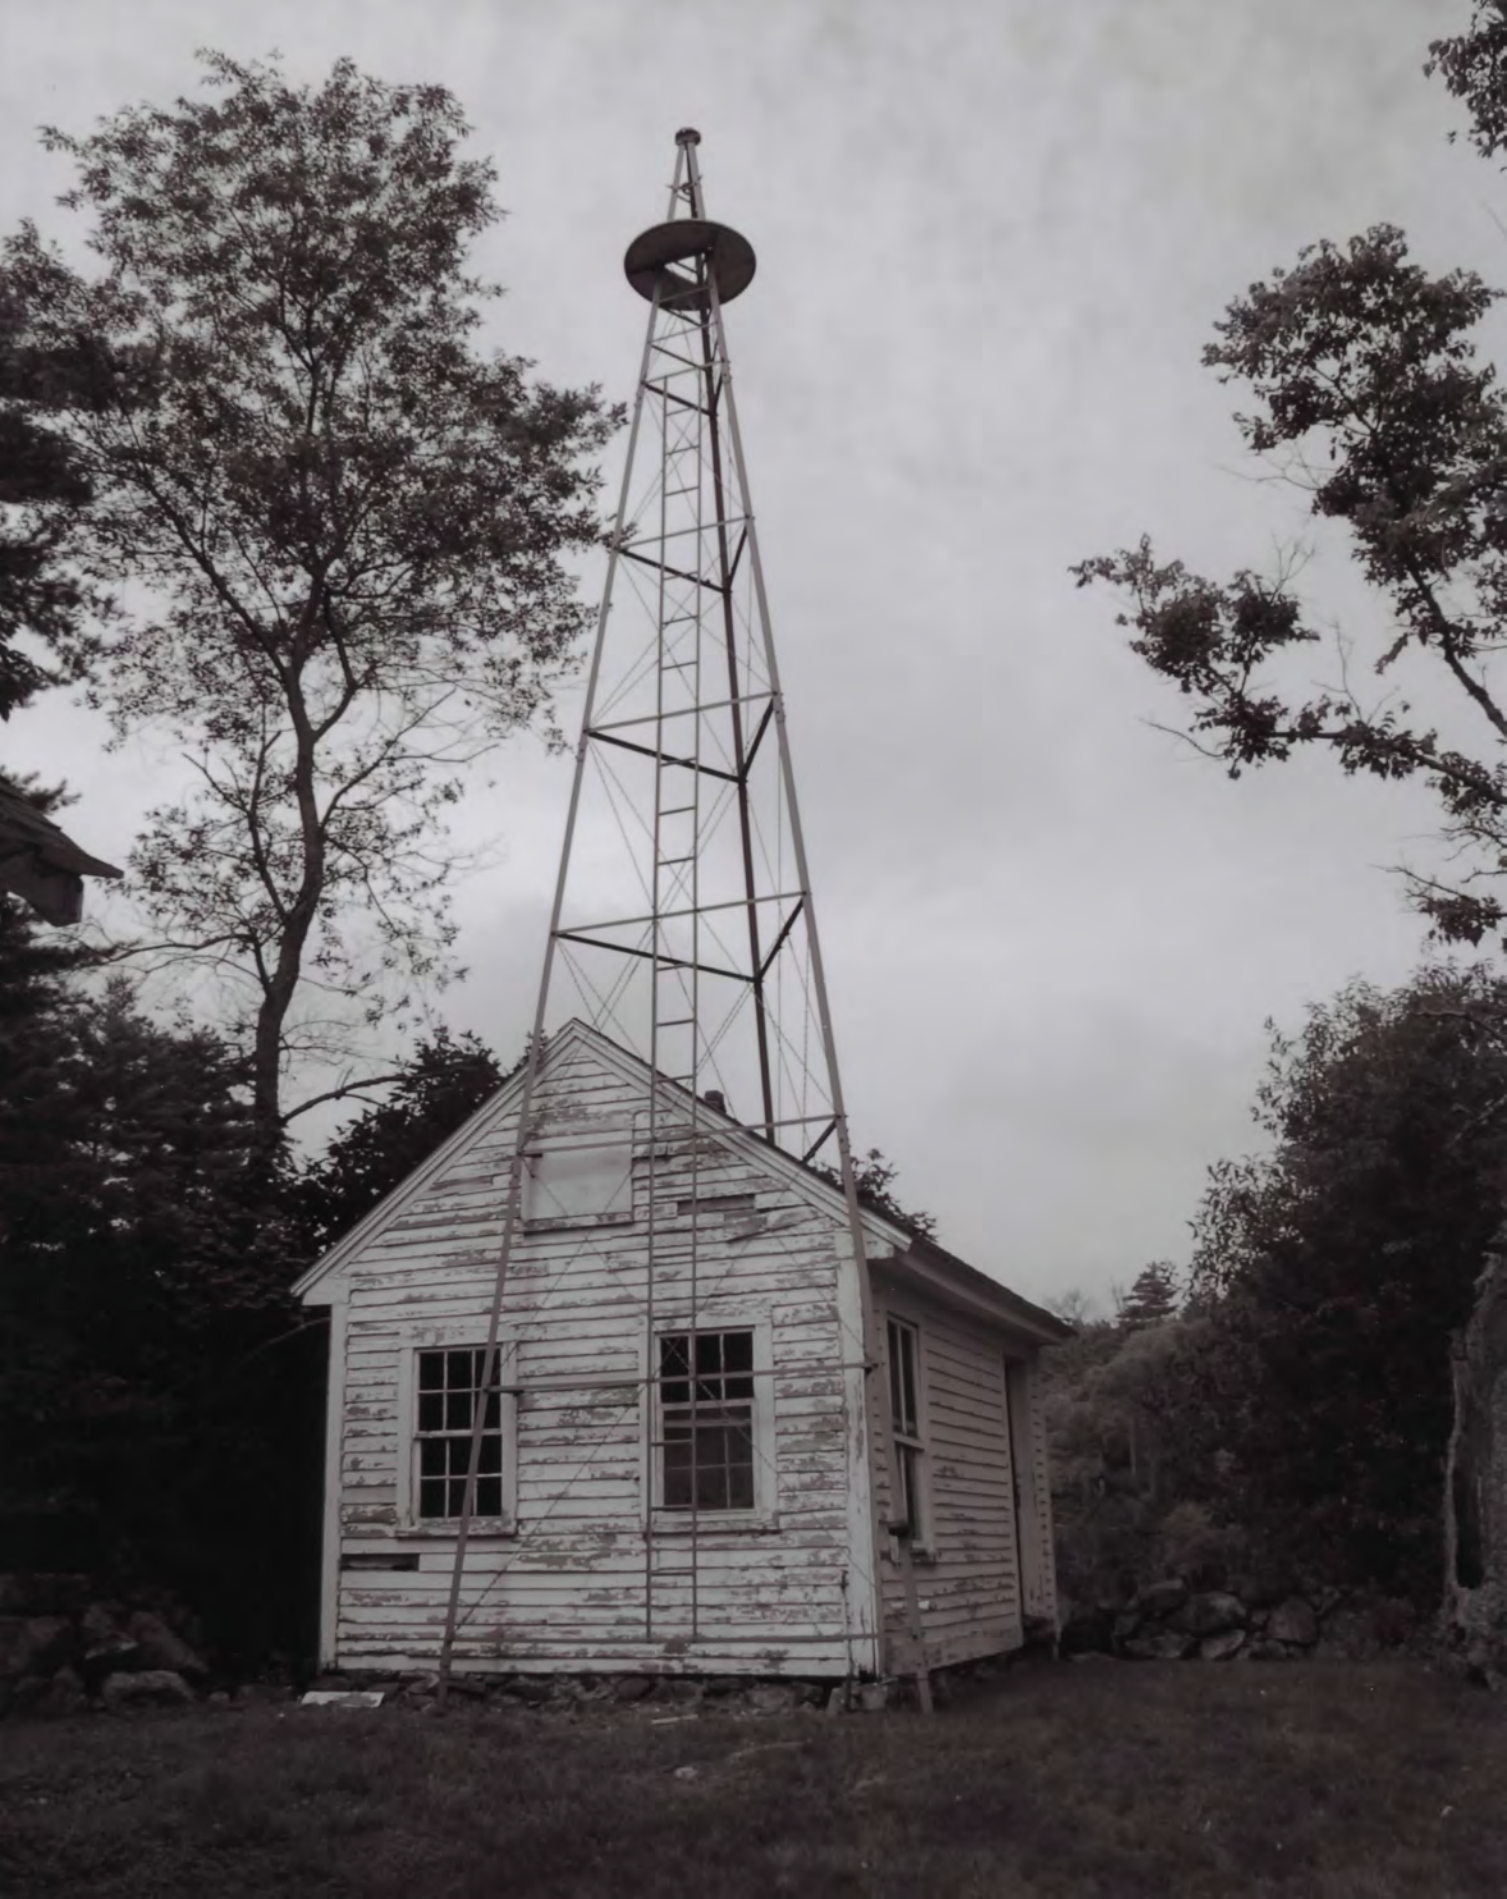
PHOTO # 8

Pump House / Windmill

Pumphouse/Windmill (1902; Photo 8)—The pumphouse is a small, rectangular structure that rises from a rough fieldstone foundation and is enclosed by a gable roof (finished with asphalt shingles). The exterior is finished with clapboards at the north, south, and east elevations, while the west elevation is finished with unpainted wood shingles. Wood trim elements include narrow cornerboards, flush window casings, and a simple box cornice. Windows hold older, double-hung wood sash (2/2 and 6/6). There are three entrances to the building: one at the north elevation holding a four-panel wood door; another on the west elevation with a sliding batten door; and a third on the south elevation, covered by a simple batten door (all doors appear to be historic features). The framework of a tall metal windmill (an original or very early feature) projects from the east end of the pumphouse, although the blades and vane are no longer in place. The windmill tower extends down through the roof to the interior of the building where it was once connected to a pump beneath the floor. The interior of the building is finished with wide-plank wood flooring and narrow beaded board over the walls and ceiling. According to Bertha (Towne) Crosby (niece of Hiram Towne), the pumphouse was originally an ell of a nearby house, and was moved to this location (noted in property scrapbook).

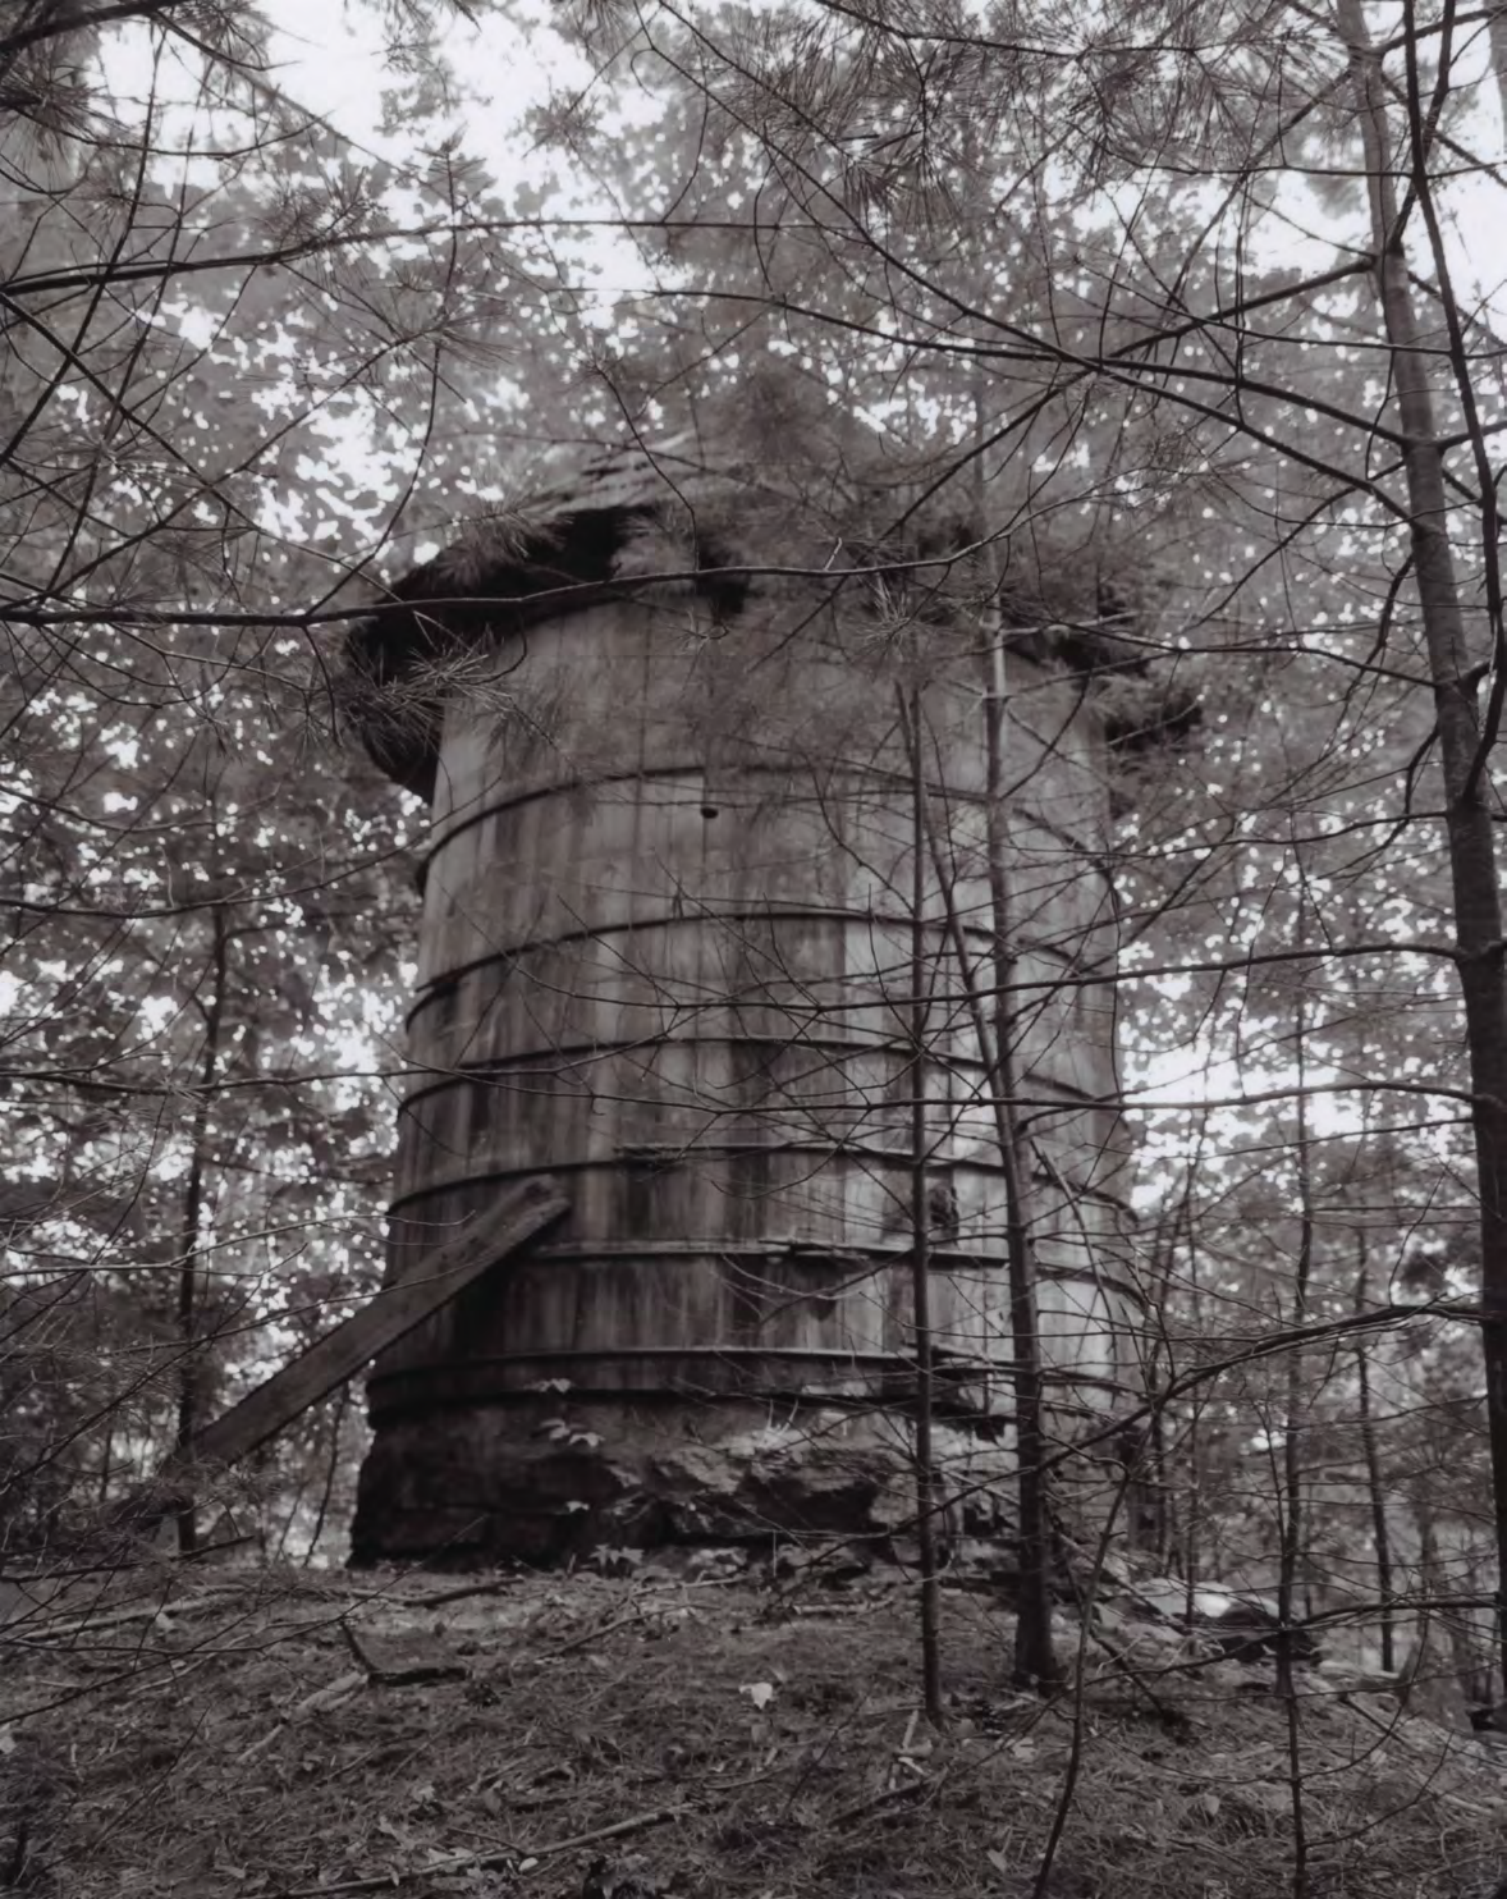
Photo # 9

Water Tower

Water tower (1907; Photo 9)—The water tower is located on a hillside south and west of the other farm buildings. Although it is now overgrown by the surrounding woods, it once stood in open space atop the hill. Historic photographs of the structure document that it has changed very little over time. This circular structure rests on a rough fieldstone foundation, and is enclosed by a conical roof finished with wood shingles. The exterior is finished with vertical staves held in place by a series of metal hoops that encircle the volume. Access to the base of the structure is by means of a low doorway on the south side of the foundation (no door remains).

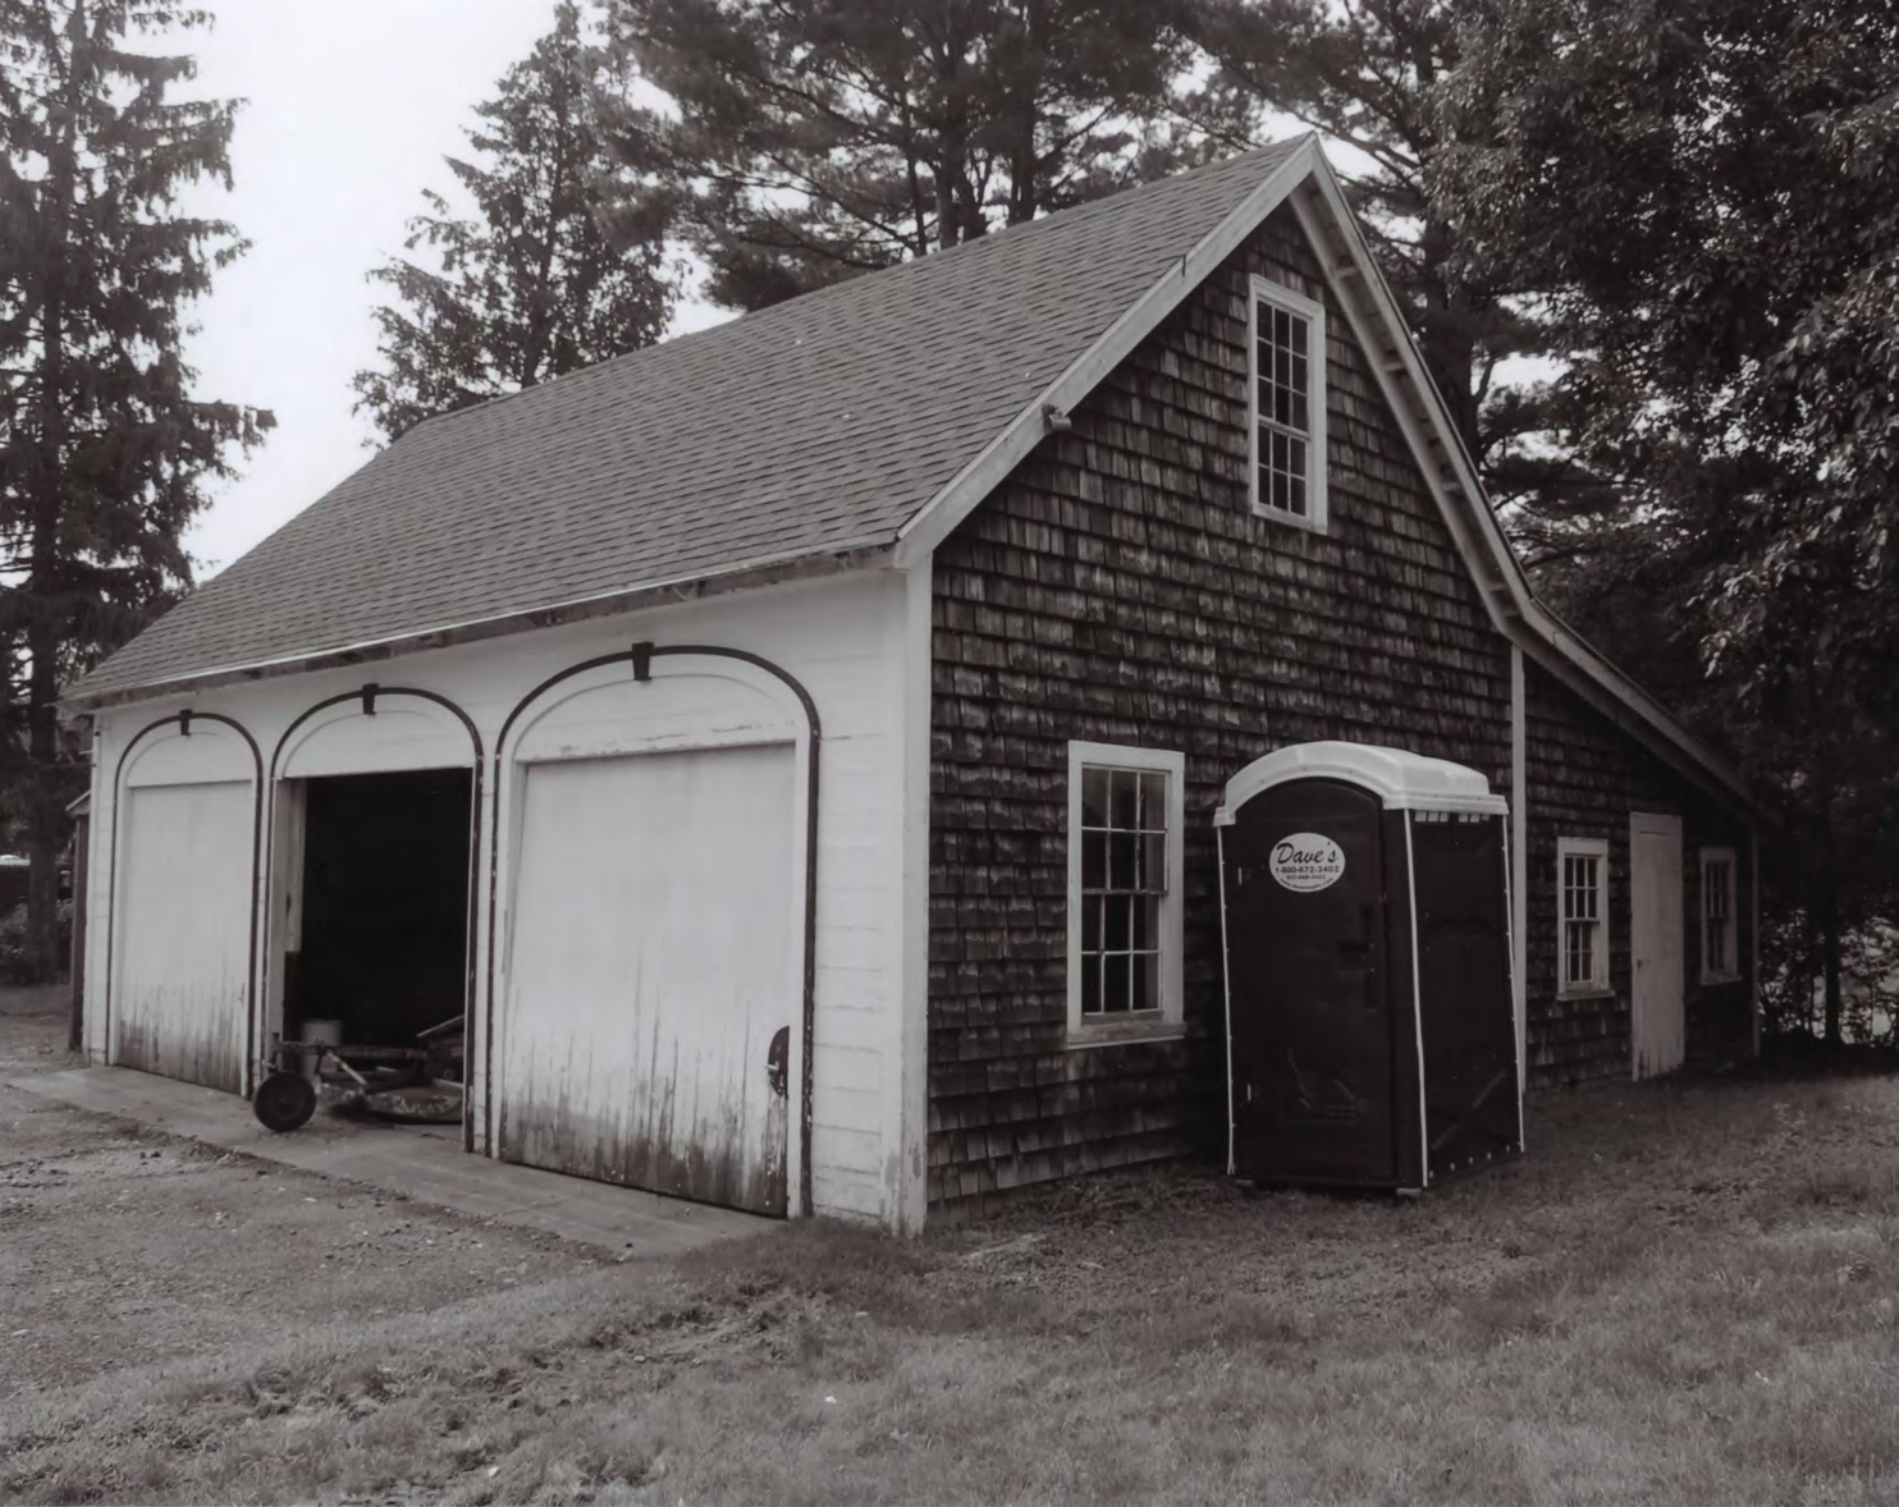
PHOTO # 10

Garage

Garage (late 19<sup>th</sup> century/early 20<sup>th</sup> century; Photo 10)—The garage is a small, single-story building with a rear ell. The exact date of construction is not known, but it appears that it was built in several phases in the late 19<sup>th</sup> and early 20<sup>th</sup> centuries, likely first serving as a shed and later enlarged and converted to hold vehicles. In fact, the rear ell appears to predate the front (northern) garage block. According to family notes, Hiram Towne acquired his first automobile in 1912, so the garage may have been constructed about that time. In addition, a photograph from 1916 confirms there was a building of the same materials in this location. Tax valuations confirm that a shed was added to the property in the early 1880s. Today the building is enclosed by a steep gable roof finished with asphalt shingles. The exposed rafter ends of the roof are visible along the deep eaves. Wide, painted clapboards cover the façade, while the secondary elevations have wood shingle siding (painted at the rear and east elevations only). The principal elevation (north) features three garage bays, two of which have large batten doors. All three bays are topped by a segmental-arched head with a decorative wood keystone. Window openings at the side and rear elevations hold older, double-hung wood sash (a combination of 8/6 and 6/6), and are framed by simple wood surrounds. There are several entrances into the rear additions, holding a variety of wood doors from various periods. A fairly recent wood lean-to covers much of the east elevation of the garage. A concrete-slab floor has been poured throughout the interior, which is divided into three principal storage areas with utilitarian finishes.
