OHIO HISTORIC INVENTORY

1. No. 2	4. Present Name(s) Lock No. 38 ("12 Mile Lock") and Spillway
2. County Cuyahoga	5. Other Name(s)
3. Location of Negatives OHS

2
Cuyahoga
Lock No. 38 ("12 Mile Lock") and Spillway

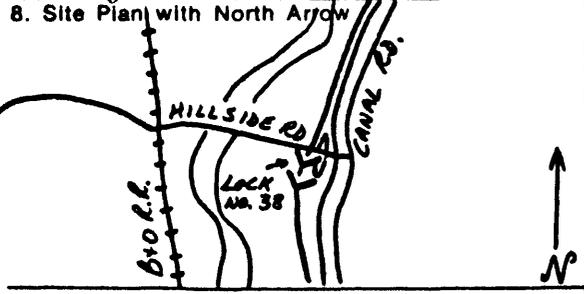
15. Name of Established District Ohio and Erie Canal	25. Open to Public? Yes <input checked="" type="checkbox"/> No <input type="checkbox"/> unrestricted	37. Condition very good XXXX XXXX

19. Sources of Information	29. Photo: looking south through railing of Hillside Rd. bridge over canal.	41. Distance from and Frontage on Road 10' X 100'

42. Further Description of Important Features
All locks on the canal are the standard mitered gate type. The lock chamber is 90 feet long by 15 feet wide. The cut stone construction is masked by a cover of concrete, applied as a stop-gap repair measure c. 1905. Both gates remain intact.
