National Register of Historic Places Registration Form

Historic name: First Congregational Church of Cornwall Parsonage
Other names/site number: _____
Name of related multiple property listing: _____
N/A
(Enter "N/A" if property is not part of a multiple property listing)

Street & number: 18 Route 74
City or town: Cornwall State: VT County: Addison
Not For Publication: N/A Vicinity: N/A

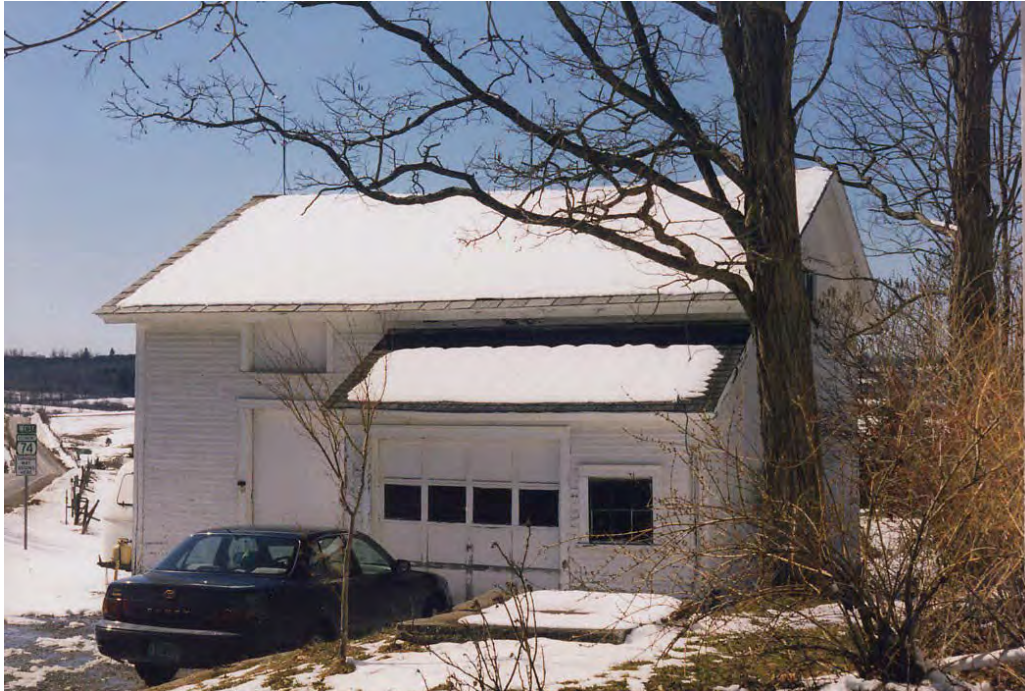
Figure 1. Barn prior to deconstruction, view southwest, c.2000 (owner's personal collection).

Southwest of the house are the remains of a large, rubble stone foundation for the carriage barn, which was disassembled c. 2000. Because building had fallen into disrepair and was located dangerously close to the north side of Route 74, the timber frame was carefully labeled and disassembled by timber framer Jan Lewandoski. It is now in storage for reconstruction on the property at a later date. Like the main house, the carriage barn timber frame has a five-sided ridgepole. In addition, the rafters are mortised into a five-sided top plate, which is a feature Mr. Lewandoski has not seen in any other timber frame structures.²

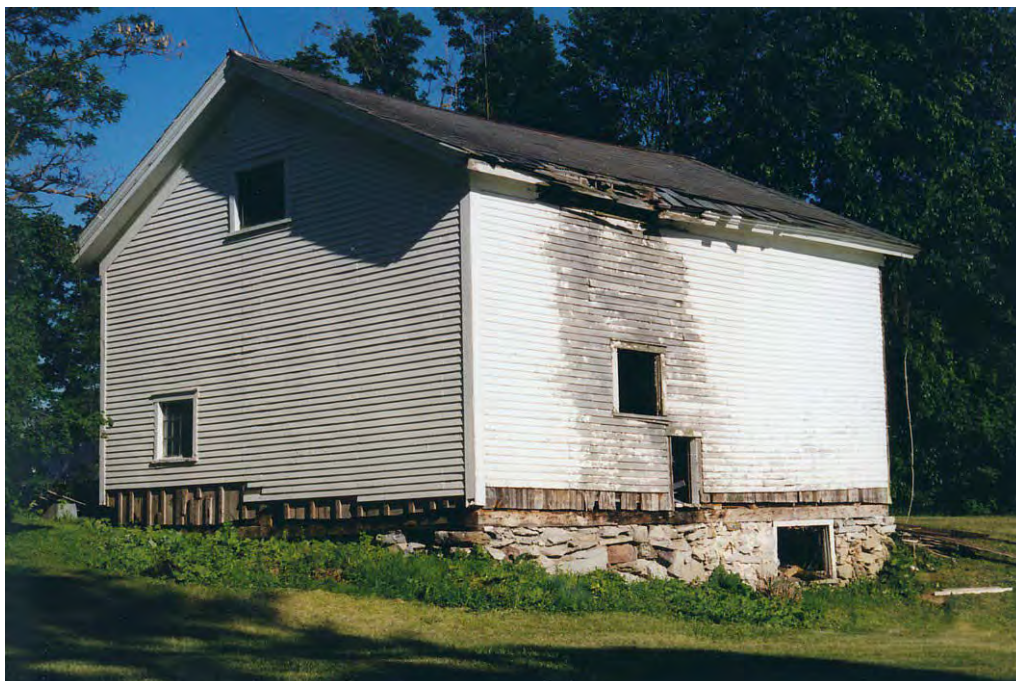
Figure 2. Barn prior to deconstruction, view southeast, c.2000 (owner's personal collection).

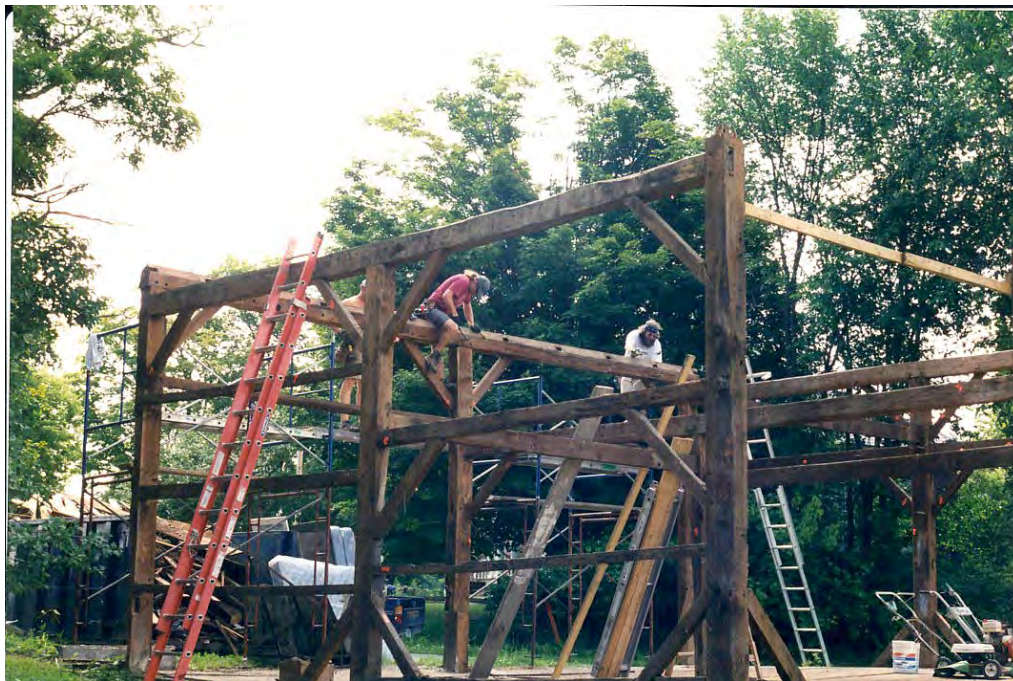
Figure 3. Barn during deconstruction (owner's personal collection).

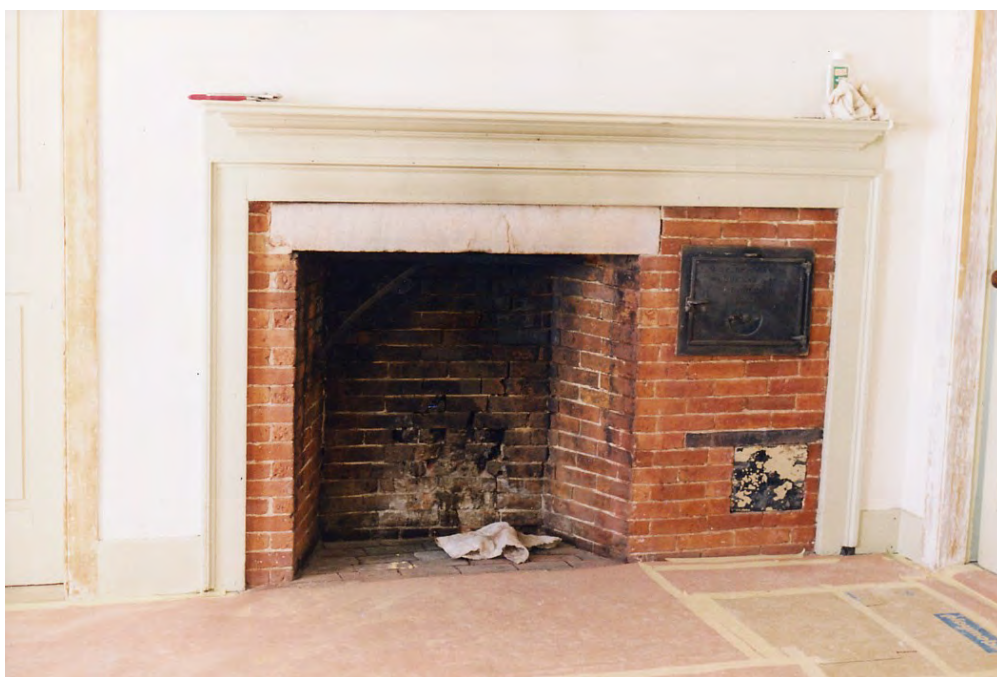
Figure 4. Rumford-style fireplace, c.2000 (owner's personal collection).

Another unusual architectural element of the Parsonage is its massive Rumford-style fireplace and set kettle, typical of the fireplaces built in the late 1700s. Its presence indicates that the Parsonage may have been built upon the ruins of the Linsly House, an earlier home that was located on this parcel of land and burned down c. 1810. The Greek Revival style of the Parsonage may have also provided inspiration for changes to the church, which was remodeled in the Greek Revival style in 1846, visually uniting the two buildings. The church was subsequently remodeled again in 1887, to incorporate elements of the Queen Anne style, but it continues to present as a predominantly vernacular Greek Revival building. The 1887 church alterations are attributed to Middlebury architect and builder Clinton Smith, and the entry porch of the Parsonage also shows the influence of Smith's work and may have been altered at the same time.

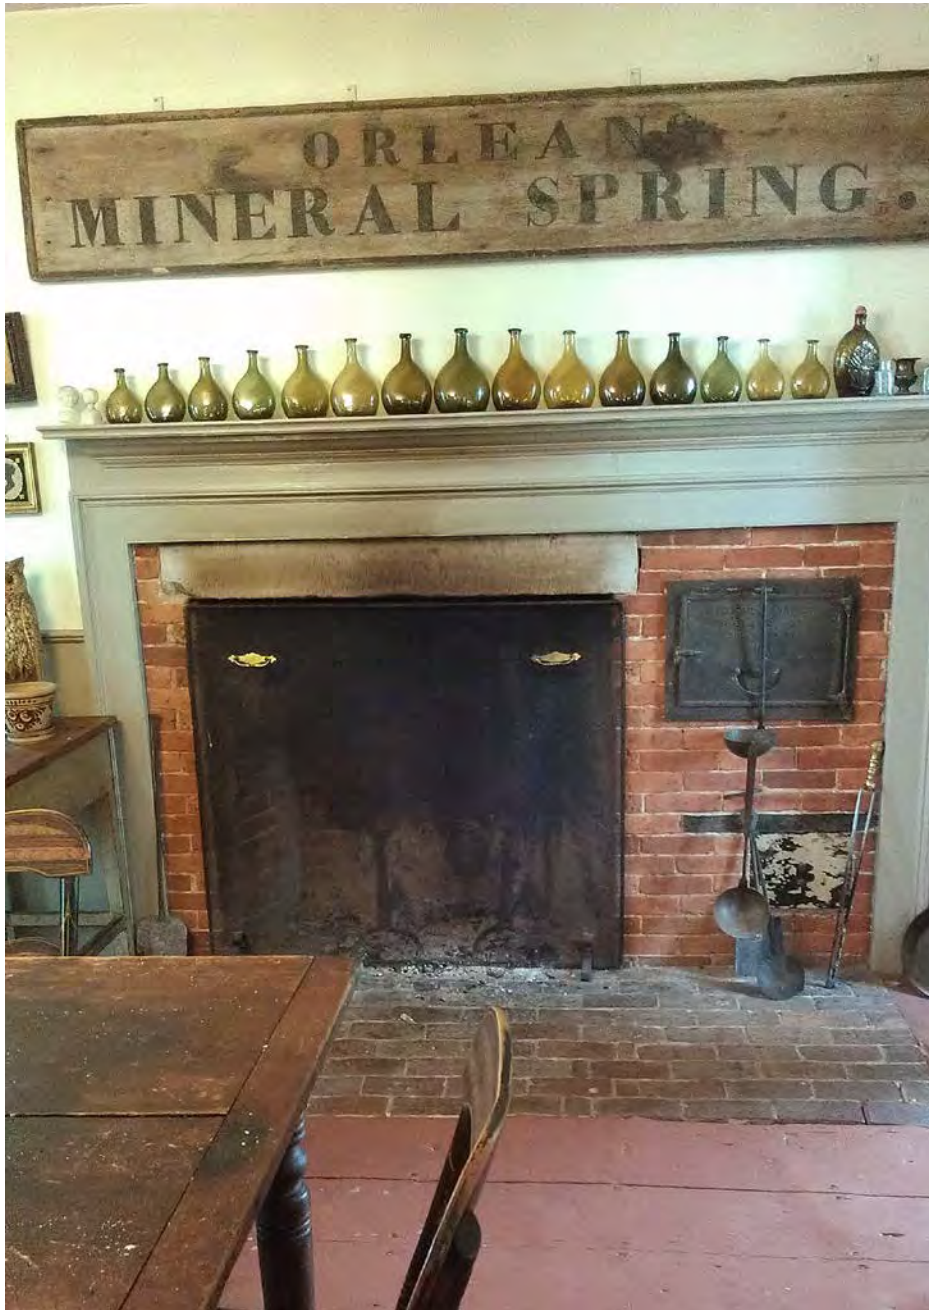
Figure 5. Rumford-style fireplace (working) in 2013 (Liisa Reimann photo)

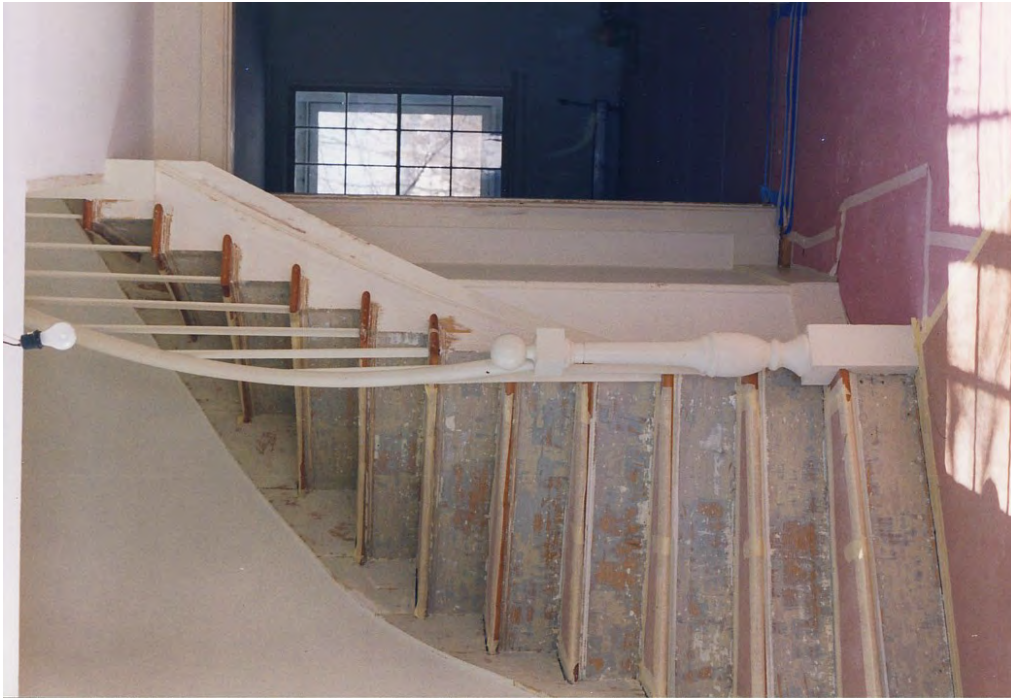
Figure 6. Curved primary stair c.2000 (owner's personal collection)

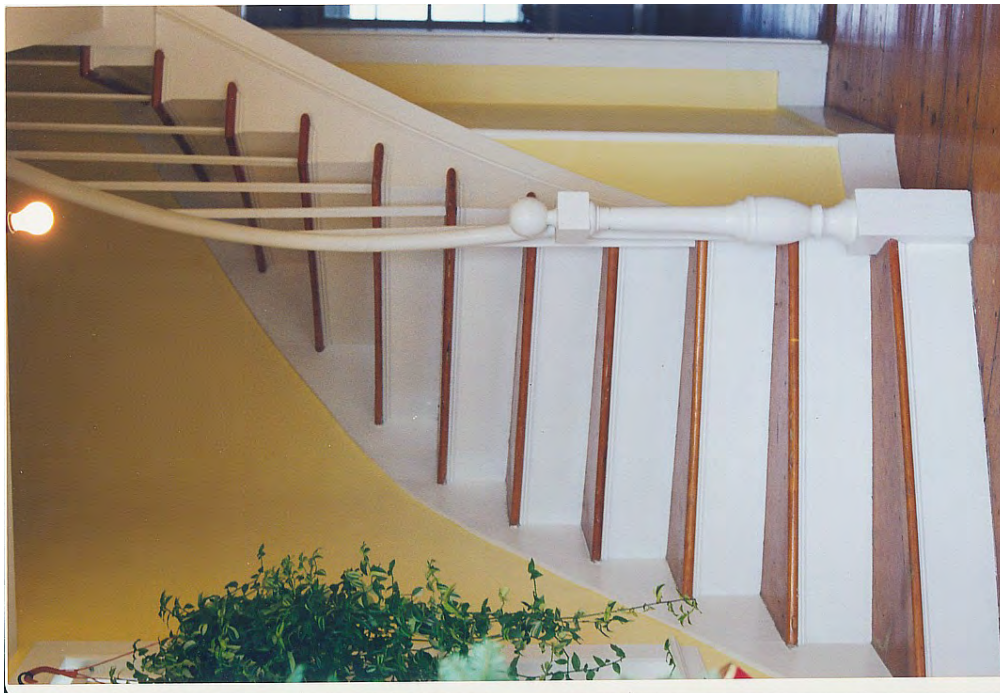
Figure 7. Curved primary stair restored c.2012 (owner's personal collection)

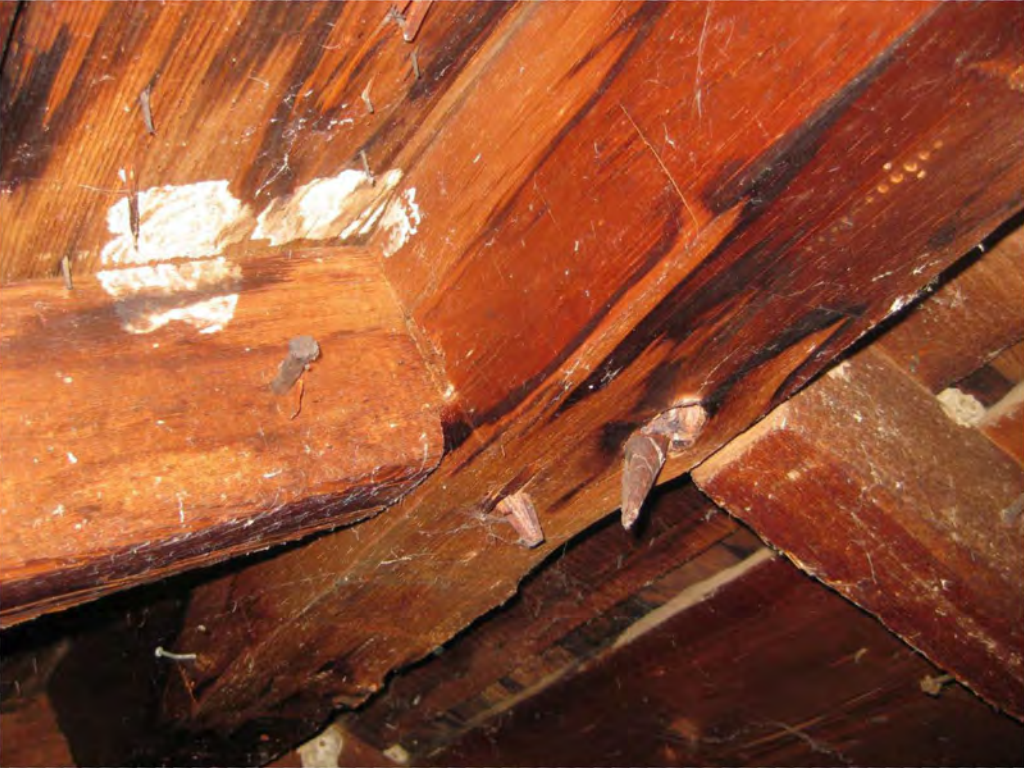
Photo number	Direction	Description
1	SW	E elevation
2	W	E elevation
3	S-SW	E & N elevations
4	SE	N & W elevations
5	E	W elevation
6	NE	W elevation, SW corner of ell (door to woodshed)
7	N	S elevation of main block, E elevation of ell
8	NW	S & E elevations of (non-contributing) outbuilding
9		Detail of five-sided ridgepole in house

Interior joinery, which is exposed in the attic spaces, indicates that house and ell were erected consecutively. The roof frame of the main house features a five-sided ridgepole, and other notable features of the interior include a slender and steep, curved, central stair leading from the entry hall to a second floor landing; a room on the first floor with seven entrances; and a Rumford-style fireplace with beehive oven and set kettle. This type of fireplace was popular in the late 1700s, not the 1830s, which lends weight to a theory that it actually predates the Parsonage and is a remnant of a previous dwelling on the same site that burned down c. 1810.

The Parsonage incorporates many of the style's typical and character-defining details, including its sidehall plan, corner boards, triangular gable light, molded cornice and eave returns, and 6/6 window sash. The timber frame structure of the Parsonage is unusual in that the roof is supported by a five-sided mortised ridgepole. According to timber frame expert Jan Lewandoski, who has inspected this building in the past, the origins of the five-sided ridgepole are not known. They are more commonly found in western New England than coastal areas, and only in areas where long, heavy timbers are available.³ Use of a five-sided ridgepole allows for the low pitch of the gable roof, essential for a Greek Revival building, and simplifies the framing process by allowing the common rafters to be let into the ridgepole with a square mortise and tenon. Because the joint is pegged through the ridgepole, it is stronger than a square ridgepole and resists the spreading of the rafters caused by the low-pitched roof.
