Munsingwear Plant, 1960.
Looking northeast.

Munsingwear Annual Report, 1960.

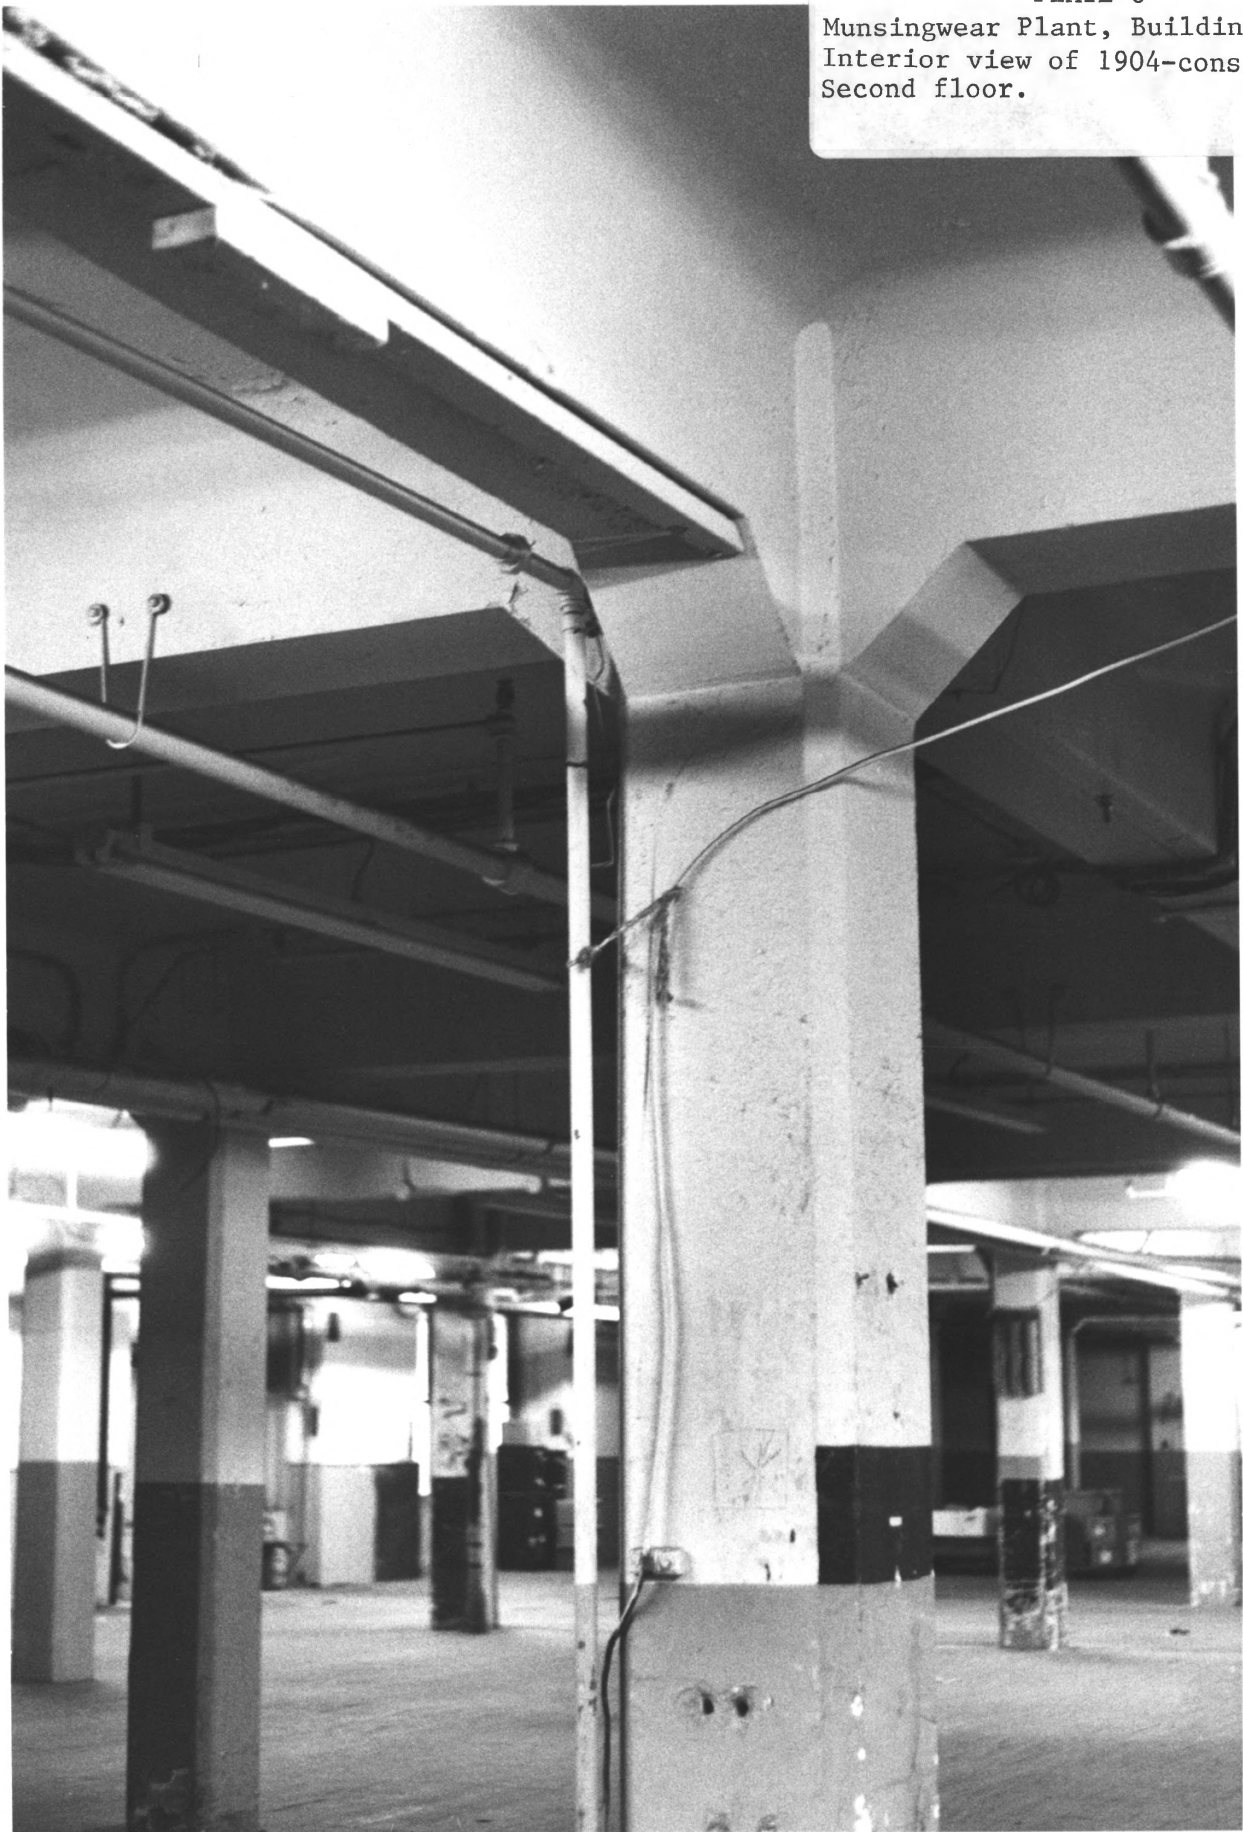
Munsingwear Plant, Building 4, 1983.
Interior view of 1904-construction.
Second floor.

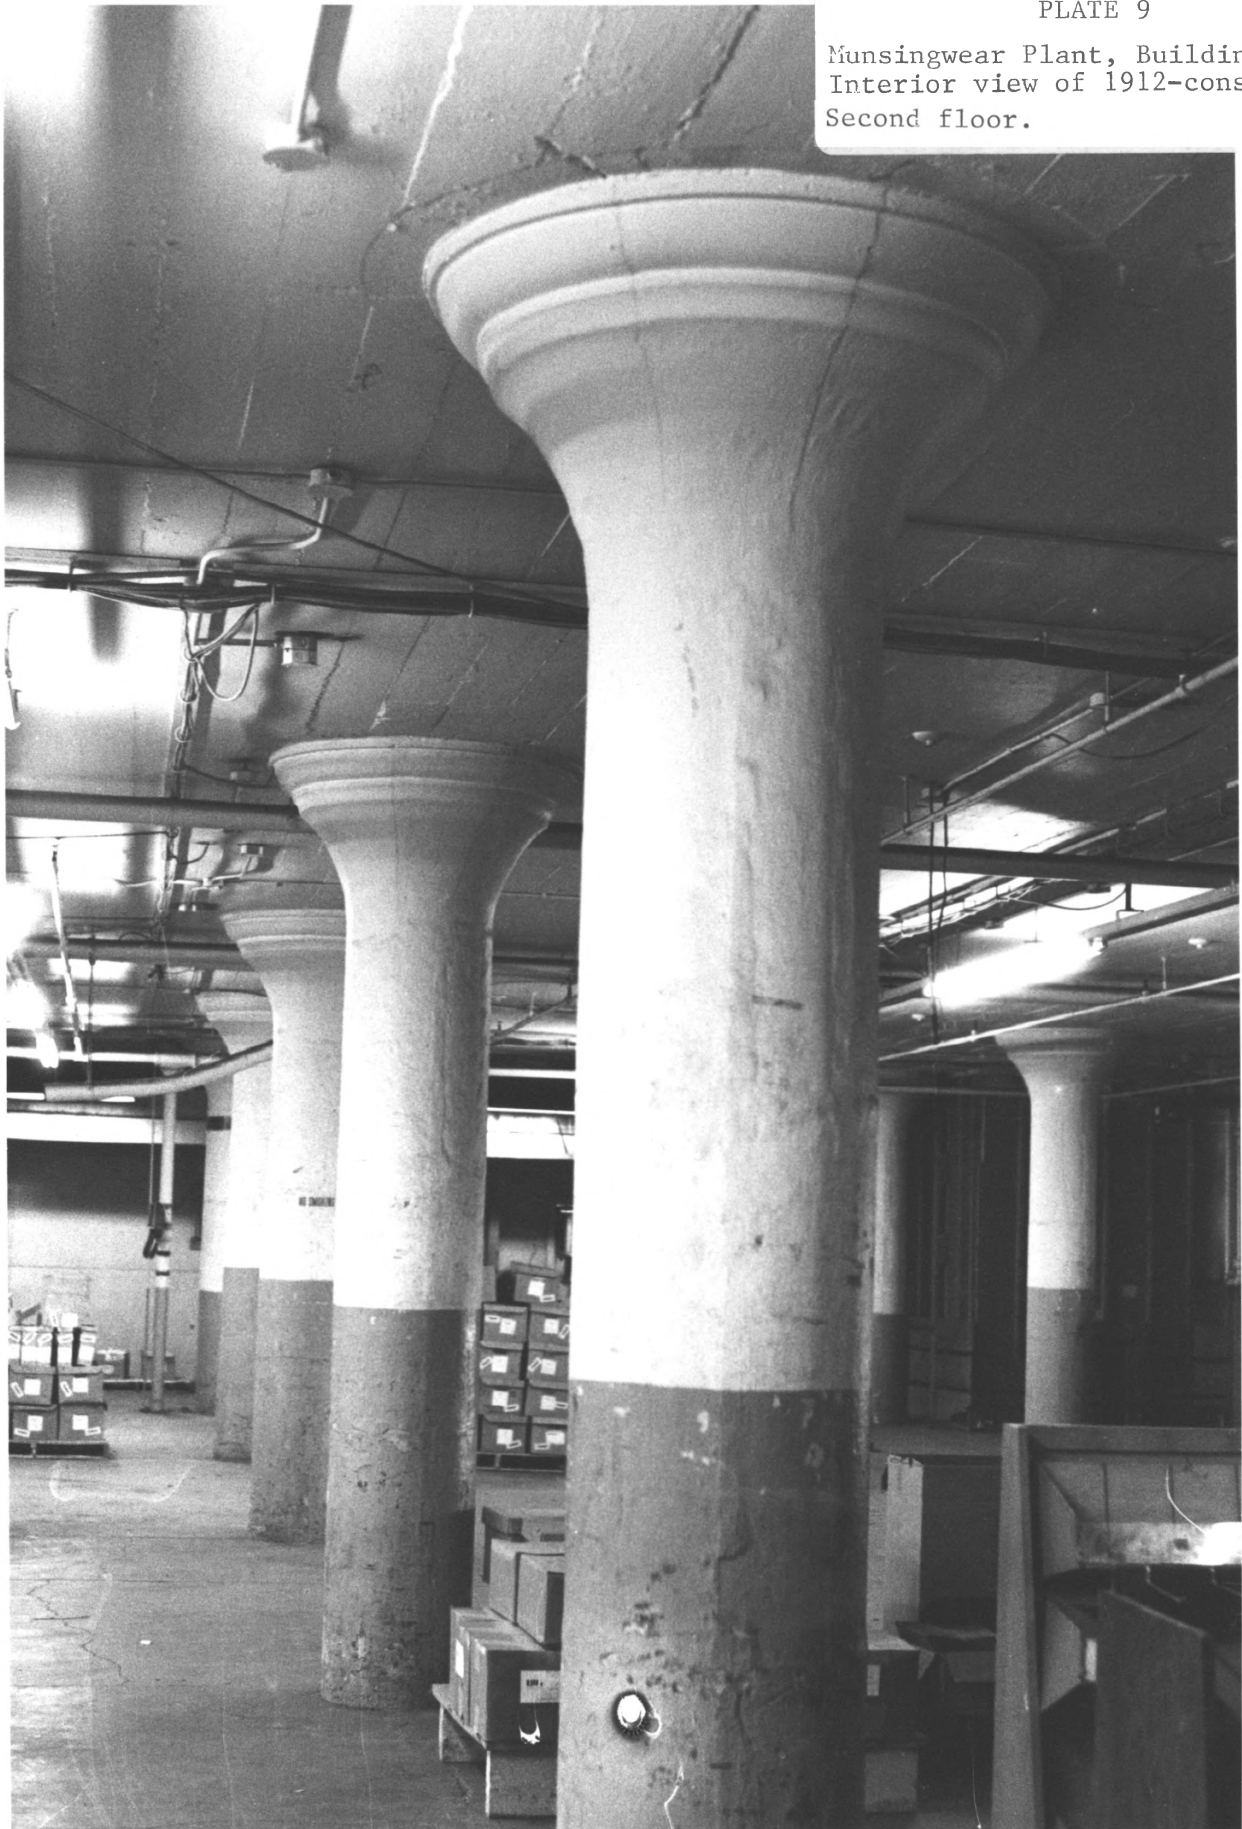
Munsingwear Plant, Building 4, 1983.
Interior view of 1912-construction.
Second floor.
