National Register of Historic Places
Registration Form

historic name Ellice School

street & number 185 Pleasant Street

city or town Millis

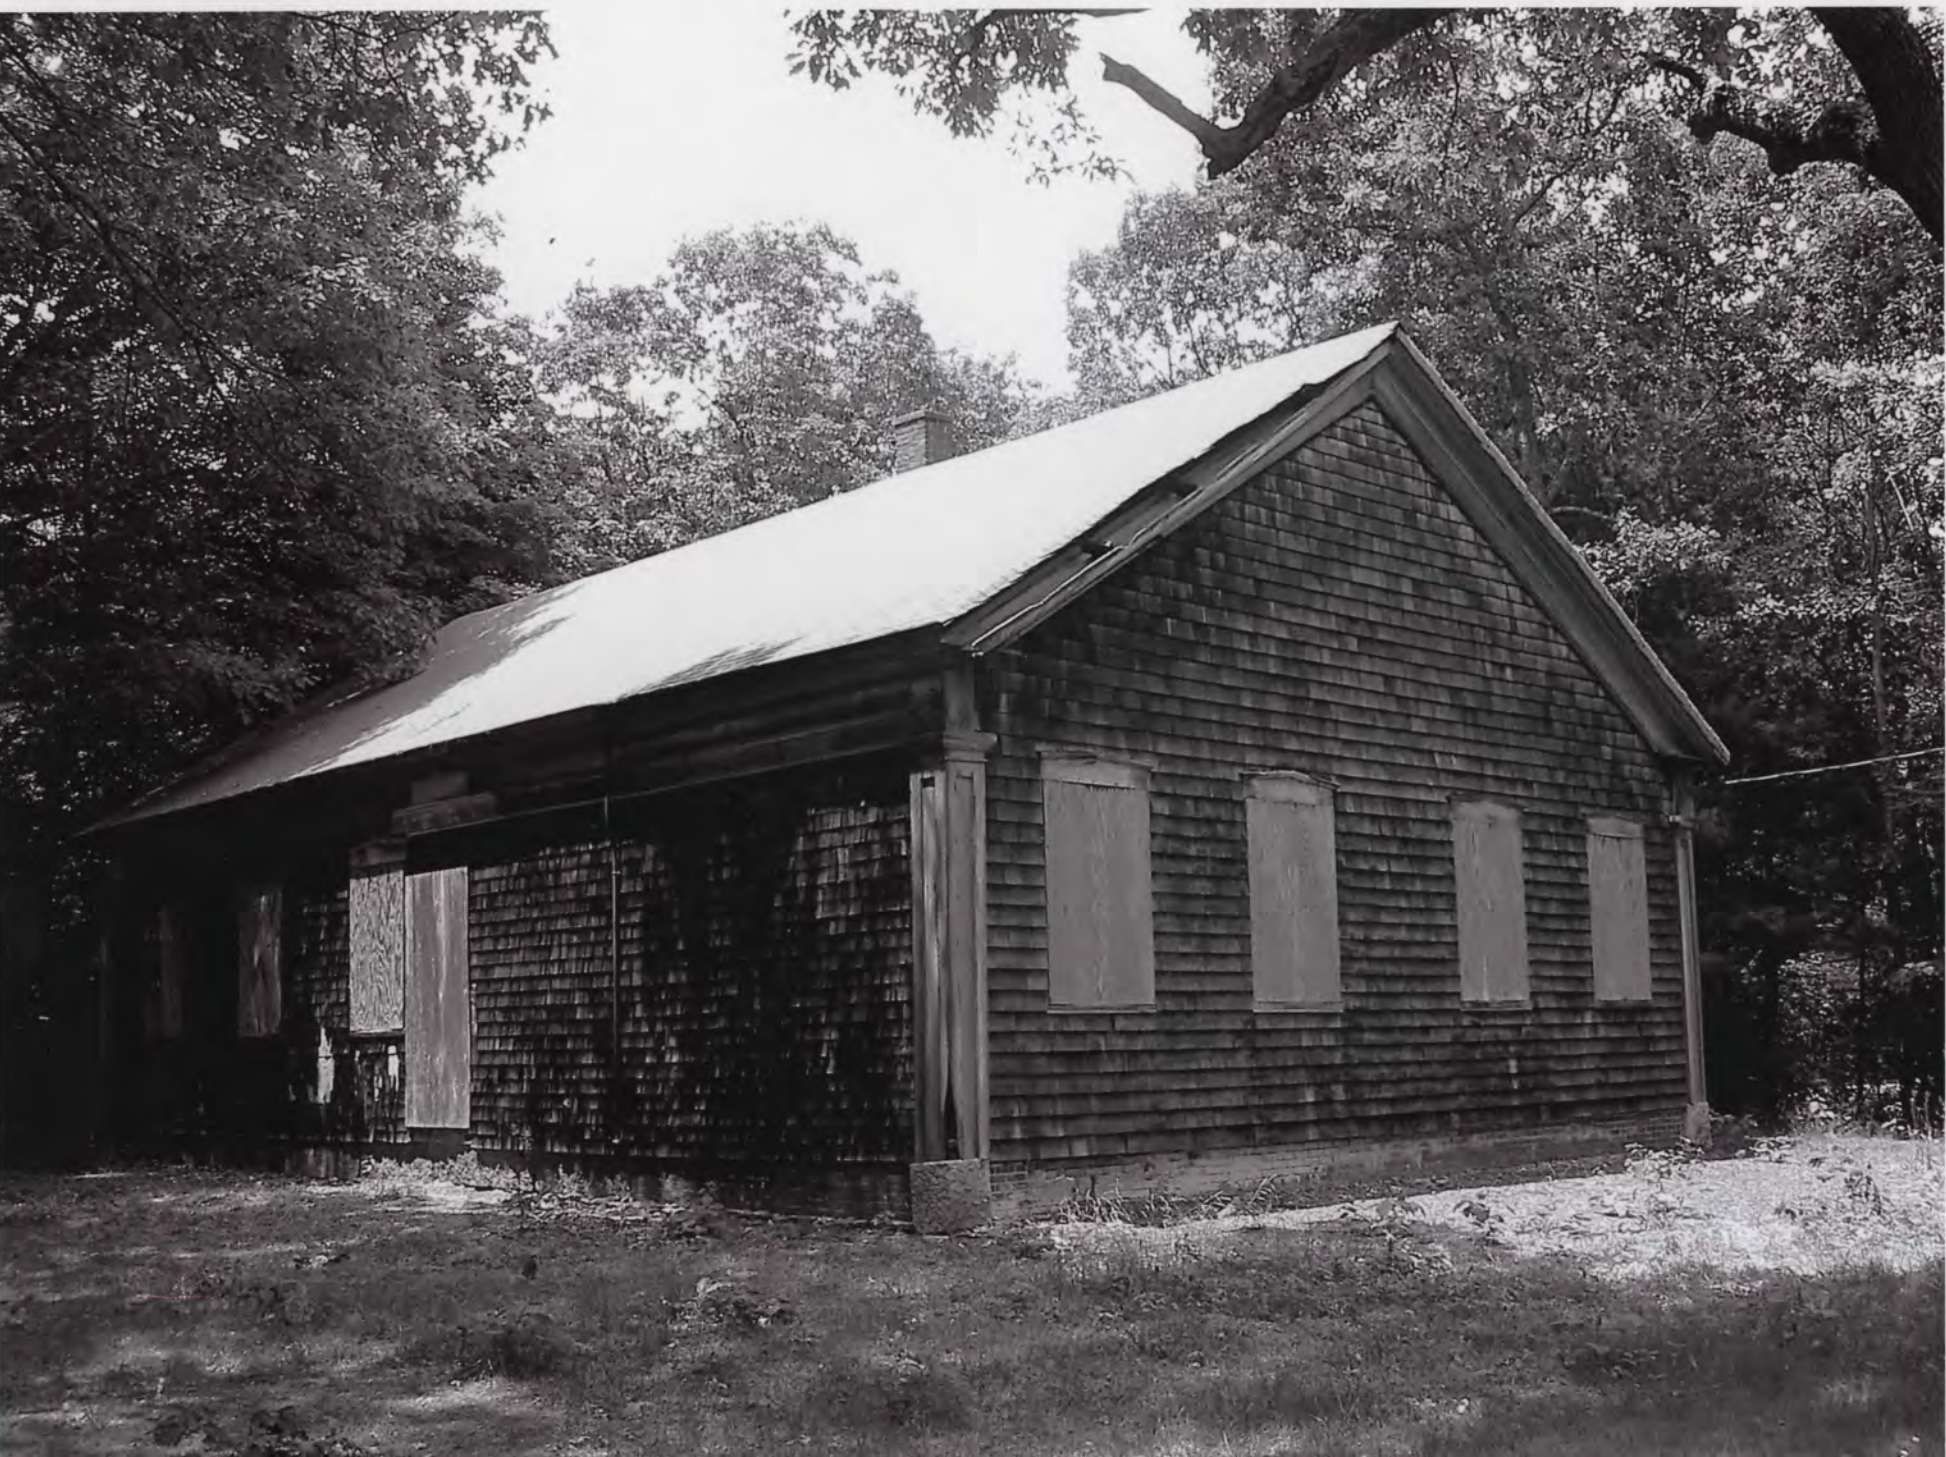
Photo #1

East South elevations Looking northwest

East Elevation. Facing Pleasant Street is the four-bay gable-front elevation with four window bays, each covered with plywood and having an exposed narrow sill and lintel capped with projecting, slightly pointed-arched molding. The raking boxed eaves are partially deteriorated and extend just to the top of the cornerpost caps. The full return (templar molding) has been removed and the entire elevation is covered with shingles as noted above. Cornerposts are as described above. The foundation under this elevation is brick.

South Elevation. Also 53 feet long with the same lengths of granite and brick foundation as the north side, this elevation has three windows bays and an entrance door, all of which are boarded over and not functional. All three window bays are west of the slightly off-center entrance bay. The front section of this elevation is shingled, with no windows. As on the north side, the cornice molding over the door has a shadow line showing where the hipped-roof entrance porch was attached to the building.

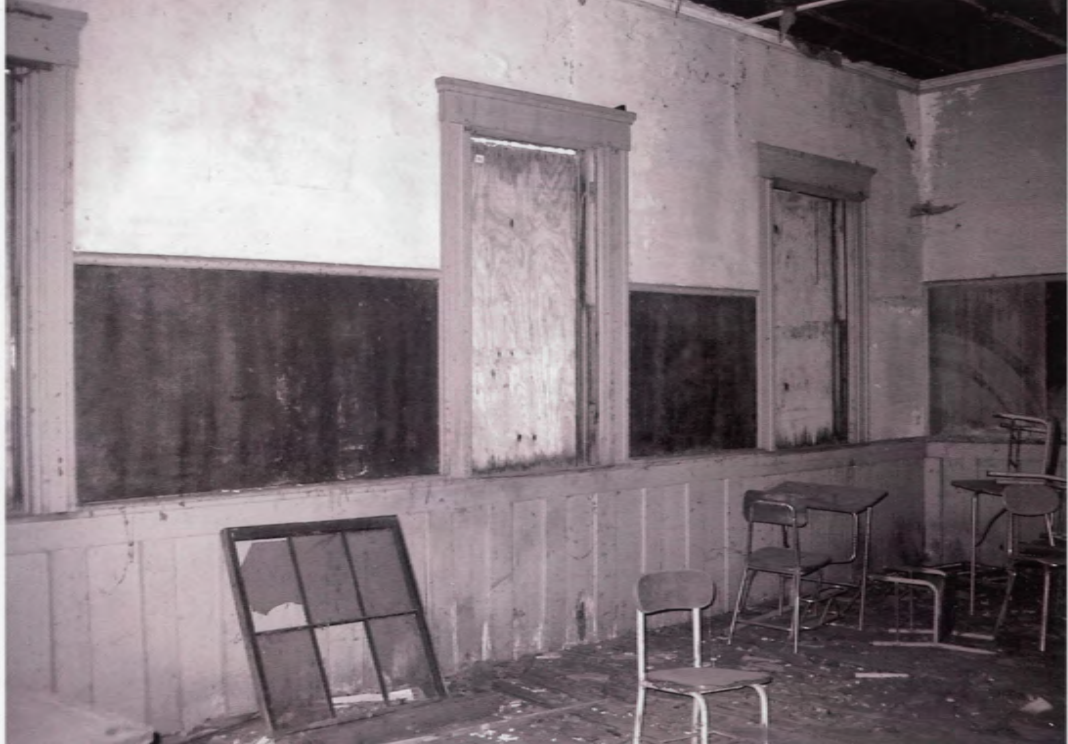
Photo # 3

East classroom

Photo #3.

The front (east) classroom has two openings (doors) leading from the middle entrance halls/coat rooms (one near the north exterior door and one immediately next to the south exterior door), four windows on the east wall, two on the north wall, and blackboards lining the full length of the south and west walls above the wainscoting. Above the blackboard on the interior west wall is a large square grill for the heating duct surrounded by a plain slightly beveled frame. An old stovepipe hole has been patched on this same wall. The floor of this room is made of narrow boards, unlike the rest of the building, which has wide board floors. This accounts for the 1908-09 School Committee report that the floor of the east room under the brick foundation needed to be replaced due to rot and drafts.

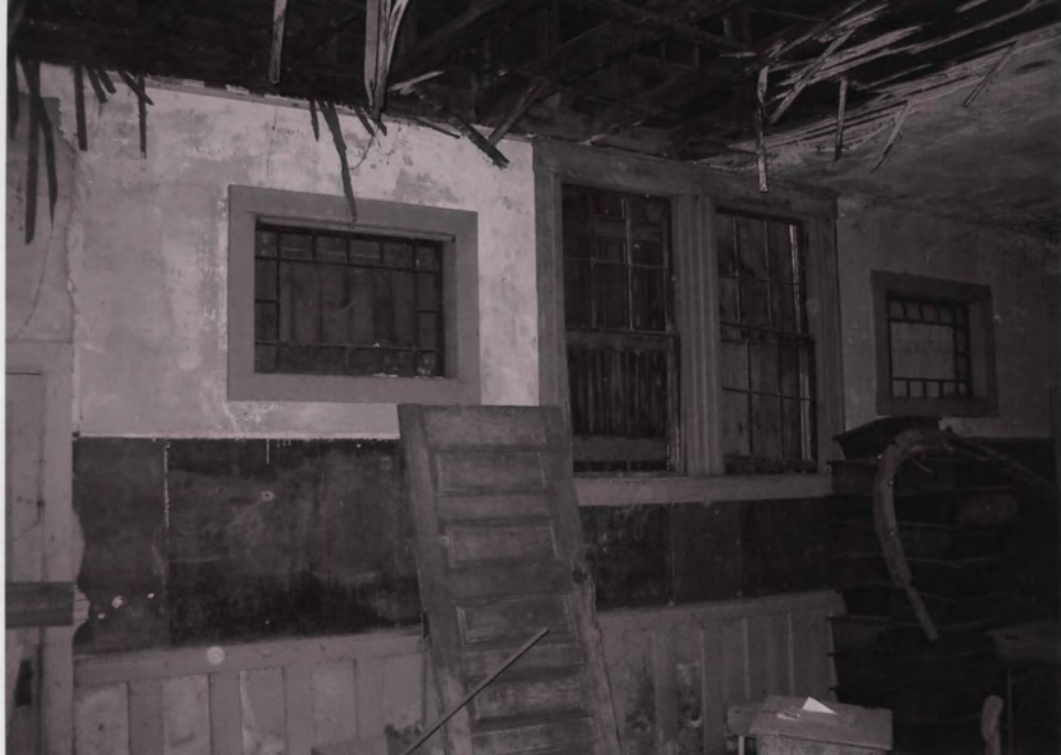
Photo #4

West Classroom

The rear (west) classroom has similarly positioned openings (doors) from the entrance halls, two window openings on the south wall, two exterior doors, a pair of double-hung windows, two horizontal multilight windows set high on the west end wall, and blackboards lining most of the north and east (interior) walls as well as the west wall between the exterior doors and under the windows. **Photo #4.** The paired windows in the west wall have casings similar to other window casings; however, it is known that they were added later (after the chimney and stove centered on this wall were removed), thus the casings must have been copied or all interior casings may have been adjusted – although there are no records of such an expense. The horizontal windows date from a later era due to the style of window and the surrounds which are flat and plain, unlike other window frames. A closet with shelves is located on the east wall under a large

metal grill of the heating vent. The door of this closet is made of narrow beaded vertical boards. The large, square heating vent is surrounded by a wide, plain beveled frame similar to the one in the east classroom. A large plaster medallion adorns the ceiling centered north to south, but not east to west. The location accounts for a formerly larger room that included the present middle section of the building, before the entrances were moved from the front of the building to the sides. This plaster round was fitted with a large wooden circular frame from which hung small lights when the building was electrified in the early 1900s. At the time of the writing of this nomination, the frame was on the floor, leaning against piled desks on the back wall of the room.

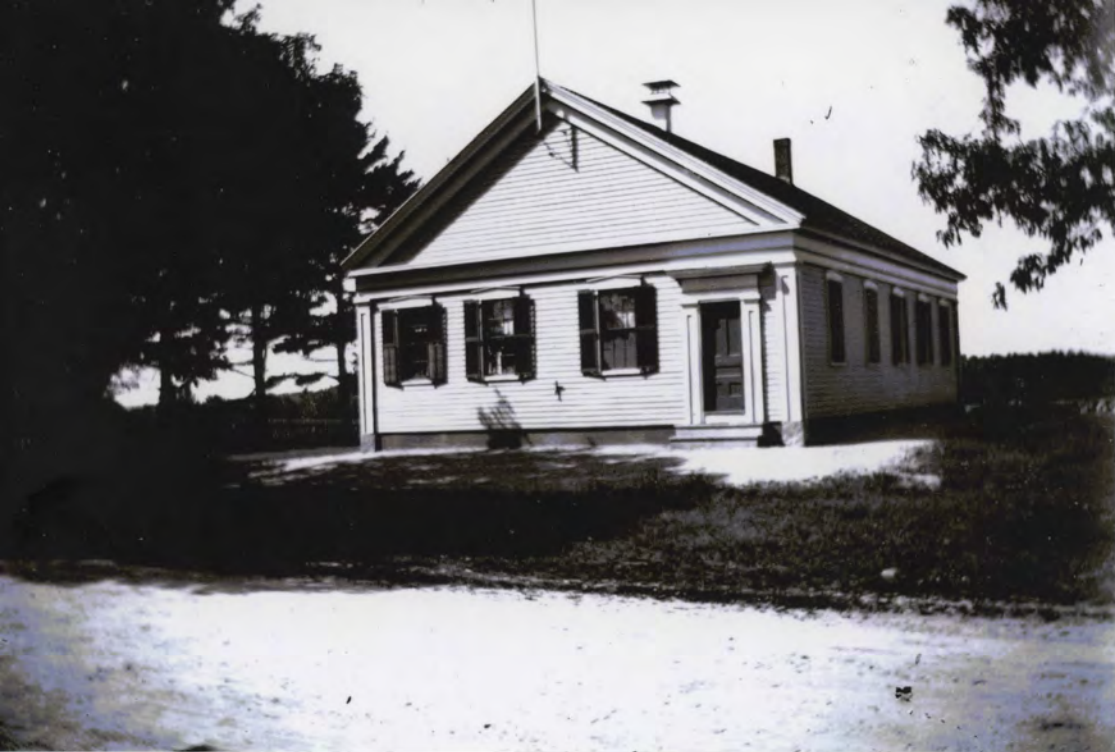
Write Photograph ca 1892 or ca 1905

Physical Changes of Ellice Schoolhouse. Exterior changes of entrances and fenestration are shown in three generations of historic photographs that help to explain the evolution of the schoolhouse. A photograph from 1901 (**Photo #5**) and two from 1920 (**Photo #7 & 8**) have definitive dates written by the photographer on the paper sleeves that cover the glass plates. A third photograph is dated 1892 by Edwin Waite's family, and is included in a short essay written by his granddaughter when in fifth grade telling the history of the Ellice School as told to her by her grandfather. (**Photo #6**) The Waite photograph shows the schoolhouse with clapboard siding, templar gable ends marked by a wide molded cornice that wrapped around the building, windows of 6/6 sash with flanking louvered shutters and pointed-arched molded lintels that butted up against the fascia board, and one entrance door in the gable-front east facade. The 1901 photograph shows the gable-front facade with two entrance doors in the two end bays, and the described windows in the middle two bays. Each door was framed by flanking pilasters carrying a wide entablature with projecting lintel. The single door in the Waite photograph had the same detailing.

The sequence of the three photographs raises some questions about the evolution of the schoolhouse doors. In question is the date of the Waite photograph, which shows three windows and one entrance only in the gable-front elevation. The one door was in the northernmost bay of the elevation and led to a hall with coat hooks that extended along the north wall to the large classroom behind. If the photograph predates the 1901 photograph, which shows two entrance doors on the main façade, it would mean that the second door was added sometime in that nine-year span. If it postdates the 1901 photograph, it would mean that the original school had two entrances – one to each of the coatroom/halls along the long sides of the schoolhouse— and that one was removed after 1901, possibly in 1904 when an interior partition was removed to increase the size of the front classroom, thus losing one of the entrance halls. Another quandary about the

Historic photographs raise more quandaries about the timing of some changes in fenestration. The earliest known photograph is dated 1892 by Edwin Waite's family, showing the brick foundation and a four-bay façade (east elevation) with three windows and one entrance. The entrance door was in the fourth bay – on the north end of the east elevation. This photograph is owned by the family of Edwin Waite, who attended school here from ca. 1892 to ca. 1898. **Photo #6.** However, there is some question about the date of this photograph because the interior plan would make more sense if this photograph was taken between 1904 and 1915, after the partition between one of the side halls and the front small stove—recitation room was removed and before the entrances were moved to the sides of the building. In addition, the tall trees behind the low stone wall (along the rear lot line) seen in the 1901 photograph (**Photo #5**) and not seen in the Waite photograph or later photographs of 1920 (**Photo #s 7 & 8**) could not have grown to their 1901 size in nine years – from 1892 to 1901 if Photo #6 is truly from 1892. It is more likely that most of this line of trees was removed soon after 1901.

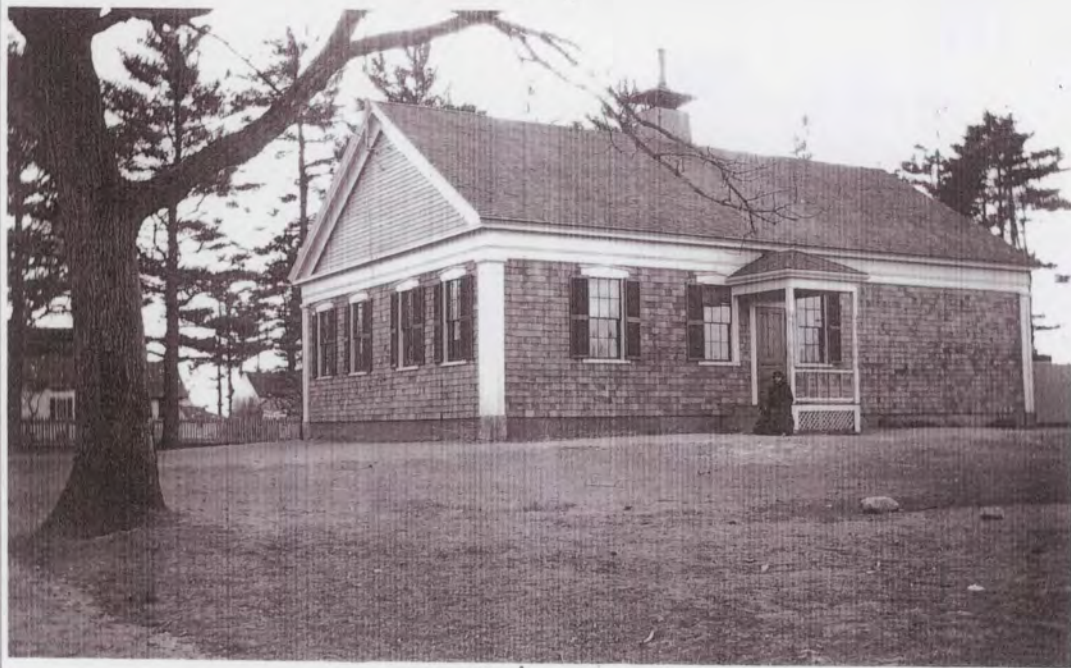
Mills, MA
Norfolk County
185 Ellie School
Ellie School
Proscott Photo - 1920
Photo # 7

The 1920 photographs show shingled siding of the main body (not in the gable peaks), the same windows and casings, windows in place of the doors in the gable-front elevation, and new entrances within modern hipped roof entrance porches on each side elevation, an alteration that was made in 1915. Two windows on each side (the front two on the

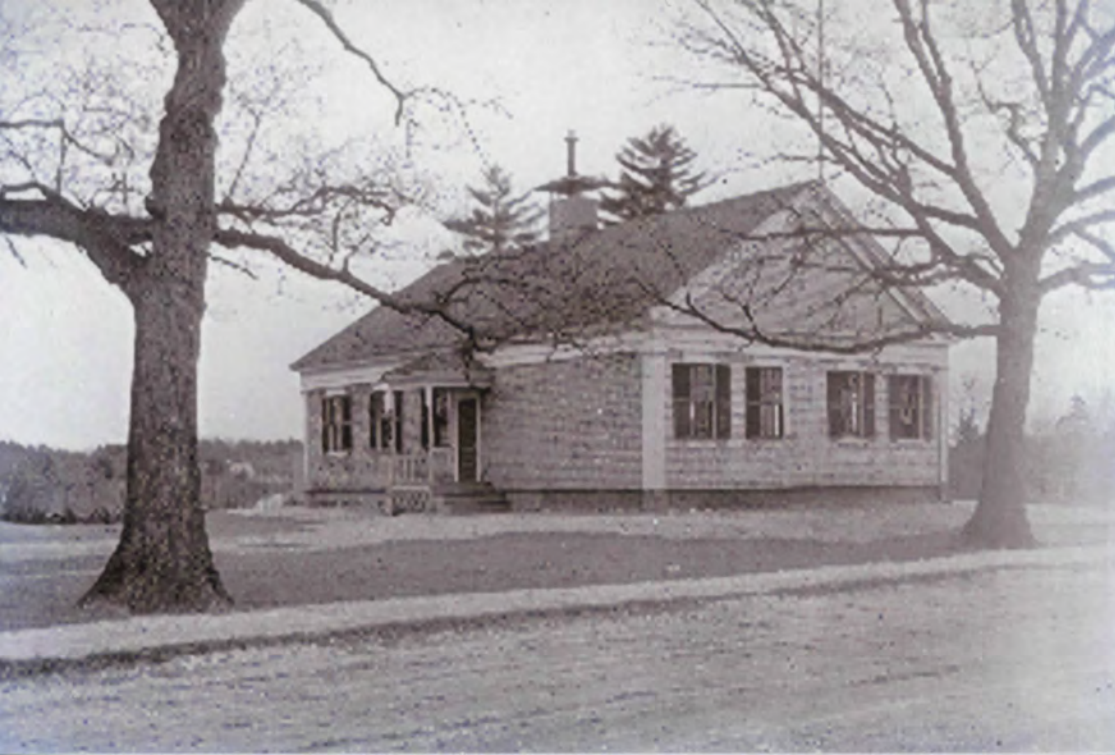
Mills, MA
Norfolk County
185 Pleasant St
Ellice School
Prescott Photo - 1920
Photo # 8
