National Register of Historic Places
Registration Form

historic name Belchertown State School

street & number 30 State Street N/A not for publication

city or town Belchertown N/A vicinity

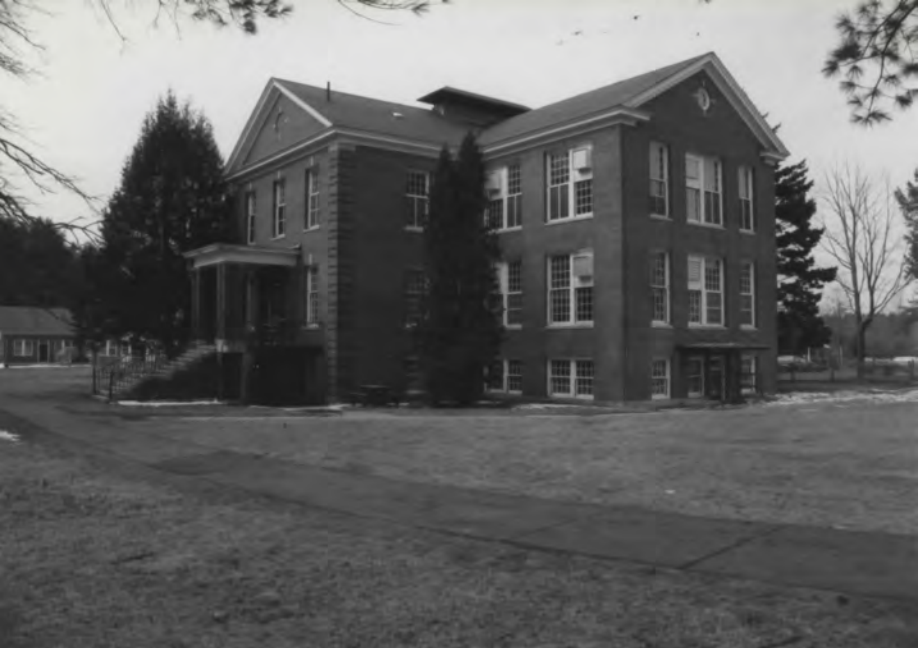
6-3 Belchertown 3/92
F Dorm

#2-8: B, C, D, E, F, L, M Dorms (1921, 1923, 1923, 1928, 1930, 1920, 1927)

Built over a nine-year period, these two-story, red-brick dormitories are built on the same cruciform plan developed at Wrentham between 1910 and 1917. They differ primarily in stylistic details, which reflect the Colonial Revival style rather than the earlier Arts and Crafts style found at Wrentham. E, D, and M Dorms rise from high brick and concrete basements to hip roofs with plain boxed cornices and are trimmed with brick quoins. B, C, and L Dorms are similar but flat-roofed. F Dorm, which was the last to be erected in 1930, has a gable roof and lacks the quoins. As was the case with the wards at Wrentham, one of the cruciform arms is treated as an entry pavilion with a one-story porch protecting an entry flanked by large windows with 16/16 sash and cast-stone keystones. Elsewhere, windows are treated in similar fashion but are usually paired, creating an even larger glazed expanse. M Dorm offers spectacular views over the campus farm to the mountains beyond.

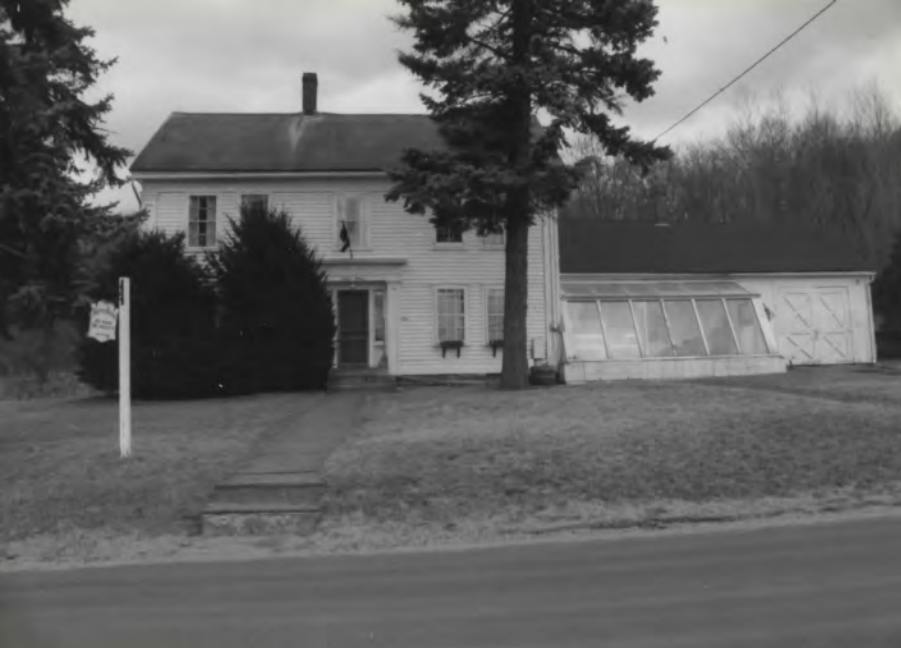
6-21 Belchertown 3/92
Farmhouse

#60: Jepson House (1829)

Jepson House was a pre-existing farmhouse acquired by the state from David Jepson; it is now used by NESFI. According to a turn-of-the-century newspaper article, it was remodeled in 1857, which would account for the dominant Greek Revival-style detail. It is a five-bay, clapboard-clad residence that rises 2 1/2 stories to a gable roof with central stove chimney. It is trimmed with paneled corner pilasters and entablature. The facade is centered on a recessed entry with trabeated surround. Windows contain 6/6 sash and are headed by triangulated lintels. A large ell with shed is attached on the south side. It is now accompanied by several modern sheds and greenhouses.

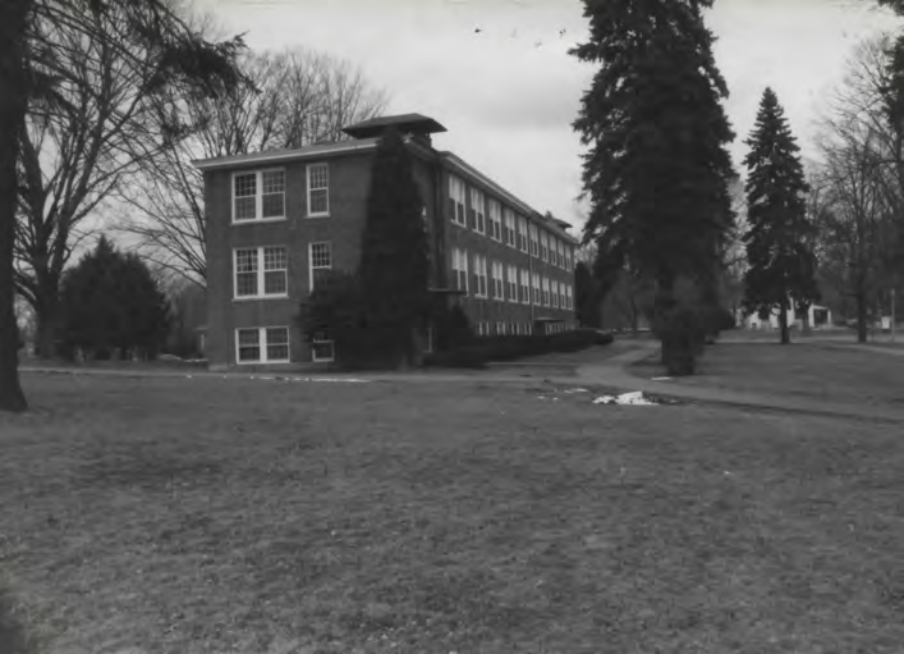
6-12 Belchertown 3/92

#27, 28: Girls' and Boys' Industrial Buildings (1930, 1932)

Both Industrial Buildings or workshops are utilitarian, three-story, red-brick structures rising from concrete foundations to flat roofs with boxed cornices. Brick piers divide the ten-bay side elevations; each bay contains paired windows at each story. Windows generally contain 12/12 sash. The entries are located at the ends and centers of the side elevations. These buildings define the north and south sides of the secondary green (#104).

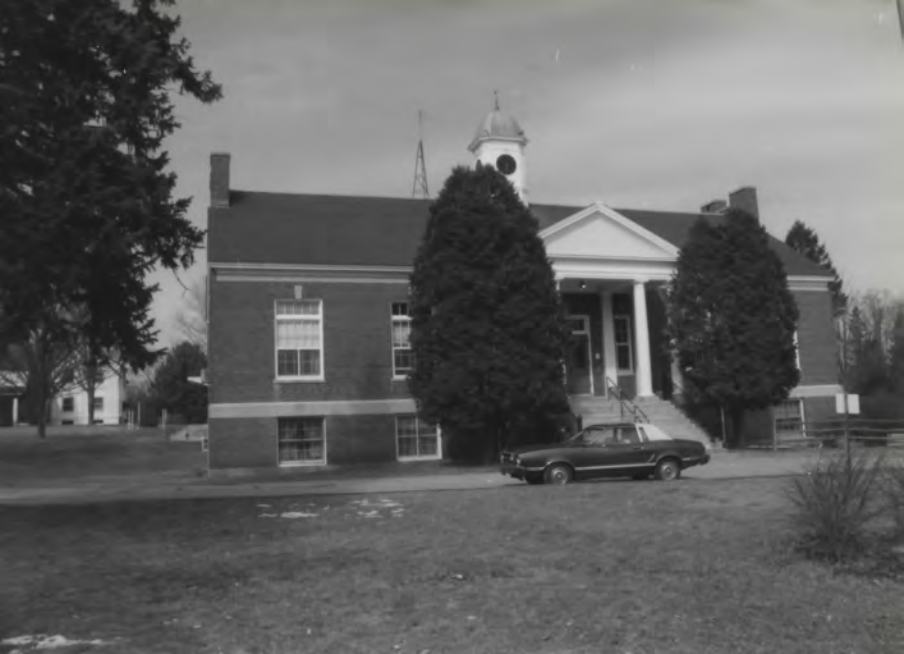
6-1 Belchertown 3/92
Administration

Representative Buildings are described below:#1: Administration (1926/1967)

The Colonial Revival-style Belchertown Administration Building is closely modeled on its 1915 predecessor at Wrentham. It is a rather small, five-by-two-bay, rectangular plan, red-brick structure that rises one story from a high brick and concrete basement to a slate

gable roof with dentilated cornice, paired end chimneys, and central clocktower. The five-bay facade is centered on a colossal pedimented entry portico with paired Tuscan columns. The double-leaf entry is headed by a transom. Exceptionally large windows with splayed brick lintels, keystones, and transoms contain 20/20 sash.

The similarly scaled and detailed rear ell was attached to the main building by a hyphen in 1967.

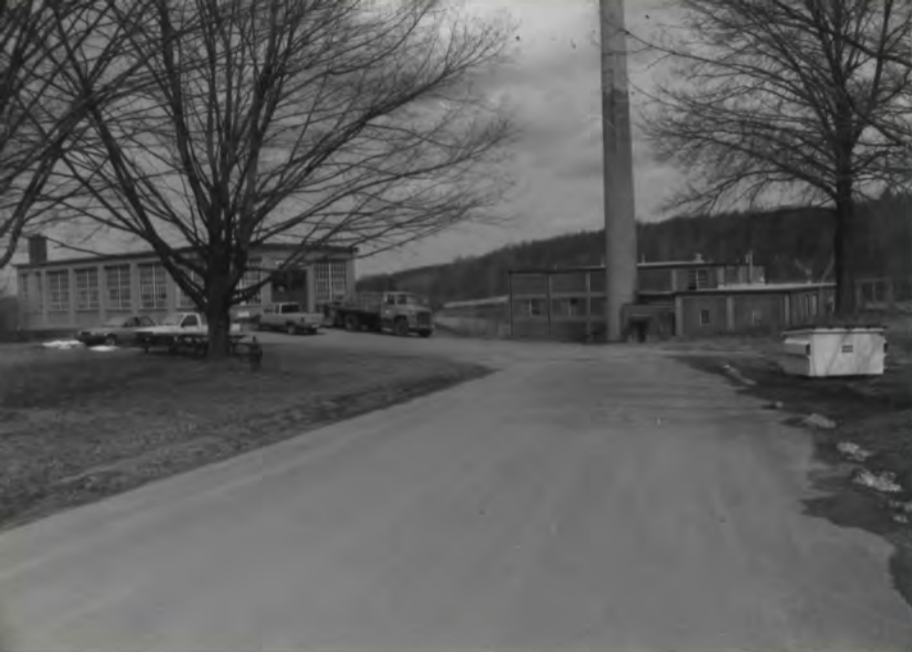
6-10 Belcher Town 3/92

#35, 36: Powerhouse and Railroad Trestle (1922/1928)

The Powerhouse is a typical Utilitarian-designed structure of rectangular plan that rises one story to a flat roof. It is constructed of red brick with concrete piers dividing window bays with small openings that contain twenty-pane metal hopper sash. A tall, yellow brick smokestack rises on the southwest side. A massive concrete railroad trestle approaches the building from the tracks on the east. It is located with the other support/utility buildings at the east edge of the campus.

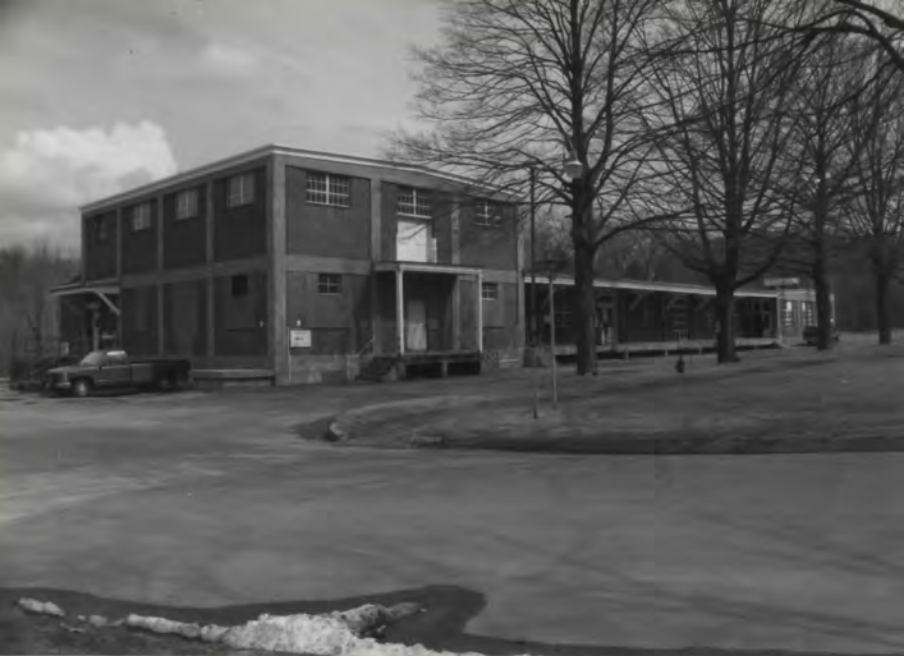
6-11 Belchertown 3/92

#34: Storehouse (1932)

Like the powerplant, the Storehouse is a simple, three-part Utilitarian-designed redbrick structure enclosed by a flat roof. A three-by-three-bay, two-story headhouse, with concrete piers dividing window bays, anchors the north end and serves as the general supply room. Extending southward is a seven-bay one-story receiving area fronted by a loading dock; the bays contain large, paired, multipane windows or double-leaf doors with transoms. At the south end is a one-story, three-bay section.

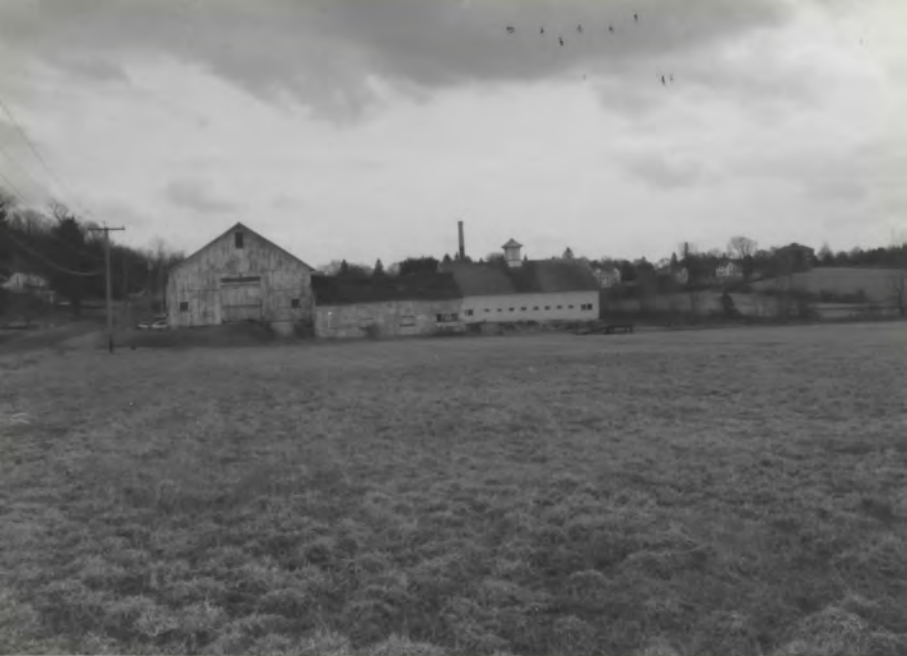
6-20 Belchertown 3/92
Horse Barn)

#74: Horse Barn (pre-1893)

The horse barn is a picturesque, wood-frame, clapboard-clad structure enclosed by a gable roof with cupola that is typical of barns throughout New England.

The main entry with small-pane transom is located on the east gable end. The long side elevations are marked by small, three-pane hopper windows. In 1924, this barn was shown further north, near the poor farm.

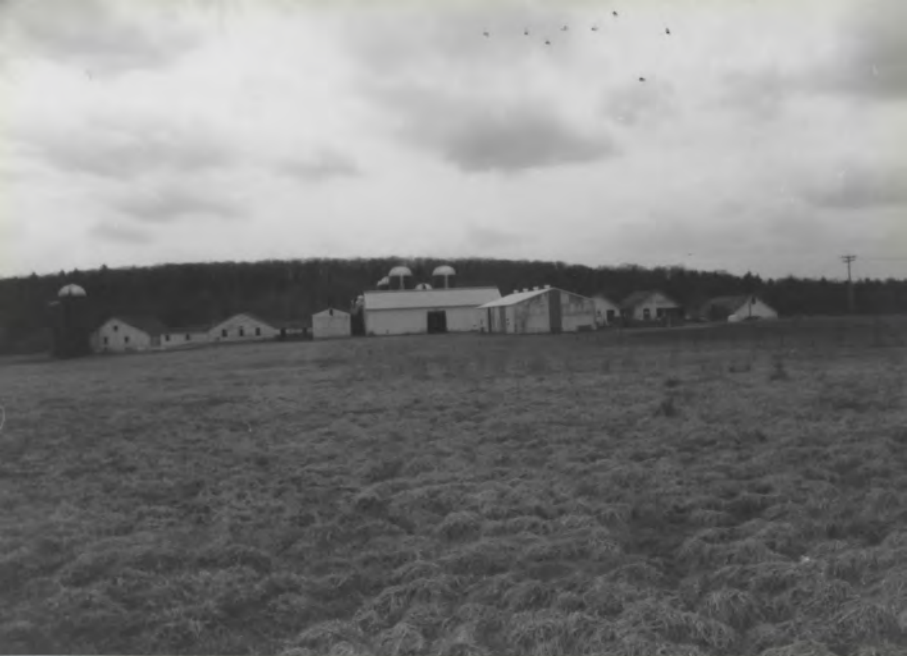
6-19 Belchertown 3A2
Farm Complex

#77-88: Main Farm Complex (1920-1950)

This large, picturesque structure consists of several wood-frame and concrete block buildings that were constructed and connected over a thirty-year period to serve a variety of purposes. Most components are enclosed by gable roofs with ventilators and/or cupolas. Doors are generally double-leaf of sufficient size for dairy cows, oxen, or horses to pass through. Windows generally contain multi-pane sash. A mid-nineteenth century barn (#91) with transom and 6/6 sash stands immediately to the north.

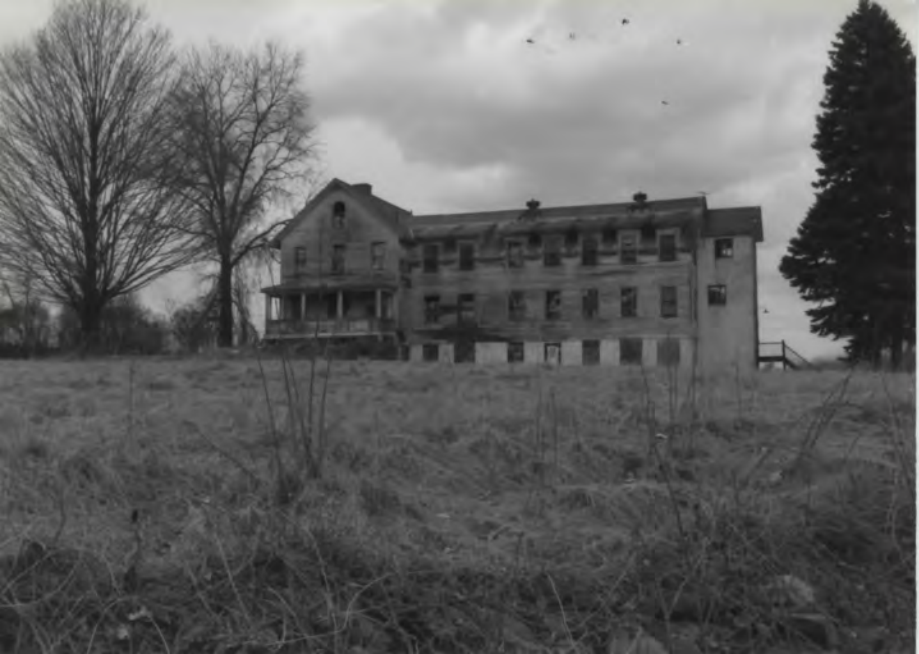
6-17 Belchertown 3/92
Pooy Farm

#72: Farmhands Dormitory site (1877)

Constructed as the Town Poor Farm, the former residence for farmhands was an unusual, two-story, clapboard-clad structure enclosed by a gable roof with off-center chimney. Distinguished by Italianate-style features such as bracketed cornice, round-arched gable window, and projecting window hoods, it dated to 1877. It consisted of a two-by-three-bay headhouse that served the warden and a seven-bay lateral wing that housed inmates in four rooms on each side of a central

corridor. The main entry was contained within an early twentieth century enclosed porch on the gable end of the headhouse. Windows contained 2/2 sash in the headhouse and 6/6 in the wing. It was approached by a curved, unpaved drive and fronted by a retaining wall. On August 30, 1993, the building burned to the ground, only the foundations remain.

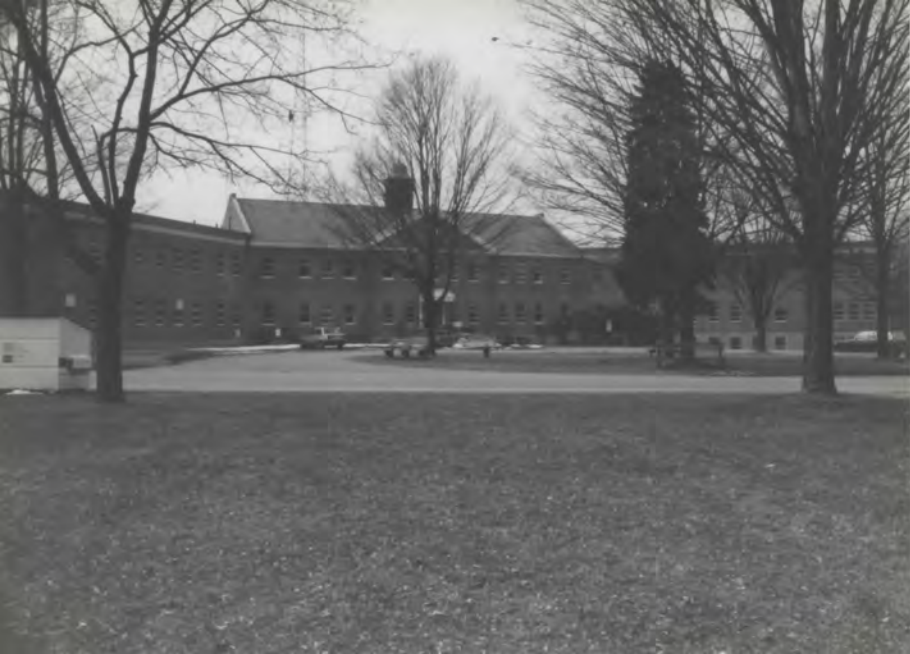
6-6 Belchertown 3/92
Infirmary

#22: Infirmary (1951)

This building is almost identical to Marion Moore Hall at Wrentham, also built in 1951. Both follow the familiar double Y-plan that was pioneered with the Medical Building at Metropolitan State Hospital in 1934. The Belchertown Infirmary is a two-story, red-brick structure with minimal Colonial Revival-style trim. It rises from a concrete foundation exposed as a basement story on the west to a slate gable roof with underscaled central cupola. The facade is centered on a five-bay pedimented central pavilion with an oculus in the gable field. Windows contain the typical hopper sash, also pioneered at Metropolitan State.

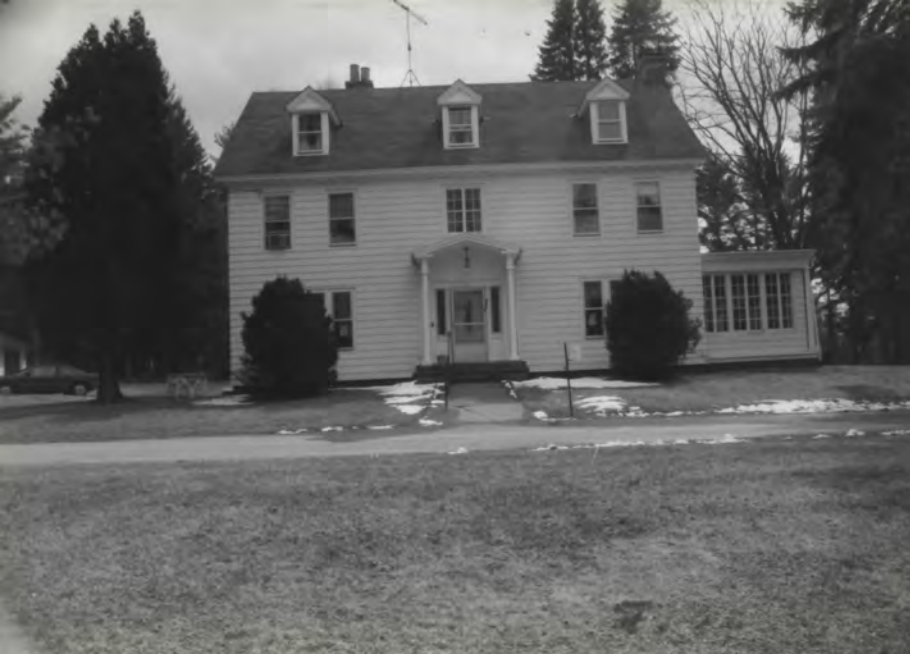
6-15 Belchertown 3/92
Supt's House

#50, 51: Superintendent's House and Garage (1924, 1930)

The Superintendent's House is similar to the several Colonial Revival-style dwellings that serve this function at the State Hospitals and Schools. All are modeled on their suburban counterparts. This example is a five-bay, center entry wood-frame structure that rises two stories to a gable roof with modillion cornice and pedimented dormers. The entry is framed by sidelights and a louvered fan, fronted by a gabled porch and flanked by three-part windows. Other windows contain 6/1 sash. A one-story sunporch extends from the right (S) elevation. The house is now aluminum-sided with an asphalt

shingle roof. It is accompanied by a period garage. The house is set on a wooded rise behind a modern town school and accompanying playing fields.

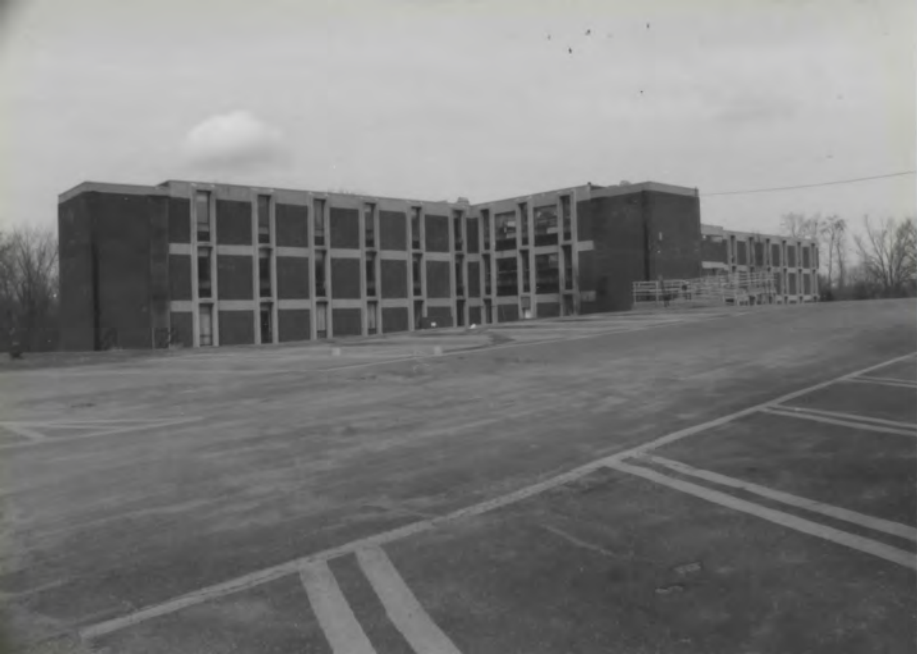
6-7 Belchertown 3/92
6 Ward

#9: G Dorm (1967)

G Dorm is located at the rear (NW) of the campus behind a large, obtrusive paved parking lot. It is a large, red-brick structure of irregular plan that rises three stories to a flat roof. Large-pane windows, arranged in vertical strips, are defined by projecting cast-stone piers. There is no well-defined major entry.

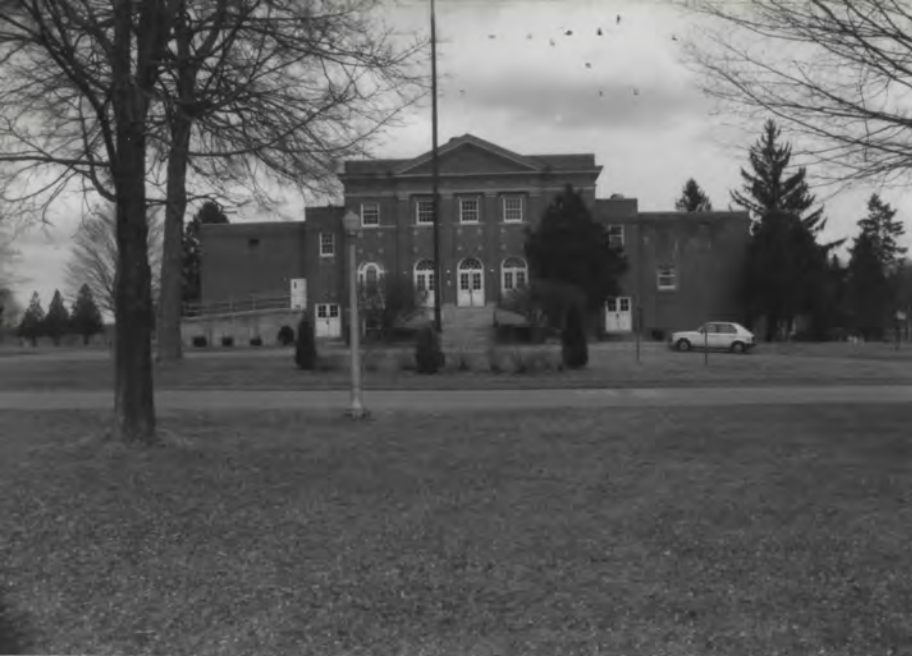
6-13 Belchertown 3/92
Schoolhouse

#29: Front Street School (1928, 1932)

The School is a large, red-brick building of rectangular plan. It consists of a two-story central pavilion flanked by one-story wings containing classroom space. The five-bay central pavilion rises to a parapet broken in the three central bays by a pediment. The three central bays are further defined by brick pilasters separating round-arched entries with glazed, double-leaf doors and fanlights. The one-story wings, which are blank on the facade, are lit by rectangular windows with double-hung 15/15 sash and transoms on the long, twenty-bay side elevations. Secondary entries are centered on the side and rear elevations. This imposing building occupies an important site at

the center of the campus where it divides the primary (#103) and secondary (#104) greens.

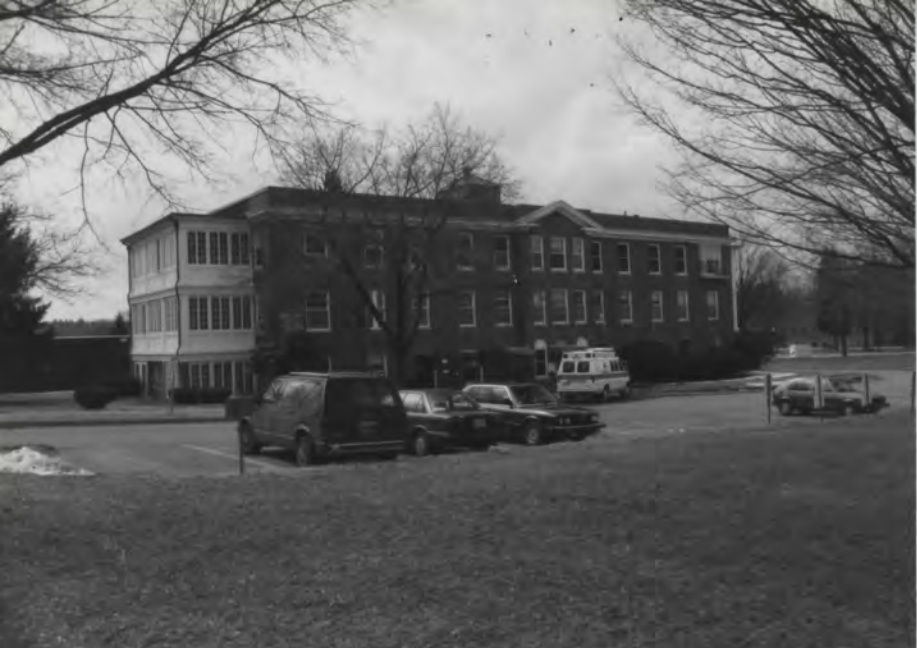
6-14 Belchertown 3/92
Hospital

#23: Old Hospital (1930)

The Old Hospital is a three-story, red-brick structure of rectangular plan with stylized Colonial Revival-style trim that faces east. It is organized with a pedimented three-bay central entry pavilion, flanked by five bay end sections that are further extended by glazed wood-frame sunporches. The main entry and flanking windows are round-arched. Other windows, with simple brick lintels, generally contain 8/8 sash. The upper stories of the rear (W) elevation are covered by screened porches. This building faces east over the primary green and defines its western end (#103).
