Name: N-3935 Biddle House

Location: Biddle's Corner, vicinity St. Georges,

Description: facade, looking south

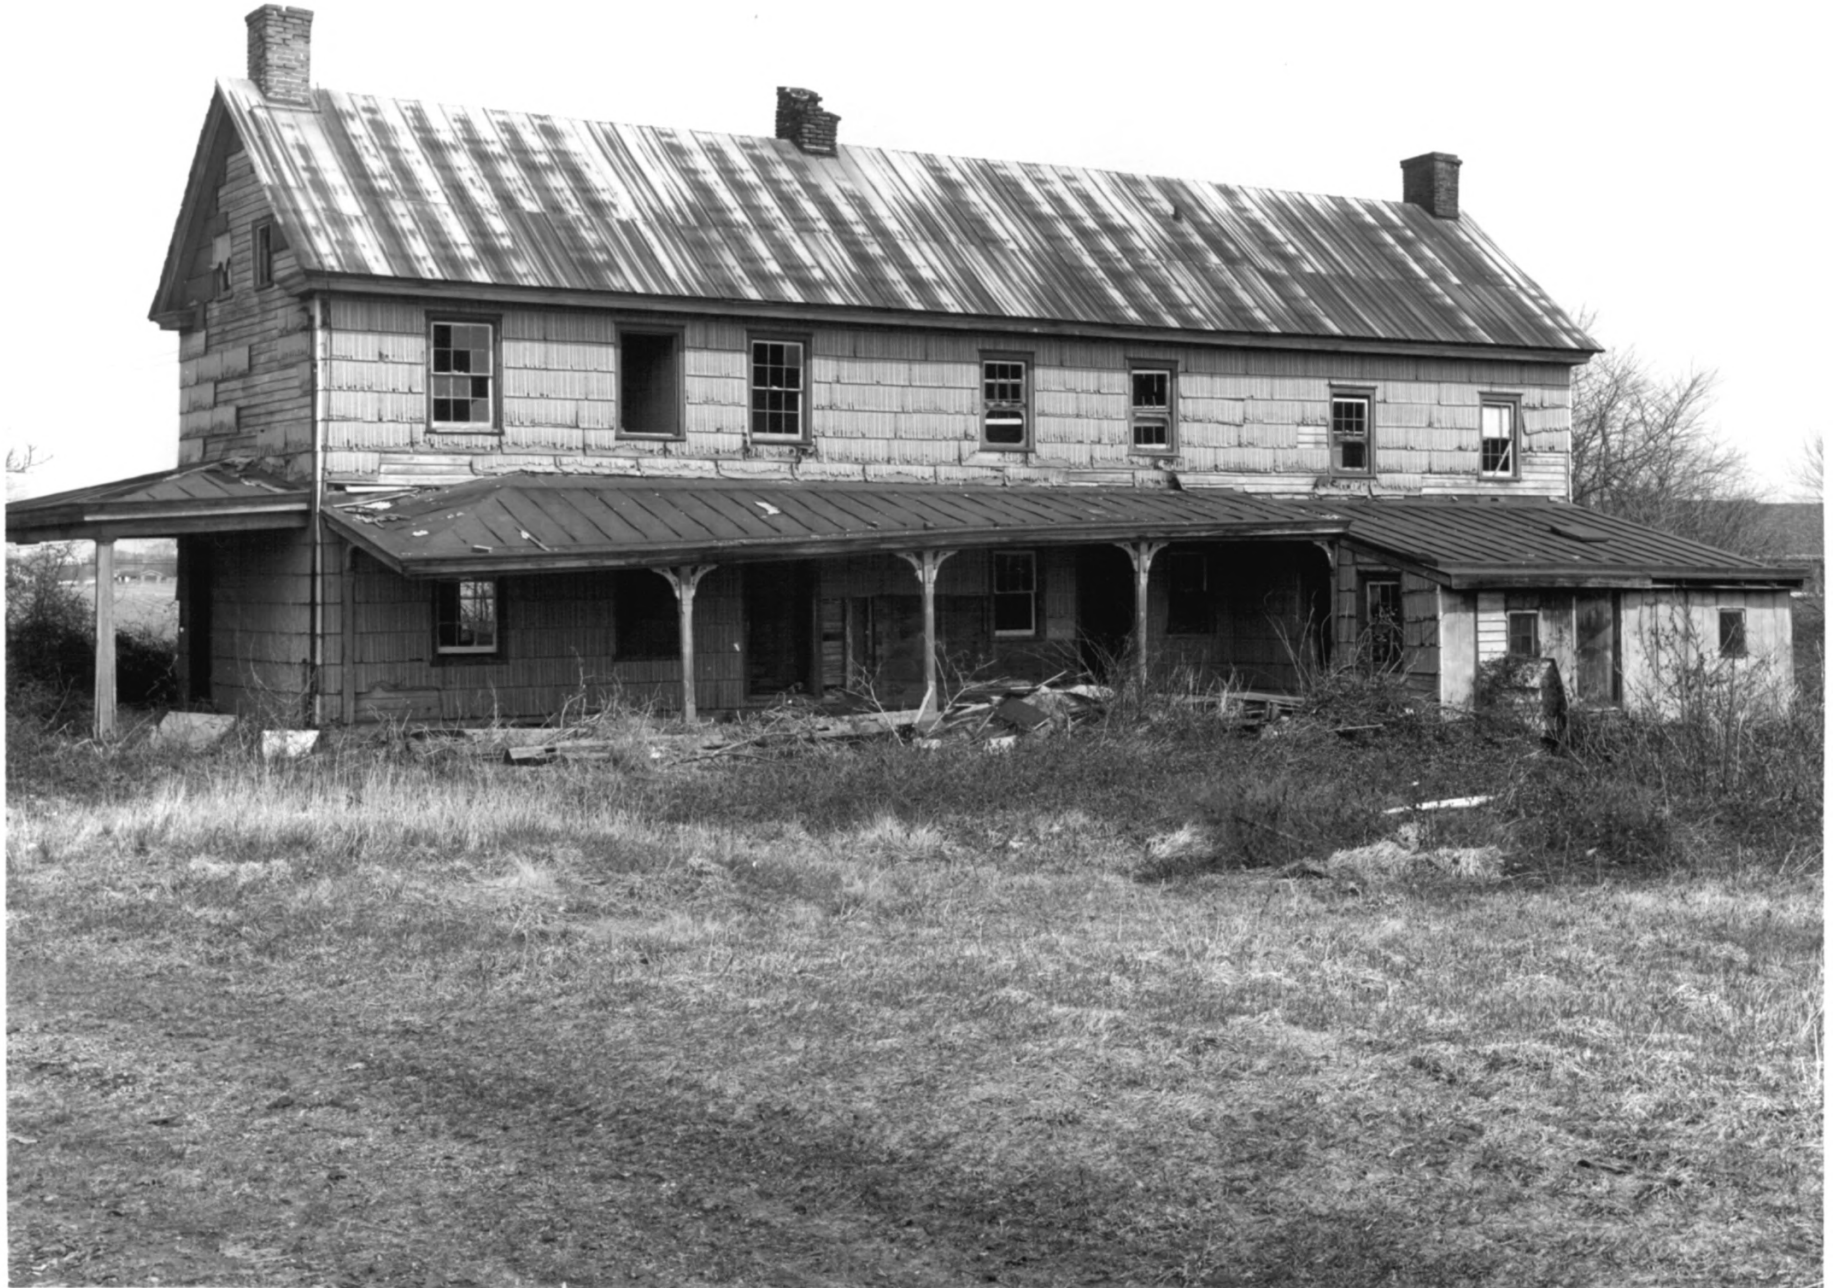
Photograph Numbers 2

Description: rear of house, looking north

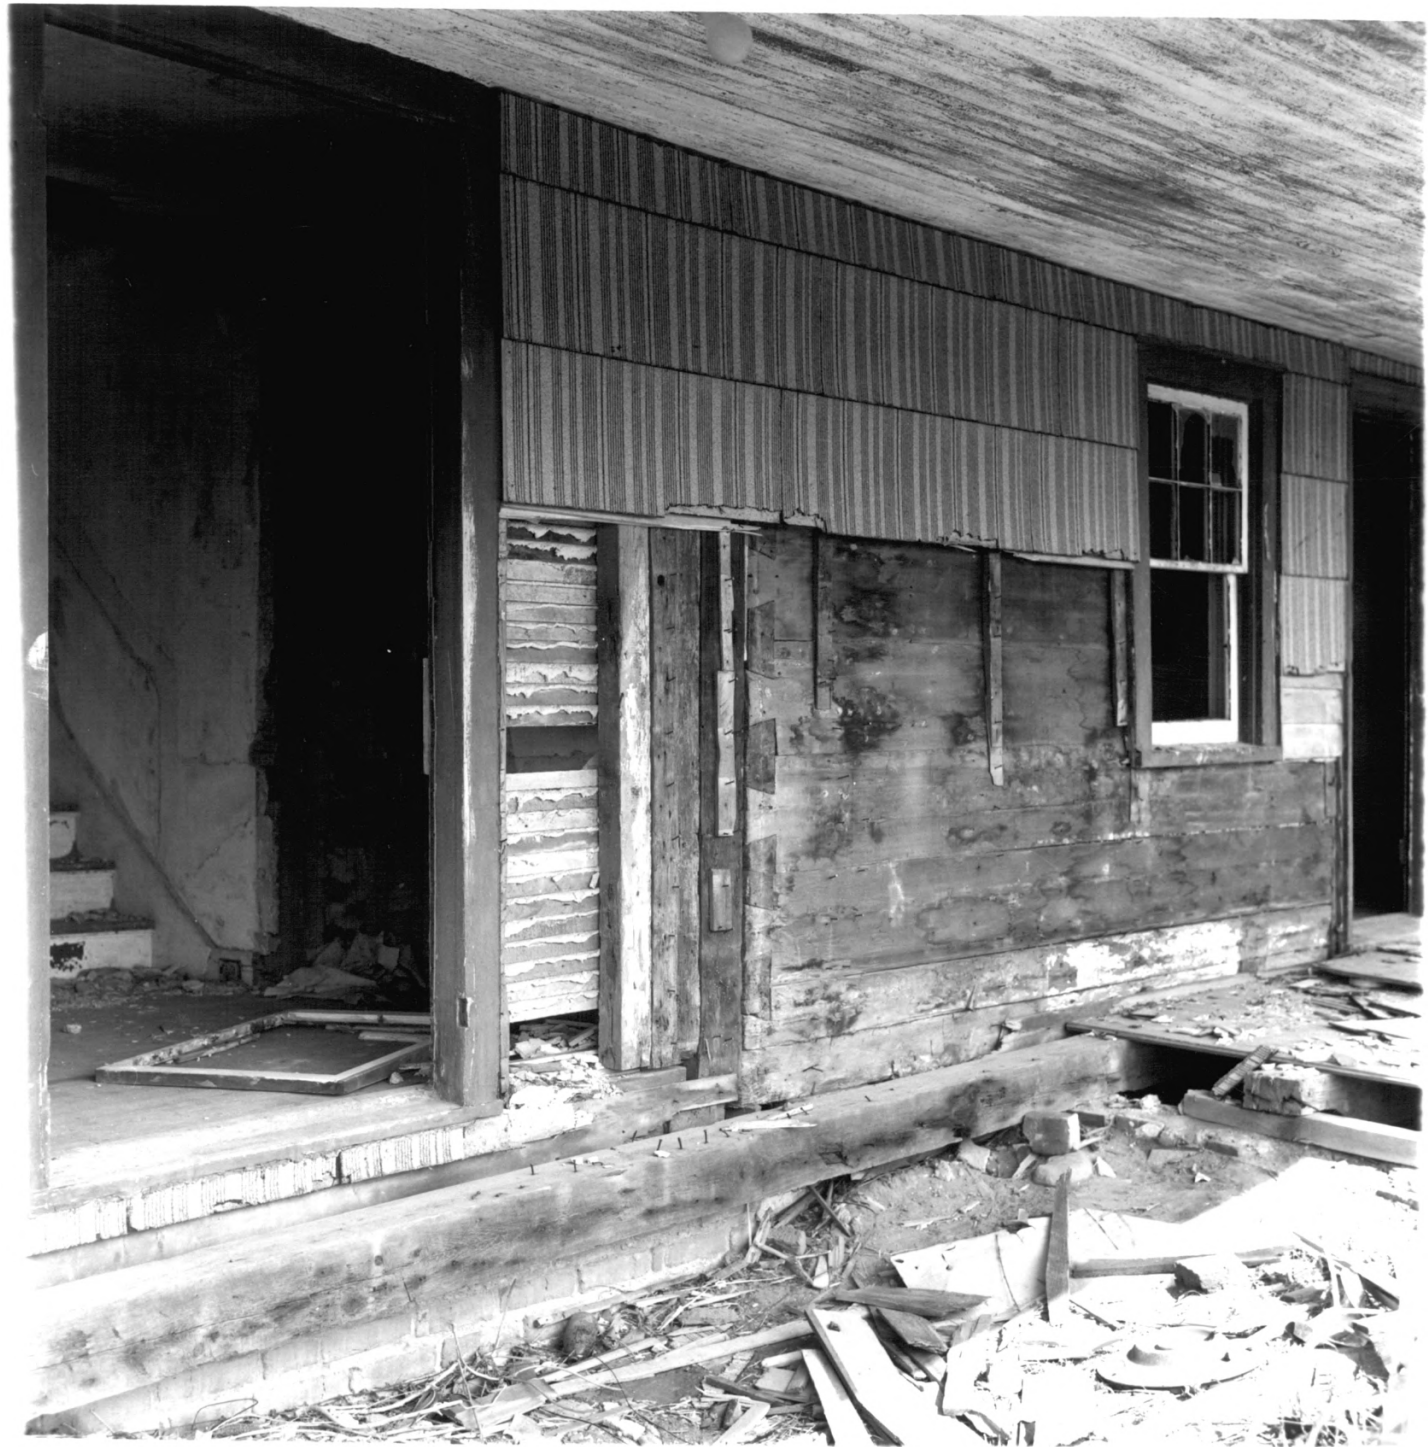
3

Descriptions: detail of juncture of plank section with braced frame section. Note plank dimension and full dovetailed corners. (Brick nogging has been removed from portion of braced frame)

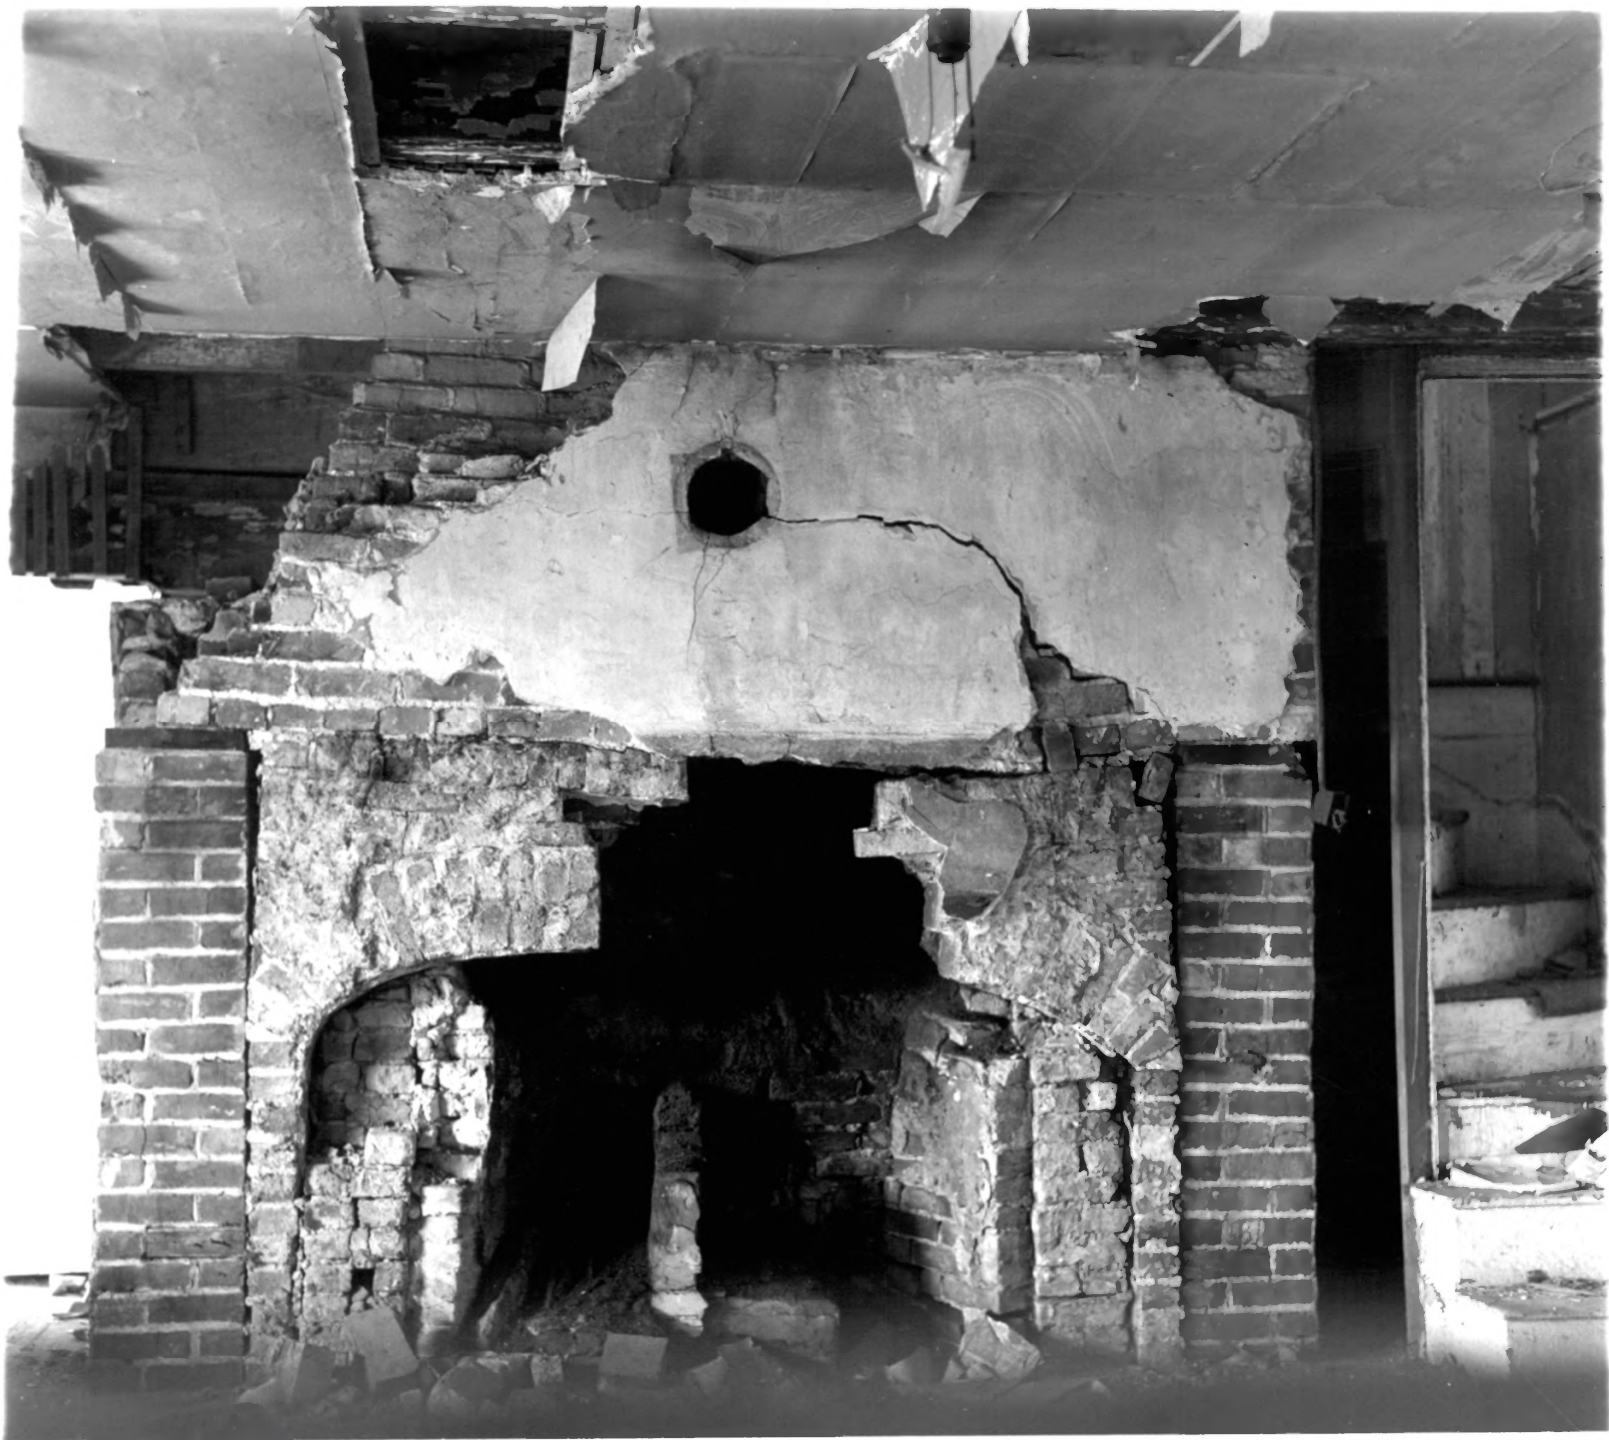
Photograph Numbers 4

Description: massive fire place in west wall of
plank section. Reduced in size to conform
to changes in the function of this portion
of the house.
